**Executive Summary:**

**Site/Project Location:** Johnson's Corner Terminal

**Date of Inspection:** 22 November 2016

246 PU-14-842 Filed: 11/30/2016 Pages: 4  
Construction Inspection Report - Johnson's Corner  
Terminal - 22 November 2016

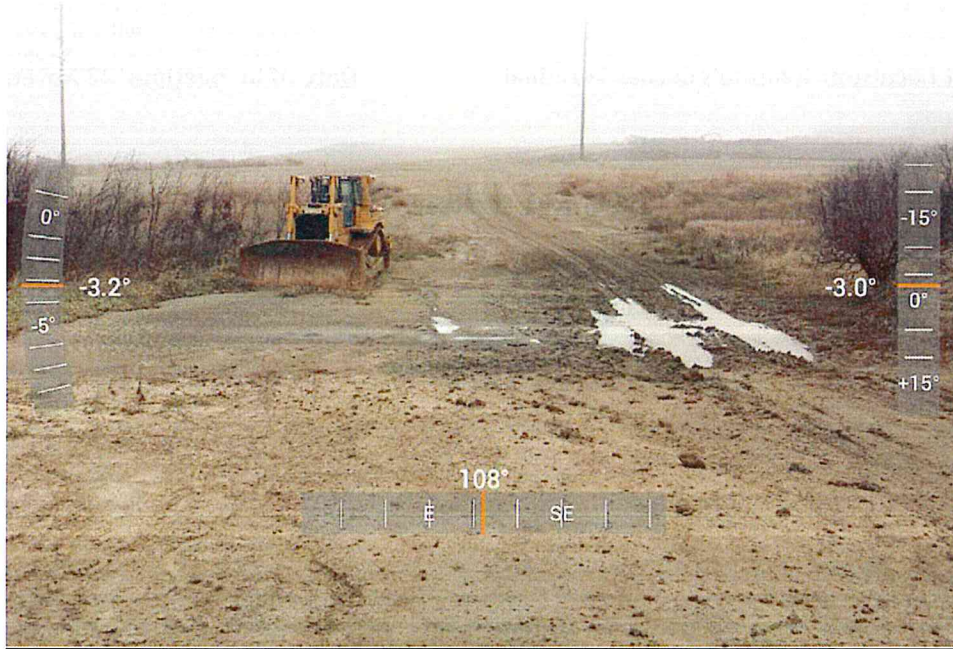
Vegetation removal and topsoil stripping was complete. Keitu noted on January 29, 2016 likelihood of tree and shrub removal based on discussions site staff. On this date, it appeared construction of the two access roads occurred. Chokecherry (*Prunus virginiana*) was identified as the likely dominant species cleared.

**Report Photo #1 Access Cleared through Trees/Shrubs**

As Built Inspection to confirm shrub mitigation actions consistent with order, not submitted plan.

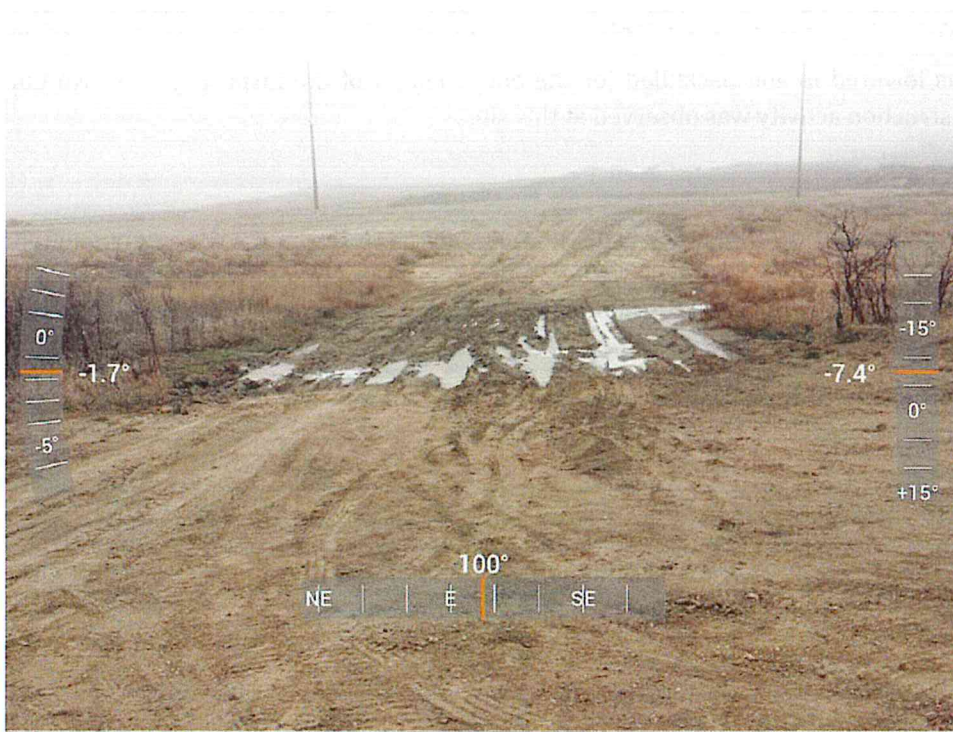
**Report Photo #2 Second Access Cleared through Shrubs**

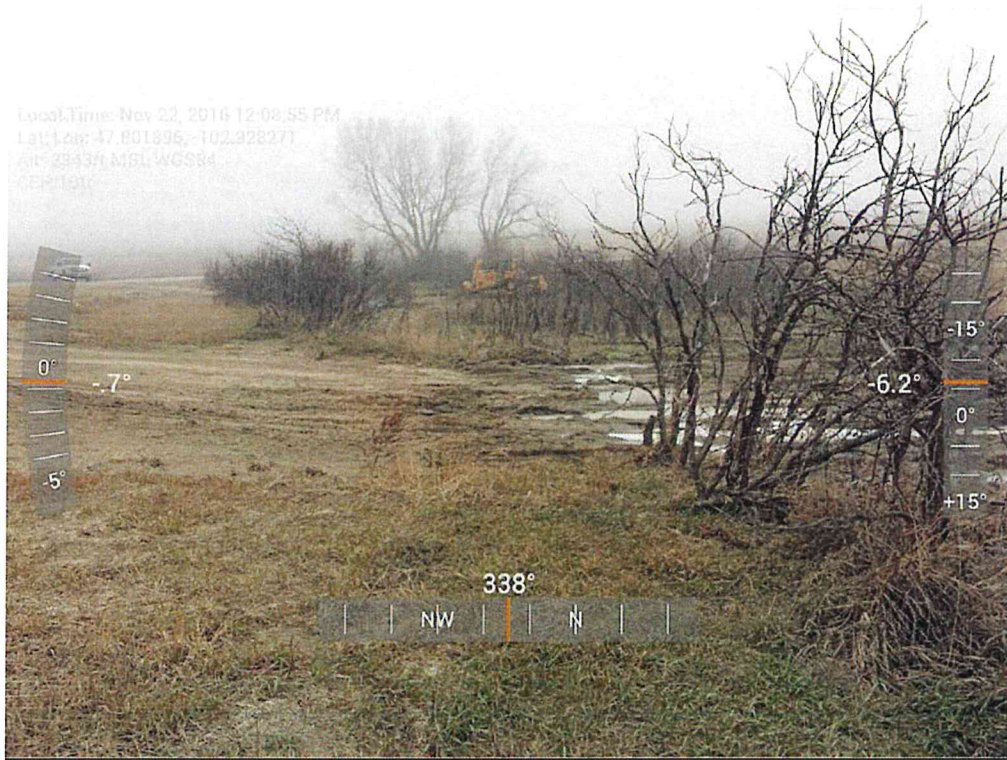
**Report Photo #3 View of the Two Accesses**

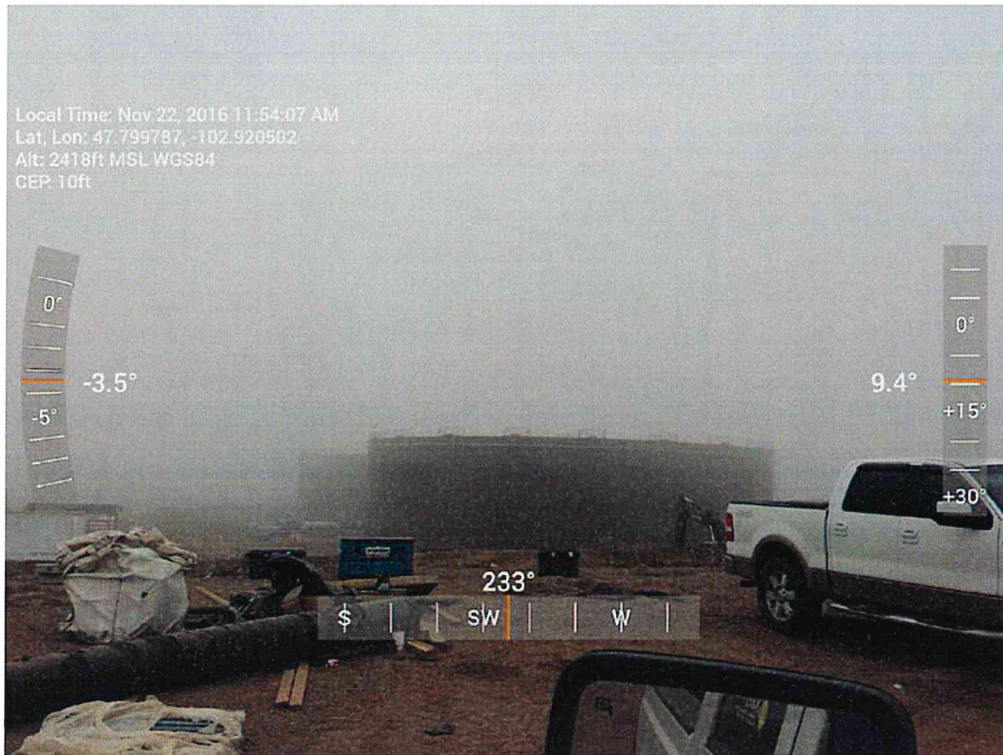
Tank and ancillary facility construction at site continues. Care was taken around terminal boundaries.

**Report Photo #4 Tanks under Construction**

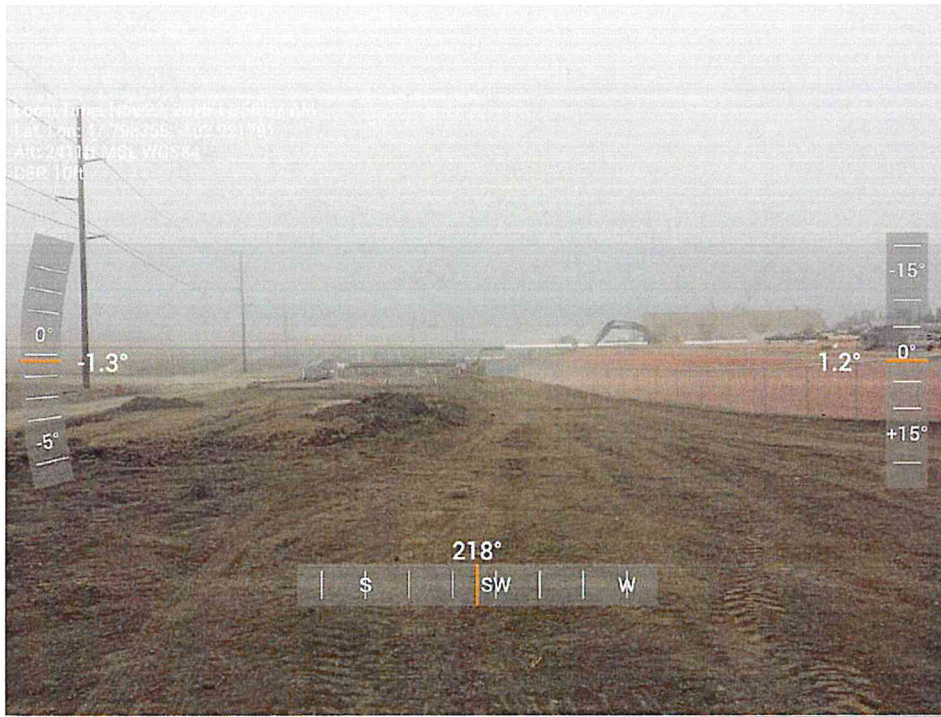
**Report Photo #5 Construction Crews Working Onsite**
