Executive Summary:

Site/Project Location: Ramberg Terminal

Date of Inspection: 20 December 2016

257 PU-14-842 Filed: 1/3/2017 Pages: 4
Construction Inspection Report - 3 January 2017

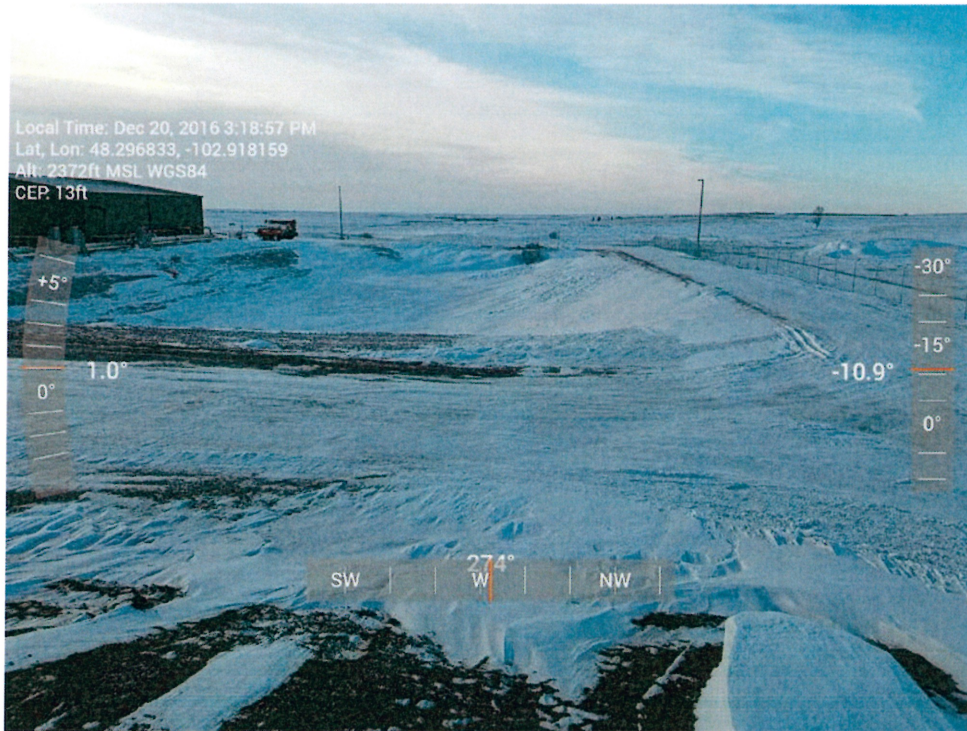
Topsoil removal was complete at the site and appeared that all soil was segregated properly. A silt fence on the southwest corner of the site was in need of repair, or removal if no longer needed. A storm water retention pond was built on the west side of the site.

Report Photo #1 Storm Water Retention Pond

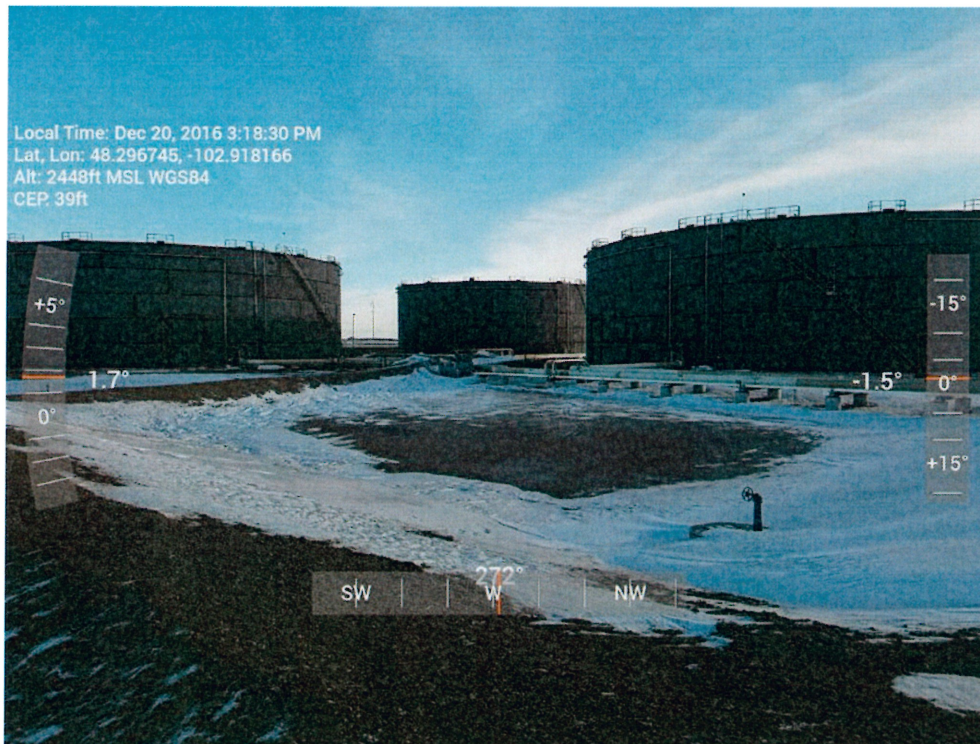
Report Photo #2 Tanks under Construction

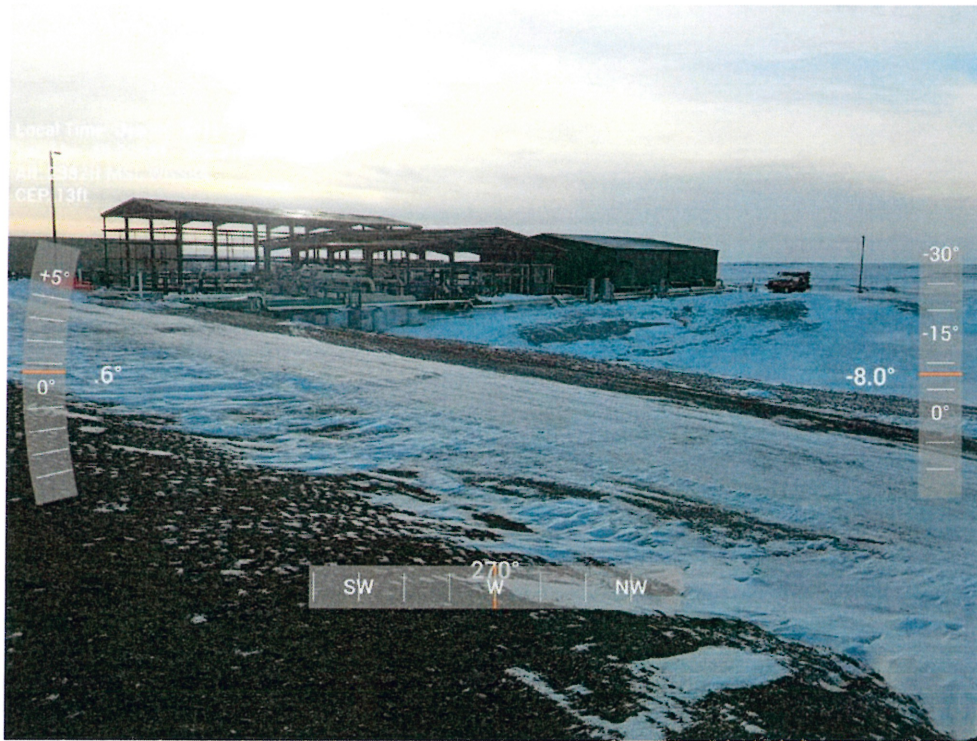
Report Photo #4 Buildings under Construction. (48.29684, -102.918154)

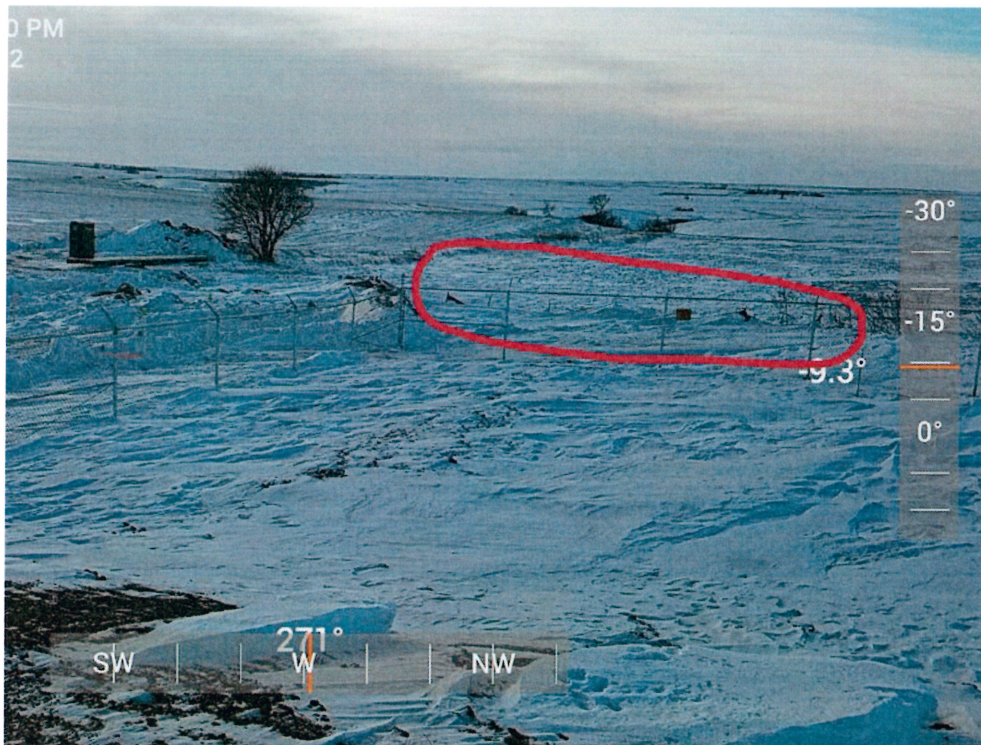
Report Photo #5 Silt Fence Behind Fence Needs Repair

The silt fence at the southwest corner of the site should be repaired or replaced before snow melt runoff occurs.
