Executive Summary:

Site/Project Location: Lake Oahe HDD Sites

Date of Inspection: 23 February 2017

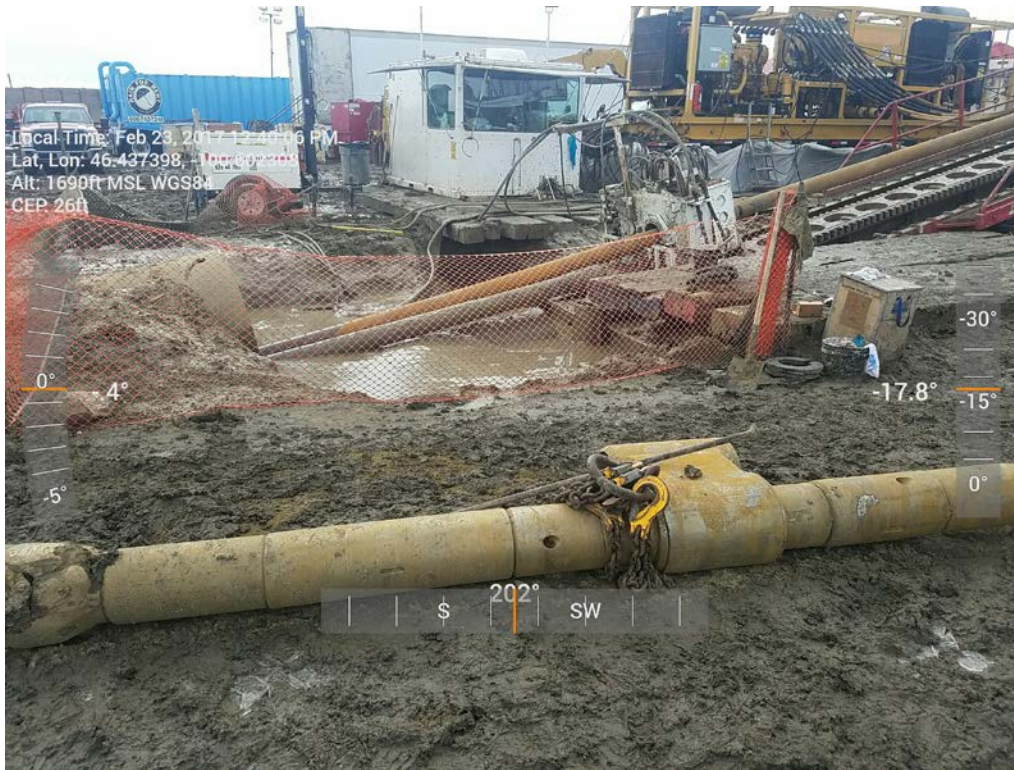
Report Photo #1 Lake Oahe HDD Bore Site in Morton County

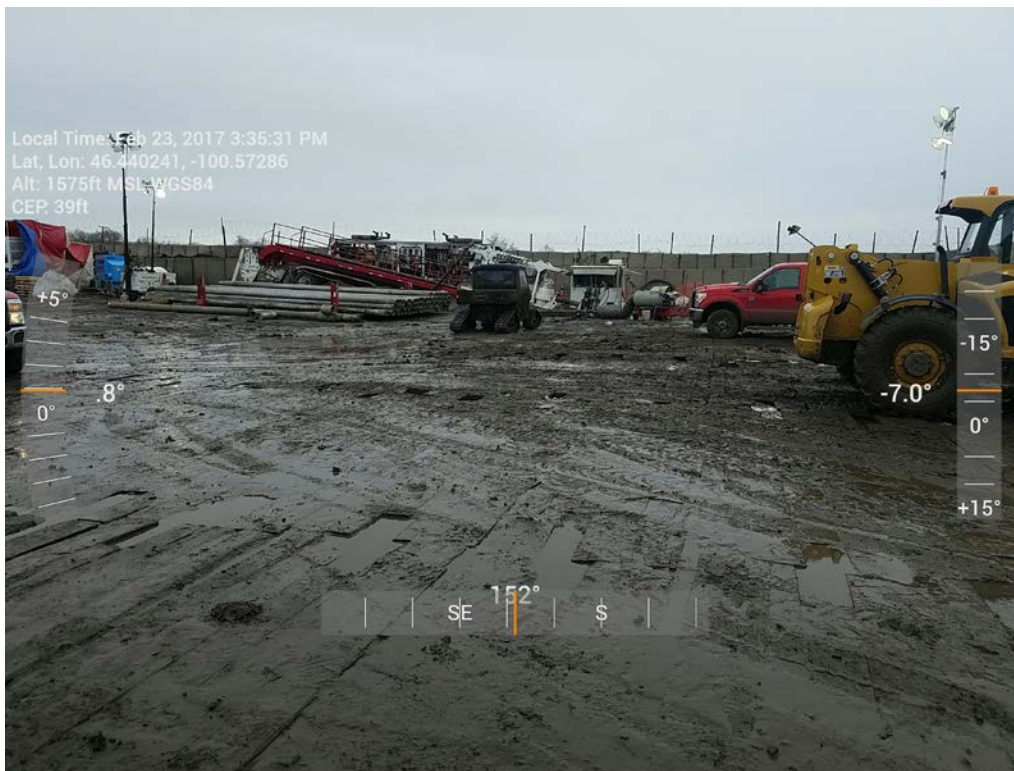
Report Photo #2 Lake Oahe HDD Bore Site in Emmons County

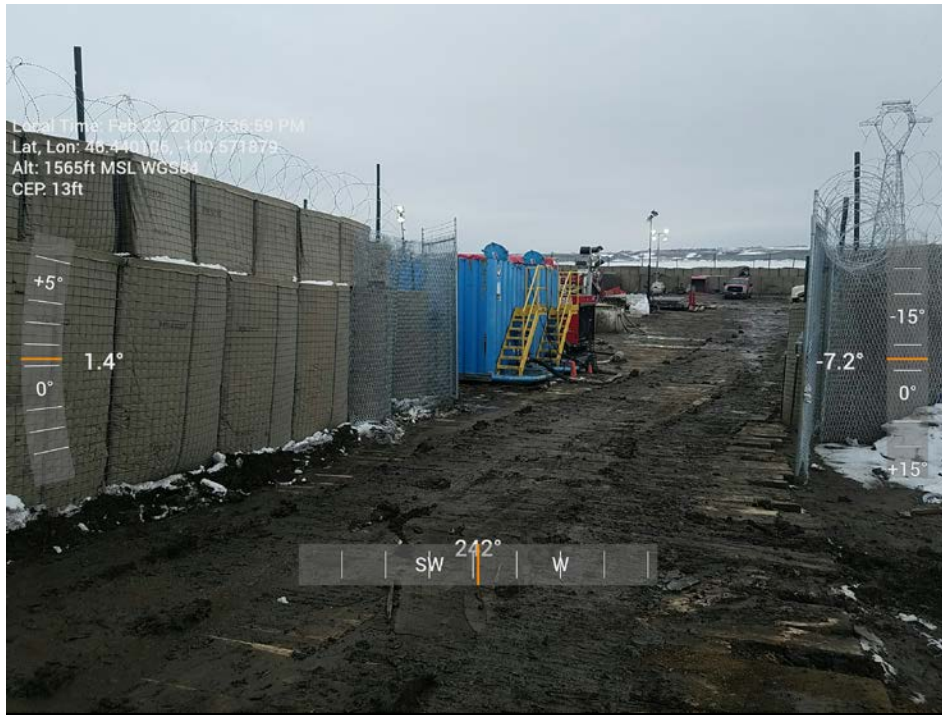
Report Photo #5 Lake Oahe HDD Site Entrance in Emmons County
