Technical Memorandum  
VIA EMAIL

**To:** Monica Howard – Dakota Access Pipeline  
**From:** Aaron DeJoia, CPSS/CPAg/ND-PSC – Duraroot Environmental, LLC  
**Date:** March 23, 2017  
**Subject:** Topsoil Salvage Review

The following technical memorandum was prepared to evaluate the removal of topsoil from the Dakota Access Pipeline (DAPL) ROW in North Dakota. The focus of this memorandum is regarding the topsoil salvage on the subject property located in Morton County, North Dakota. The area in question stretches from approximately milepost 125.0 to 125.5 on Spreads 7/8 of the DAPL right-of-way (ROW). The following information was reviewed and analyzed by North Dakota Professional Soil Classifier, Aaron DeJoia.

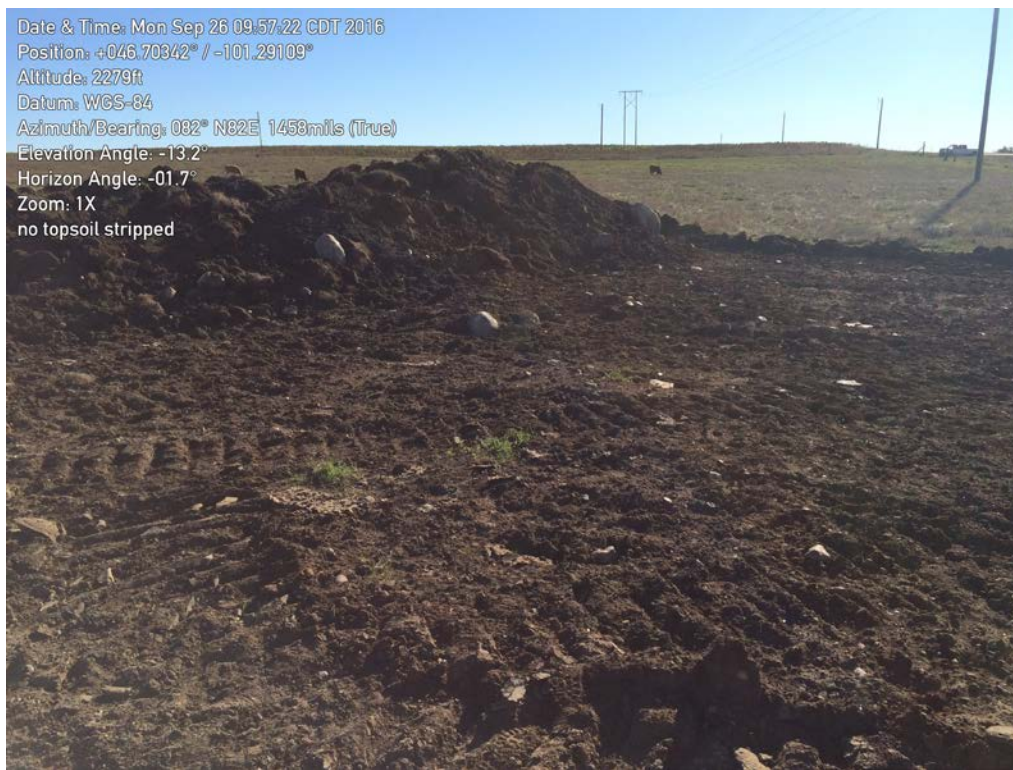
**Report Photo #1 “Topsoil Not Completely Stripped”:**

It appears that stripping activities are active and ongoing in this photo. There are still small stands of grass that indicate that the surface has not been completely stripped. The appearance of the rounded stone, or glacial till, indicate that subsoil levels had been encountered in places and that the depth of topsoil had been reached. The soil map unit for this location based off the NRCS soil survey is the Cabba soil series. This soil series is characterized as having a relatively shallow topsoil depth, approximately 3.0 inches, before encountering the underlying subsoil which is similar in color but having a higher clay content (Bk in this instance). We believe that topsoil depths are shallow in this region and that although topsoil salvage is not completed it appears that the topsoil will be appropriately salvaged.

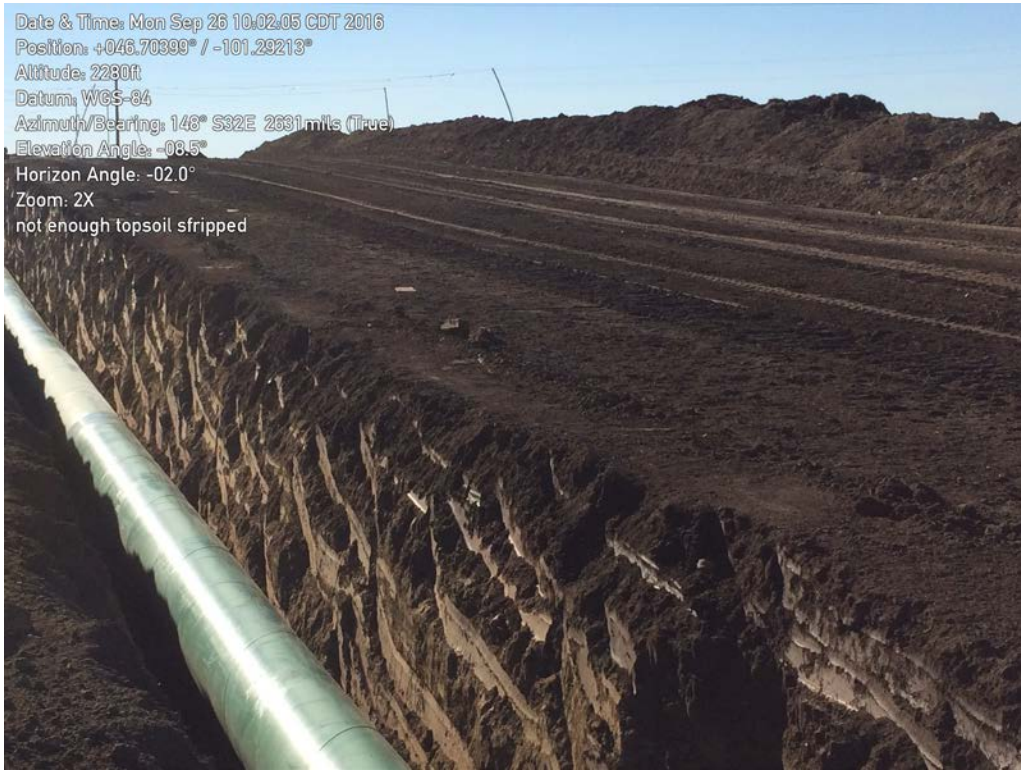
**Report Photo #2 "1+ Foot of Topsoil Not Stripped":**

Based off the trench line soil conditions in the foreground of the photo, it appears that a clayey soil was encountered. Topsoil in this region doesn't typically have a high enough clay content where “smearing” or slicken sides are observed. The soil profile in this photo shows these smeared soil characteristics from the current soil surface down into the trench line. The NRCS soil survey for this particular area shows subsoil horizons with “Bt” designations meaning that the underlying subsoil is argillic with a significant increase in clay content from the overlying topsoil. This Bt horizon would exhibit a smeared appearance when contacted with a piece of equipment such as a trackhoe. It appears from this picture that topsoil depths were appropriately salvaged and that the current surface is the Bt soil horizon. The large topsoil spoil in the background of the photo is indicative that 12” of topsoil likely has already been stripped.

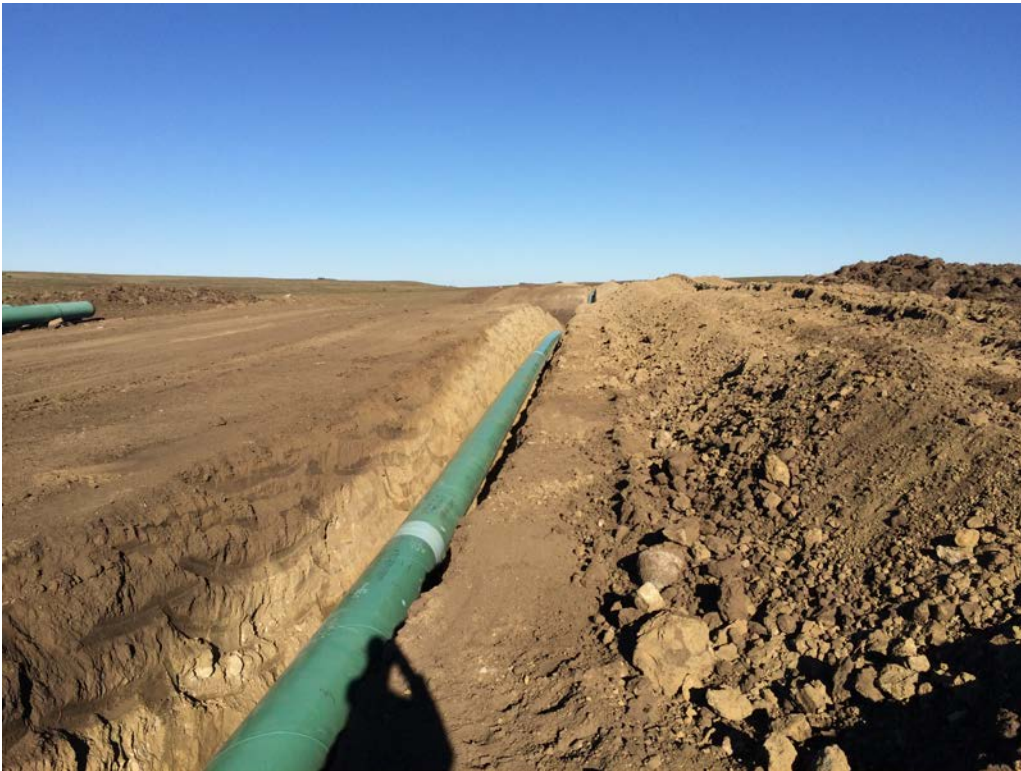
**Report Photo #3 "1+ Foot of Topsoil Not Stripped":**

This photo also shows the heavier clay content of the underlying subsoil based on the smearing of the soil faces at the soil surface. According to the NRCS soil survey for this area (primarily the Savage and Belfield soil series), the underlying subsoil has very similar color to the overlying topsoil but exhibits properties of higher clay contents (i.e. Bt or Btn designations). Topsoil in this area doesn't always extend to the upper portion of the C horizon, or weathered bedrock level, as observed by the lighter colored subsoil in this photo. It should also be noted that the subsoil horizons change in depths, which is part of the natural soil formation process. This picture indicates that the topsoil was appropriately salvaged at this location.

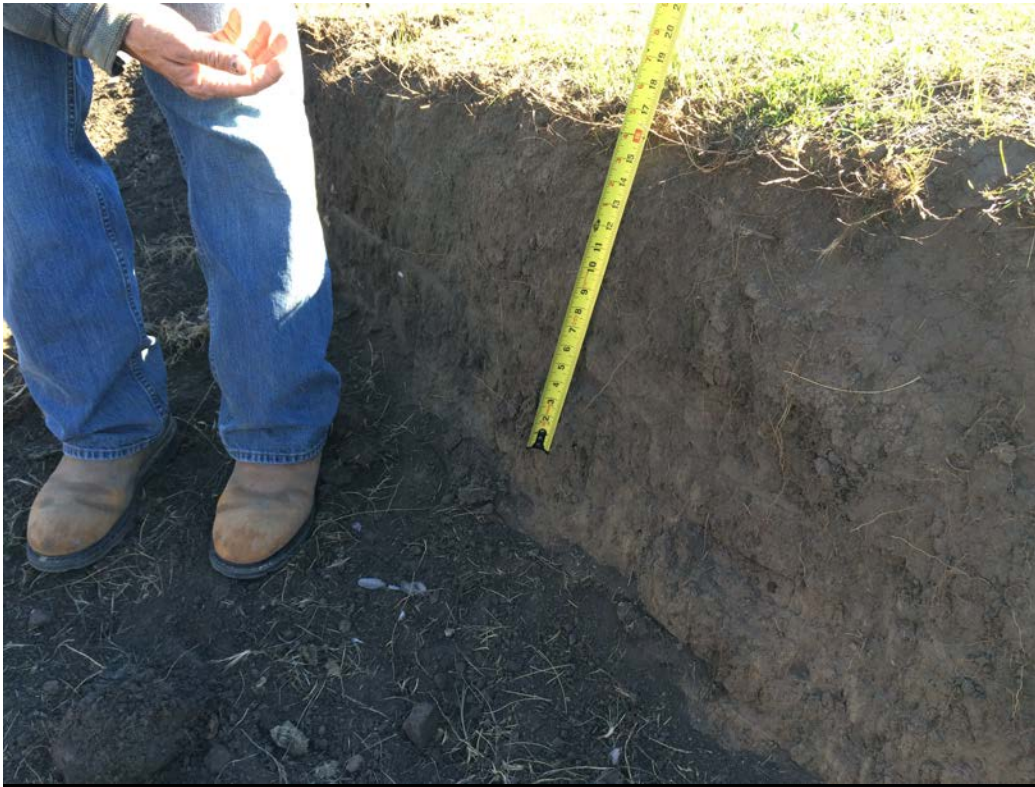
**Report Photo #4 "Cutout - Estimate of Topsoil Depth":**

This photo is difficult to characterize given that the photo was taken in the shade and there is not much to contrast the soil profile with. Topsoil depths could have been determined from the 7” depth to the 16” depth per the landowner's measuring tape. This is based off the observed differences in soil structure and color of the soil profile on the right side of the photo. Root mass appears to significantly decrease after the 7” depth indicating different soil horizons also. It is our professional opinion that topsoil depth at this location is approximately 7” inches not 16”. The coordinates for this photo provided in the 3<sup>rd</sup> party inspection report do

not match the centerline or ROW for this particular tract. The depth of topsoil beyond 12" is inconsequential to compliance with the permit condition as segregation of topsoil up to 12" is the condition.

It was assumed for this evaluation that Report Photos #4, #5, #6, and #7 were obtained from the subject property even though the GPS coordinates provided in the 3<sup>rd</sup> party inspection report do not correspond with the subject property. Photo #4 likely helps represent the major issue that is encountered throughout this report. In this photograph, if we agree that the topsoil depth is 16 inches (which is hard to determine from the picture), the conditions of the permit (#16) indicate that only the top 12 inches would need to be removed, thus leaving the other 4 inches of dark soil material in place.

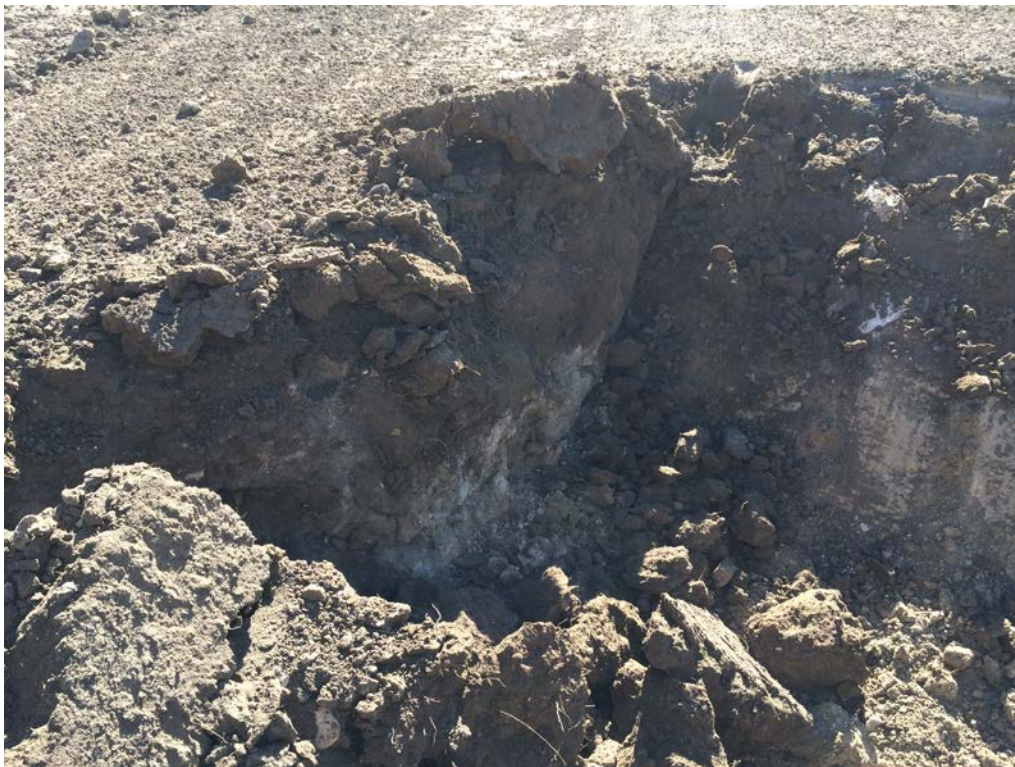
**Report Photo #5 "Center of ROW - Visible Topsoil Layer":**

Based off the condition of the soil in this photo, it is difficult to determine if any topsoil is present. Topsoil is hardly ever encountered directly over C horizons or bedrock. The absence of plant roots also indicates that this soil horizon is neither fertile nor wet enough to support vegetative growth. The coordinates provided in the 3<sup>rd</sup> inspection report for this photo do not match the centerline or ROW for this particular tract.

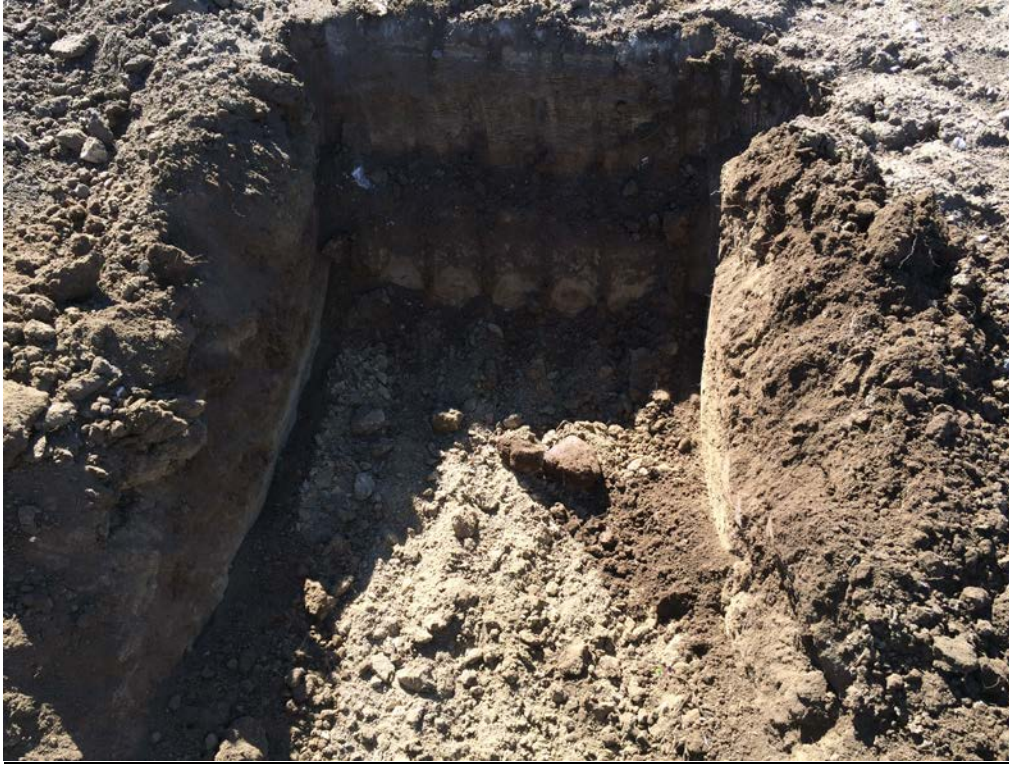
**Report Photo #6 “Center of ROW – Visible Topsoil Layer”:**

The presence of root mass in a soil horizon doesn't always indicate that that particular soil is topsoil. Taproots will often move through the soil profile to find plant available nutrients and soil moisture. This often means that these roots will penetrate deep into the subsoil. In the instance of these three photos, the presence of rocks and mottling indicate that this dark subsoil soil horizon is likely an underlying Bt or Btn soil horizon, not topsoil. There also appears to be rock fragments in the soil horizon being identified as topsoil. Topsoil in this area would not contain rocks and bringing these rock fragments to the soil surface would limit reclamation success. There are no conditions in the Permit that exclude placing subsoil on top of subsoil which we believe is what these photos are indicating.

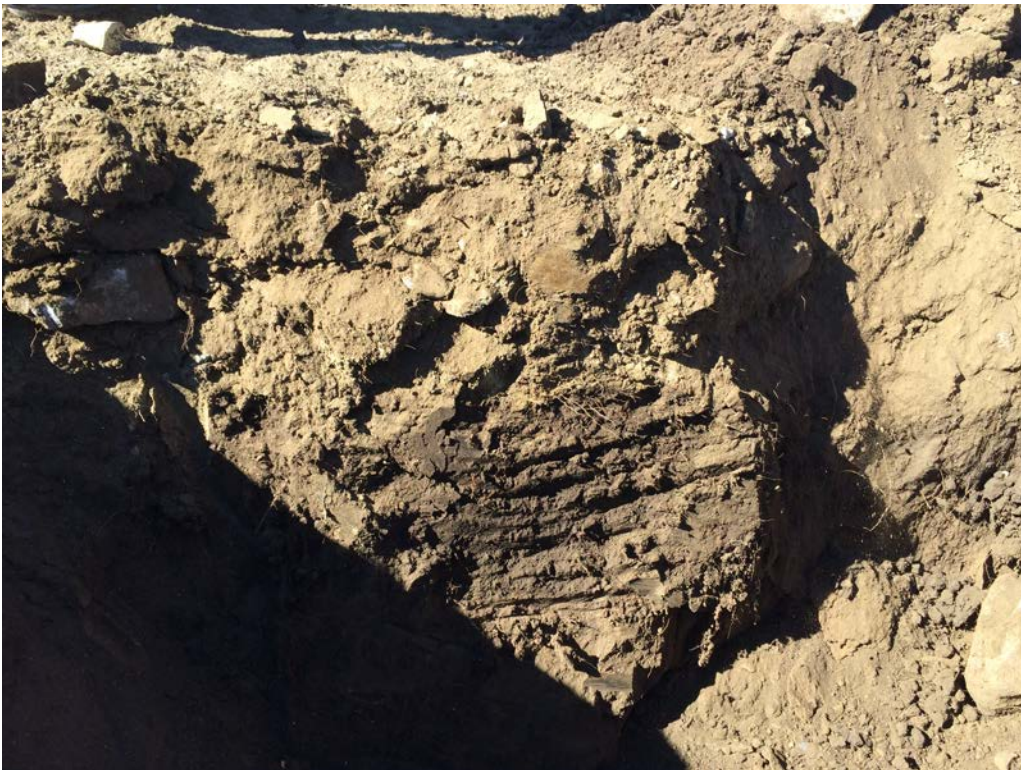
**Report Photo #9 "Center of ROW - Visible Topsoil Layer":**

The soil horizon in this photo being identified as topsoil has little root mass and appears to have a high clay content based off the presence of smeared soil faces and a blocky soil structure. Subsoils in this area have been surveyed by the NRCS as having these types of soil horizons and are designated as having a Bt or Btn soil horizon. The Cabba soil series is the designated soil map unit for this location per the NRVS soil survey. While the topsoil is shallow in this soil series (approximately 3.0 inches), the topsoil has a similar color to the underlying subsoil while exhibiting very different characteristics. The subsoil has similar color but a higher clay and different soil structure. Based on the photos we do not believe that there was improper backfilling of topsoil in this area.

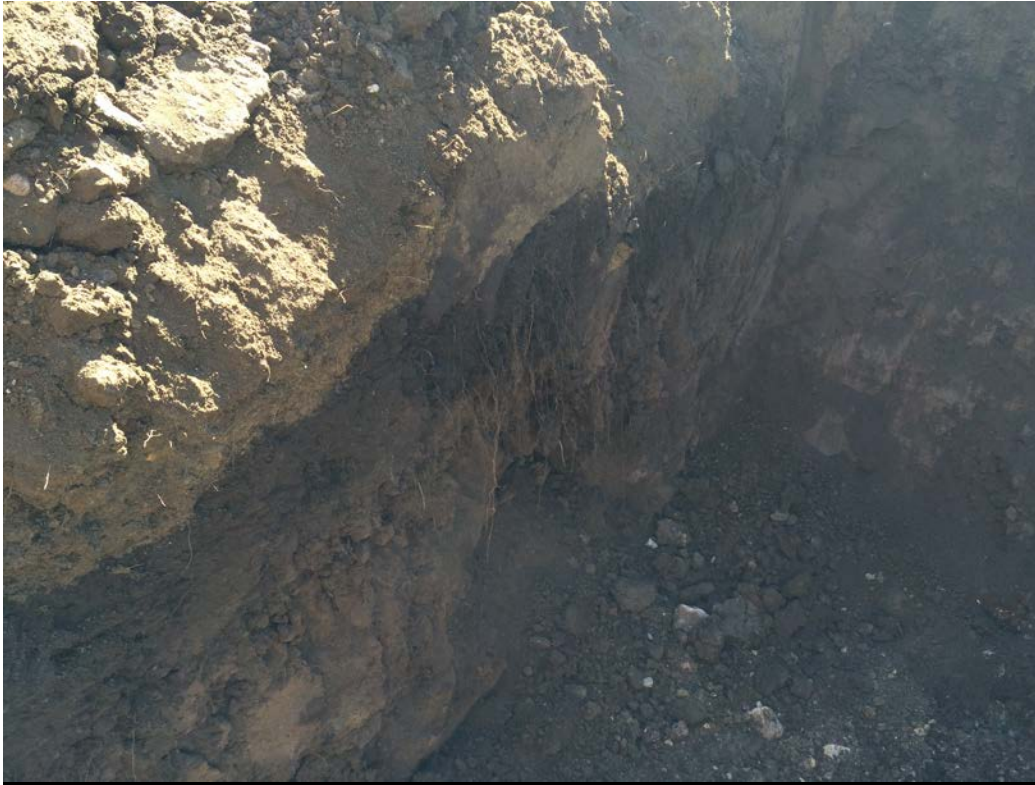
**Report Photo #10 “Visible Topsoil Layer Topped w/Subsoil”:**

Based off the color, presence of root mass, and observed soil structure, this appears to be buried topsoil. The buried topsoil depth appears to be 1 or 2 inches. However, there is a large rock in the center of the identified soil horizon and there are several sandstones just a few inches below that soil horizon. If a soil scientist were determining topsoil depths with a manual soil push probe, or an automated soil auger, they would likely hit refusal when encountering one of these rocks. It is easy to believe that the topsoil would be determined above that refusal layer if that's where the probe struck during surface penetration. Soil series surveyed by the NRCS at this location have identified topsoil horizons, or A horizons, with depths of 3.0 – 5.5 inches before encountering subsoils with similar colors but higher clay contents. Although it appears that 1 to 2 inches of topsoil may have been buried; the rocks within the profile could exclude this from being classified as a topsoil layer.
