282 PU-14-842 Filed: 4/26/2017 Pages: 72
**Construction Inspection Field Reports not
previously filed**

Keitu Engineers & Consultants, Inc.

Construction Inspection Report

Dakota Access Pipeline Project

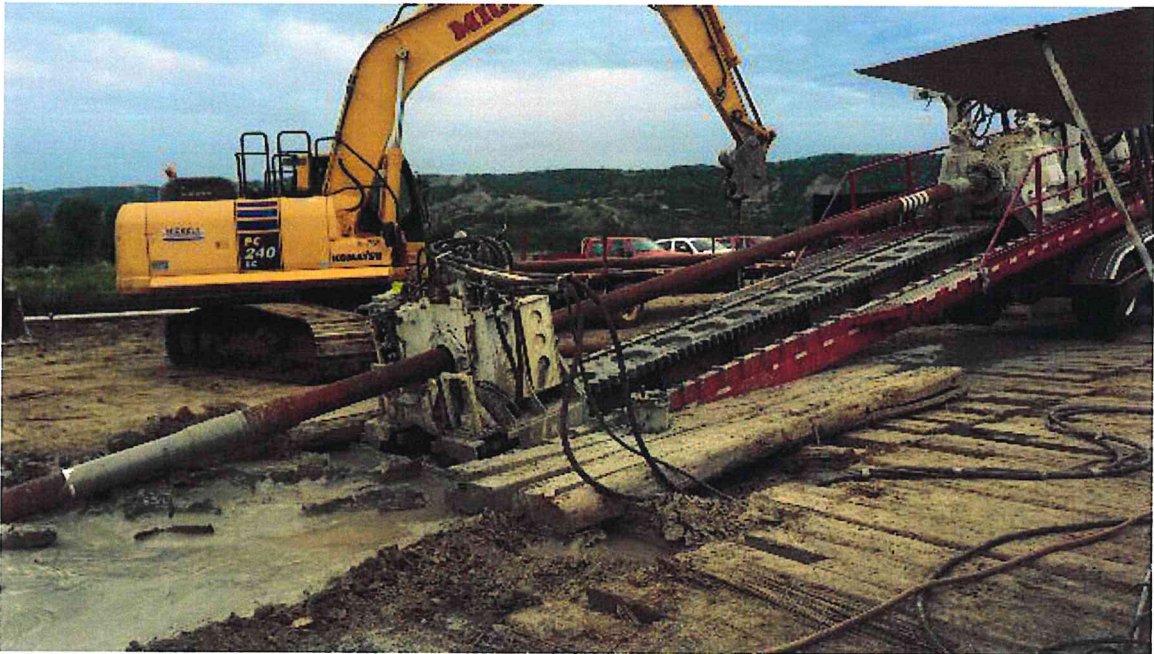
Trenching for pipeline installation not yet started. One active HDD site was observed. The HDD was being used to route the pipeline through a steep cliff area.

Report Photo #1 Cliff HDD site at GPS Coordinates:

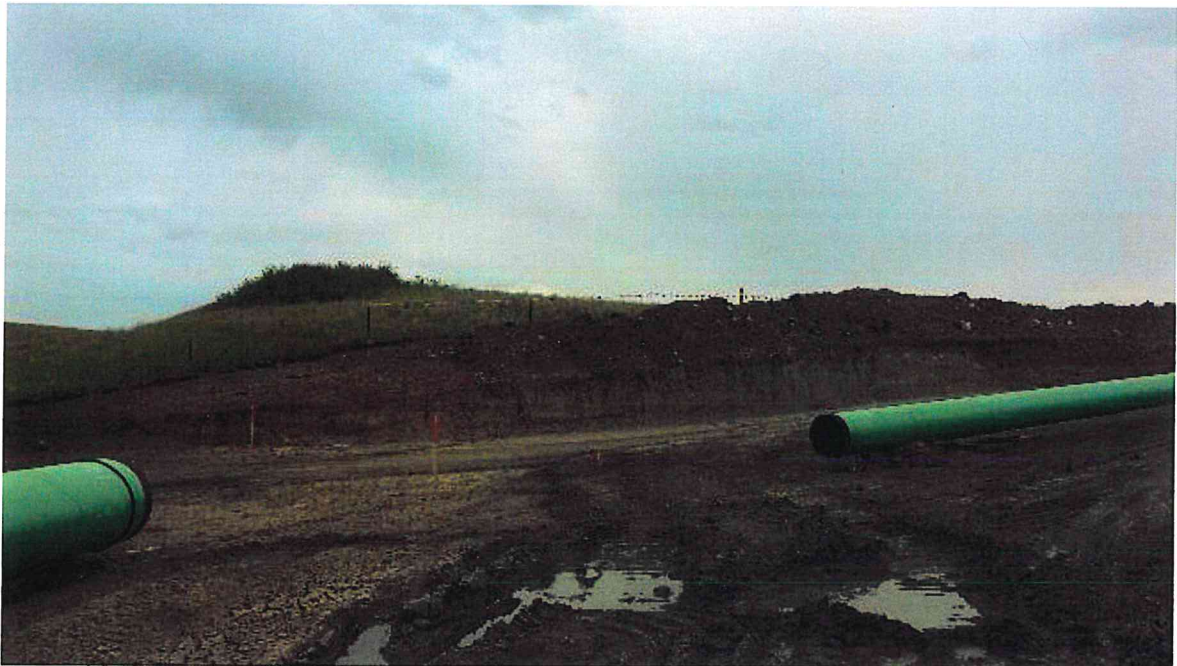
Report Photo #2 Archy Site Flagged and Untouched at GPS Coordinates:

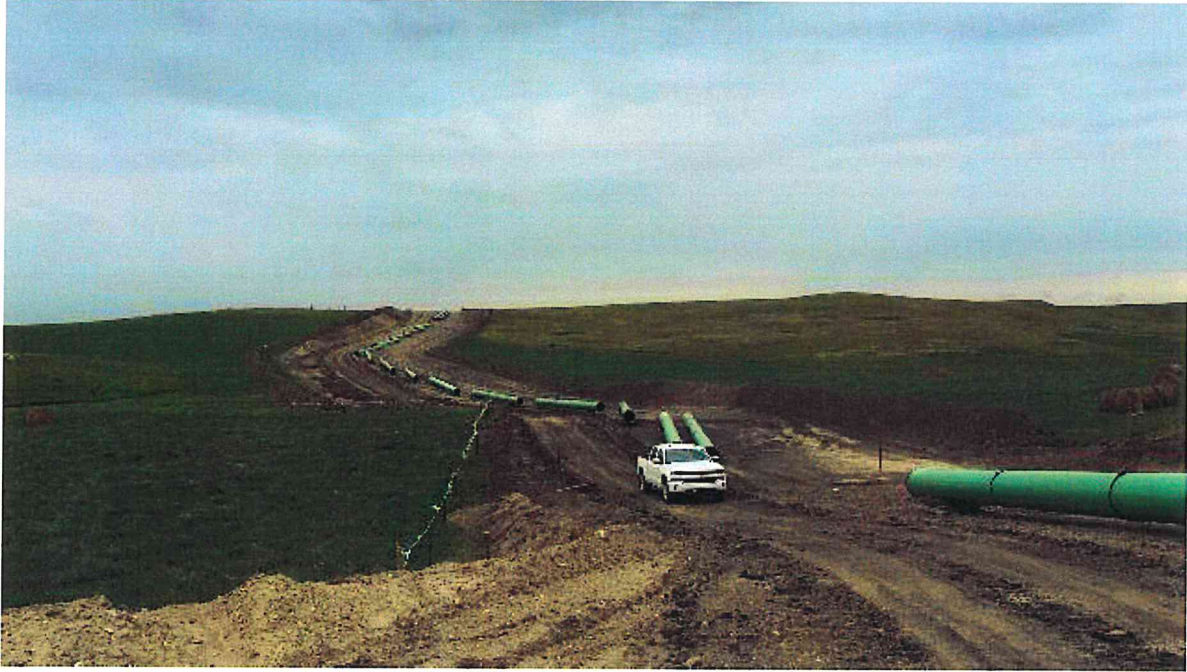
Report Photo #3 Archy Site Flagged and Untouched at GPS Coordinates: 47.333889° N 102.243333° W

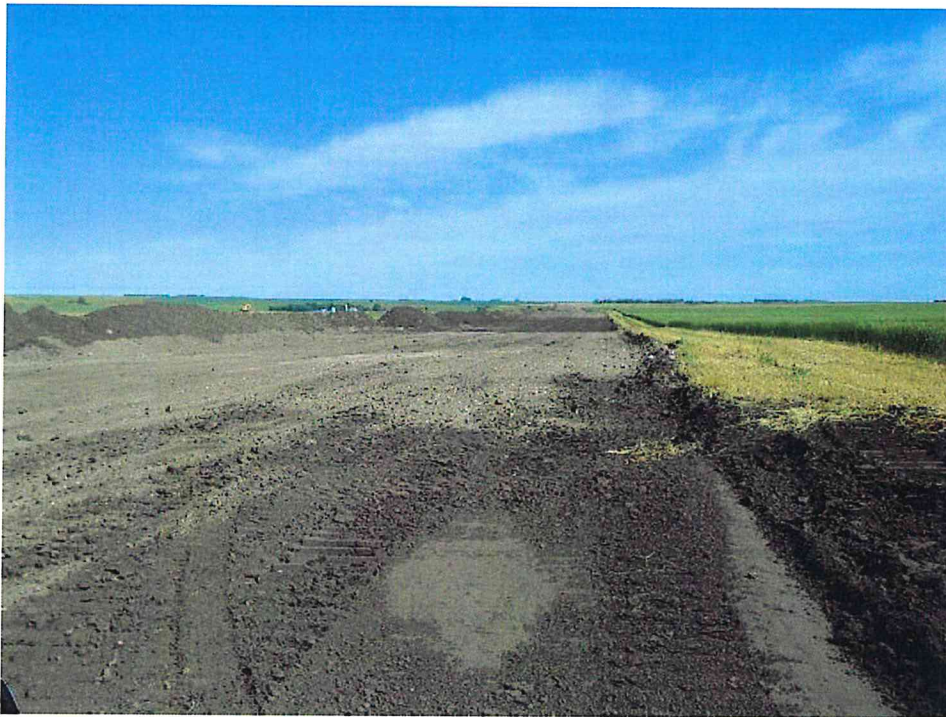
Report Photo #1 ND border facing North at GPS Coordinates:

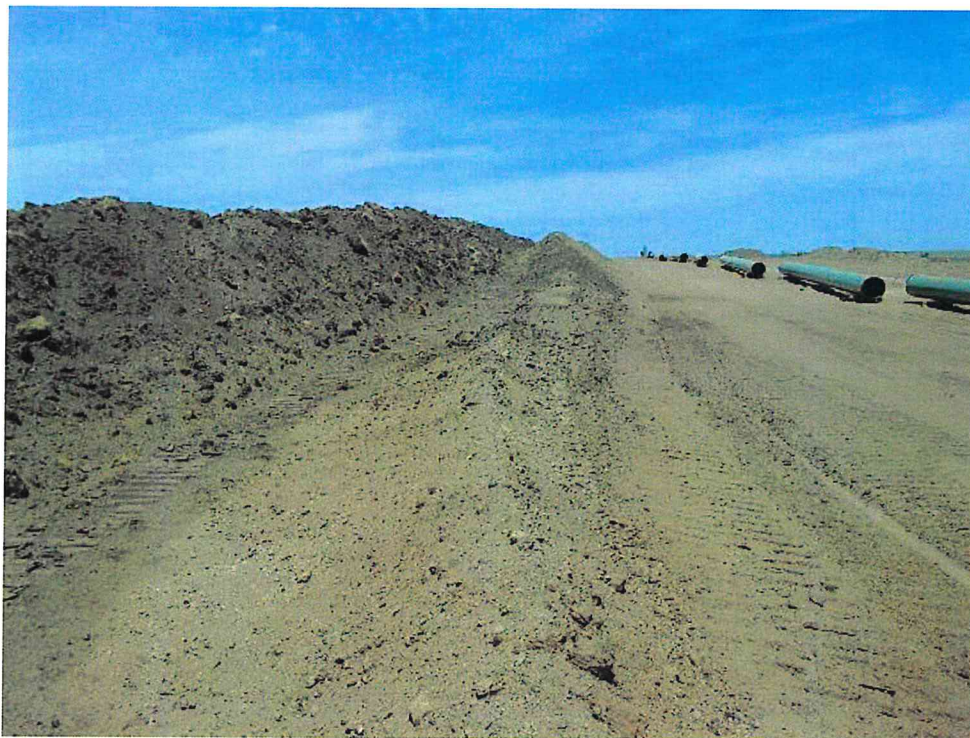
Report Photo #2 Topsoil-Subsoil Segregation at GPS Coordinates:

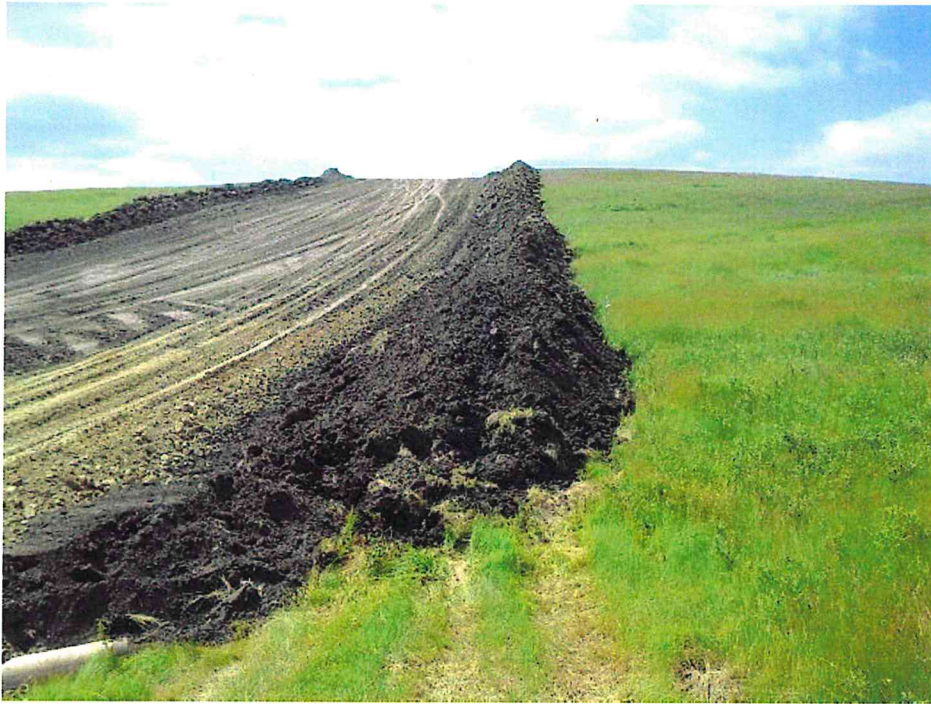
Topsoil segregation and storage was completed and deemed sufficient. Storm water management practices were implemented in their respected areas along ROW. Topsoil had rolled near or over the ROW boundary as the soil piles settled overtime. Third Party Coordinator and Keitu Inspector agreed that operators should be notified to leave more space between the soil pile and the ROW boundary. Subsoil pile from bore pit was stacked on unstripped surface. Third Party Coordinator notified crew about making sure soil piles from bore pits were stripped of topsoil before stockpiling.

Report Photo #1 Soils clumps near ROW boundary at GPS Coordinates: 47.4675° N 102.743056° W

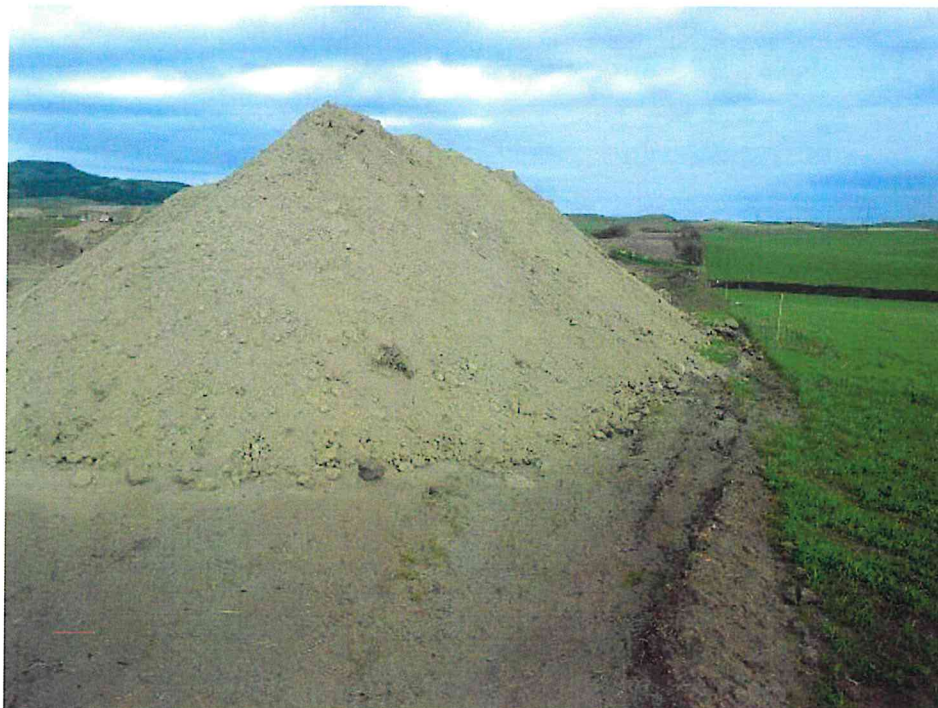
Report Photo #2 Subsoil piled on un-stripped ground at GPS Coordinates: 47.516944° N 102.835278° W

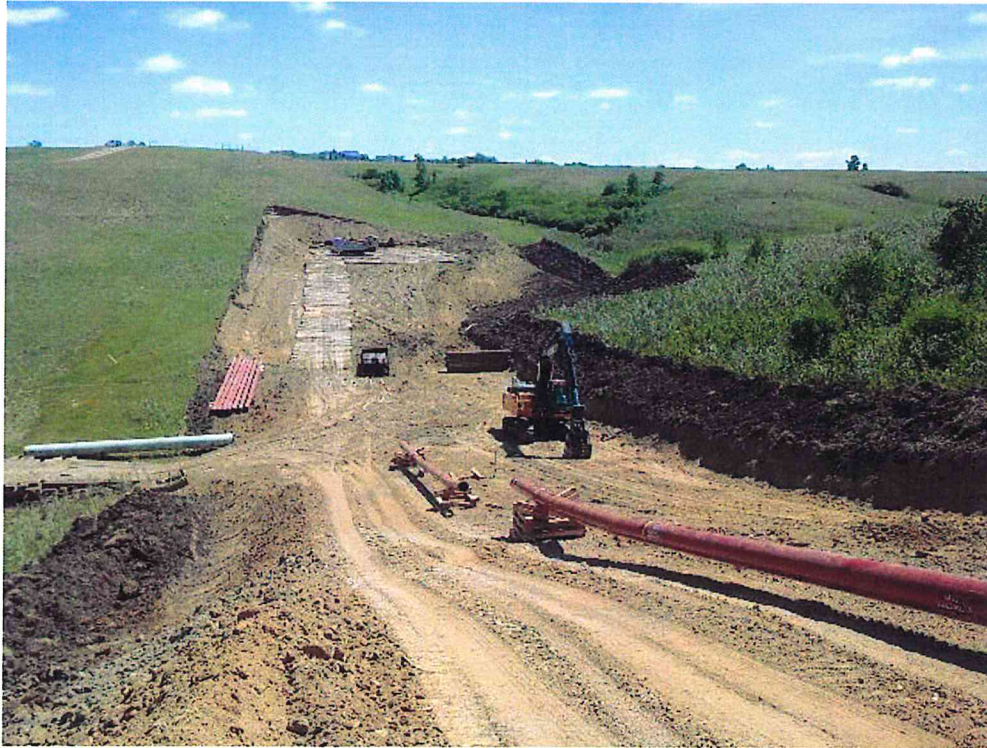
Report Photo #1 "HDD Environmental Area" at GPS Coordinates:

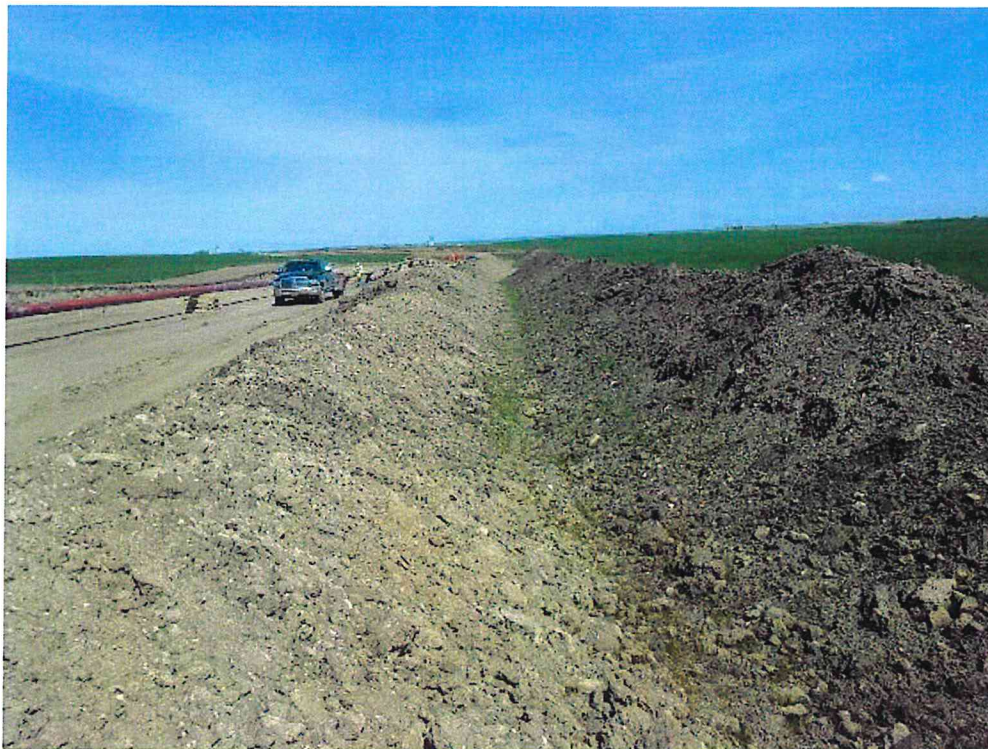
Report Photo #2 "Soils Segregation with Rye Grass" at GPS Coordinates:

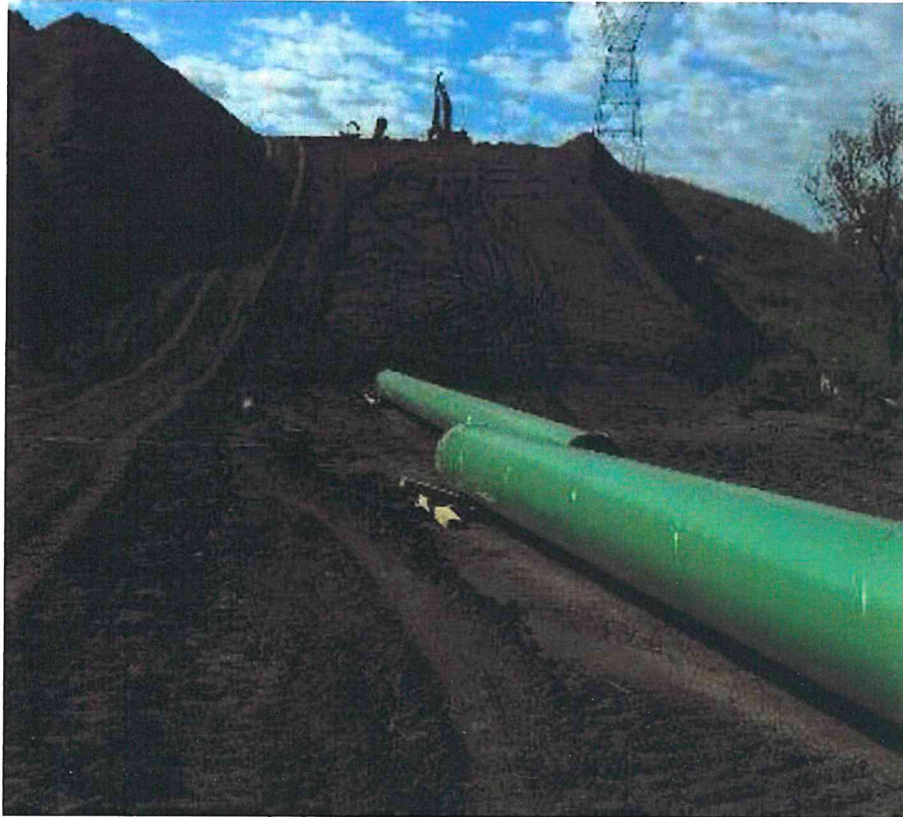
Report Photo #1 Pipeline Stringing at GPS Coordinates:

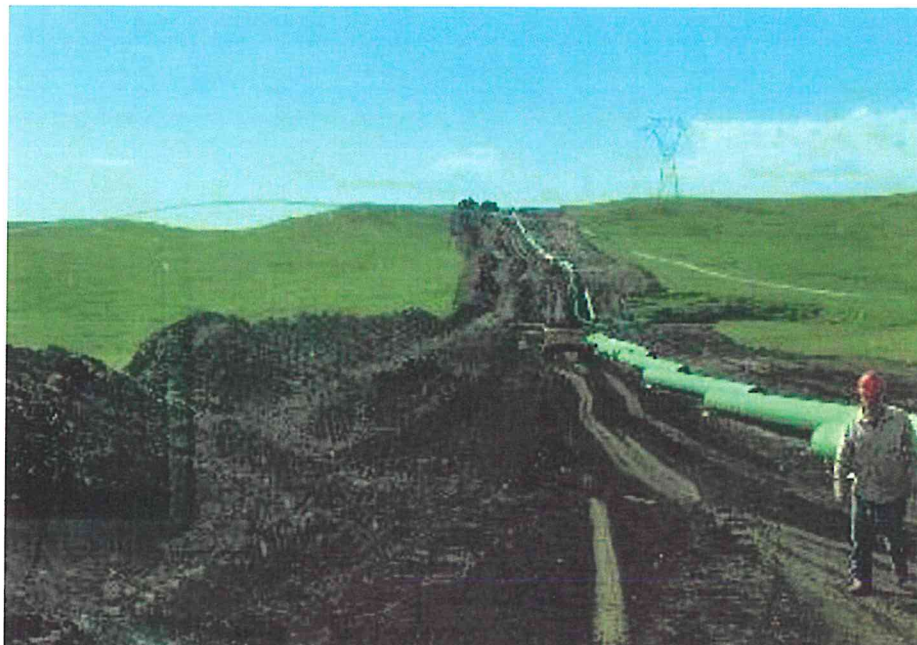
Report Photo #2 Adequate Soil Separation at GPS Coordinates:

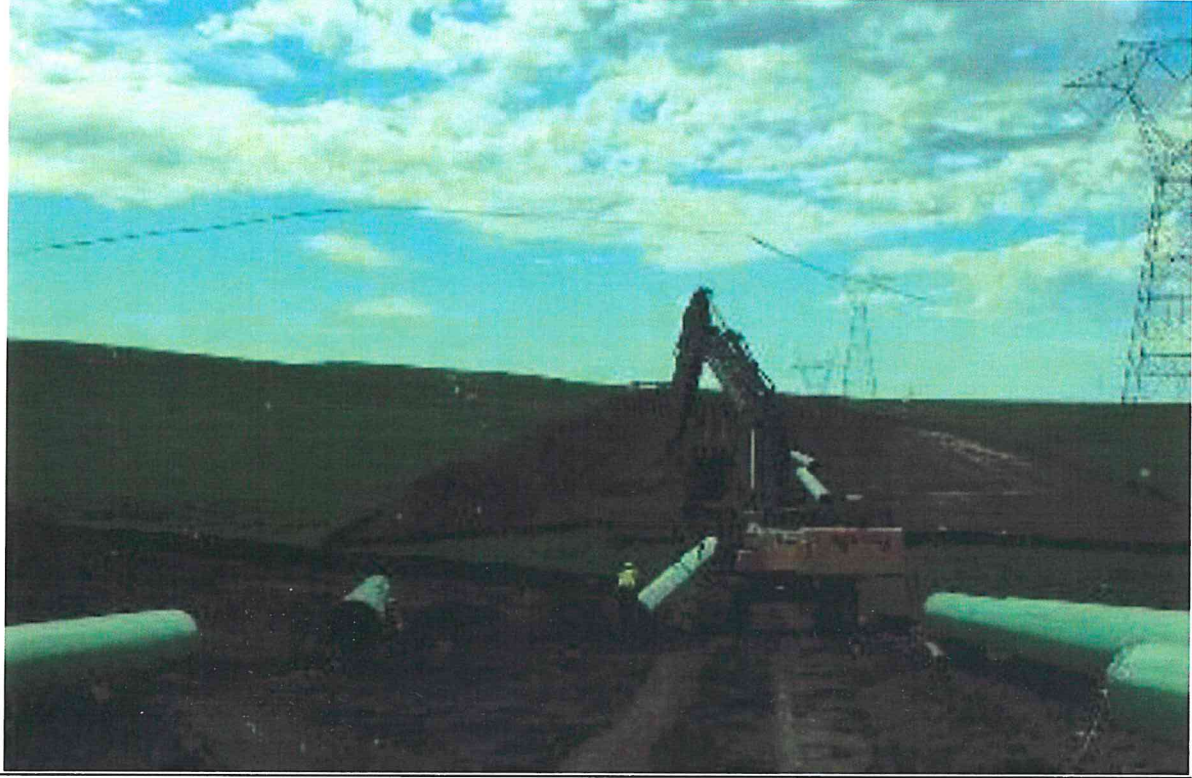
Spotter was seen guiding pipe while equipment operator was moving it. There was no tag line attached to the pipe and the spotter was at times between the heavy equipment and the suspended pipe.

Report Photo #3 Spotter Holding Moving Pipe at GPS Coordinates:

A tag line is recommended to ensure pipe isn't accidentally released from the equipment can cause injury to nearby workers.

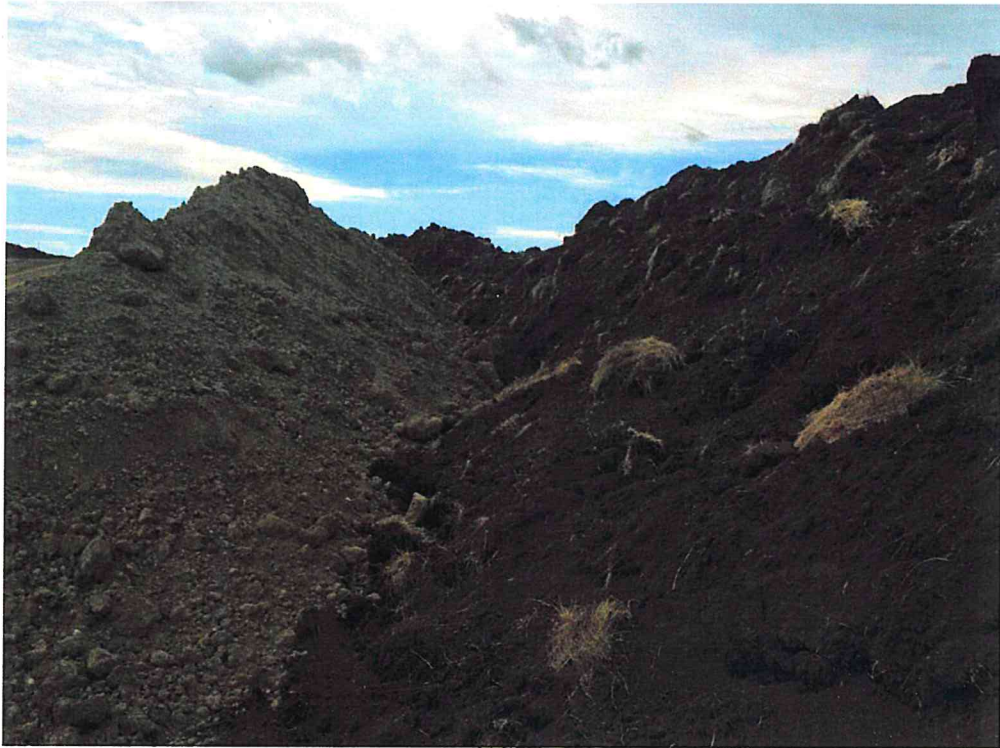
Topsoil segregation and storage was completed and deemed sufficient from M.P. 129.5 to 130.25. Many areas between M.P. 20.5 to M.P. 23 had inadequate storage between topsoil and subsoil piles. One area appeared to have subsoil stacked on topsoil, although the topsoil could have been already stripped to one foot. Storm water management practices were implemented in their respected areas along R.O.W.

Storage of topsoil from subsoil piles was deemed inadequate in many areas from M.P. 20.5 to M.P. 23. Further re-segregation will be coordinated. Topsoil around the cut looked to be down to the mandatory 12 inch depth, and construction workers will be advised.

Report Photo #1 Topsoil and Subsoil Piles Bordering at GPS Coordinates: 47.524167° N 102.848444° W

During visit, Keitu inspector and 3rd party coordinator noticed and documented many areas from M.P. 20.5 to M.P. 23 that need further separation between topsoil and subsoil piles. Extra spotters for heavy equipment drivers should be discussed and a solution to the technical separation between topsoil and subsoil piles.

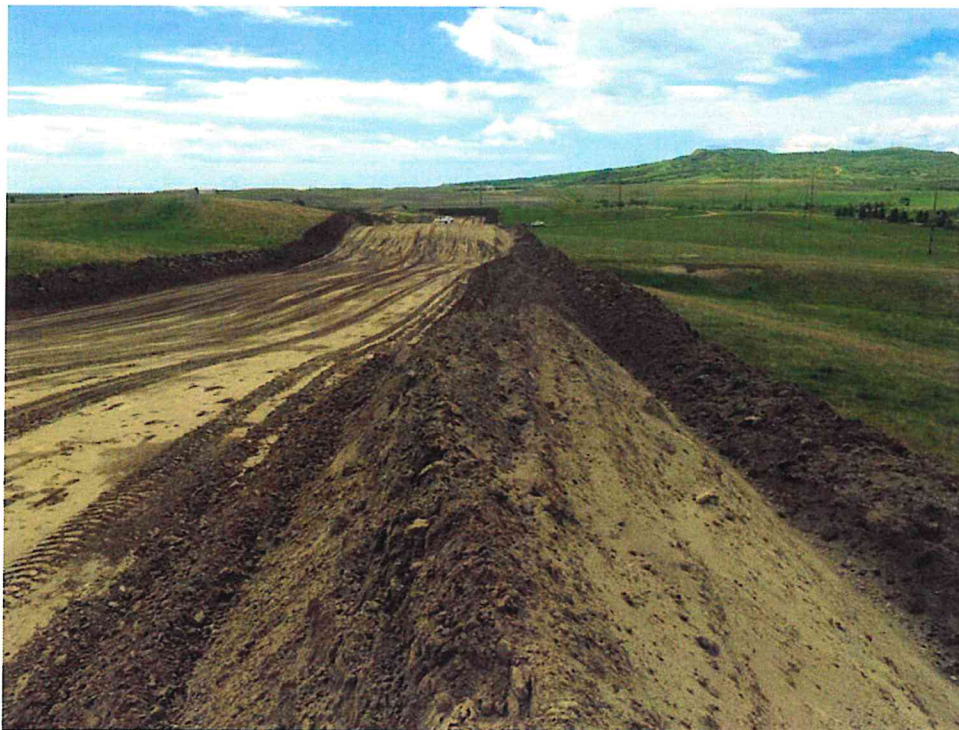
Report Photo #2 Adequate Separation/ROW at GPS Coordinates:

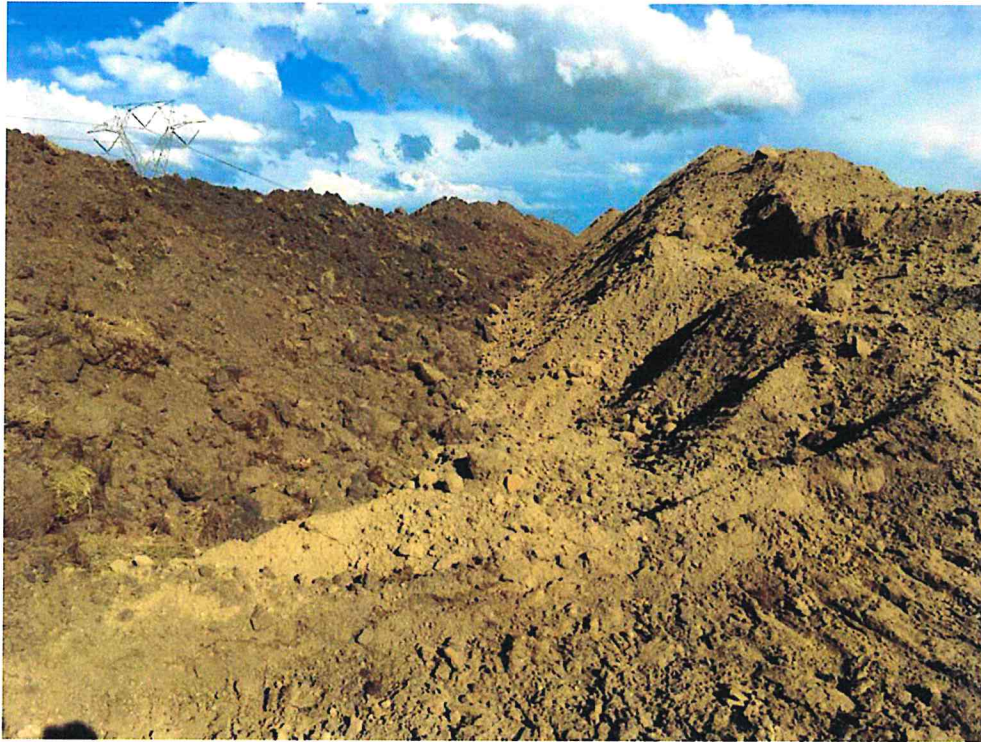
Storage of topsoil from subsoil piles was deemed inadequate in many areas upon visit. These areas were recorded by 3rd Party Coordinator for further re-segregating. An unapproved re-route was stripped and graded about a day before the re-route was to be reviewed by the North Dakota PSC.

Report Photo #1 Topsoil and Subsoil Piles Bordering at GPS Coordinates: 46.417778° N 100.499722° W

During visit, Keitu inspector and 3rd party coordinator agreed construction crews should be keeping a 2 foot buffer between segregated topsoil and subsoil piles. Areas where extra re-segregating will occur were recorded by 3rd Party Coordinator. The soil stripping of an unapproved re-route was documented.

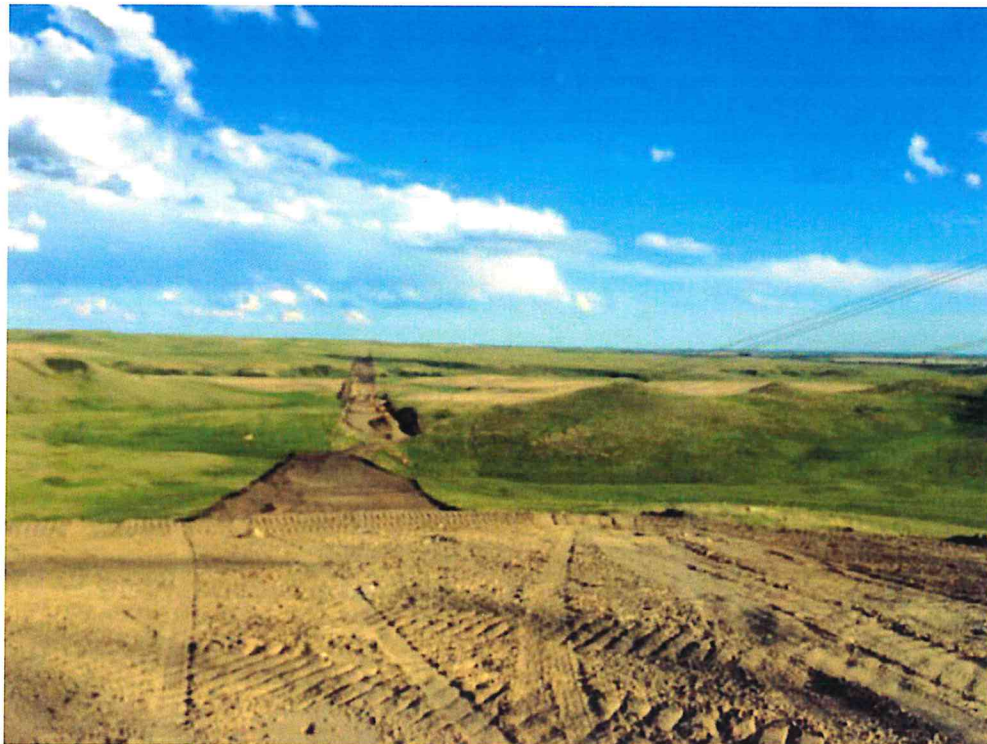
Report Photo #2 Un-Approved Re-Route Stripped at GPS Coordinates: 46.412778° N 100.491667° W

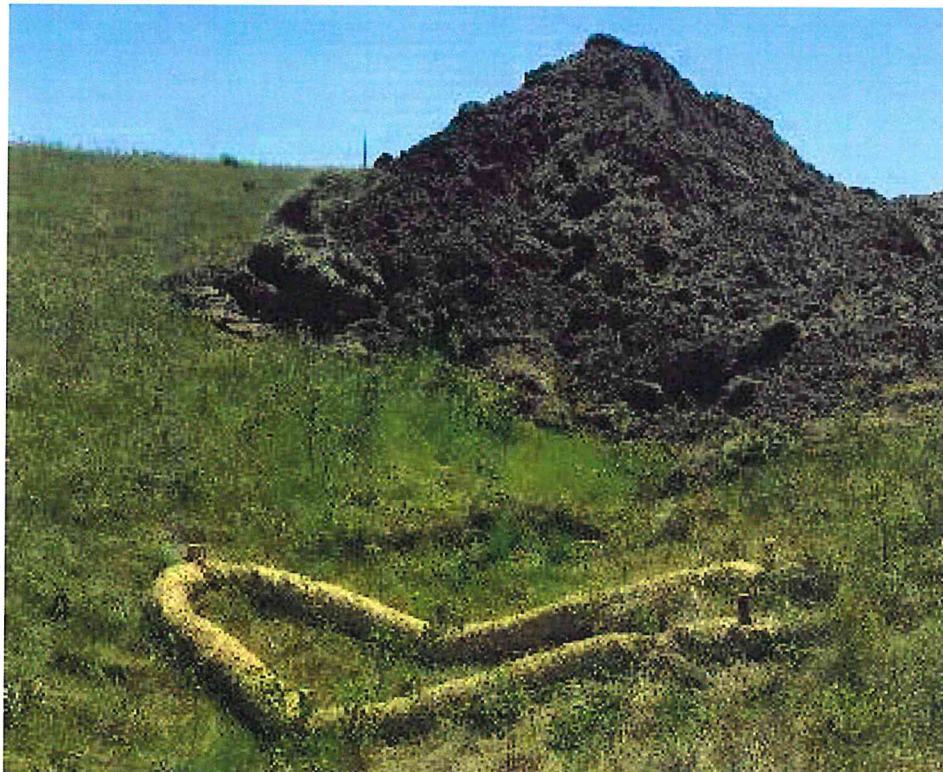
Report Photo #1 Topsoil with Erosion Control at GPS Coordinates:

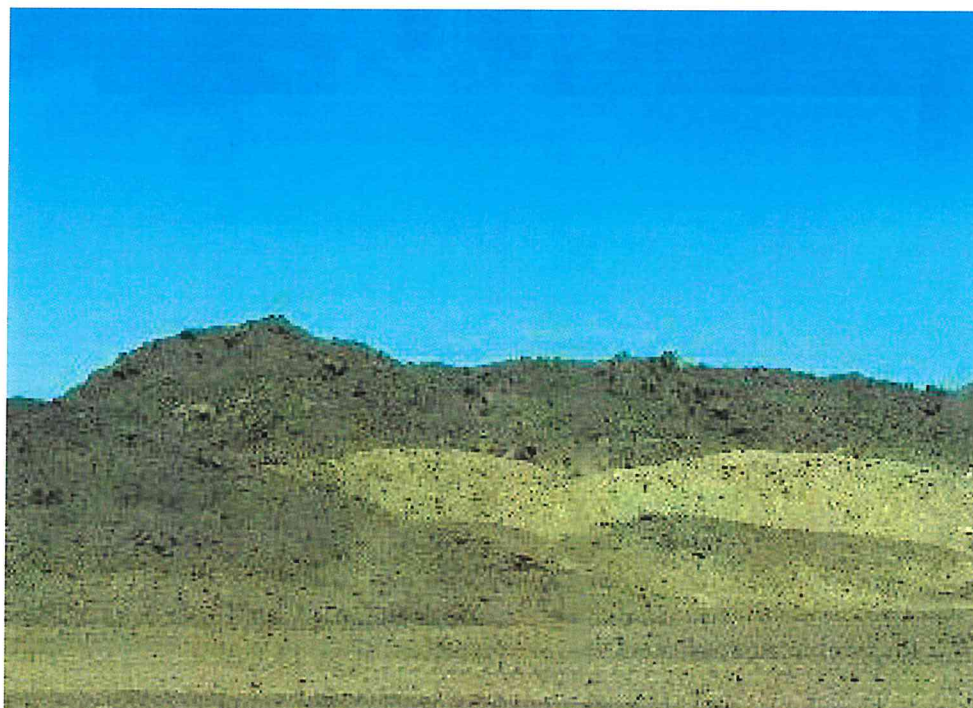
Topsoil segregation from subsoil was not adequate. Excessive amounts of subsoil was mixed with topsoil. Subsoil piles were also touching the topsoil pile.

Report Photo #2 Topsoil and Subsoil Mix at GPS Coordinates:

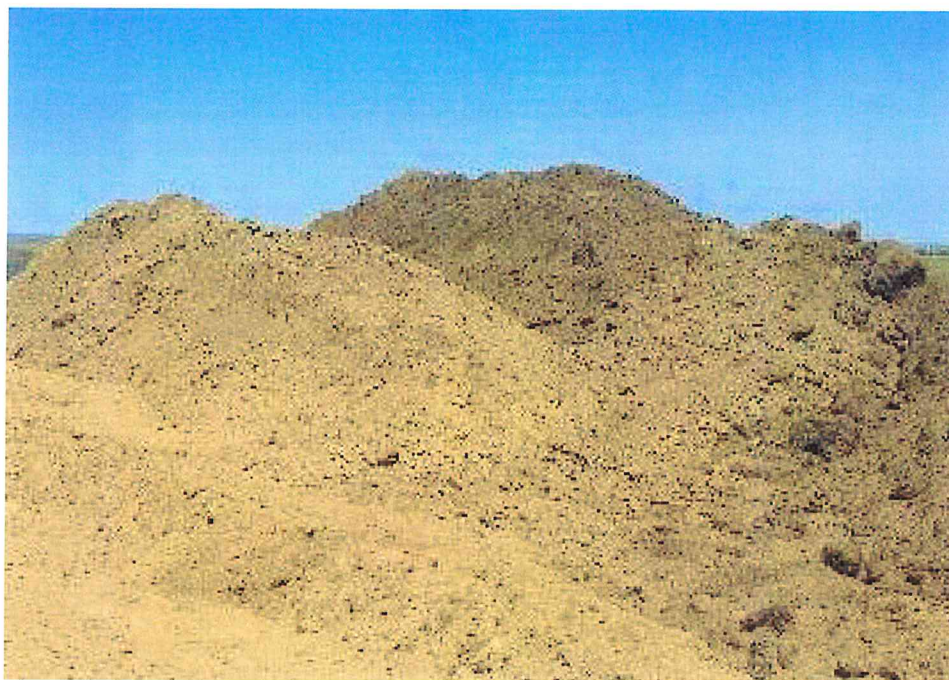
Report Photo #3 Top Soil and Sub Soil Touching at GPS Coordinates: 46.43599° N 100.55867° W

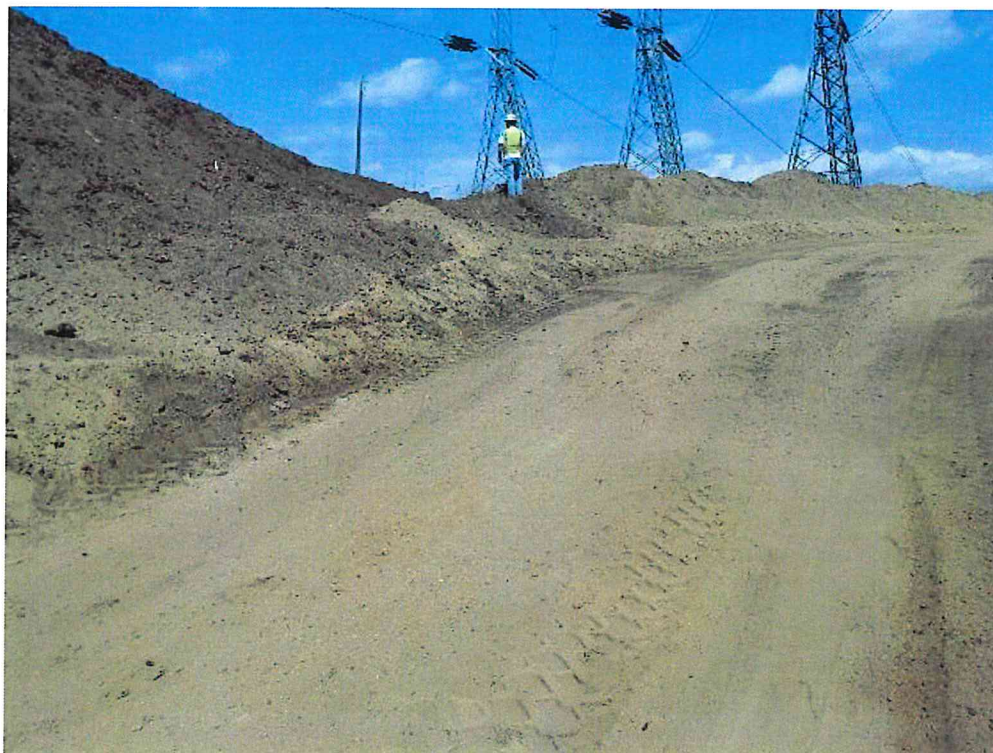
Topsoil and subsoil segregation and storage was completed up to about M.P. 168. Many areas of excessive subsoil mixed with topsoil, and subsoil piles were touching topsoil piles. Storm water management practices were being implemented upon site visit. R.O.W. conditions were good and dry.

Report Photo #1 "Subsoil Mixing with Topsoil" at GPS Coordinates:

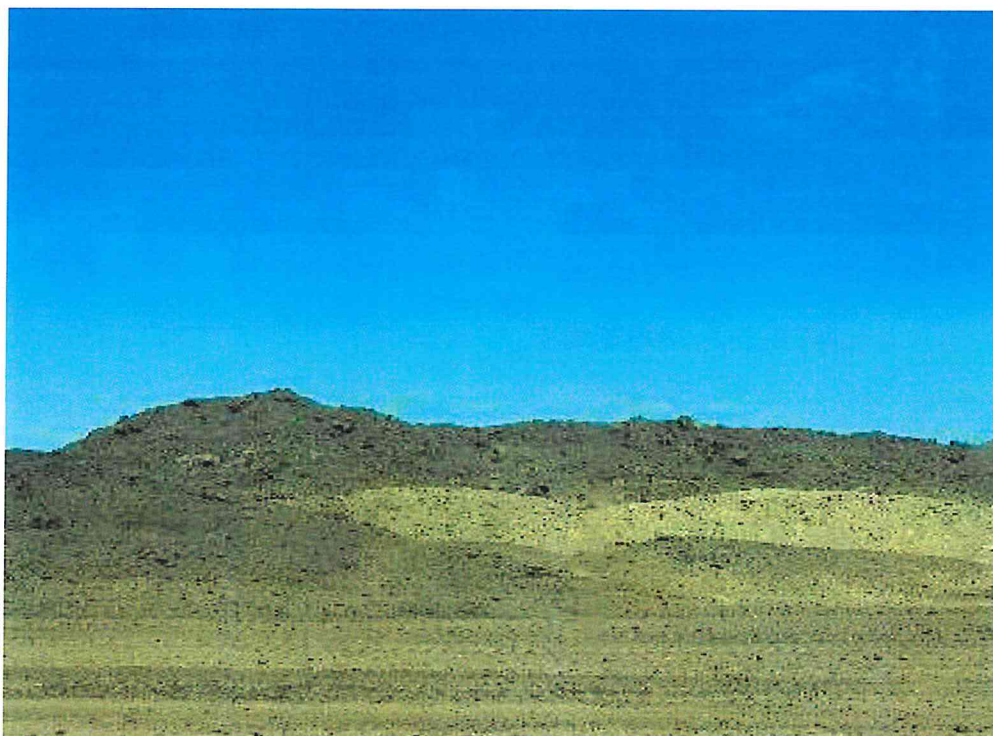
Report Photo #2 "Subsoil stacked against topsoil" at GPS Coordinates:

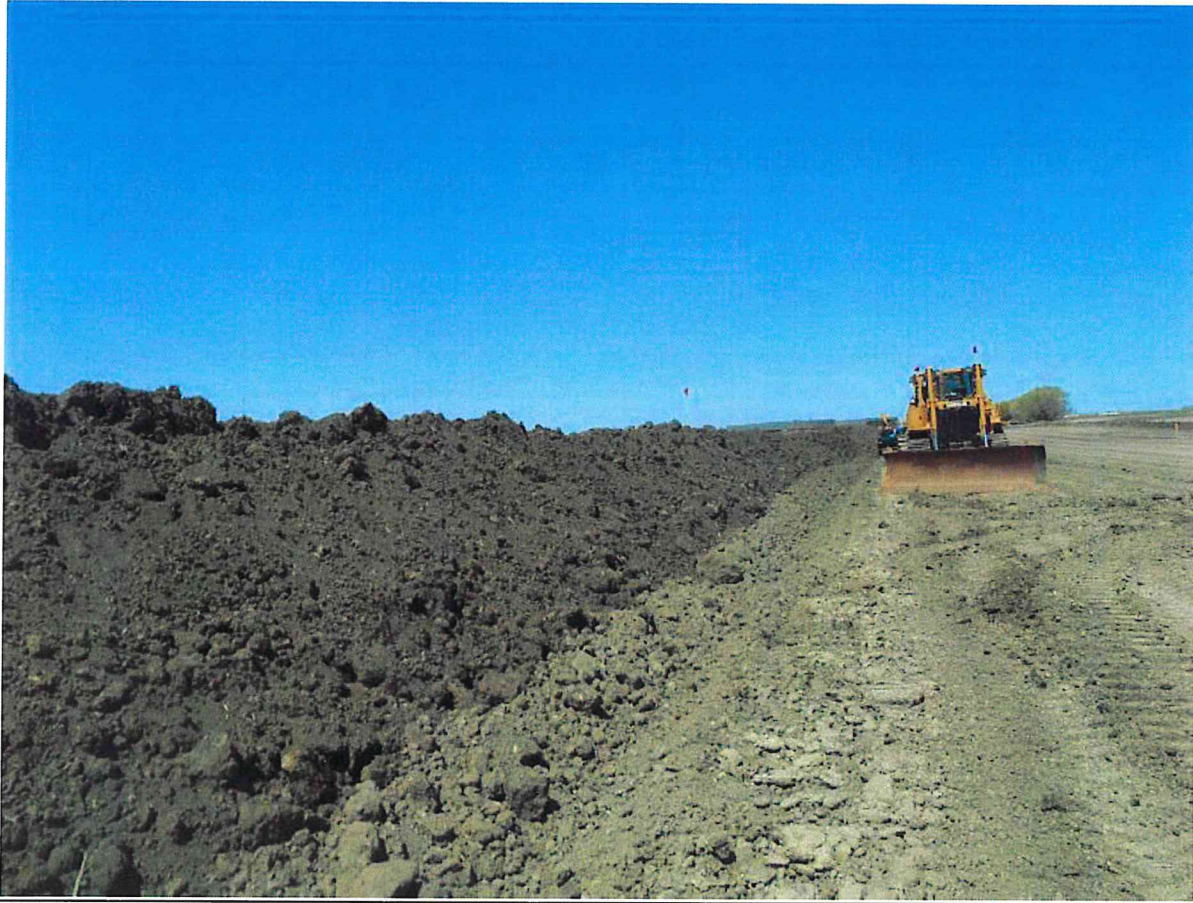
Topsoil and subsoil segregation adequate throughout the area. No evidence of topsoil and subsoil mixing or improper replacement was observed. Erosion controls had been installed. Erosion control measures all appeared to be in good repair and working properly.

Report Photo #1 Topsoil Pile Facing North at GPS Coordinates:

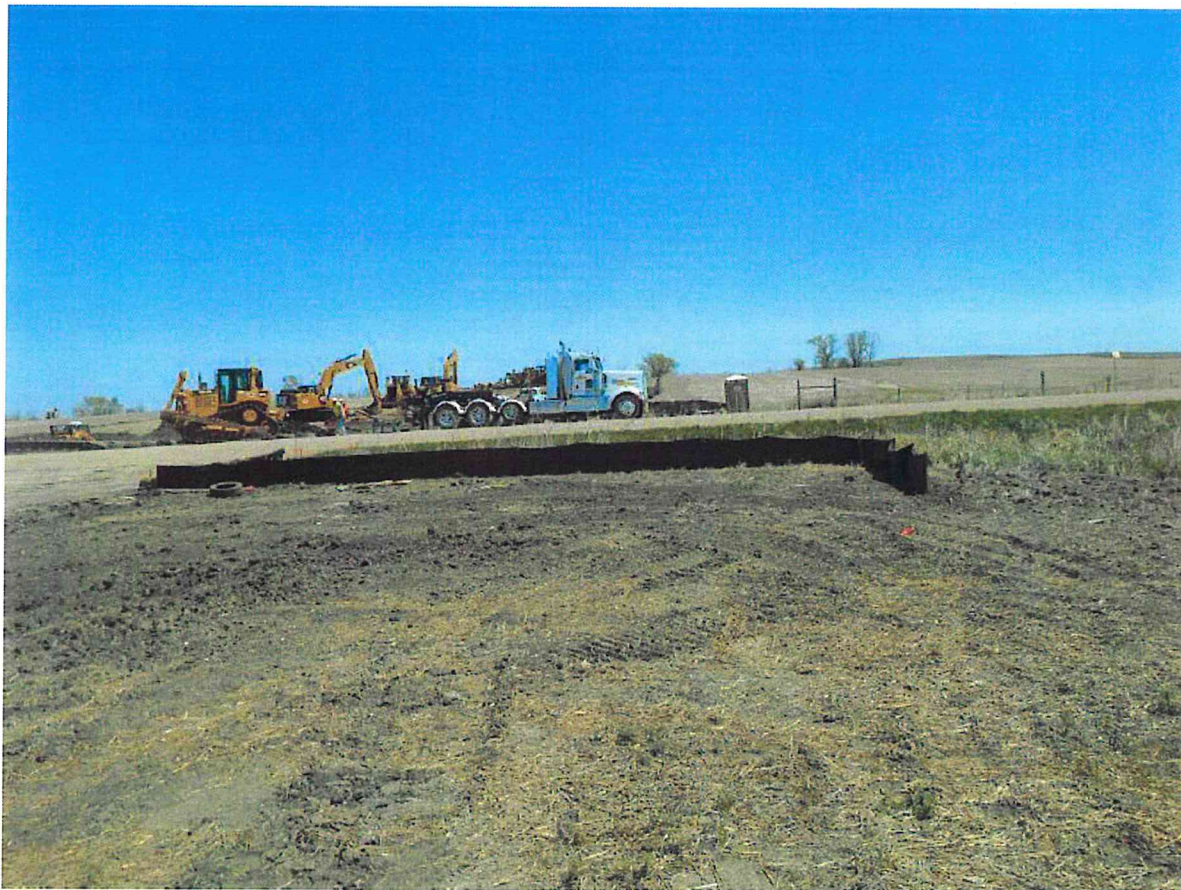
Report Photo #2 Soil Stripping End. BMPs Installed at GPS Coordinates: 48.291944°N 102.461389°W

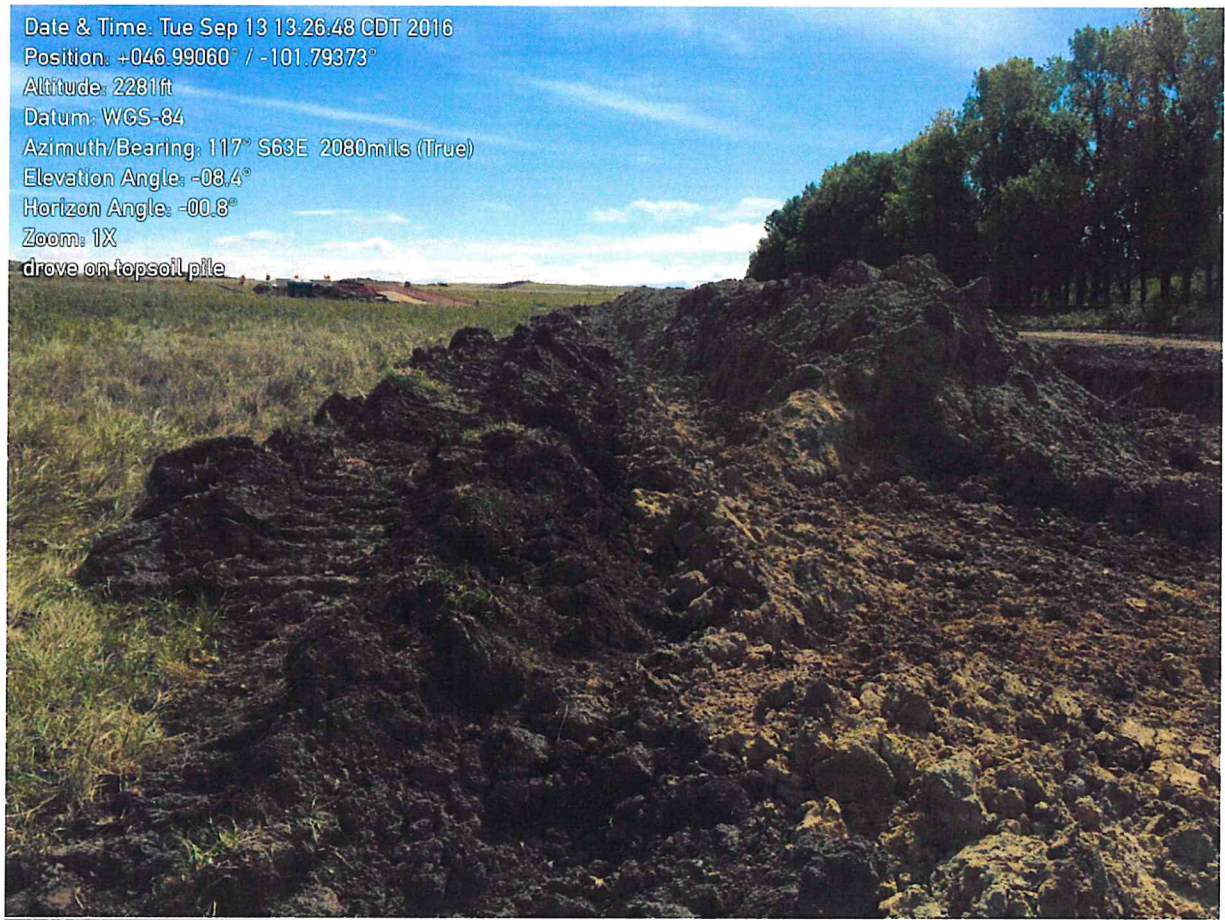
The most common deficiency found throughout the construction inspections was inadequate soil segregation. Typical issues observed were contact between the subsoil and topsoil piles and subsoil stored above unstripped vegetation and/or topsoil in workspace. Communication was made with on-site personnel over several visits on soil piles that needed segregation. On September 15, 2016, Keitu staff observed construction equipment driving over topsoil and subsoil piles causing the two to mix (Docket #215). Docket #'s 205, 213, 215, 216, 218, 222, and 327 refer to soil deficiencies found during Keitu's construction inspections.

Photo 3 -Subsoil cast on topsoil likely during flow-breaker install at 47.2539°N -102.1294°W.
