Site/Project Location: Spread 7-8 Morton & Dunn Counties

Date of Inspection: 21 October 2016

Inspected Spread 7-8 of pipeline ROW approximately starting near Fort Rice, North Dakota and concluding near Zap, North Dakota.

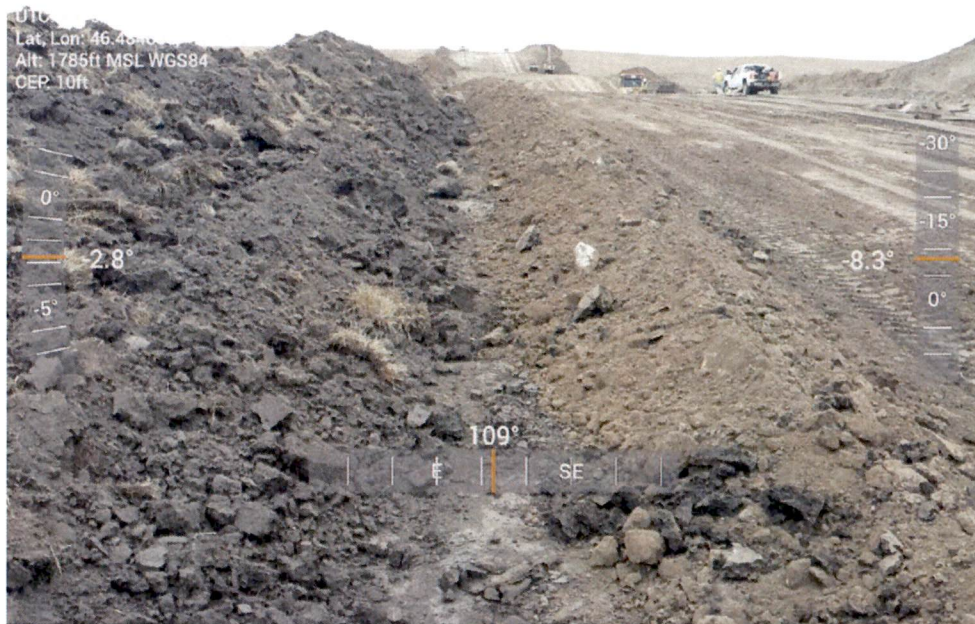
Topsoil and subsoil segregation appeared to be adequate. Topsoil depth was as thin as 0.5" on hilltops while up to or exceeding 12" on the bottom of hill slopes. A majority of the top soil and subsoil piles from stripping and trenching showed clear separation. Where subsoil and topsoil piles were bordering each other it appeared to occur near where the ROW was narrowed near wetland crossings. Even though they were bordering each other, it was observed care was taken to keep the soils segregated. Storm water BMPs remain in place and in good repair. Drainage points protected with straw bales or silt fence were cleared of silt.

Report Photo #1 Subsoil and Topsoil Segregation

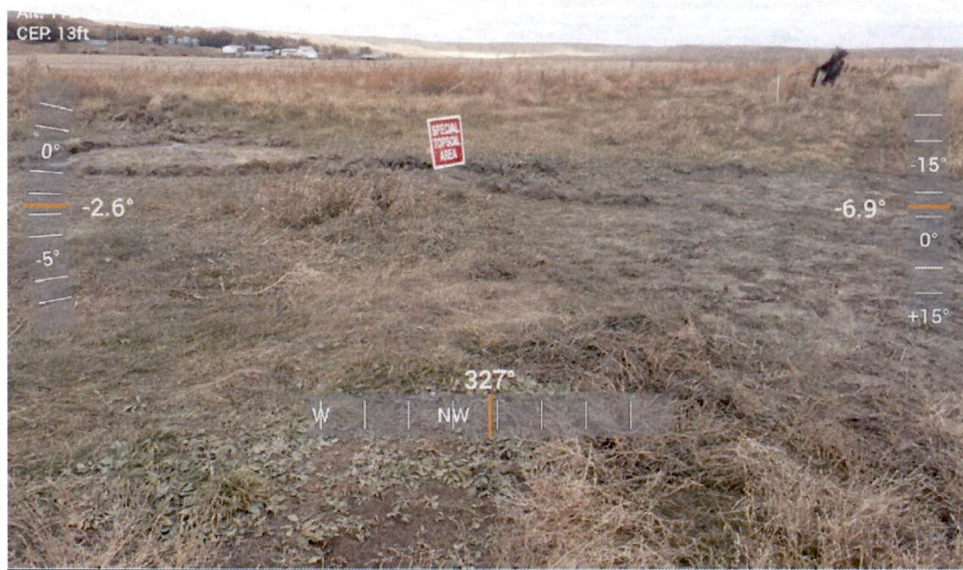
Report Photo #2 Sodic Soils Area

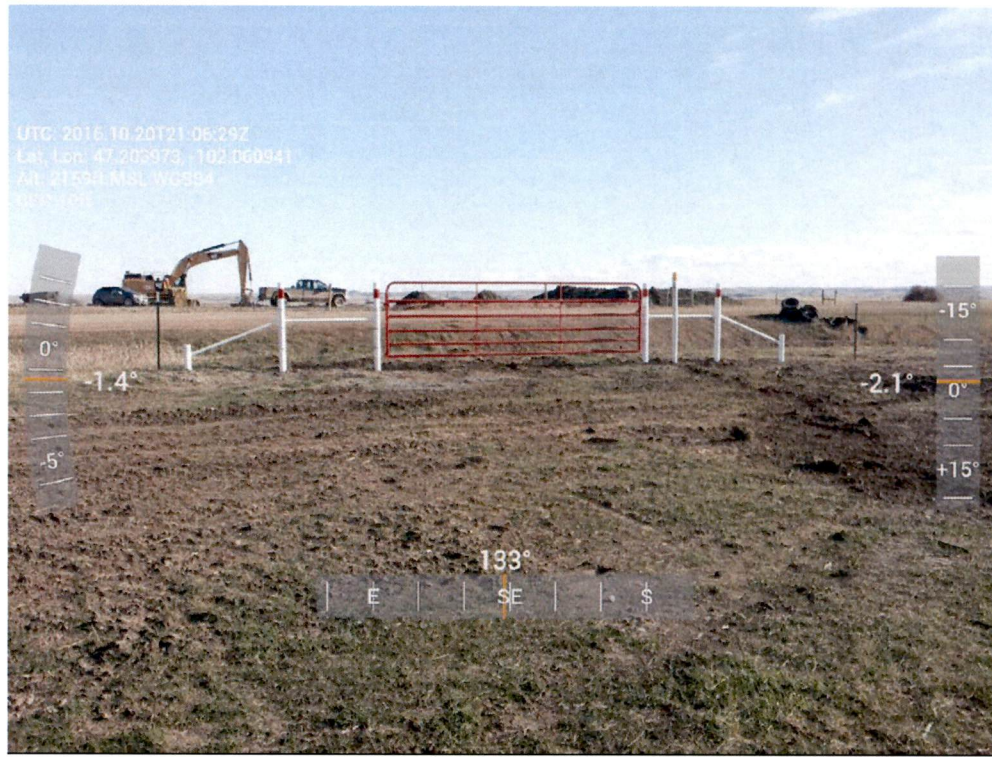
Report Photo #3 Permanent Gates Being Installed

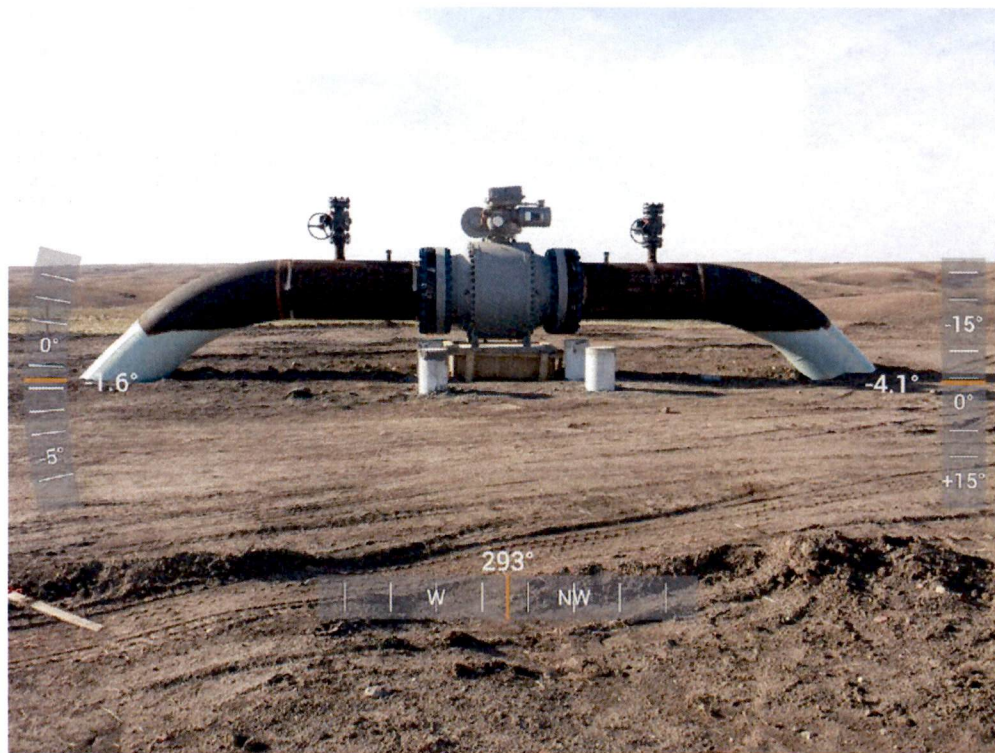
Report Photo #4 Valve Being Installed

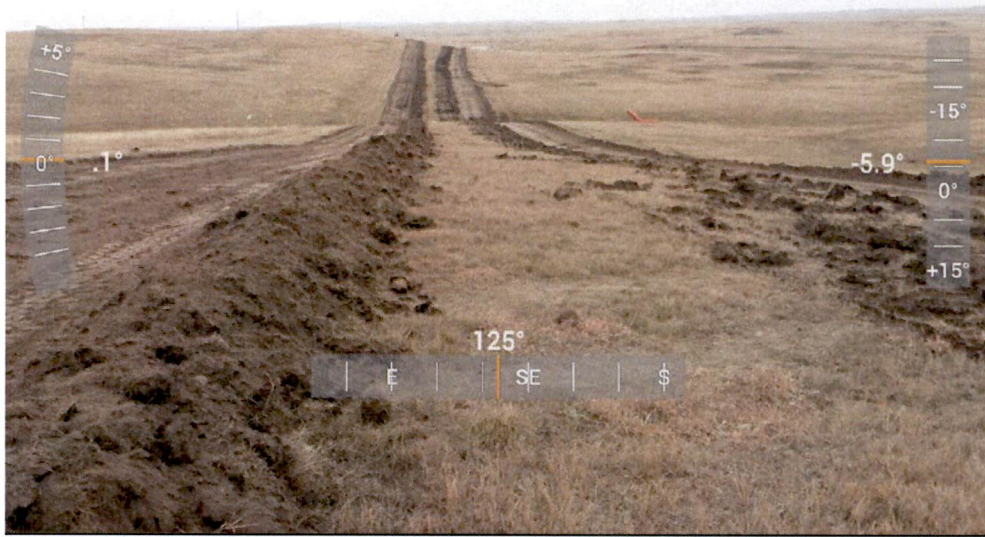
Report Photo #5 Topsoil Stripping

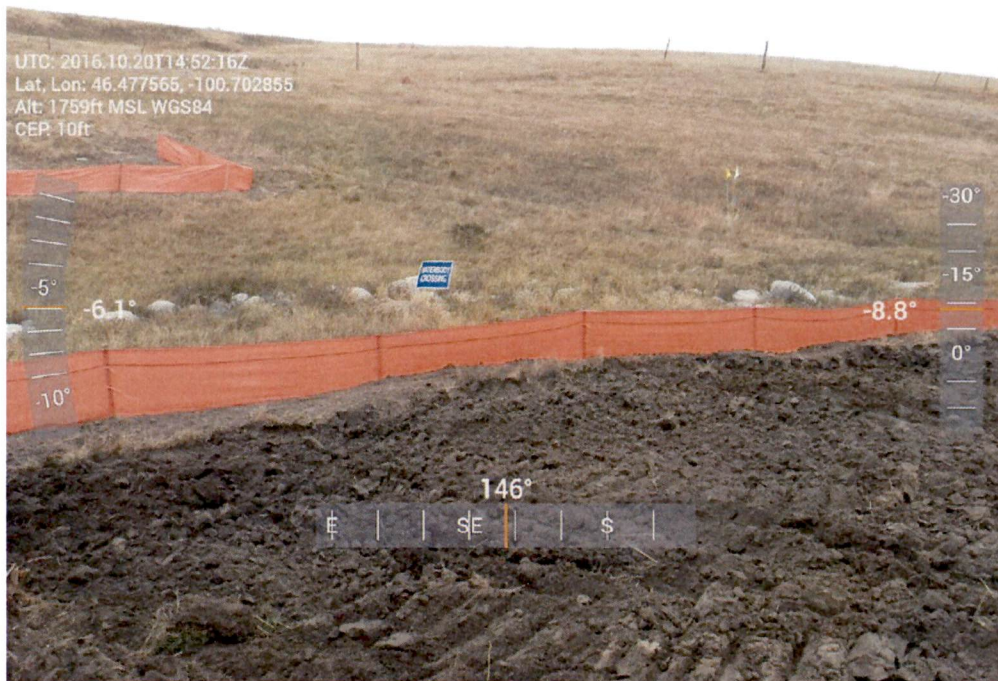
Report Photo #6 Waterbody Crossing

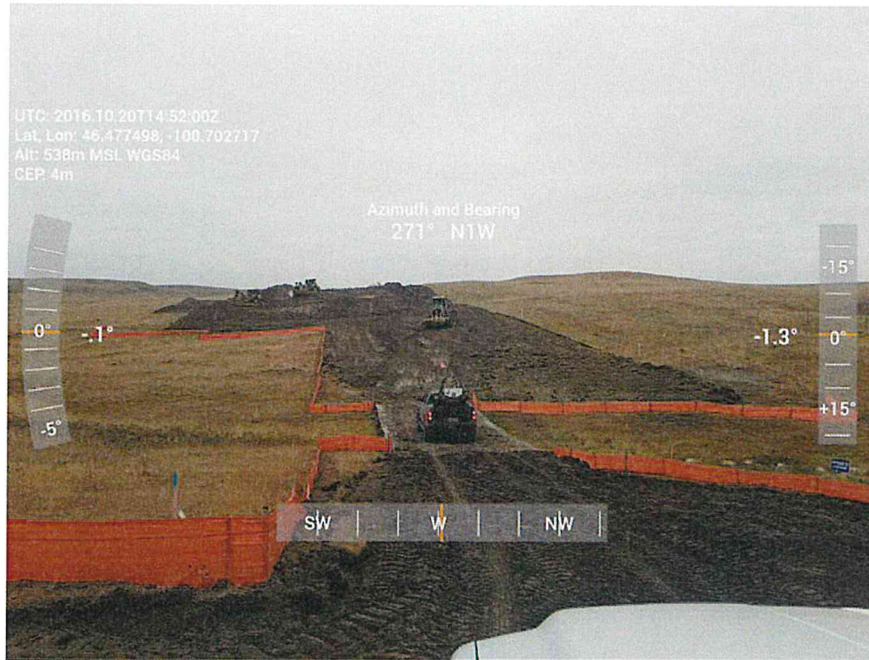
Report Photo #7 BMPs along Wetland
