PUBLIC SERVICE COMMISSION OF THE STATE OF NORTH DAKOTA

DATE: July 21, 2017
TO: The Commissioners
FROM: John M. Schuh and Sara Cardwell
RE: PU-14-842 Investigation Hearing

STAFF MEMORANDUM IN RESPONSE TO OPENED INVESTIGATION

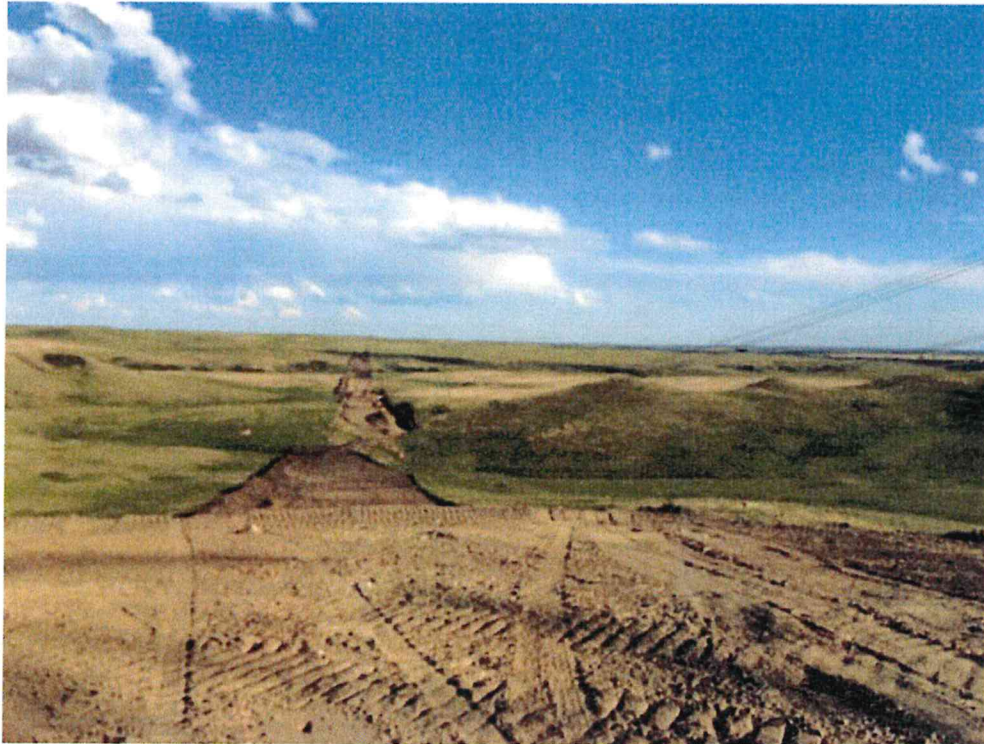
On May 25, 2016, Dakota Access filed a certification and accompanying documentation for route adjustment 64 pursuant to N.D.C.C. § 49-22-16.3 and Provision 40 of the Certification Relating to Order Provisions.¹⁶ The filing included the correct documentation required, however, an inspection on May 23, 2016 showed that the ROW had already been stripped prior to the reroute for MP 172-172.5 being filed with the Commission. The inspector documented the deficiency.¹⁷

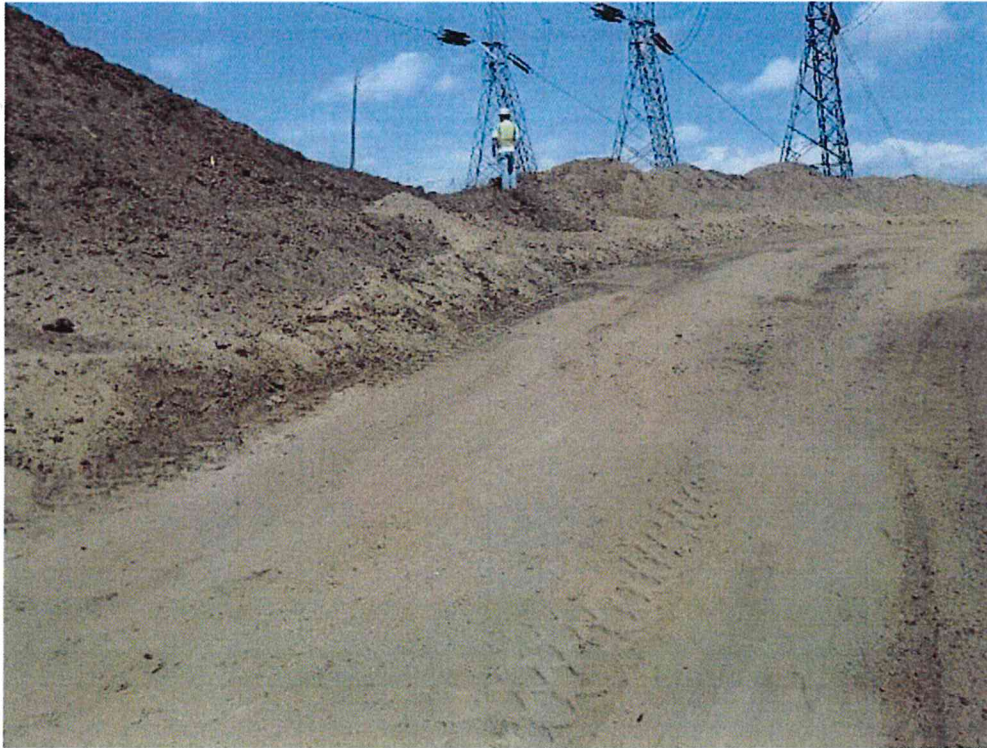
Report Photo #1 "Subsoil Mixing with Topsoil" at GPS Coordinates:

touching the topsoil pile.⁴¹ The inspector observed many areas of concern and met with the third party coordinator to explain the issues. The talks regarding the concerned areas were reported to go nowhere and no action was taken during the visit. Upon communication with the Project leader, another field visit was deemed required to immediately address and correct the issues.

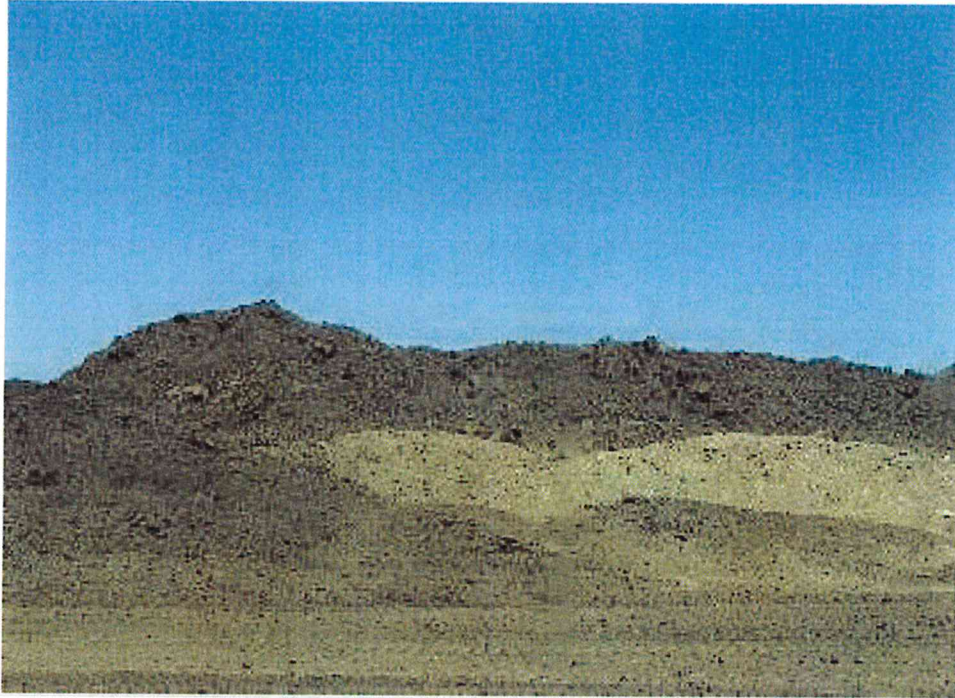
Report Photo #2 Topsoil and Subsoil Mix at GPS Coordinates:

- 5. May 20, 2016 – MP 167-170 in Emmons County near Cannonball –** An inspection showed many areas of excessive subsoil mixed with topsoil and subsoil piles touching topsoil piles.⁴² Topsoil segregation was found to be not adequate. Keitu inspector advised the third party coordinator to notify construction crews that there was insufficient segregation of topsoil and subsoil. Due to the inspection being from the same MP area in follow-up of the May 19, 2016 inspection, there is a redundant use of a documented picture.

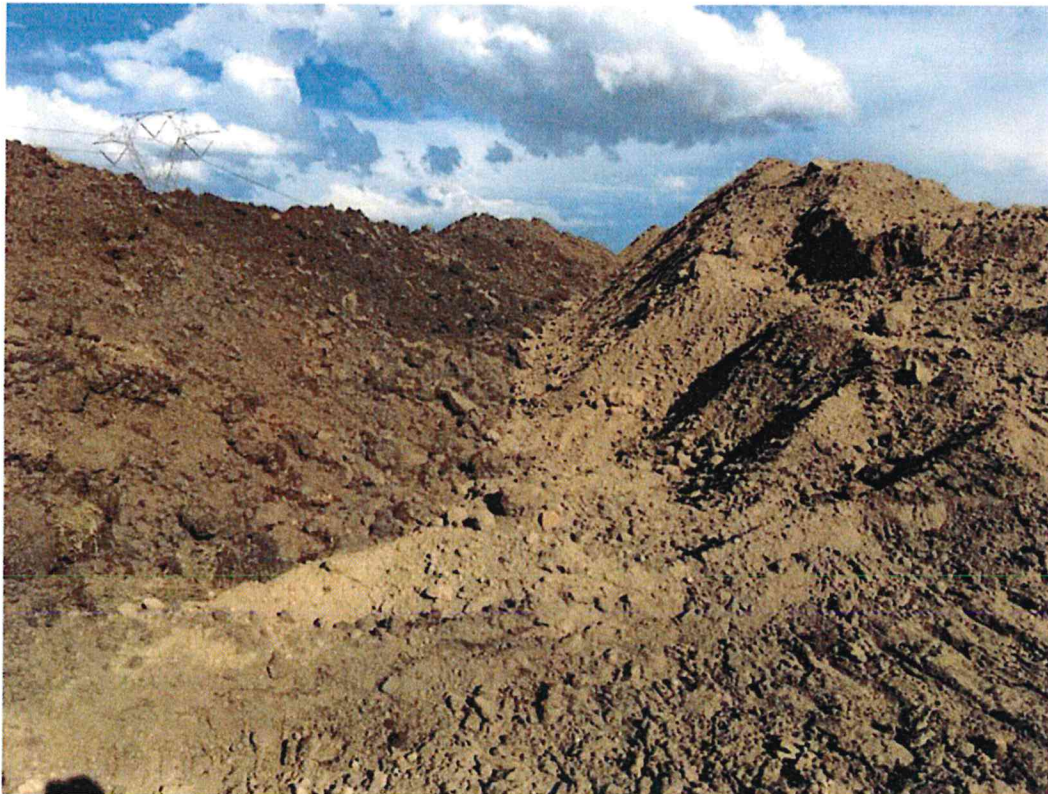
Report Photo #1 Topsoil and Subsoil Piles Bordering at GPS Coordinates: 46.417778° N 100.499722° W

6. **May 23, 2016 – Spread 6 in Emmons County near Cannonball** – An inspection reported storage of topsoil from subsoil piles to be inadequate in many areas upon visit.⁴³ Keitu inspector and third party coordinator agreed that a 2 foot buffer between the topsoil and subsoil piles should be kept.

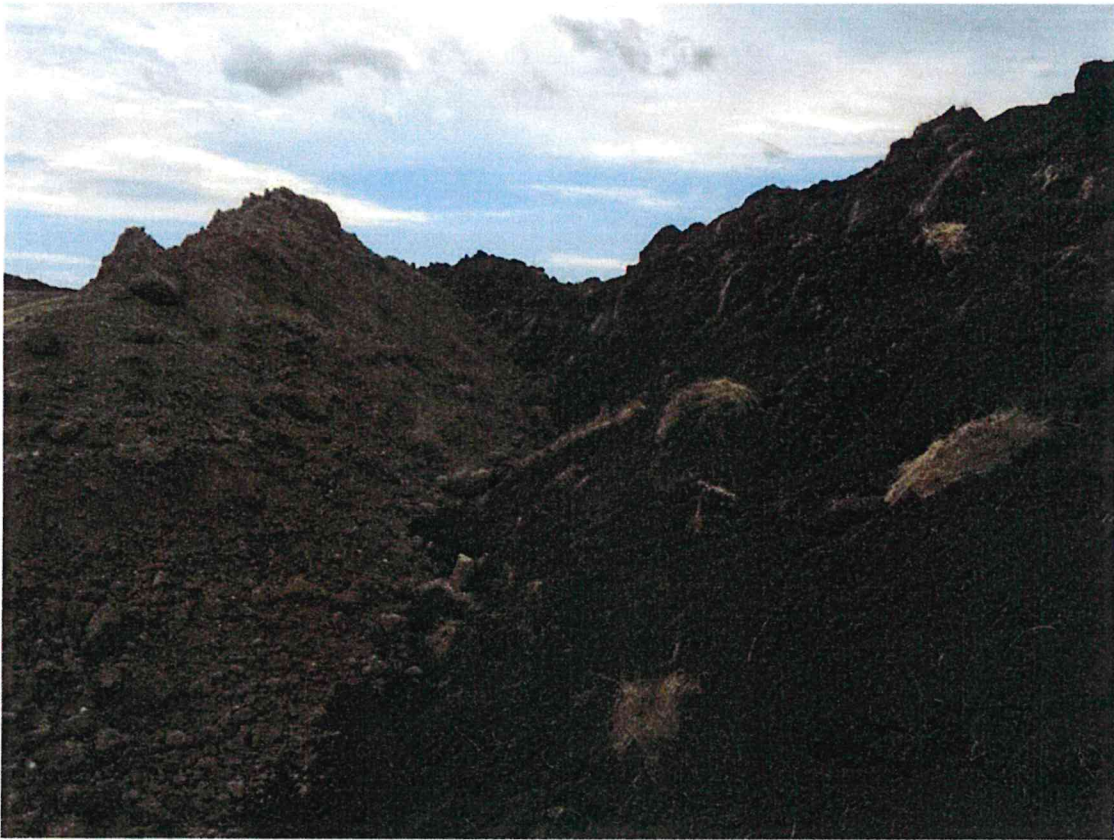
Report Photo #1 Topsoil and Subsoil Piles Bordering at GPS Coordinates: 47.524167° N 102.848444° W

7. **May 24, 2016 – MP 20.5-130.25 in Dunn County near Killdeer** – Storage of topsoil and subsoil piles was deemed inadequate in many areas. One area appeared to have subsoil stacked on topsoil.⁴⁴ During the visit, the inspector and third party coordinator documented many areas that needed further separation between topsoil and subsoil piles.

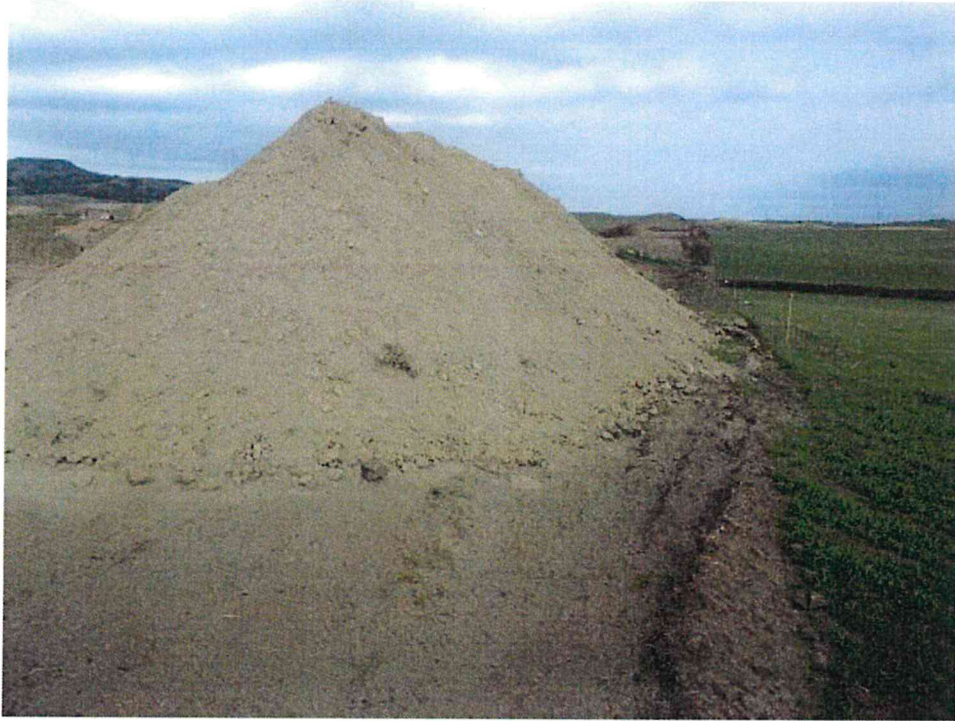
Report Photo #2 Subsoil piled on un-stripped ground at GPS Coordinates: 47.516944° N 102.835278° W

- 8. June 16, 2016 – Spreads 7 & 8 in Mountrail County near Medicine Hole -** During a 16 June 2016 inspection, Spreads 7 & 8 in Mountrail County, it was observed that the topsoil had rolled near or over the ROW boundary as the soil piles settled. The third party coordinator and Keitu inspector agreed that operators should be notified to leave more space between the soil pile and ROW boundary. Subsoil pile from the bore pit was stacked on unstripped surface. The third party coordinator notified the crew about making sure soil piles from bore pits were stripped of topsoil before stockpiling.⁴⁵

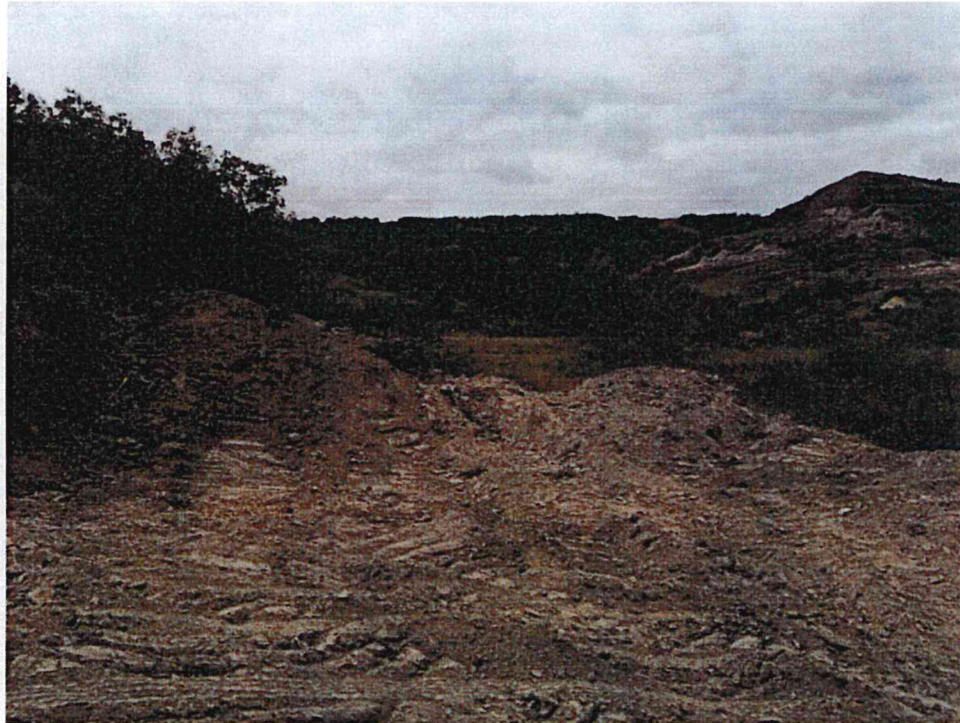
Report Photo #5 "Marginal Topsoil Segregation":

- 9. August 4, 2016 – Slip HDD South of the Little Missouri River in Dunn County** - During the 4 August 2016 site inspection, Keitu reported a deficiency where one area of topsoil was stacked on top of stripped subsoil.⁴⁶ Keitu recommended leaving the soil pile at its current location as moving the pile would likely cause as much damage as leaving it at the current location.

NOTE: Topsoil stacked on subsoil

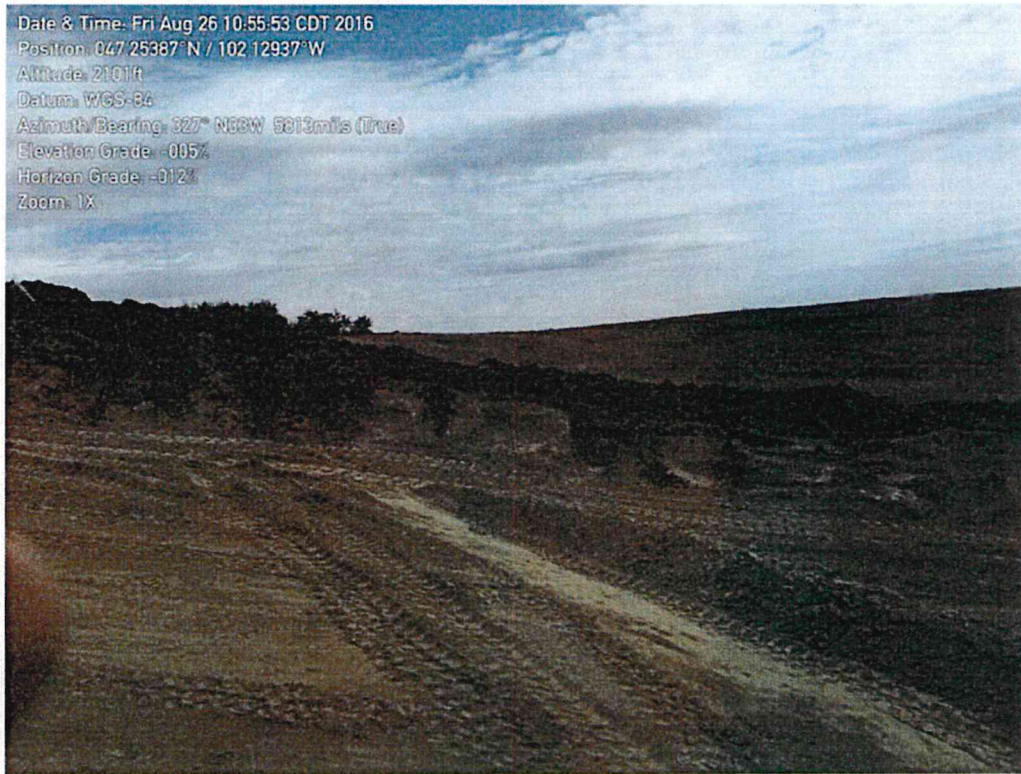
10. August 26, 2016 – MP 61 to 65, 2.3 miles SE of Dodge, ND - On a 26 August 2016 site inspection trip, Keitu reported a minor probable violation including 3 short areas of minor subsoil contact with topsoil or surface vegetation with one area specifically associated with a late stage install of a flow breaker on a steep slope of the ROW as opposed to the initial top soil stripping⁴⁷.

Report Photo #4 "Subsoil Cast on Topsoil Likely During Flow-breaker Install: 47.2539°N 102.1294°W

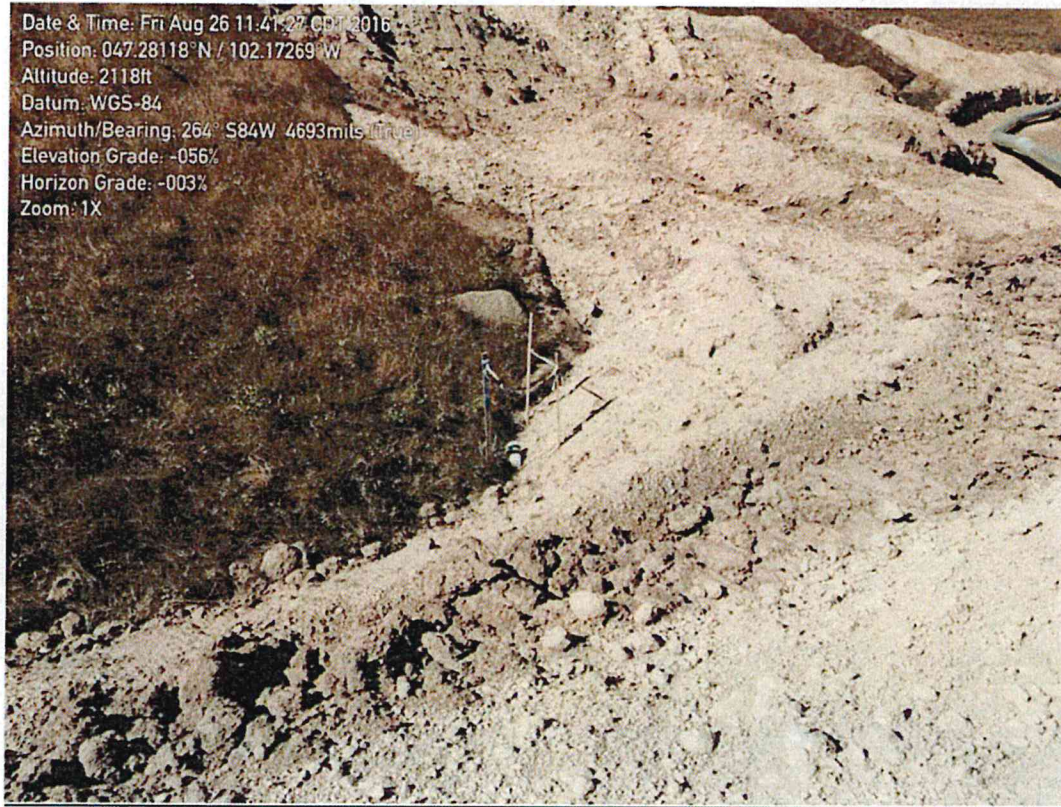
Report Photo #5 "Subsoil Thrown Beyond Stakes/On Top of Vegetation":

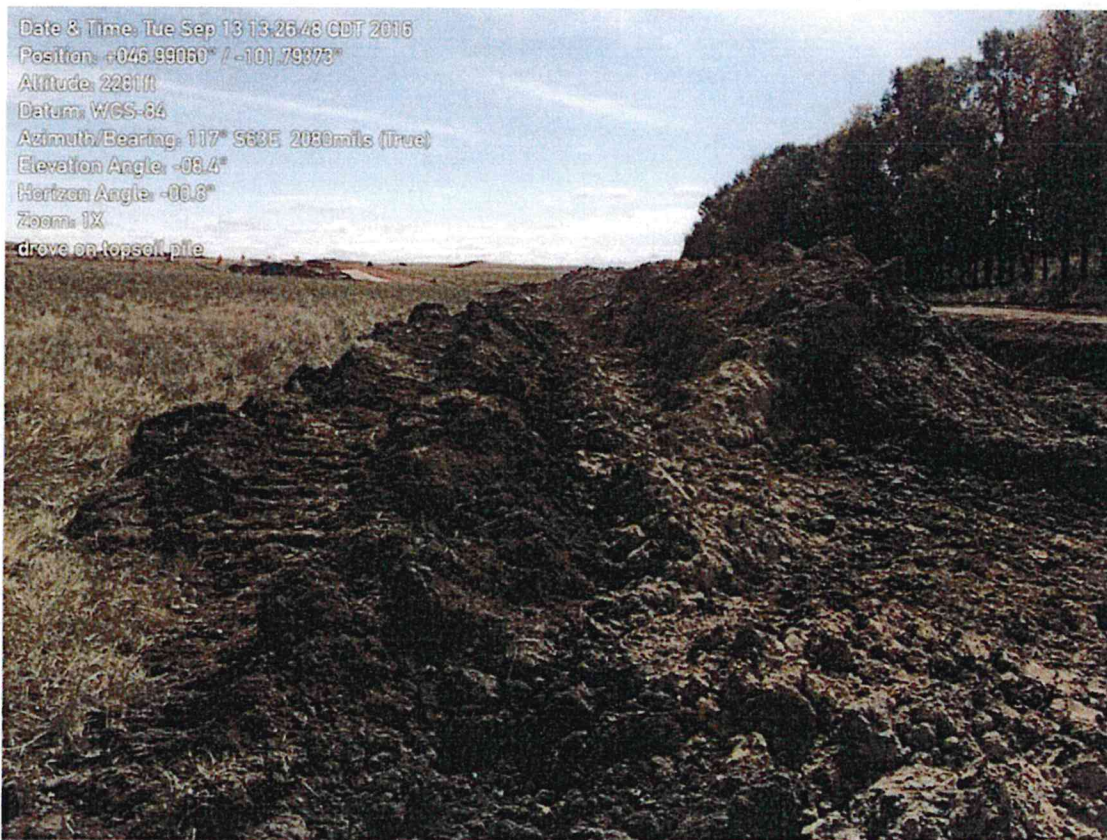
11. September 13, 2016 – MP 75-92 – 17 miles South of Beulah in Mercer County - A 13 September 2016 site inspection trip stated that although the majority of the topsoil/subsoil segregation was adequate for the inspected ROW, there were three deficient spots where topsoil/subsoil was missing, piled on vegetated surfaces, or had heavy equipment drive over the piles, mixing topsoil and subsoil⁴⁸.

Report Photo #1 "Topsoil Driven over, Soils Mixing at M.P. 92":

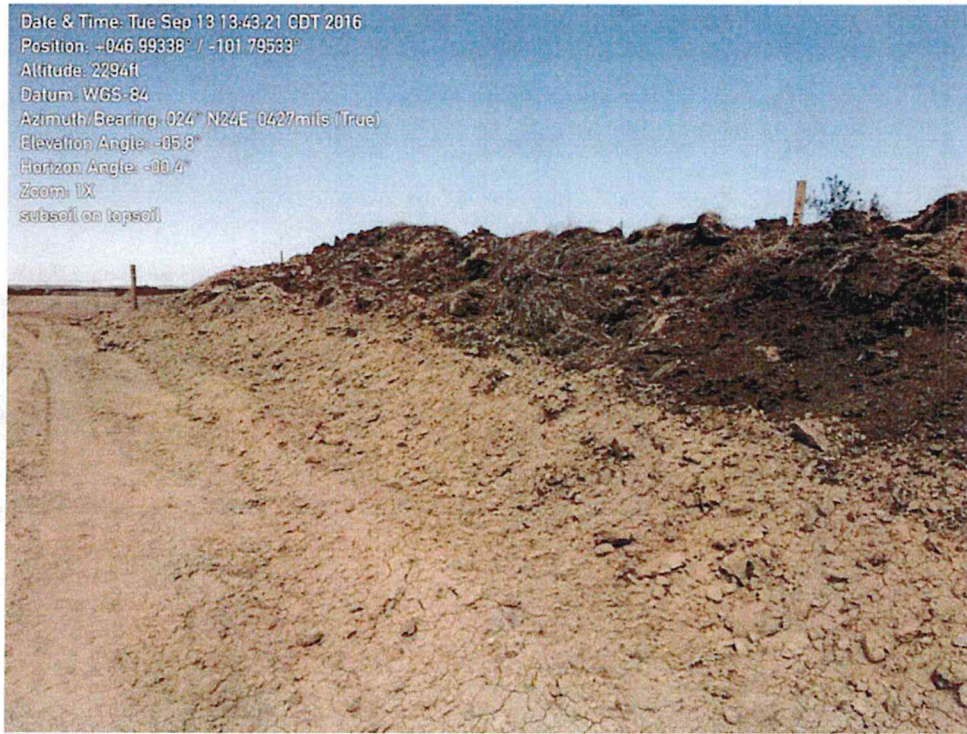
Report Photo #3 "Subsoil Plowed onto Topsoil at M.P.91.25:"

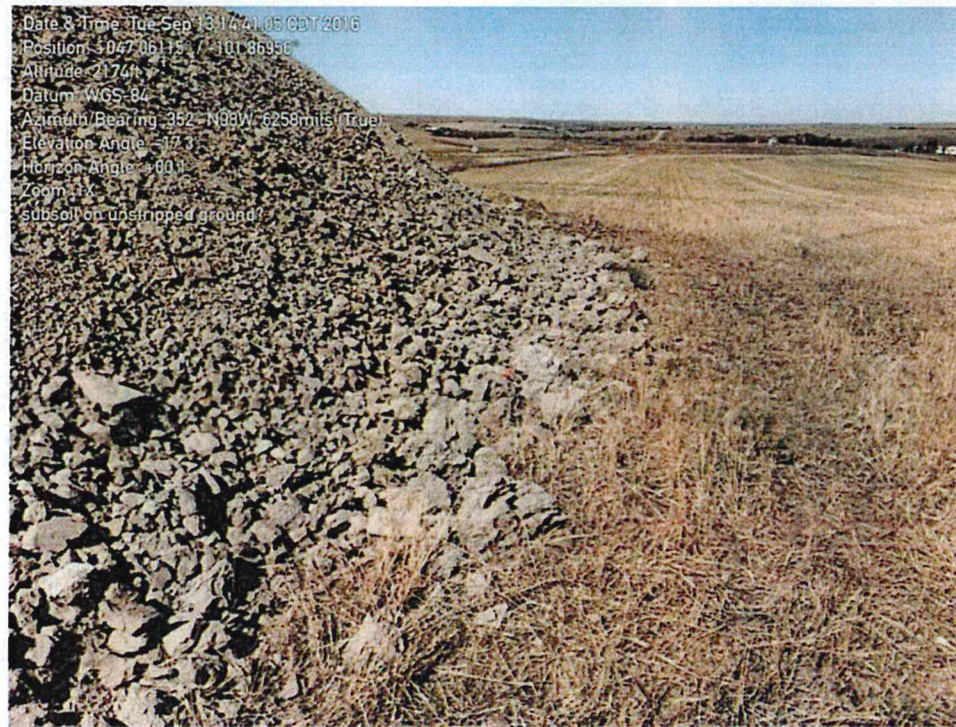
Report Photo #5 "Subsoil On Top of Vegetation. No ROW Stakes":

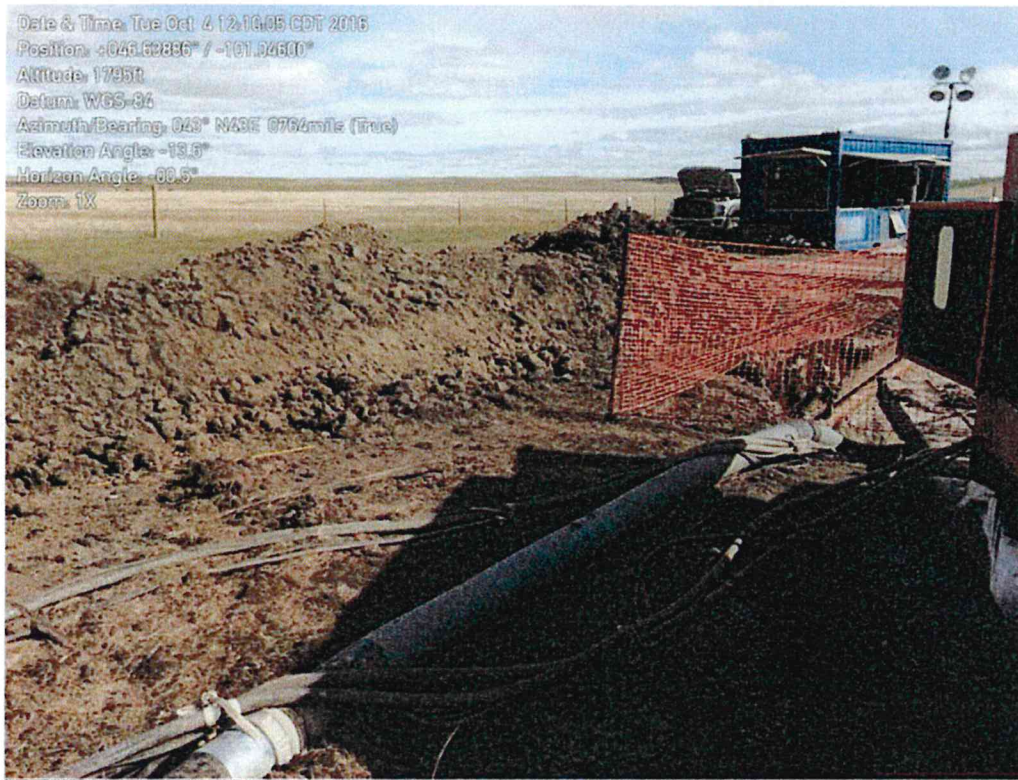
An inspection showed that subsoil piles from trenching were bordering and overlapping with the topsoil pile and subsoil was stored over unstripped ground. The lead inspector claimed he was advised by an Ag inspector to place straw mulch under the pile when piling on topsoil. However, straw mulch was not visible during the site visit in these areas. Rainfall appeared to have caused much of the overlapping. Two areas had subsoil cast on or plowed onto adjacent topsoil for a limited duration.⁵³

Report Photo #2 "Subsoils from HDD Bore Entry Pit on Unstripped Ground: 46.63866°N 101.04600°W

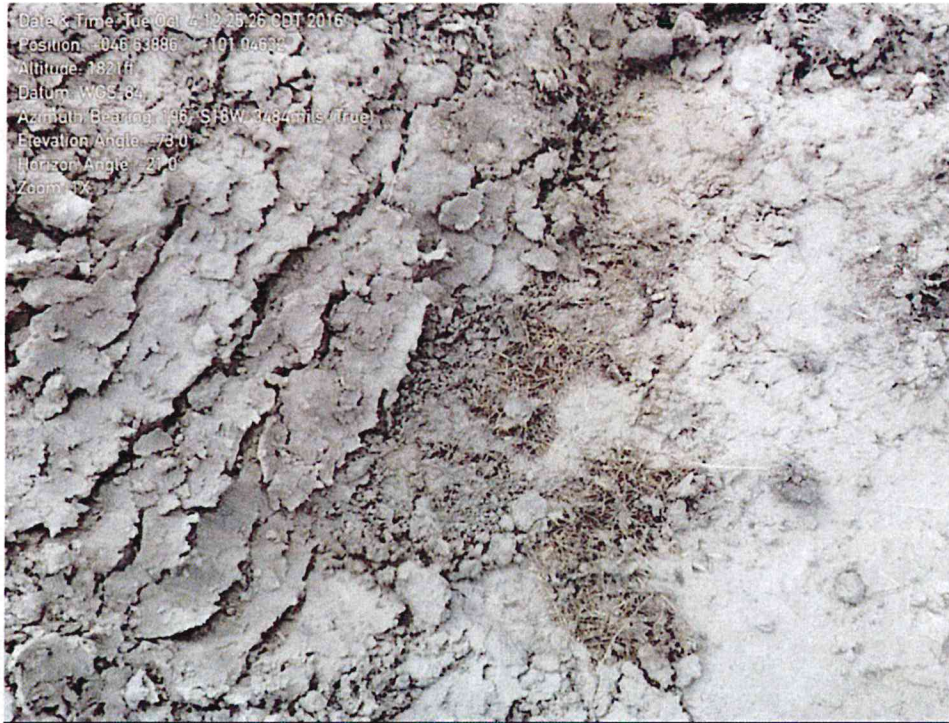
Report Photo #3 "No Straw Mulch Visible Under Bore Pit's Subsoil Pile:

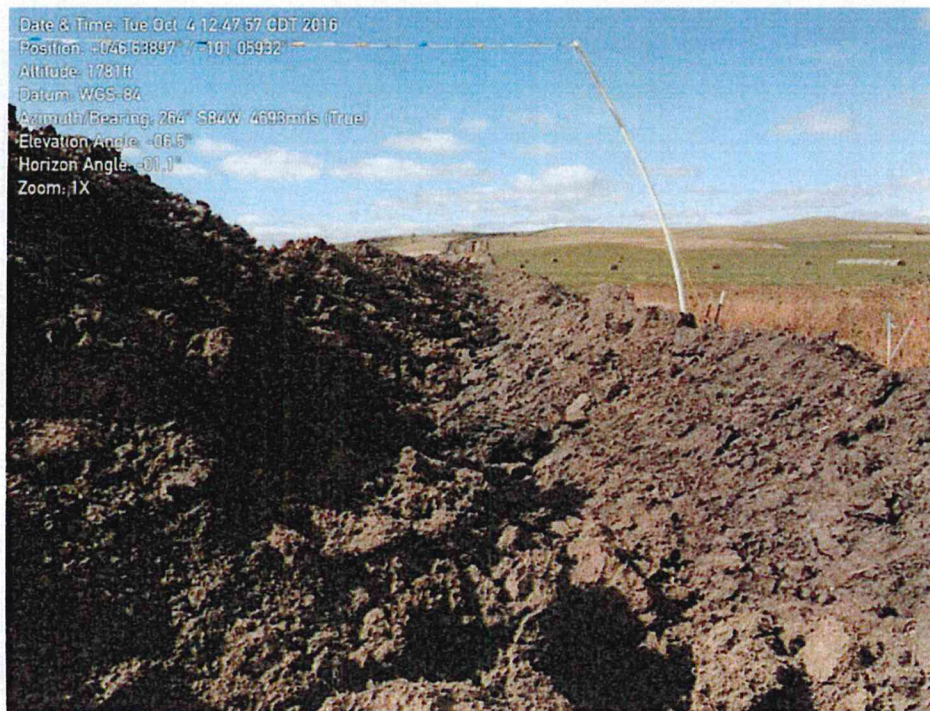
Report Photo #4 "Trench Subsoils Bordering/Overlapping with Topsoil Pile: 46.63897°N 101.05932°W

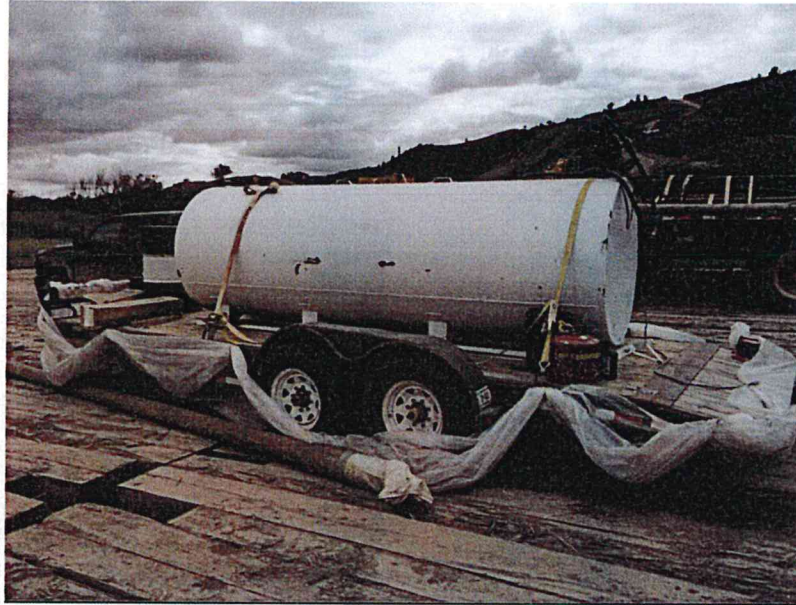
Report Photo #8 “Fueling Trailer” at GPS Coordinates: 47.6087°N 102.8765°W

On August 4, 2016, the inspector noted a deficiency where a secondary fuel tank located at the worksite trailer had been at the site for four days protected only by plastic

sheeting beneath the tank.⁶¹ The inspector stated that the “[s]ite personnel understood, without prompting, that the secondary containment for the fuel trailer was not adequate. Possible modifications were discussed to correct item.”⁶²
