STATE OF NORTH DAKOTA
PUBLIC SERVICE COMMISSION

Dakota Access, LLC
Dakota Access Pipeline Project
Siting Application

Case No. PU-14-842

STAFF MEMORANDUM IN RESPONSE TO OPENED INVESTIGATION

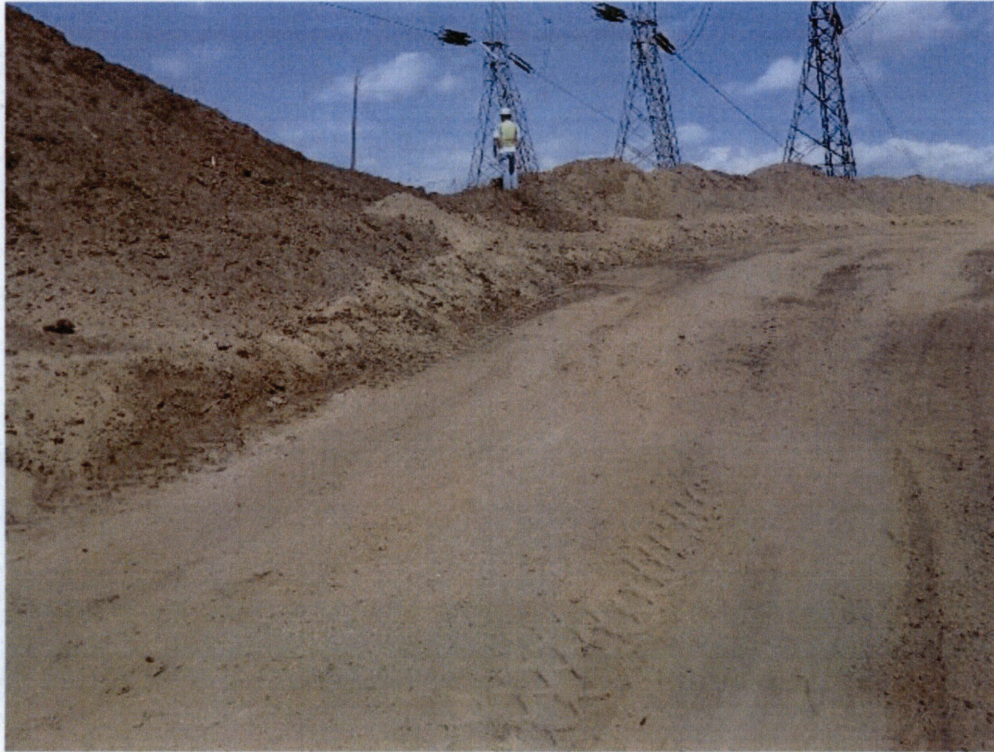
Report Photo #1 "Subsoil Mixing with Topsoil" at GPS Coordinates:

touching the topsoil pile.⁴¹ The inspector observed many areas of concern and met with the third party coordinator to explain the issues. The talks regarding the concerned areas were reported to go nowhere and no action was taken during the visit. Upon communication with the Project leader, another field visit was deemed required to immediately address and correct the issues.

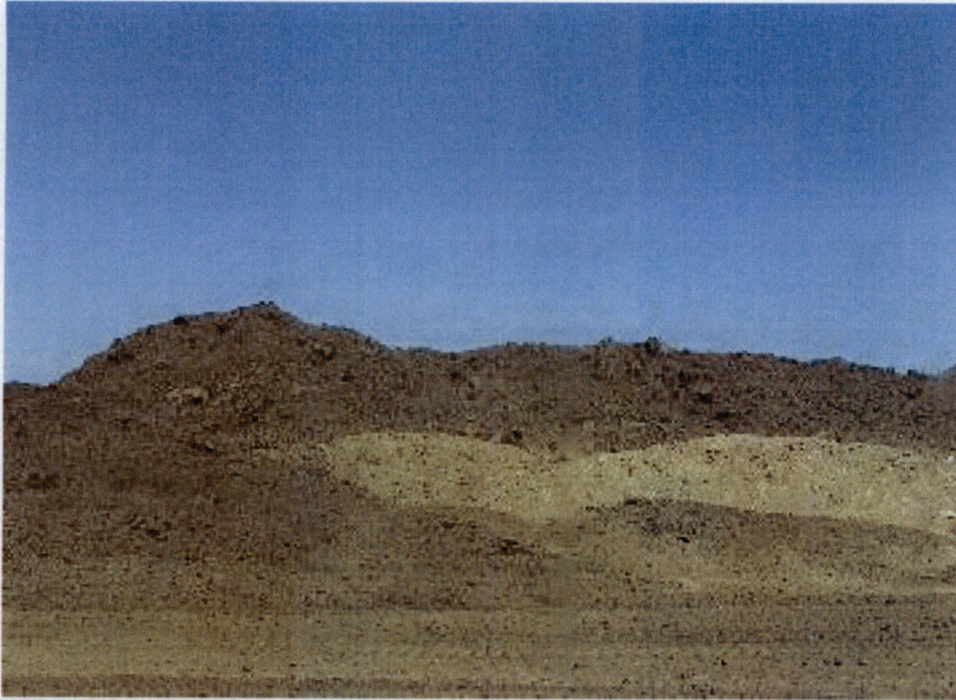
Report Photo #2 Topsoil and Subsoil Mix at GPS Coordinates:

- 5. May 20, 2016 – MP 167-170 in Emmons County near Cannonball –** An inspection showed many areas of excessive subsoil mixed with topsoil and subsoil piles touching topsoil piles.⁴² Topsoil segregation was found to be not adequate. Keitu inspector advised the third party coordinator to notify construction crews that there was insufficient segregation of topsoil and subsoil. Due to the inspection being from the same MP area in follow-up of the May 19, 2016 inspection, there is a redundant use of a documented picture.

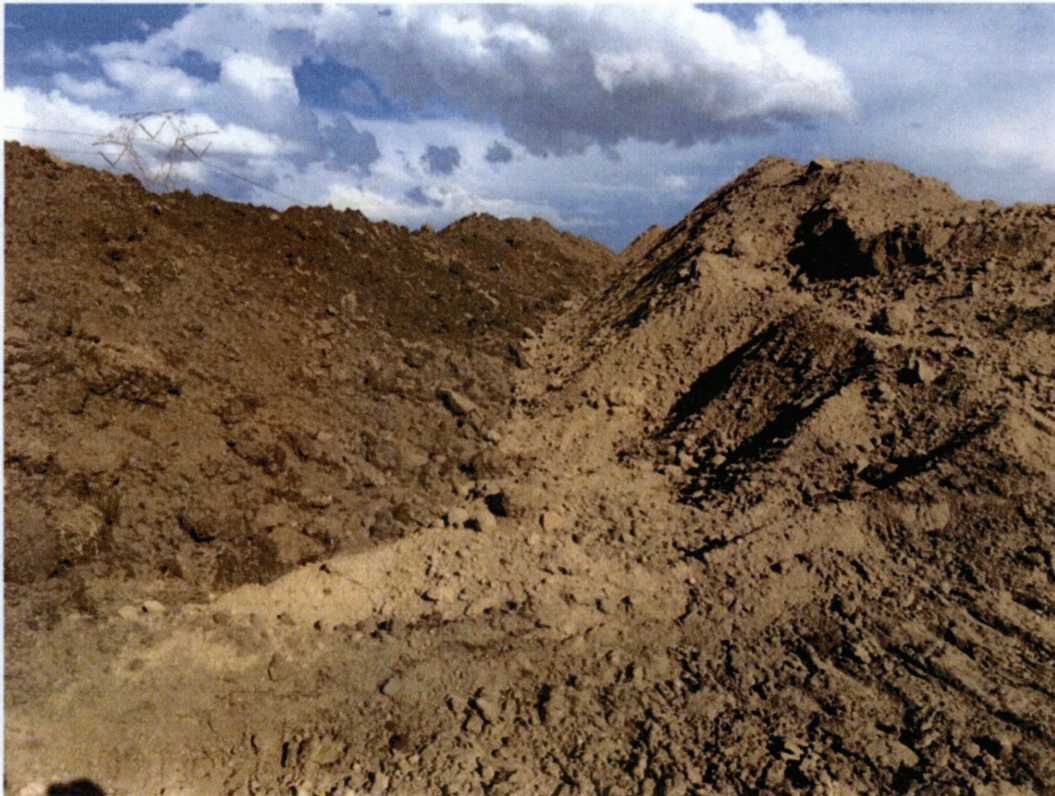
Report Photo #1 Topsoil and Subsoil Piles Bordering at GPS Coordinates: 46.417778° N 100.499722° W

6. **May 23, 2016 – Spread 6 in Emmons County near Cannonball** – An inspection reported storage of topsoil from subsoil piles to be inadequate in many areas upon visit.⁴³ Keitu inspector and third party coordinator agreed that a 2 foot buffer between the topsoil and subsoil piles should be kept.

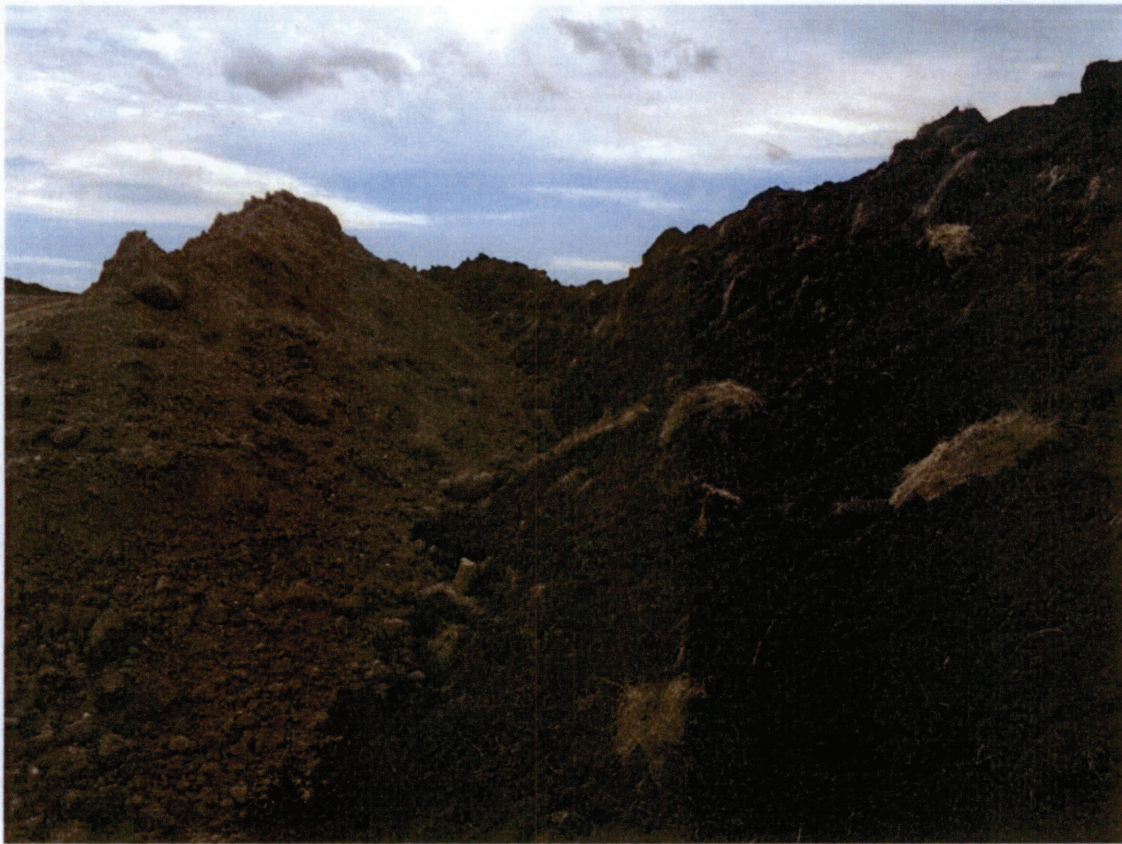
Report Photo #1 Topsoil and Subsoil Piles Bordering at GPS Coordinates: 47.524167° N 102.848444° W

7. **May 24, 2016 – MP 20.5-130.25 in Dunn County near Killdeer** – Storage of topsoil and subsoil piles was deemed inadequate in many areas. One area appeared to have subsoil stacked on topsoil.⁴⁴ During the visit, the inspector and third party coordinator documented many areas that needed further separation between topsoil and subsoil piles.

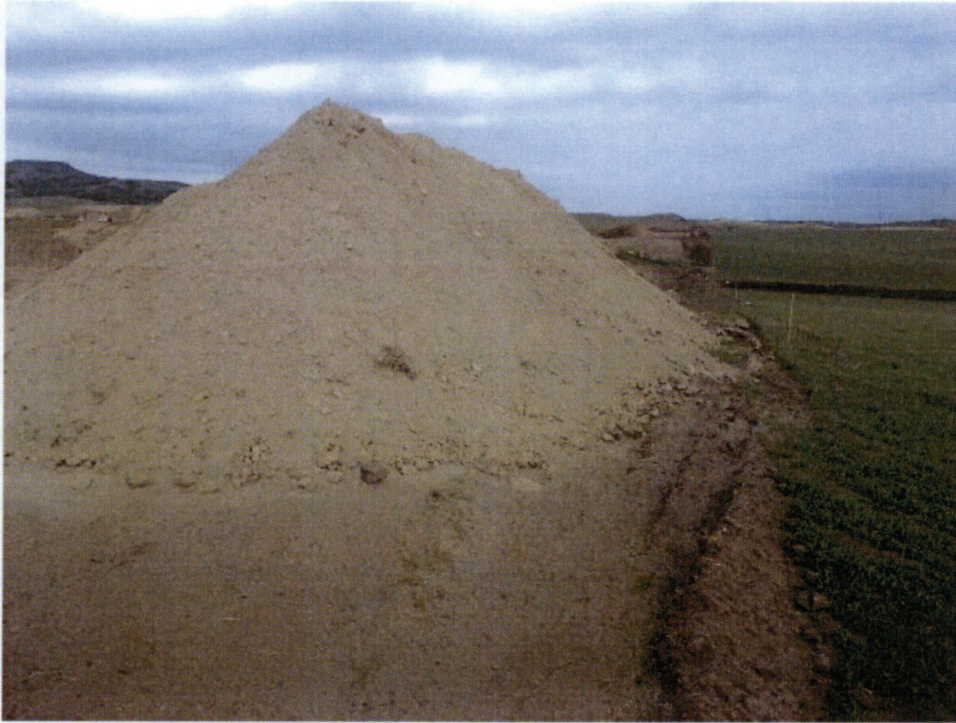
Report Photo #2 Subsoil piled on un-stripped ground at GPS Coordinates: 47.516944° N 102.835278° W

- 8. June 16, 2016 – Spreads 7 & 8 in Mountrail County near Medicine Hole -** During a 16 June 2016 inspection, Spreads 7 & 8 in Mountrail County, it was observed that the topsoil had rolled near or over the ROW boundary as the soil piles settled. The third party coordinator and Keitu inspector agreed that operators should be notified to leave more space between the soil pile and ROW boundary. Subsoil pile from the bore pit was stacked on unstripped surface. The third party coordinator notified the crew about making sure soil piles from bore pits were stripped of topsoil before stockpiling.⁴⁵

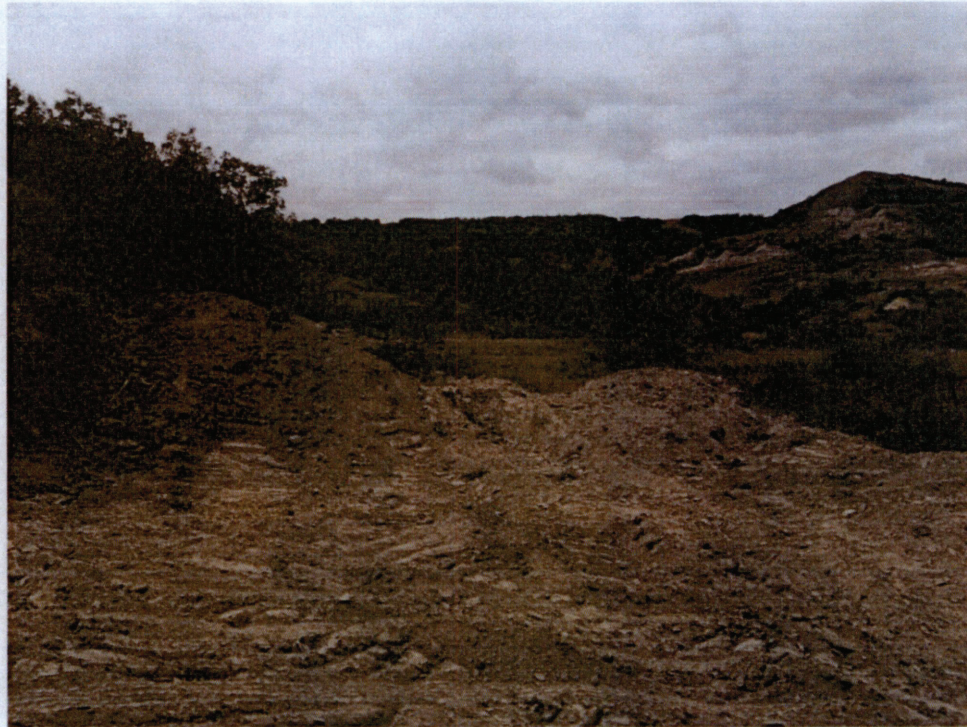
9. **August 4, 2016 – Slip HDD South of the Little Missouri River in Dunn County** - During the 4 August 2016 site inspection, Keitu reported a deficiency where one area of topsoil was stacked on top of stripped subsoil.⁴⁶ Keitu recommended leaving the soil pile at its current location as moving the pile would likely cause as much damage as leaving it at the current location.

NOTE: Topsoil stacked on subsoil

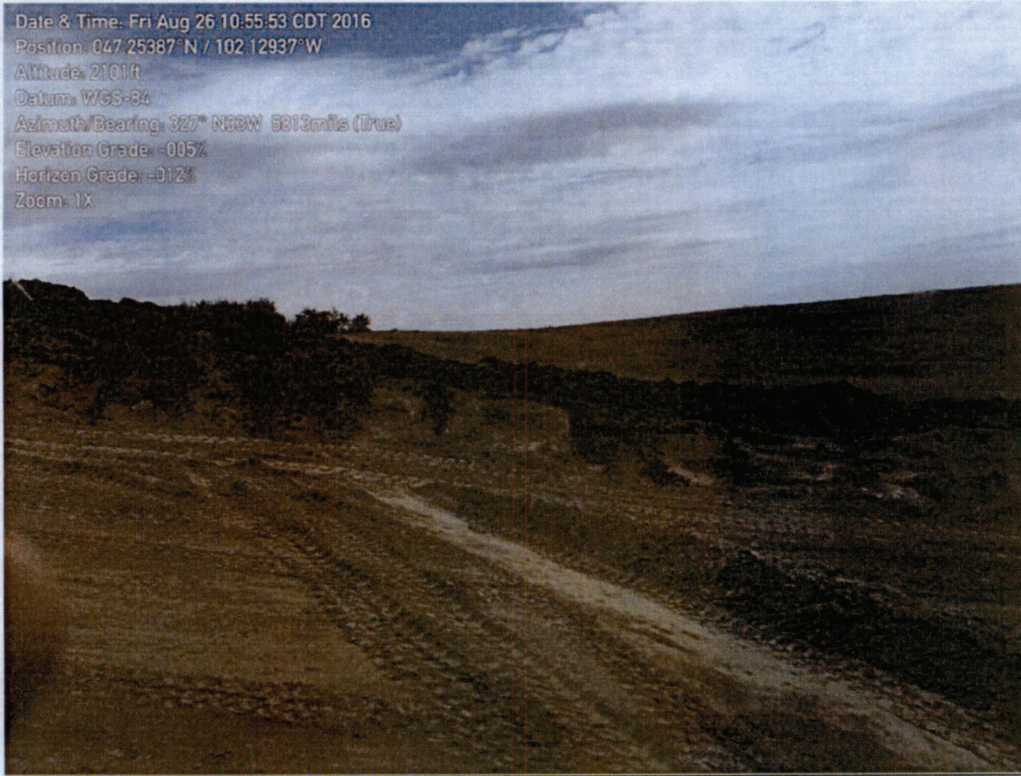
Report Photo #4 "Subsoil Cast on Topsoil Likely During Flow-breaker Install: 47.2539°N 102.1294°W

- 10. August 26, 2016 – MP 61 to 65, 2.3 miles SE of Dodge, ND** - On a 26 August 2016 site inspection trip, Keitu reported a minor probable violation including 3 short areas of minor subsoil contact with topsoil or surface vegetation with one area specifically associated with a late stage install of a flow breaker on a steep slope of the ROW as opposed to the initial top soil stripping⁴⁷.

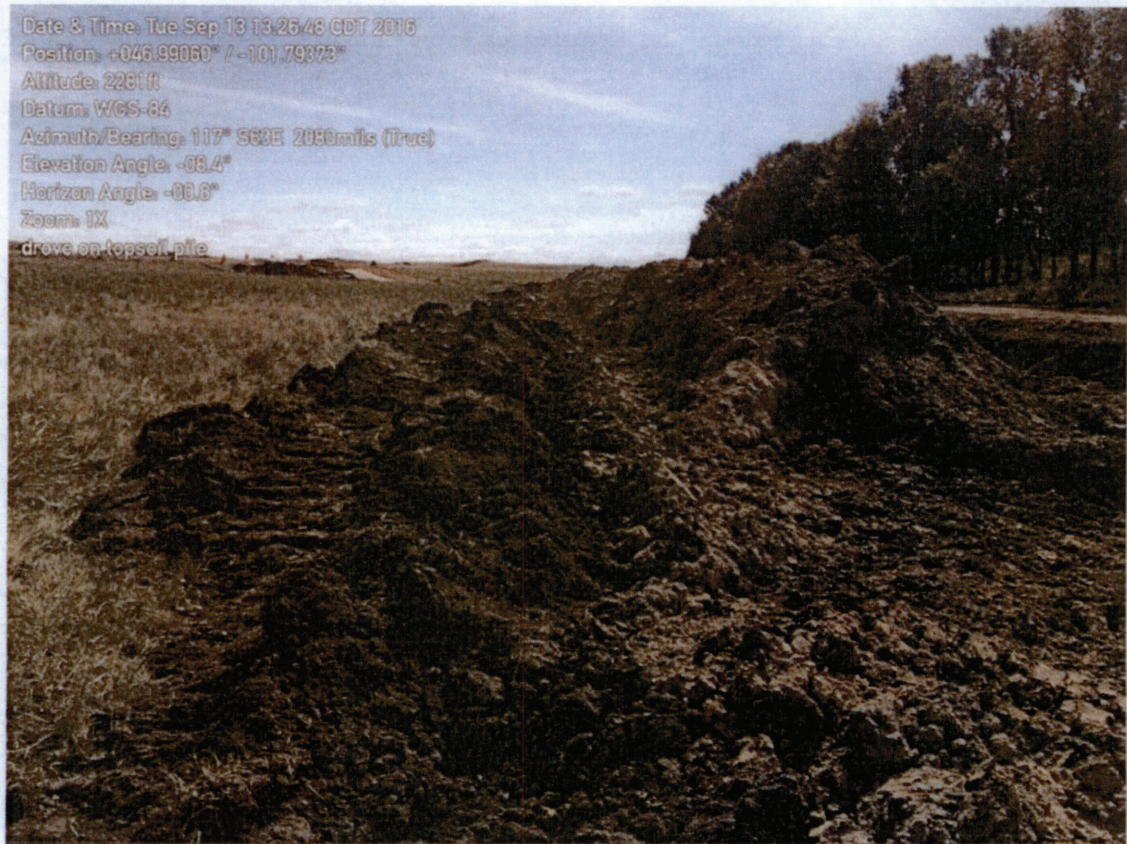
Report Photo #1 "Topsoil Driven over, Soils Mixing at M.P. 92":

- 11. September 13, 2016 – MP 75-92 – 17 miles South of Beulah in Mercer County** - A 13 September 2016 site inspection trip stated that although the majority of the topsoil/subsoil segregation was adequate for the inspected ROW, there were three deficient spots where topsoil/subsoil was missing, piled on vegetated surfaces, or had heavy equipment drive over the piles, mixing topsoil and subsoil⁴⁸.

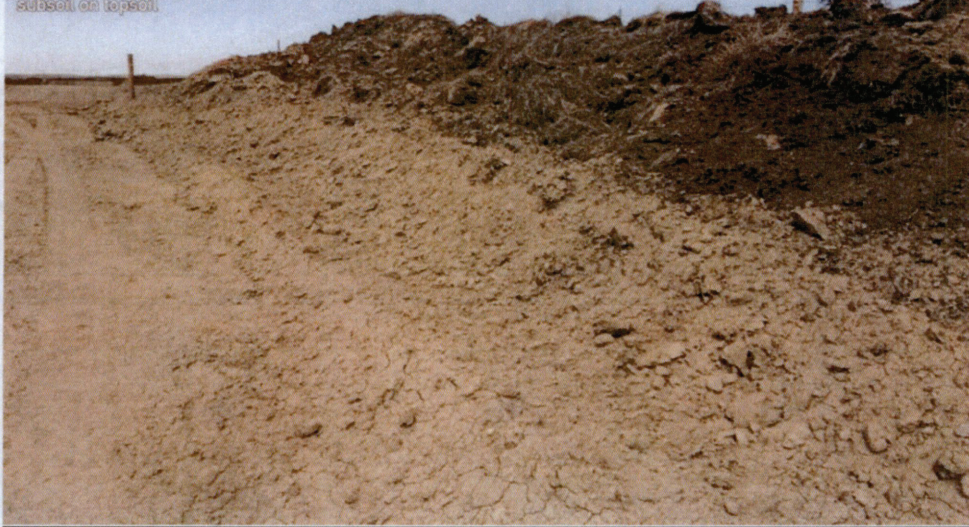
Report Photo #3 "Subsoil Plowed onto Topsoil at M.P.91.25:

Date & Time: Tue Sep 13 13:43:21 CDT 2016
Position: +046.99338° / -101.79533°
Altitude: 2294ft
Datum: WGS-84
Azimuth/Bearing: 024° N24E 0427mils (True)
Elevation Angle: -05.8°
Horizon Angle: -00.7°
Zoom: IX
subsoil on topsoil

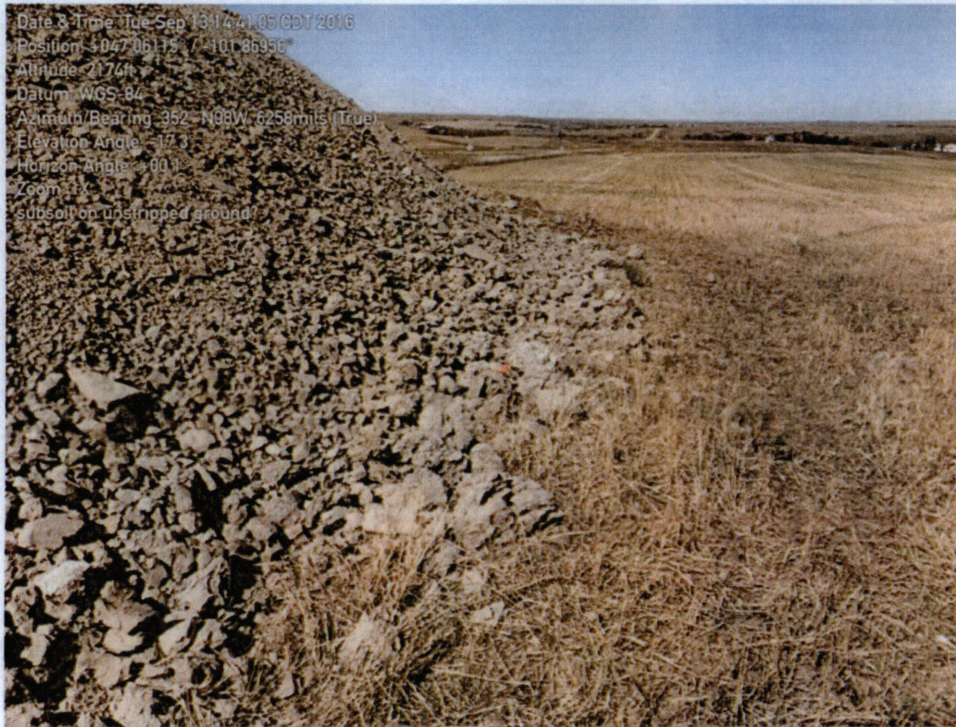
Report Photo #5 "Subsoil On Top of Vegetation, No ROW Stakes":

Date & Time: Tue Sep 13 14:41:05 CDT 2016
Position: +047.06115° / -101.86956°
Altitude: 2174ft
Datum: WGS-84
Azimuth/Bearing: 352° N08W 6258mils (True)
Elevation Angle: -17.3°
Horizon Angle: -00.1°
Zoom: IX
subsoil on unstripped ground

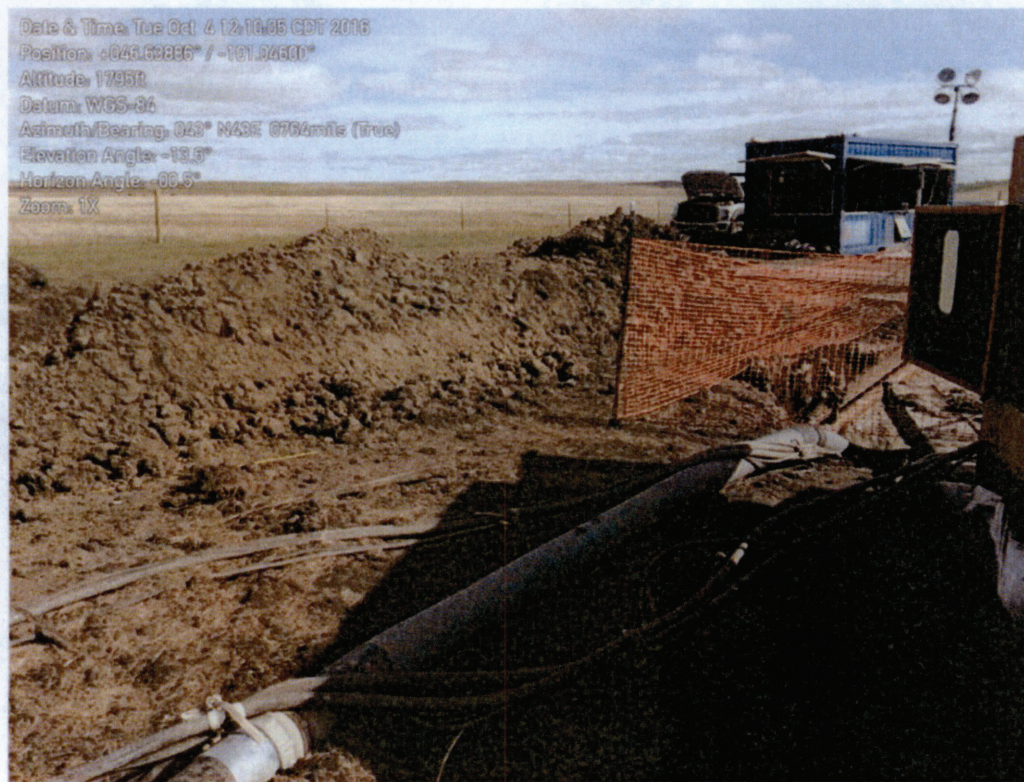
Report Photo #2 "Subsoils from HDD Bore Entry Pit on Unstripped Ground: 46.63866°N 101.04600°W

An inspection showed that subsoil piles from trenching were bordering and overlapping with the topsoil pile and subsoil was stored over unstripped ground. The lead inspector claimed he was advised by an Ag inspector to place straw mulch under the pile when piling on topsoil. However, straw mulch was not visible during the site visit in these areas. Rainfall appeared to have caused much of the overlapping. Two areas had subsoil cast on or plowed onto adjacent topsoil for a limited duration.⁵³

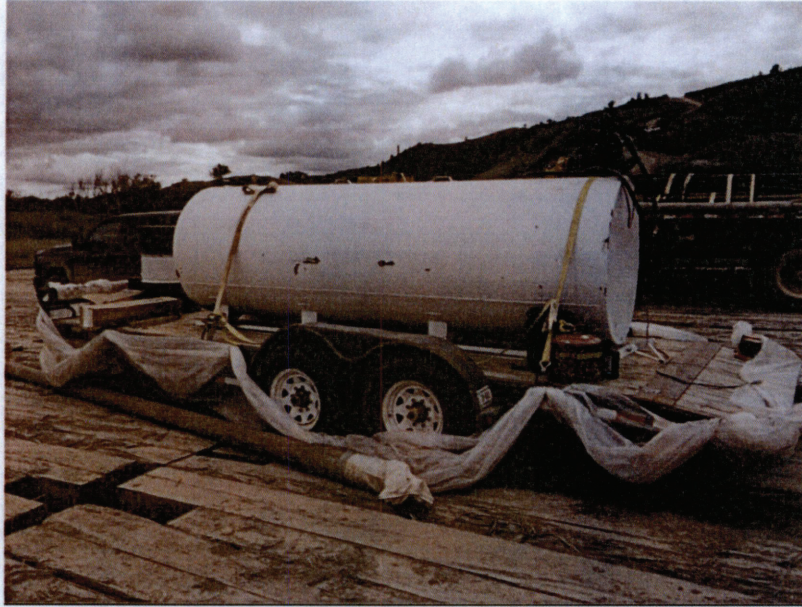
Report Photo #8 “Fueling Trailer” at GPS Coordinates: 47.6087°N 102.8765°W

On August 4, 2016, the inspector noted a deficiency where a secondary fuel tank located at the worksite trailer had been at the site for four days protected only by plastic

sheeting beneath the tank.⁶¹ The inspector stated that the “[s]ite personnel understood, without prompting, that the secondary containment for the fuel trailer was not adequate. Possible modifications were discussed to correct item.”⁶²
