Revegetation and Reclamation Inspection Report
Dakota Access, LLC
Dakota Access Pipeline Project
ND PSC Case No. PU-14-842

Reclamation and Revegetation Inspection Report

Dakota Access Pipeline Project

ND PSC Case No. PU-14-842

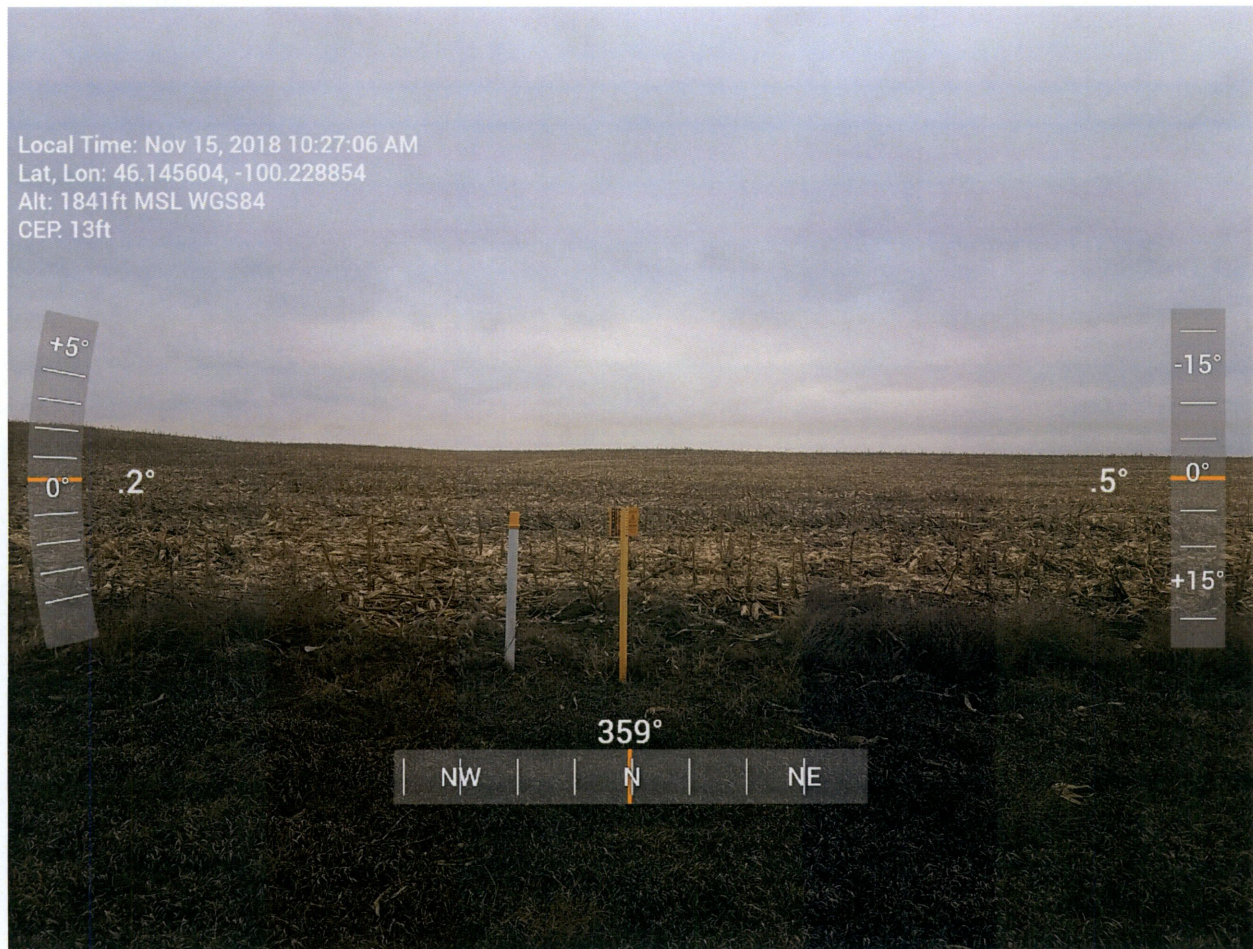
Report Photo #1: Typical ROW conditions in corn field. Vegetation appeared to be the same within the ROW as outside of the ROW.

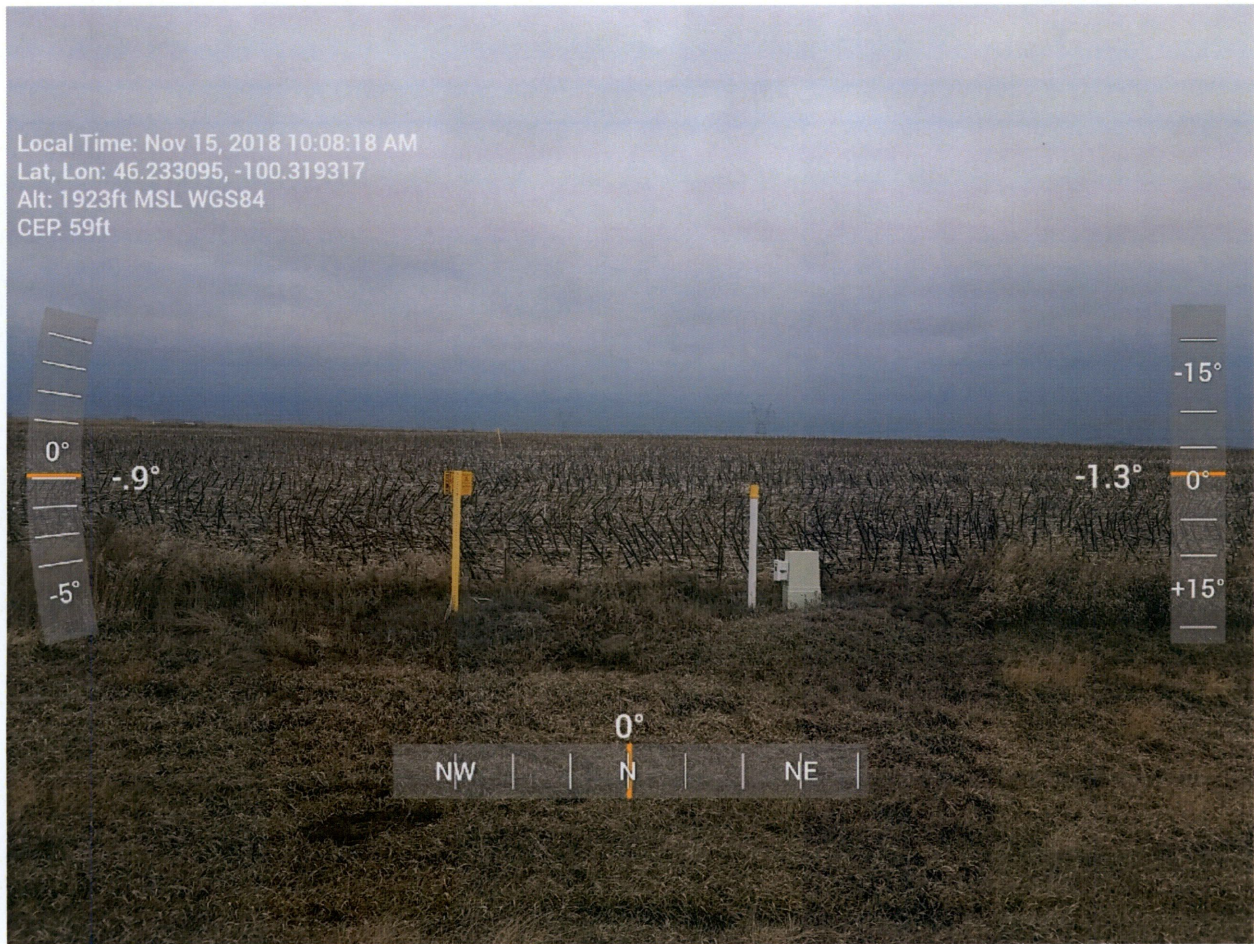
Report Photo #2: Typical ROW conditions in sunflower field. Vegetation appeared to be the same within the ROW as outside of the ROW.

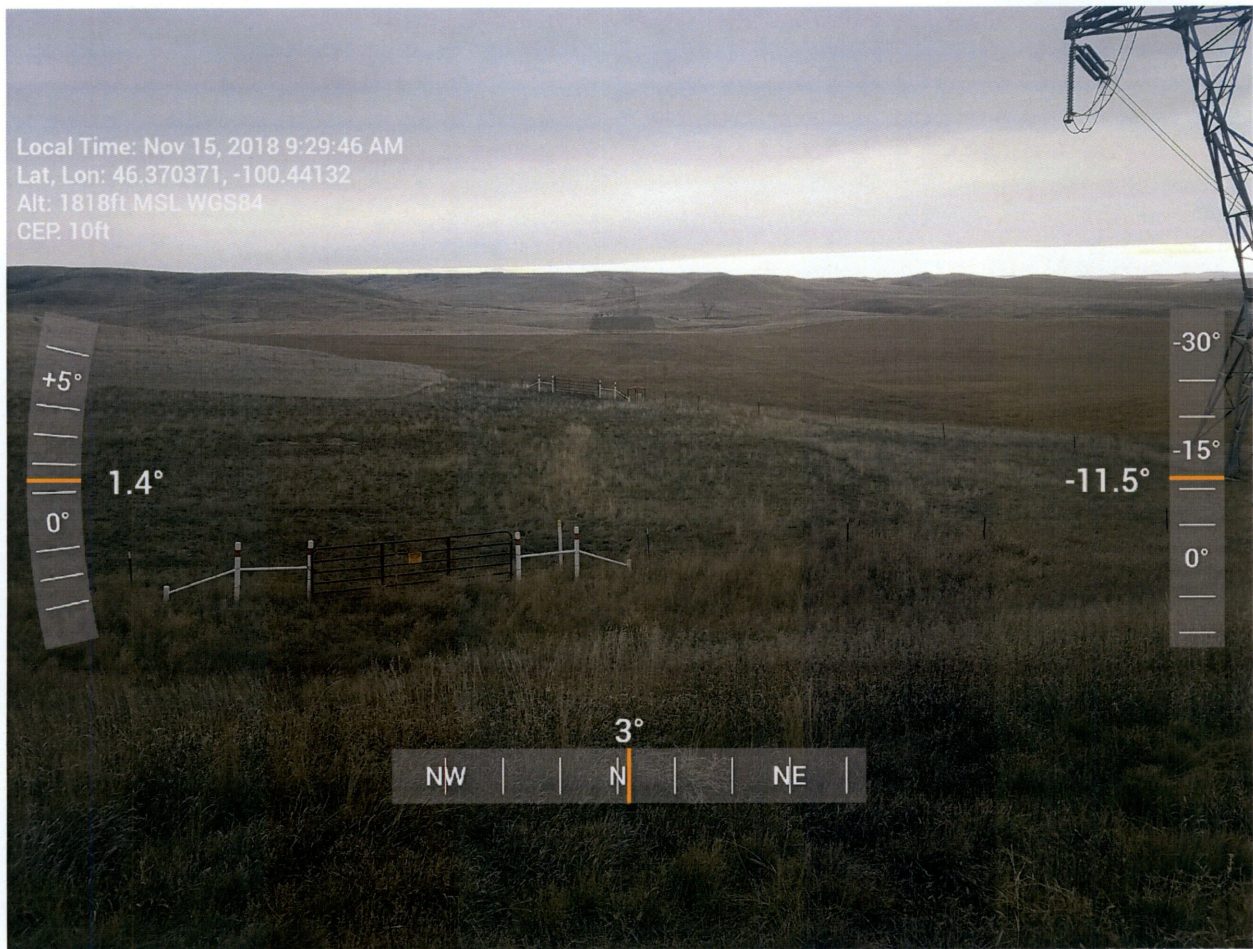
Project areas occurring in crop lands appeared to be largely returned to pre-construction conditions at the time of visit. Cropland density appeared to be similar within the Right-of-Way (ROW) as it is adjacent to the ROW. Portions of the Project occurring in range or pasture land had approximately 50-100% ground cover and generally is comprised of a different mixture of vegetative species than surrounding range and pastureland. It is noteworthy that seeding of these non-cropland areas involved a specific seed mixture as detailed in the Project's revegetation plan, and consistent with NRCS recommendations. However, some small areas of non-cropland appeared to have dominant undesirable species present, which unfortunately is common during the early stages of revegetation.

Report Photo #3: View of typical ROW across pasture and agriculture fields. Revegetation is not identical to adjacent land outside of ROW.

Active maintenance, including herbicide application, should continue for at least another year to discourage growth of weeds or other undesirable species.

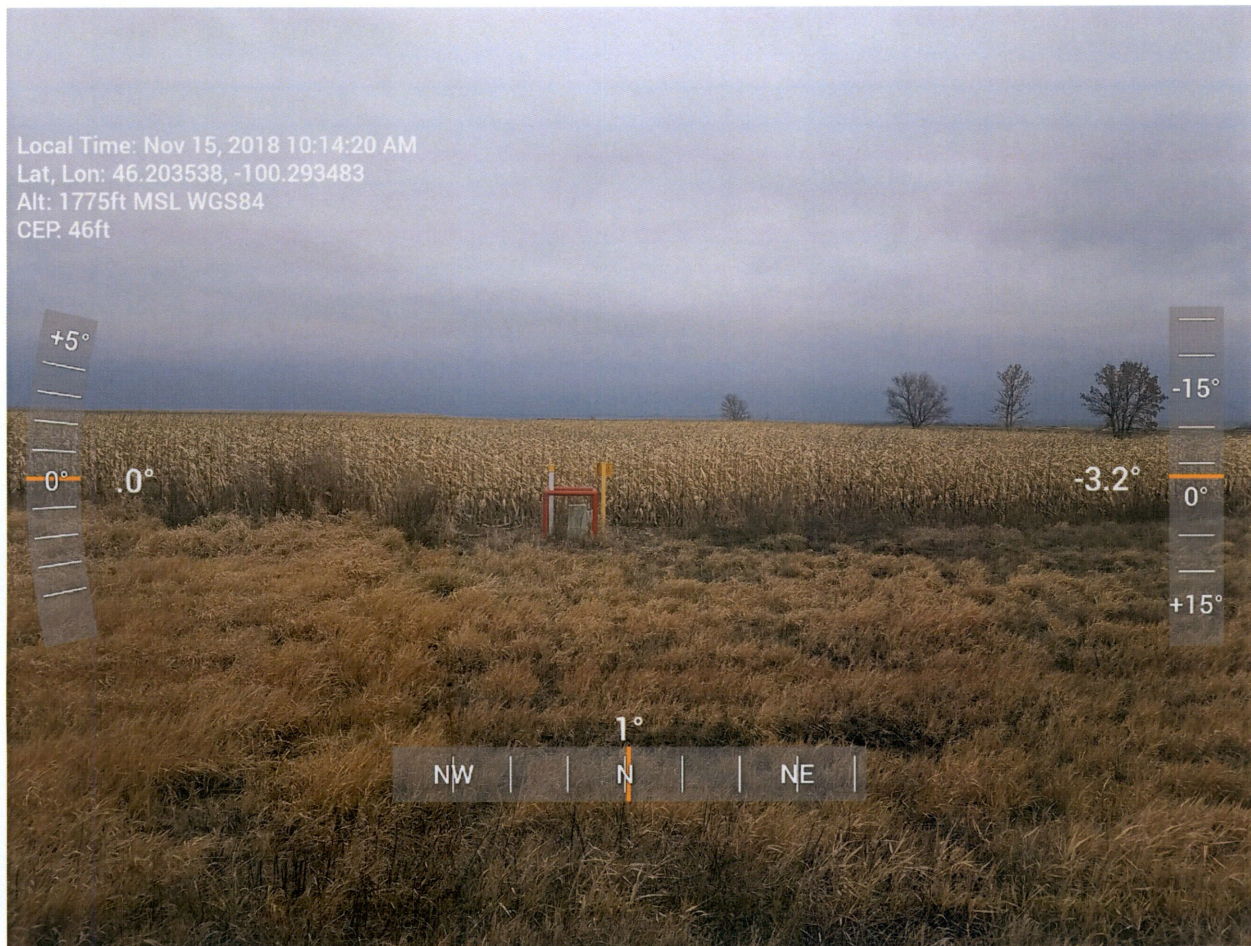
Report Photo #4: Typical ROW conditions in corn field. Vegetation appeared to be the same within the ROW as outside of the ROW.

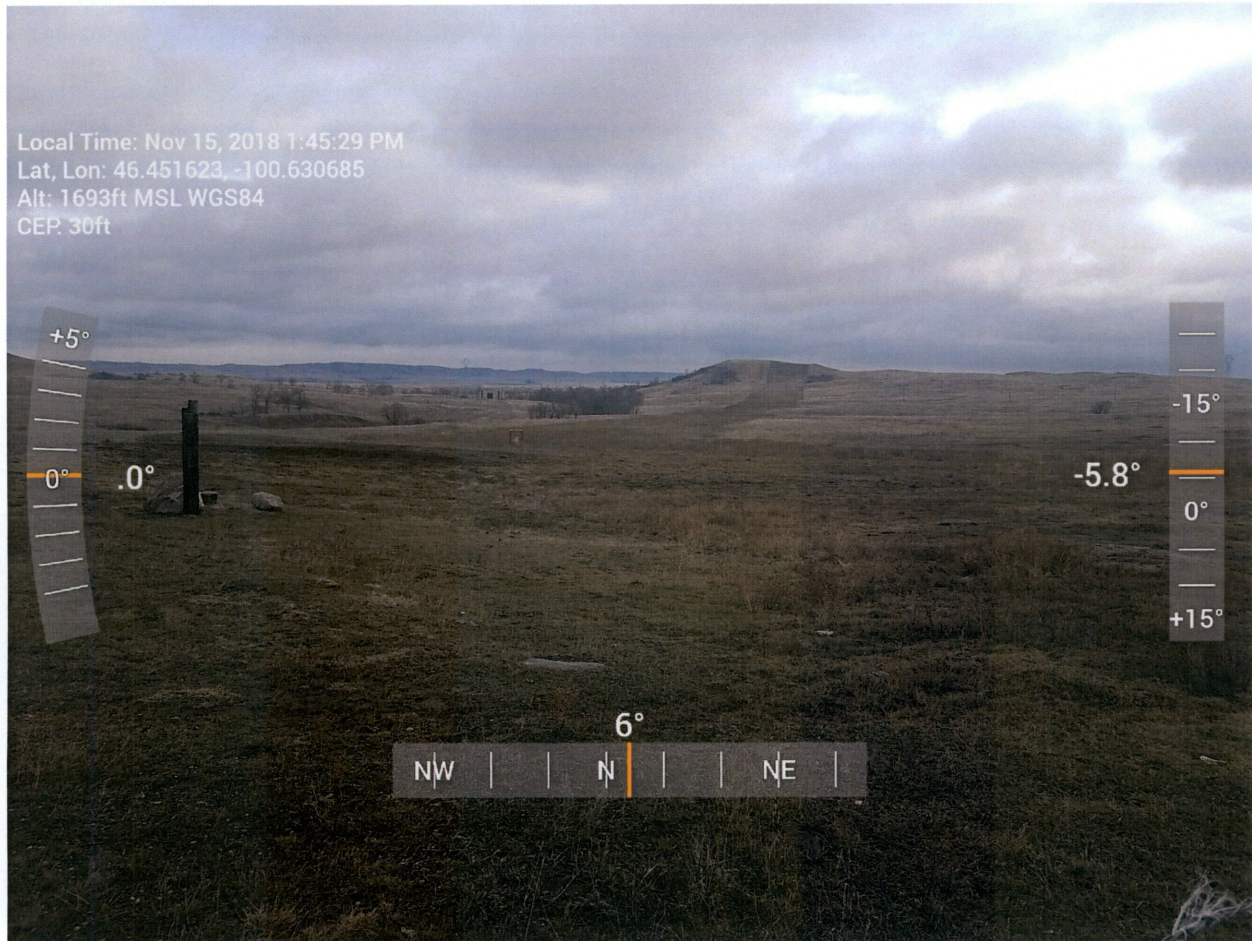
Report Photo #5: Visible Project ROW across pastureland.

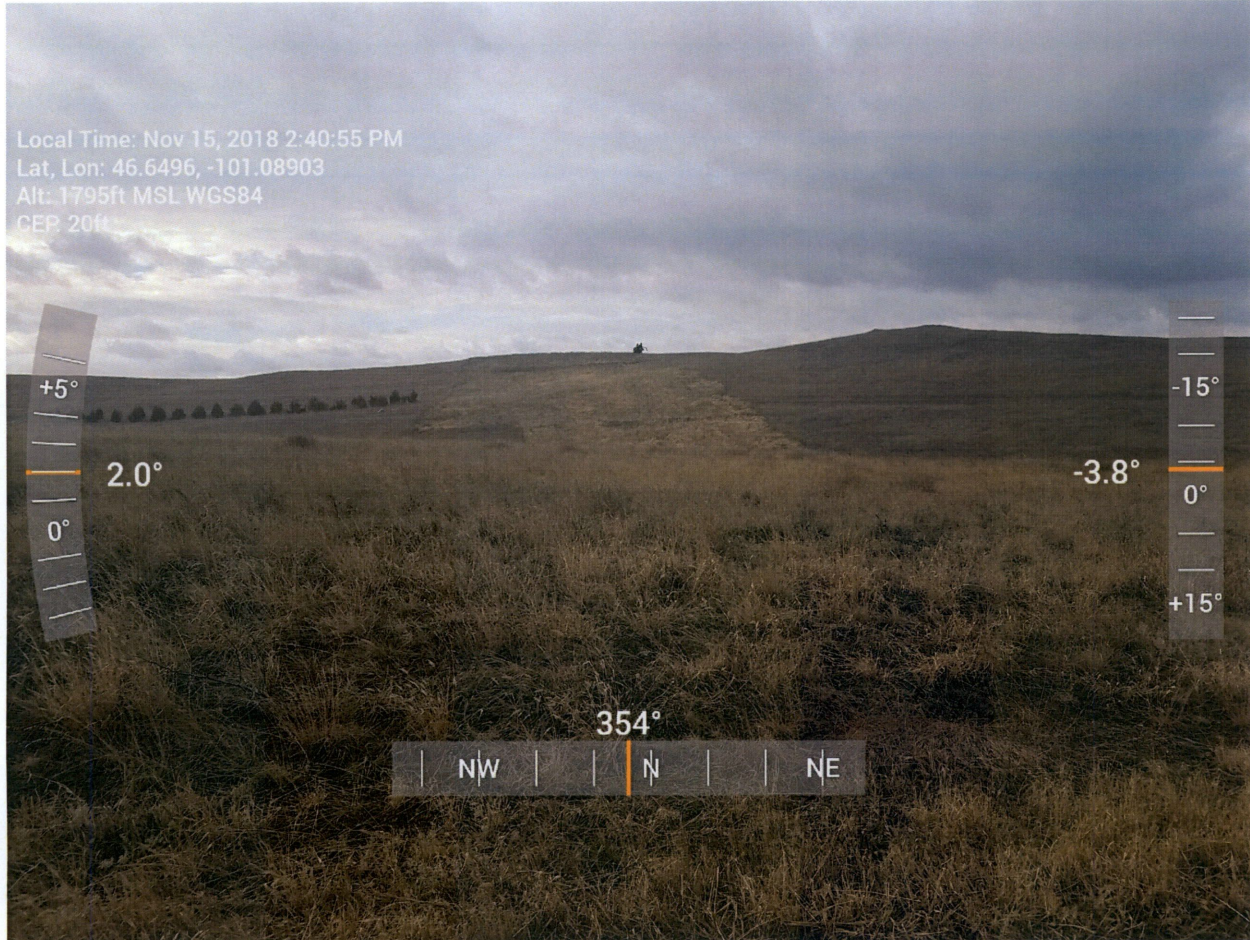
Report Photo #6: Visible Project ROW across pastureland.

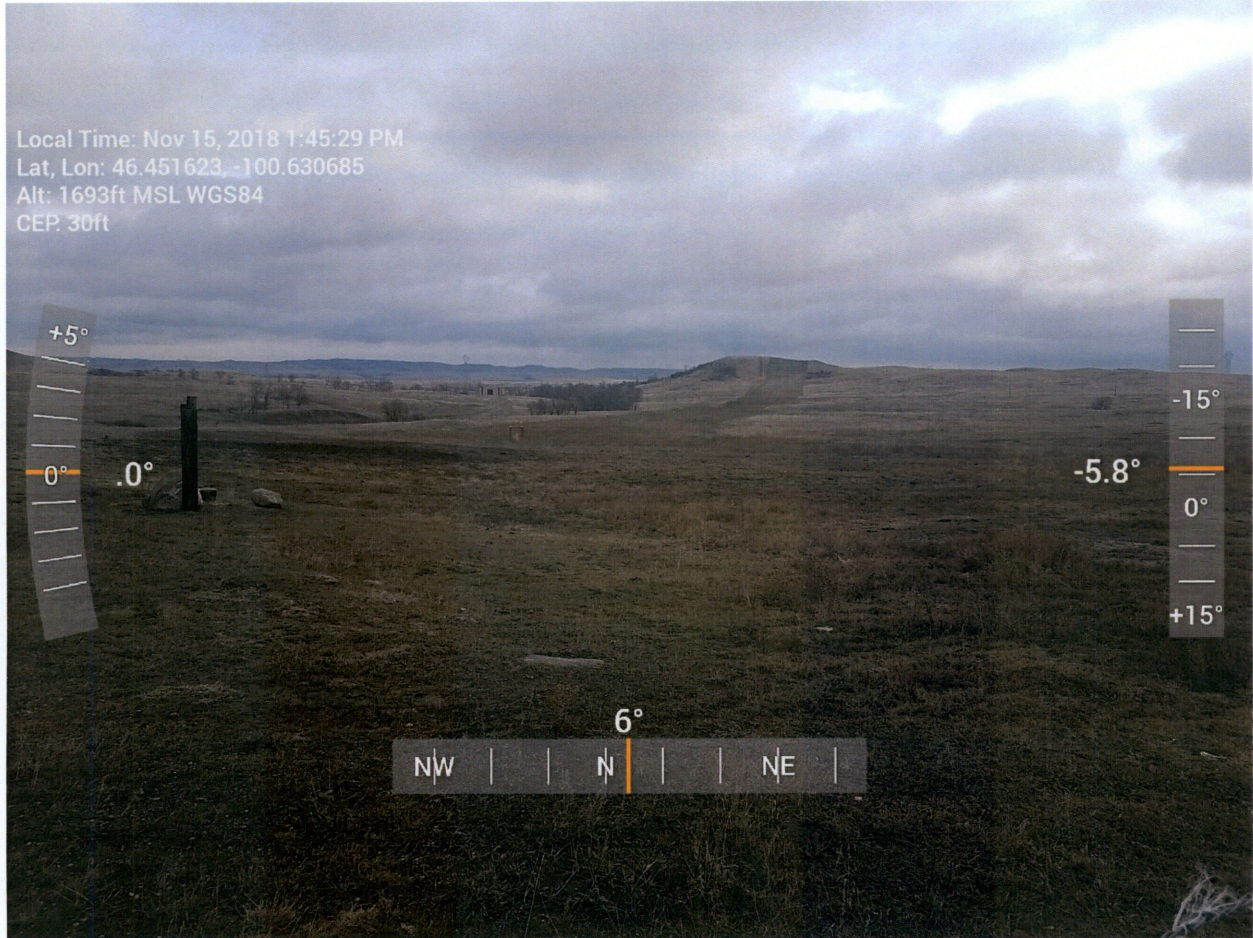
Report Photo #7: Visible Project ROW across pastureland.
