## LONESOME CREEK STATION PHASE III PROJECT

GENERAL INFORMATION		
<b>Environmental Inspector:</b>  Bernie Campbell	<b>Inspection Date &amp; Time:</b>  09/15/2015	<b>Report Number:</b>  LCSP3-20150916-BC
<b>Weather:</b>  55* clear & calm	<b>Precipitation (last event):</b>  9/5/15  7/8"	<b>On-Site Staff Worked With &amp; Affiliation:</b>  Chris Miller – Basin Electric
	<b>ROW Conditions:</b>  Dry	
DAILY CONSTRUCTION ACTIVITIES		
<p>Provide a description of construction activities (i.e. construction techniques, meetings, construction progress, route adjustments, etc.). Additionally, provide a description of general environmental impact mitigation efforts on site (i.e. top soil segregation, depth of cover, fuel storage areas, erosion control devices, restoration activities etc.)</p> <p>Site grading, other earth works, structure construction, and general construction are all on-going. No adjustments in construction plans were relayed to inspector.</p> <p>Top soil storage had been prepared for seeding, which will take place in the next few days per Chris Miller.</p> <p>ECDs west of pond; silt fence installed incorrectly (south portion not keyed in), silt fence overwhelmed and knocked do

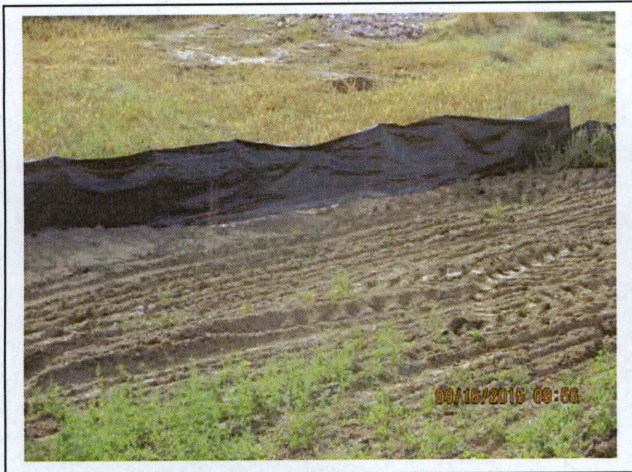
1. West of pond, silt fence installed incorrectly (not keyed in)

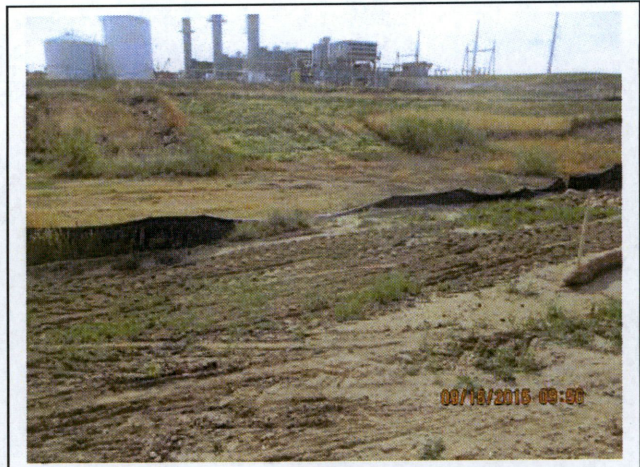
2. West of pond, silt fence overwhelmed and knocked down.

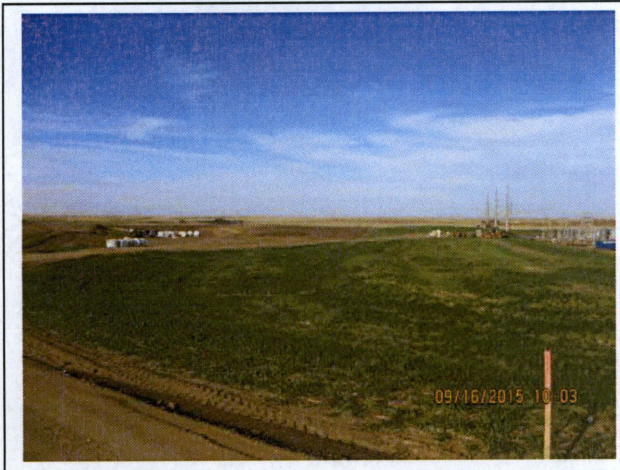
3. Top soil storage area in background, prepared for seeding.
