Basin Electric Lonesome Creek Station Phase III Project (PU-14-852)

62 **PU-14-852** Filed: 5/9/2016 Pages: 9
Construction Inspection Report

Project Name: Lonesome Creek Station Phase III **Date:** 4/28/2016
PSC Case Number: PU 14-852 **Time:** 0900
Inspector: Jon Knudsen, E3 Environmental, LLC **Weather:** Cloudy, saturated

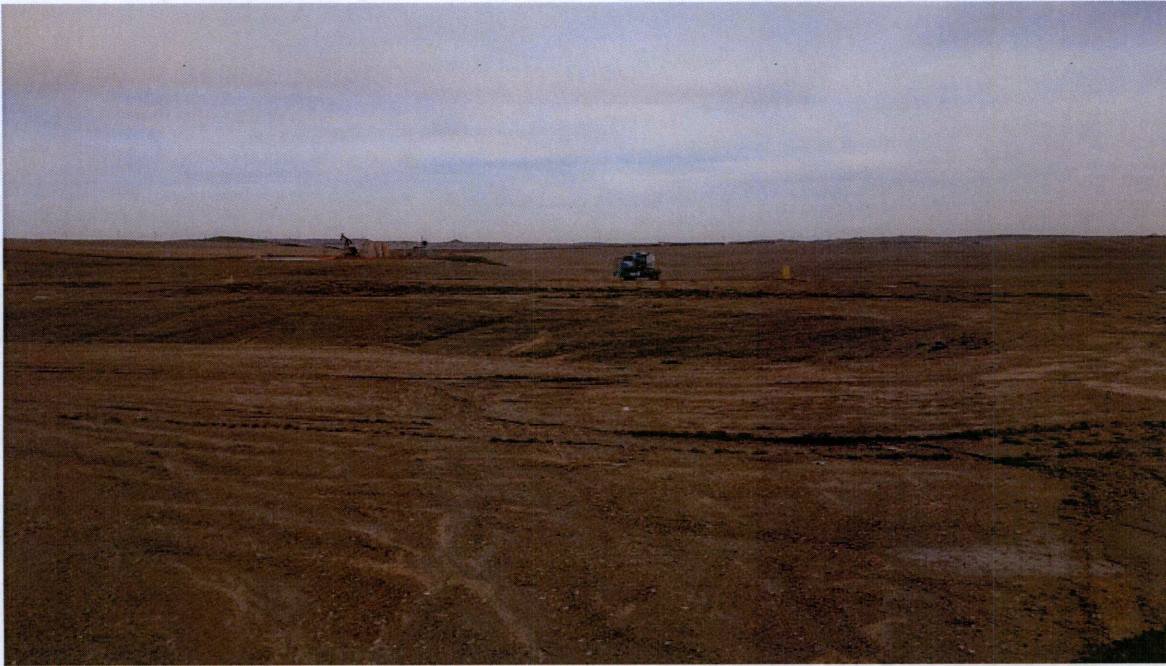
Photo 1. Unseeded/reclaimed portion of Project site with equipment sitting on level ground.

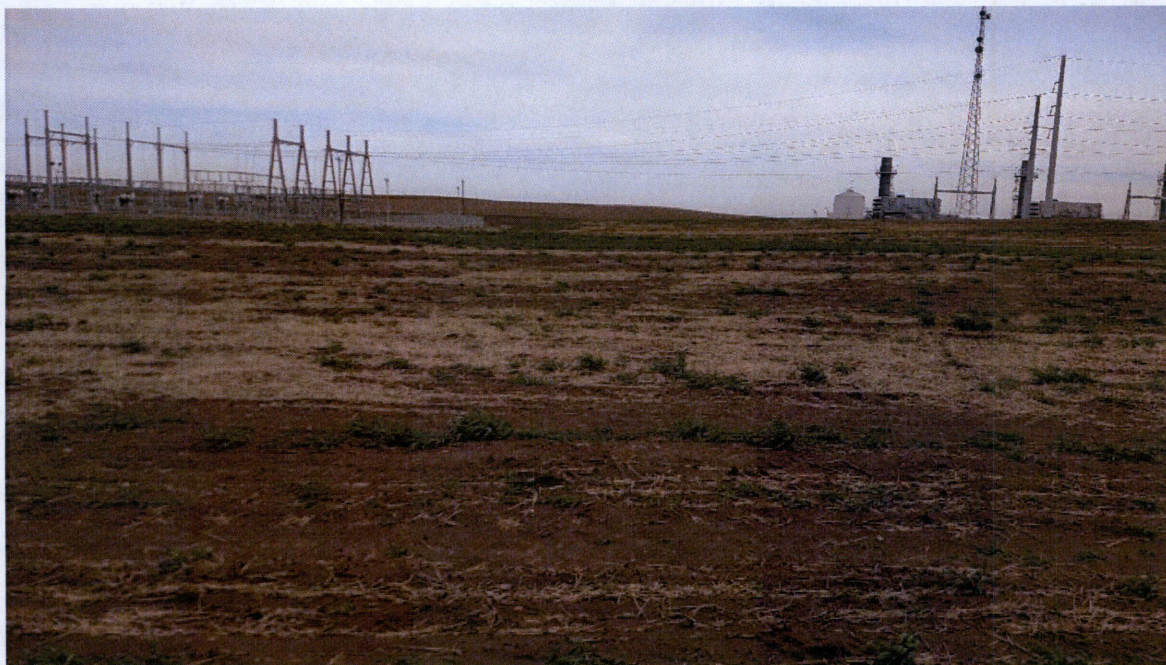
Photo 2. Partially re-seeded area of the Project site, showing reclamation progress.

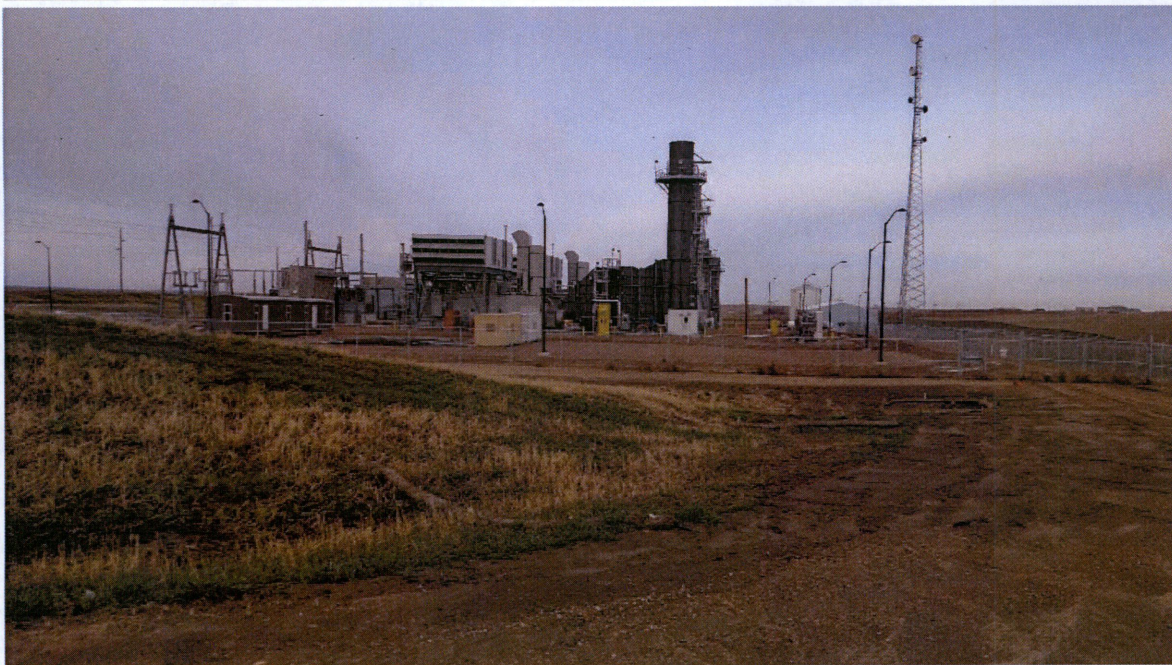
Photo 3. Lonesome Creek Station with partially-reclaimed sideslope and properly-installed waddles.

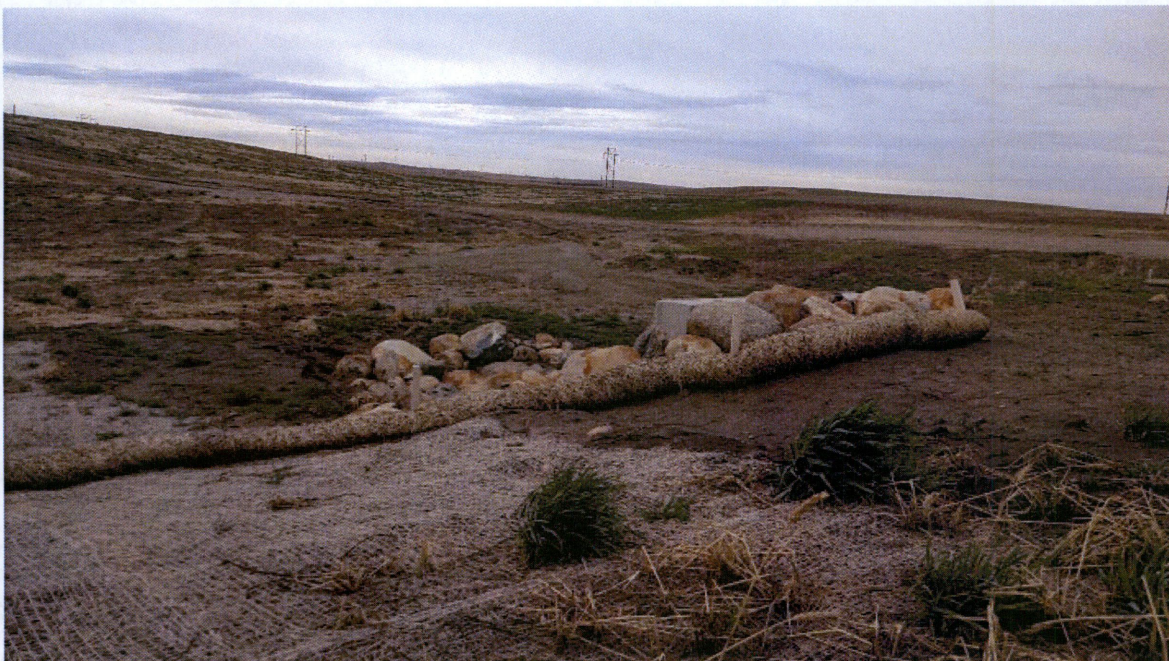
Photo 4. A wetland armored by riprap, a culvert, erosion mats, and waddles.

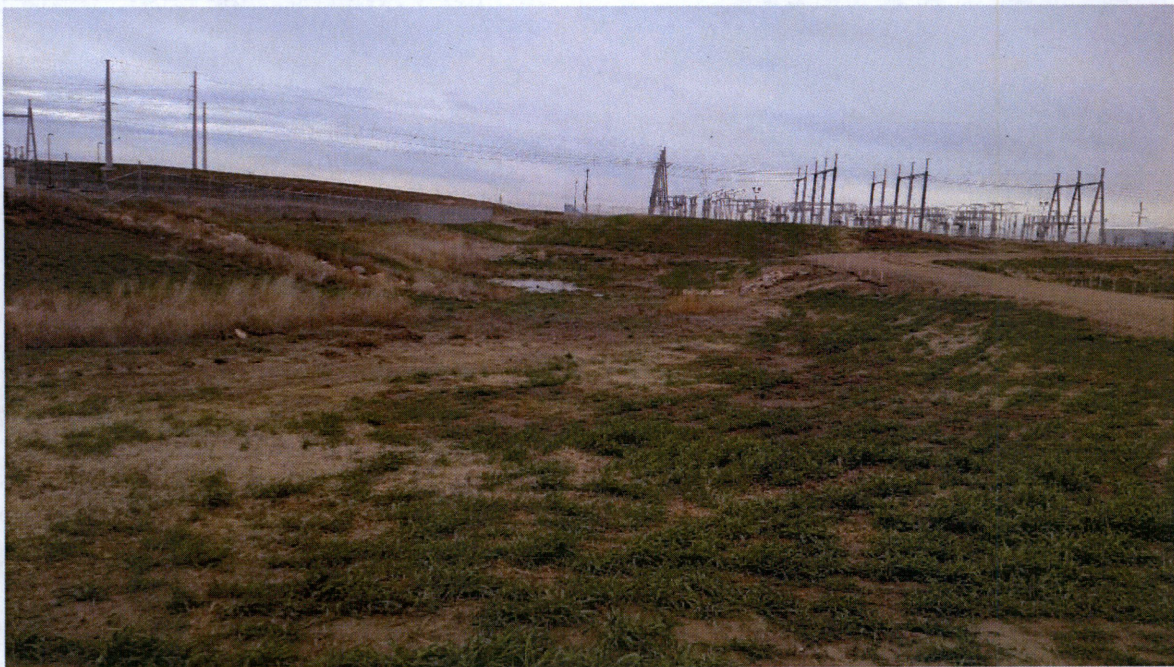
Photo 5. A wetland within the Project site with a culvert, riprap, and waddles.

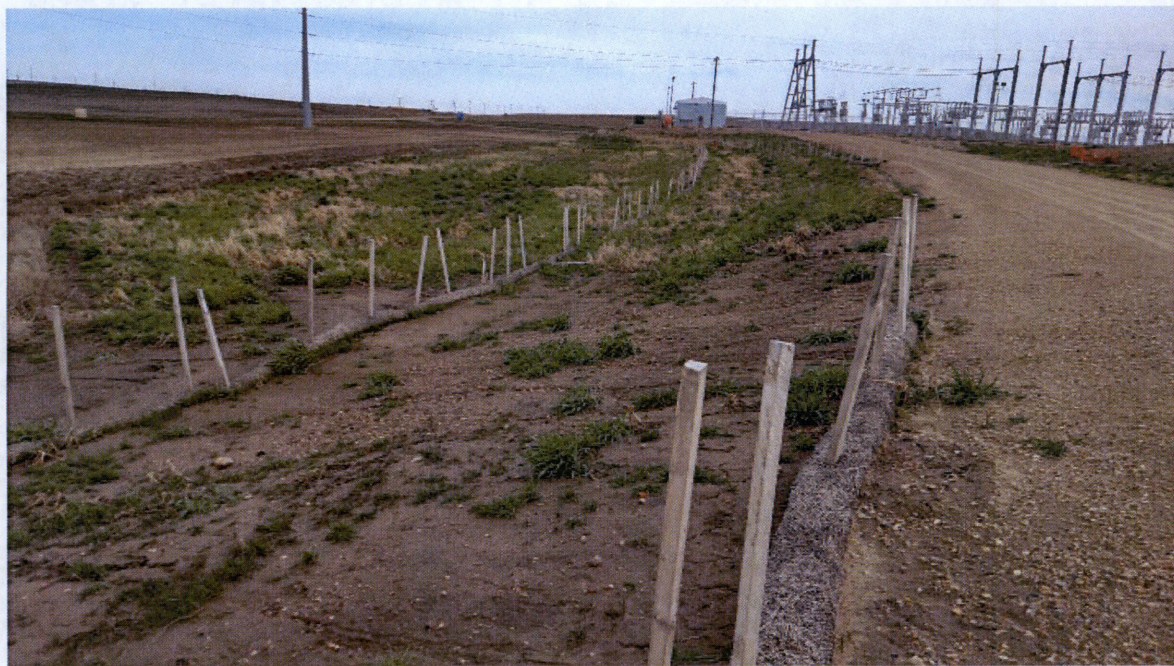
Photo 6. Waddles beginning to load up with sediment from recent rain event.
