RE: PU-14-853 3rd Party Inspections

64 PU-14-853 Filed: 6/10/2019 Pages: 7
Construction Inspection Report

Project Name:	Little Missouri Gas Plant	Date:	5/30/2019
PSC Case Number:	PU 14-853	Time:	0945
Inspector:	Chris Schmidt, E3 Environmental, LLC	Weather:	Sunny and dry

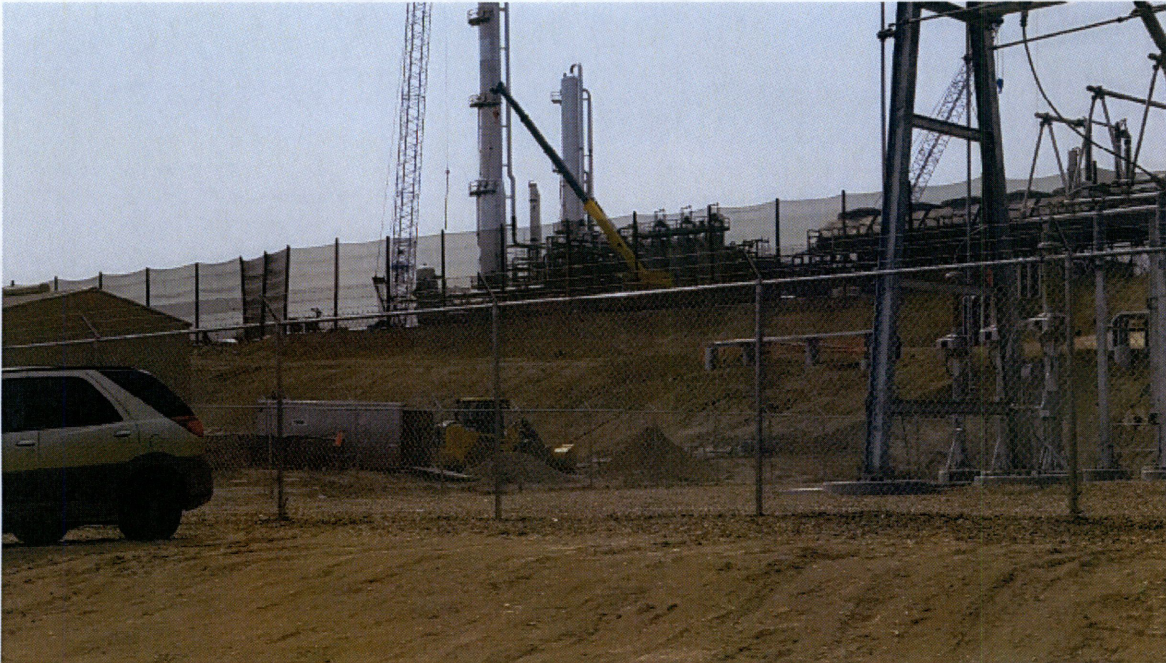
Photo 1. Looking southeast at LMGP IV from electrical substation in Parcel 3. Construction still underway with restoration activities to follow.

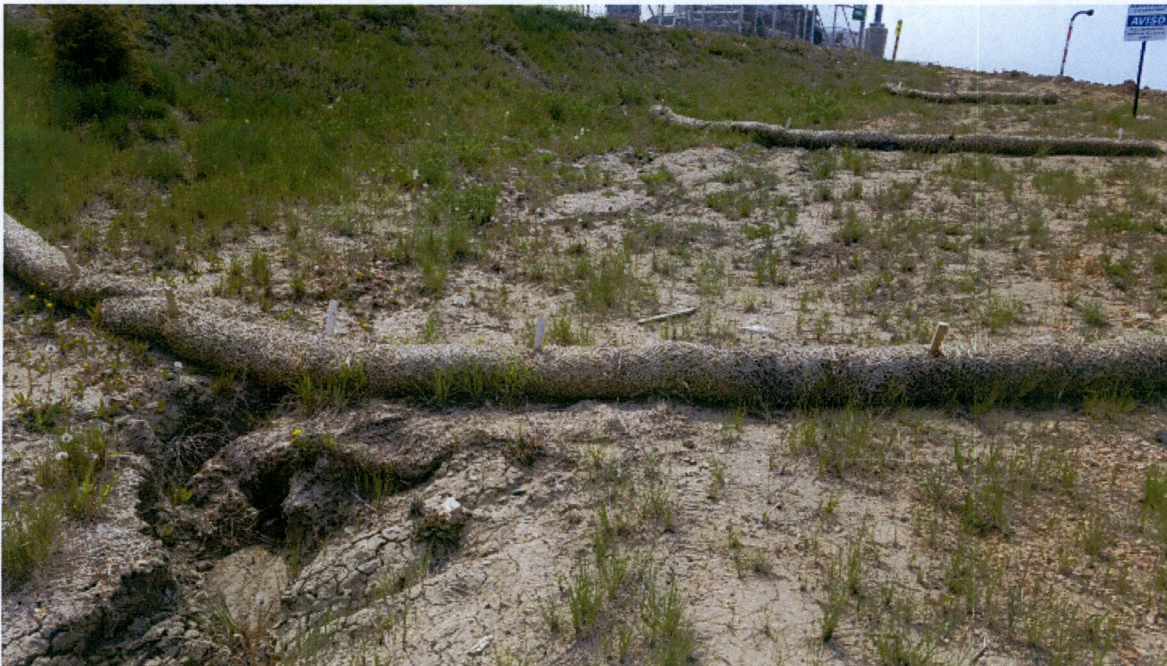
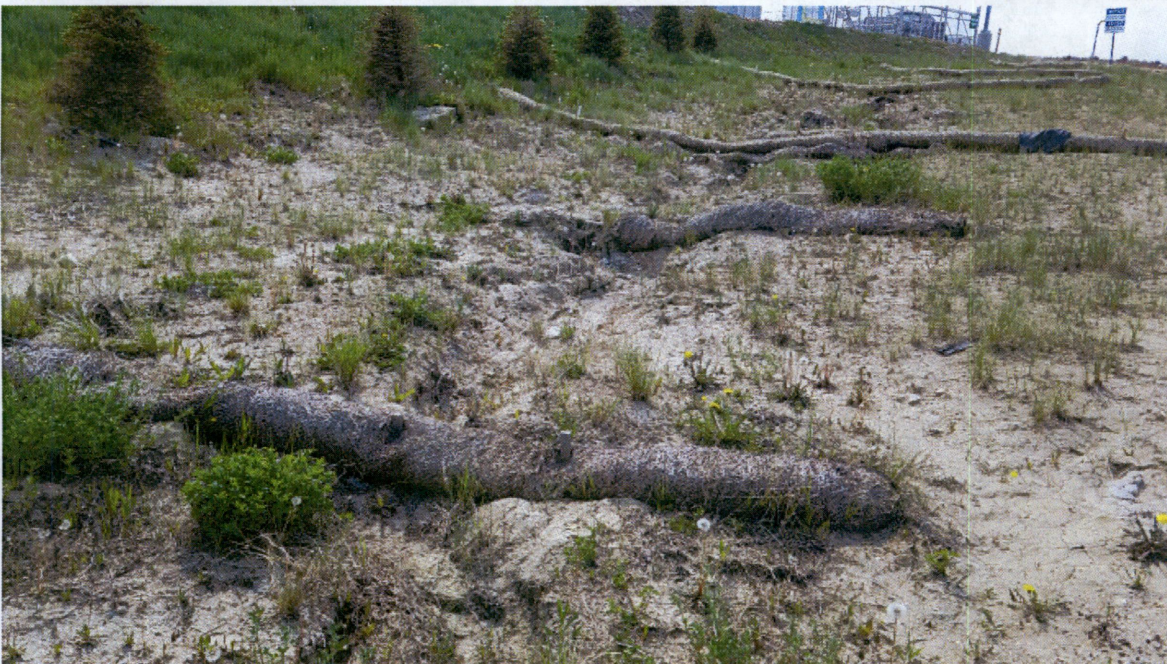
Photo 2 & 3. Wattles along southern edge of Parcel 2 near access road. Rilling/erosion has occurred under the wattles. Recommend re-contouring/grading and replacing ECDs.

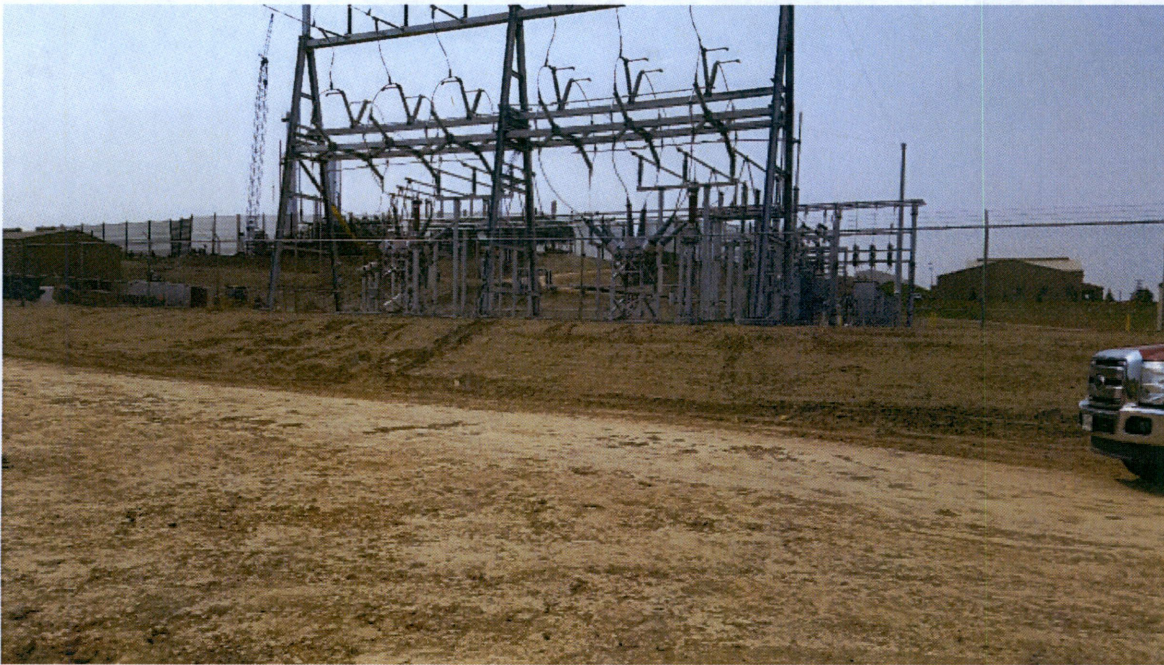
Photo 4. Looking south at electrical substation located within Parcel 3.

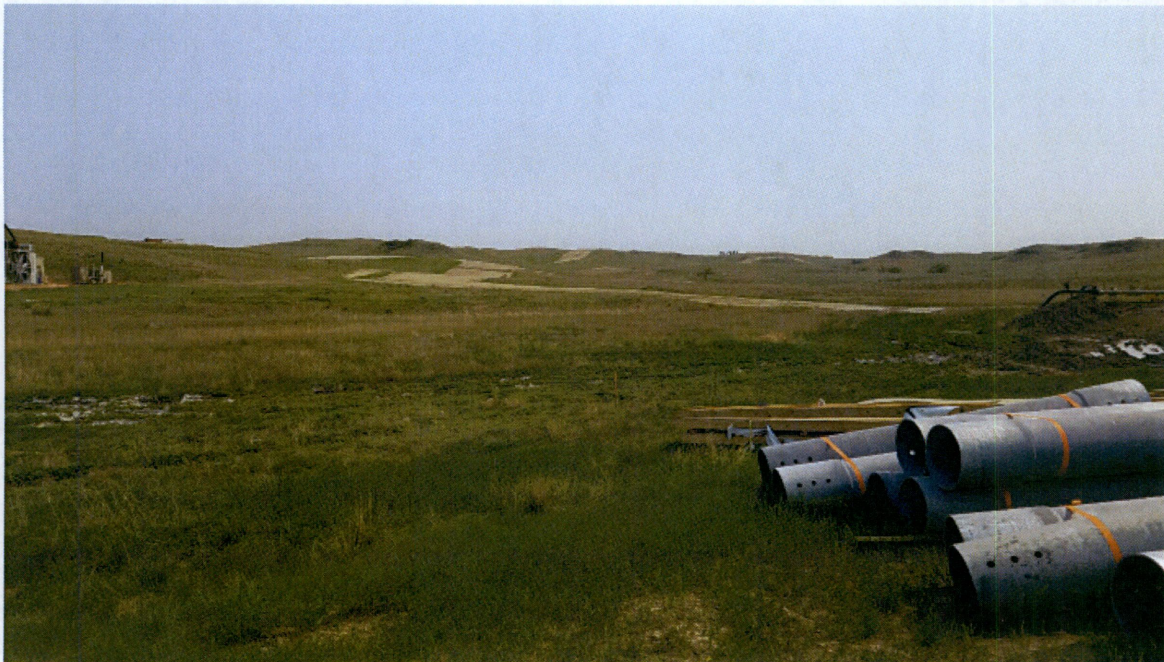
Photo 5. A wetland north of the electrical substation within Parcel 3. Recommend ECDs be placed along project areas edge to protect wetland.

- All wetlands/waterways appear to be avoided, however it is recommended that ECDs be placed on the northern edge of the electrical substation to avoid impacts to the nearby wetland in Parcel 3.
- Equipment storage was stored appropriately on footprint, away from wetlands.
- Overall the Project was tidy, though some ECDs may need to be replaced/reset.
- ECDs along access road within Parcel 2 have been rendered ineffective by rilling/erosion.
- No archeological sites were located onsite.
- No woody vegetation or bird nests were identified during preconstruction survey.
