**RE: PU-14-853 Reclamation Inspection**

## Overview

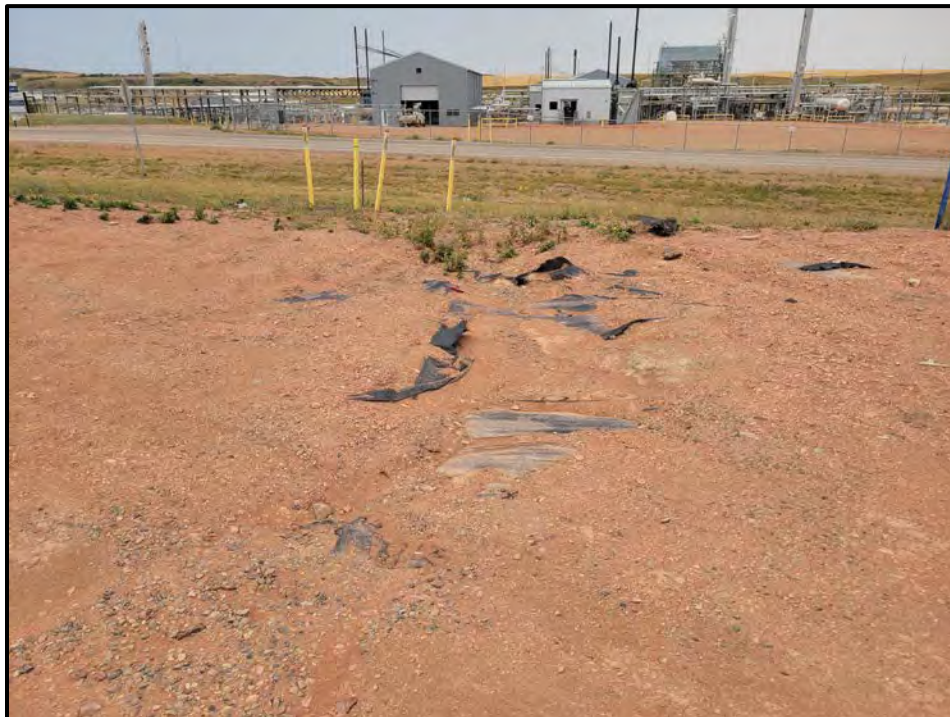
**Photo 1. View of surface flow erosion in the main parking area of the Targa Badlands LMGP.**

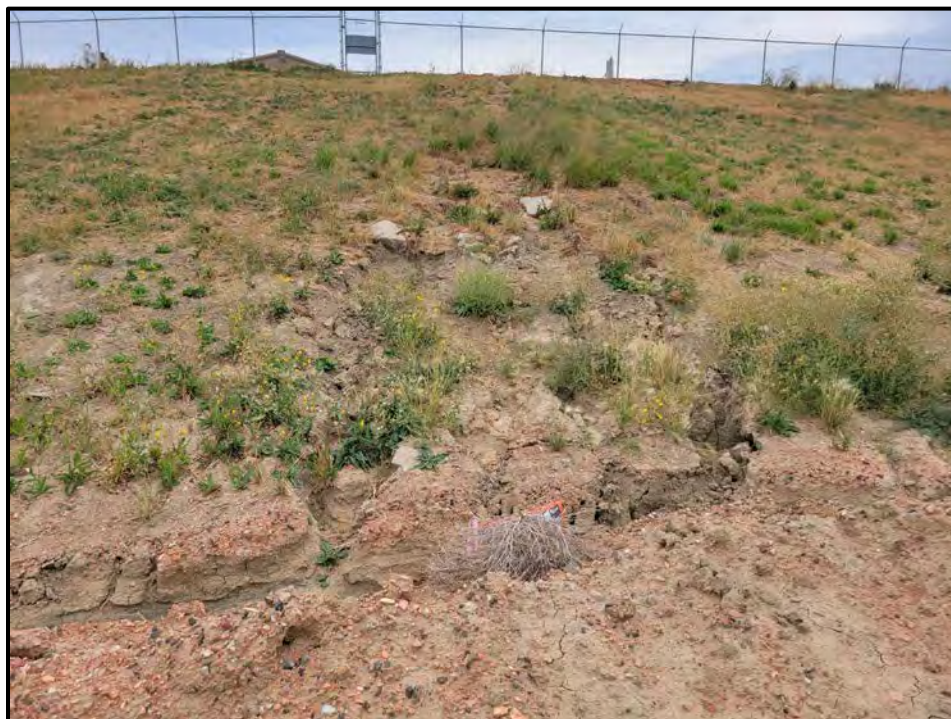
**Photo 2. View of run-off erosion from the parking lot of the LMGP, likely due to lack of established vegetation planting.**

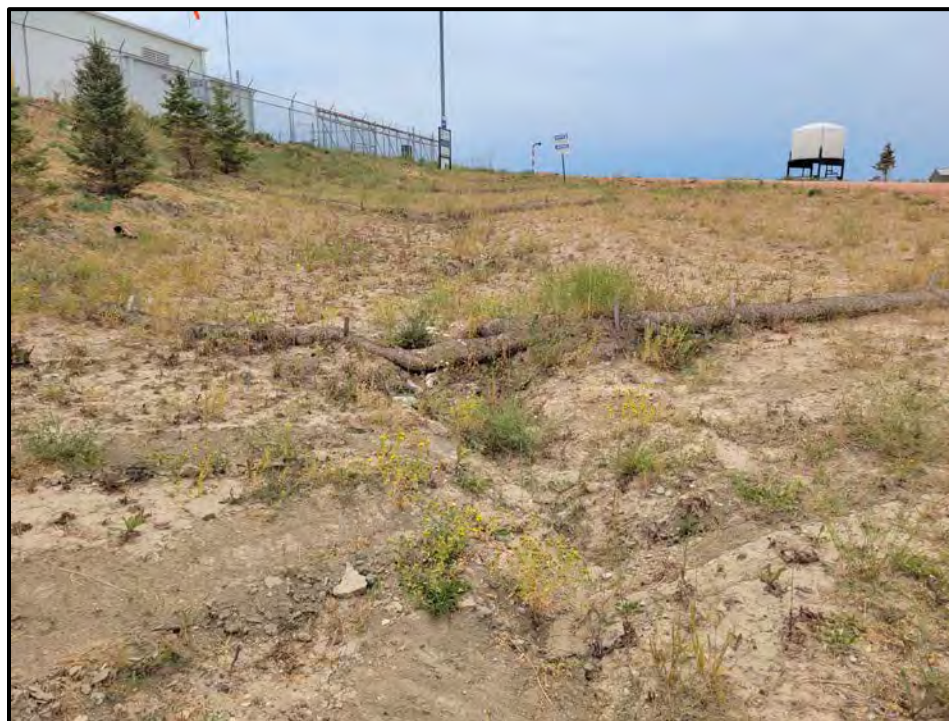
**Photo 3. A contoured drain with un-maintained straw waddles. A lack of established grass planting has resulted in erosion.**

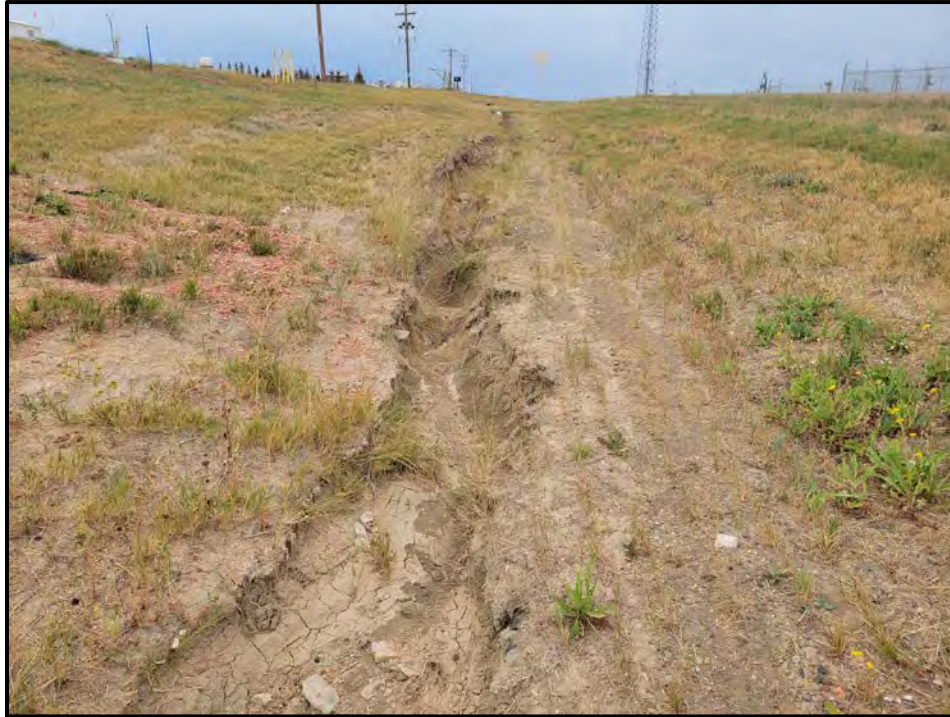
**Photo 4. Erosion in the Road ditch on the east side of 125th Avenue NW.**

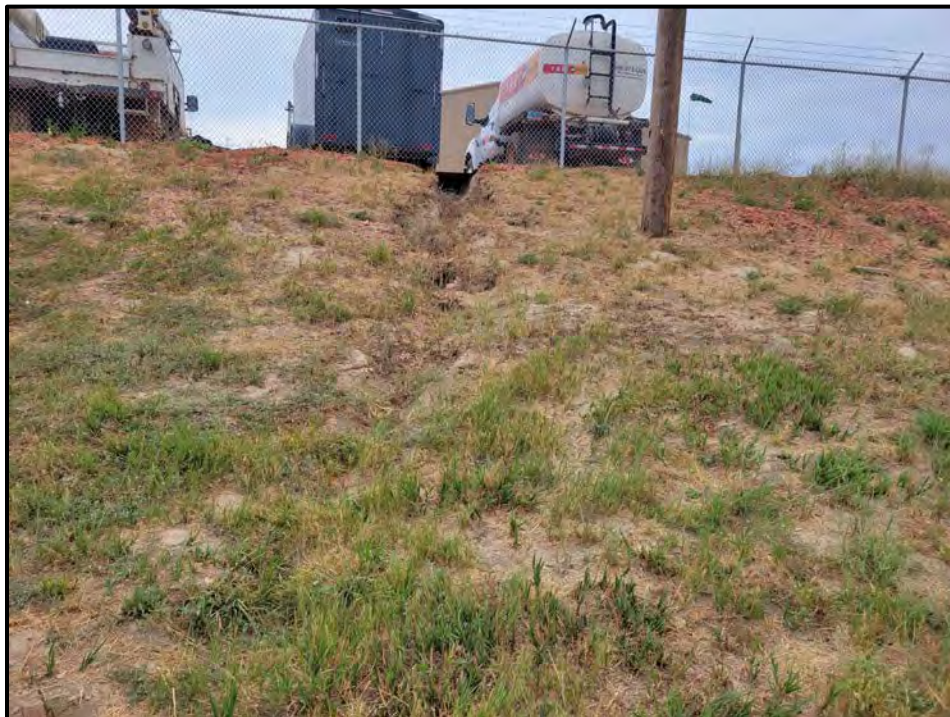
**Photo 5. Surface flow erosion coming from parking area in Parcel 2.**

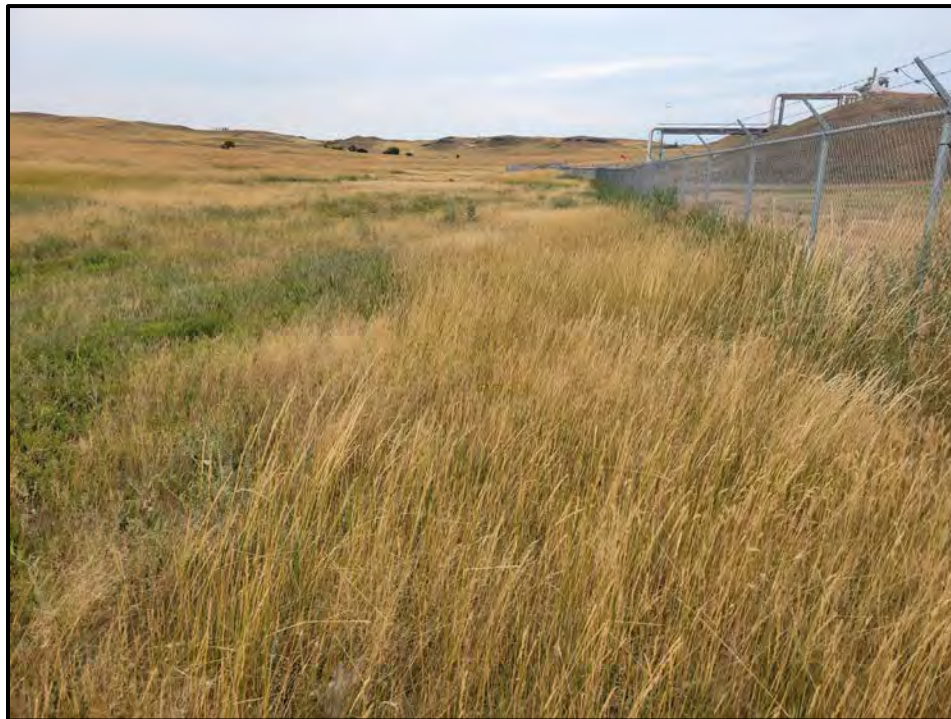
**Photo 6. Grass planting in Parcel 3, north of the substation, have been established and appear in good condition.**

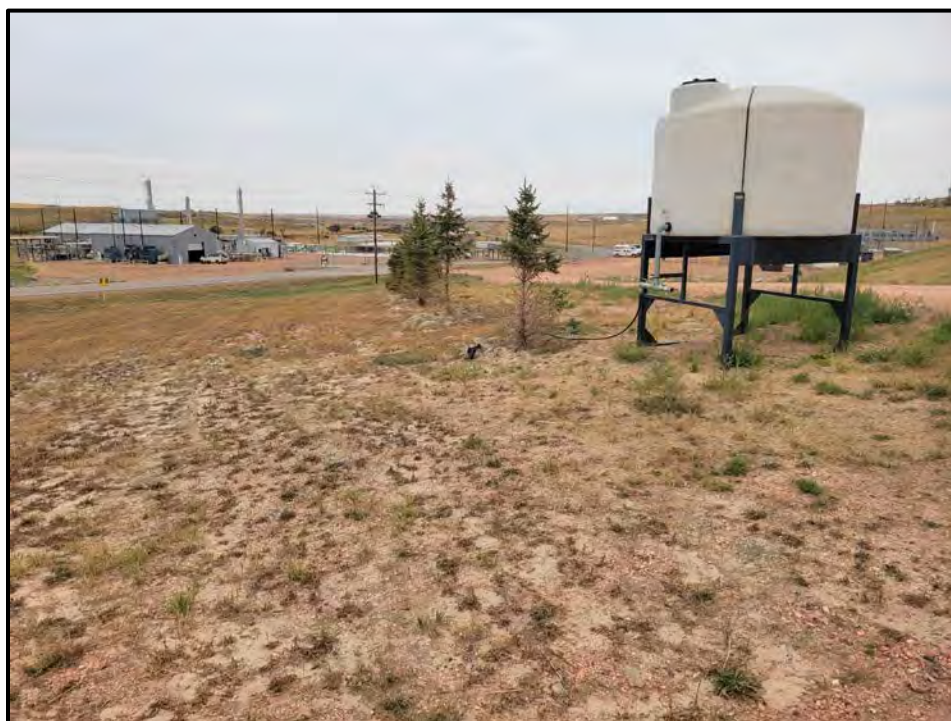
**Photo 7. Tree planting in poor condition with empty water tank and little herbaceous vegetation growing.**

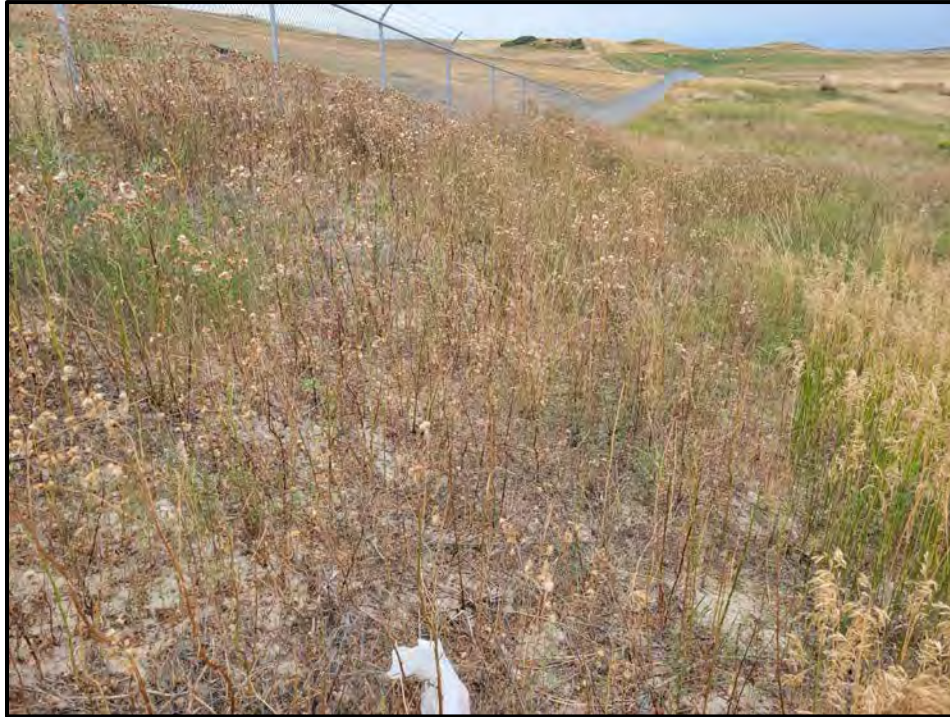
**Photo 8. Canada thistle is common on the south side of Parcel 2.**
