E3 Environmental, LLC (E3) conducted an on-site inspection of the Hess Hawkeye Pipeline Project (PU-15-31) and the Basin Electric Lonesome Creek Station Phase III Project (PU-14-852) in September 2015. Enclosed please find hard copies of each of these reports.

### GENERAL INFORMATION

<b>Environmental Inspector:</b>  Bernie Campbell	<b>Inspection Date &amp; Time:</b>  09/15/2015	<b>Report Number:</b>  HessHawk-20150915-BC
<b>Weather:</b>  55° light rain, foggy	<b>Precipitation (last event):</b>  9/5/2015 - 1.7"	<b>On-Site Staff Worked With &amp; Affiliation:</b>
	<b>ROW Conditions:</b>  Dry

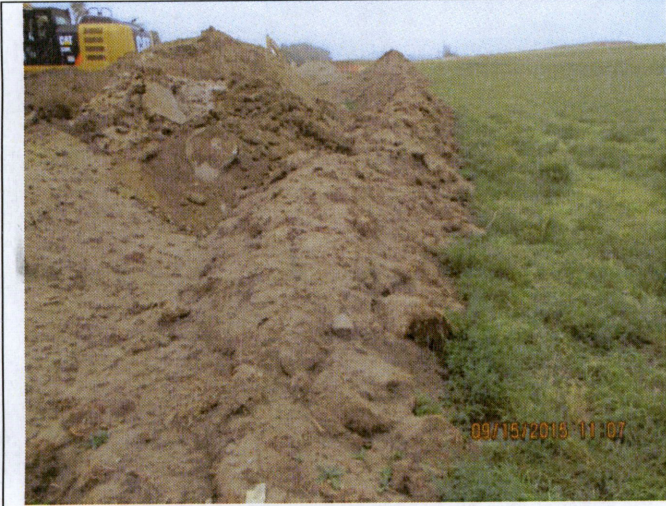
Observed two tie ins with group, (984+00 & 986+00) both digs had not maintained soil segregation spoil has been placed up onto stored top soil. Also observed top soil storage beyond the staked ROW, communicated to group that the sub soil needs to be removed off of the stored top soil immediately, also communicated that the top soil outside of the staked limits could be left until restoration to minimize the risk of comingling of soils trying to access the back side of windrowed top soil. Observed other areas (968+00) along inspection route with same issues of sub soil being stored up onto top soil, this is a issue throughout the project, also observed an area approximately 200' in length (194+00 – 196+00) with spoil stored in travel lane and no evidence of top soil being stored in same area, no one had an answer as to where the top soil was, possible comingling at this location as well.

**Photograph 1:** Station # 984+00, spoil stored up onto stored top soil, top soil is also outside of staked project limits.

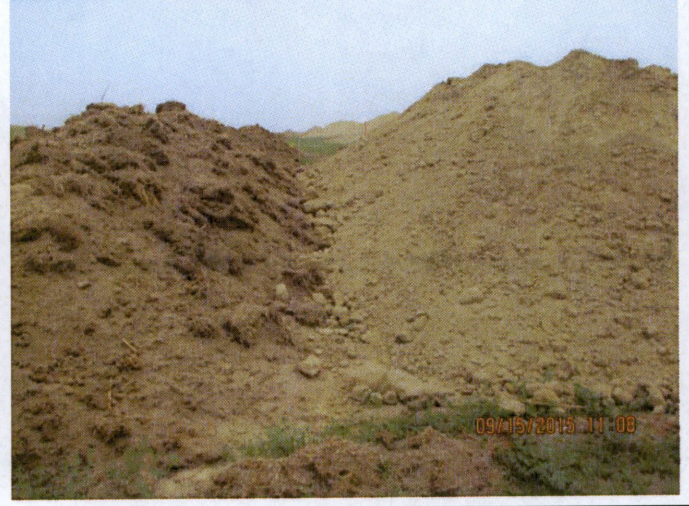
**Photograph 2:** Station # 986+00, spoil stored up onto stored top soil, top soil is also outside of staked project limits.

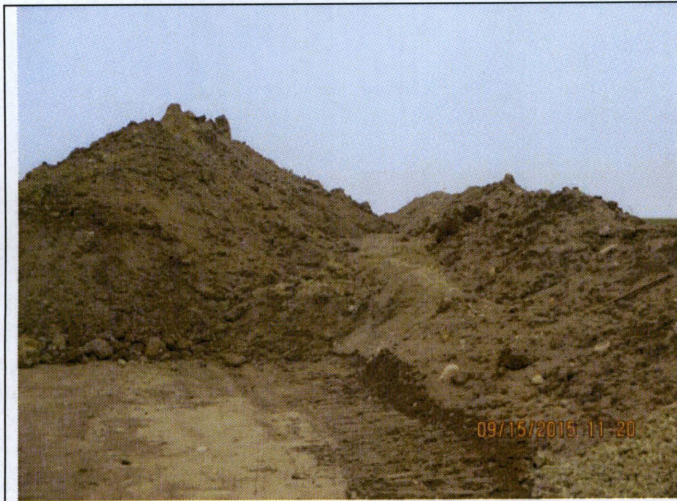
**Photograph 3:** Station # 968+00, spoil stored up onto stored top soil.

Overall attention is needed at bell holes to ensure soil segregation, straw logs need to be repaired/replaced/installed correctly and the remainder of features not visited should be inspected by project personnel to armor them with the proper ECDs.

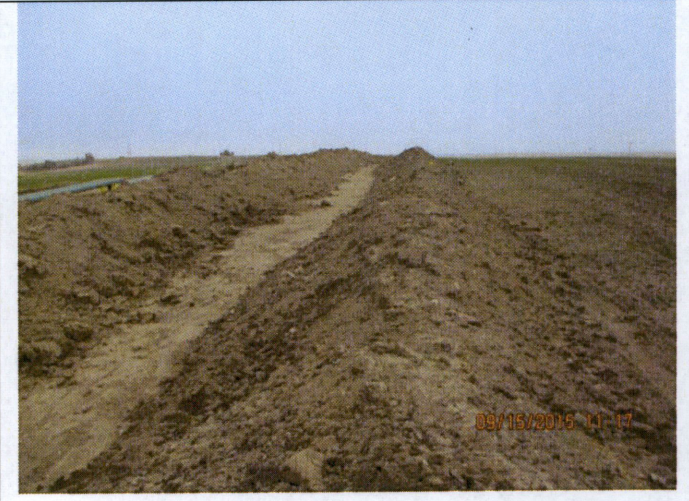
**Photograph 4:** Station # 966+00, spoil and top soil with proper separation.

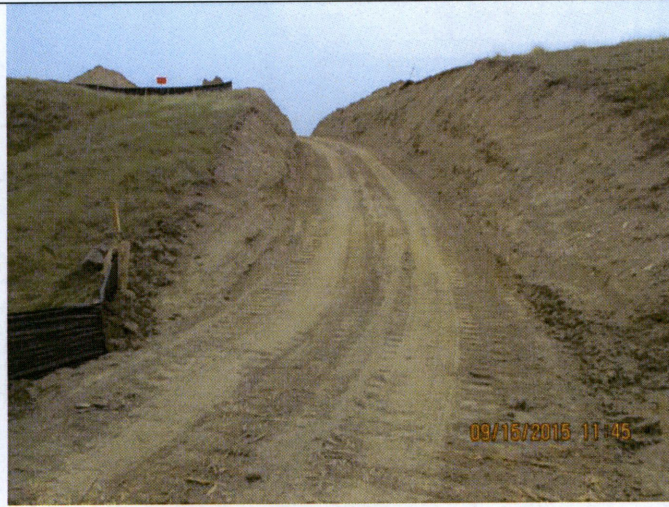
Observed wetland crossings (643+50) needs water bars installed across travel lane at base of slopes to protect feature from deposits of upland sediments during rain events, (30+00) crossing was installed very well. Feature had water bars at base of slopes and ECDs installed to prevent upland sediments from entering due to rain event.

**Photograph 5:** Station # 643+50, wetland without ECDs in travel lane on slopes.

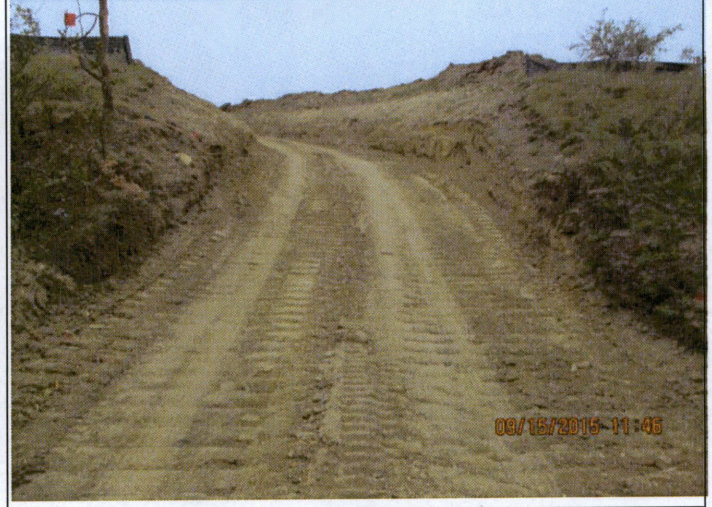
**Photograph 6:** Station # 643+50, pic 2 of wetland on opposite slope.

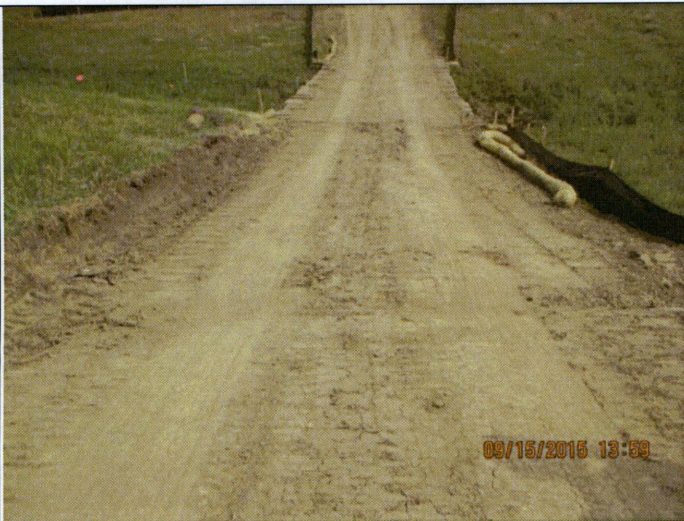
**Photograph 7:** Station # 29+40, wetland armored up with proper ECDs.

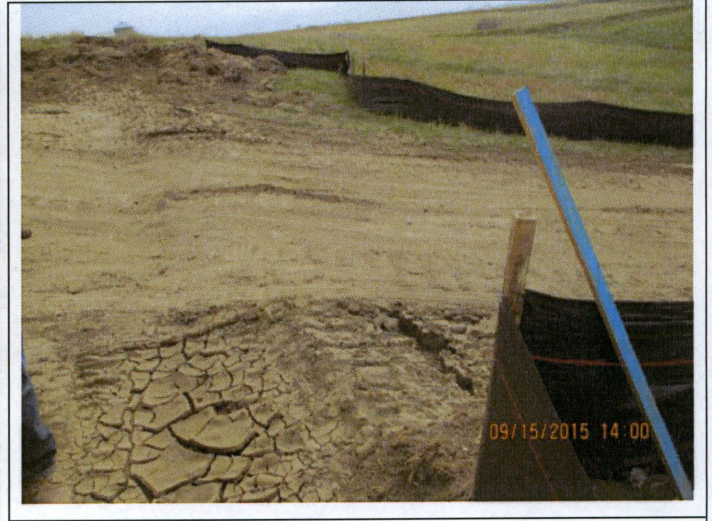
**Photograph 8:** Station # 29+40, pic 2 of water bars at wetland.

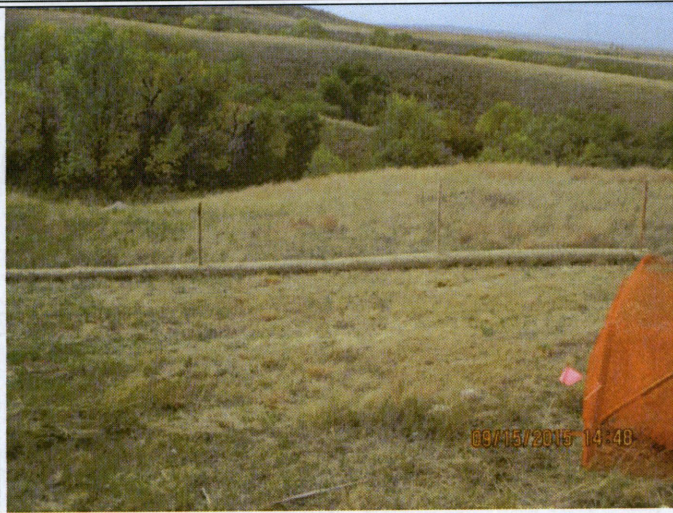
ECDs (straw logs) observed were not installed properly, logs should be keyed in below grade just as silt fence and hay bales are required to be keyed to function correctly, observed straw logs contained with sediments more than 50%.

**Photograph 9:** Station # 281+00, one of many locations of straw logs not properly installed.

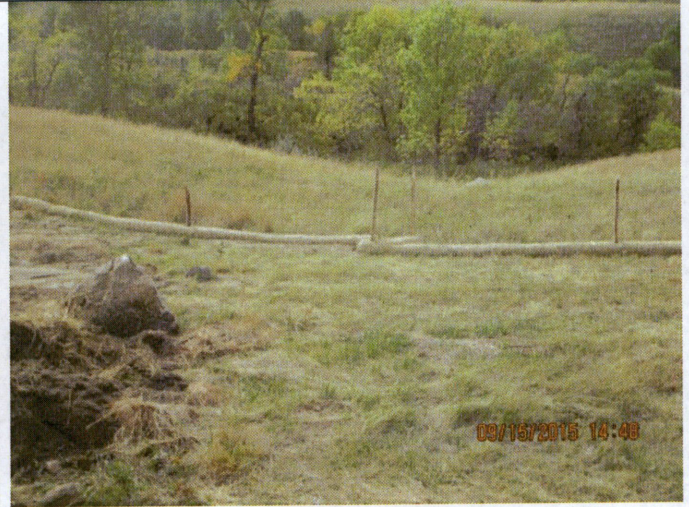
**Photograph 10:** Station # 283+00, straw logs more than 50% contained with sediments and not installed properly.

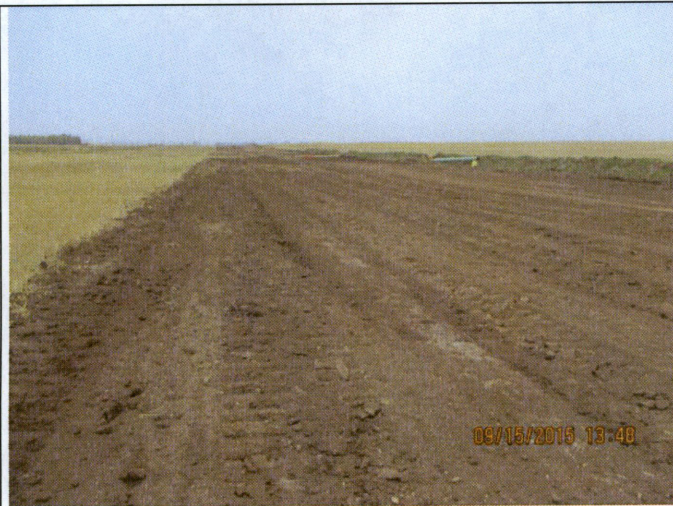
**Photograph 11:** Station # 7+50 viewing to the north of ROW after backfill.
