Bridger Crude Oil Loop Pipeline Project Topsoil Inspection Report PU-15-097

Prepared for:
**North Dakota
Public Service Commission**

Prepared by:

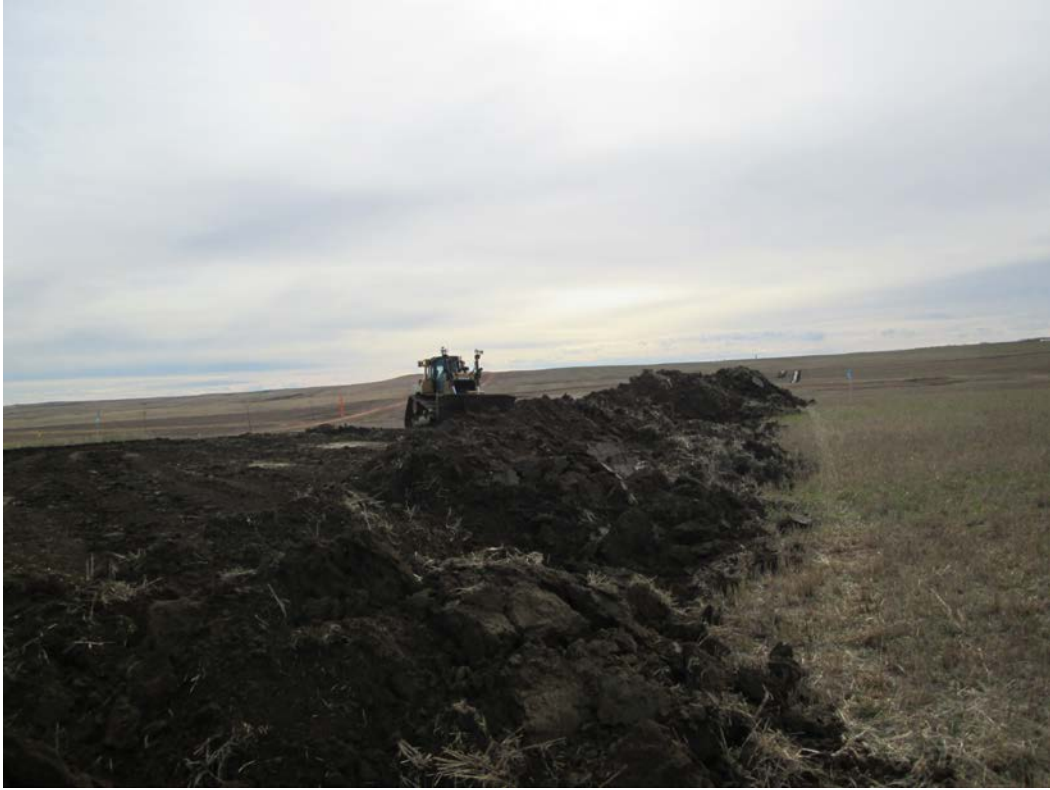
Above: Photo 1 (Point 201) – Direction looking south near Skunk Hill Station. Start of topsoil stripping.

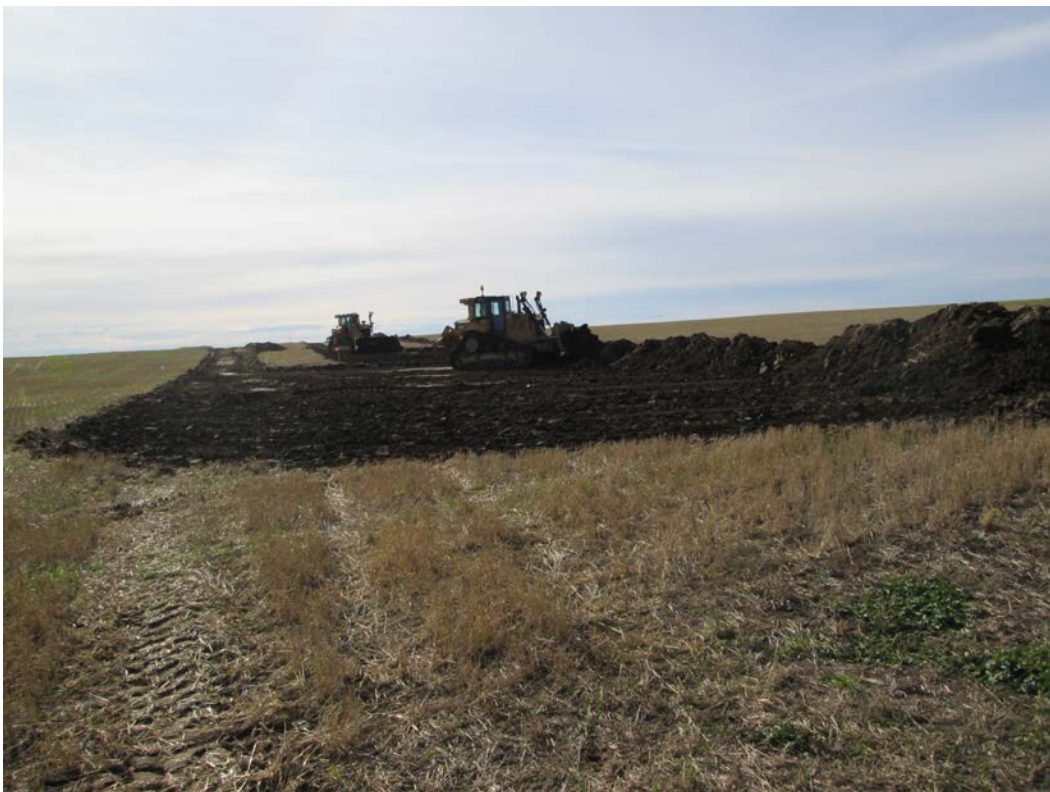
Below: Photo 2 (Point 200) – Direction looking south by Skunk Hill Station. Start of topsoil stripping.

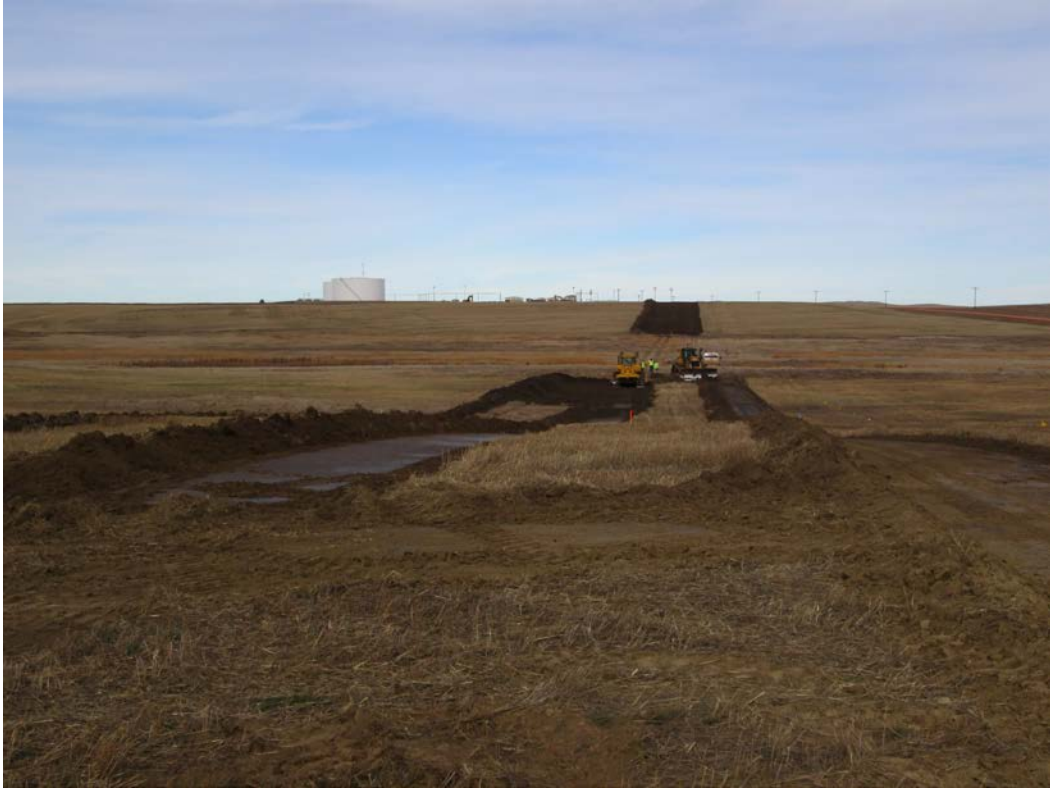
Along parts of the pipeline ROW near where it paralleled another pipeline, Wenck observed lighter topsoil where the grader went through at a depth of approximately 4 inches. This could potentially be from subsoil and topsoil mixing from the previous pipeline's ROW activities (**Appendix B, Photos 3, 4**).

Above: Photo 3 (pt. 202) - Direction looking north toward Skunk Hill Station. Start of topsoil stripping. Parallel pipeline to the right on photo (yellow and orange flags). In some areas soil is lighter near parallel pipeline's ROW.

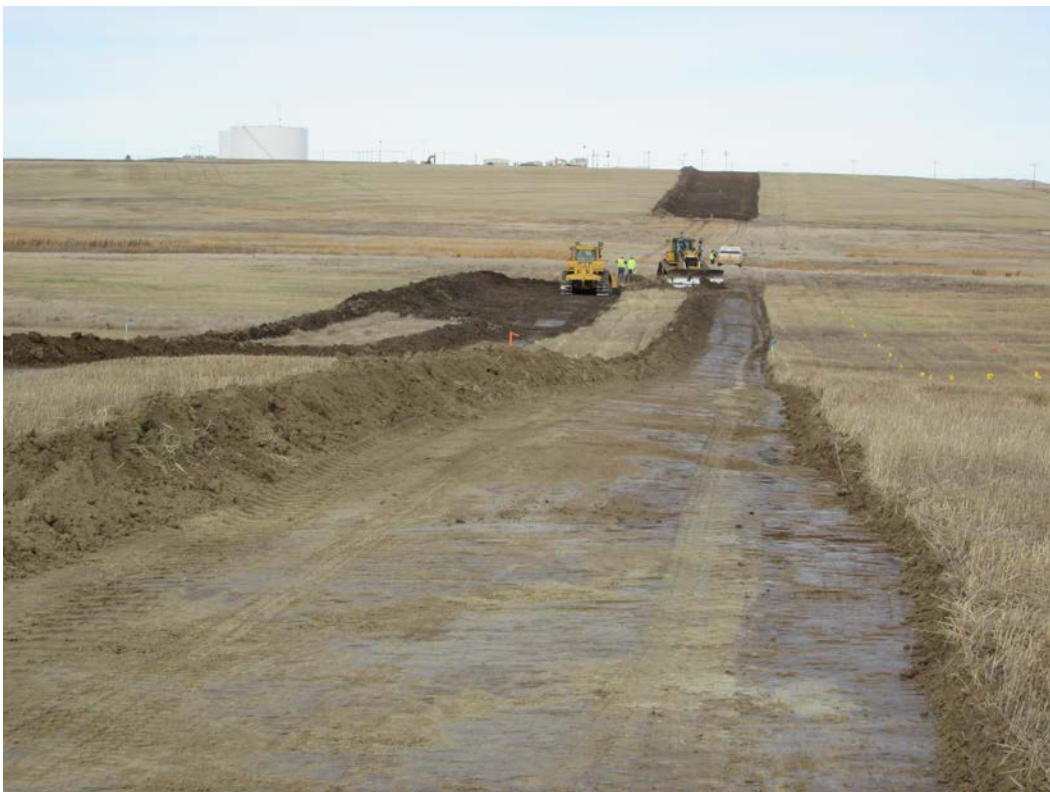
Below: Photo 4 (pt. 202) – Direction looking north toward Skunk Hill. Parallel pipeline to the right on photo (orange flags). In some areas soil is lighter near parallel pipeline.

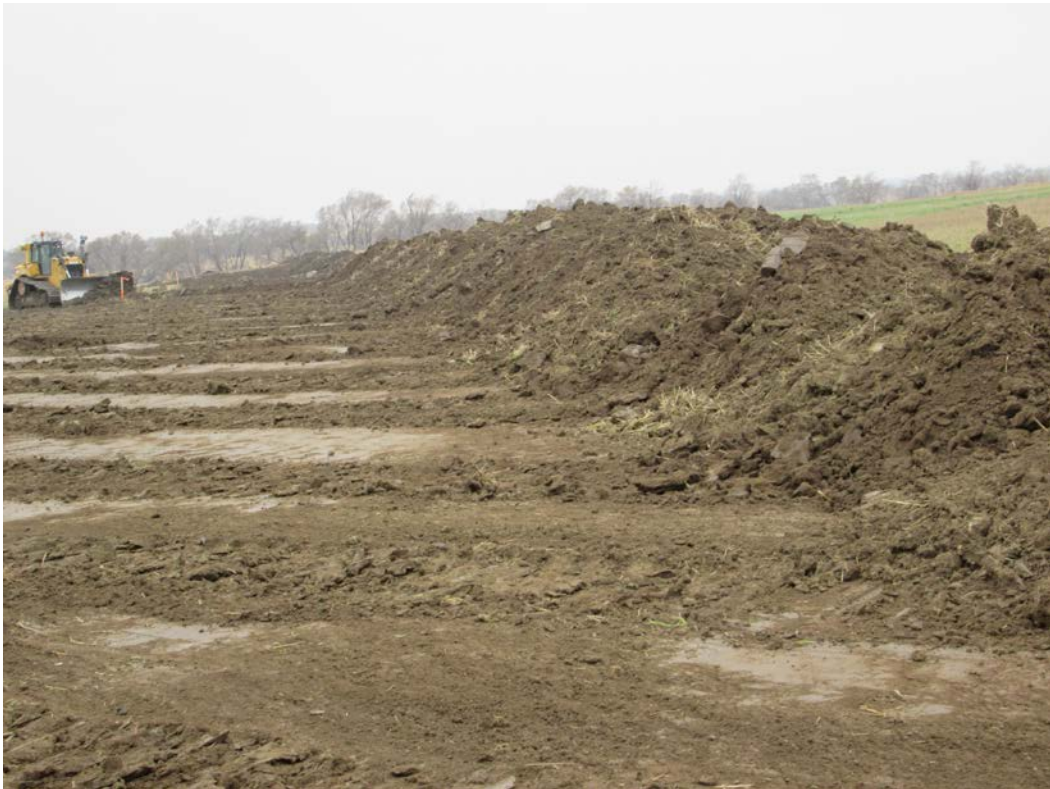
Equipment operators noticed a coal vein running through the ROW; this was found within the top approximate 4 inches of the soil profile (**Appendix A, Photo 9**). Operators took less topsoil from this area, so as not to mix coal with topsoil.

Above: Photo 9 (pt. 207) – Coal vein observed approximately 4 inches deep. Less topsoil was stripped in this small area, as to not mix coal with soil.

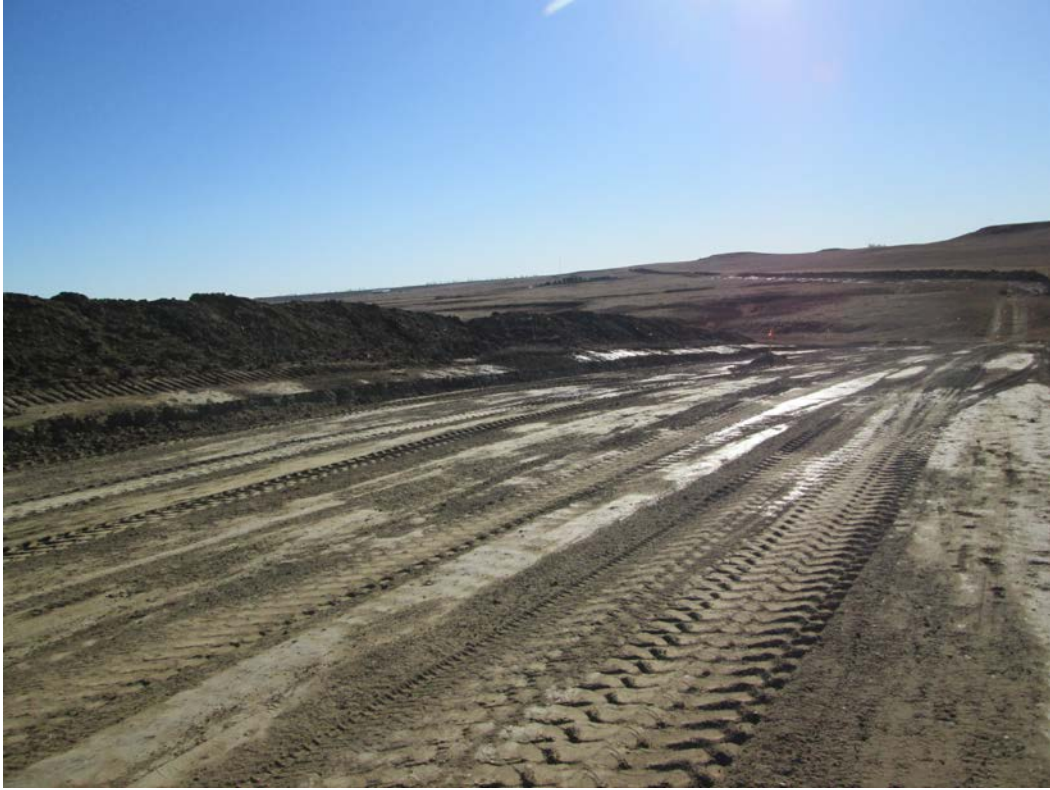
Below: Photo 12 (near pt. 209) – Pipeline ROW, topsoil to the left. There are two white areas that appear to from saline/alkaline deposits. Looking north-northeast.

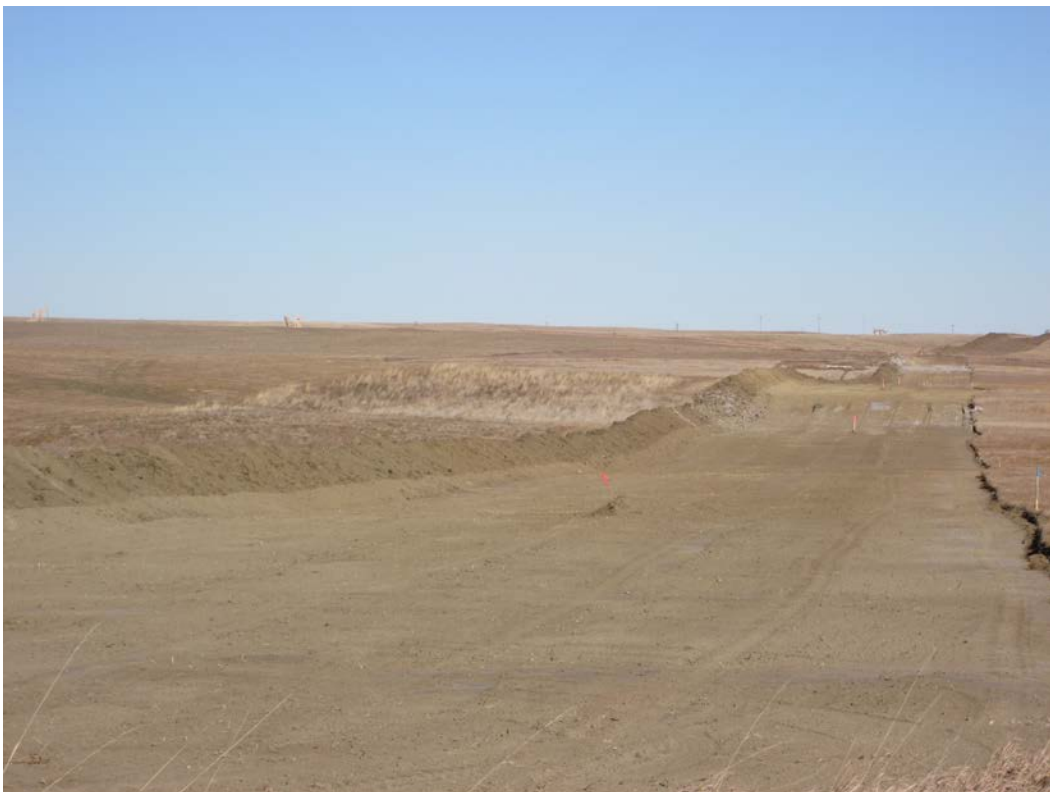
White crusts were observed on some areas of the pipeline ROW, likely indicating an alkaline/saline area (**Appendix B, Photos 13, 14**). The white color was observed on the stripped ROW area, on the topsoil pile and on the surface of the background (undisturbed) area. These areas may have problems with re-vegetation establishment due to the natural alkalinity of the soils.

Above: Photo 13 (pt. 210) – Topsoil pile has white crusts. Likely saline/alkaline area.

White crusts on the soil were observed on some areas (Observation Point 210, **Appendix A, Figure 1 and Appendix C**) of the pipeline. During reclamation and revegetation of these areas, a seed mix using species of the undisturbed surrounding alkaline areas should be considered or perhaps a saline-alkaline seed mix. Along with soil amendments and irrigation management, such as frequent irrigation that provides drainage to avoid build up of salinity. Wenck recommends monitoring and documentation of this area to ensure the vegetation becomes established after reclamation.

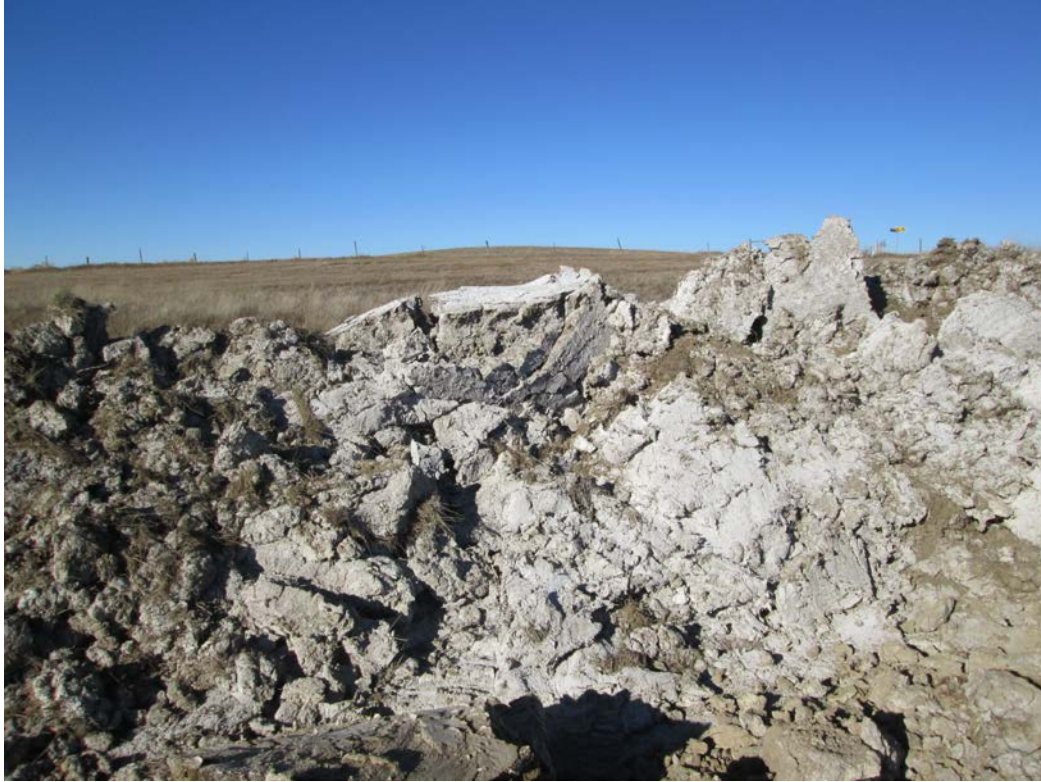
Below: Photo 14 (pt. 210) – Topsoil pile has white crusts. Note white area in background in undisturbed area.

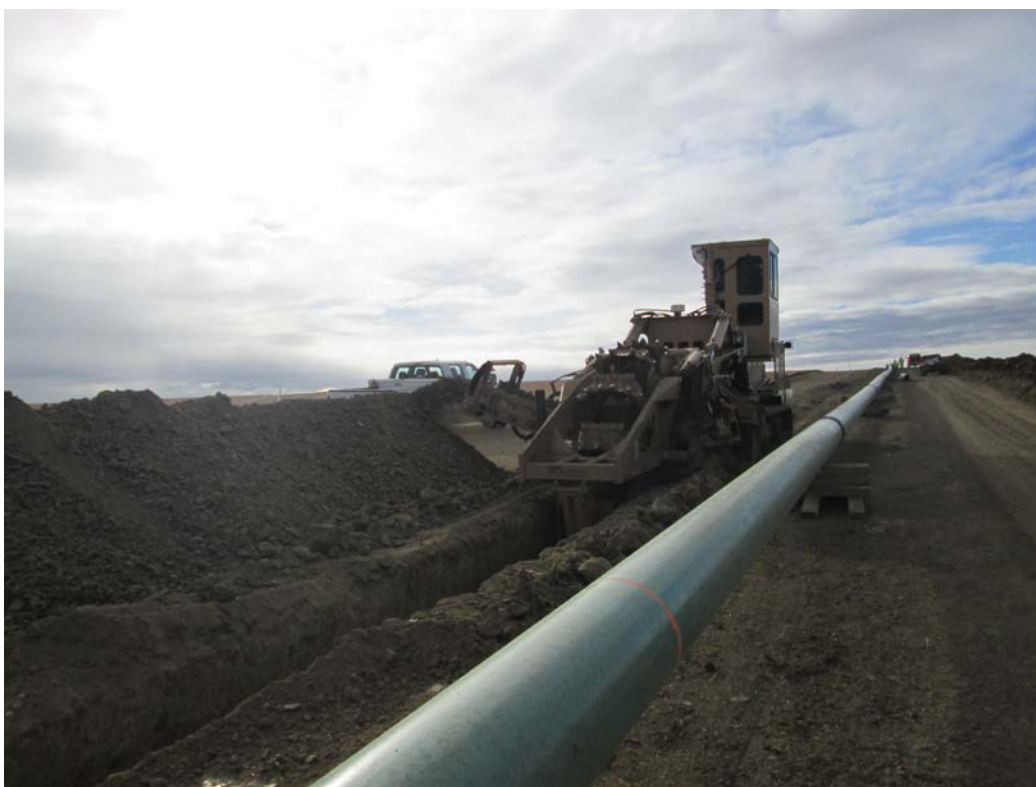
Above: Photo 23 (pt. 217) – Bell hole needed for tie-ins. Larger amount of subsoil needed to be removed for slope and work space. Looking north-northeast toward 30th St.

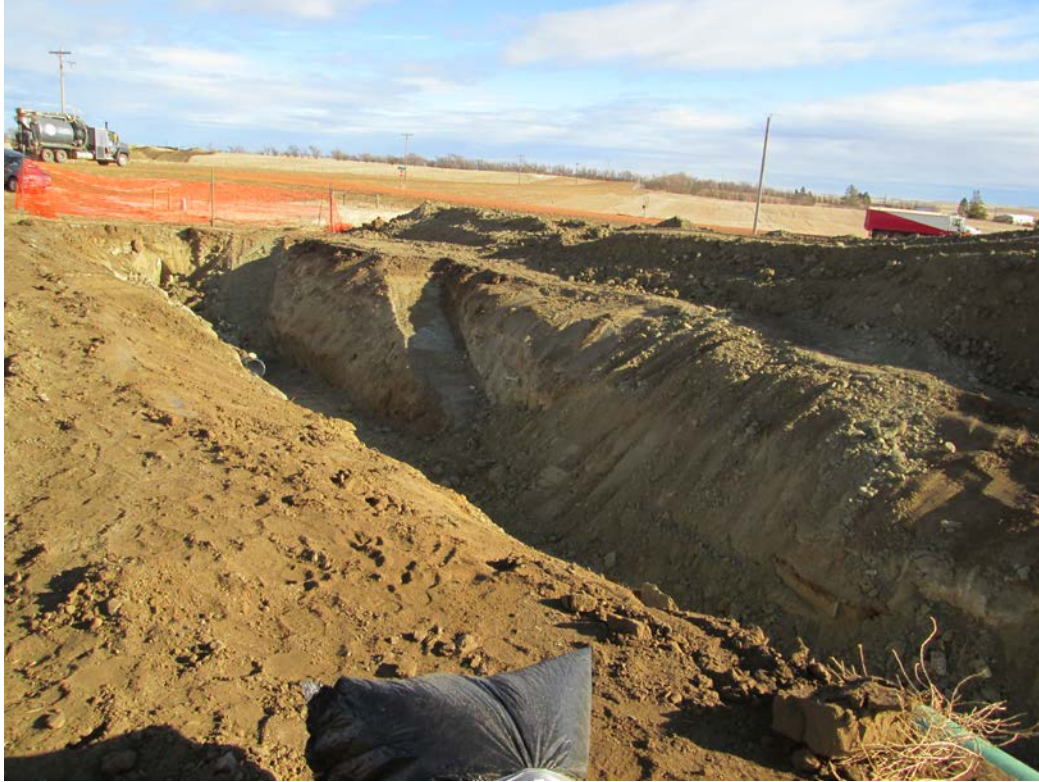
Below: Photo 24 (pt. 217) – Topsoil pile to left of pipe on far left of photo. Bell hole subsoil pile shown in middle of photo is touching small second topsoil pile on far right (darker color) from where they extended the ROW to 100ft. Looking north-northeast toward 30th St.

When the topsoil inspection of the project was conducted, there was one location where the subsoil pile was observed touching the topsoil pile at a bell hole location (Observation Point 217, **Appendix A, Figure 1 and Appendix C**). Contractors/equipment operators need to take special care in this area not to mix the topsoil and subsoil. Wenck recommends monitoring and documentation of this area to ensure vegetation becomes established after reclamation.

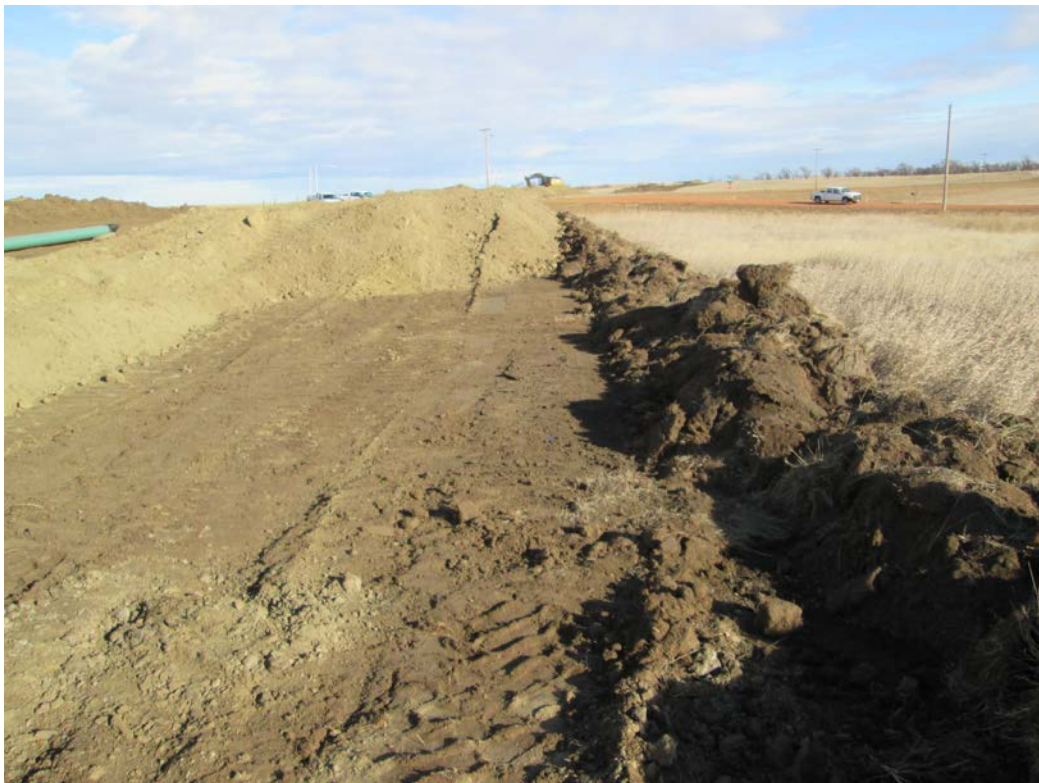
Above: Photo 25 (pt. 216) – Topsoil replaced. Lighter colored subsoil at very bottom of photo where topsoil has not been replaced yet. Looking southwest.
