To: Patrick Fahn, North Dakota Public Service Commission
From: Samantha Swanberg, Wenck Associates, Inc.
Copy: Kevin Magstadt, P.E., Wenck Associates, Inc.
Date: February 12, 2016
Subject: PU-15-097 Bridger Crude Oil Pipeline Loop - Construction Inspection Report

Construction Inspection Report

Site Visit: February 3, 2016

Bridger Pipeline, LLC – 16-inch Crude Oil Loop Pipeline also known as the “Heart River Pipeline” – PSC Case No. PU-15-097

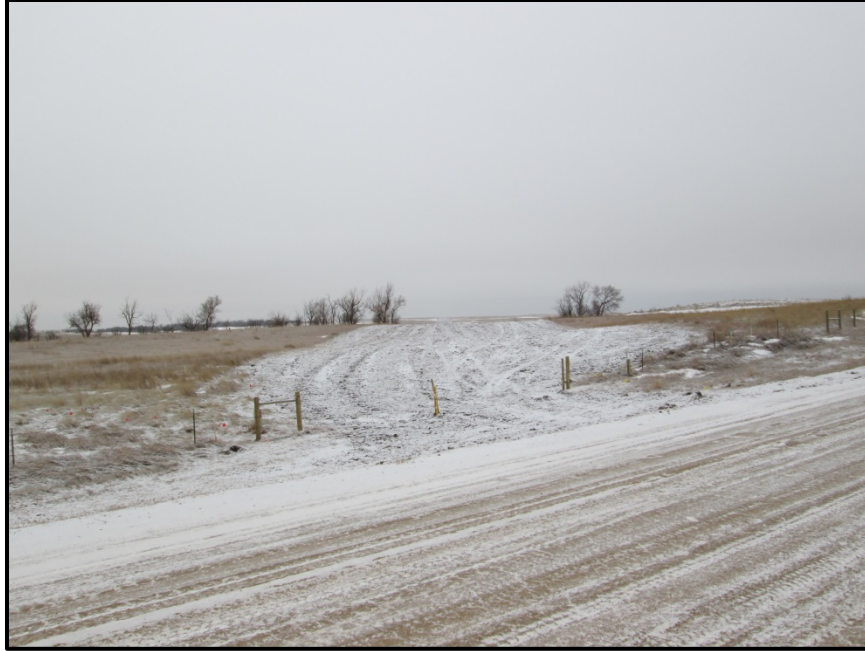
- Road bore work area for 30th St. used 100 ft. ROW (Photo #1, Point #222);
- Open cut wetland, did not use the full ROW to reduce impacts to the area. This wetland was not originally on Bridger’s maps, but their environmental inspector said it was a wetland (note cattails on edges in photo) (Photo #2, Point #223);
- Road bore work area for unnamed road used 100 ft. ROW. Topsoil piles observed on the sides, subsoil pile in middle. Not all subsoil has been replaced (Photo #3, Point #224);
- Road bore for unnamed road. Pipeline passed through a break in a tree row; avoided impacts to trees within ROW. On the right side of the road, soil had been replaced;

Photo 1. Direction: Southwest (GPS Point #222). Road bore work area for 30th St. used 100ft ROW.

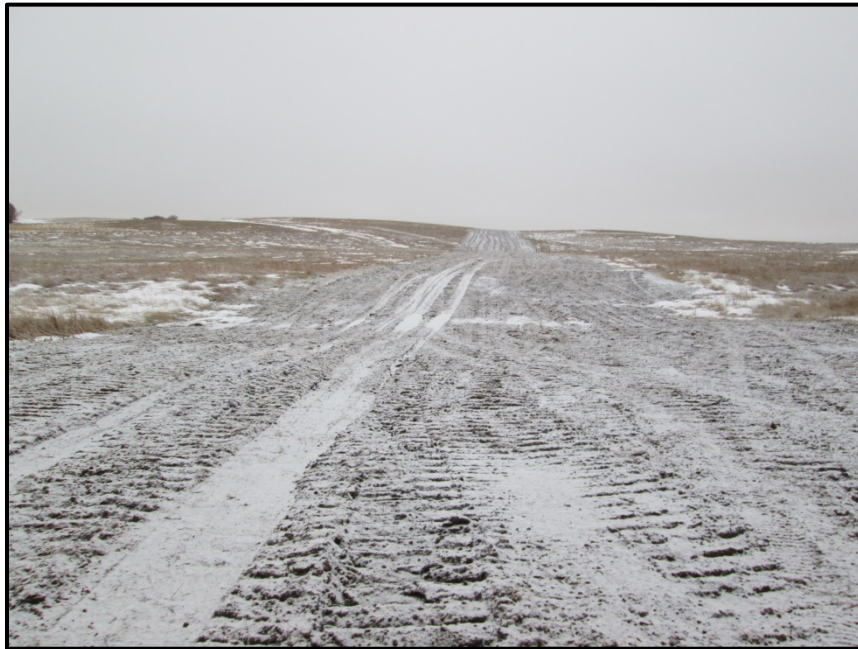
Photo 2. Direction: Southwest (GPS Point #223). Open cut wetland, did not use the full ROW to reduce impacts to the area. This wetland was not originally on Bridger's maps, but their environmental inspector said it was a wetland (note cattails on edges in photo).

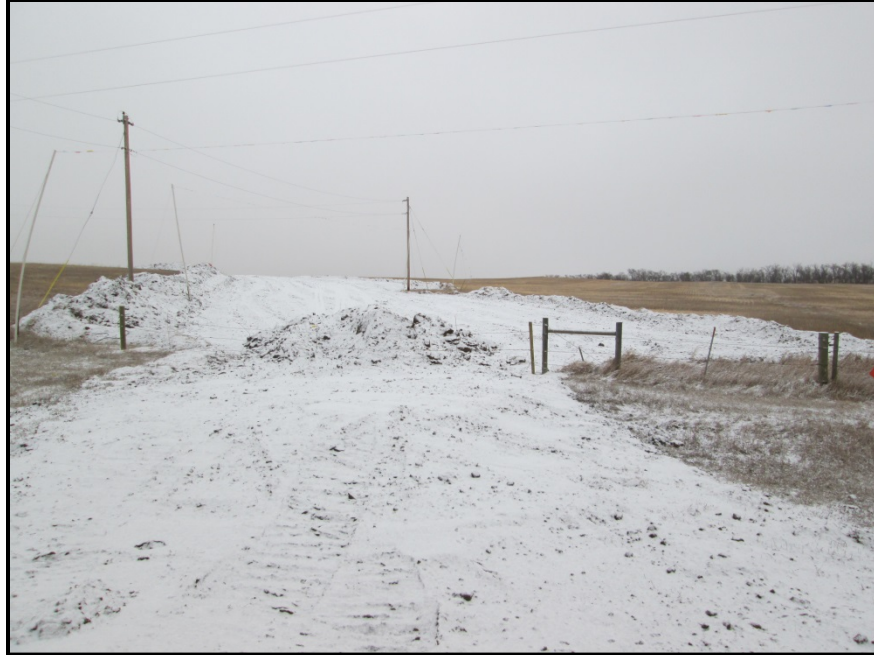
Photo 3. Direction: Northeast (GPS Point #224). Road bore work area for unnamed road used 100ft ROW. Topsoil piles observed on the sides, subsoil pile in middle, not all subsoil has been replaced.

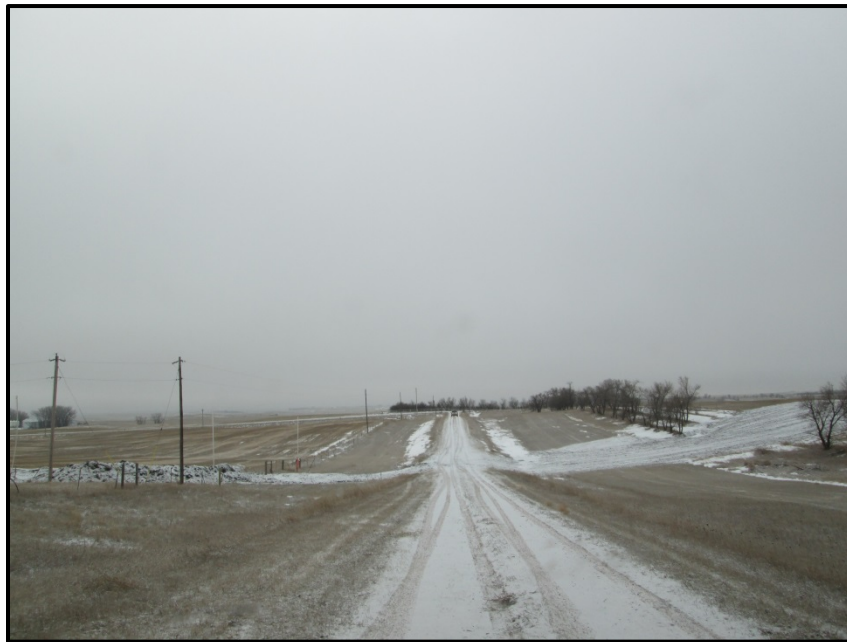
on the left side of the road, topsoil and some subsoil still had to be replaced (Photo #4, Point #224);

Photo 4. Direction: South (GPS Point #224). Road bore (unnamed road); pipeline passed through a break in a tree row (on right); avoided impacts to trees within ROW. On the right of the road, soil has been replaced; on the left of the road, topsoil and some subsoil still had to be replaced.

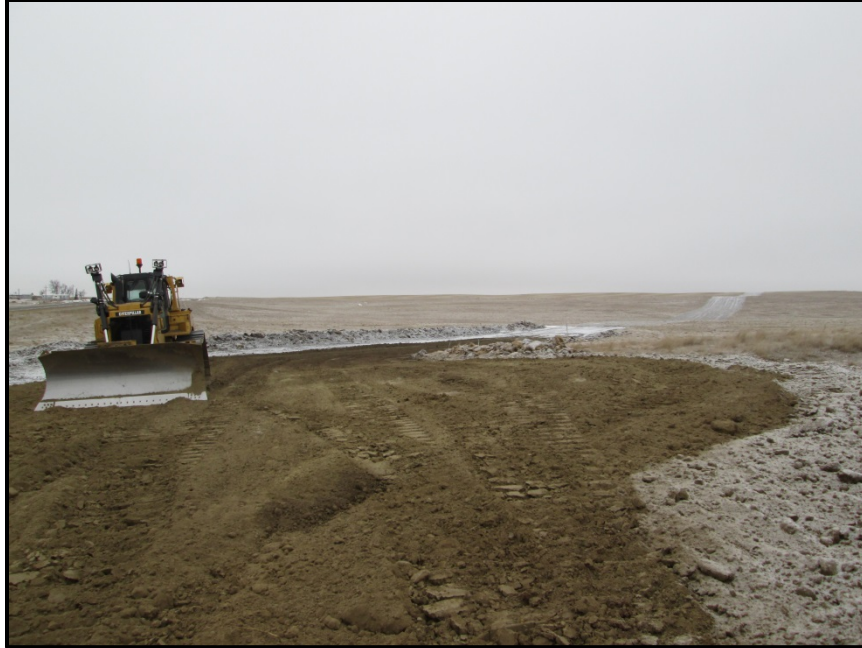
- Road Bore area for 32nd St. bore. Topsoil piles visible along sides of ROW. Backfilling area had just been completed (Photo #5, Point #225);
- Pipeline bored underneath wetland area with minimal impact. Trucks had been driving on higher frozen ground near wetland; this could be an area of concern for soil compaction, especially if area is wet rather than frozen (Photo #6, Point #226);

Photo 5. Direction: North (GPS Point #225). Pipeline road bore area for 32nd St. bore. Topsoil piles visible along sides of ROW. Backfilling area had just been completed.

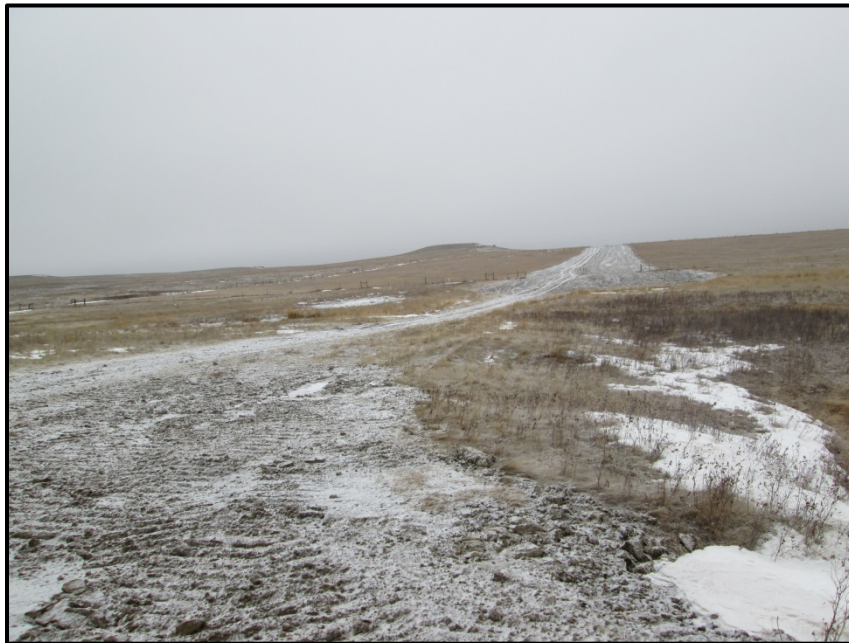
Photo 6. Direction: North (GPS Point #226). Pipeline bored underneath wetland with minimal impact. Trucks had been driving on higher frozen ground near wetland; this could be an area of concern for soil compaction, especially if area is wet rather than frozen.

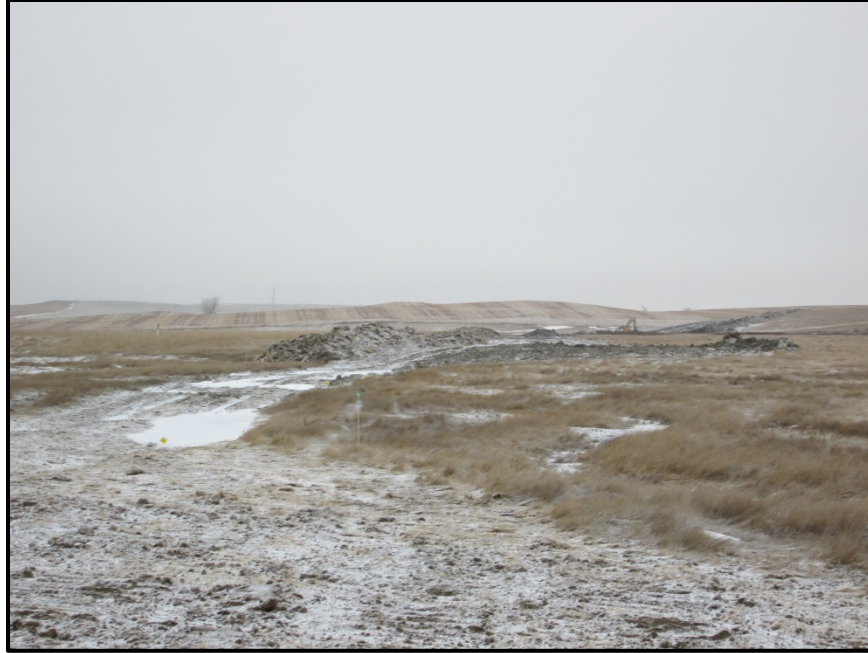
- Pipeline bore underneath wetland area, topsoil piles along sides, extended ROW to 100 ft. for bore pull-back/work area. Topsoil had been replaced on south bore side, but not north side. Discing and reseeding have not been completed for any of the project. Trucks have been driving on higher frozen ground near wetland; this could be an area of concern for soil compaction, especially if area is wet rather than frozen (Photo #7, Point #227);

Photo 7. Direction: North (GPS Point #227). Pipeline bored underneath wetland area, topsoil piles along sides, extended ROW to 100ft for bore pull-back/work area. Topsoil had been replaced on south bore side, but not north side. Discing and reseeding have not been completed for any of the project. Trucks have been driving on higher frozen ground near wetland; this could be an area of concern for soil compaction, especially if area is wet rather than frozen.

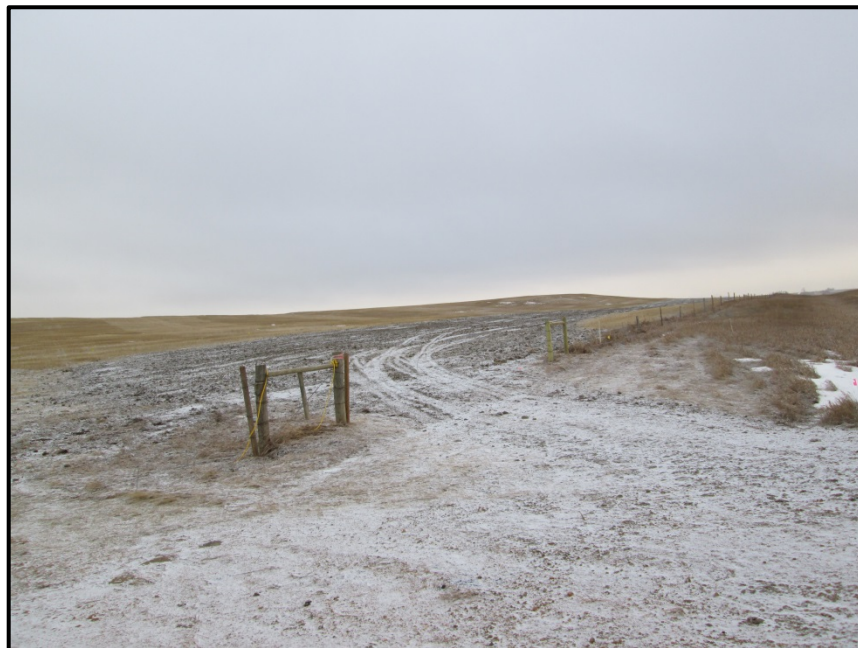
- Road bore work area, pipeline going west through agriculture field (Photo #8, Point #228);
- Two roads bored; bore crosses 35th St. on left of photo at a diagonal and unnamed road (Photo #9, Point #229);

Photo 8. Direction: Southwest (GPS Point #228). Road bore work area; pipeline going west through agriculture field.

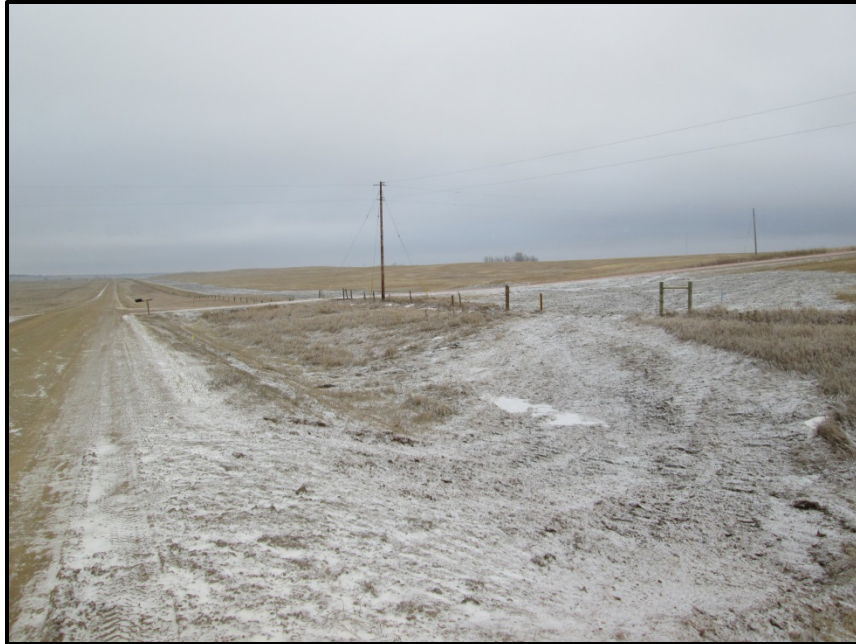
Photo 9. Direction: Southeast (GPS Point #229). Two roads bored; bore crosses 35th St. on left of photo at a diagonal and unnamed road.

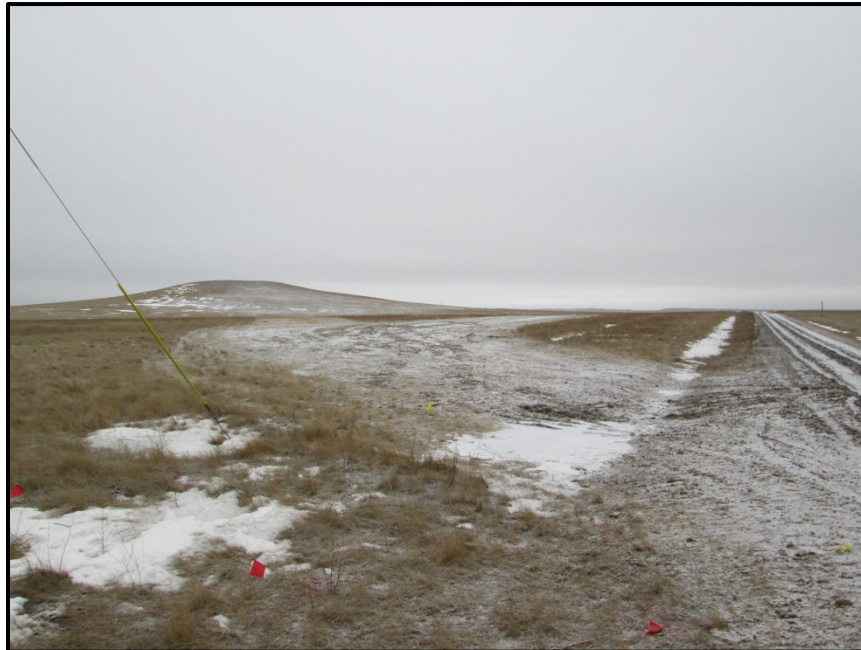
- Road bore area near 134th St. Pipeline continues on to Forest Service Land, which is prairie (Photo #10, Point #230);
- Road bore work area of 134th St. Pipeline continues along tree rows, bottlenecks (smaller ROW area) as to not disturb two trees visible in distance. No trees were removed (Photo #11, Point #230);

Photo 10. Direction: West (GPS Point #230). Road bore area near 134th St. (not pictured). Pipeline continues on to Forest Service Land, which is prairie.

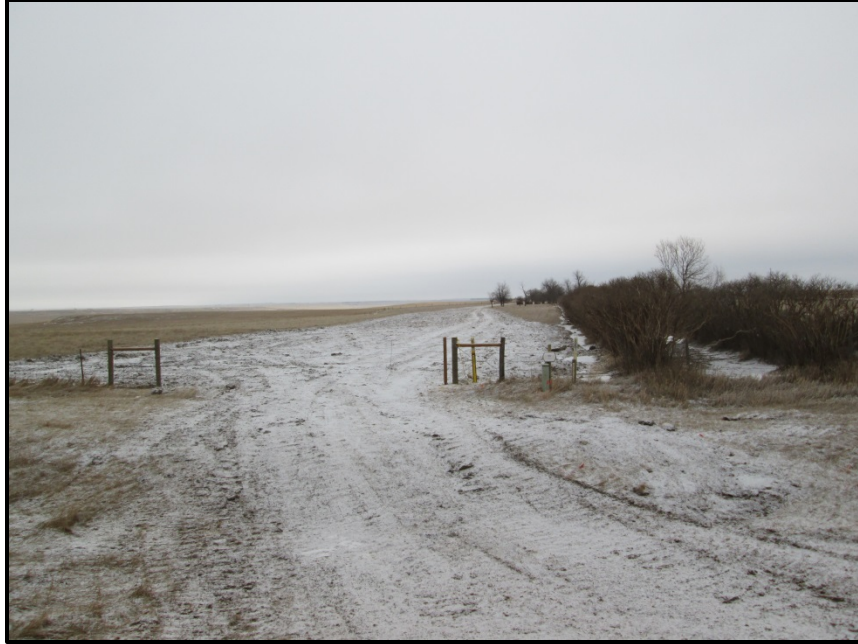
Photo 11. Direction: East (GPS Point #230). Road bore work area of 134th Ave. Pipeline continuities along tree rows, bottlenecks (smaller ROW area) as to not disturb two trees visible in distance. No trees were removed.

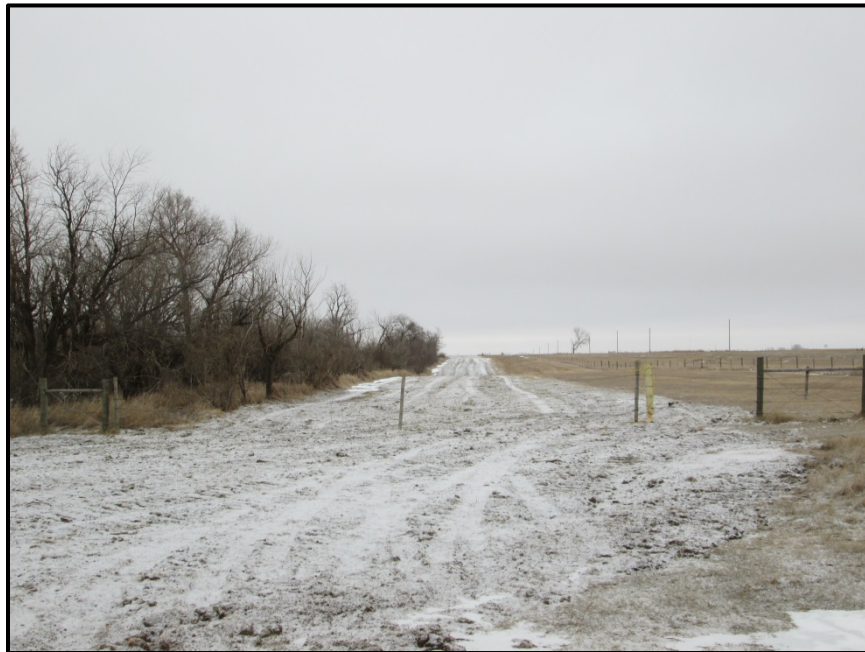
- Pipeline ROW alongside tree row. No trees were removed (Photo #12, Point #231).

Photo 12. Direction: East (GPS Point #231). Pipeline ROW alongside tree row. No trees were removed.
