To: Patrick Fahn, North Dakota Public Service Commission
From: Luke Toso, Wenck Associates, Inc.
Date: August 28, 2017
Subject: PU-15-097 Bridger Crude Oil Pipeline Loop - Revegetation Inspection Report

**Bridger Pipeline, LLC – 16-inch Crude Oil Loop Pipeline also known
as the “Heart River Pipeline” – PSC Case No. PU-15-097 –
Revegetation Inspection Report**

Site Visit: August 14, 2017

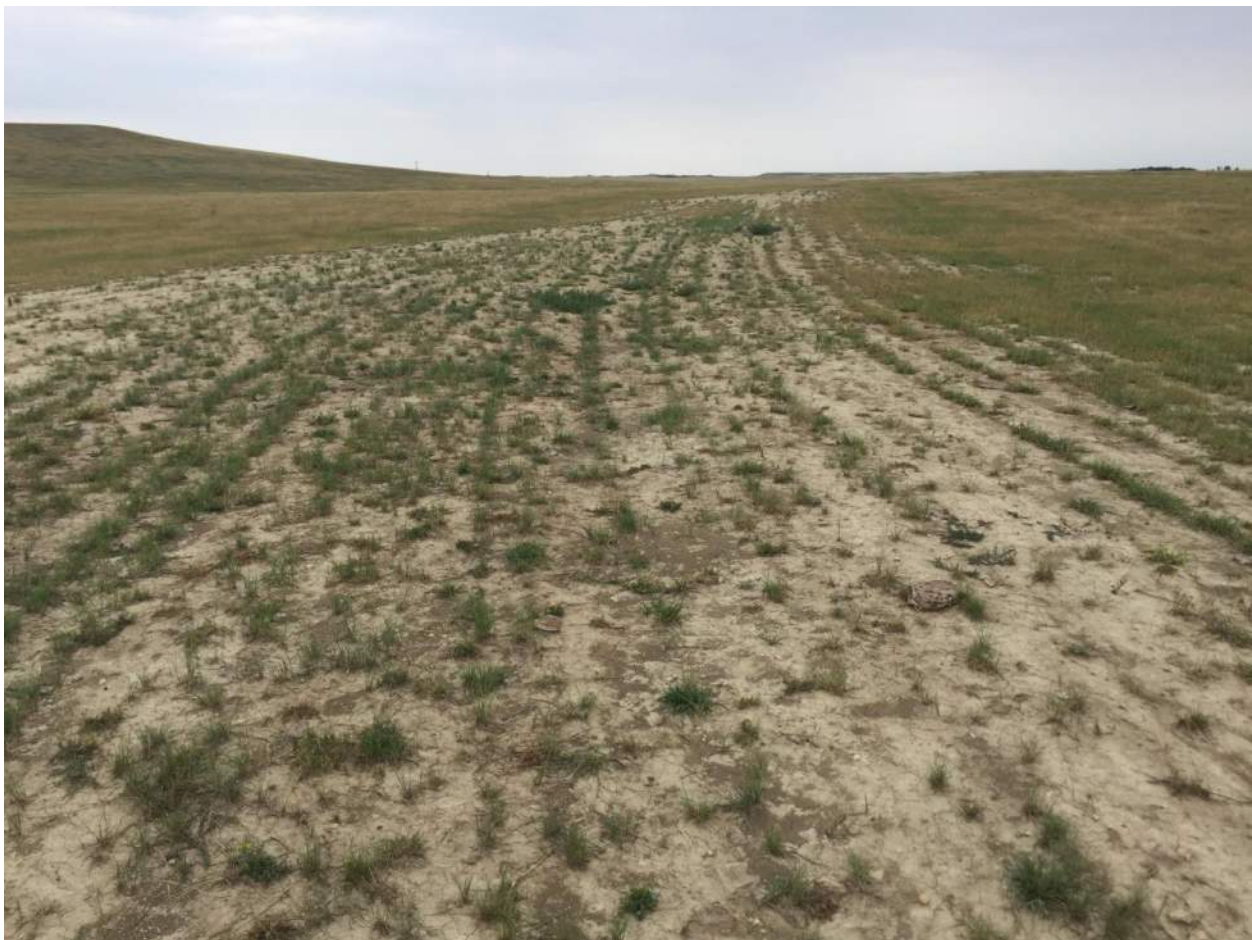
Photo 1. Location: 46.904706, -103.274497. Facing: West. View of a reclaimed grassland area on USFS lands that had the least vegetation cover of grassland areas in the project area. Note the grasses germinating where seed has been drilled, although vegetation covered approximately 50 percent of the reclaimed area. While some bare ground exists, the presence of germinating grasses in planted areas indicates that given time and moisture grasses will continue to establish in this area. This area lacks vegetation cover mainly because during construction this area was double ditched.

During the site visit, Bridger stated that drought conditions have affected reclamation results. Bridger plans to conduct reseeding on a portion of USFS lands to encourage plant growth where seed has not taken due to drought conditions (**Photo 1**). Bridger demonstrates a willingness to continue monitoring reclamation within the Project ROW. No further inspections on behalf of the PSC are recommended based on field verification of satisfactory plant establishment and Bridger's commitment to continue to monitor the site.

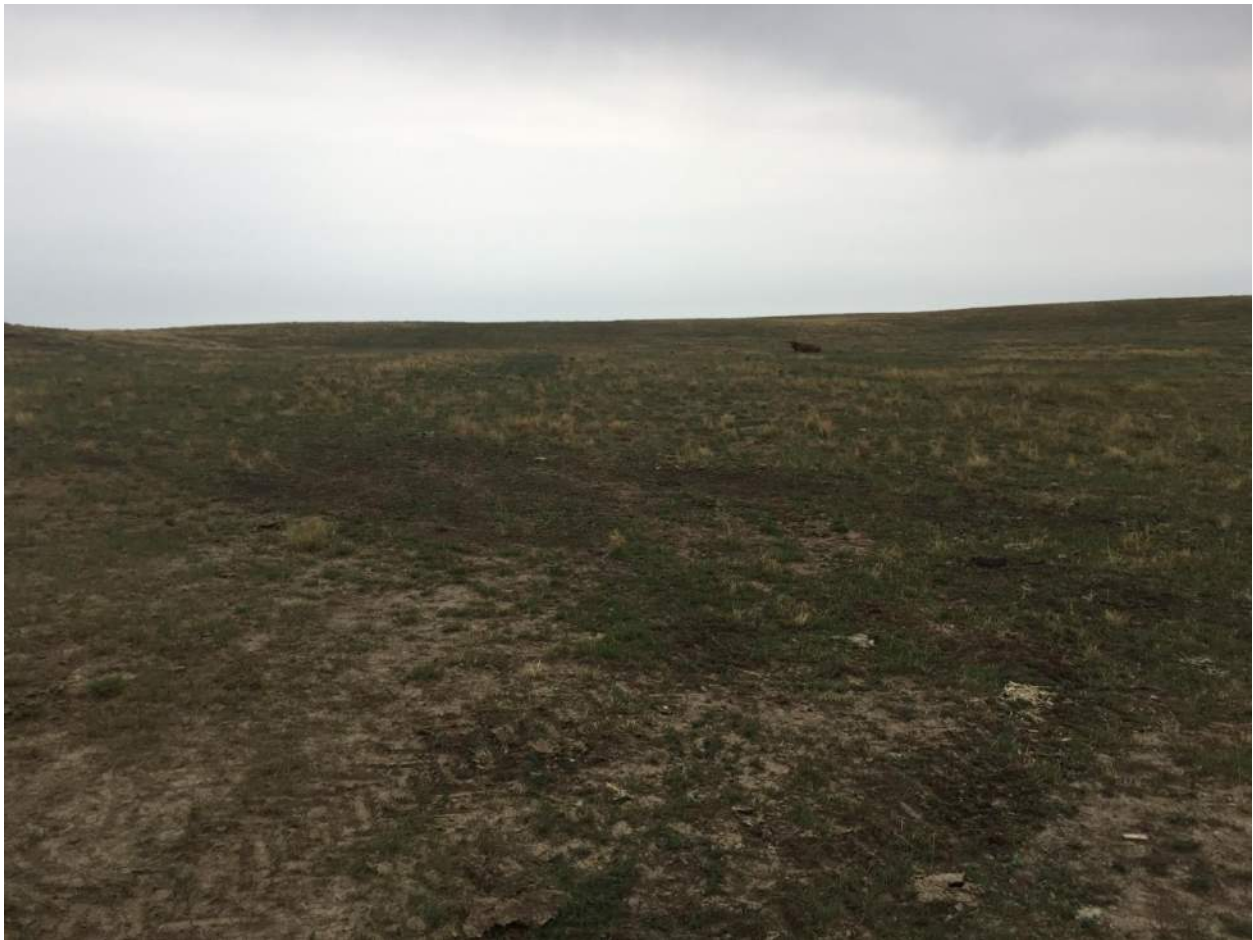
Photo 2. Location: 46.941353, -103.210511. Facing: Northeast. View of a reclaimed grassland area on private lands. Native species accounted for approximately 70 percent cover in this area, which was the average cover on grassland areas in the project area.

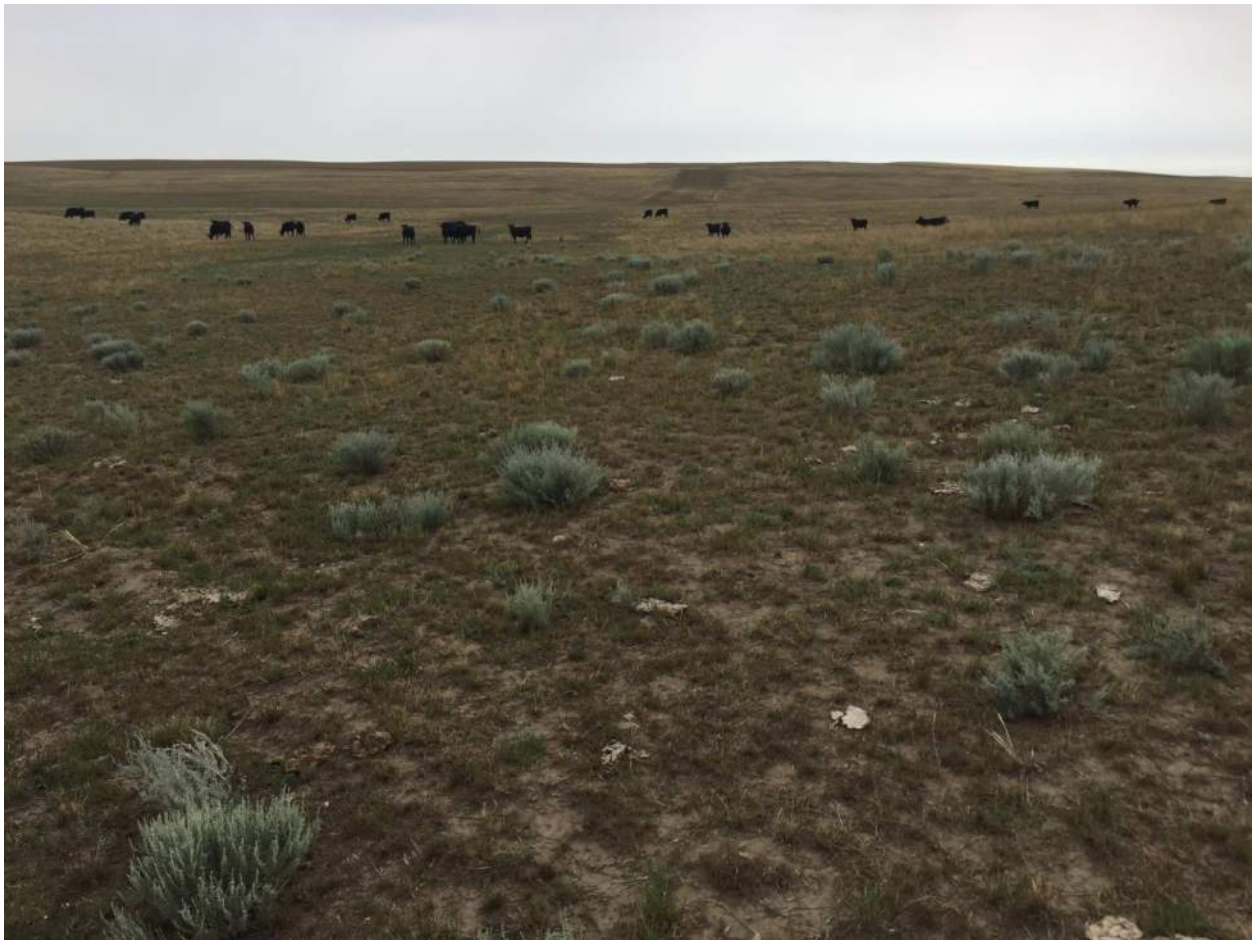
Photo 3. Location: 46.948911, -103.188758. Facing: Northeast. View of a reclaimed grassland area on private lands. Native species accounted for approximately 80 percent cover in this area, which was on the high end for grassland areas in the project area. Note the prevalence of fringed sage (*Artemisia frigida*) in this area, which is a common species that occurs after grazing. Considering current drought conditions and grazing pressure, vegetation appears to be establishing well throughout the reclaimed area. This area had soil settling issues during the initial inspection which have now been remediated by adding additional topsoil in areas that had settled.

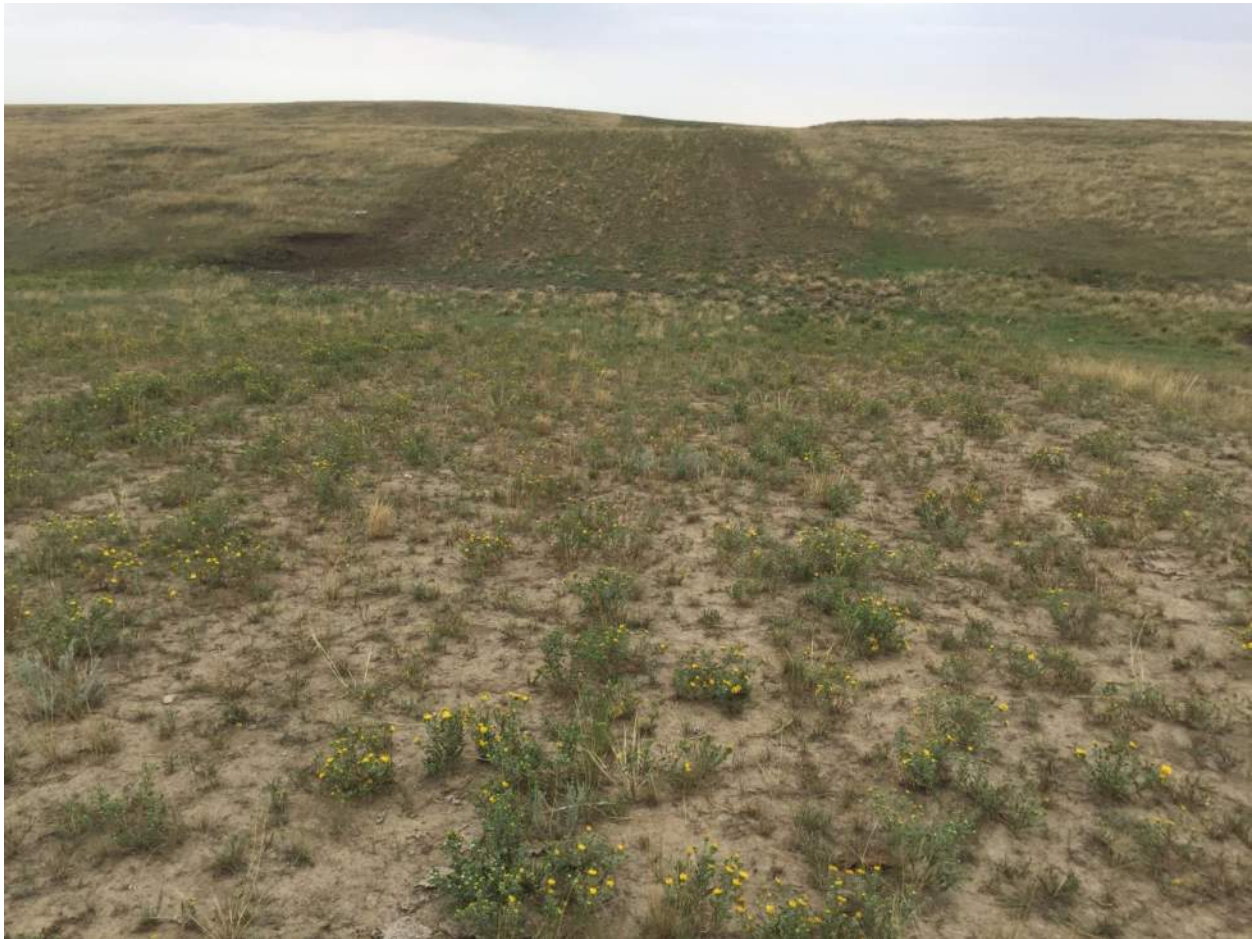
Photo 4. Location: 46.945256, - 103.203347. Facing: West. View of a reclaimed wetland drainage within a native pasture. Note the dominance of native grasses throughout this area. Native vegetation covered approximately 80 percent of the disturbed area. This area had soil subsidence issues during the initial inspection which have now been remediated.

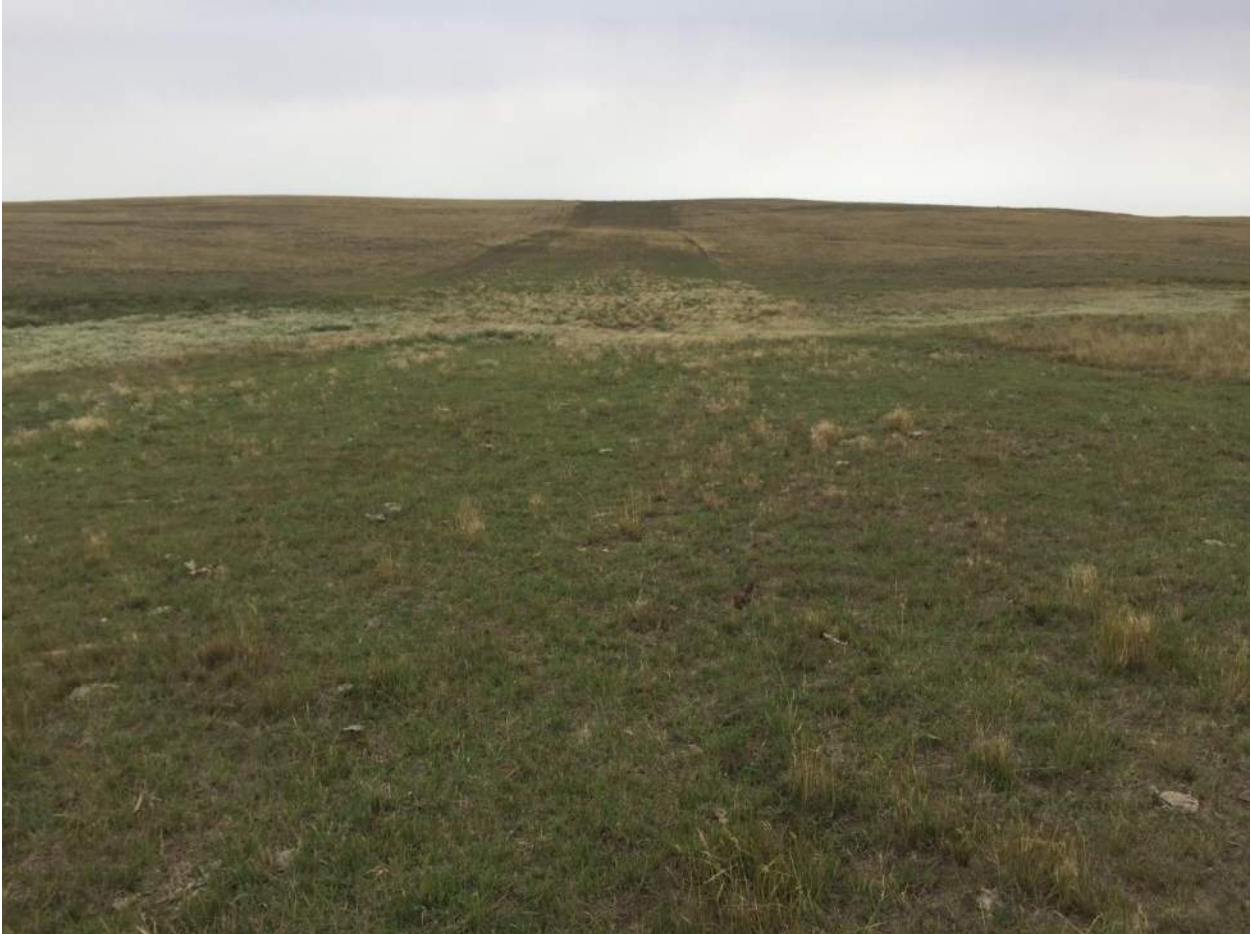
Photo 5. Location: 46.950853, -103.186644. Facing: Northeast. View of a reclaimed wetland drainage within a native pasture. Note the dominance of native grasses throughout this area. Native vegetation covered approximately 80 percent of the disturbed area.

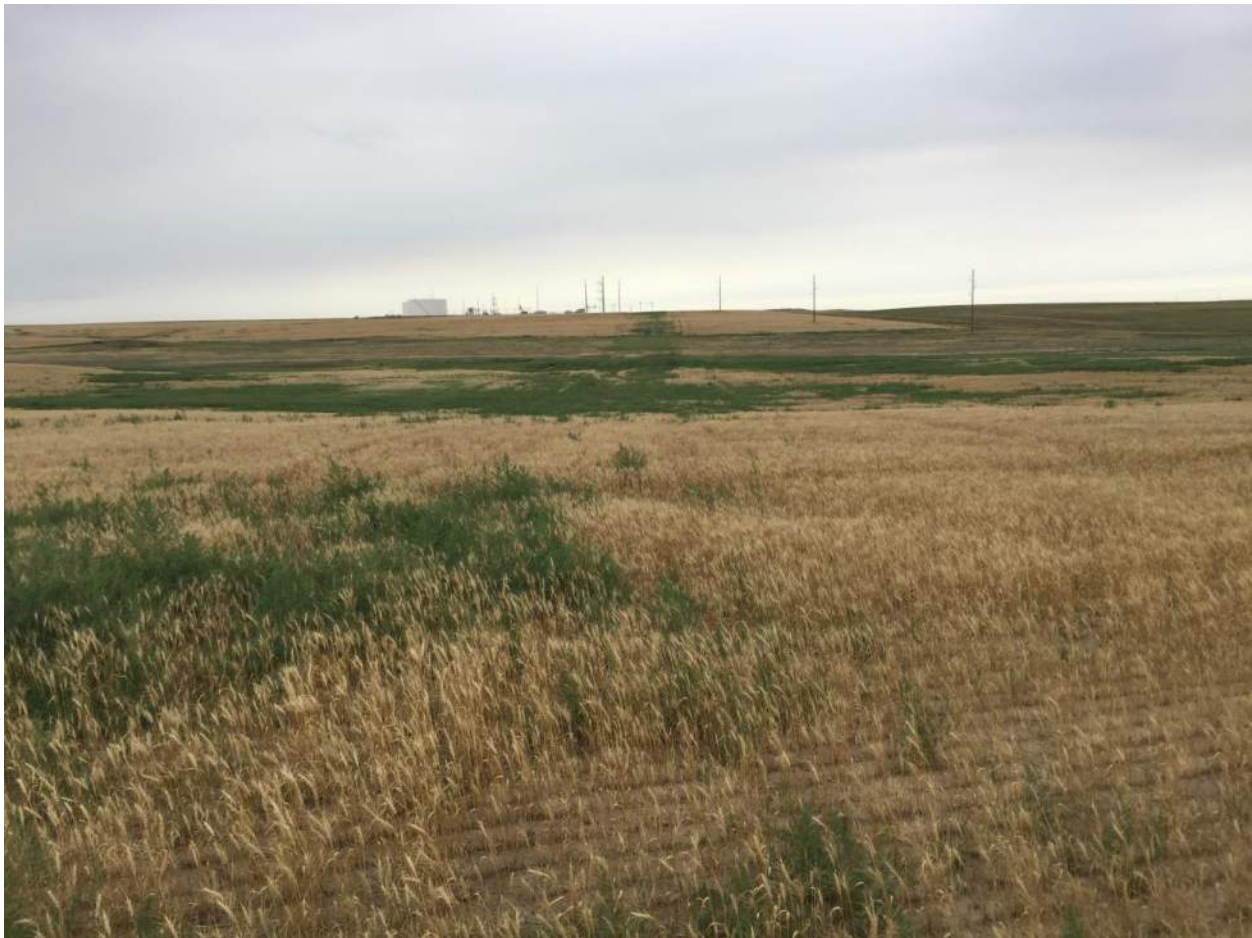
Photo 6. Location: 47.023955, -103.099708. Facing: North. View of a wetland crossing near the end of the pipeline route (green vegetation in the middle of the photo). Native vegetation covered approximately 80% of the disturbed area in this basin. The cropland in this area also appeared uniform compared to undisturbed areas.

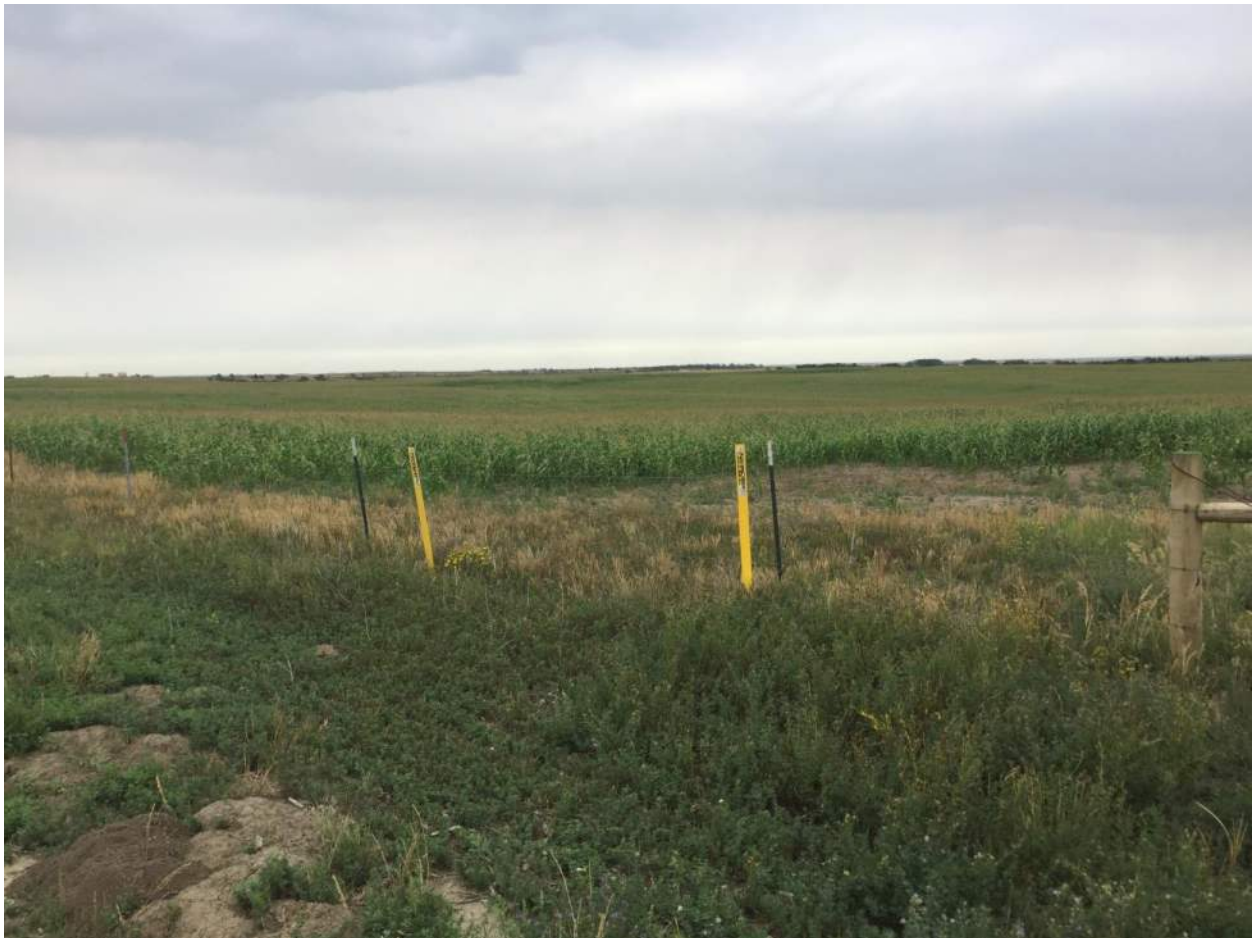
Photo 7. Location: 46.964736, -103.168219. Facing: Northeast. View of the Project ROW through a corn field. No difference was observed between the Project ROW and other cropped areas. Pipeline markers were present.

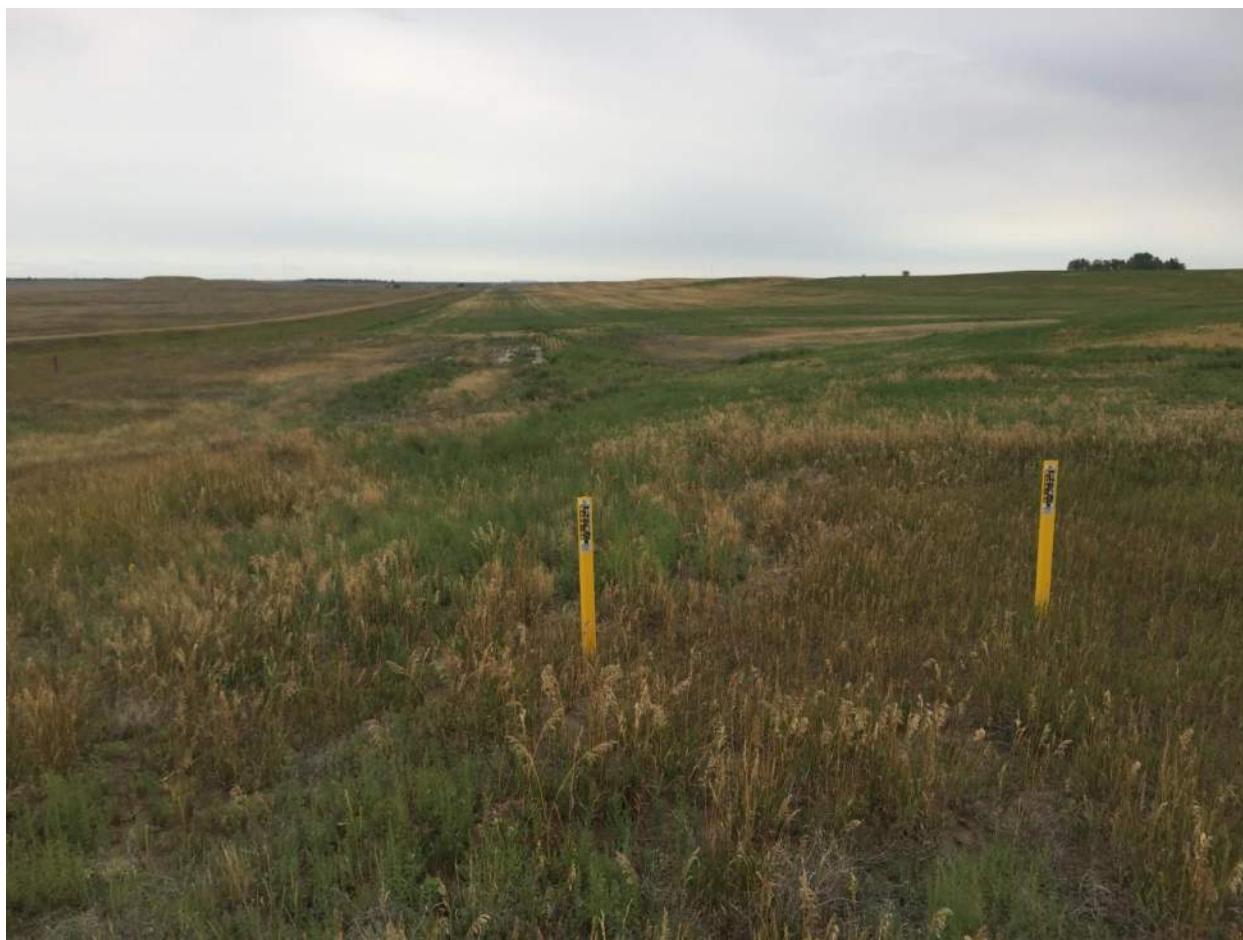
Photo 8. Location: 46.904683, -103.252433. Facing: East. View of the Project ROW through a wheat field. No difference was observed between the Project ROW and other cropped areas. Pipeline markers were present.
