August 3, 2016

**Re: Notice of Potential Violation  
Sacagawea Pipeline Company, LLC  
16-inch Crude Oil Pipeline – McKenzie & Mountrail  
Case No. PU-15-114**

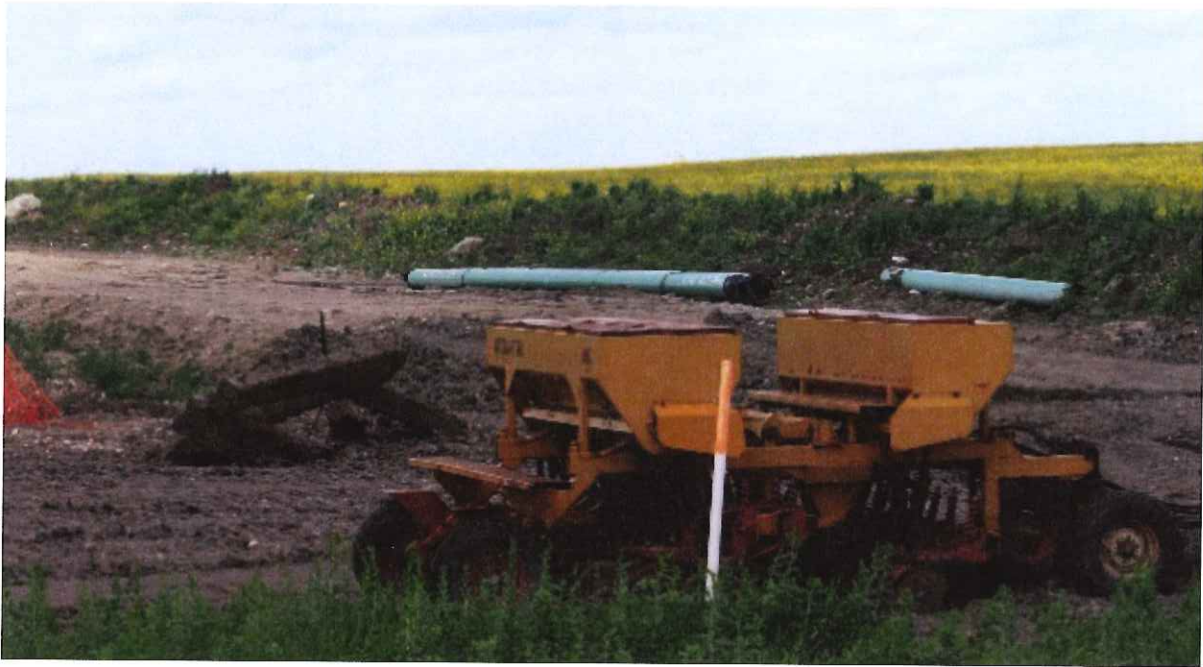
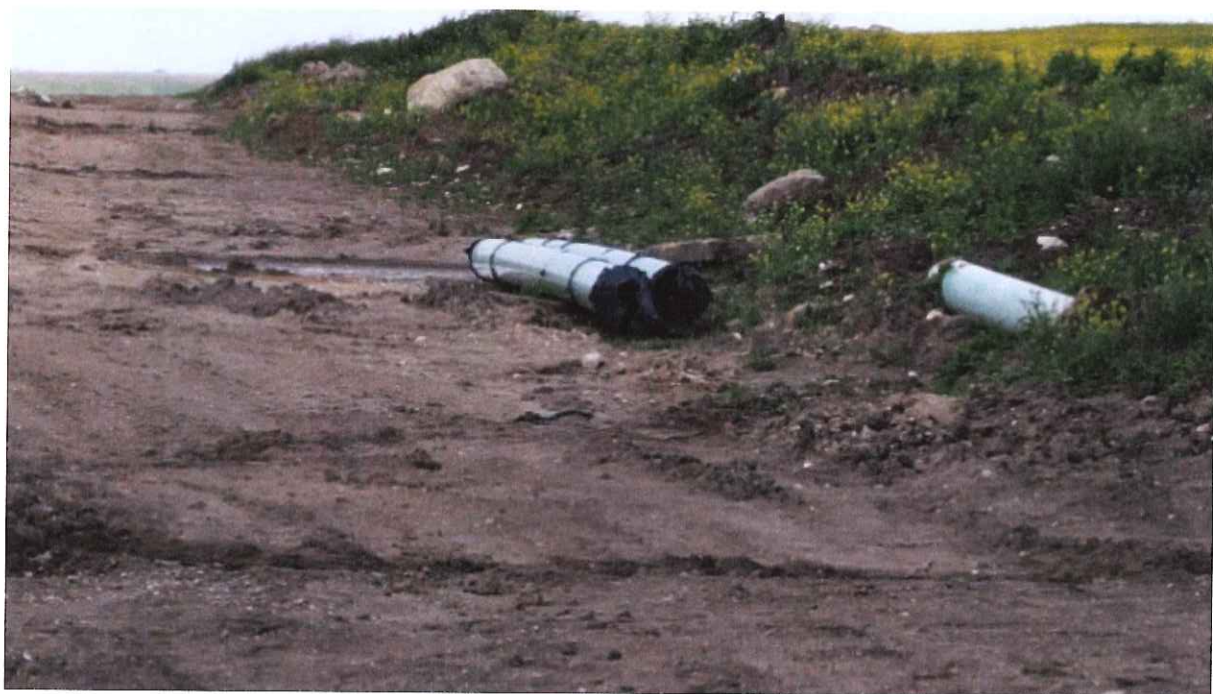
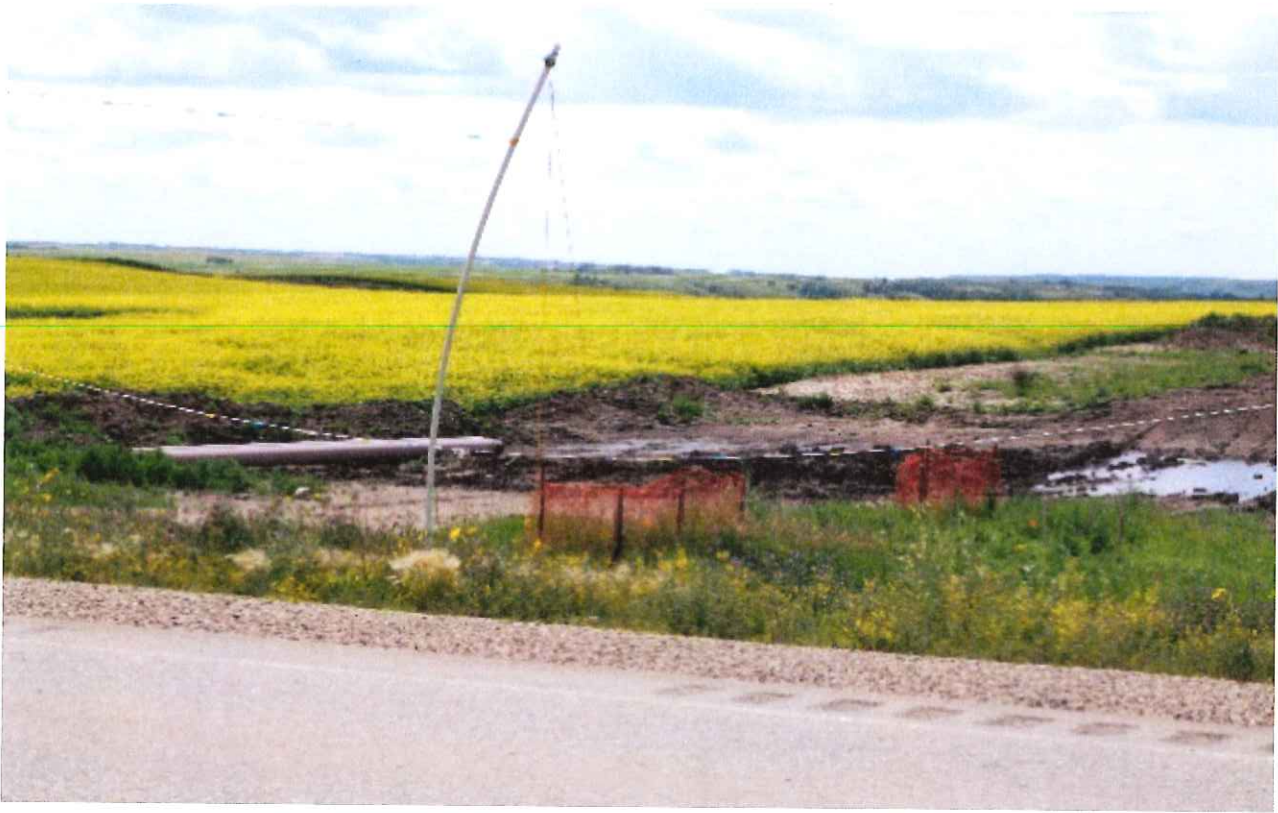
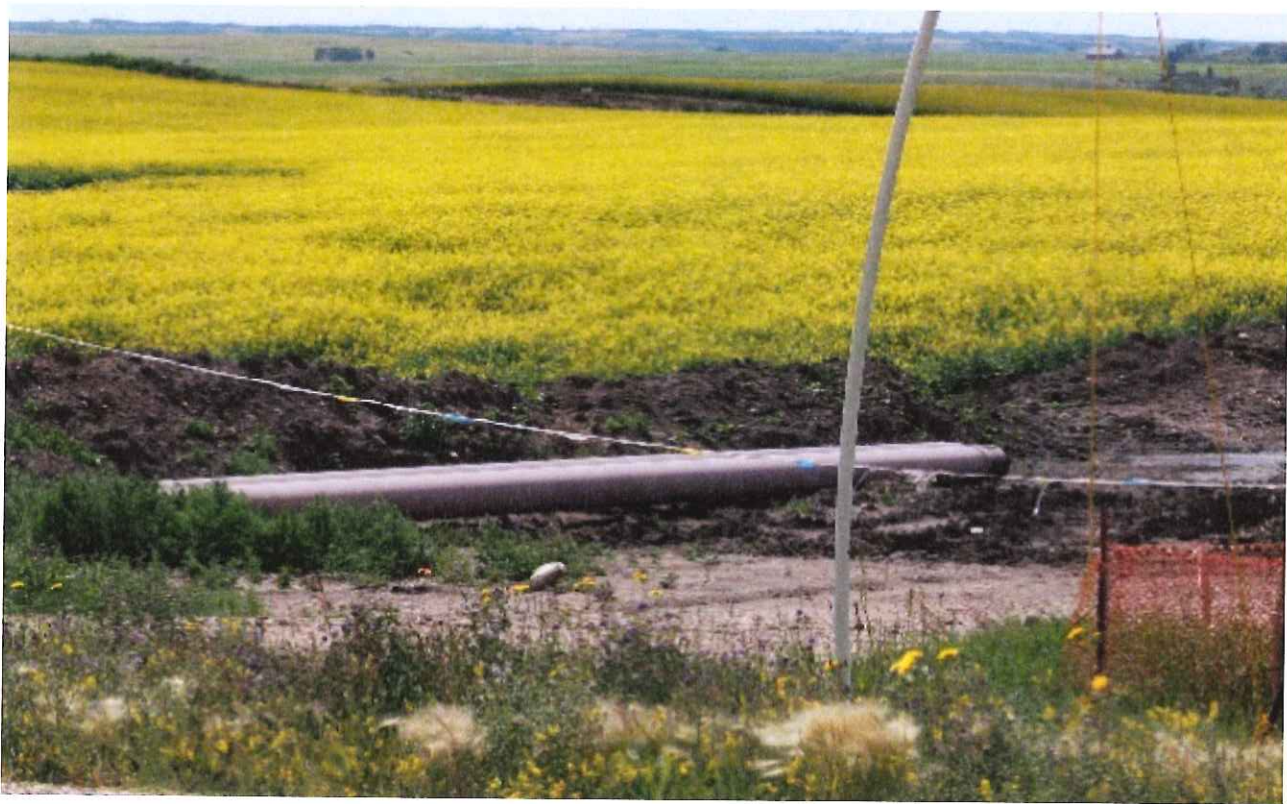
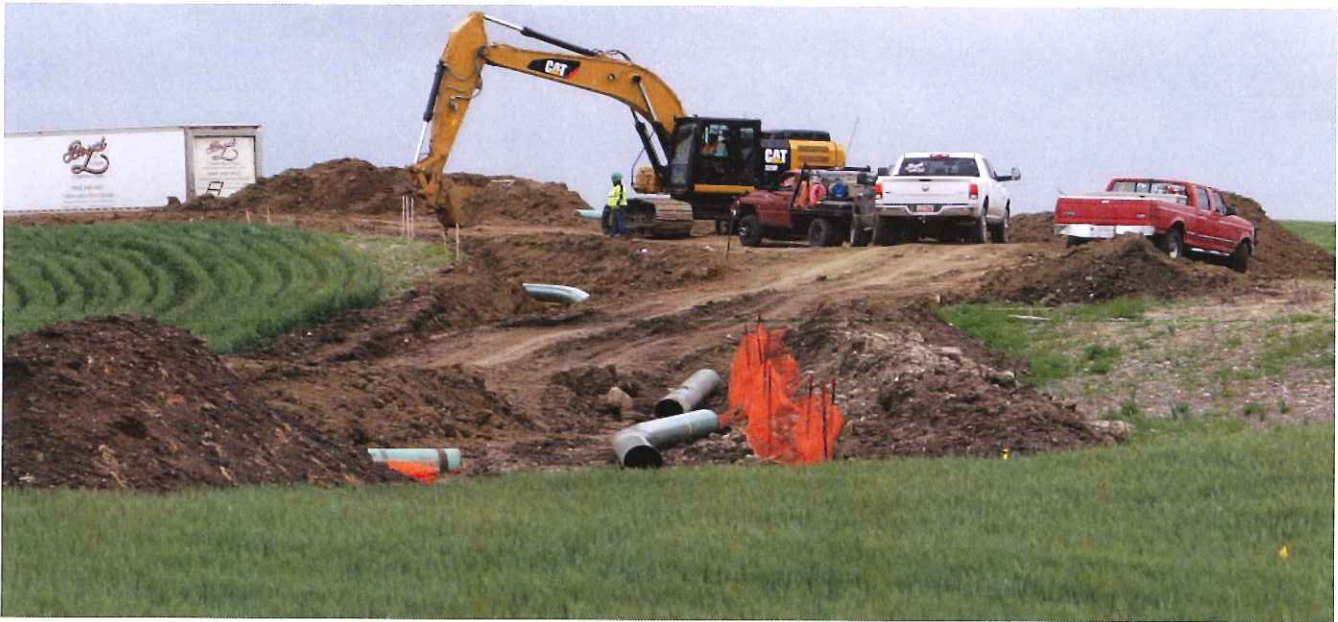
approximately two miles west of Highway 8, the second two were taken near Highway 8 south of 53<sup>rd</sup> Street NW, and the last was taken at 59<sup>th</sup> Street west of 80<sup>th</sup> Avenue NW. Skilled pipeline workers are taught never to place pipe on the ground because rocks and dirt can scratch the factory coating, which can contribute to corrosion and integrity problems down the line.

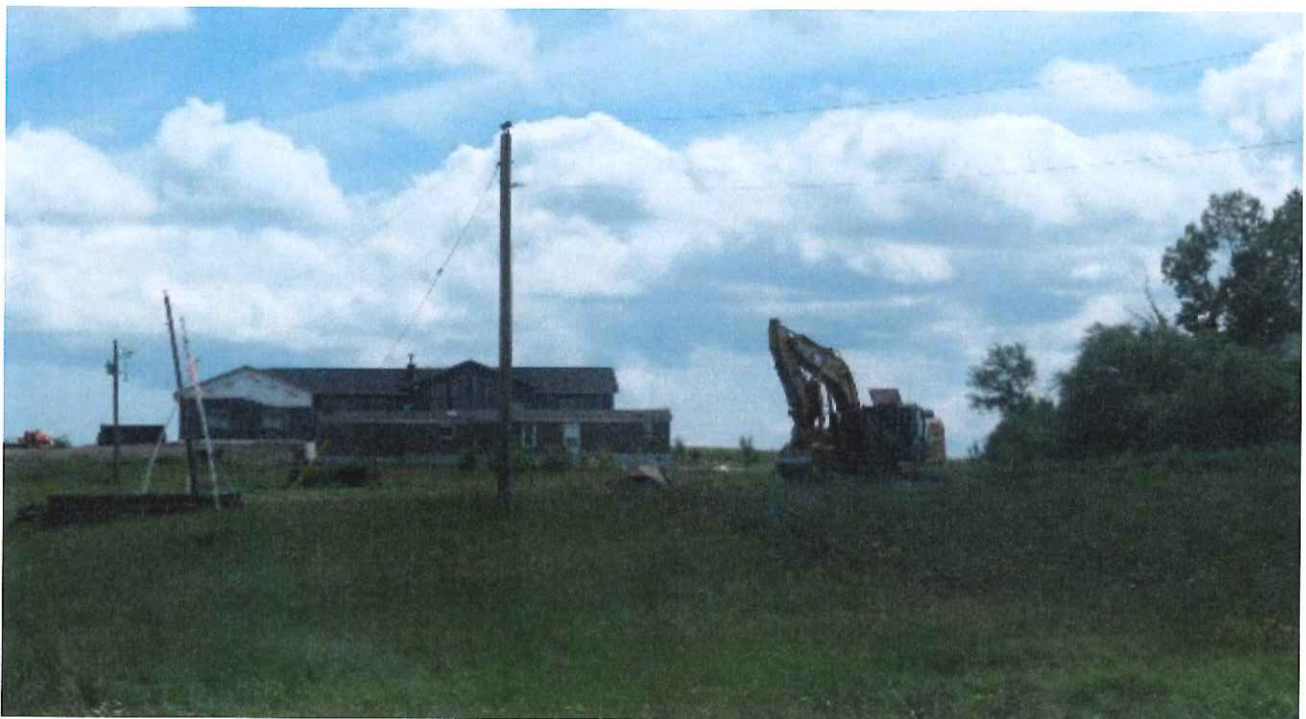
The photo below, taken near 53<sup>rd</sup> Street NE east of Highway 8 in Mountrail County, shows an excavator working near overhead power lines without a spotter. In my experience a responsible contractor will not allow use heavy equipment in the vicinity of a live power line without a spotter because contact with the line can injure or kill the operator in addition to the potential for damage to the equipment and the power system.

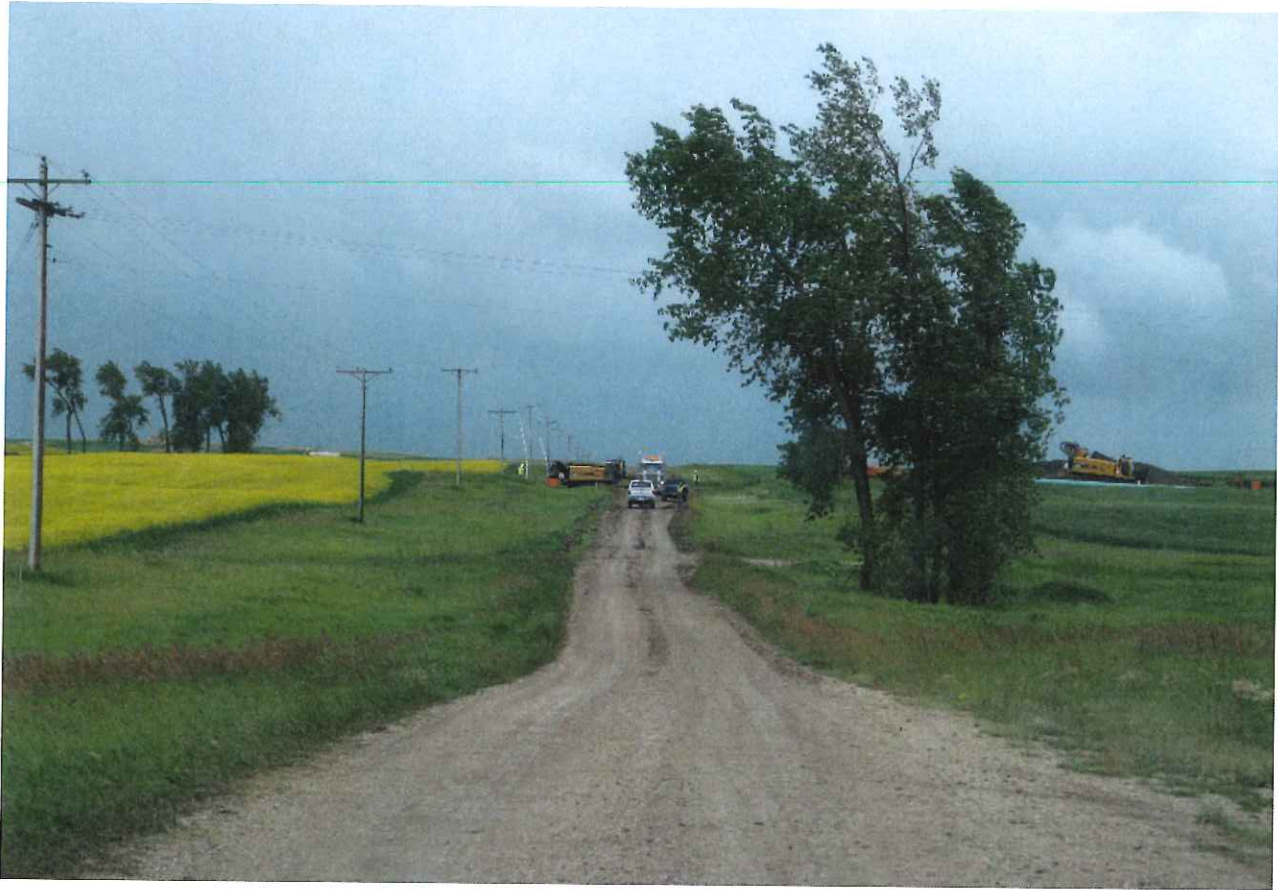
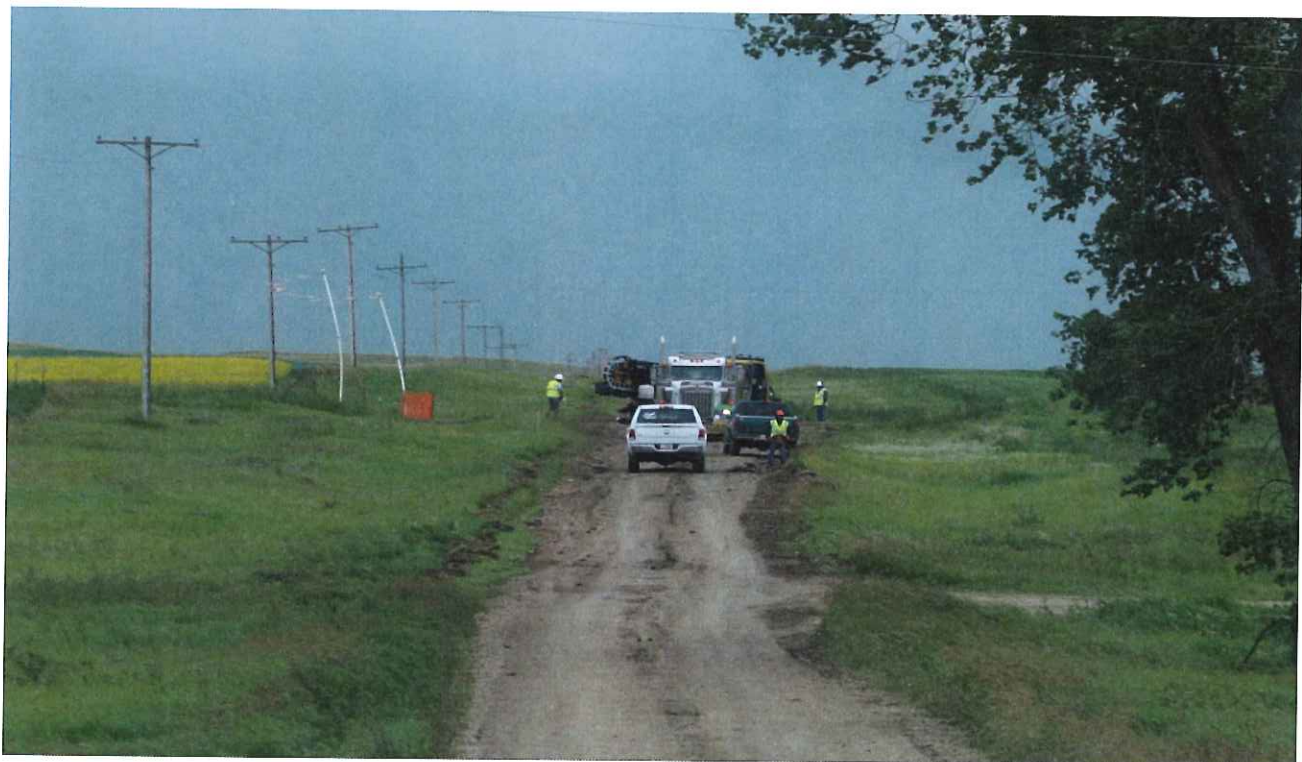
The next two photos, taken near 59<sup>th</sup> Street west of 80<sup>th</sup> Avenue NW, shows construction activity along a road that has not been adequately posted to warn drivers of potential hazards

ahead. In this situation, there should be signs and the flagger should be more visible for the safety of drivers and the crew.

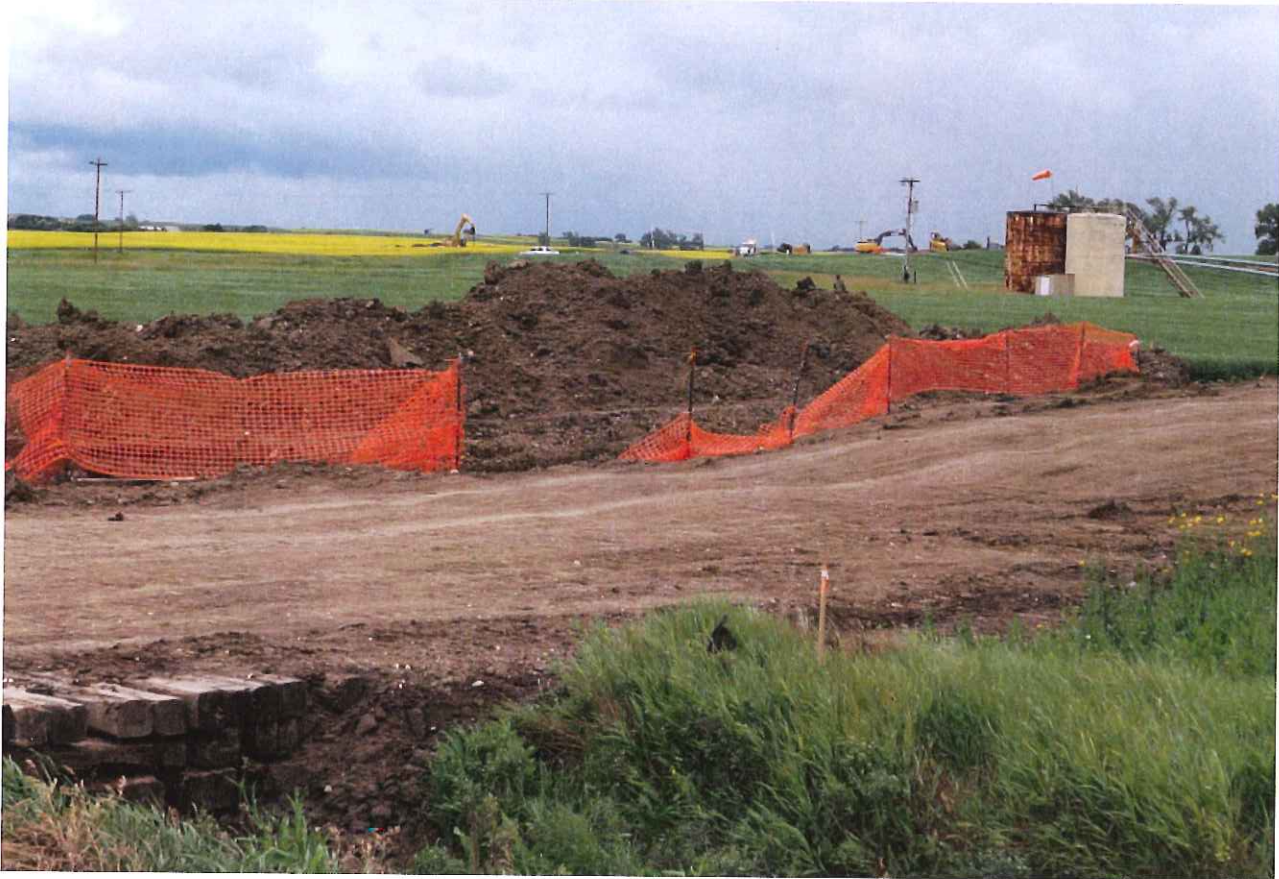
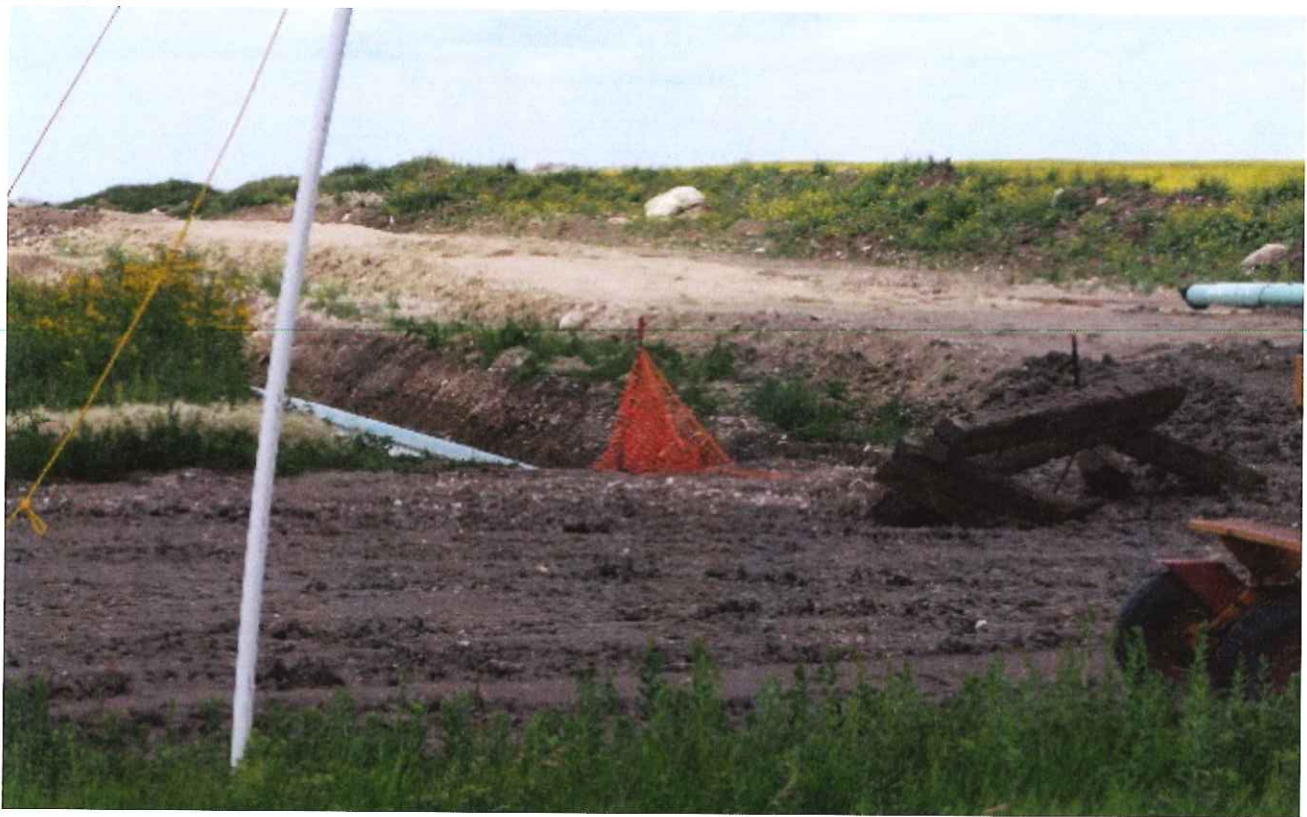
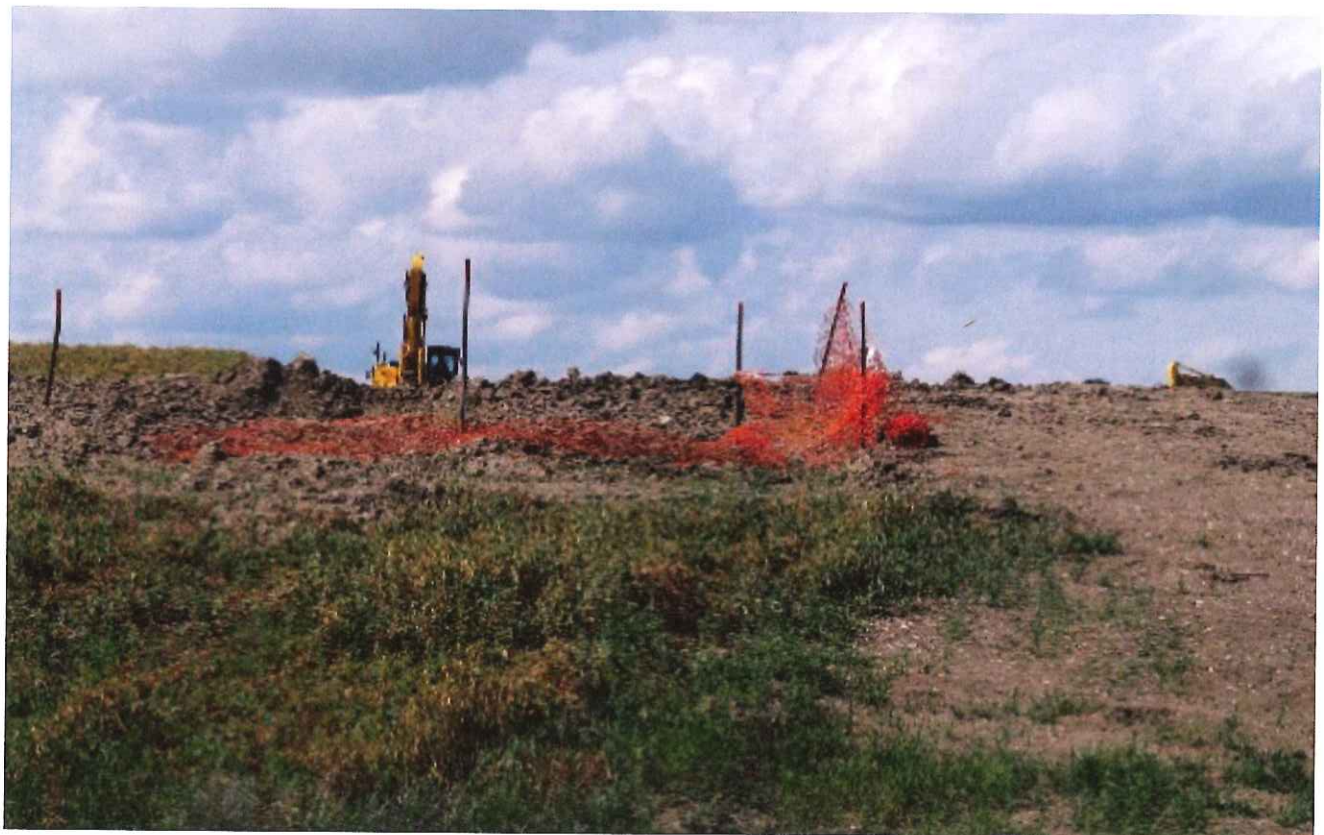
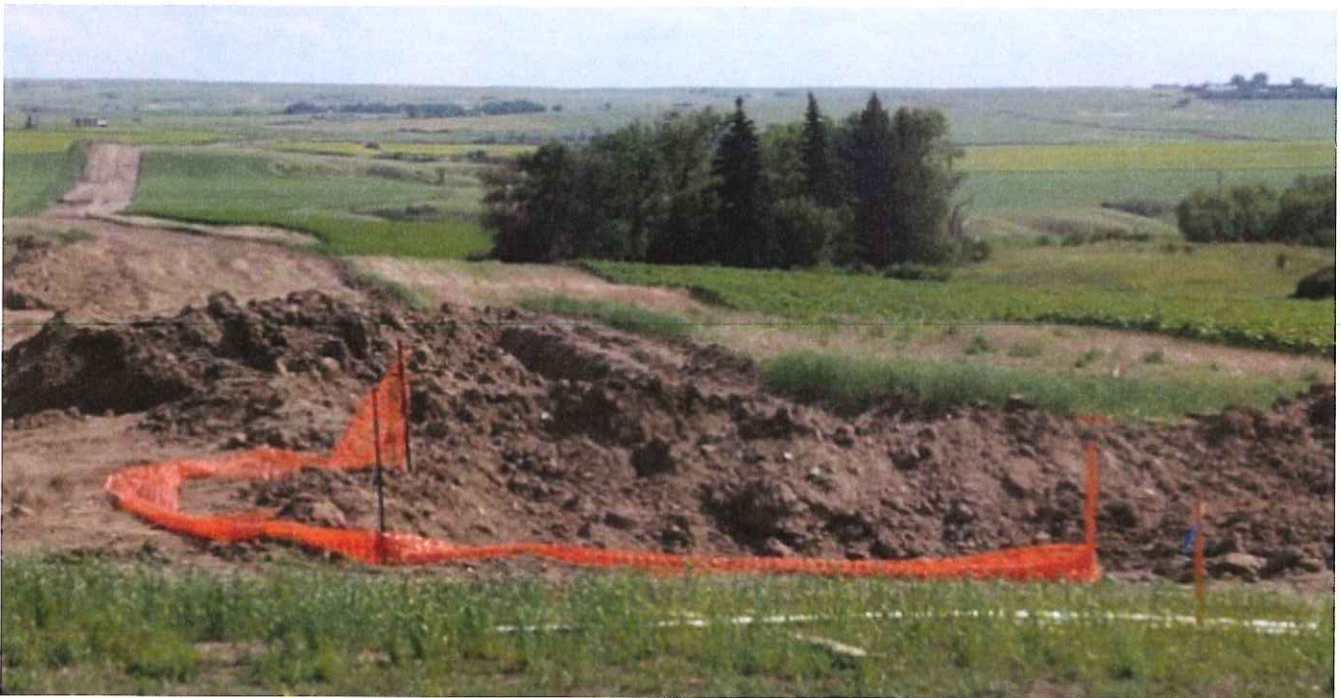
The photos below – the first taken 59<sup>th</sup> Street west of 80<sup>th</sup> Avenue, the second taken near 49<sup>th</sup> Street approximately two miles west of Highway 8, and the rest taken two miles west of 92<sup>nd</sup> Avenue NW on an unnamed road south of Newton – show collapsed safety fence near road crossings that is no longer helping to protect people, animals, or vehicles from injury or damage that can result from a fall into a bore pit.

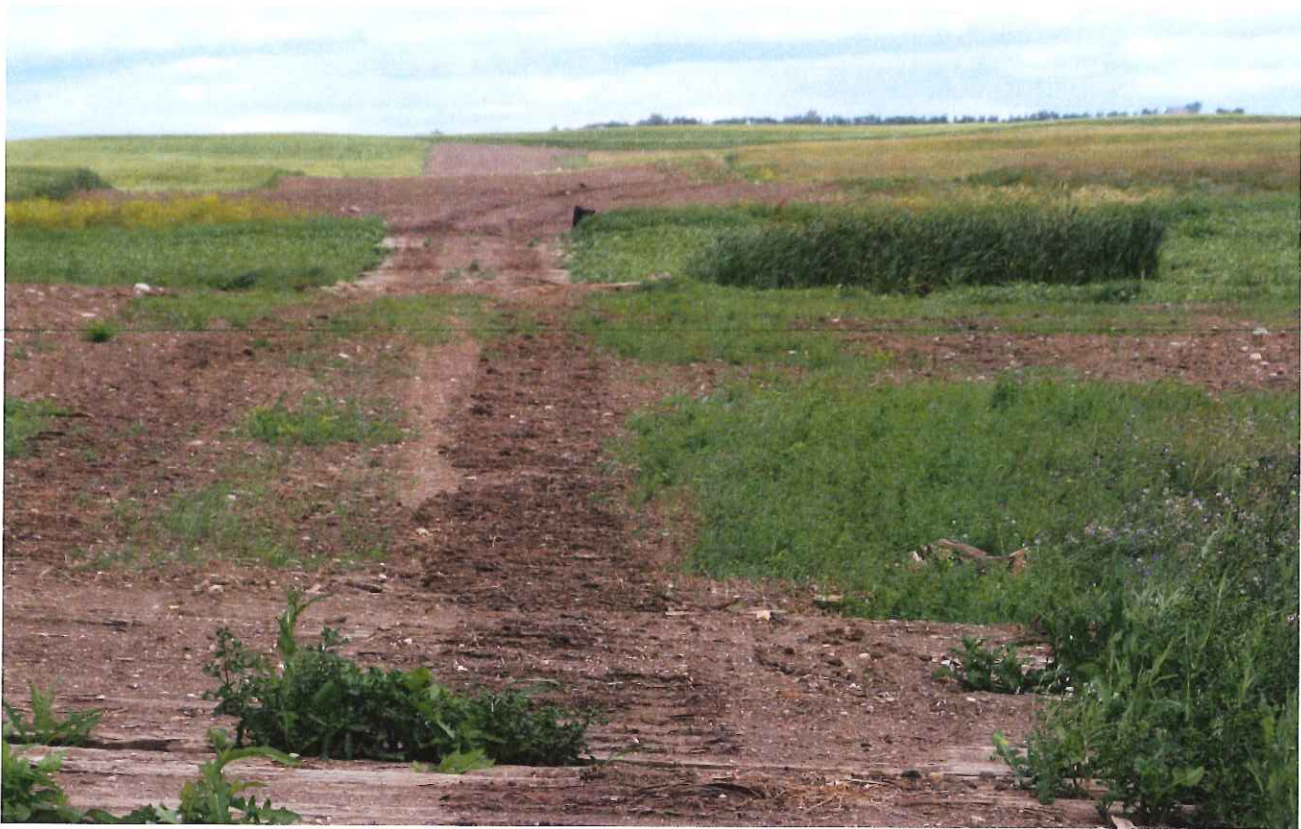
The next photo, taken in the vicinity of 60<sup>th</sup> Street a mile west of 79<sup>th</sup> Avenue, shows a section of the right-of way where heavy equipment has obviously been moved across unprotected wetland, leaving a clear set of tracks. Heavy equipment can permanently damage fragile wetland soil and vegetation, which is why a responsible contractor will use a mat bridge when wetland crossings are unavoidable.

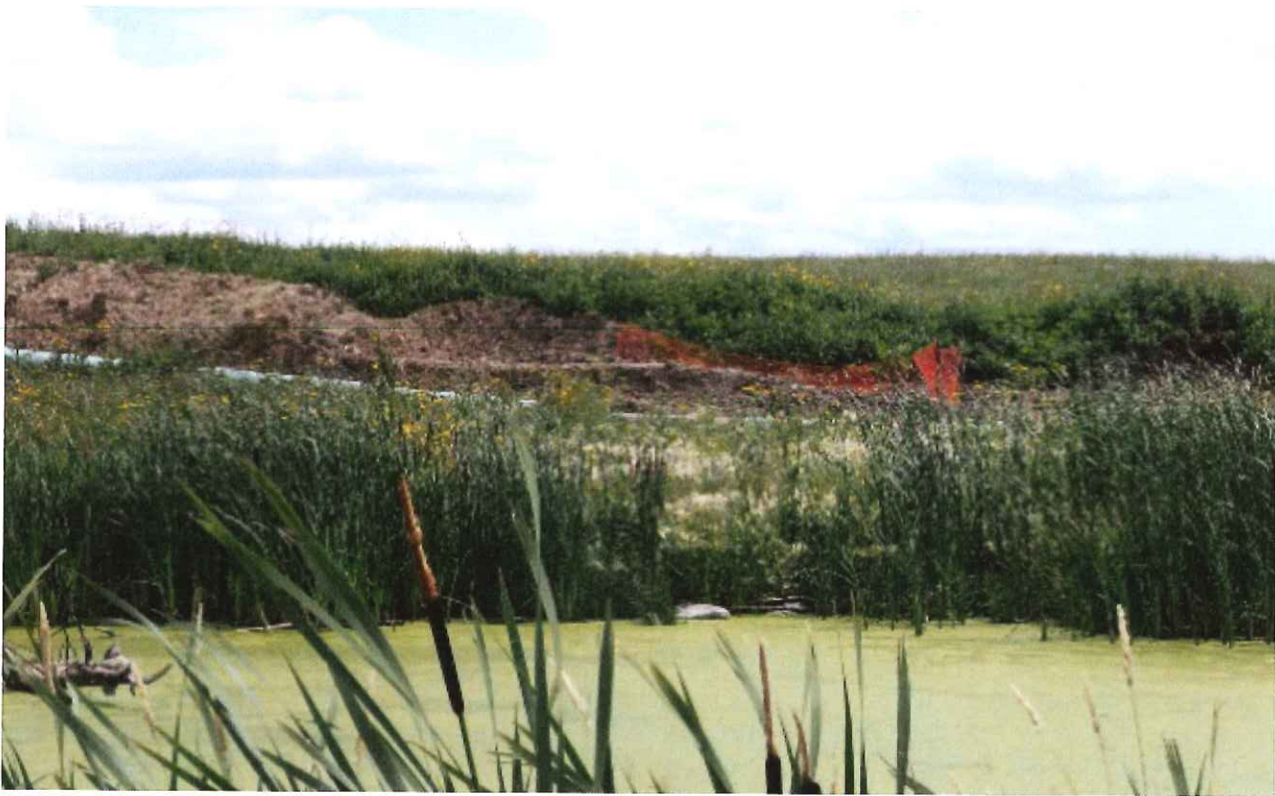
The photos below show areas where the contractor has failed to properly install or maintain silt fence or other erosion controls. Skilled pipeliners are trained to install and maintain proper erosion controls, because erosion can kill wetland vegetation, while removing topsoil necessary to sustain native plant life or cultivation on exposed areas. The following photo shows a section of the right-of-way on 53<sup>rd</sup> Street NW East of Highway 8 in Mountrail County where no silt fence has been put in place to prevent runoff into a wetland.

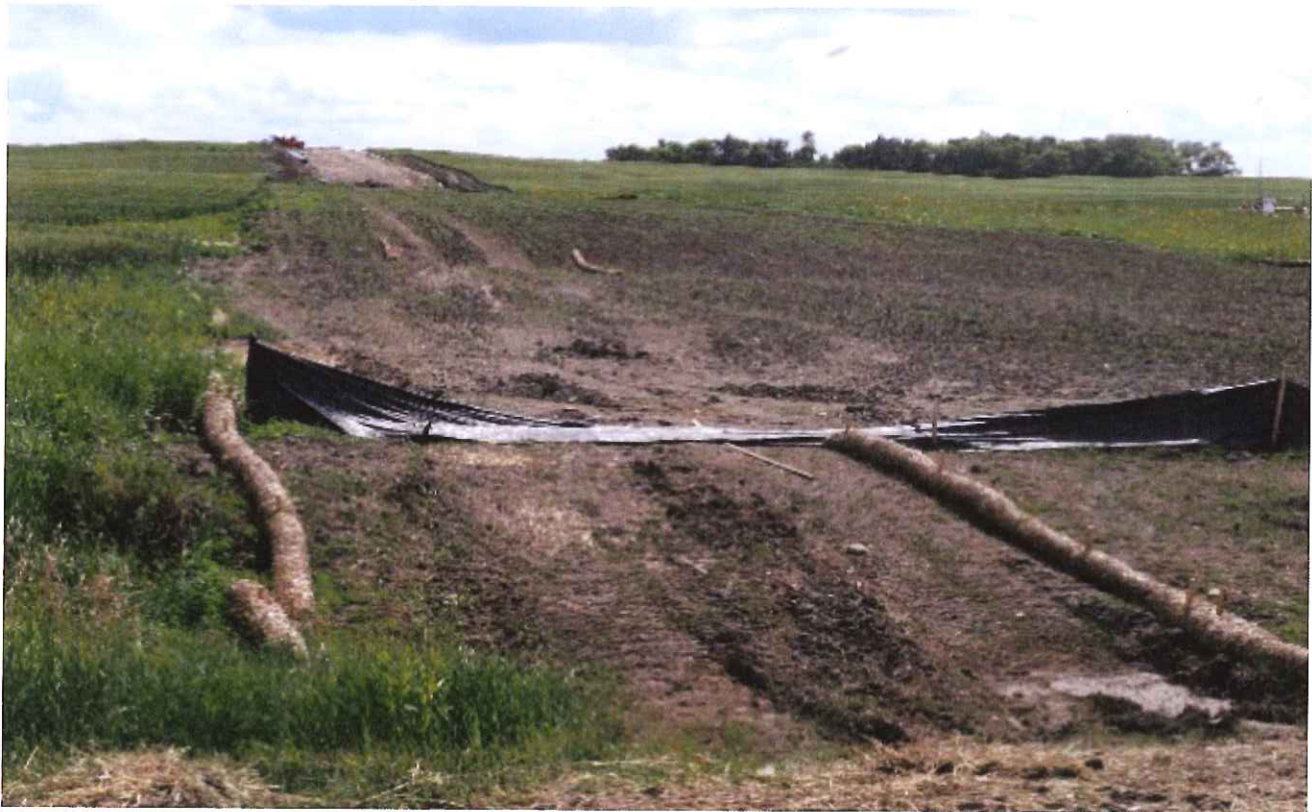
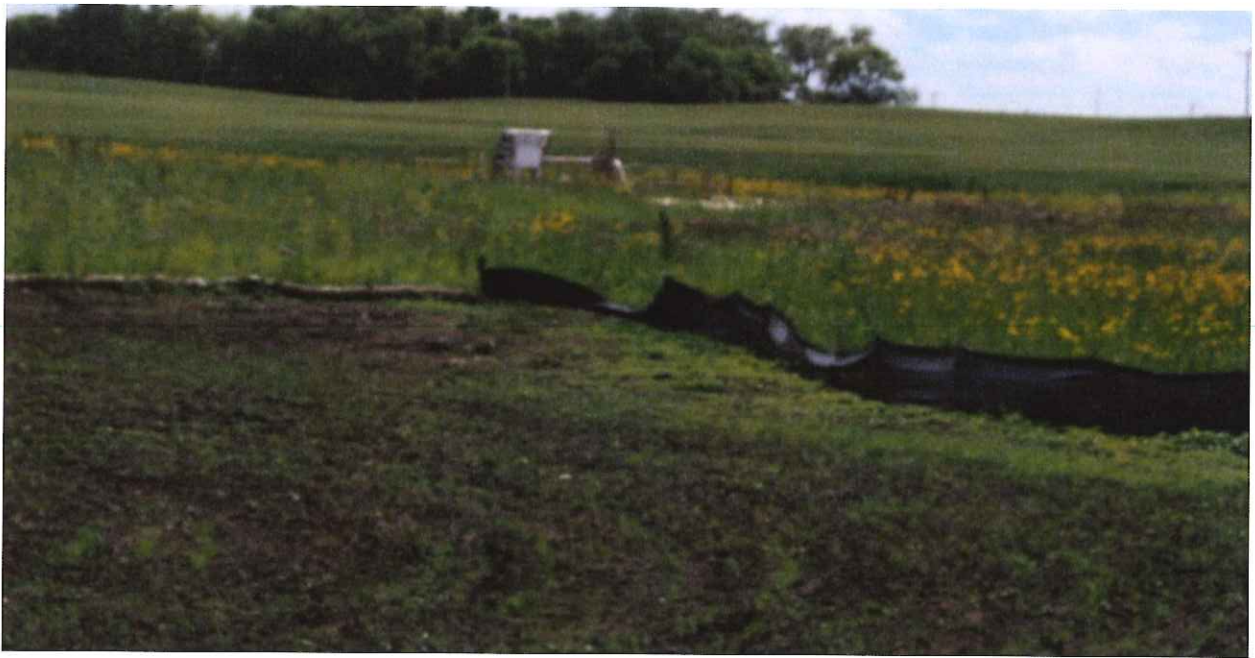
The next two photos, taken at a location east of 87<sup>th</sup> Avenue on an unnamed road in Mountrail County, show an area where silt fence was installed but then evidently run over and neglected.

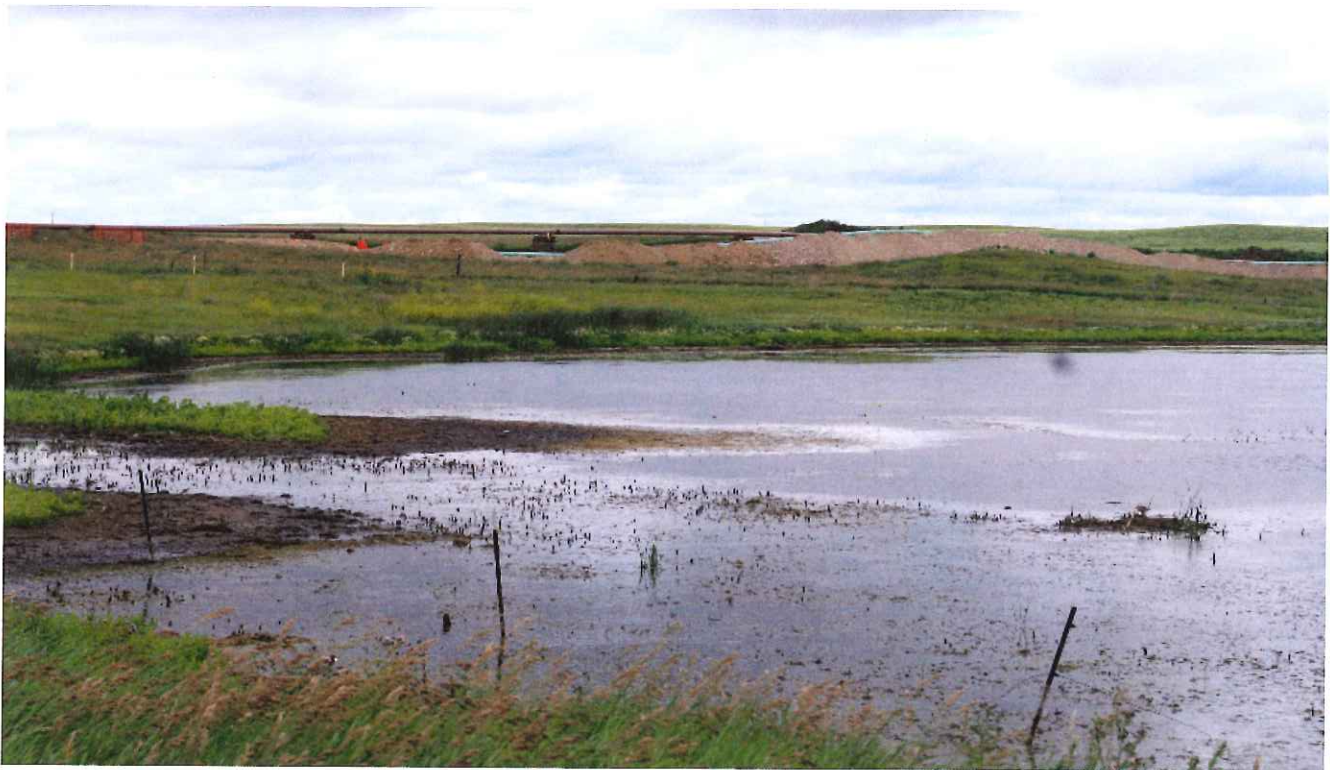
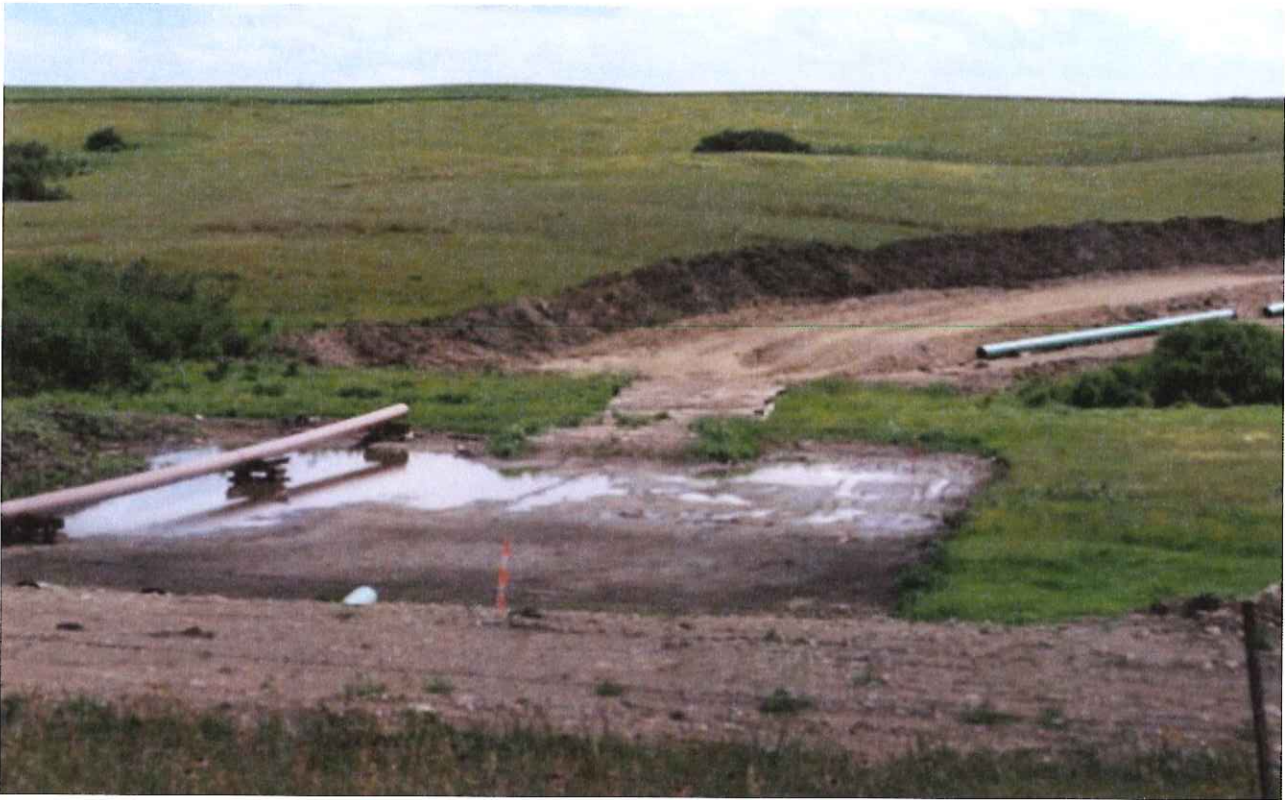
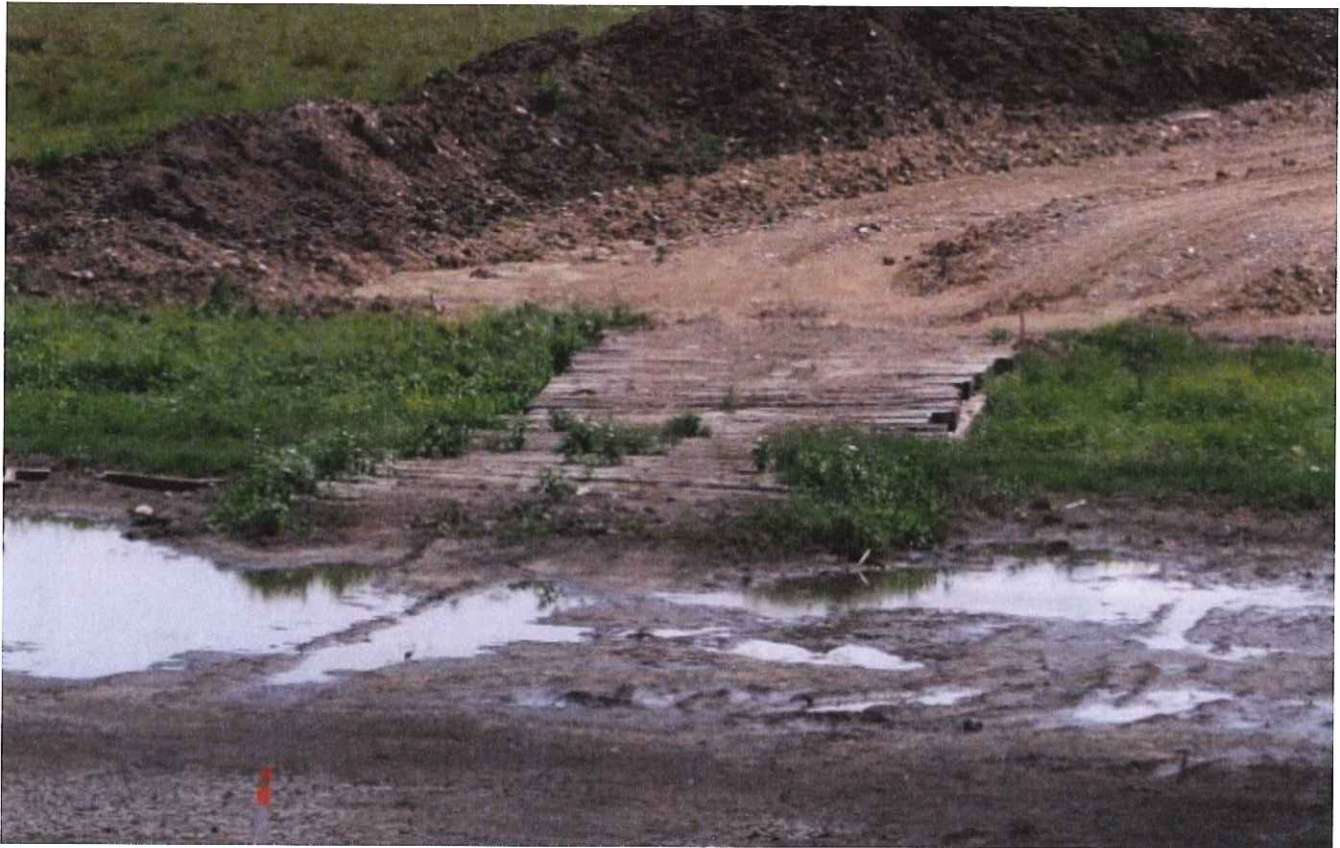
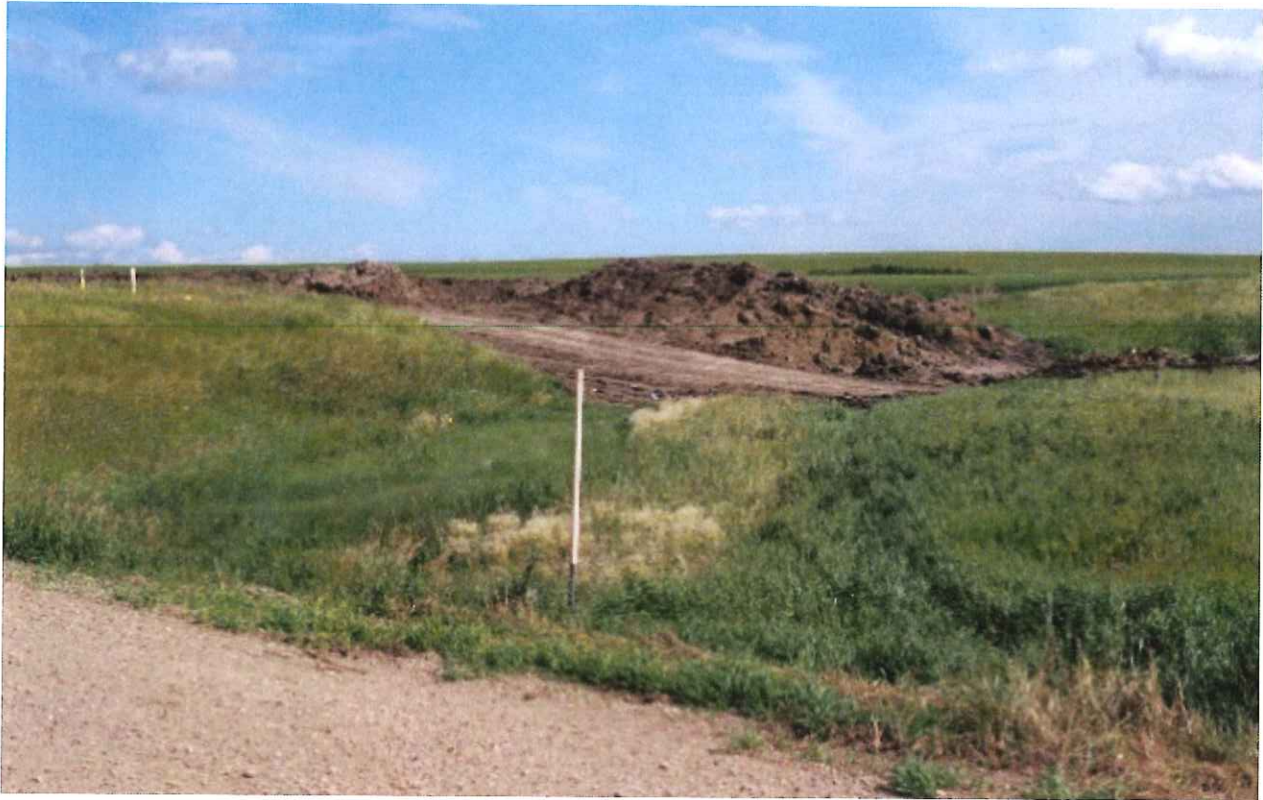
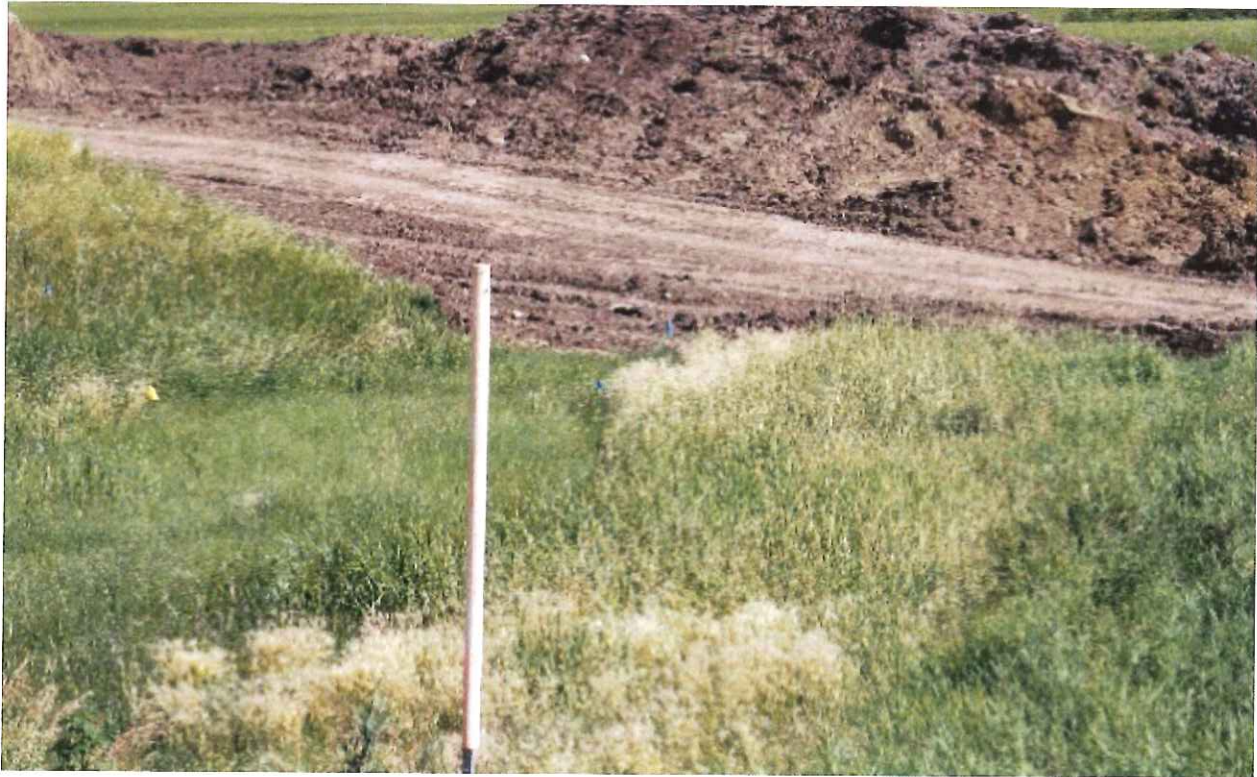
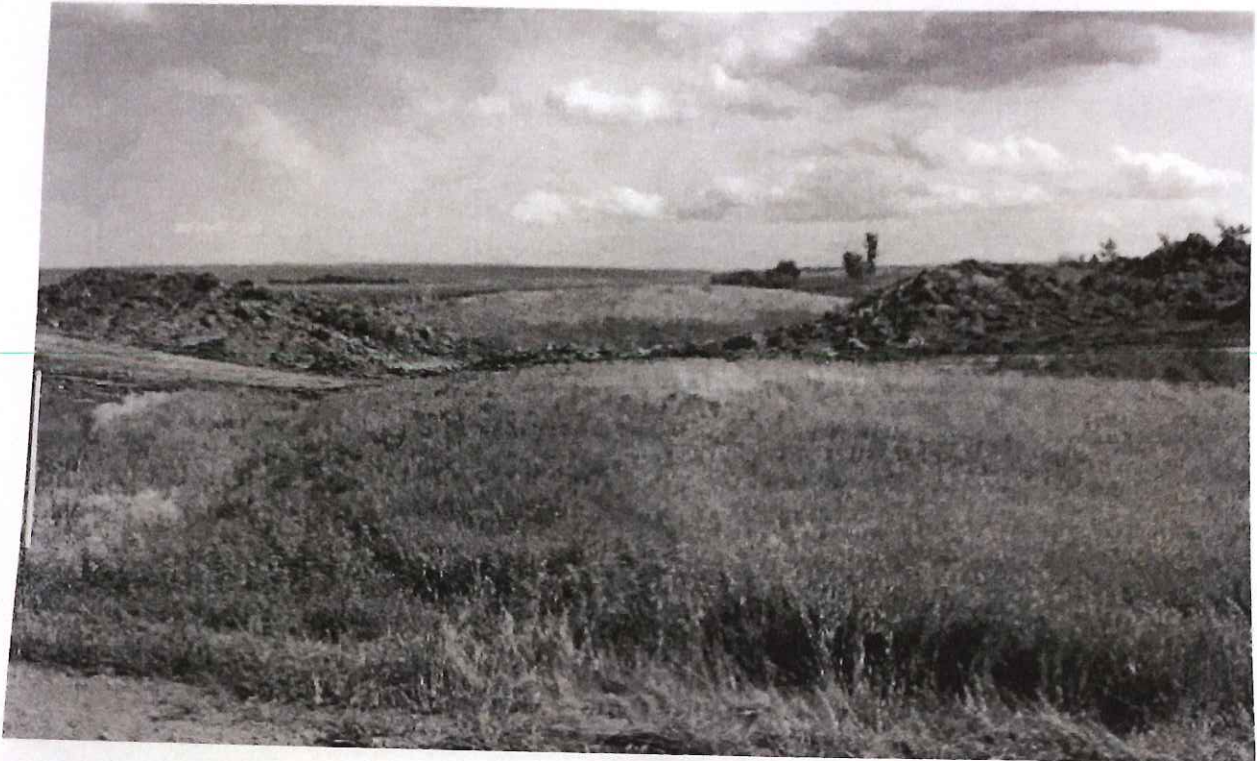
The photos below show locations along the right-of-way where there is clearly no silt fence in place to protect a wetland area. The first photos was taken near 80<sup>th</sup> Avenue NW north of 59<sup>th</sup> Street NW; the second two were taken approximately a half-mile west of 87<sup>th</sup> Avenue NW along an unnamed road north of Newtown; and the remainder were taken about two miles west of 9nd Avenue NW on an unnamed road soth of Newtown.
