Sacagawea Pipeline Project Topsoil Inspection Report PU-15-114

Prepared for:
**North Dakota
Public Service Commission**

Prepared by:

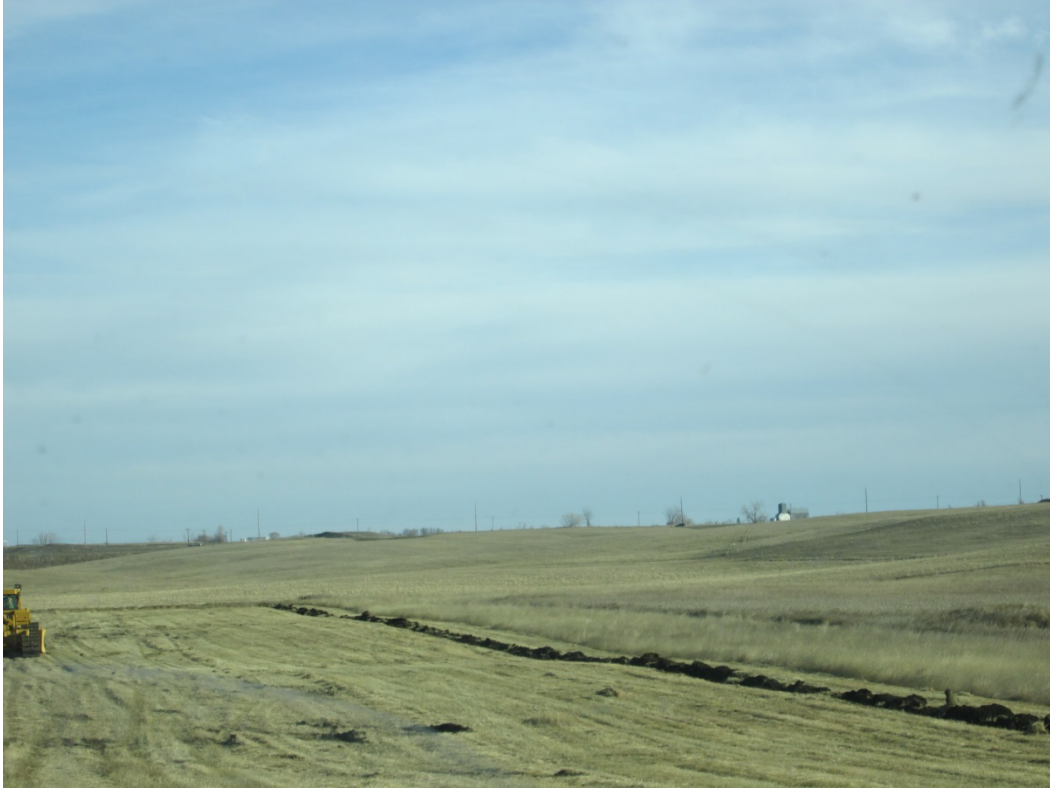
Above: Photo 1 (Point 232) – Start of topsoil stripping. The far right of the photo you can see where the dozer scraped a line in the ground for the topsoil pile to be placed, to stay in the ROW. Grass was previously mowed. Direction looking north.

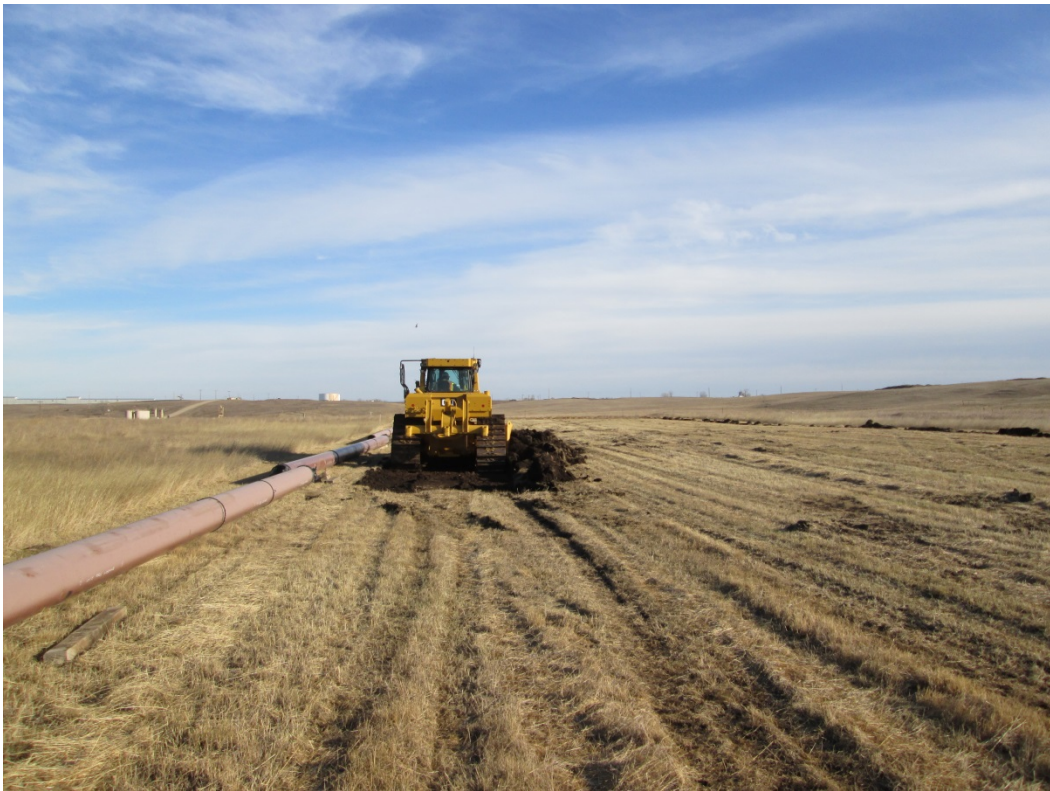
Below: Photo 2 (Point 232) – Start of topsoil stripping. Bore pipe along the left side. Direction looking north toward Palermo station.

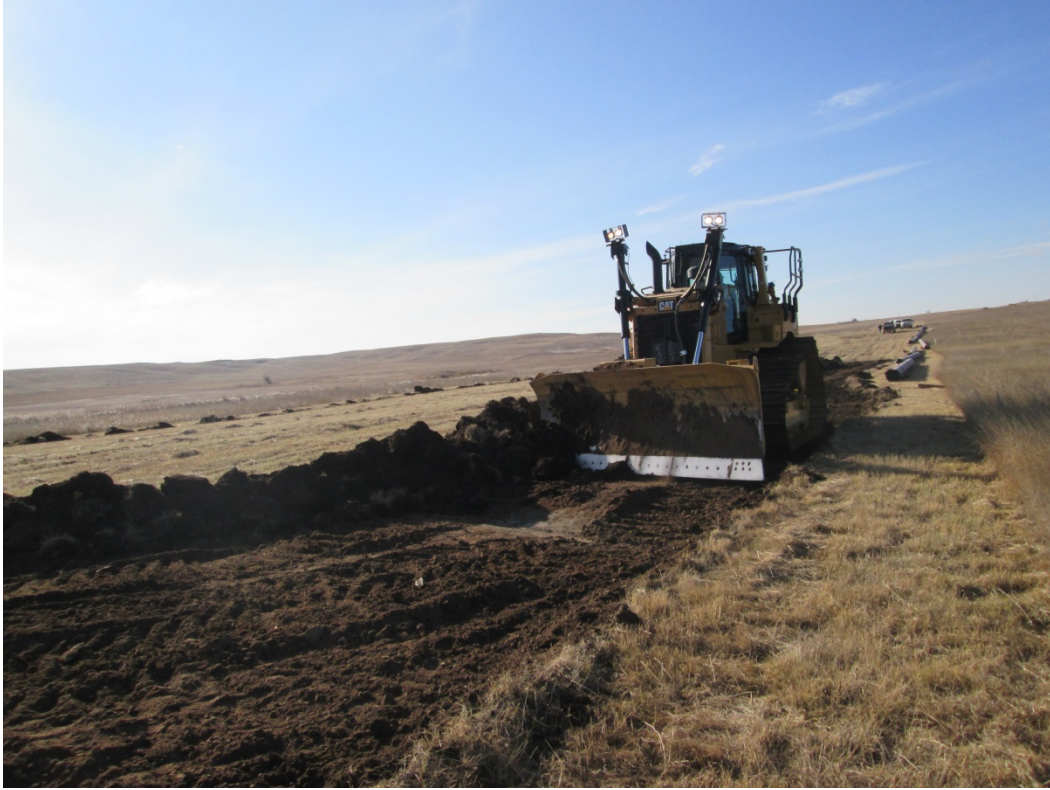
Above: Photo 3 (pt. 232) - Start of topsoil stripping. Direction looking south.

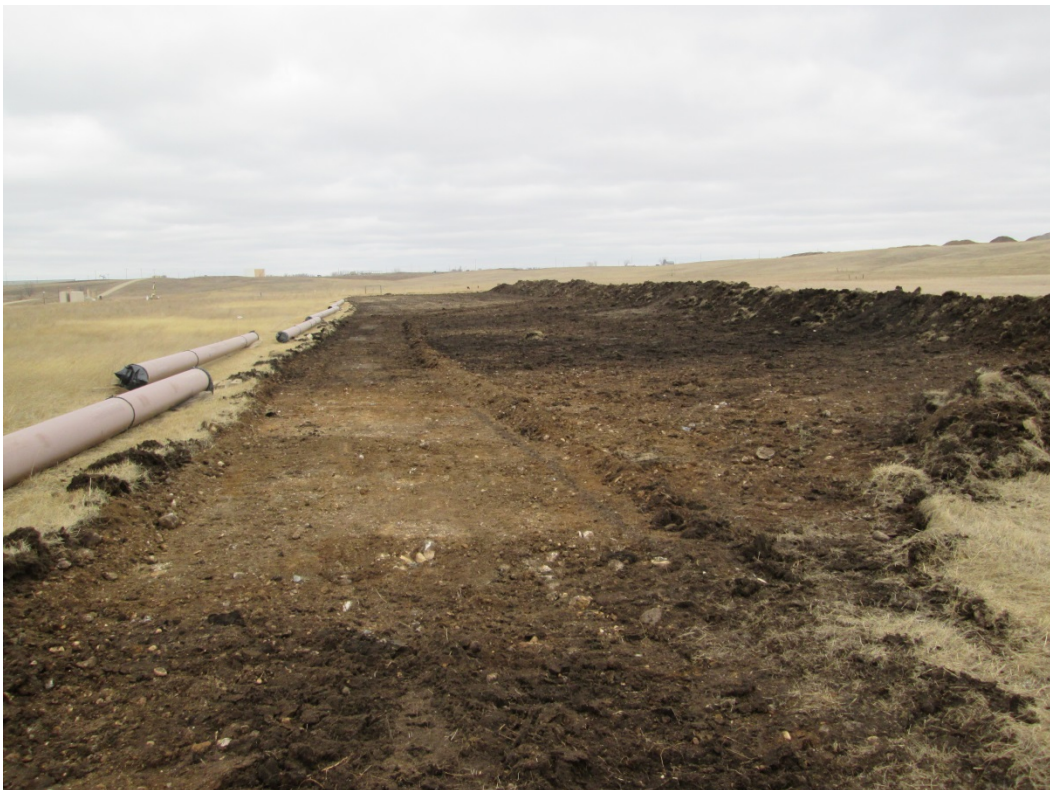
Below: Photo 4 (pt. 232) – Dozer stripped topsoil in this area to a depth of approximately 5-6 inches. Grader still needs to go through and will likely take another inch off. Direction looking north.

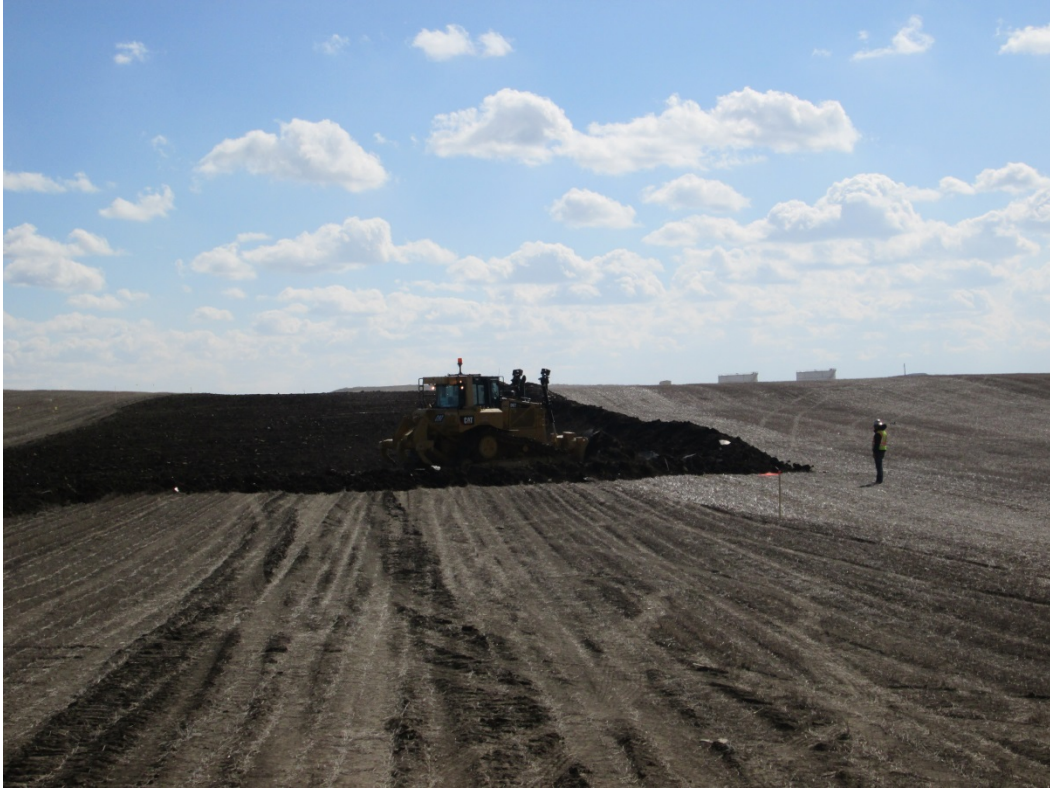
Above: Photo 5 (pt. 233) – Start of topsoil stripping on cropland near the Keene terminal. Spotter to the right of photo to make sure topsoil pile stays in the ROW. Soil was dry. Direction looking south.

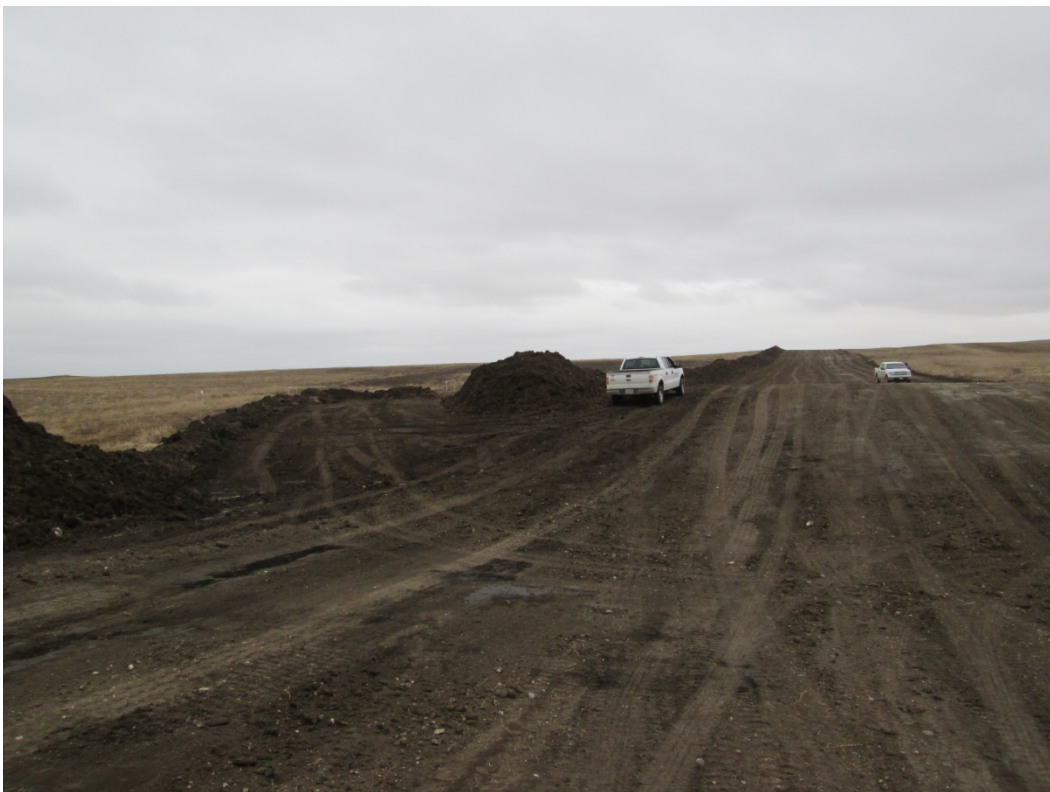
Below: Photo 6 (pt. 234) – ROW and bore pull back area. The additional ROW to the left of the photo is for additional work space for the bore. Direction looking east.

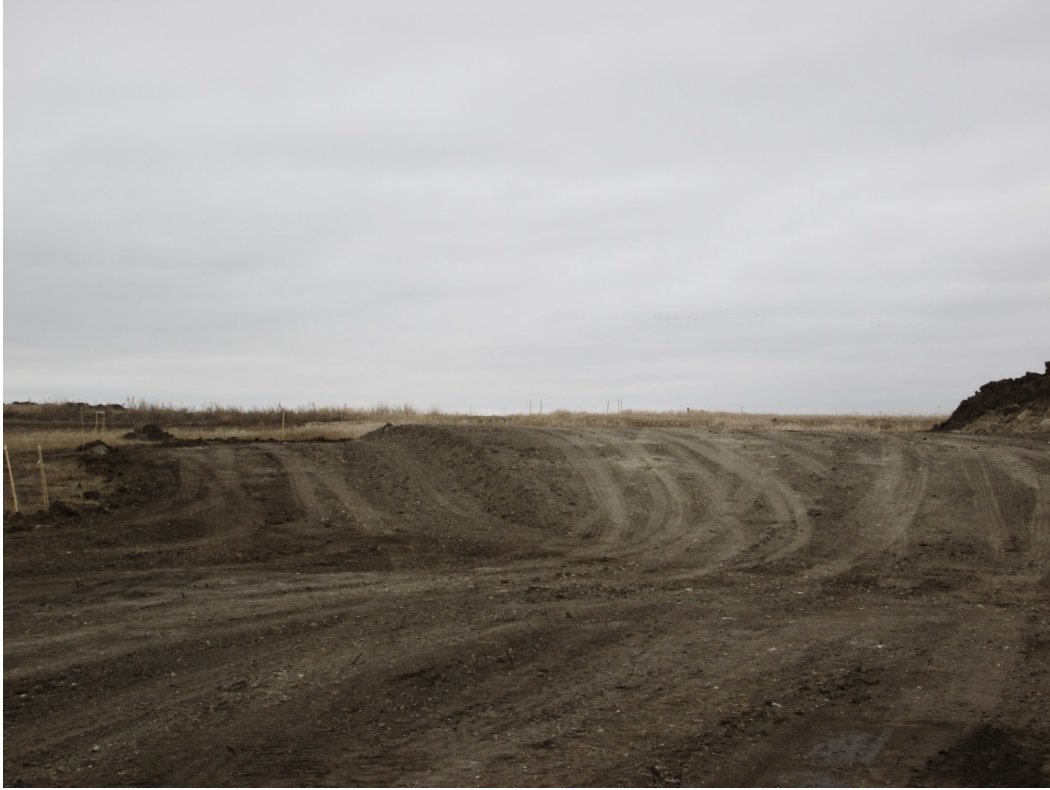
Above: Photo 7 (pt. 234) – Bore location (leveled and smoothed). Notice small amount of subsoil on top of the bottom of the topsoil pile to right of photo. Direction looking west.

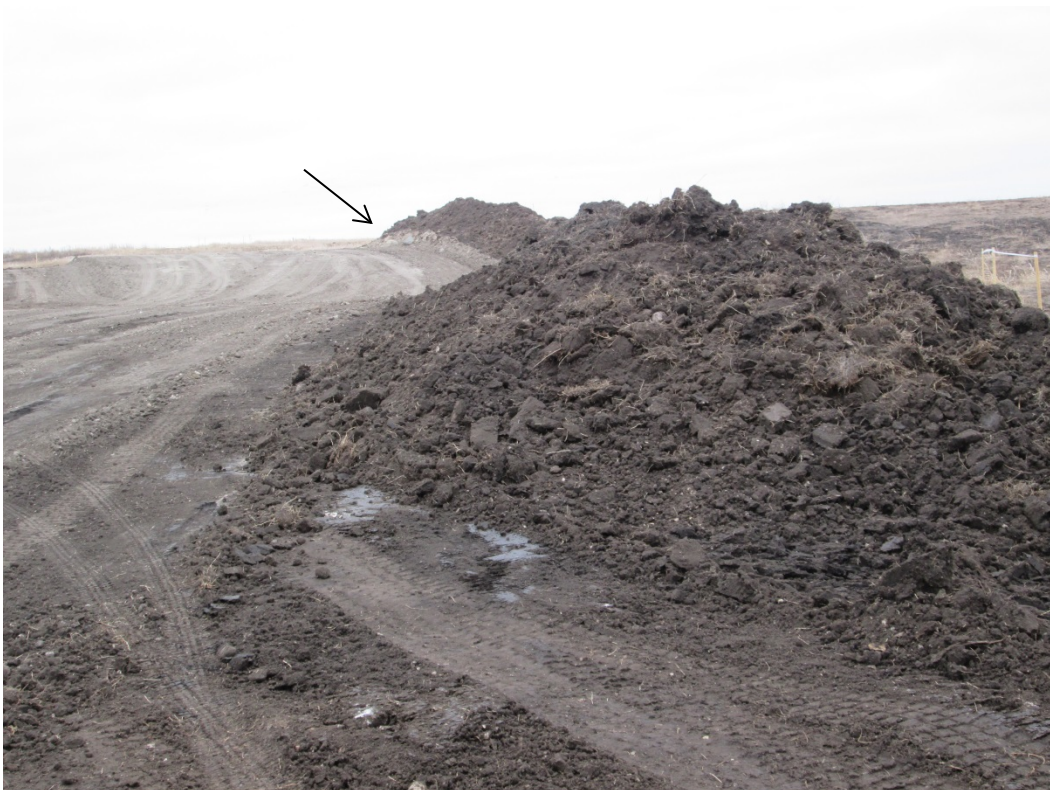
Below: Photo 8 (pt. 234) – Bore location (leveled and smoothed). Notice small amount of subsoil on top of the bottom of the topsoil pile (shown by arrow). Direction looking west.

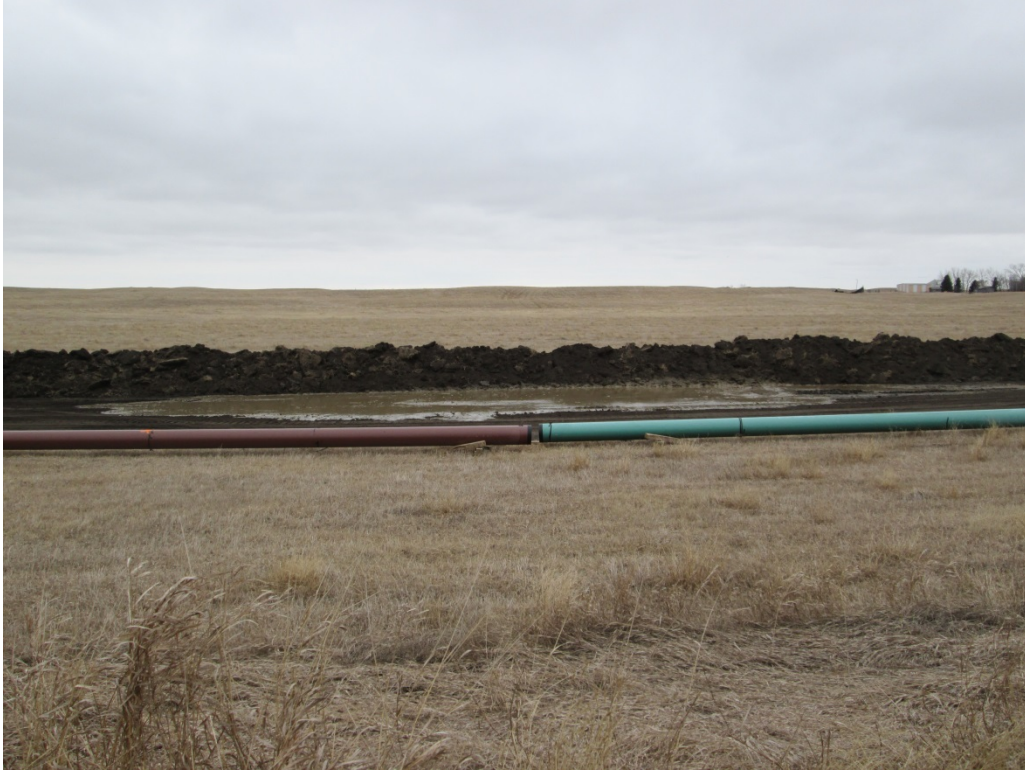
On the 22 March site visit, an area where a hydrovac truck dumped water on the ROW was observed. It was stated that it was clean water and dirt collected at a pot hole site (**Appendix B, Photo 9**). It appeared to all be dumped in one location, rather than being spaced out along the ROW. It is unknown if landowner approved.

Above: Photo 9 (pt. 235) – Hydrovac truck dumped water in this location. Environmental inspector stated they were told clean water was used. Unknown if landowner approved.
Direction looking west.

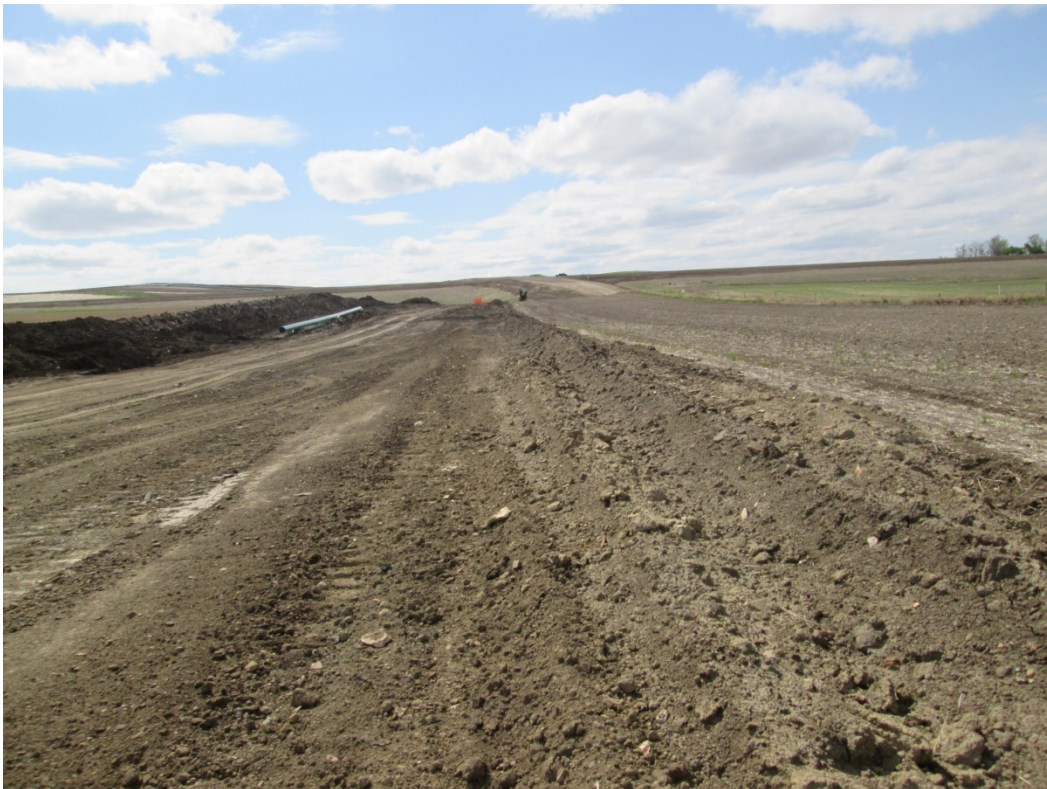
Below: Photo 10 (pt. 279) – Topsoil stripped, on far left; Subsoil was on right side. Pipe has been buried; area still needs to be finished/smoothed. Direction looking east.

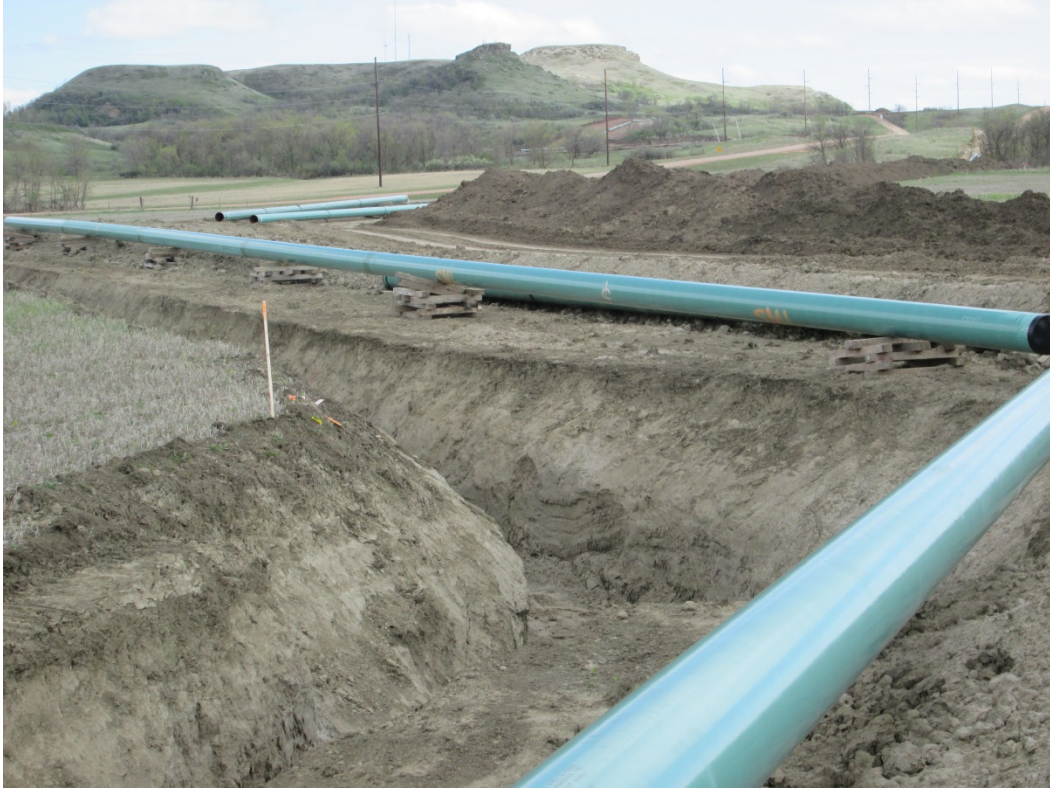
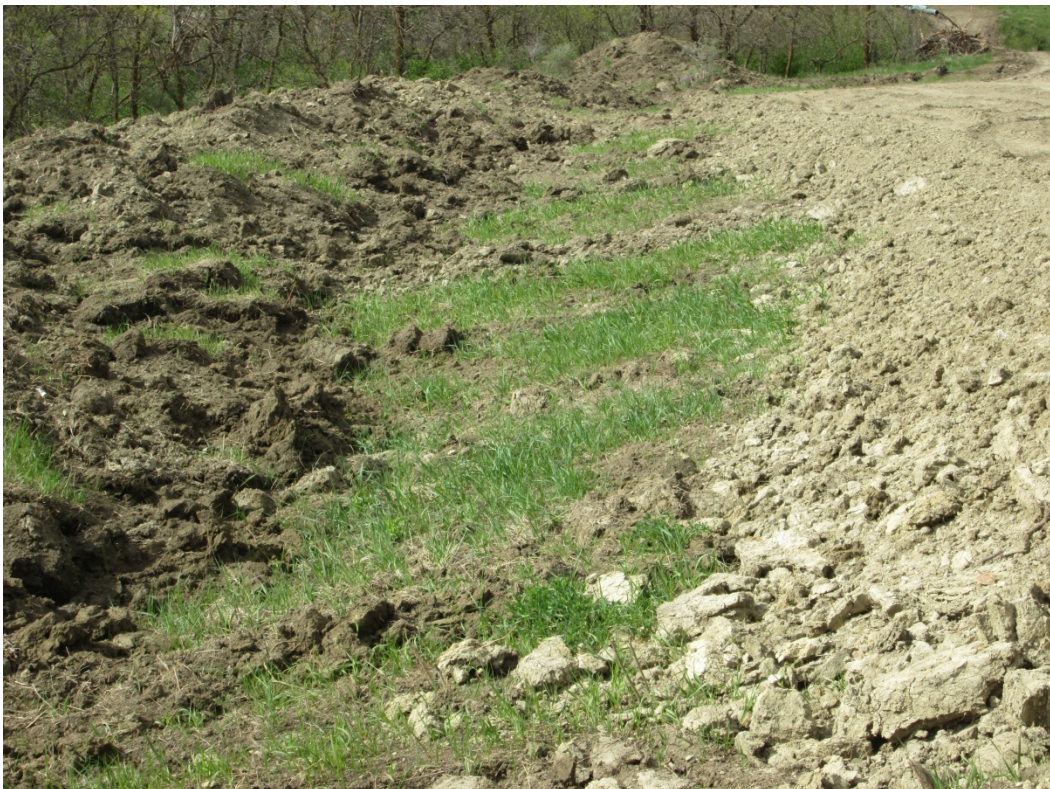
On the 12 May site visit, problem areas were observed which included subsoil and topsoil piles touching, subsoil on top of the topsoil piles, and poor topsoil stripping in areas. There was an area where vegetation was growing between the topsoil pile and the subsoil area on the ROW (**Appendix B, Photo 12**). It is unknown if topsoil was stripped here or if an inadequate amount was stripped. The PSC was informed 13 May 2016 of the poor topsoil management situation. A follow up site visit on 17 May showed improvement on areas of new construction (the north side of the lake, on the reservation) that were being worked on (**Appendix B, Photo 26, 27, 28, 29**). Also, a ravine area that was not bored was observed, where the topsoil pile had a lot of woody debris on or in it, along with some subsoil on top of the pile along the side (**Appendix B, Photo 25**).

Above: Photo 11 (pt. 280) – Open trench, with pipe strung along side and subsoil pile flattened on the other side of the pipe to create a work space. Topsoil on far ROW edge.
Below: Photo 12 (near pt. 281) – Topsoil pile to the far left and subsoil to the right of photo. Grass growing in-between piles. This area may not have been properly stripped of topsoil, potentially may have subsoil on top of topsoil and vegetation.

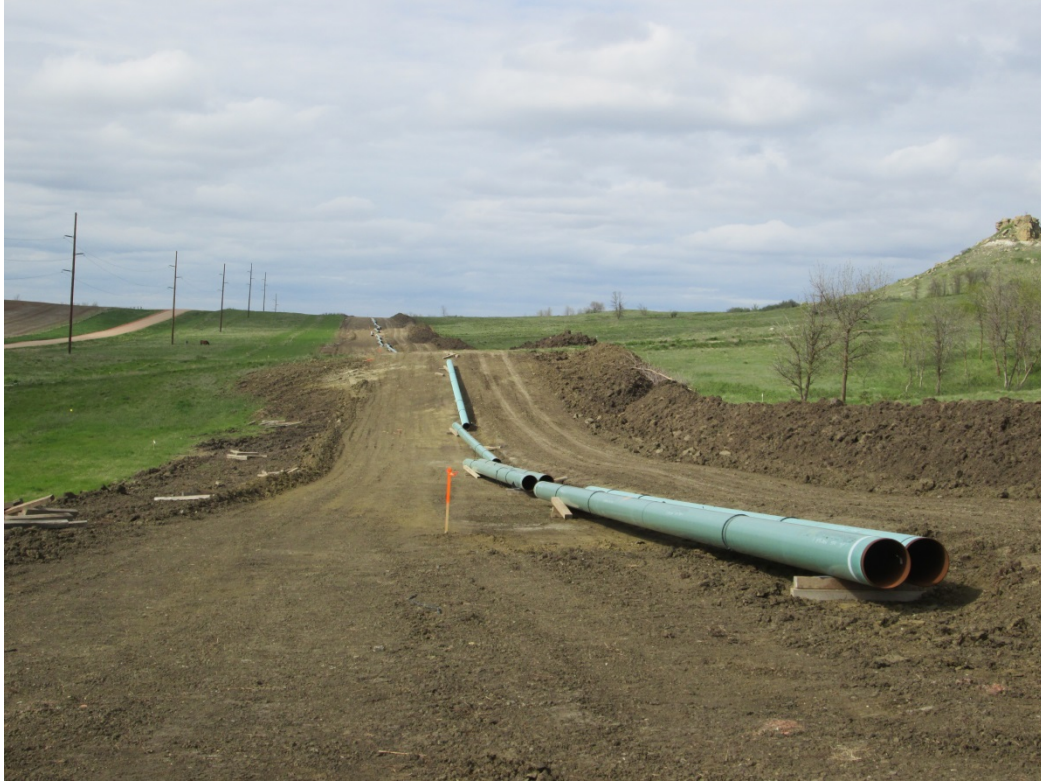
Above: Photo 13 (pt. 282) – Topsoil pile to the right of photo. Topsoil pile was moved from the left to the right side of the ROW. Direction looking north.

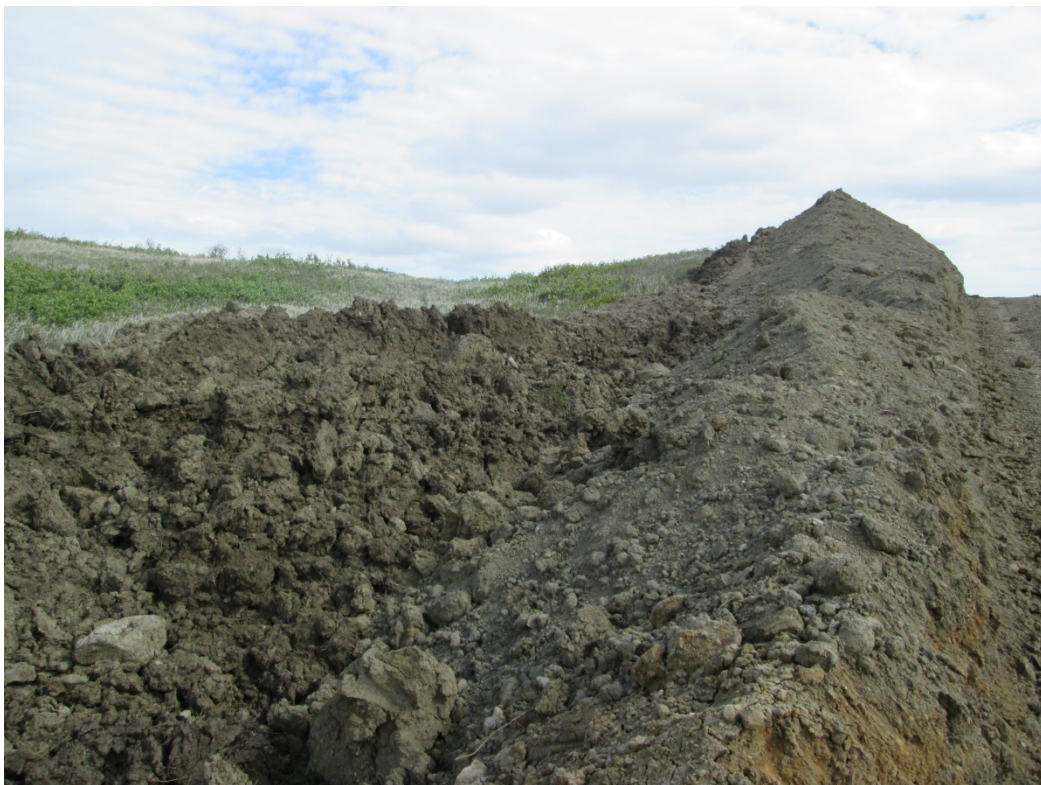
For the majority of the project, the subsoil pile for the trench was placed in the middle of the ROW while the topsoil pile would be placed on one edge (south side) of the ROW, with the pipe along the other edge (north side) of the ROW. Subsoil piles would be placed next to the topsoil pile where two-toning/side sloping and bell holes were located. Two-toning or side sloping refers to a construction technique where the uphill side of the construction ROW is cut during grading. The material removed from the cut is used to fill the downhill side of the construction ROW to provide a safe and level surface from which heavy equipment can operate. It usually requires extra workspace to accommodate the additional volumes of material generated by using this technique (Folga, 2007). A bell hole is a widening of the trench over a given distance, to provide space for installing a tie-in, valve, etc.; in this area more subsoil is removed creating a bell-shaped trench. At many locations, the subsoil pile was observed touching or overlapping the lower portion of the topsoil piles (**Appendix B, Photos 14, 15, 17, 21, 25**). Two-toning areas often had poor topsoil segregation from subsoil.

Below: Photo 14 (pt. 283) – Two-tone area. Subsoil pile appears to be pushed into and on top of the topsoil pile. There needs to be separation between the topsoil and subsoil piles. Direction looking south.

During site inspections, there were several locations where the subsoil pile was observed touching the topsoil pile, and locations where subsoil was on the topsoil pile (Observation Point 283, 286, 290, 295, **Appendix A, Figure 2**). Two-toning areas often had poor topsoil segregation from subsoil. Contractors/equipment operators and inspectors need to take special care to ensure topsoil and subsoil is not mixed. When topsoil and subsoil piles overlap, it is more difficult to keep the soil separated when replacing them over the trench and thus more mixing occurs. Ultimately, soil mixing can affect reclamation efforts and can make revegetation difficult. Wenck recommends monitoring and documentation of the noted areas to ensure vegetation becomes established after reclamation.

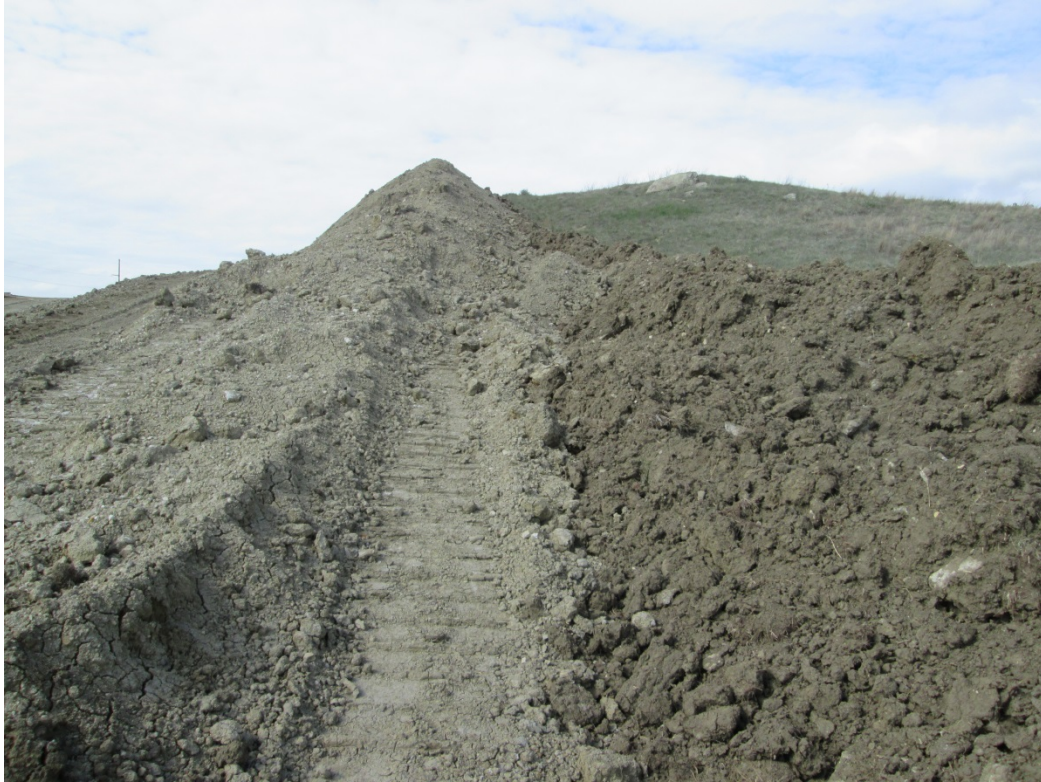
Above: Photo 15 (near pt. 283) – Two-tone area. Subsoil pile appears to be pushed into and on the topsoil pile. There needs to be separation between the topsoil and subsoil piles.
Looking north.

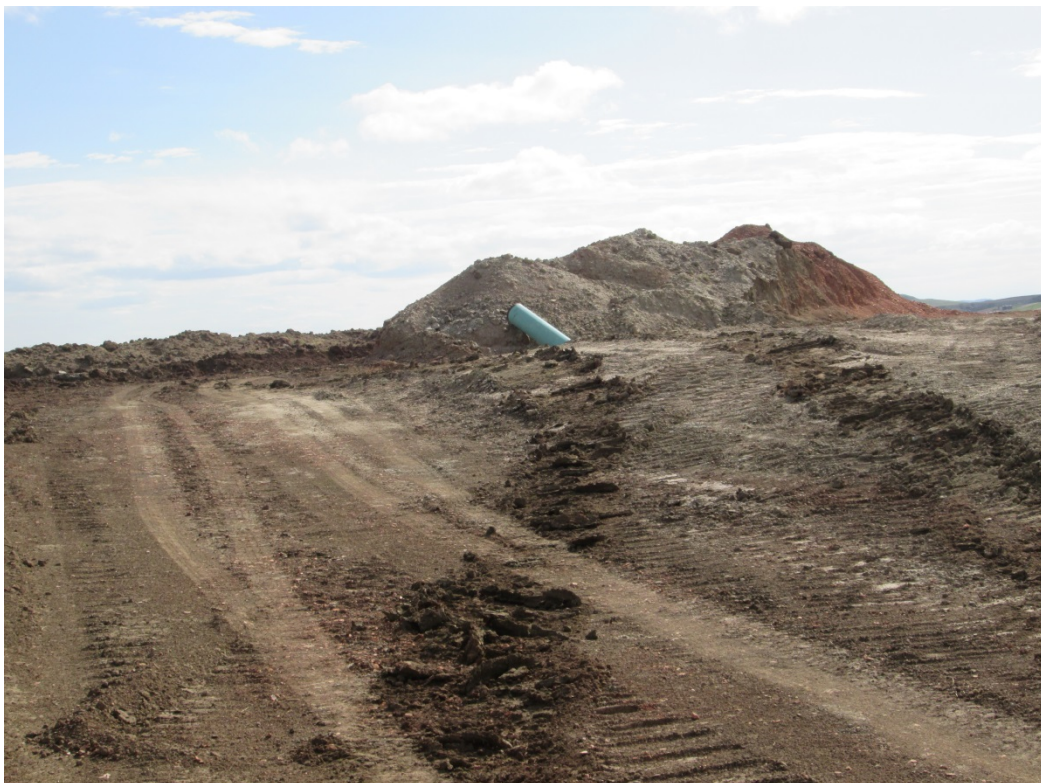
Below: Photo 16 (pt. 285) – Subsoil pile in middle of ROW. Clinker, also called “scoria,” is mixed in the pile which was from an old wellpad site.

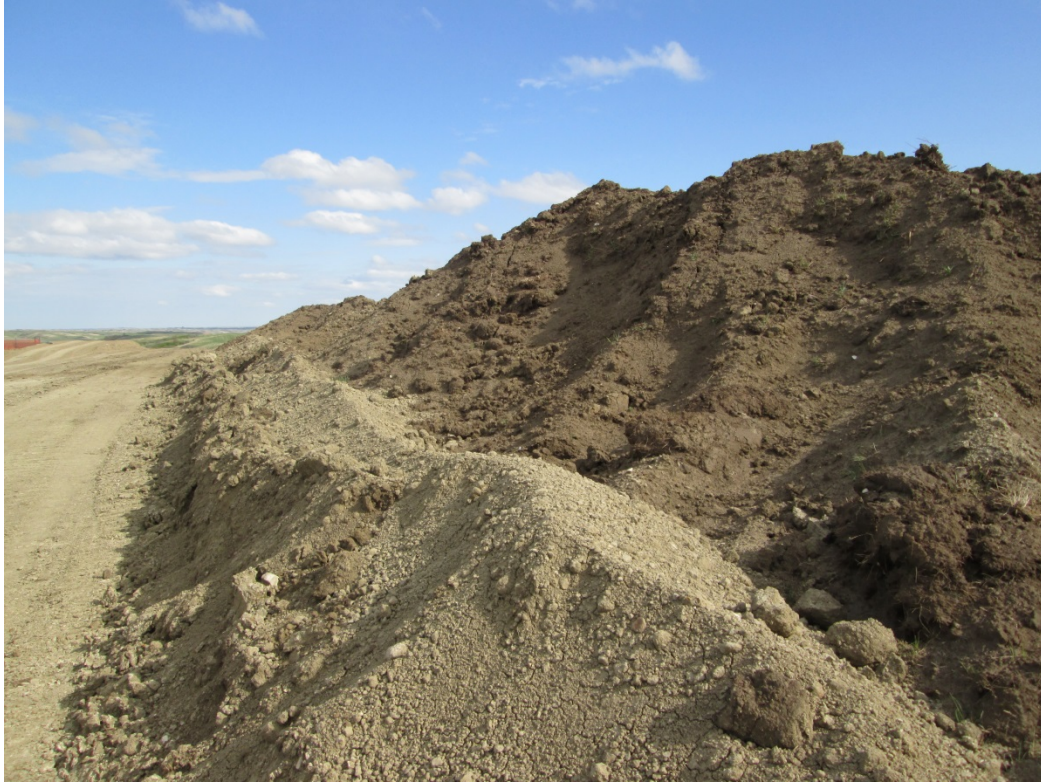
Above: Photo 17 (pt. 286) – Topsoil pile to the right of photo. Subsoil pushed on top of the bottom of the topsoil pile.

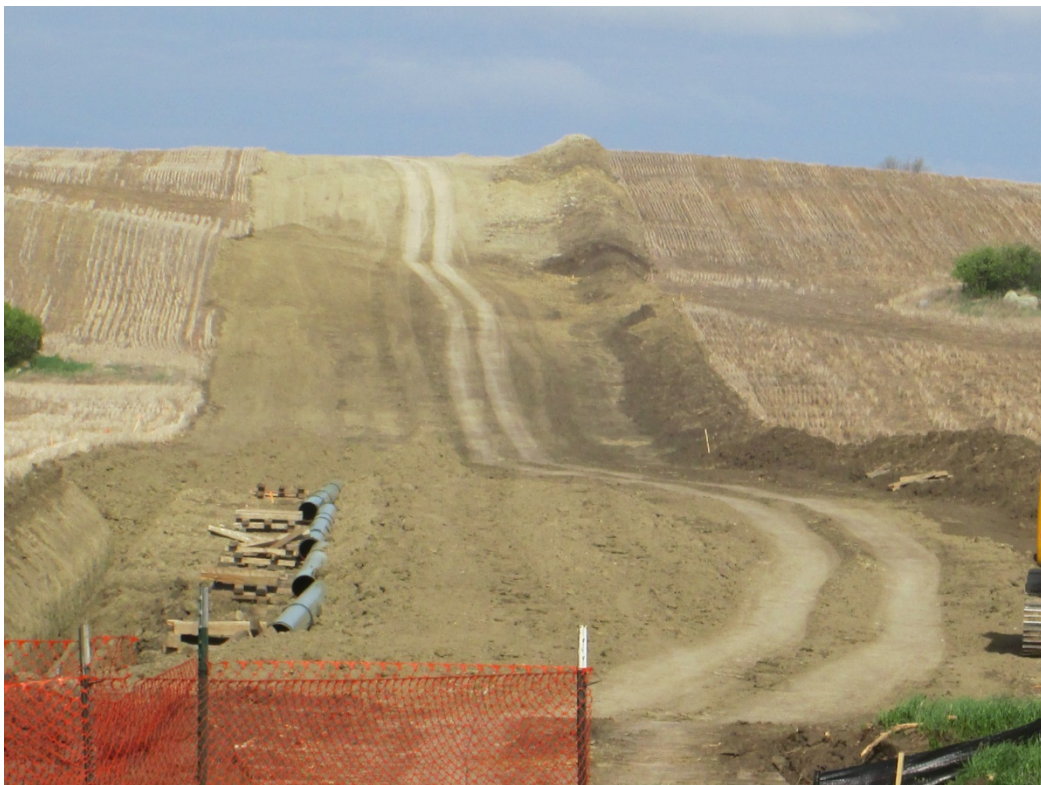
side slopes and toeslopes, especially in tilled areas. It appeared the contractors had stripped hilltops to an incorrect topsoil depth and went into the subsoil. In many areas the topsoil pile appeared approximately the same size throughout the changing topography (summit, shoulder, backslope, footslope and toeslope), indicating the volume excavated was based on a standard depth rather than site-specific conditions.

Below: Photo 18 (east of pt. 288) – Most of the trench has been backfilled to the left of photo. Topsoil on the right, notice the light soil colors in the piles and consistent volume excavated across the topography. Direction looking east.

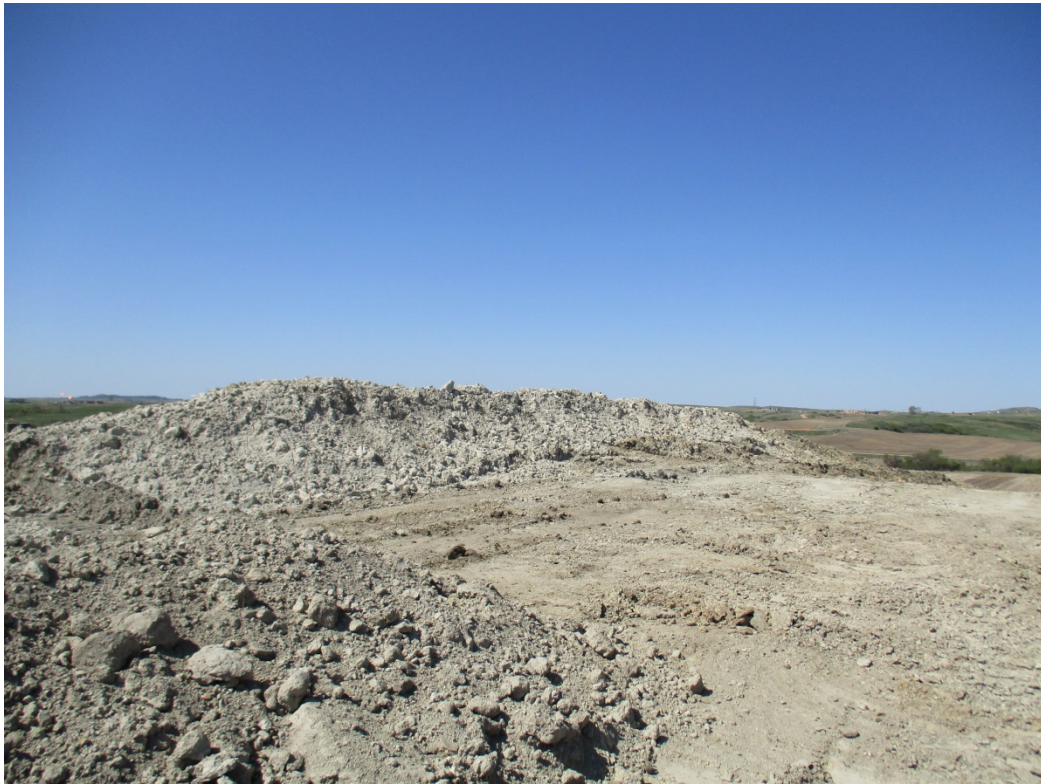
Specifically, topsoil piles on some of the hilltops appeared to be the same color as the subsoil piles, and appeared to have too much subsoil in the topsoil piles (**Appendix B, Photos 19, 20, 24**). Hilltops (summits and shoulders) are known to have less topsoil than

Above: Photo 19 (pt. 289) – Topsoil pile on hilltop area. Pile is very light in color and appears to have a lot of subsoil in pile.

Topsoil piles in some areas, especially some of the hilltops, appeared to be the same color as the subsoil piles, and appeared to have too much subsoil in the topsoil piles. There were also a few areas that appeared they had not been stripped of enough topsoil and there was still topsoil left on the ROW (Observation point 281, 288, 289, 290, 443, **Appendix A, Figure 1**). Large amounts of woody debris were observed on a topsoil pile near a ravine (Observation point 295, **Appendix A, Figure 2**). Hilltops (summits and shoulders) are known to have less topsoil than side slopes and toeslopes. It appeared that some of the hilltops and other areas were stripped to an incorrect topsoil depth and went into the subsoil. Wenck recommends monitoring and documentation of the noted areas to ensure vegetation becomes established after reclamation.

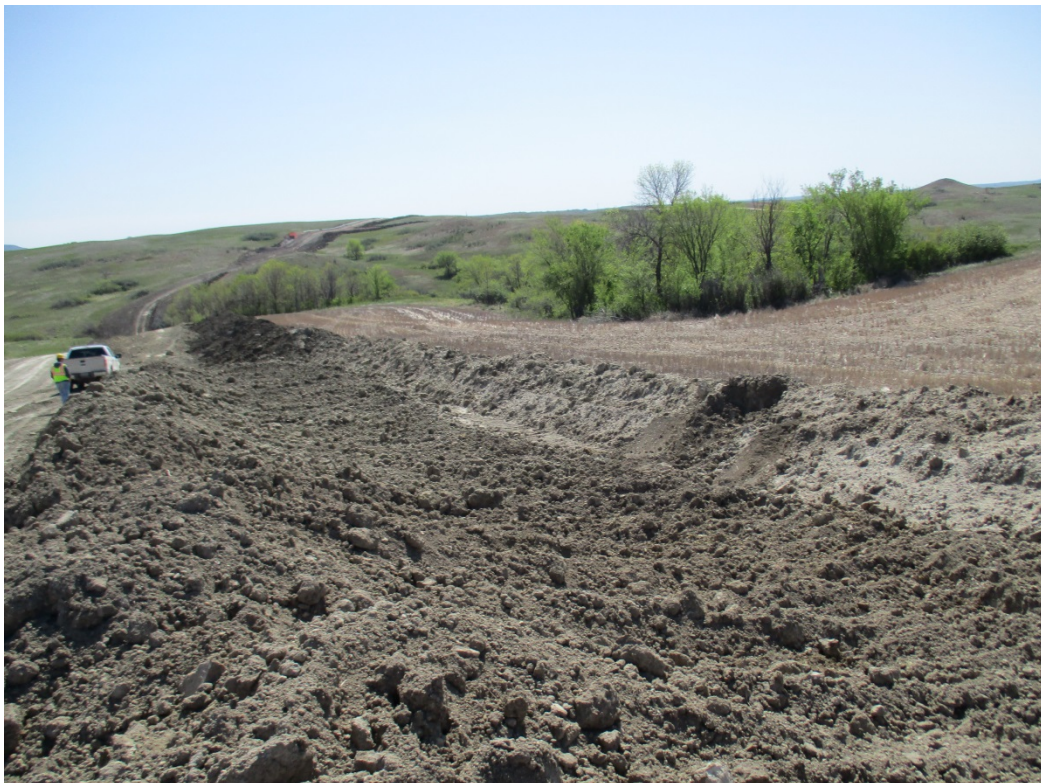
Below: Photo 20 (pt. 289) – Two-tone area. Topsoil pile to the far right, subsoil to the left of photo. Both piles appear to be the same color. Direction looking east.

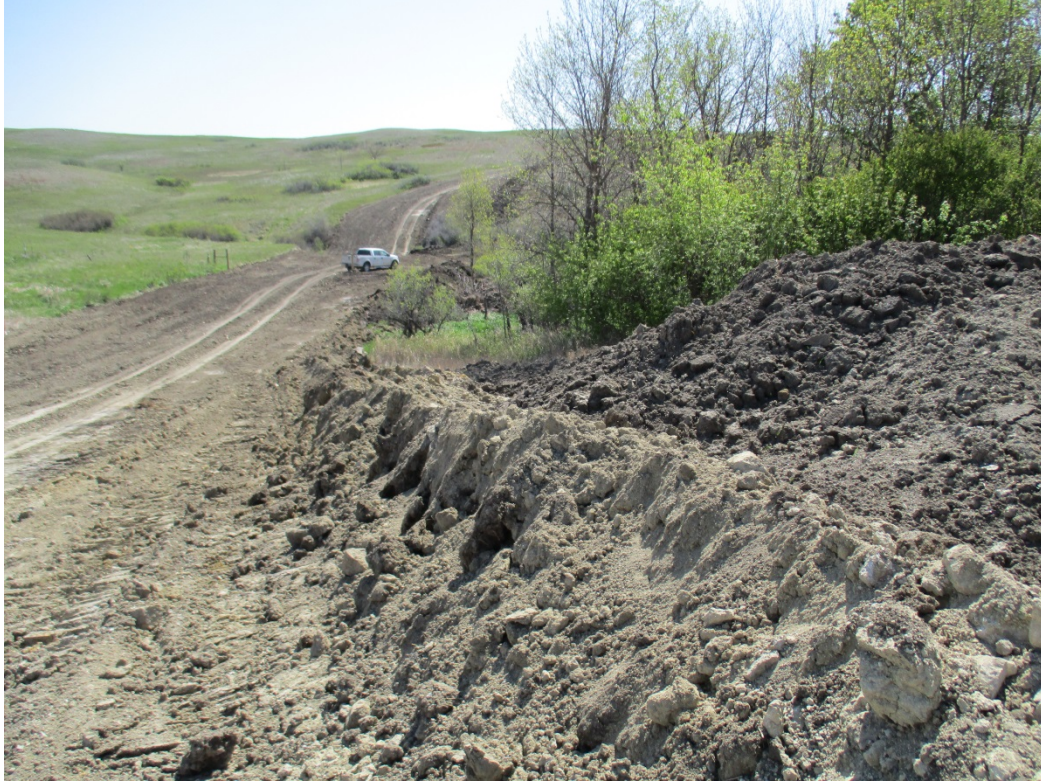
Above: Photo 21 (pt. 290) – Topsoil pile with a small amount of subsoil pushed on top of topsoil pile. Direction looking east.

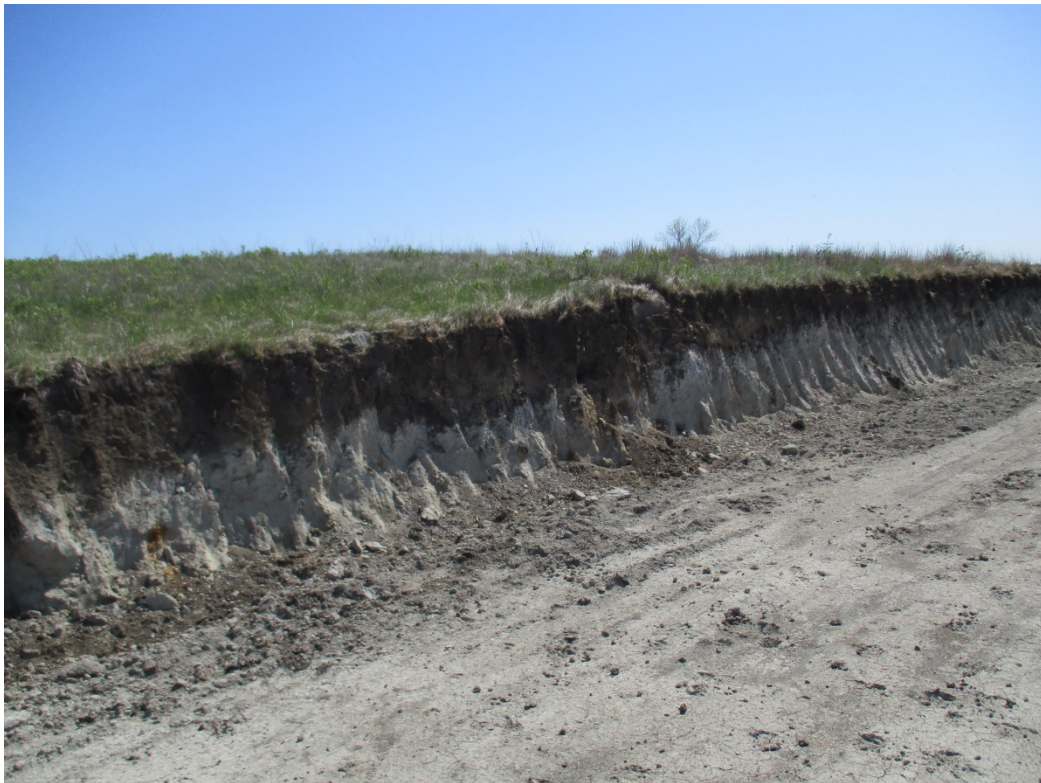
Below: Photo 22 (pt. 291) – Side-cut in two-tone area showing soil profile.

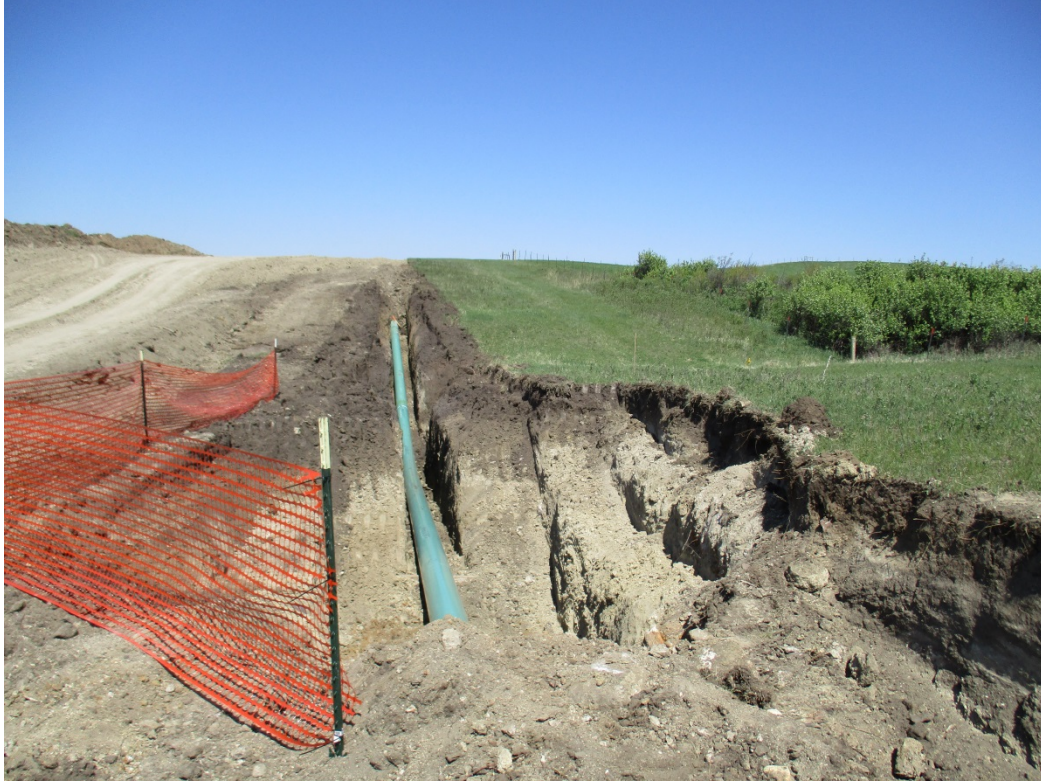
Above: Photo 23 (pt. 292) – Open trench, with only partial fence around area.

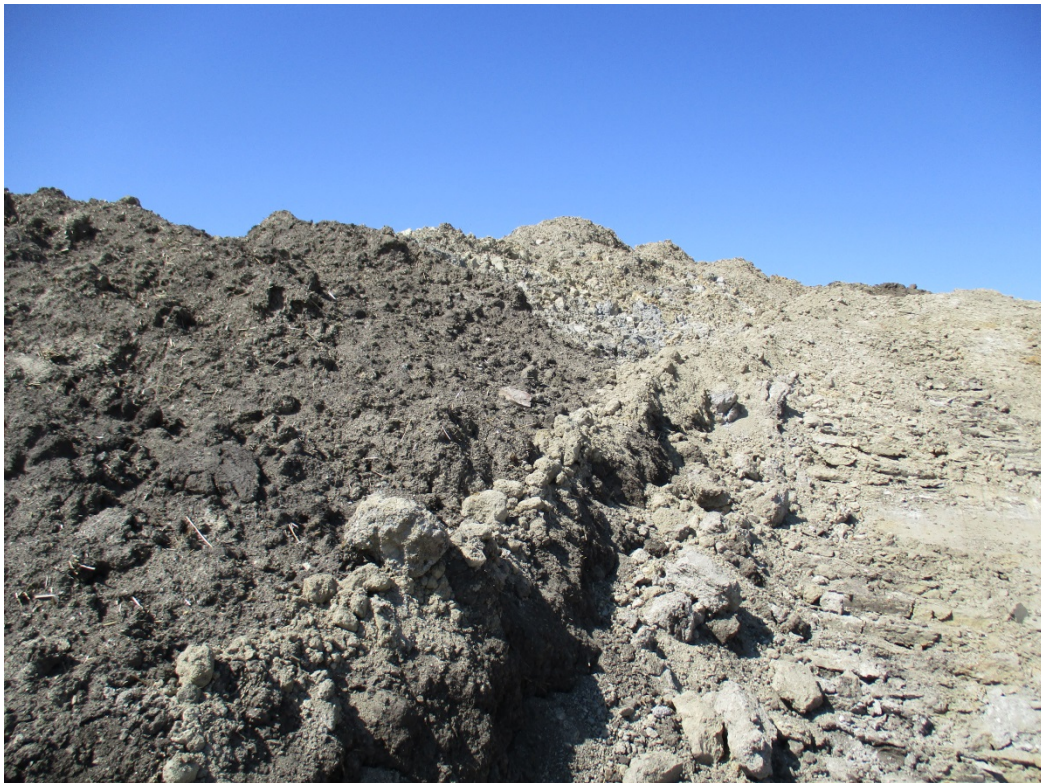
Below: Photo 24 (pt. 290) – Two-tone area. Notice the change in color of the topsoil pile, it starts at a dark brown and as you go back the color is the same as the subsoil.
