Sacagawea Pipeline Project Topsoil Inspection Report PU-15-114

Prepared for:
**North Dakota
Public Service Commission**

Prepared by:

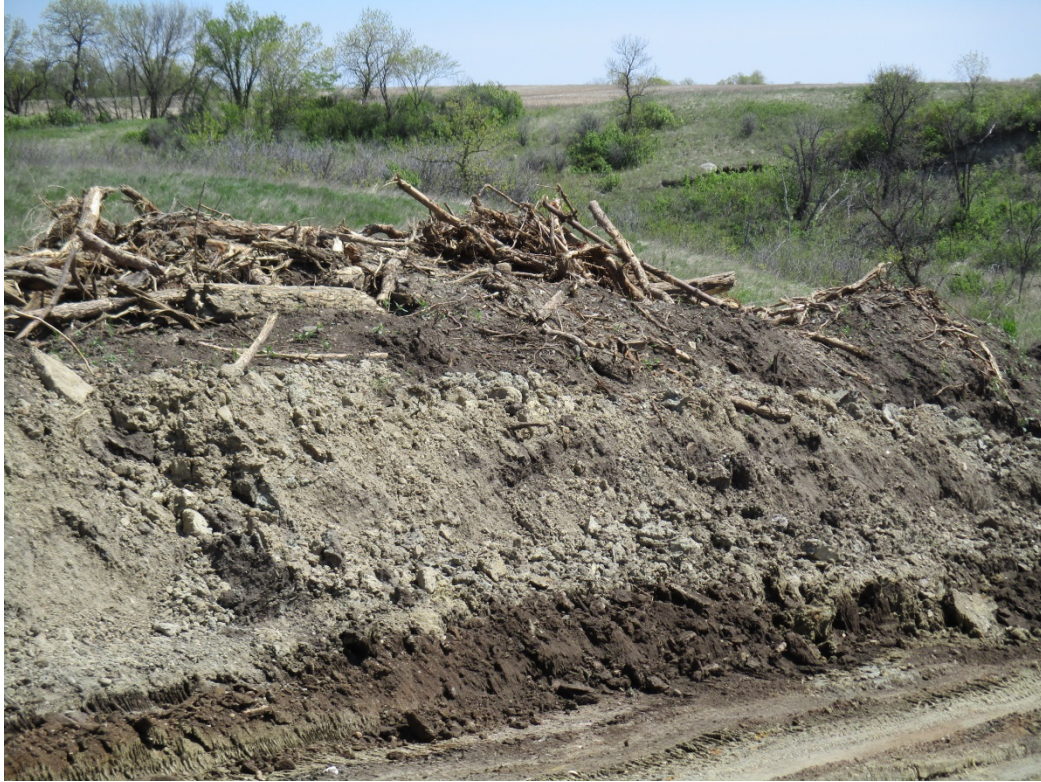
On the 12 May site visit, problem areas were observed which included subsoil and topsoil piles touching, subsoil on top of the topsoil piles, and poor topsoil stripping in areas. There was an area where vegetation was growing between the topsoil pile and the subsoil area on the ROW (**Appendix B, Photo 12**). It is unknown if topsoil was stripped here or if an inadequate amount was stripped. The PSC was informed 13 May 2016 of the poor topsoil management situation. A follow up site visit on 17 May showed improvement on areas of new construction (the north side of the lake, on the reservation) that were being worked on (**Appendix B, Photo 26, 27, 28, 29**). Also, a ravine area that was not bored was observed, where the topsoil pile had a lot of woody debris on or in it, along with some subsoil on top of the pile along the side (**Appendix B, Photo 25**).

Above: Photo 25 (pt. 295) – Topsoil pile with some subsoil on it, along with woody debris. Unknown what will be done with the woody debris.

During site inspections, there were several locations where the subsoil pile was observed touching the topsoil pile, and locations where subsoil was on the topsoil pile (Observation Point 283, 286, 290, 295, **Appendix A, Figure 2**). Two-toning areas often had poor topsoil segregation from subsoil. Contractors/equipment operators and inspectors need to take special care to ensure topsoil and subsoil is not mixed. When topsoil and subsoil piles overlap, it is more difficult to keep the soil separated when replacing them over the trench and thus more mixing occurs. Ultimately, soil mixing can affect reclamation efforts and can make revegetation difficult. Wenck recommends monitoring and documentation of the noted areas to ensure vegetation becomes established after reclamation.

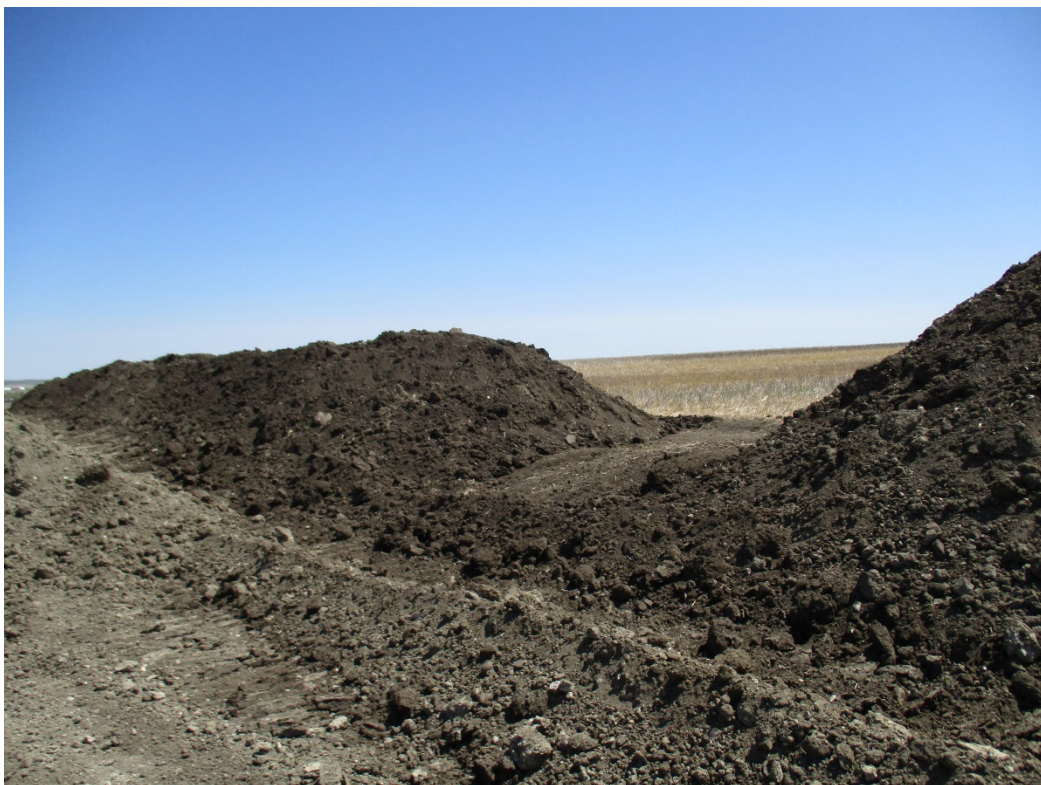
Below: Photo 26 (pt. 296) – Topsoil pile with space left in it for farm equipment, livestock and/or animals to pass through.

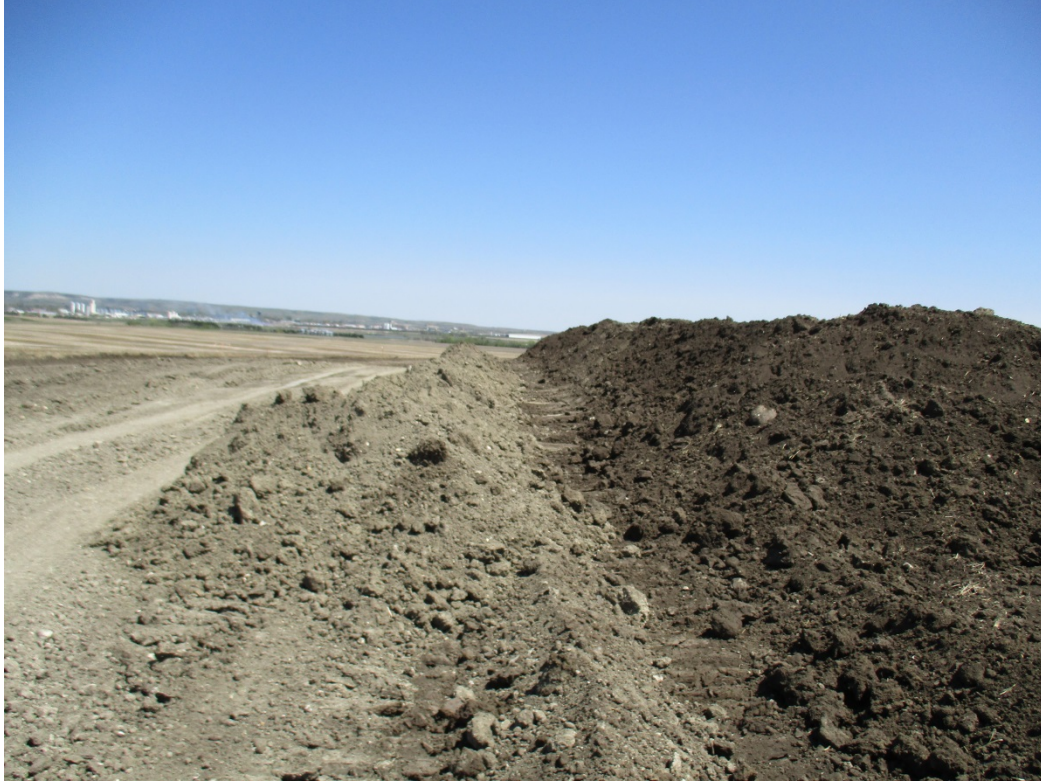
Above: Photo 27 (pt. 296) – Topsoil and subsoil pile with space between them. Work done after May 12, area observed on May 17, 2016.

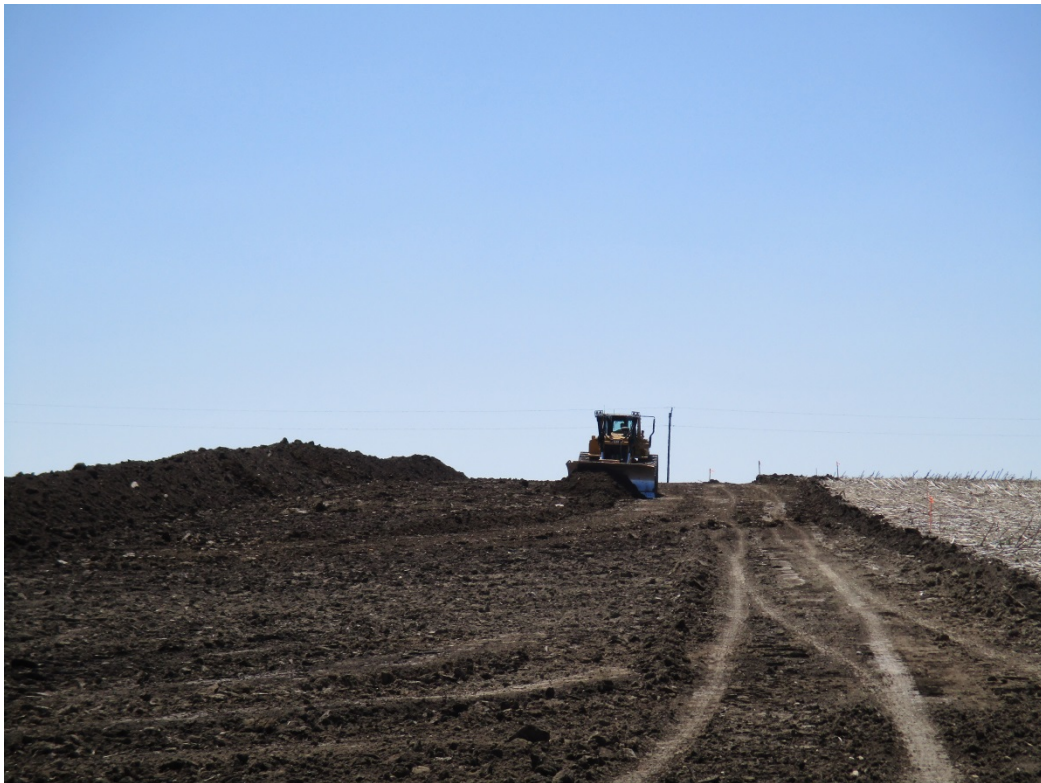
Below: Photo 28 (pt. 298) – Dozer stripping topsoil, pile to the left of photo.

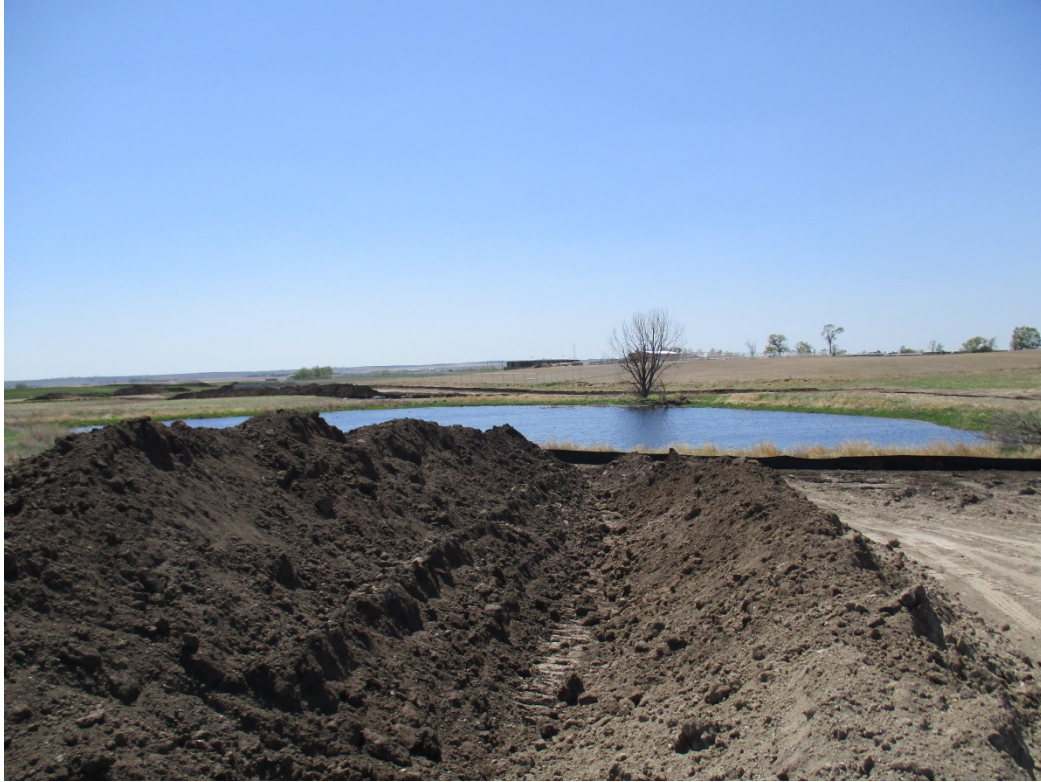
Above: Photo 29 (pt. 300) – Bore area near wetland. Access road located on the right, going around the wetland. Topsoil and subsoil piles have space between them. Silt fence near wetland. Direction looking west.

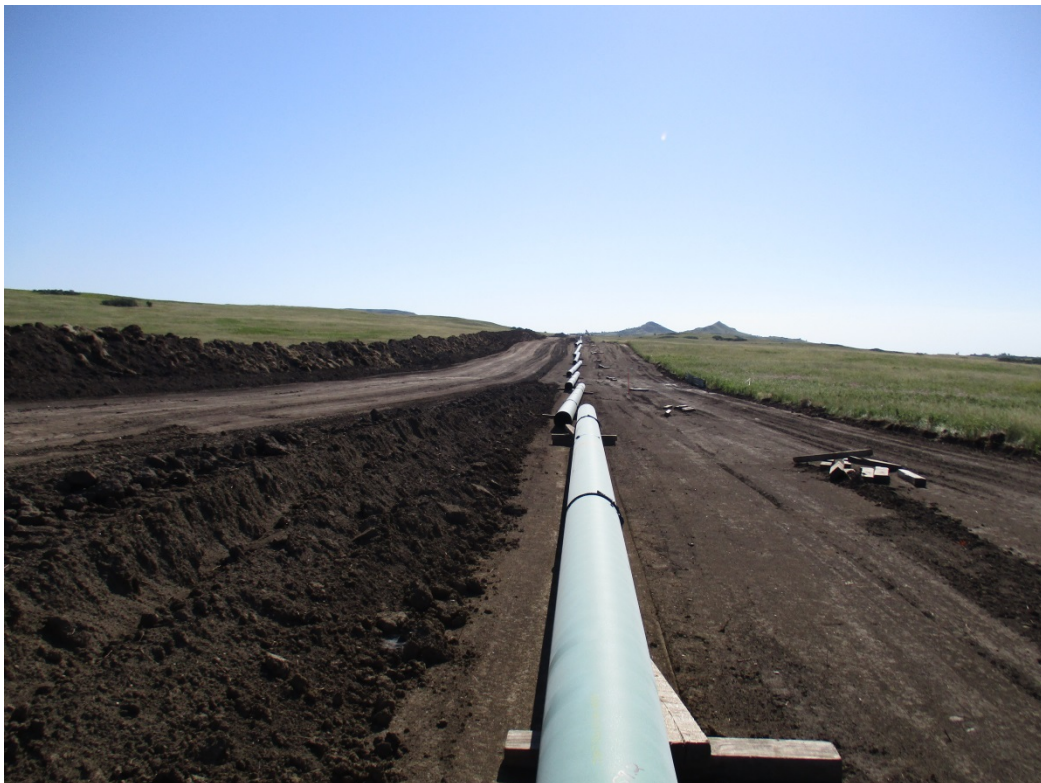
Below: Photo 30 (pt. 443) – Two-tone area, topsoil pile to the left. Looks to be an inadequate amount of topsoil was stripped. Notice the dark colored two-tone subsoil pile area.

Topsoil piles in some areas, especially some of the hilltops, appeared to be the same color as the subsoil piles, and appeared to have too much subsoil in the topsoil piles. There were also a few areas that appeared they had not been stripped of enough topsoil and there was still topsoil left on the ROW (Observation point 281, 288, 289, 290, 443, **Appendix A, Figure 1**). Large amounts of woody debris were observed on a topsoil pile near a ravine (Observation point 295, **Appendix A, Figure 2**). Hilltops (summits and shoulders) are known to have less topsoil than side slopes and toeslopes. It appeared that some of the hilltops and other areas were stripped to an incorrect topsoil depth and went into the subsoil. Wenck recommends monitoring and documentation of the noted areas to ensure vegetation becomes established after reclamation.

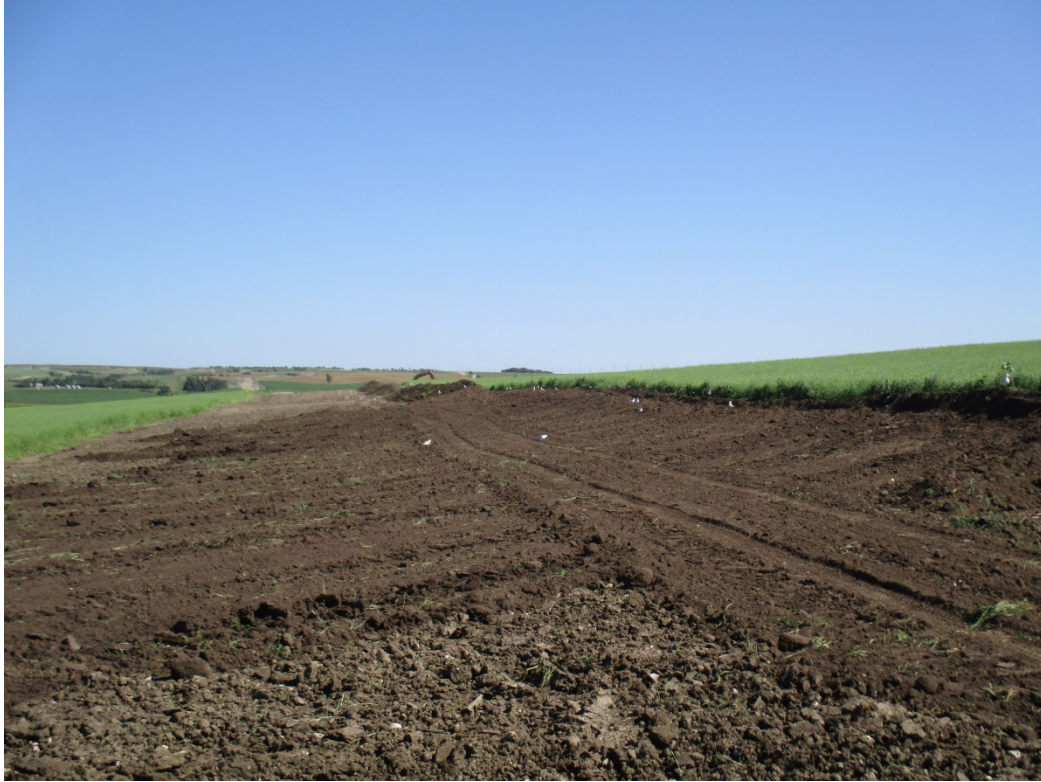
Above: Photo 31 (pt. 445) – Unfinished, started topsoil replacement.

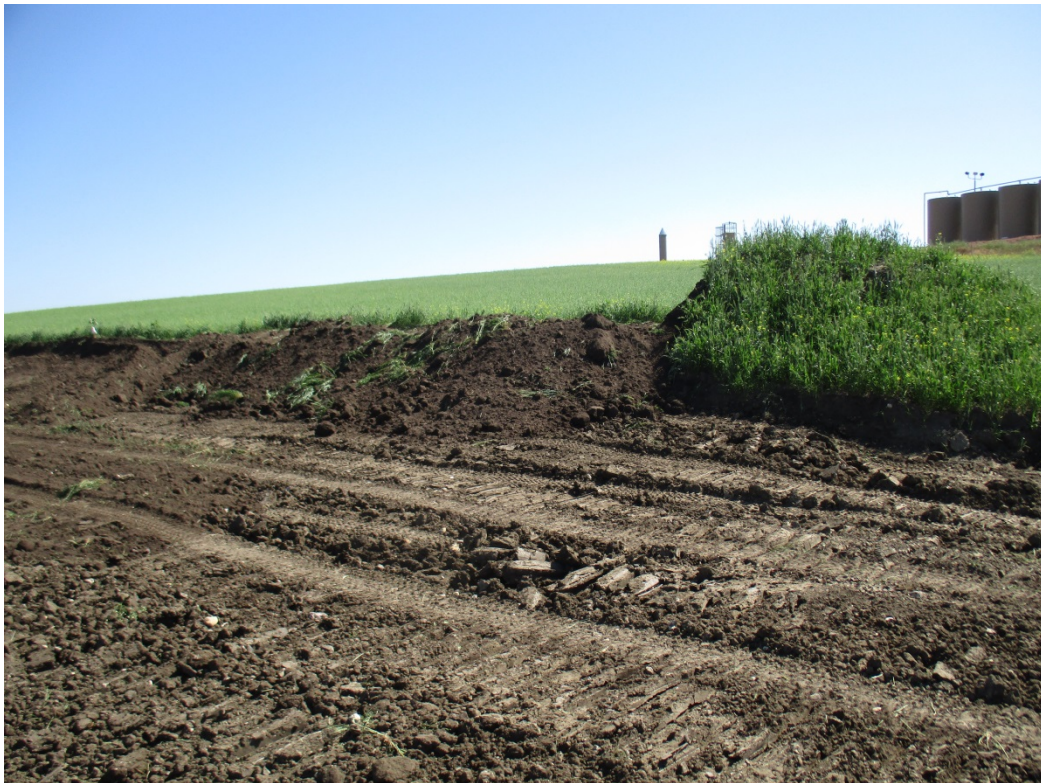
Below: Photo 32 (pt. 445) – Unfinished, started topsoil replacement. Vegetation growing on topsoil pile, part of pile replaced back on ROW. Direction looking northeast.

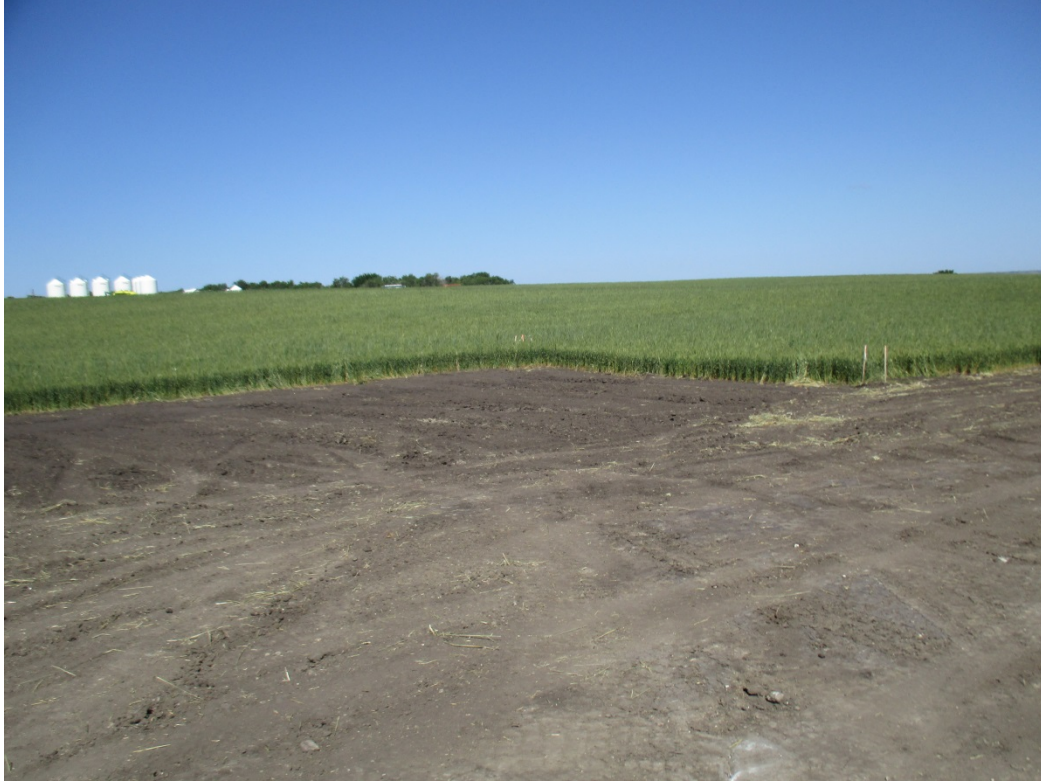
Above: Photo 33 (pt. 447) – Topsoil replaced on ROW and extended ROW for bore area. Contours appear to match up. Direction looking northwest.

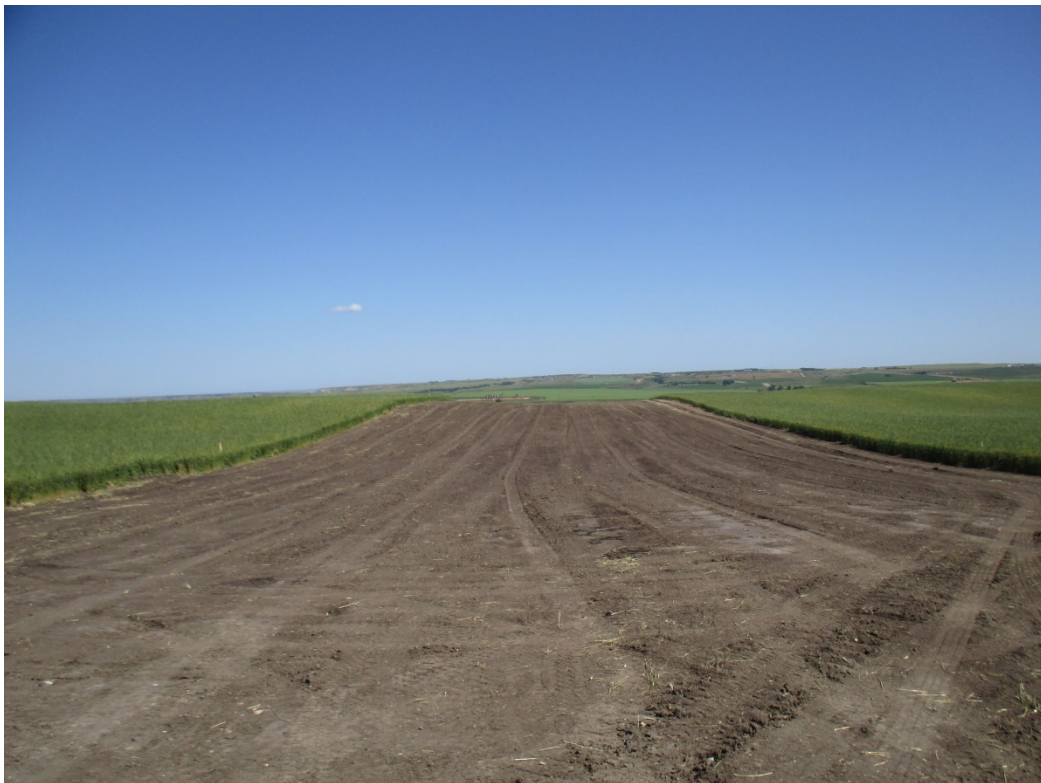
Below: Photo 34 (pt. 446) – Topsoil replaced on ROW area. Contours appear to match up. Direction looking west.

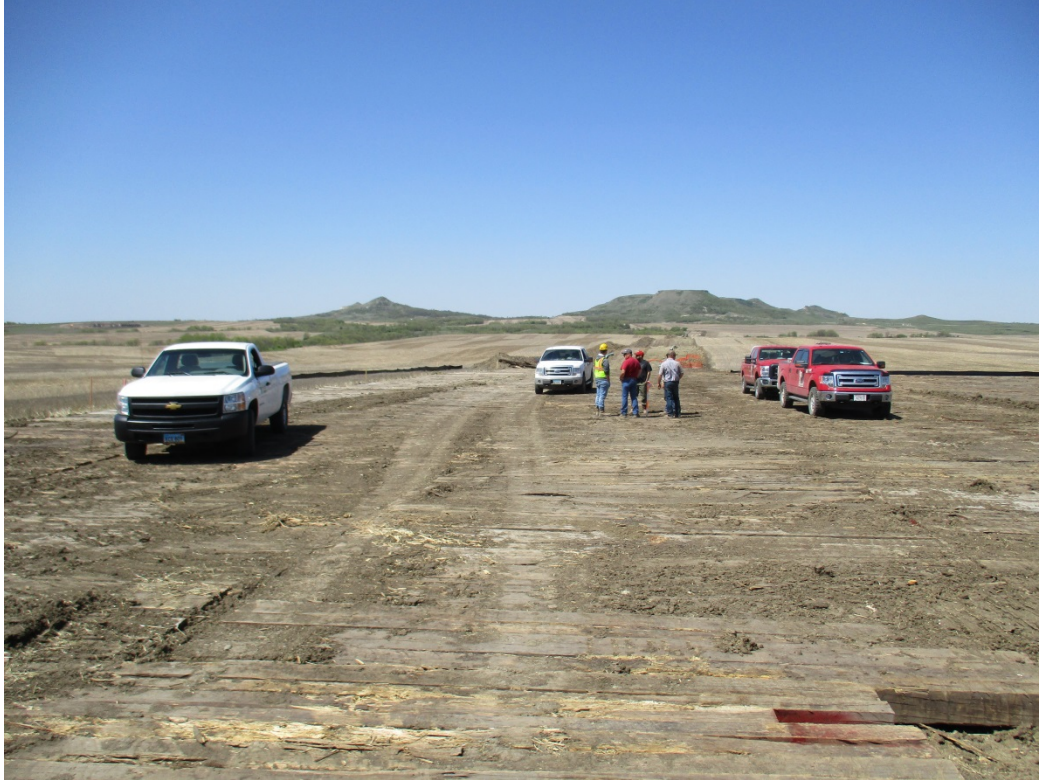
Above: Photo 35 (pt. 294) – Lake Sakakawea bore location with mats and some silt fences placed along area. Observed May 17, 2016. Direction looking west.

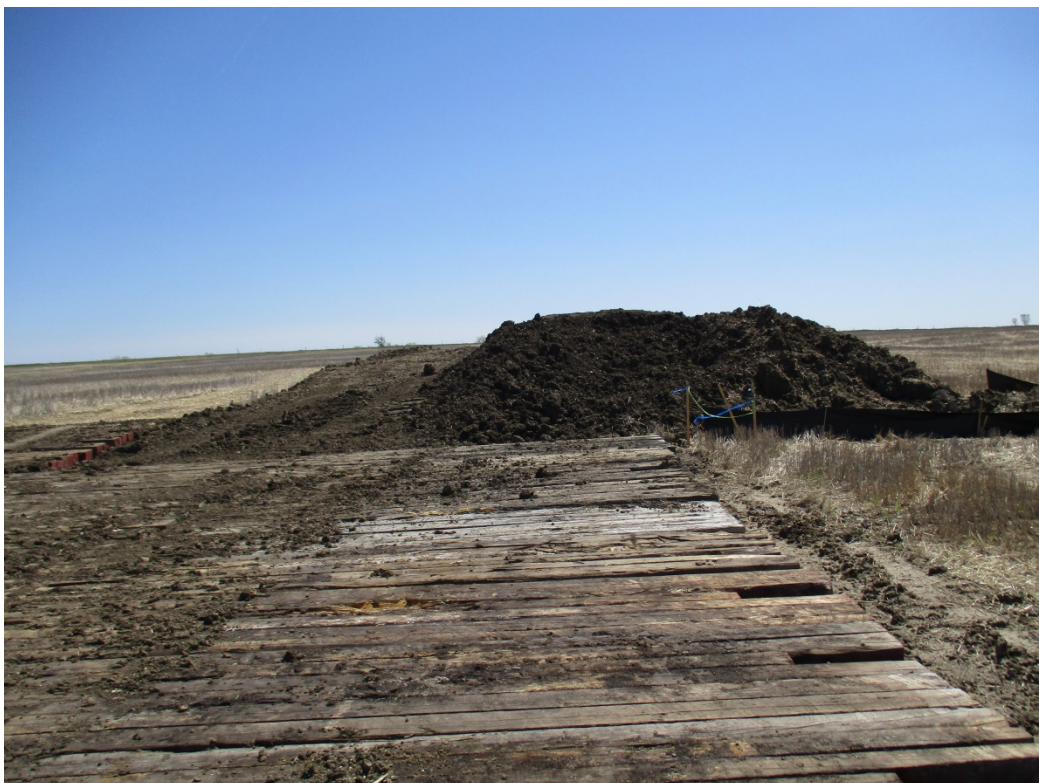
Below: Photo 36 (pt. 294) – Lake Sakakawea bore location with mats and some silt fences placed along area. Topsoil pile near mats with partial silt fence. Direction looking east.
