Technical Memo

Responsive partner.
Exceptional outcomes.

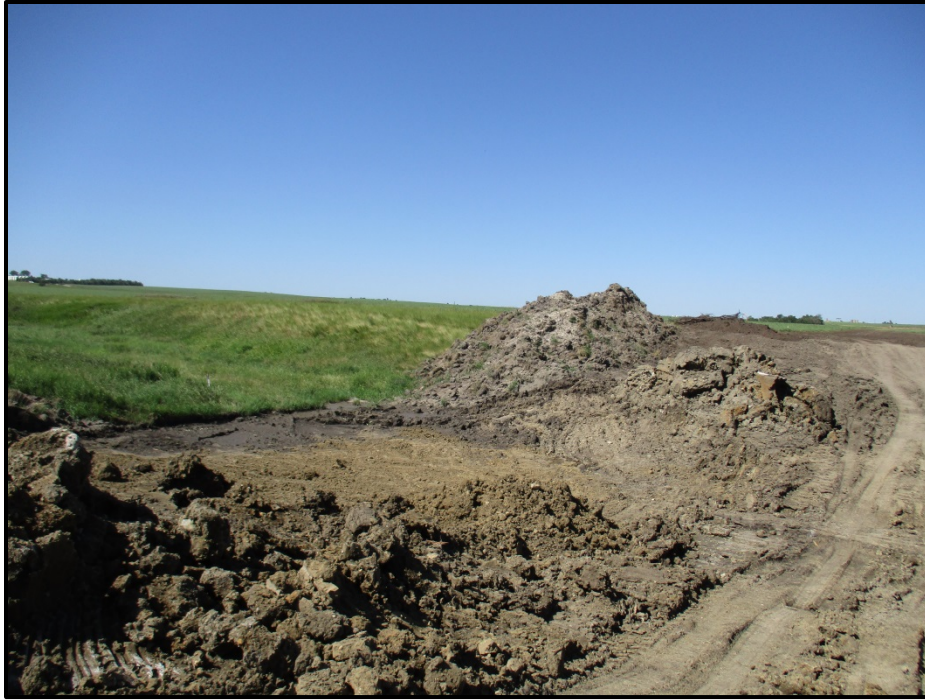
Photo 3. (GPS Point #446) - Drainage area along ROW, which appeared to be a potential wetland based on the topography, moist soil (along ROW edge) and change in vegetation. Topsoil pile along the left of photo. Drainage area looks like a potential wetland area.

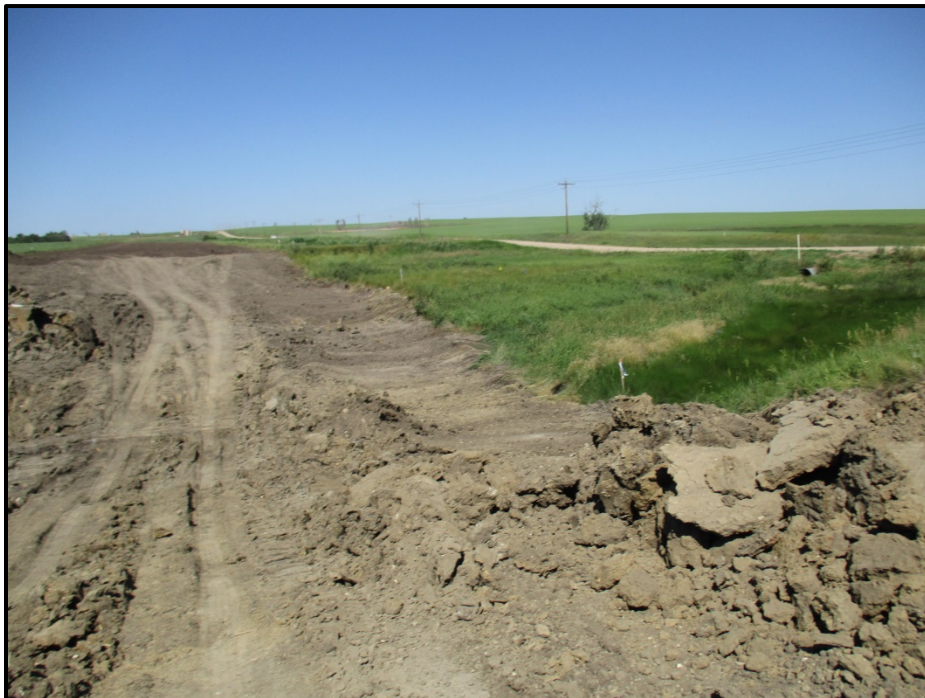
Photo 4. (GPS Point #446) - Drainage area intersected by ROW. Pipe trenched and backfilled along the edge of the ROW. The drainage area appeared to be a potential wetland. Notice the vegetation change. However, the environmental inspector stated it was not a wetland. No erosion control devices were observed. The PSC was informed of this site the day after the inspection.

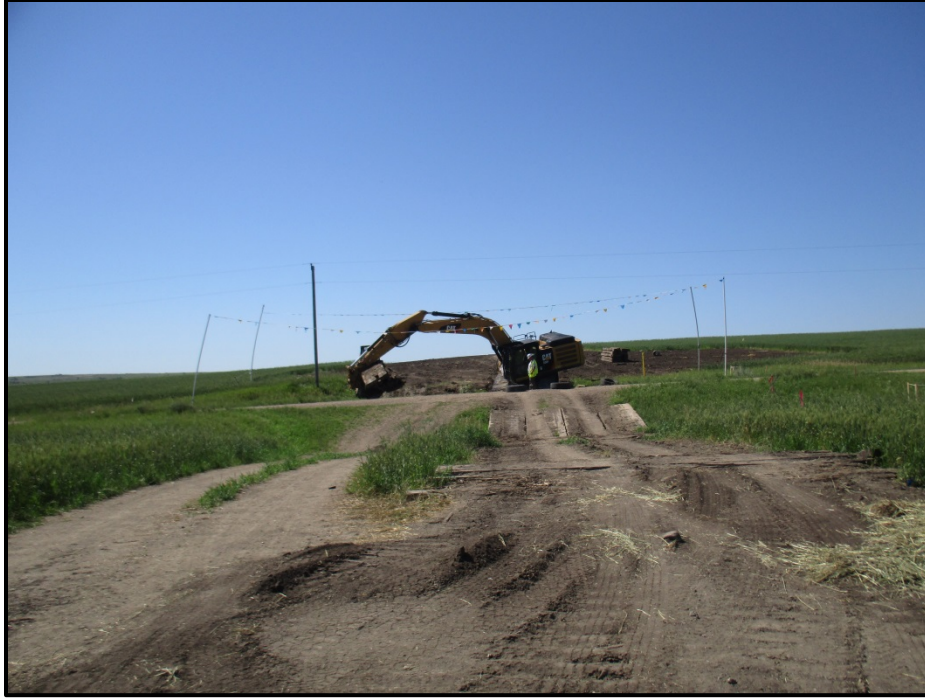
Photo 5. (GPS Point #447) – Excavator removing mats from road ditch (far side of the road), which was used for access to the ROW. Most of the topsoil had been replaced in this area. Direction: South

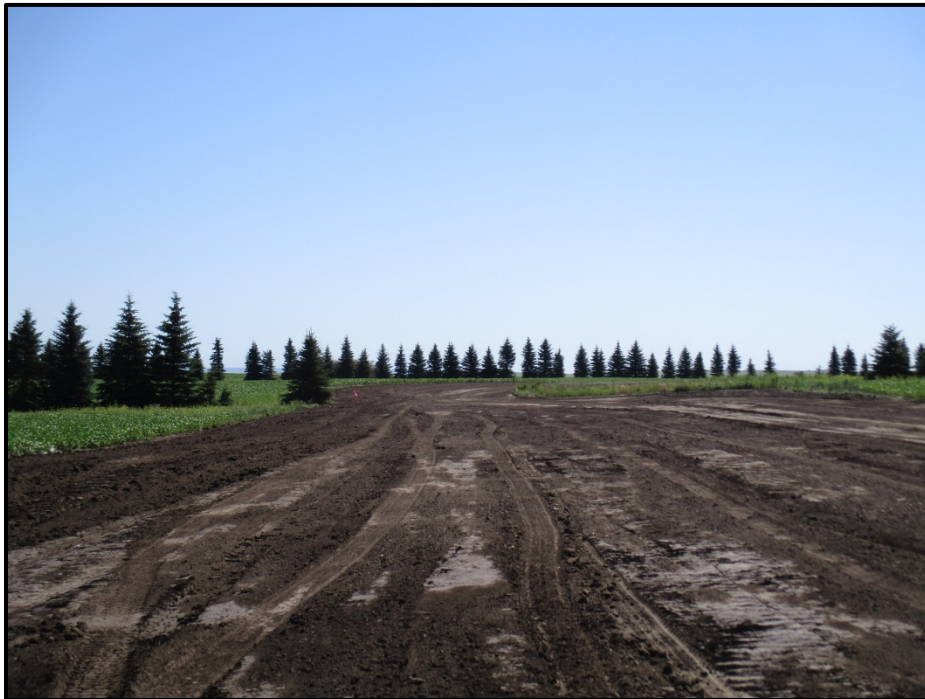
Photo 6. (GPS Point #448) – ROW necked down to 50 ft width through tree rows. Unknown if or how many trees were taken out in this area. Topsoil replaced back on the ROW. Direction: East.

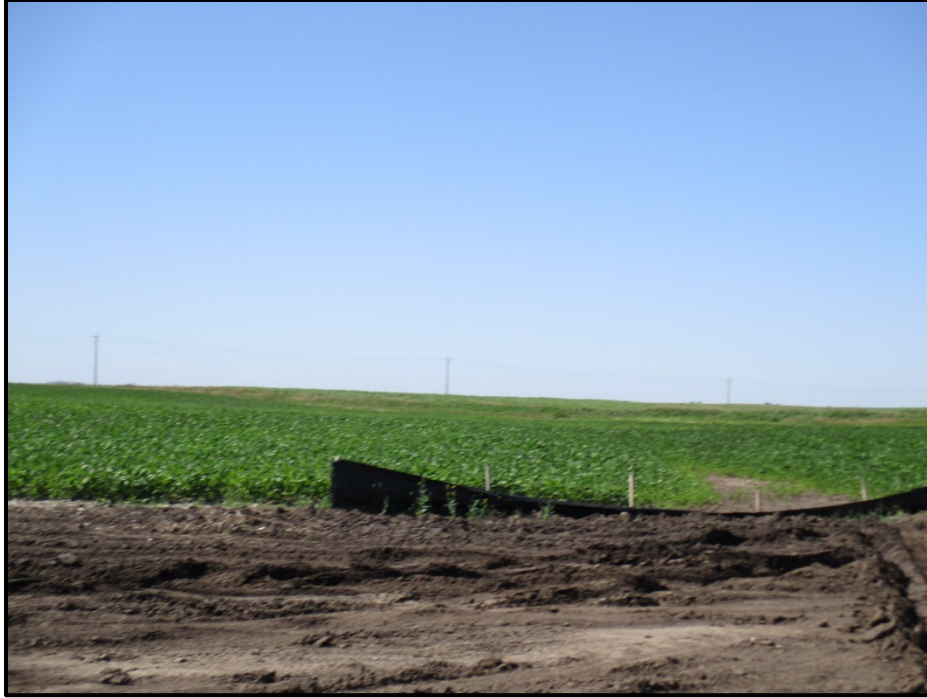
Photo 7. (GPS Point #448) - Silt fence observed in drainage area near crop field, which needs maintenance. The area was rutted up and needs to be smoothed out again. Topsoil had been replaced back on the ROW.

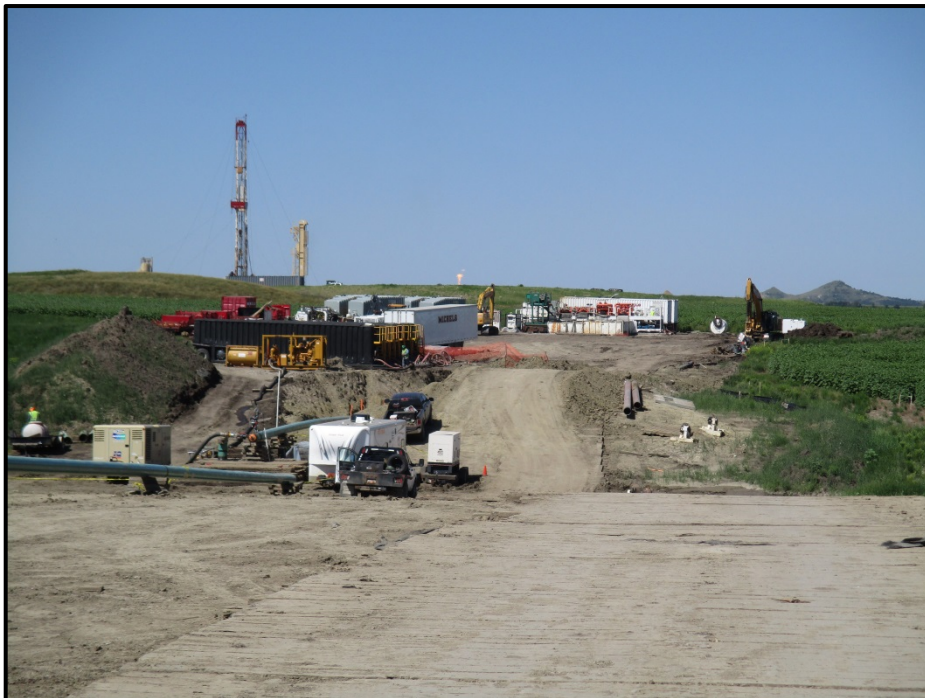
Photo 8. (GPS Point #449) – Lake Sakakawea bore area. Direction: West

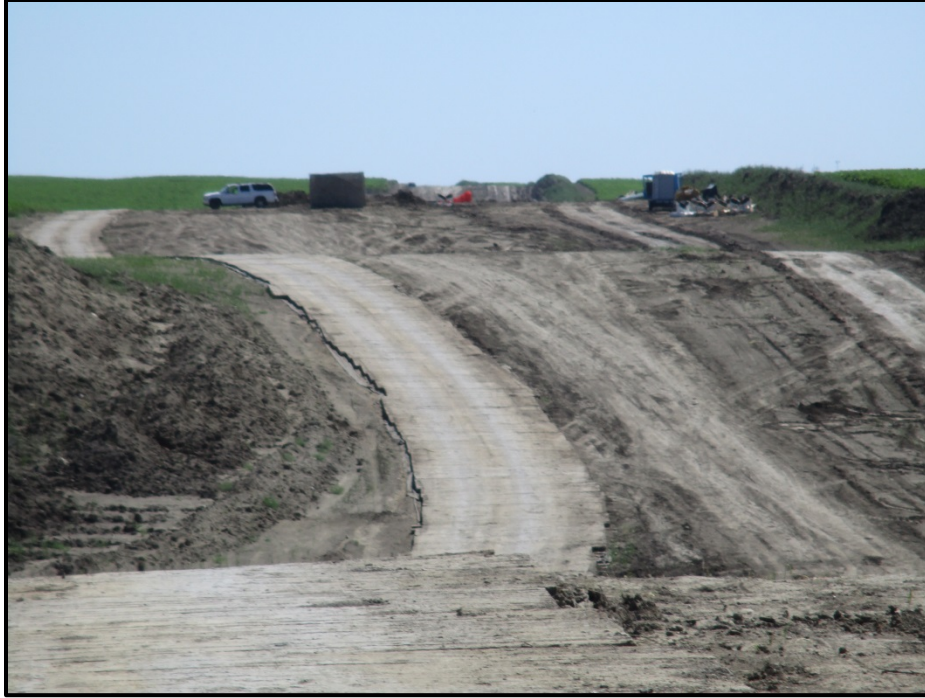
Photo 9. (GPS Point #449) – ROW going up to Lake Sakakawea bore area. The bore contractor wanted mats placed on ROW up to bore area. Mats are observed on the left side of the ROW. Direction: East

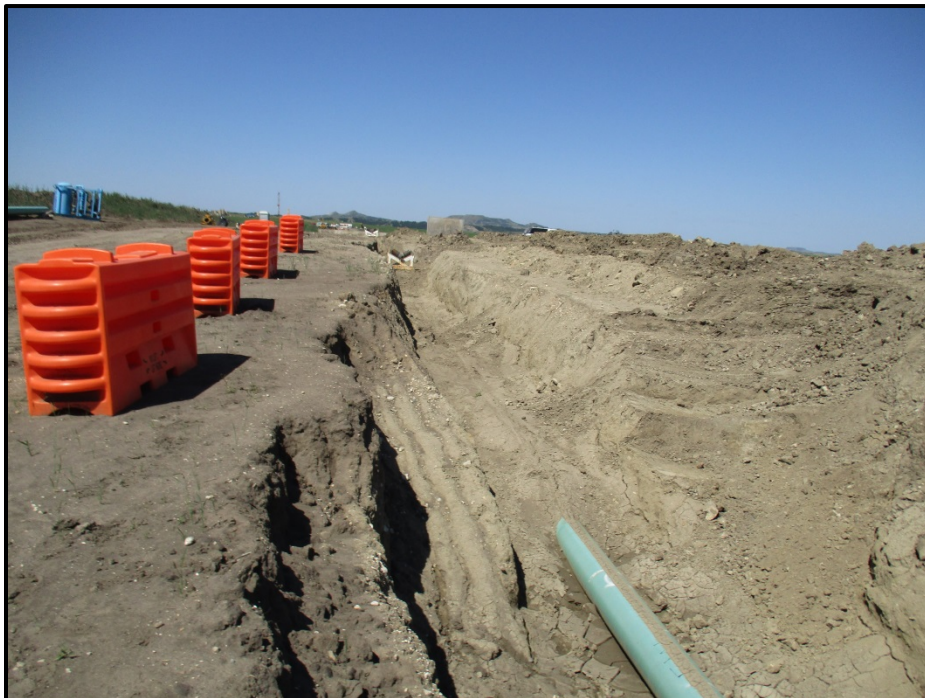
Photo 10. (GPS Point #450) - Open trench with partially covered pipe in trench. Orange safety blockades to the left of photo. White and black pipe rollers (visible in trench in far distance of photo) were used to guide the bore pipe into bore hole. Direction: West

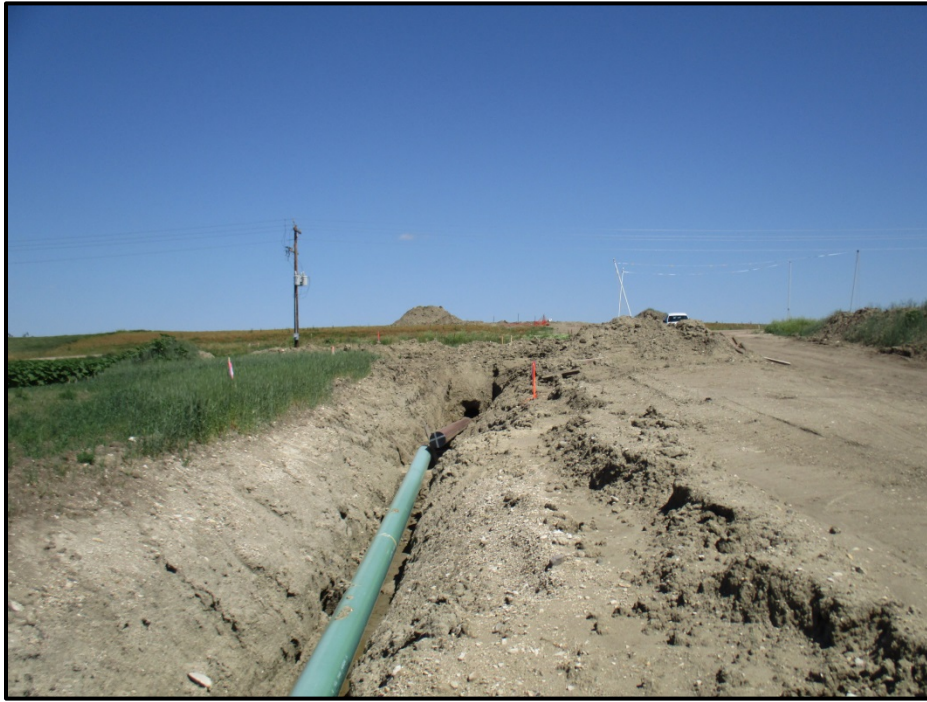
Photo 13. (GPS Point #444) - Area near rural water line break. Open trench to the left of photo. No standing safety fence observed. Environmental inspector thought they hit the rural water line while they were doing boring activities. Direction: North

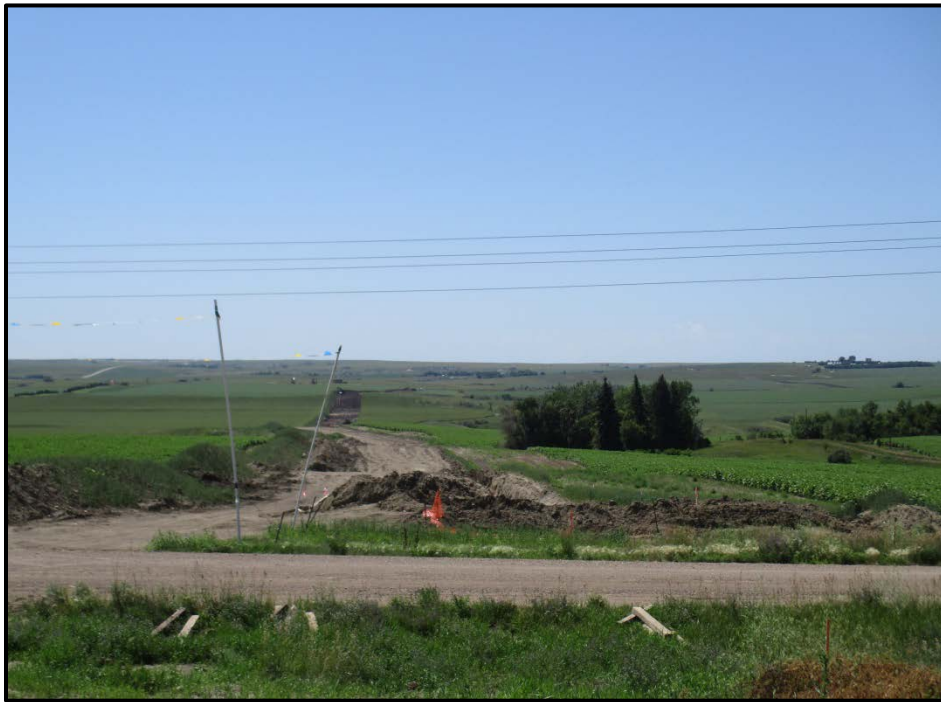
Photo 14. (GPS Point #444) - Area near rural water line break. Extended ROW for bore area. Topsoil pile to the left of photo on left side of ROW with vegetation growing on it. Direction: South

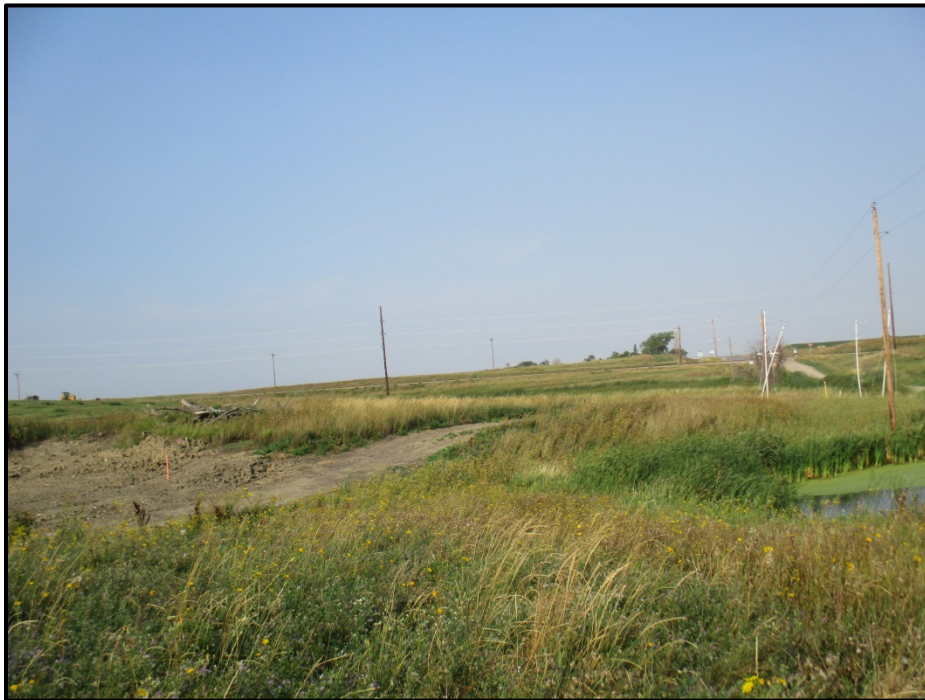
Photo 16. (GPS Point #481) - ROW and access road next to wetland. No erosion control devices observed. Site visit 9/1/2016. Direction: West

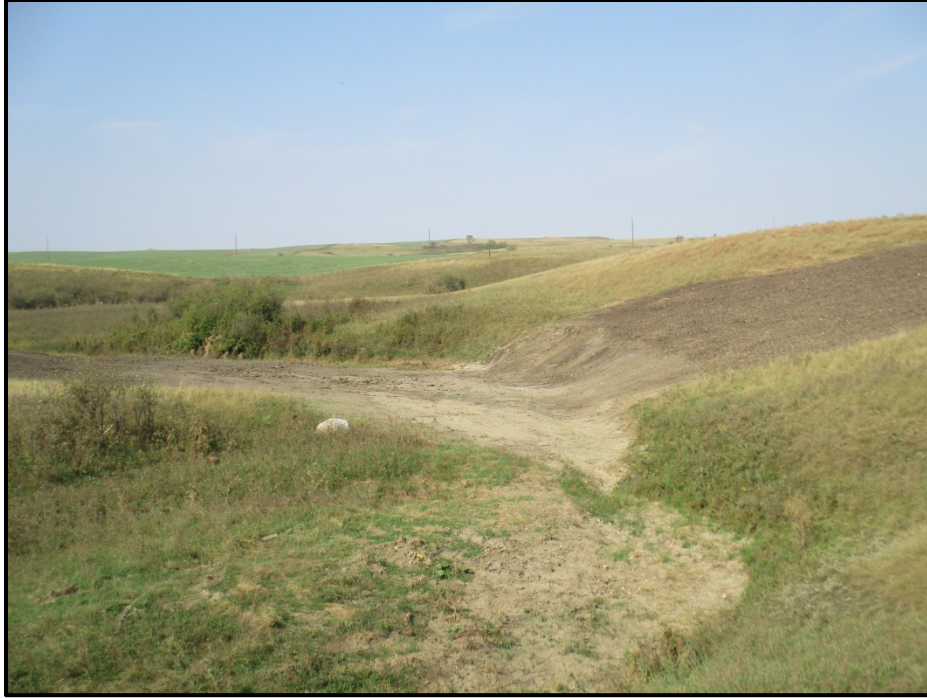
Photo 17. (GPS Point #482) - Drainage area, no erosion control device. Area along the drainage pathway looks light in color, possibly due to topsoil erosion. Direction: West

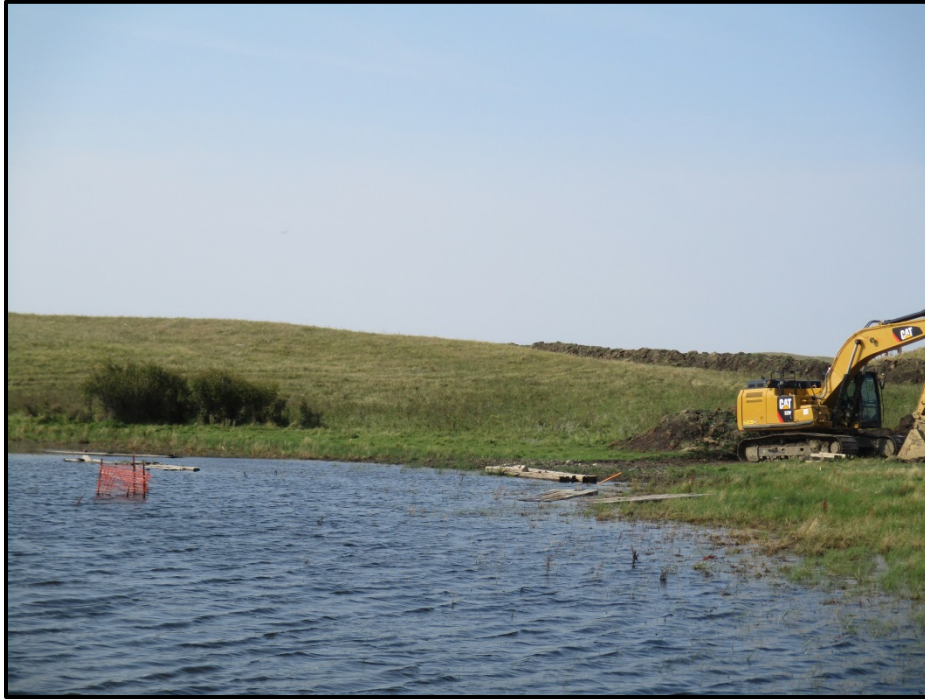
Photo 19. (GPS Point #483) - Swamp mats floating in wetland, no erosion control devices observed. Small orange fenced in area, possible pot holing site, under water. Direction: South

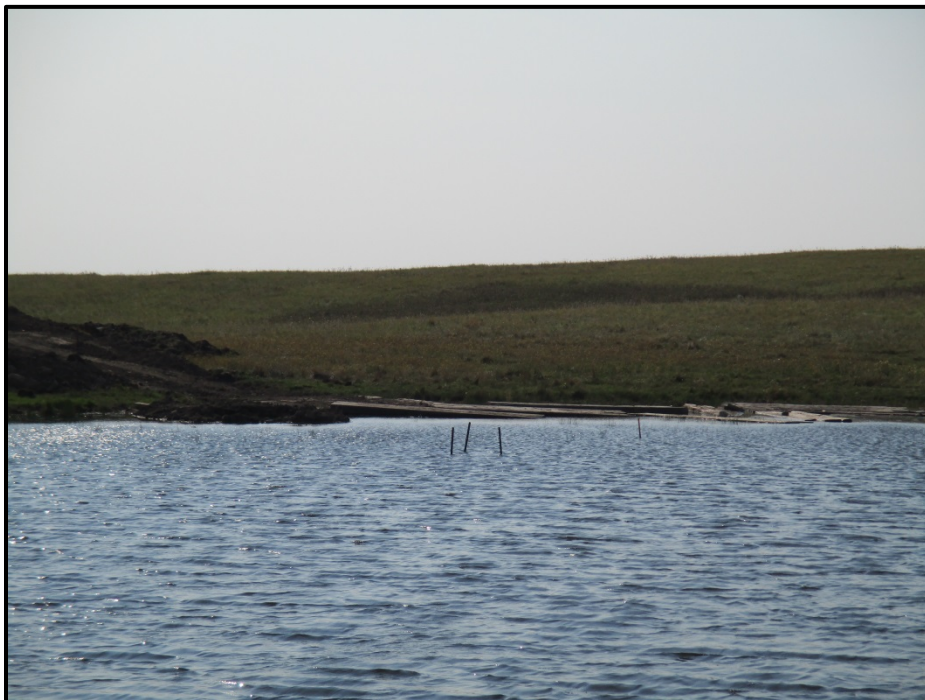
Photo 20. (GPS Point #483) - Swamp mats floating in wetland. Dirt pile in water seen to left of photo on wetland edge. No erosion control devices observed. Direction: South

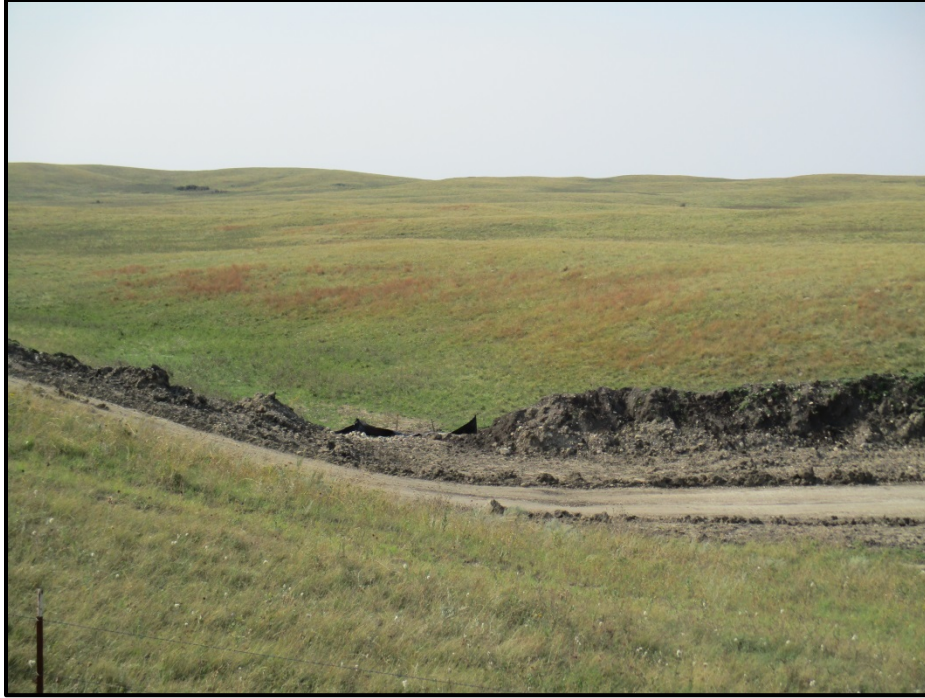
Photo 21. (GPS Point #484) - Silt fence in drainage area, needs maintenance. Direction: South

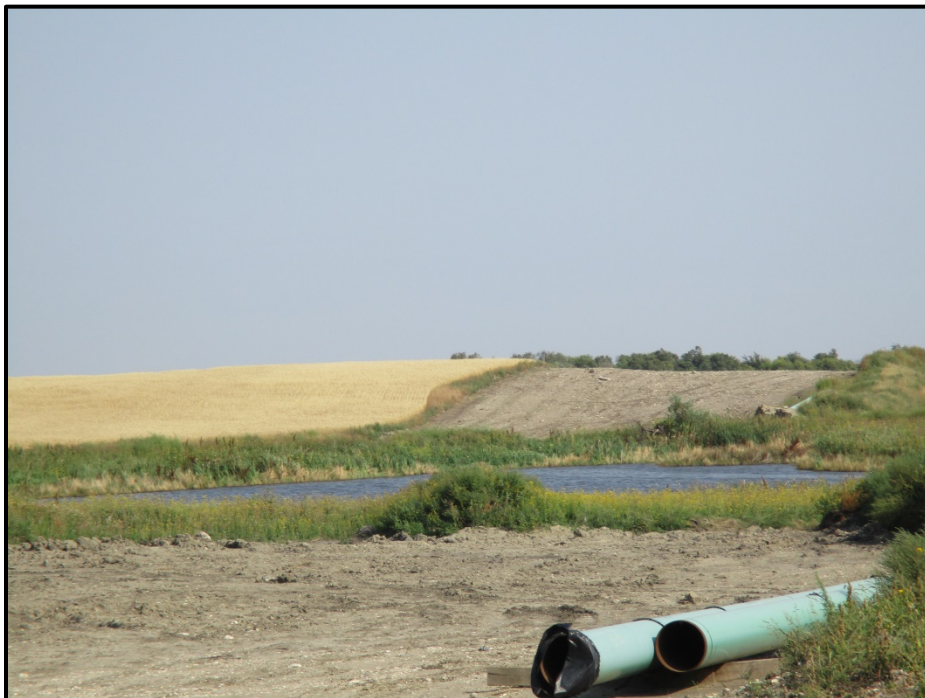
Photo 22. (GPS Point #485) - Pipeline ROW goes down the hill in the distance and wetland was bored under. No erosion control devices observed. Direction: North

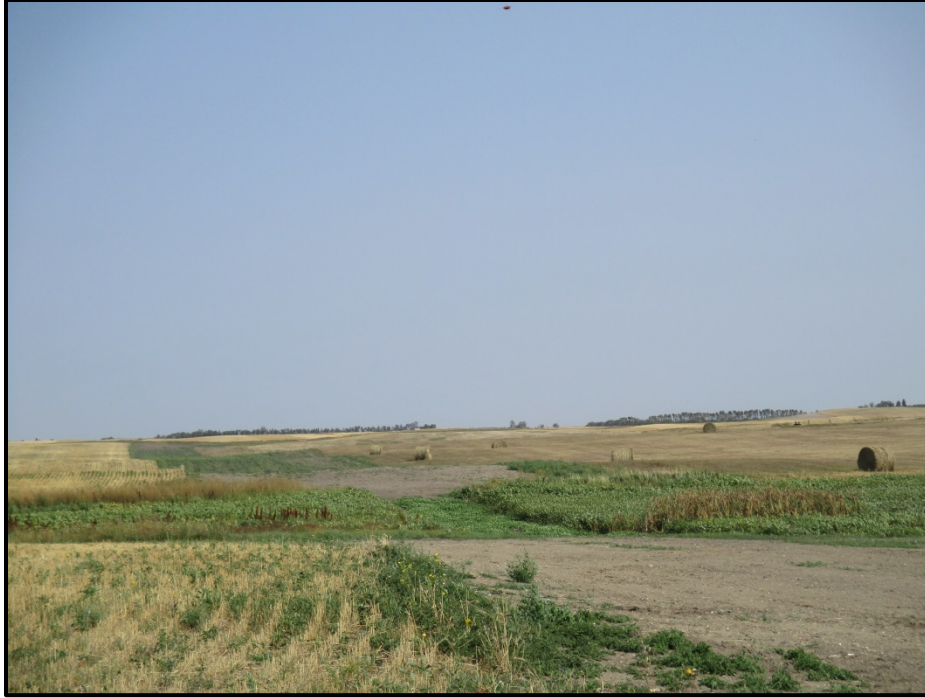
Photo 23. (GPS Point #488) - No erosion control devices observed. Area appears to have been bored but it looks like the wetland was driven through.

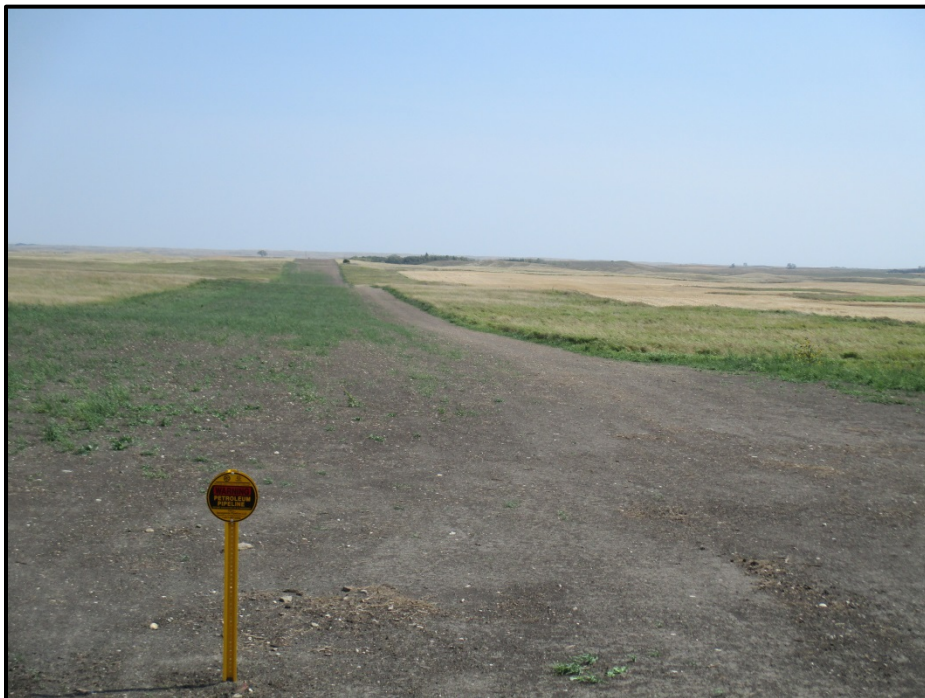
Photo 24. (GPS Point #490) - Pipeline ROW has vegetation growing. Looks like the right side of the ROW, where no vegetation is growing, has been/or is being used as a travel lane. Direction: East
