Sacagawea 16-inch Pipeline Project Revegetation Inspection Report PU-15-114

Prepared for:
**North Dakota
Public Service Commission**

WENCK Associates, Inc.
301 1st Street NE, Suite 202
Mandan, ND 58554
Phone: 701-751-3370
Fax: 763-479-4242

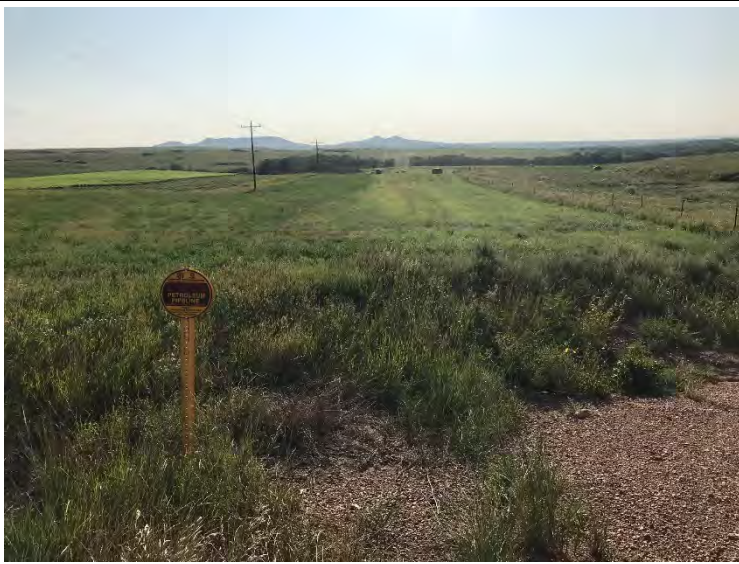
Observation Point: 657

Photo Description: Hayland. Landowner did not specify seed mix to be used for this parcel, so a mix of green needlegrass, slender wheatgrass, western wheatgrass, and sideoats grama was used.

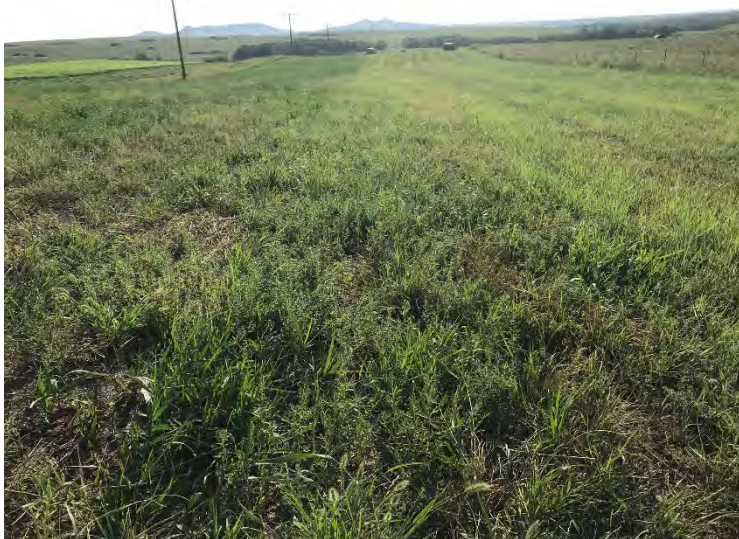
Observation Point: 657

Photo Description: Close-up of vegetation in hayland. All seeded species except sideoats grama were a dominant part of the stand at 70-80% cover. A minor amount of annual weeds were present, including kochia, Russian thistle, and pigeon grass, and less than 5% of the introduced smooth brome grass and yellow sweetclover were present.

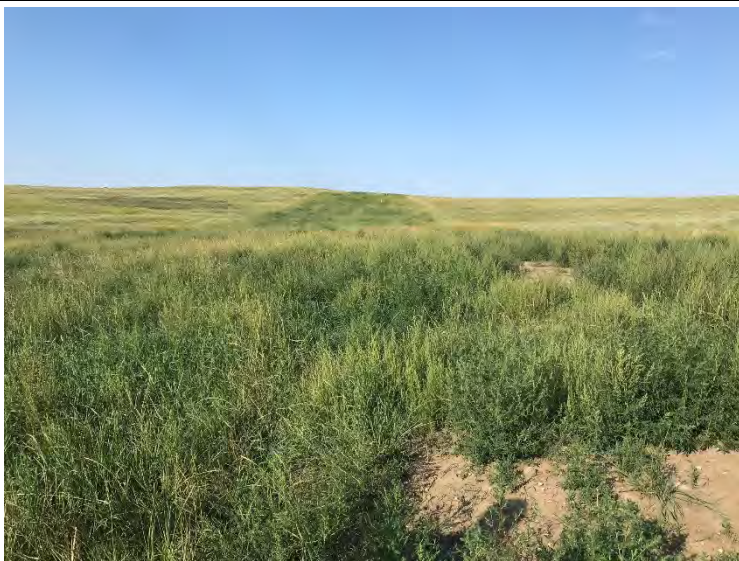
Observation Point: 658

Photo Description: Route through parcel of native rangeland. Multiple pipelines running adjacent; the Sacagawea line in on the north (right) side. Rangeland had not been grazed this year. Species composition on Sacagawea right-of-way (ROW) was about 75-80% quackgrass; 10-20% kochia; and less than 5% western wheatgrass, slender wheatgrass, pigeon grass, and green needlegrass along the edge of the ROW.

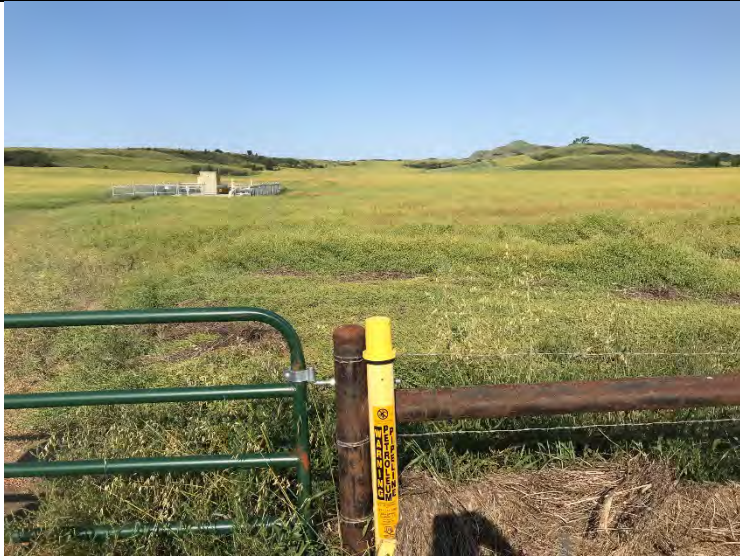
Observation Point: 659

Photo Description: ROW through field of canola. Crop looked comparable height and color within and outside of ROW.

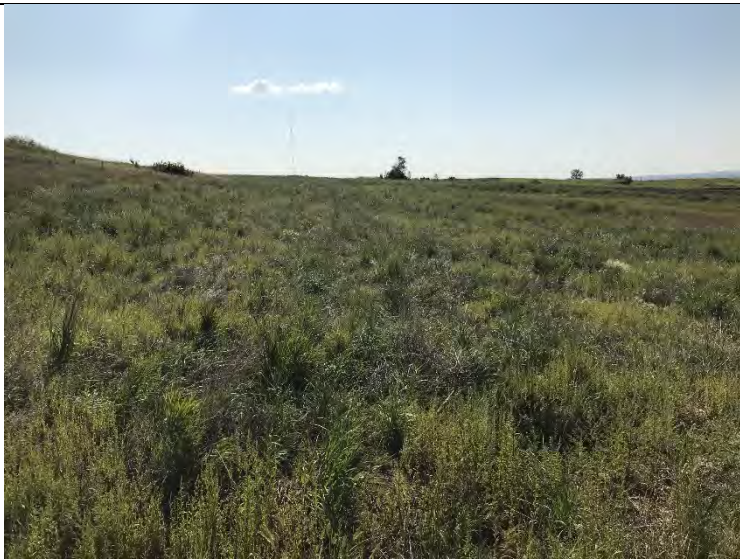
Observation Point: 660

Photo Description: Sacagawea ROW along the south side of Saddle Butte, adjacent and intersecting other pipeline ROWs. The composition was about 50% grass and 50% annual weeds; patches of annual weeds were higher (about 80%) where ROW turned north and intersected a Hess gas line. Species included kochia (dominant), green needlegrass, smooth brome, Russian thistle, crested wheatgrass, wheat (cover crop), intermediate wheatgrass, slender wheatgrass, sweetclover, western wheatgrass, and sideoats grama.

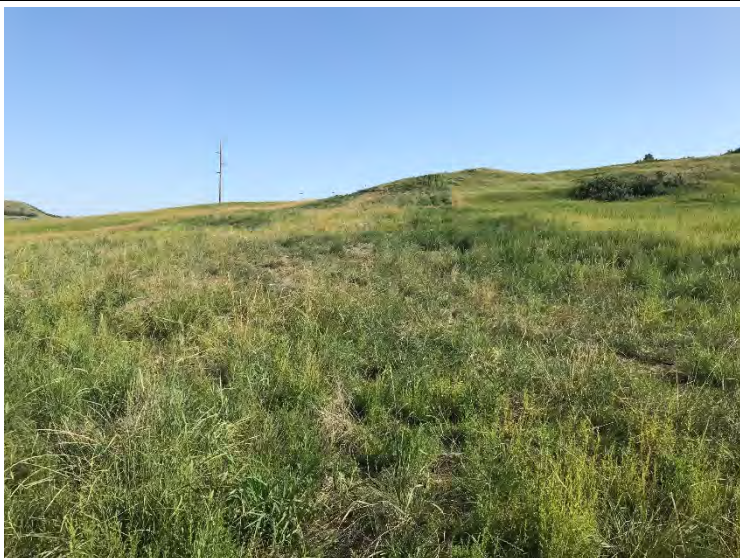
Observation Point: 661

Photo Description: Continuing north along the west side of Saddle Butte, the ROW consisted of green needlegrass, western wheatgrass, sideoats grama, and slender wheatgrass, all distributed evenly with vigorous growth and about 50% total cover. Kochia was present between 10-40% cover. Erosion control was in place and recontouring was good on the slope. Lighter colored soils on the slope indicate topsoil/subsoil mixing and likely a lack of adequate original topsoil. Vegetation is establishing despite these conditions.

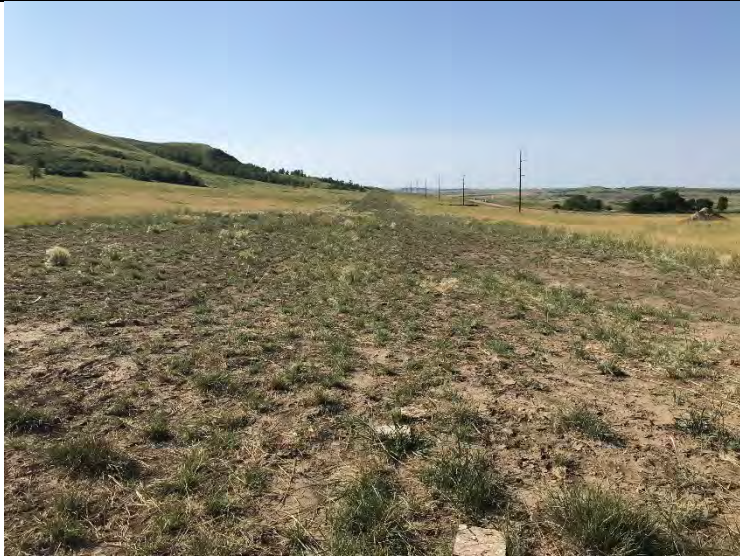
Observation Point: 662

- Area northwest of Saddle Butte. Observation Point: 662, 663/Photos 1002, 1003, 1004. This portion of the ROW has had multiple seedings and was seeded again this year. Composition was about 30% vegetation and 70% bare ground.
- Irrigation dike repair area east of Keene office. Observation Point: 667/Photos 1009. Recently re-worked portion of the ROW where a landowner requested irrigation dikes be repaired. Bare soil has been seeded and irrigation dikes have an erosion control blanket installed over them to stabilize the soil.

Photo Description: View along ROW toward Saddle Butte (on left of photo). This portion of the ROW has had multiple seedings and was seeded again this year. Composition was about 30% vegetation and 70% bare ground. Species were crested wheatgrass, smooth brome, western wheatgrass, slender wheatgrass, green needlegrass and foxtail barley. Minimal to no annual weed cover indicates it may have been sprayed.

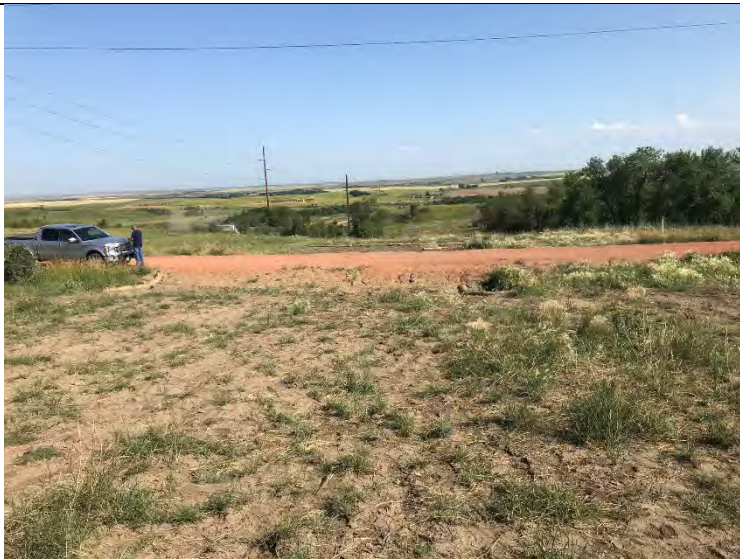
Observation Point: 663

Photo Description: Erosion control is in place at a washout along the gravel road in the photo, which needs further repair.

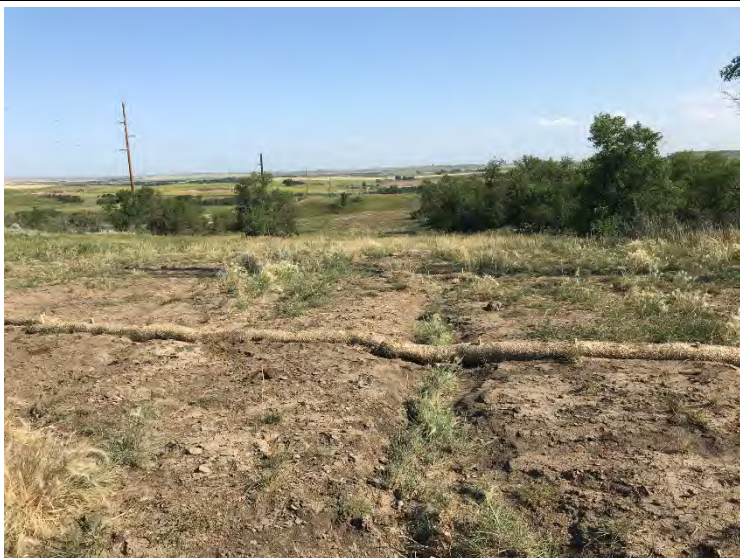
Observation Point: 663

Photo Description: Another closer view of washout and repair efforts. Growth of foxtail barley (grass with light-colored seed heads) likely indicates salts on soil surface and therefore some subsoil mixing. Seeded grasses were present, though at low cover, and should establish over time.

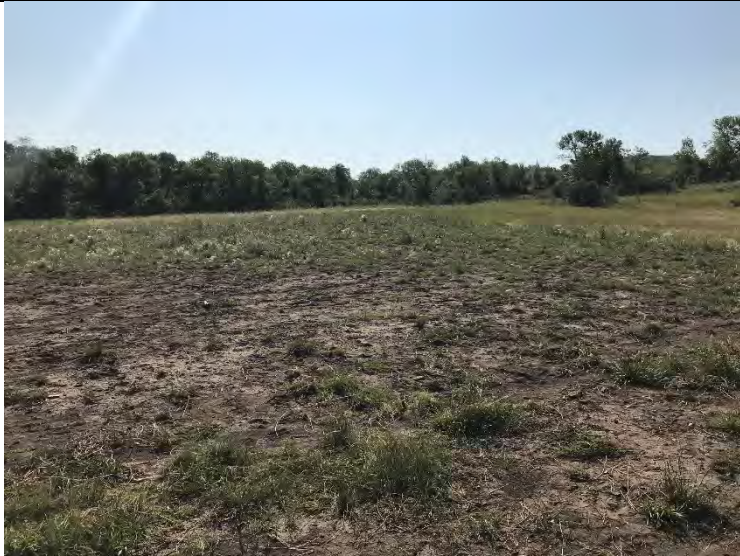
Observation Point: 664

Photo Description: Another view of reseeded portion of ROW north of Saddle Butte. Grass cover at 30-40%.

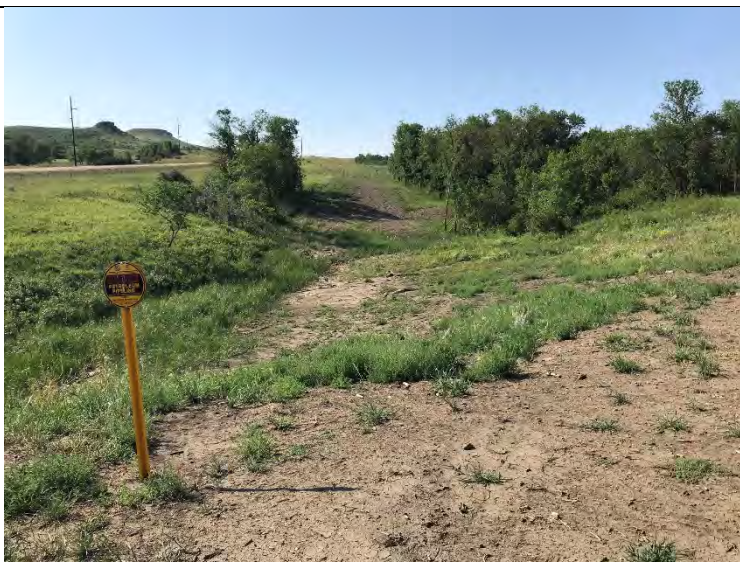
Observation Point: 665

One intermittent drainage was observed during the inspection which had been open trenched during construction (Appendix B; Observation Point 665/Photo 1005). The channel of the drainage had been naturally recolonized by wetland vegetation and there were no noxious weeds observed, however the grass seed mix had not germinated well or

Photo Description: ROW trenched through an intermittent stream. Wetland vegetation has reestablished within the stream channel. Adjacent slopes were 80-90% bare soil with the remainder of the vegetation annual weeds. Seed mix did not appear to germinate here.

established along the slopes of the drainage and bare soils and annual weed cover were prevalent. Wenck recommends that a seed mix is applied in spring 2020 to this area and annual weeds are mown in June or early July to minimize seed set.

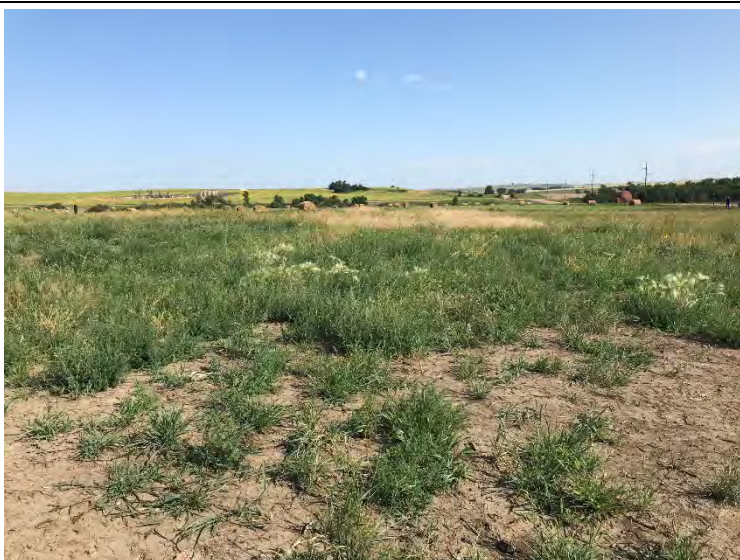
Observation Point: 665

Photo Description: Upland flat north of the stream channel in previous photo. This parcel appears to be hayland but had not been hayed this year; vegetation outside of the ROW was crested wheatgrass, alfalfa, and silver sagebrush. Within the ROW, annual weed cover was about 80%, comprised of wild oats, ragweed, kochia, wild mustard, pigeon grass, and annual wild sunflower. Green needlegrass was present at a cover of less than 5%.

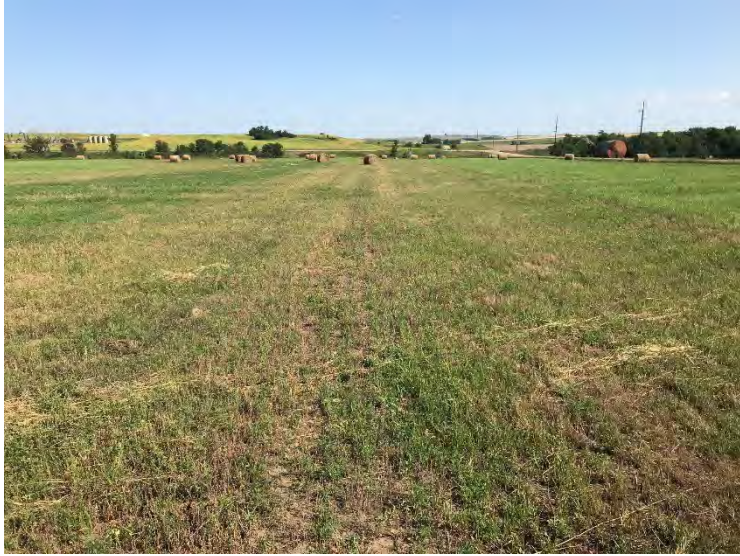
Observation Point: 666

Photo Description: Hayland parcel. ROW was about 30% alfalfa, 30% grass, and 10-20% annual weeds.

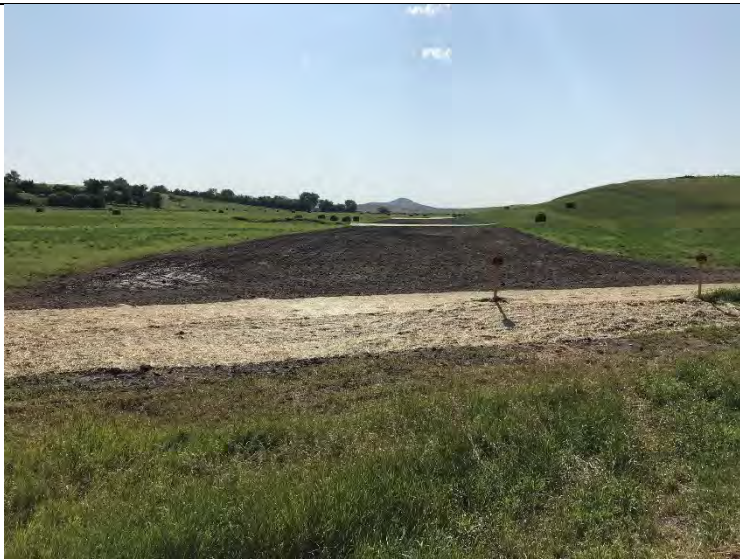
Observation Point: 667

One parcel of hayland had recently had irrigation dikes repaired within the ROW and reseeded (**Appendix B; Observation Point 667**).

Photo Description: Recently re-worked portion of the ROW where a landowner requested irrigation dikes be repaired again. Bare soil has been seeded and irrigation dikes have an erosion control blanket installed over them to stabilize the soil.

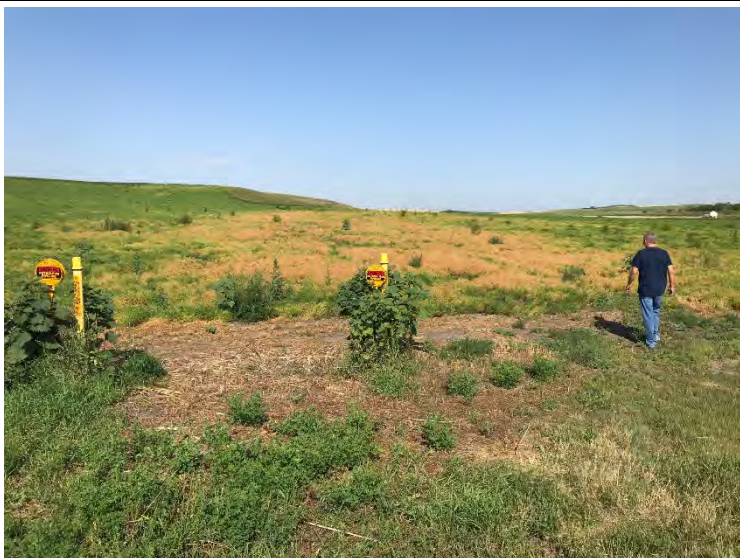
Observation Point: 667

Photo Description: Opposite side of road from irrigation dikes, showing crop field of lentils. The crop within the ROW appeared to have ripened faster. The plants were drying up and turning brown, but the pods were filled. Cover was similar within and outside ROW.

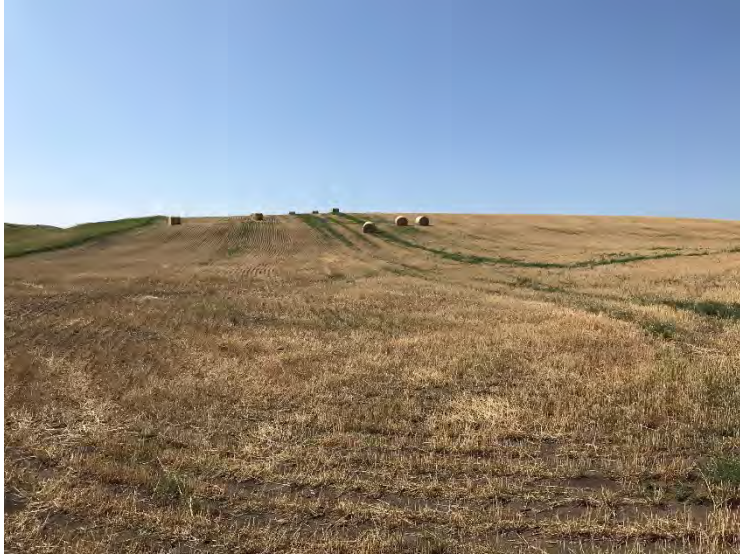
Observation Point: 668

Photo Description: ROW through cropland north of Keene substation, on west side of Highway 23. Appeared to have been barley, possibly baled for hay. The ROW appeared to have more annual weed cover compared to adjacent cropland.

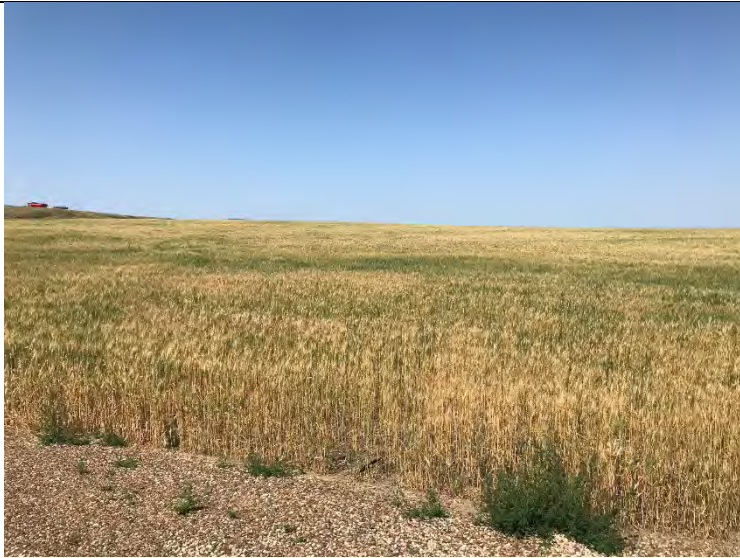
Observation Point: 669

Photo Description: View across the area of the Lake Sakakawea bore entry/exit workspace. The wheat crop in this area looked good and appeared comparable to the field outside of the workspace area.

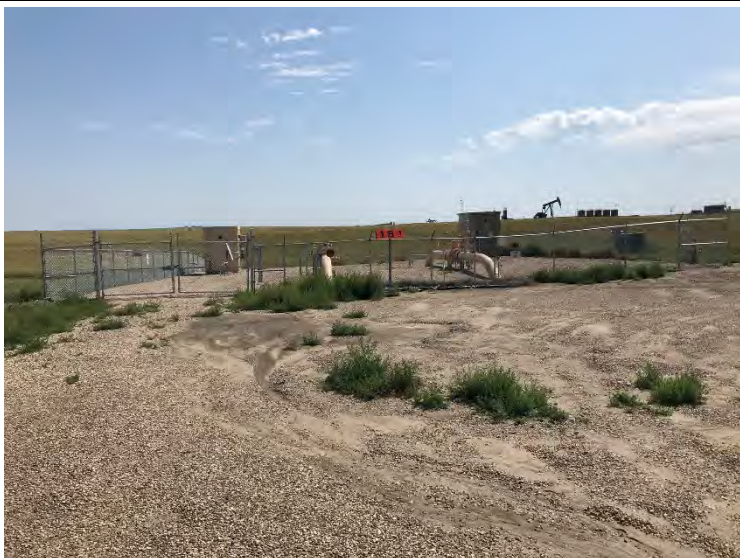
Observation Point: 669

Photo Description: Valve site at east bore location; maintained well with minor scattered annual weeds. ROW continues east over hill in distance. Cropland appeared to have no difference within or outside of ROW.

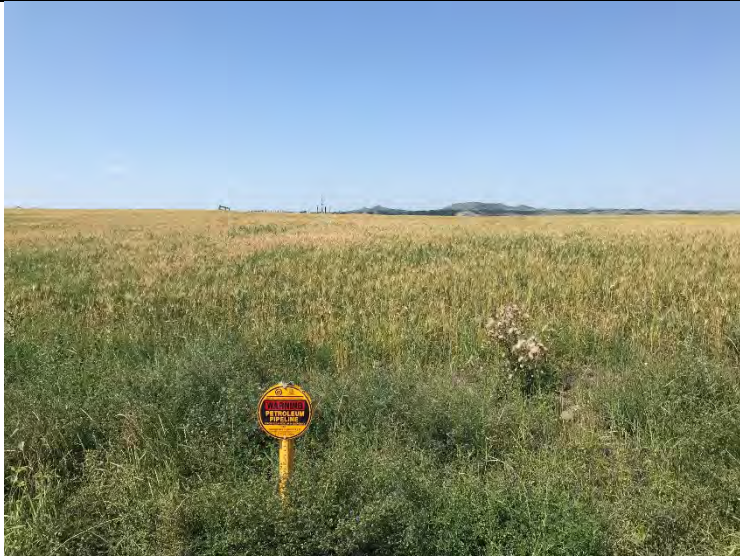
Observation Point: 670

Photo Description: Wheat field. Appeared to be no visual difference within or outside of ROW.

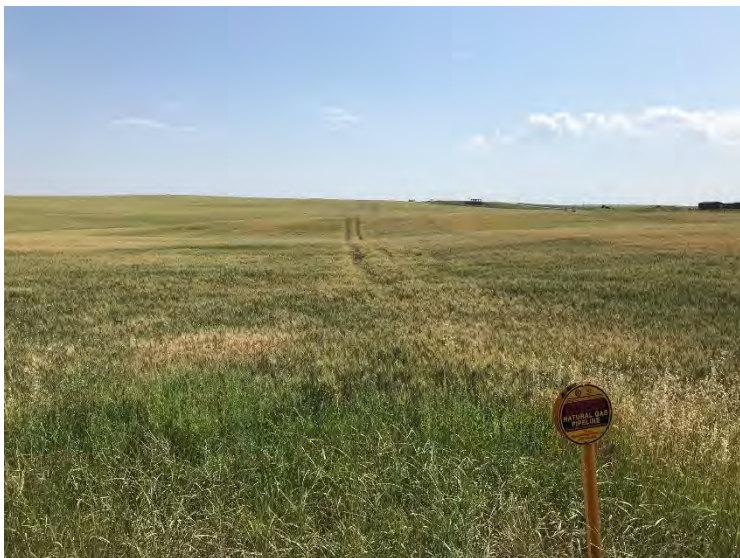
Observation Point: 670

Photo Description: Another wheat field. Appeared to be no visual difference within or outside of ROW. Tracks along ROW for unknown reason.

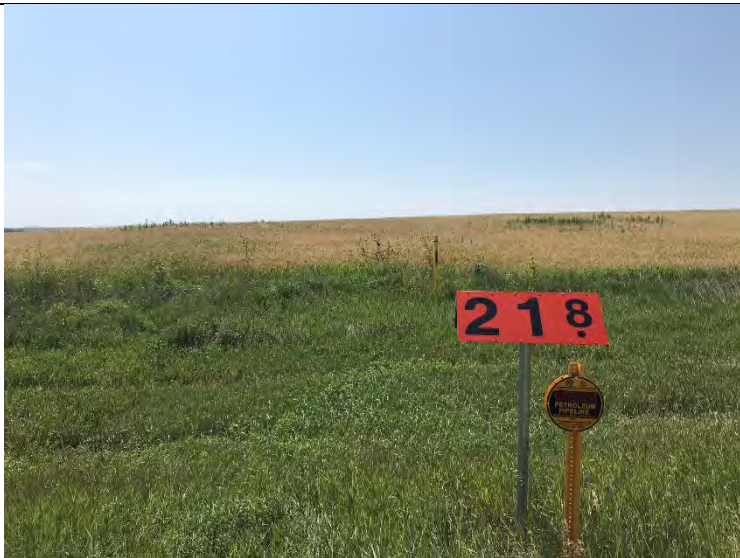
Observation Point: 671

Photo Description: Wheat field. Appeared to be no visual difference within or outside of ROW.

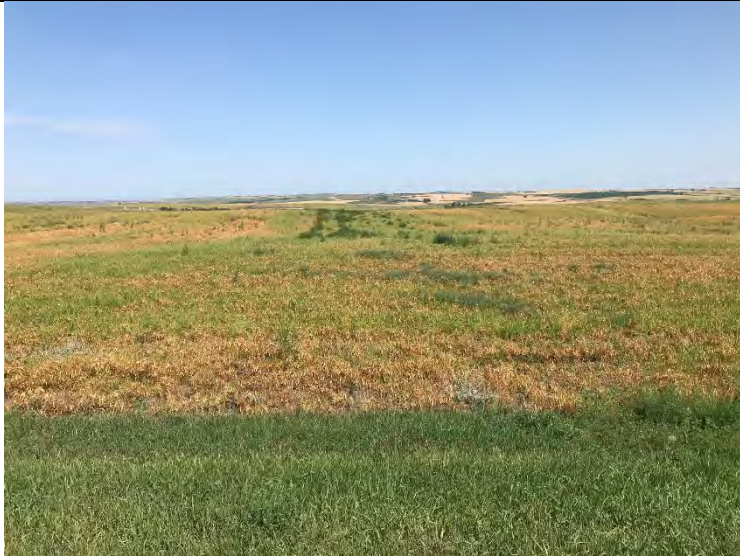
Observation Point: 671

Photo Description: Soybean field. Higher cover of kochia was apparent within the ROW compared to outside of ROW (dark green vegetation growth).

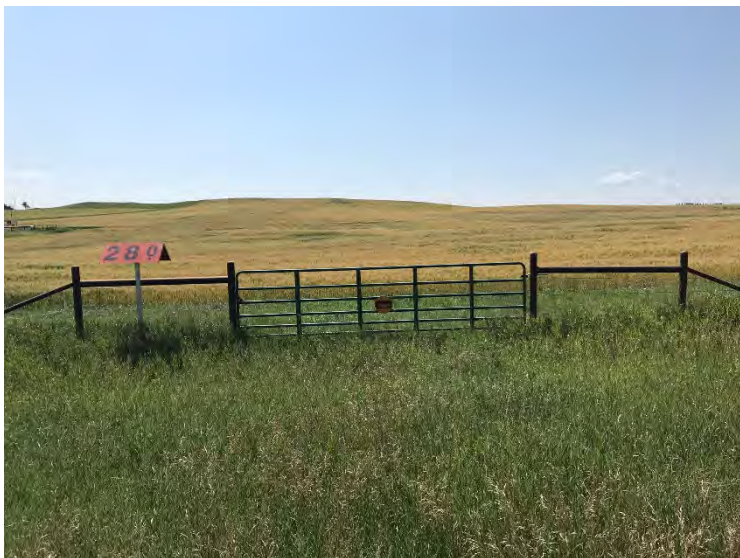
Observation Point: 672

Photo Description: Wheat field. No visual difference within or outside of ROW.

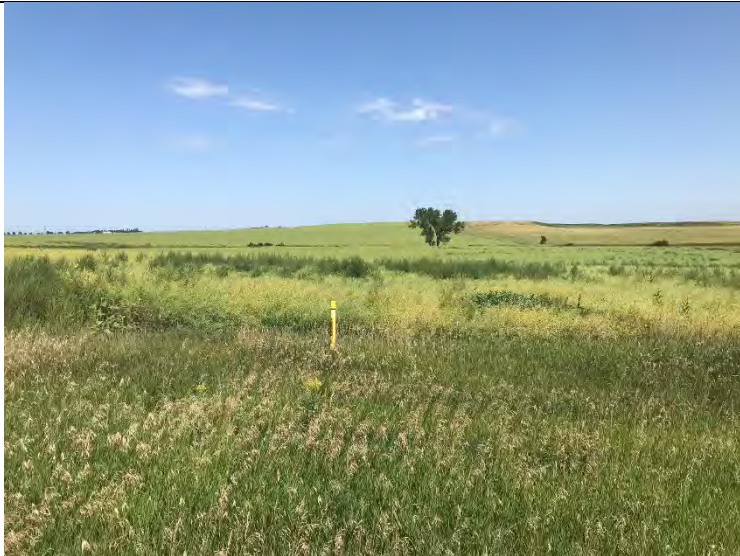
Observation Point: 672

Photo Description: Canola field. No visual difference within or outside of ROW. Annual weed growth in foreground was not associated with Sacagawea ROW.

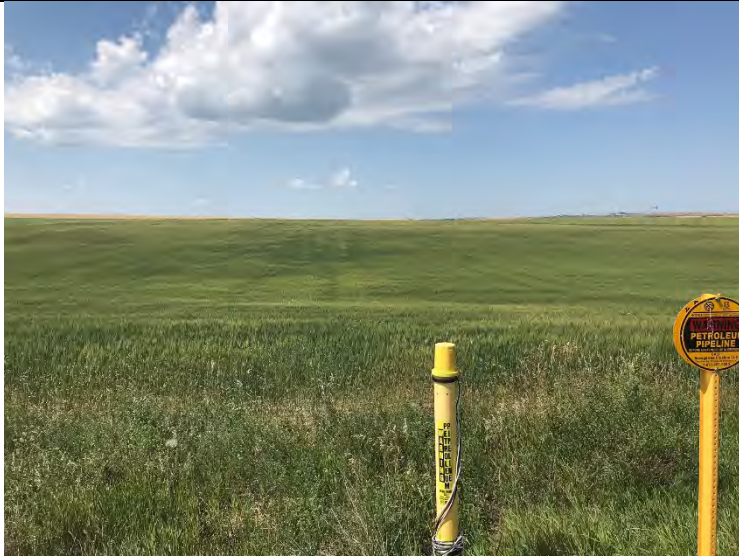
Observation Point: 673

Photo Description: Wheat field. Crop was visually similar within and outside of ROW. Appeared to be slight subsidence within ROW.

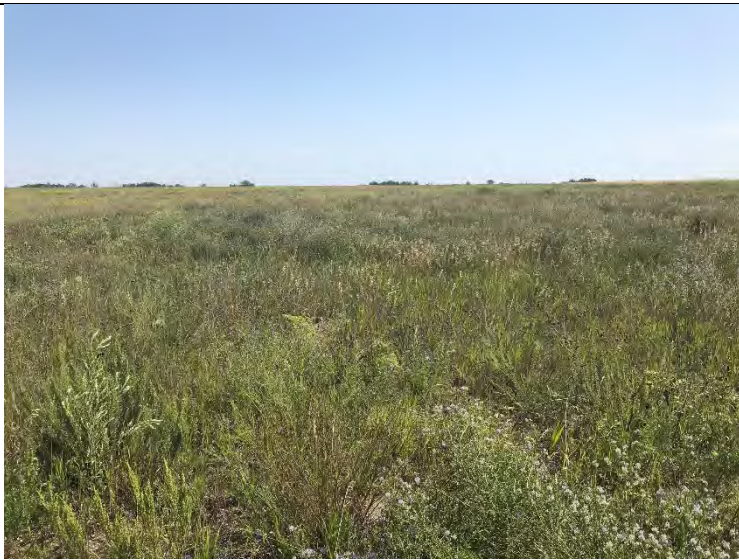
Observation Point: 674

Photo Description: Hayland or CRP parcel. ROW vegetation was coming in very well with over 90% cover and an even mixture of alfalfa, intermediate wheatgrass, western wheatgrass, green needlegrass, smooth brome, slender wheatgrass, and white sweetclover. The adjacent area appeared to have been planted with a native seed mix including native forbs (Canada milkvetch, black-eyed Susan, purple prairie clover) and little bluestem.

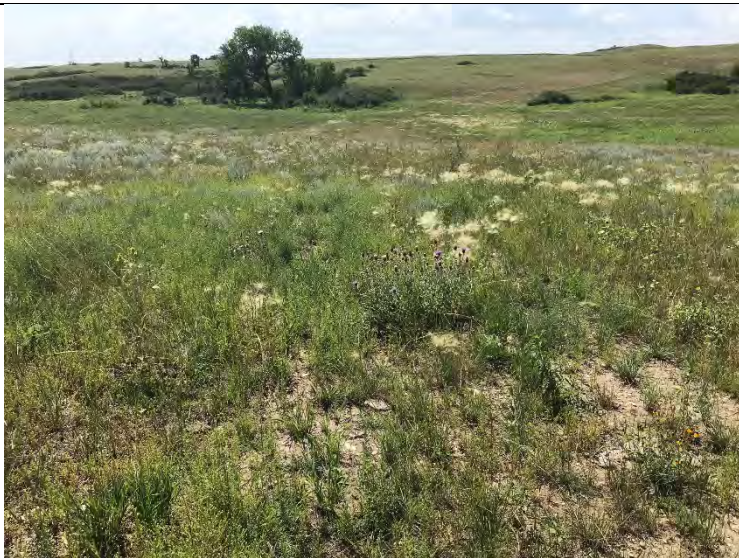
Observation Point: 675

Photo Description: ROW through a parcel of native rangeland. Vegetation was approximately 20-30% cover each of planted grasses; native forbs including fringed sagewort and waveleaf thistle; and annual or weedy species including foxtail barley. A small patch of the noxious weed Canada thistle was noted at this point.

Sacagawea has been treating known locations of noxious weeds and there was improvement from last year's inspection at several locations. Three locations of noxious weeds were observed which should continue to be monitored and treated, along with any other locations along the ROW. Canada thistle was noted at Observation Points 675 and 688 and absinthe wormwood was noted at Observation Point 678.

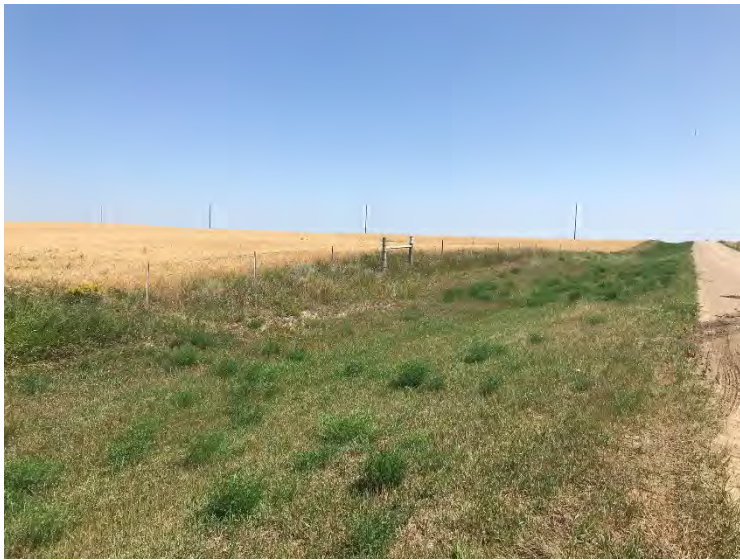
Observation Point: 675

Photo Description: ROW parallels road in wheat field. No visual difference apparent in wheat crop.

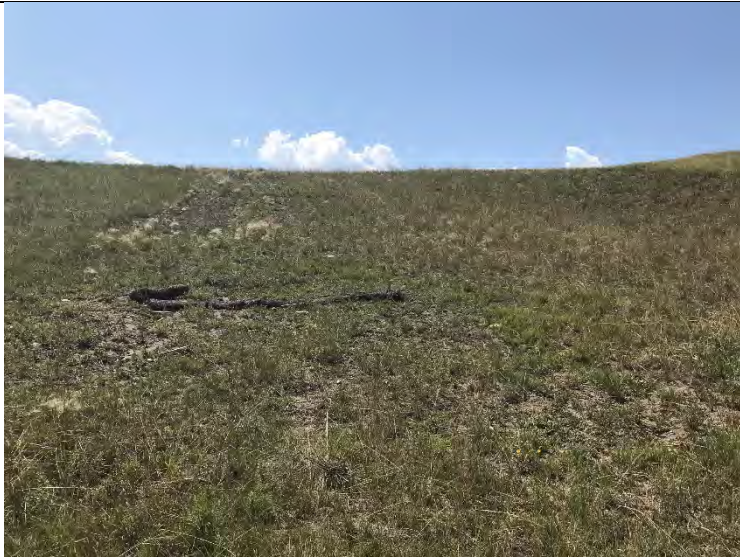
Observation Point: 677

Photo Description: ROW through native grassland. Grass cover was at approximately 50% including seeded species, inland saltgrass, and smooth brome. Erosion control in place on steep slope.

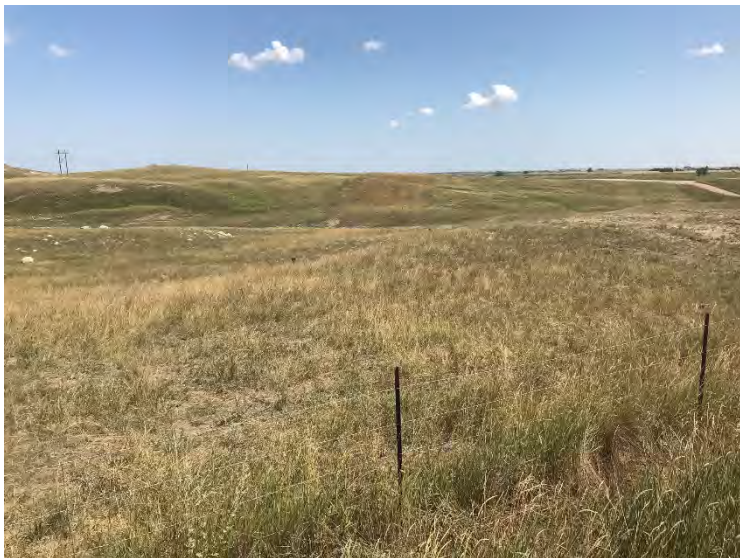
Observation Point: 677

Photo Description: Continuation of ROW across road in previous photo. Grass had better growth at 70% cover, with a few bare spots. Species included green needlegrass, smooth brome, and western wheatgrass.

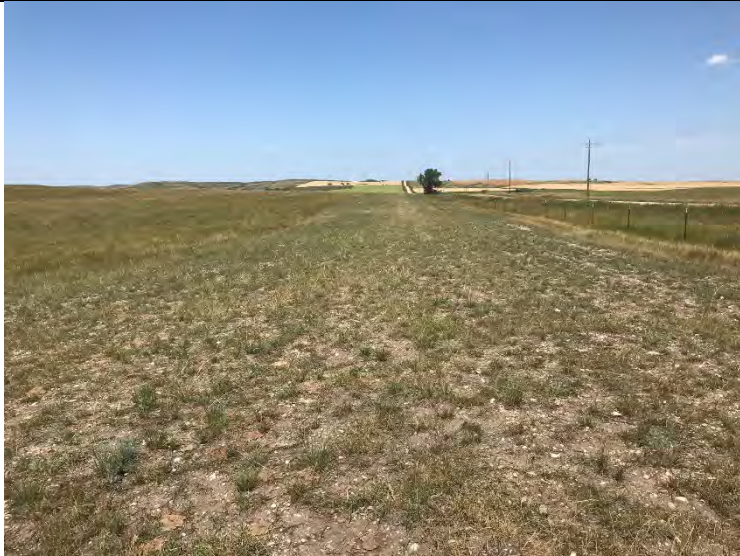
Observation Point: 678

Photo Description: Parcel of crested wheatgrass grassland, possibly used for rangeland. Within ROW was 50-70% cover of crested wheatgrass, western wheatgrass, sideoats grama, and green needlegrass with bare, gravelly soils between.

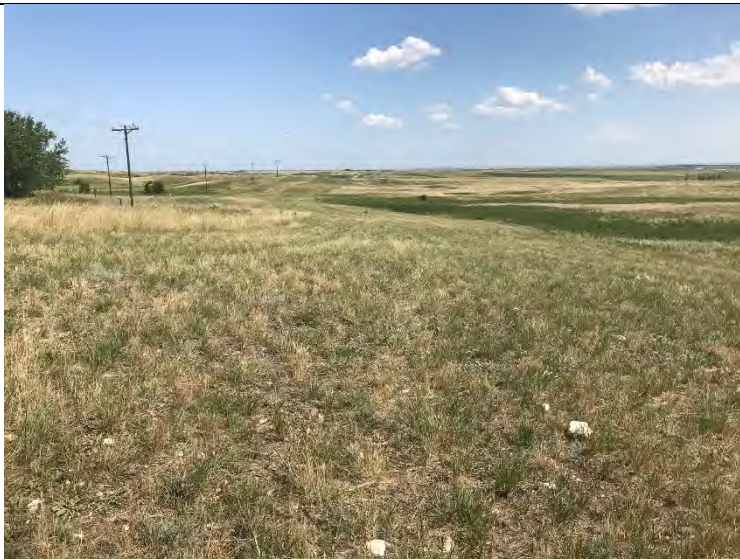
Observation Point: 678

Photo Description: Same parcel as previous photo showing ROW grass establishment. This point had a few scattered plants of absinthe wormwood, a noxious weed. During last year's inspection, this location had dense wormwood across the parcel and it had been effectively sprayed last year after the inspection.

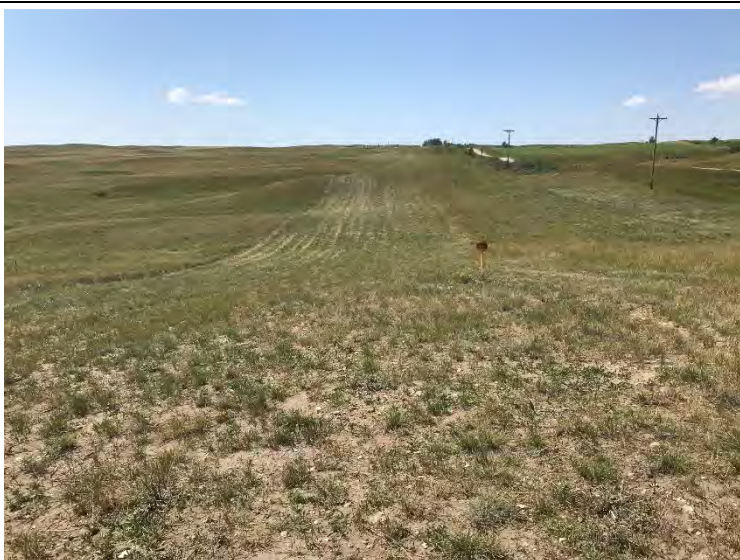
Observation Point: 680

Photo Description: State land parcel of native rangeland. The ROW had been mown. The ROW in this area had between 50-80% total vegetation cover, of which 30-50% was grass. Species included green needlegrass, western wheatgrass, foxtail barley, Flodman's thistle, common dandelion, fringed sagewort, and black medick. Hilltops had areas with more bare soil between plants.

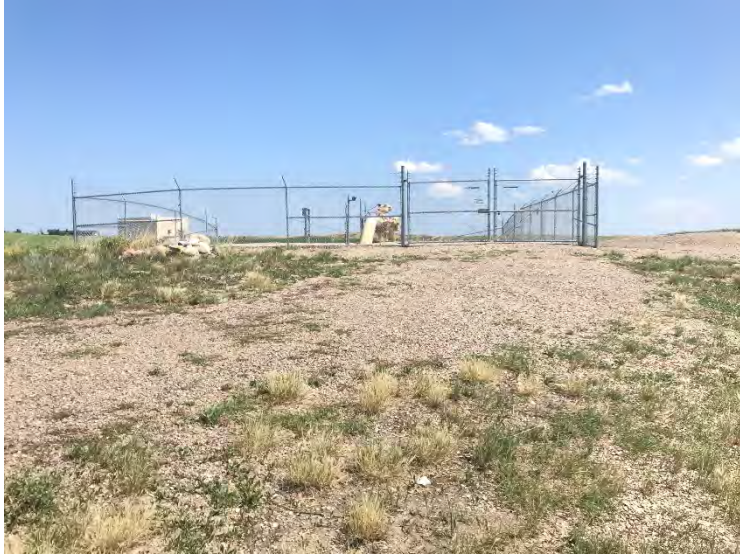
Observation Point: 680

Photo Description: Valve site on top of hill on state land. Maintained in good condition.

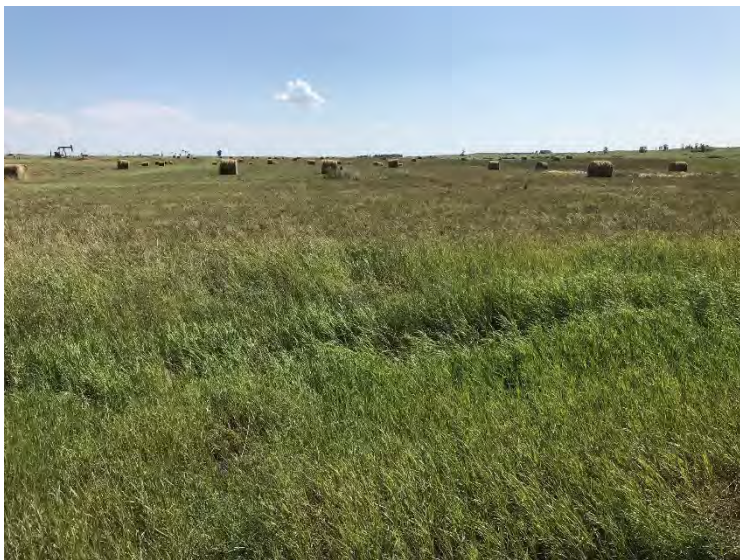
Observation Point: 692

Photo Description: Hayland. Good establishment of alfalfa and grass mix. No obvious visual difference within and outside ROW.

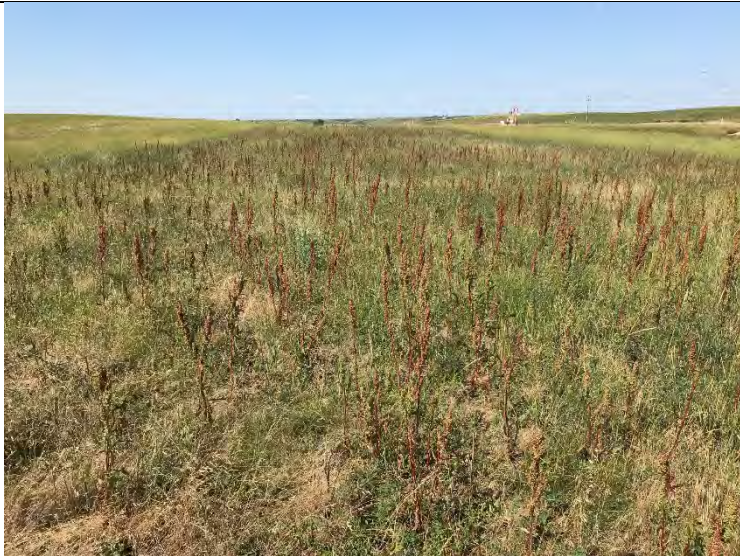
Observation Point: 691

Photo Description: Parcel of CRP or hayland with intermediate wheatgrass and alfalfa (vegetation adjacent to ROW). Within the ROW the vegetation cover was high at over 90%, but composition was weedy. Species included curly dock (tall, dark brown plant in photo), Kentucky bluegrass, intermediate wheatgrass, slender wheatgrass, foxtail barley, field brome, and yellow sweetclover.

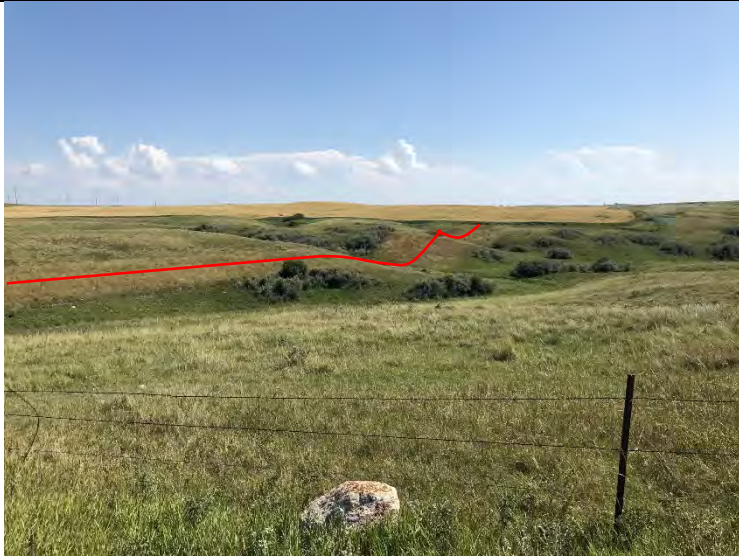
Observation Point: 690

Photo Description: ROW is routed along hills in distance, indicated by red line. Vegetation growth was higher cover compared to last year's inspection. Some minor spots of bare soils were still visible on steep parts of slope and tops of hills.

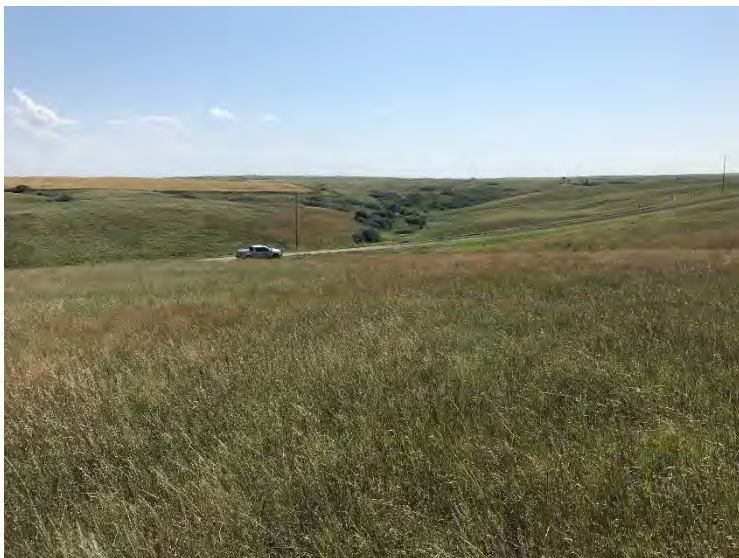
Observation Point: 689

Photo Description: ROW on parcel of idle grassland on a hillslope between fields and road. Grass cover was over 90% on slope in foreground.

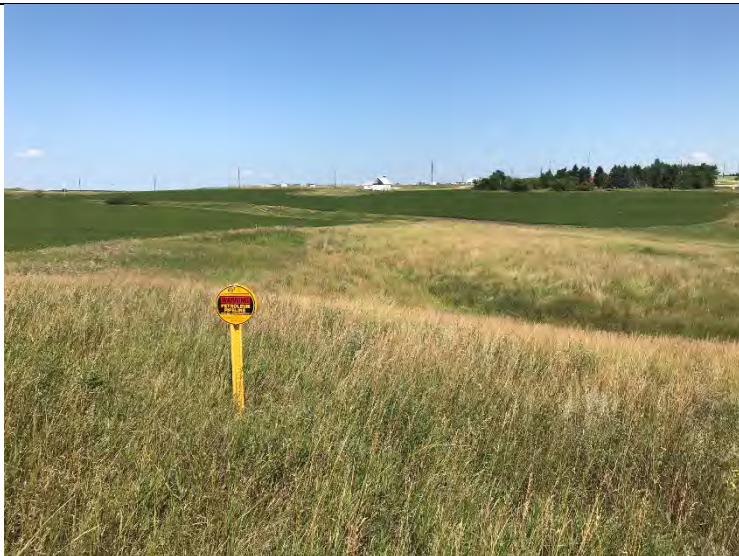
Observation Point: 688/689

Photo Description: ROW with dense stand of smooth brome, alfalfa, green needlegrass, slender wheatgrass, Canada wildrye, and Canada thistle (a noxious weed). A small amount of crested wheatgrass and foxtail barley were also present. Point 688 marks a dense area of Canada thistle, which needs treatment within the Sacagawea ROW and adjacent ROW and fields.

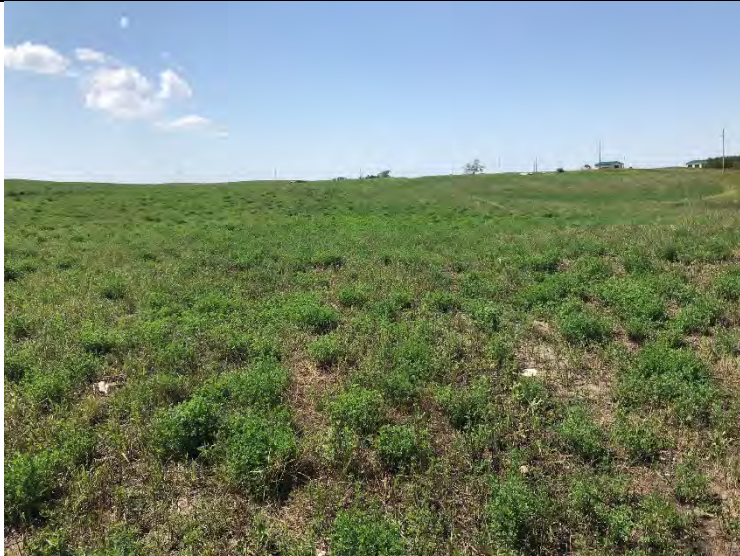
Observation Point: 681

Photo Description: Alfalfa hayland and some grass cover. Vegetation cover was similar within and outside of ROW.

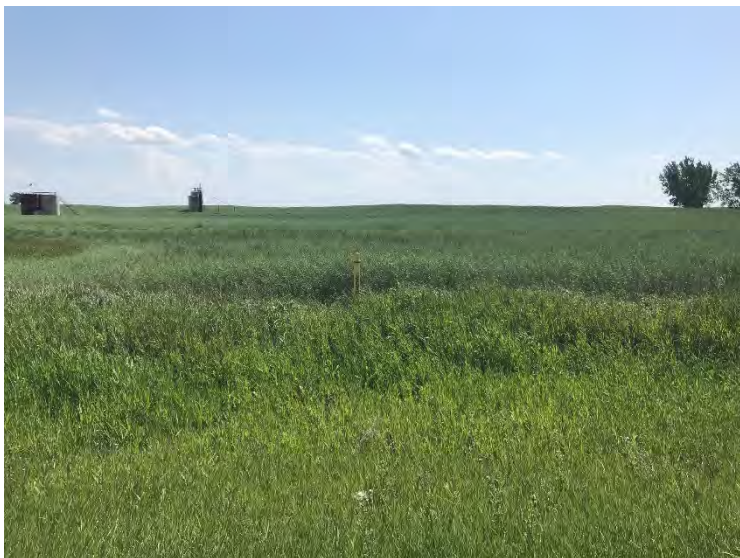
Observation Point: 681

Photo Description: Pipeline bored underneath road and wetland in foreground of photo. Pipeline marker visible.

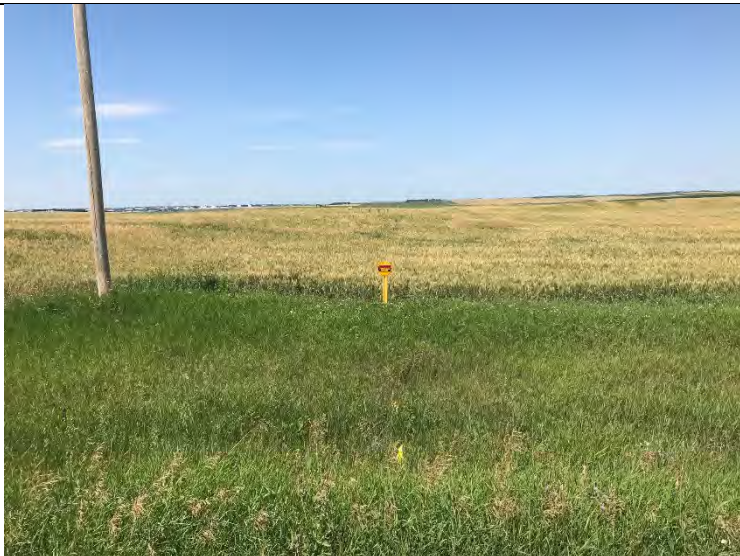
Observation Point: 682

Photo Description: Cropland. No visual difference within or outside of ROW.

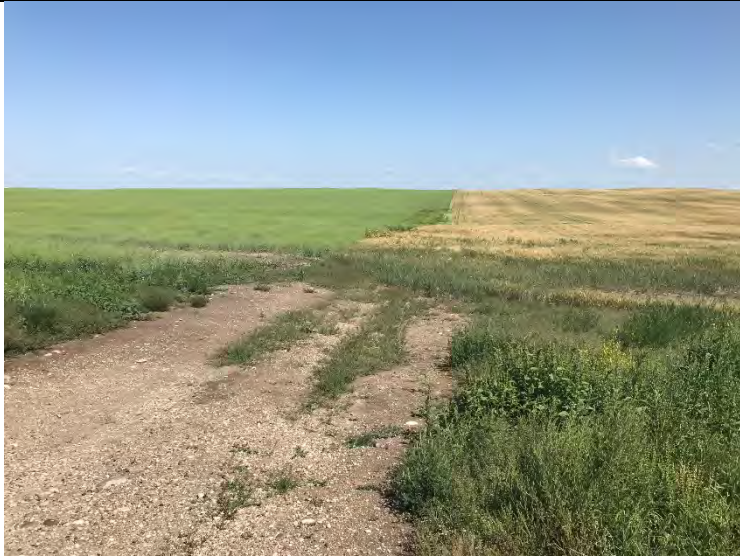
Observation Point: 684

Photo Description: ROW through canola field on left side of photo. Few weeds visible but otherwise crop growth was similar within and outside of ROW.

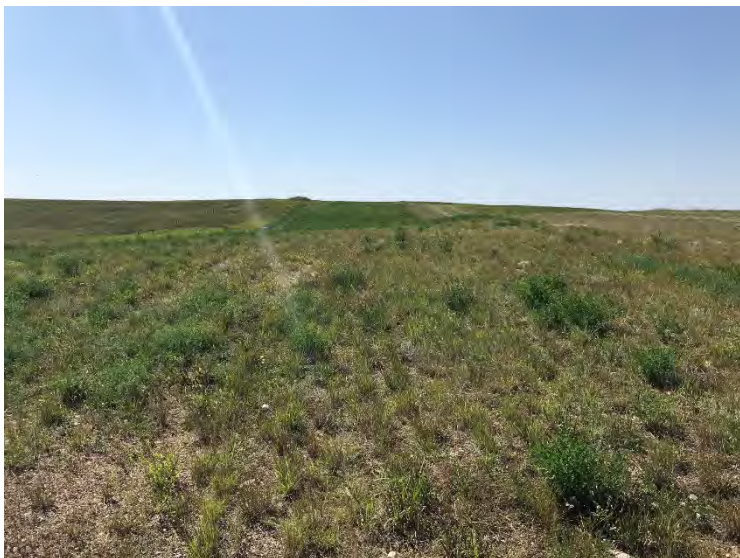
Observation Point: 686

Photo Description: Hayland of alfalfa and grass at 50-75% cover. Grasses included sideoats grama, western wheatgrass, and green needlegrass.
