November 30, 2015

Julie Prescott  
North Dakota Public Service Commission  
600 East Boulevard Avenue, Dept. 408  
Bismarck, ND 58505-0480

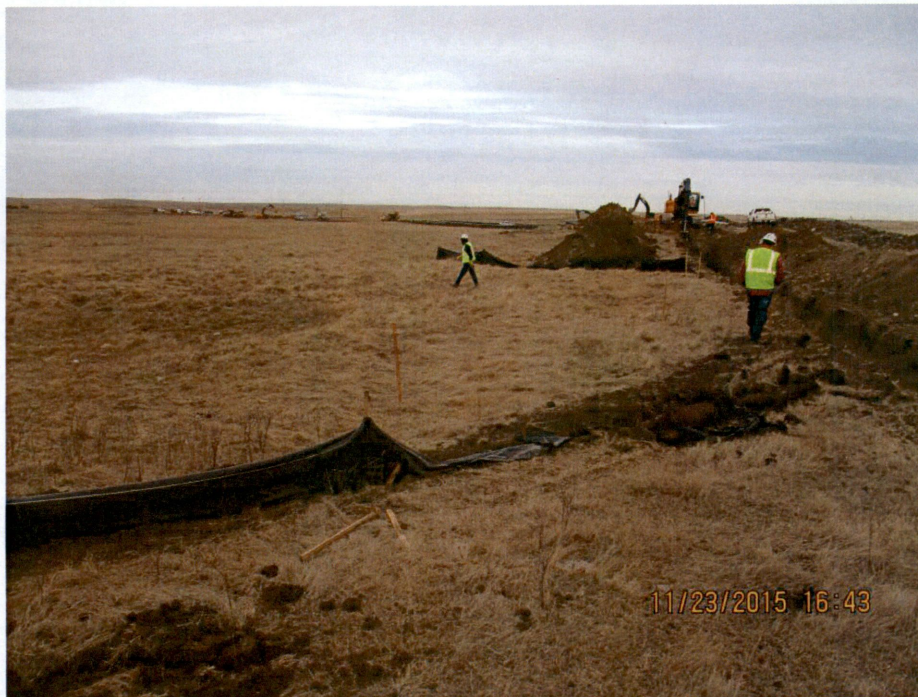
Figure 70. Photo of ditch construction along wetland boundary and silt fencing damaged. The Tomahawk maintenance crew was notified to repair the fence.
