Carlson McCain, Inc. (CMI) conducted an onsite inspection of the Vantage West Spur Lateral Pipeline Project (Case No. PU-15-142) on January 21, 2016, on behalf of the North Dakota Public Service Commission (PSC). The project consists of installing 47.8 miles of pipelines, which will connect the Stateline II Gas Processing Plant to the existing Vantage ethane pipeline system near Stady, North Dakota.

45 **PU-15-142** Filed: 1/25/2016 Pages: 6
Construction inspection report

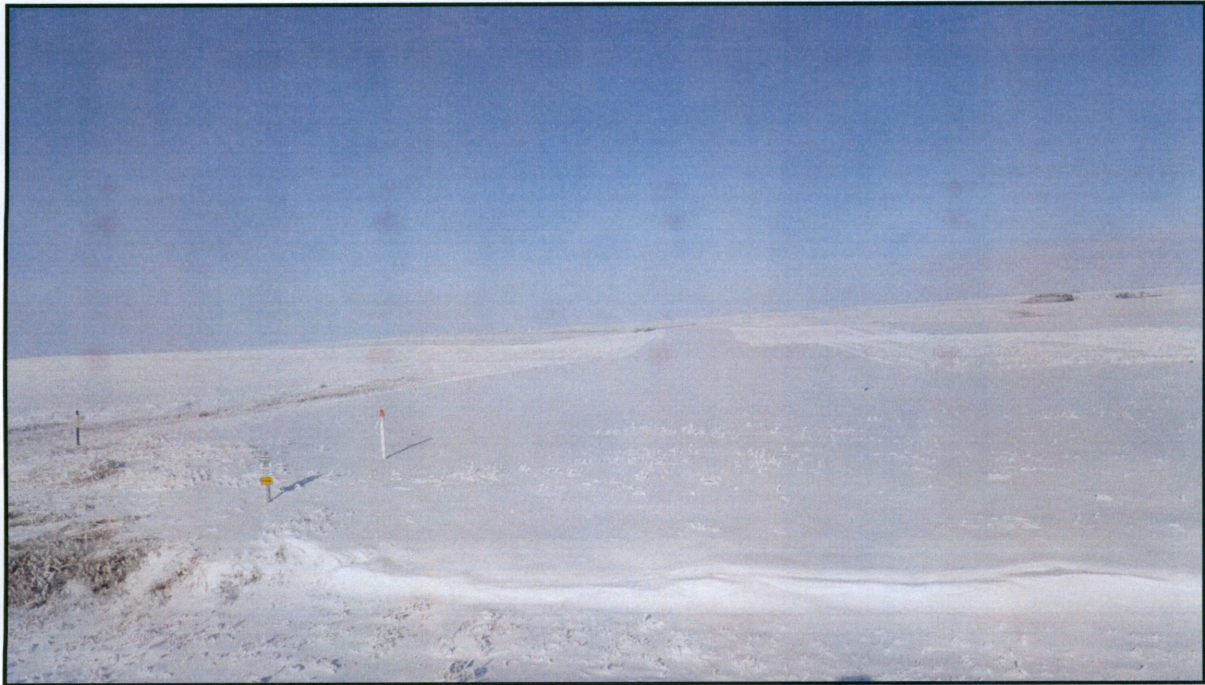
Figure 1. Photo taken of ROW looking north from 64th Street NW. Test lead for cathode protection and reclamation are visible.

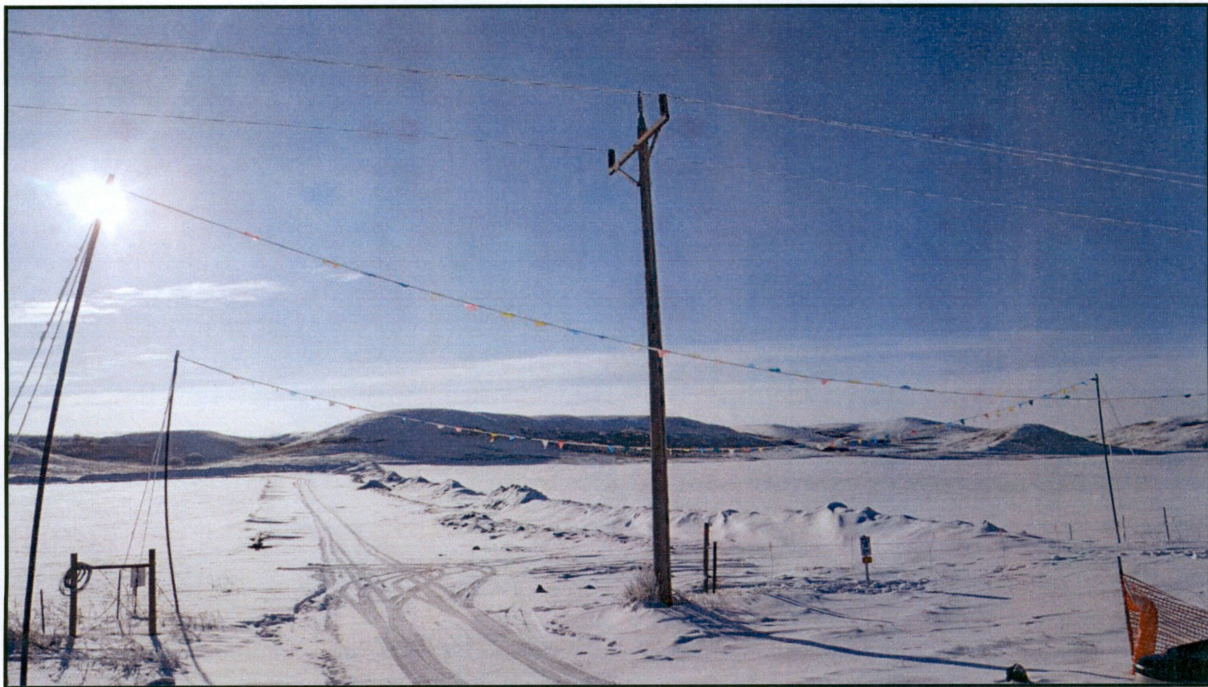
Figure 2. Overhead protection in place while working around the powerlines and preparing to bore under the road. Wooden matting was also installed for easier access onto the site.

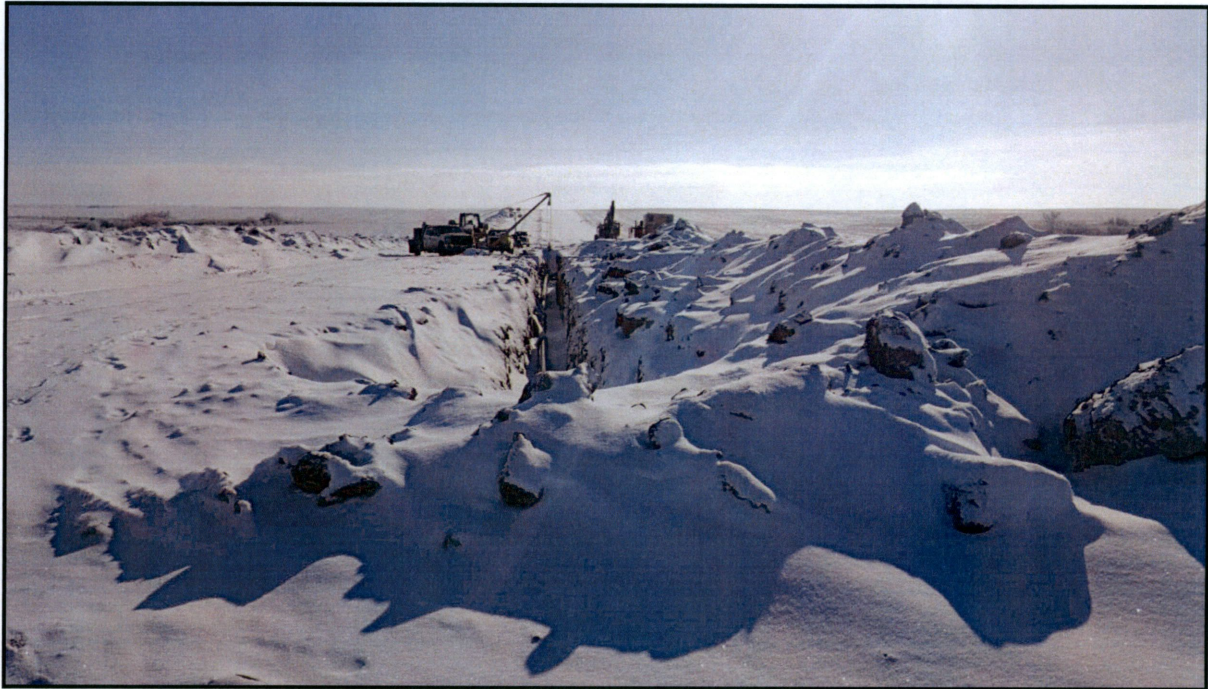
Figure 3. Beginning location for the pipeline's "pigging" process. The pipeline was pressurized and the "pig" was being sent north to the very end of the pipeline. Proper indicators and safety practices were in place.

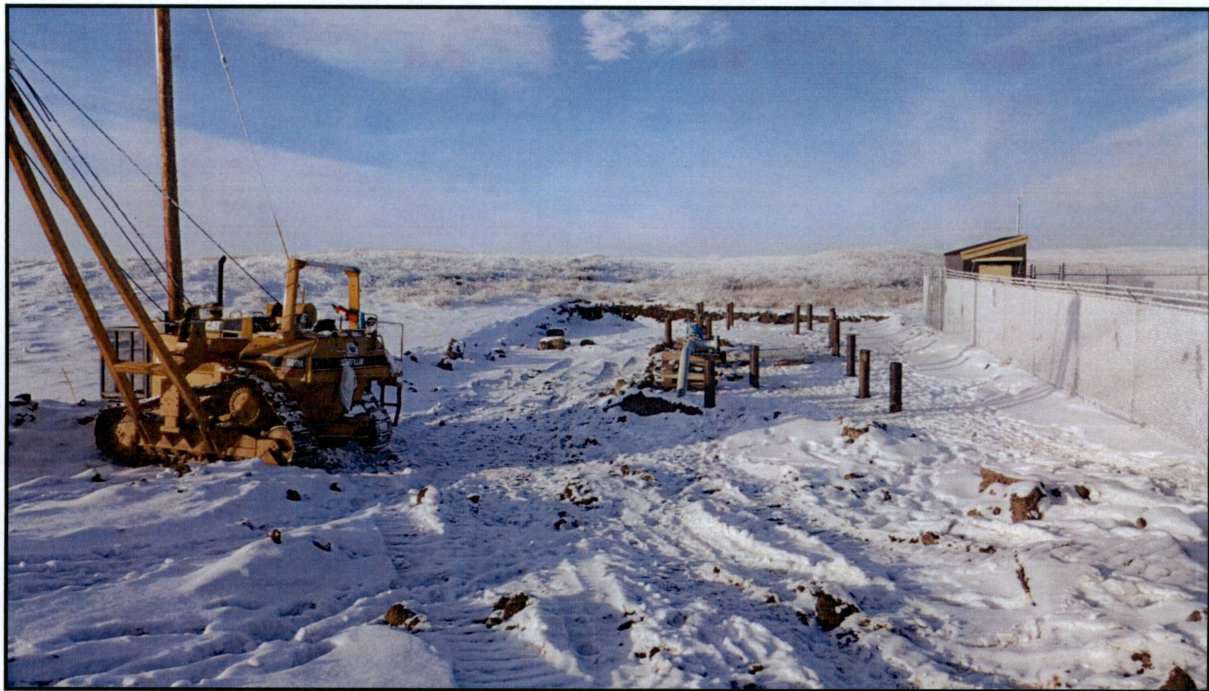
Figure 4. The northern end of the pipeline where the tie-in is located into the already existing Vantage pipeline. Also where the "pig" was being directed to for the pipeline's quality inspection. A monitor observing the process is always present.

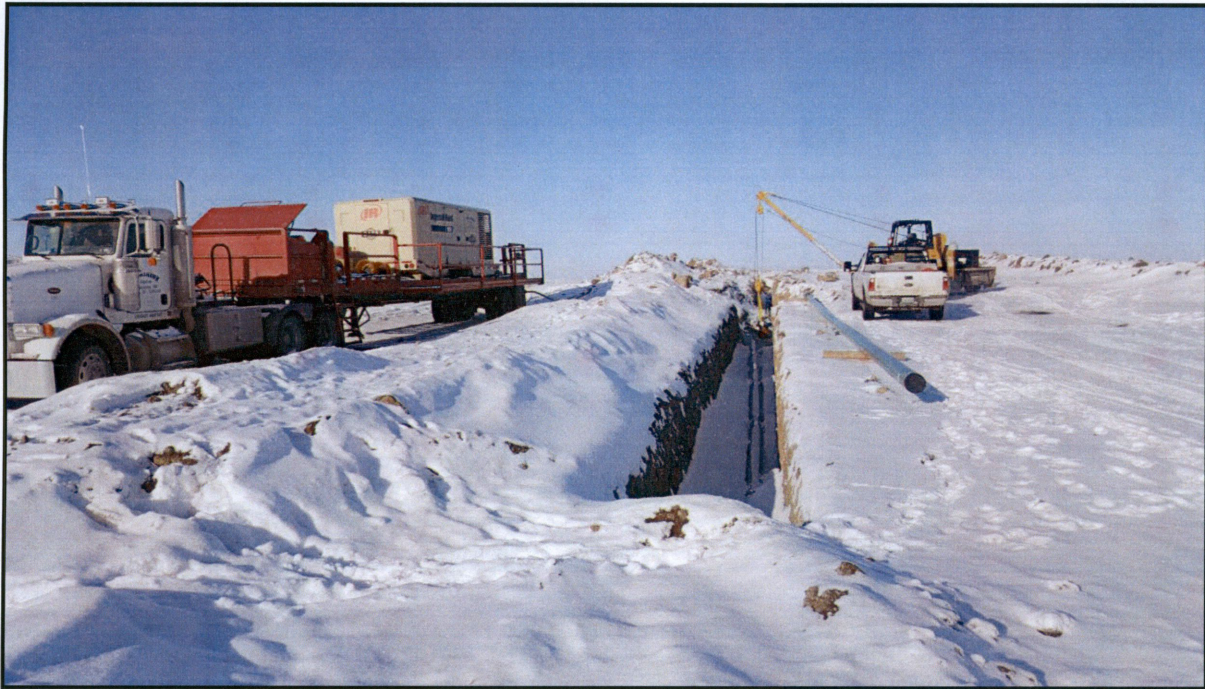
Figure 5. Open trench and compressor tank on the back of the truck where the pipeline inspection for the “pigging” process was being done.

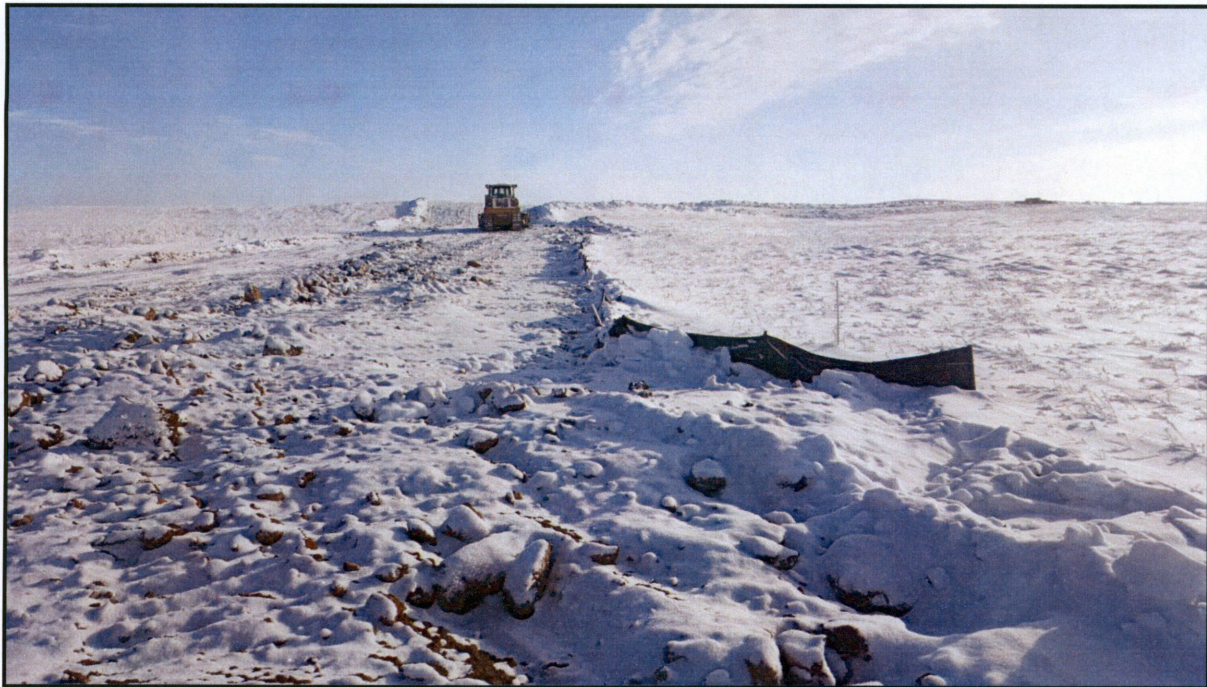
Figure 6. Installed silt fence that is in place separating the construction ROW from a small wetland. The silt fence is partially buried to prevent any soil from escaping underneath the silt fence into the wetland.

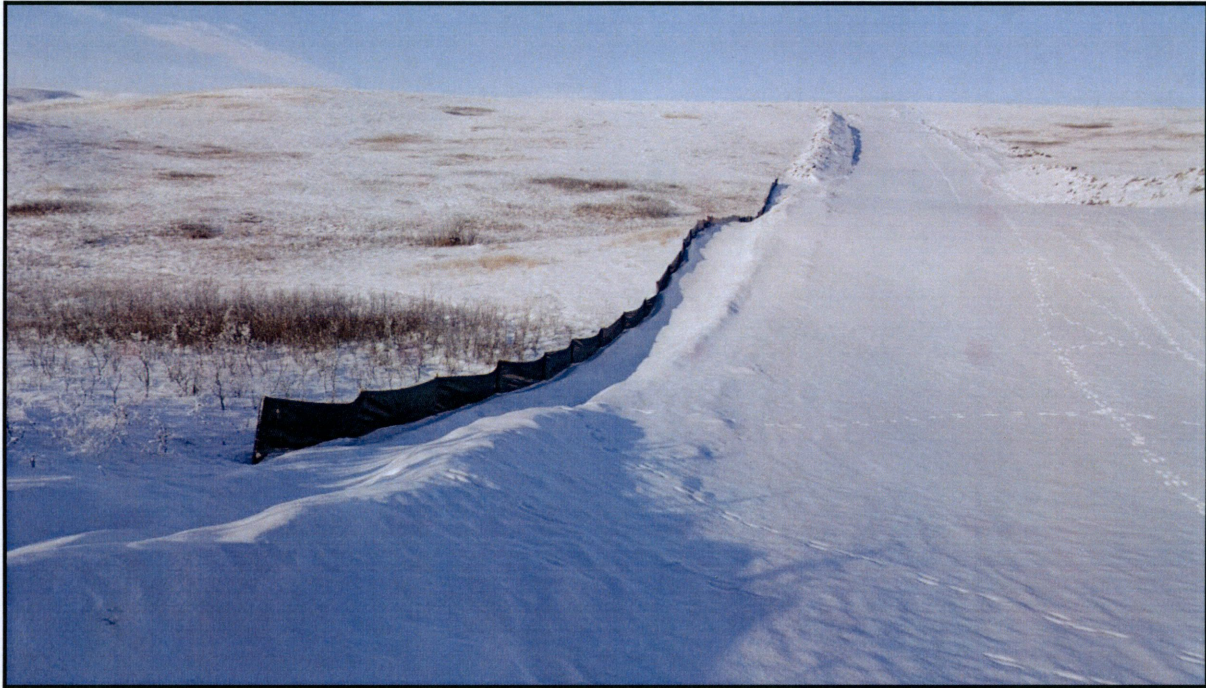
Figure 7. Silt fencing around the construction area to prevent soils from eroding off the ROW during the initial ground breaking activities and during spring snowmelt.

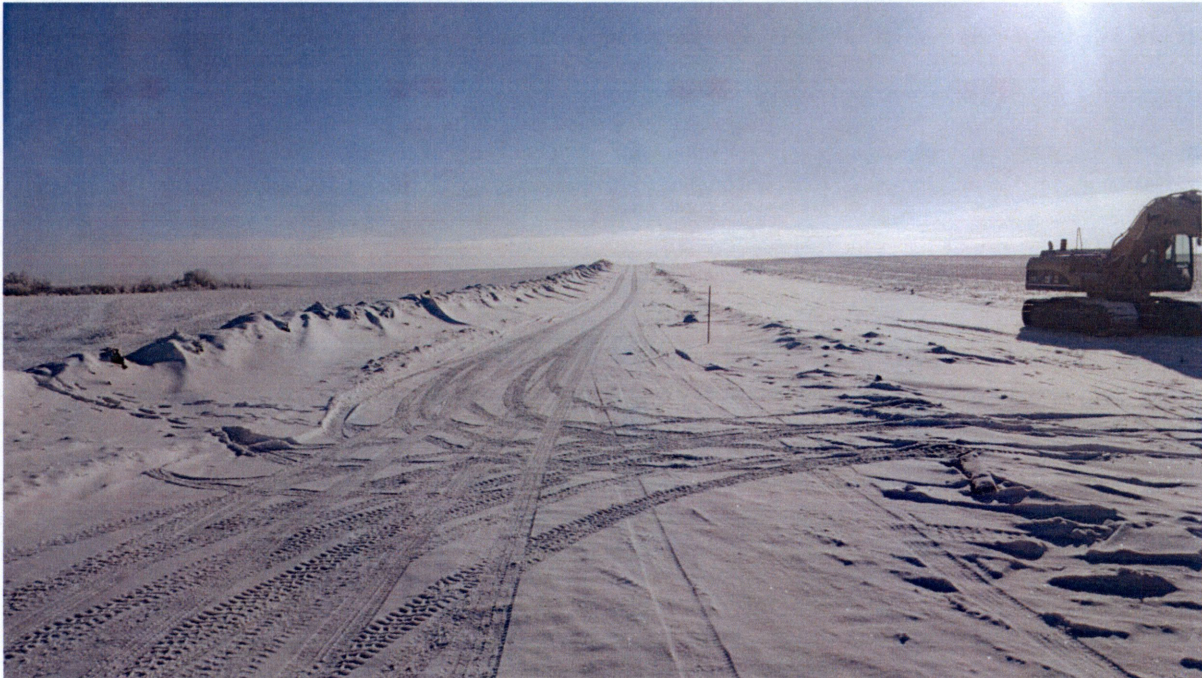
Figure 8. View of the travel route onto a construction site, the topsoil pile that is laid off to the side, and construction equipment that are all entirely found within the 100-ft wide ROW.
