NST EXPRESS, LLC

Permit Compliance Inspection Report #1

The North Dakota Public Services Commission has contracted with Houston Engineering, Inc. (HEI) to perform permit compliance inspection services for the NST Express, LLC project, (Case No. PU-15-232), a 12-inch crude oil pipeline spanning 23 miles in McKenzie County, North Dakota. This report documents the inspection compliance site visit, which was conducted on May 10, 2016. This site visit focused on observation of the topsoil separation activities.

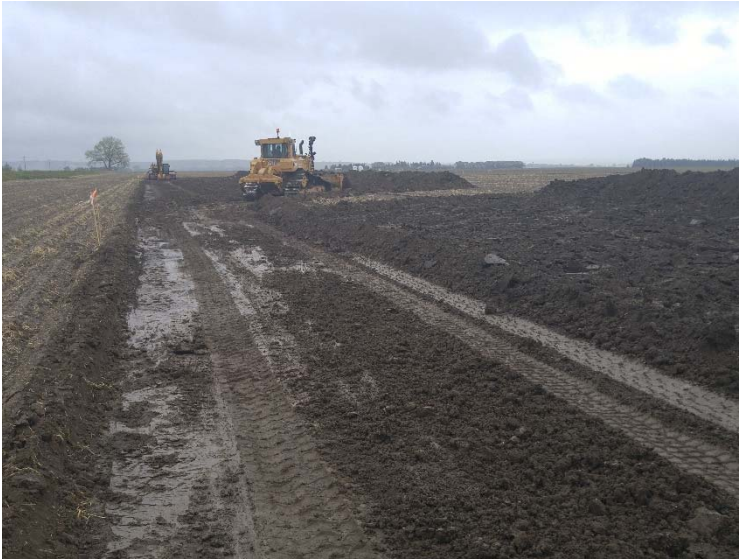
**Photo 1: Topsoil removed by
bull dozer, facing ESE.**

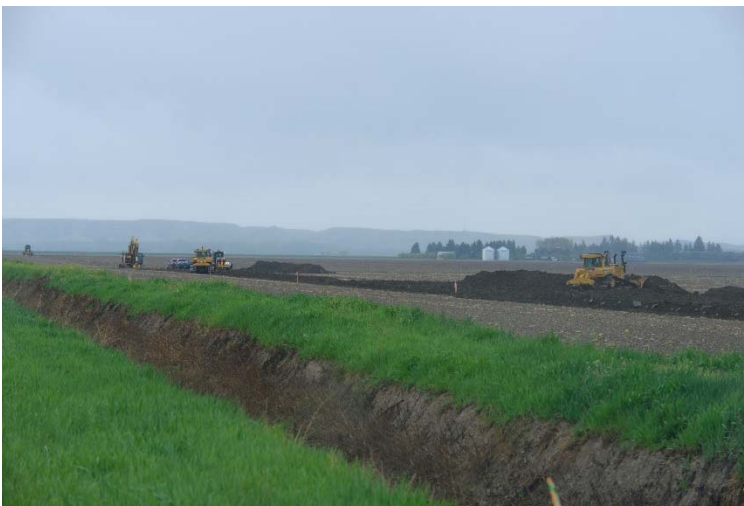
**Photo 2: Removal stages and
equipment. Facing SE.**

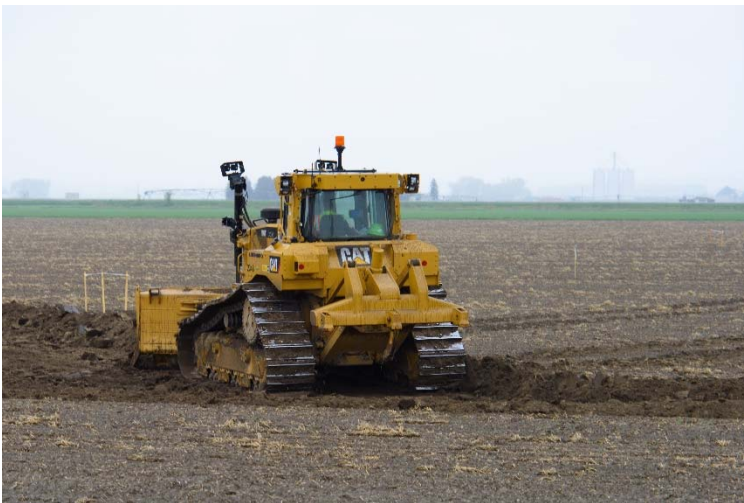
**Photo 3: Dozer and removal
depth. Facing south.**

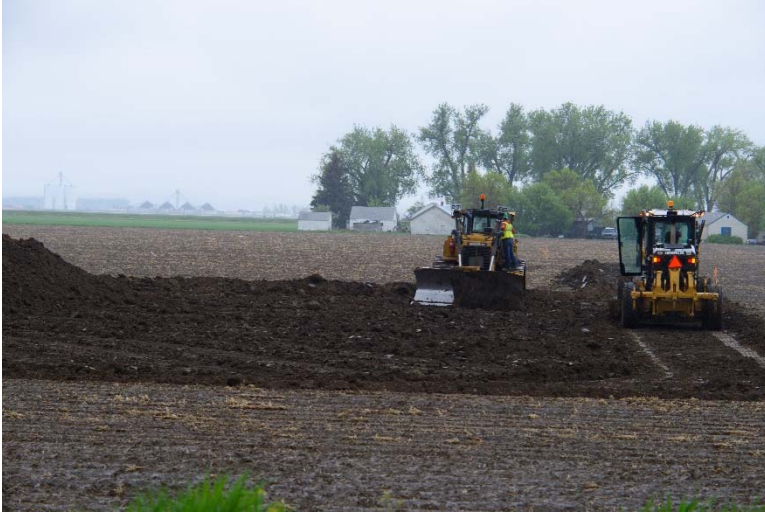
Photo 4: Dozer and blade removal. Facing south.

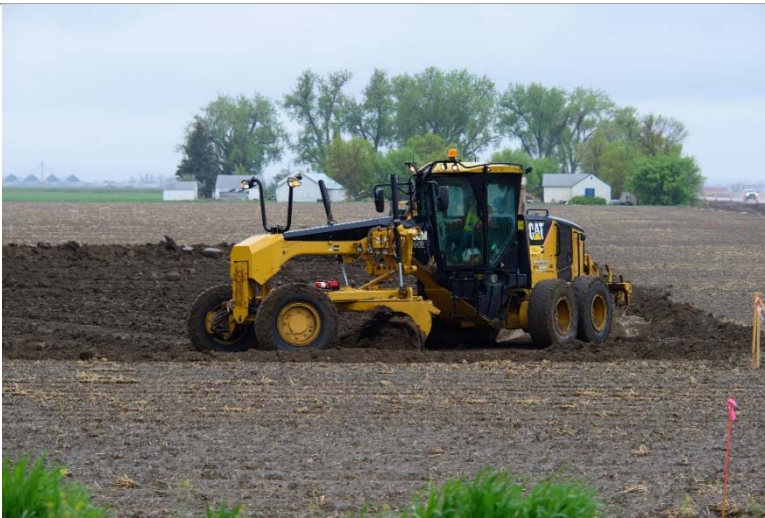
Photo 5: Grader removal depth, Facing south.

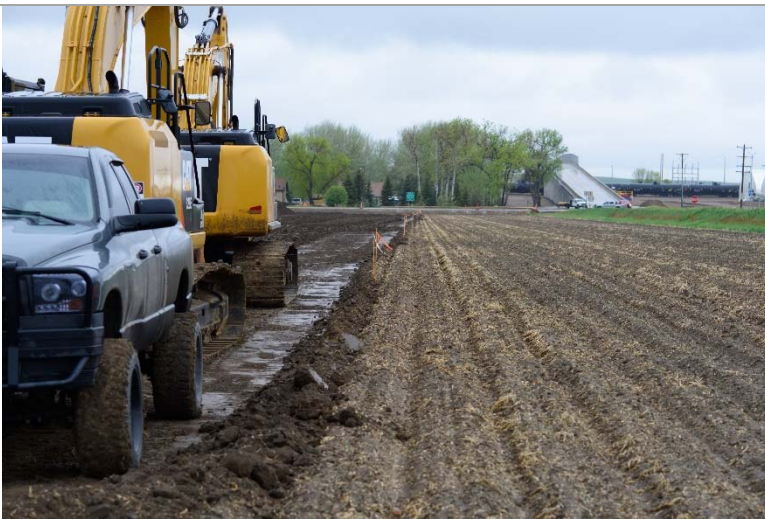
Photo 6: Removal northern extents. Facing west.
