NST EXPRESS, LLC

Permit Compliance Inspection Report #3

NDPSC CASE NO. PU-15-232

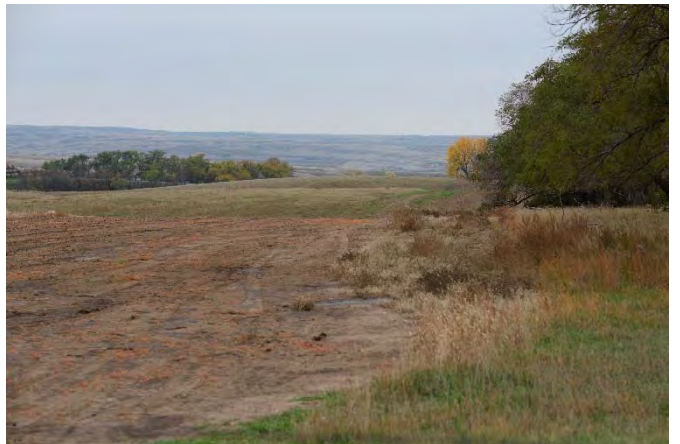
Photo 4: Reclamation facing south. Wetland avoidance to the west.

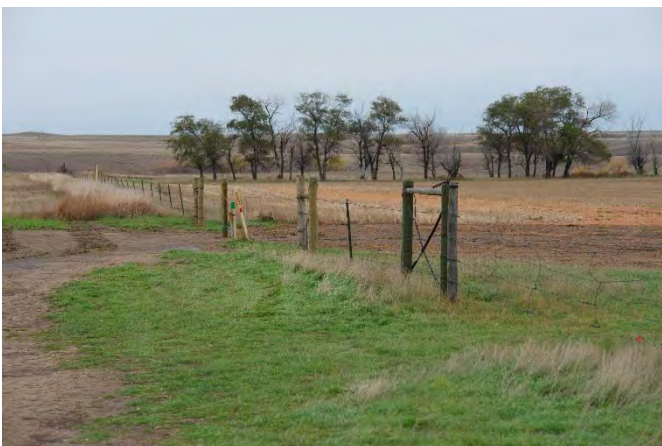
- An excavation footprint was observed through a wetland area (**Photo 10**). The area had recently been seeded, yet no germination had been observable at this time. The location of this area is presented in the attached site visit and photo location map (**Exhibit 1**). This area will be revisited in a year to observe the revegetation efforts.
- A replacement fence was observed (**Photo 5**), and is in the same or better condition than the existing fence.

Photo 5: Fence repair facing east.

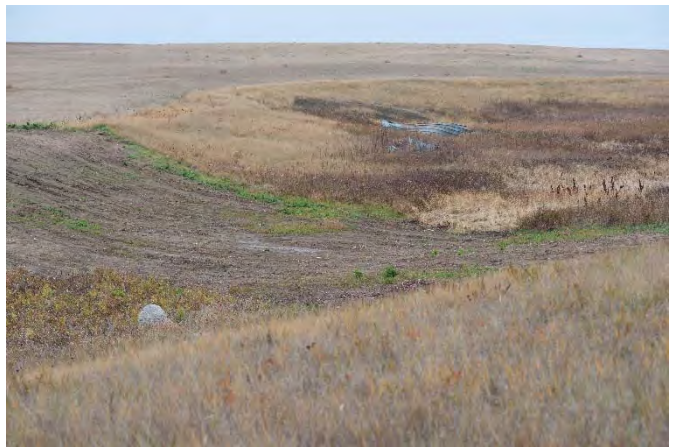
Photo 10: Wetland reclamation facing northwest.

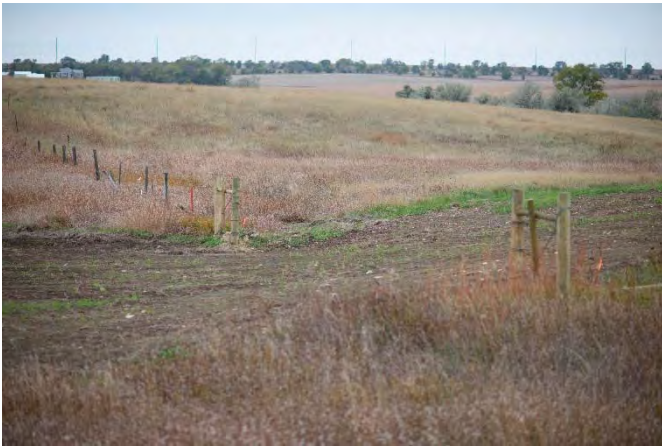
Photo 13: Fence repair facing northwest

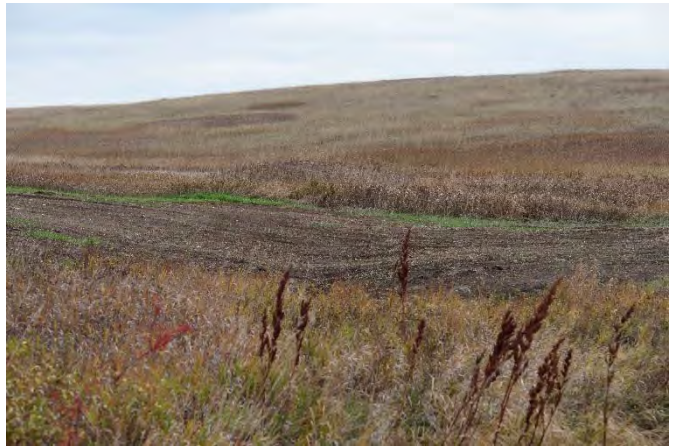
Photo 28: Wetland reclamation facing north.
