NST EXPRESS, LLC

Permit Compliance Inspection Report #4

NDPSC CASE NO. PU-15-232

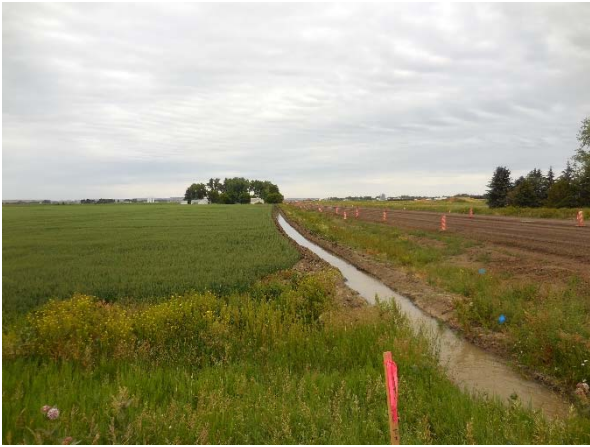
Photo 1: Corridor facing south near Highway 58, on far west side of project.

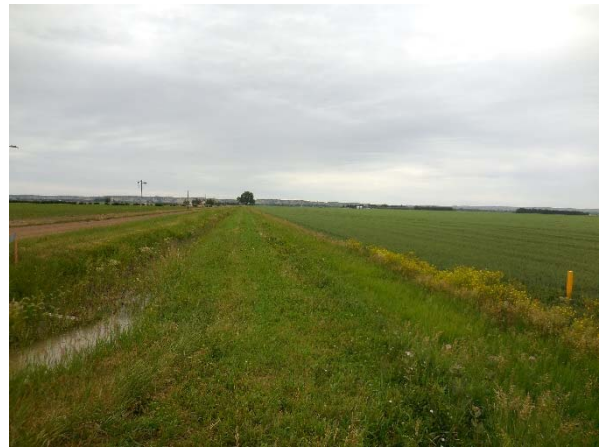
Photo 2/3: Pipeline corridor facing east, at 32nd Street NW, near far west side of project.

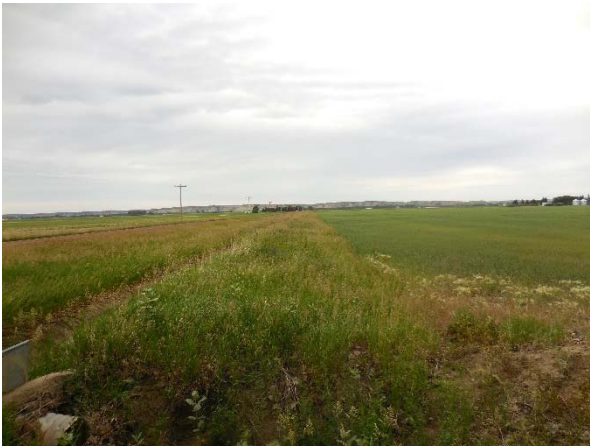
Photo 4: Pipeline corridor facing east near a wetland. Parallel to 32nd Street NE.

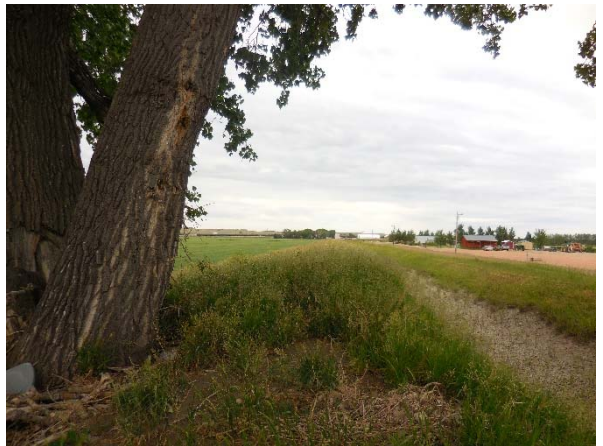
Photo 5: Corridor facing west. Parallel to 32nd Street NE.

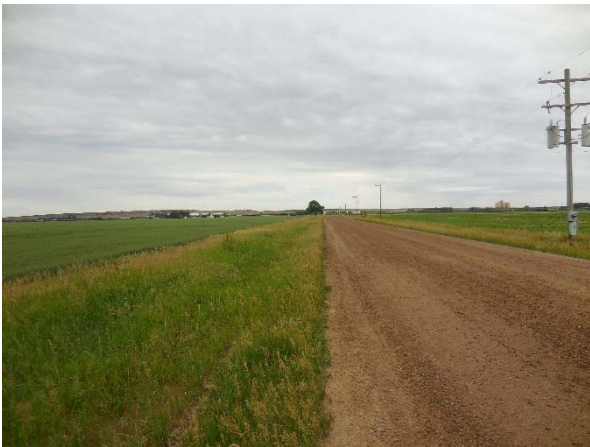
Photo 6/7: Pipeline corridor facing west along 32nd Street NW.

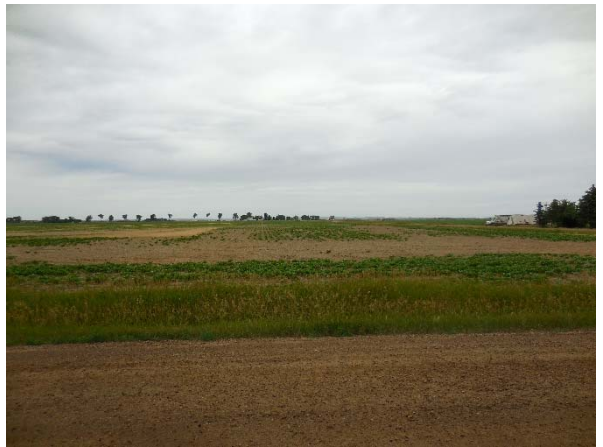
Photo 8: Pipeline corridor facing north and northeast, perpendicular to 32nd Street NW.

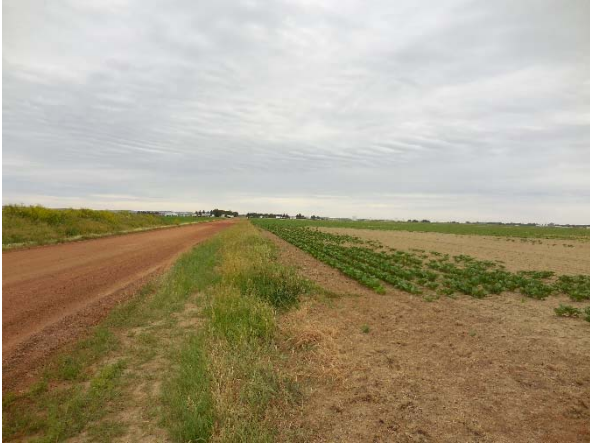
Photo 9: Corridor facing south parallel to 160th Avenue NW.

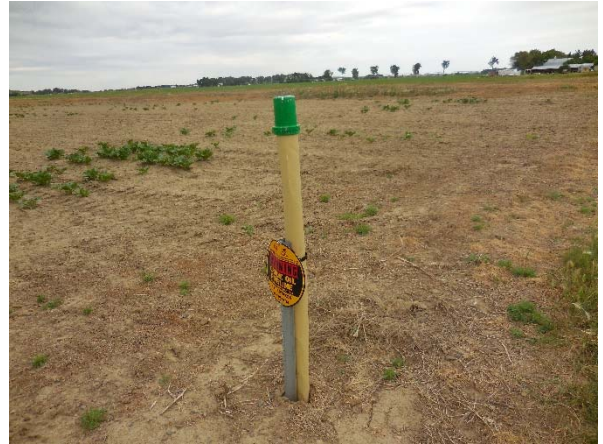
Photo 10/11: Pipeline signage at 160th Avenue NW.

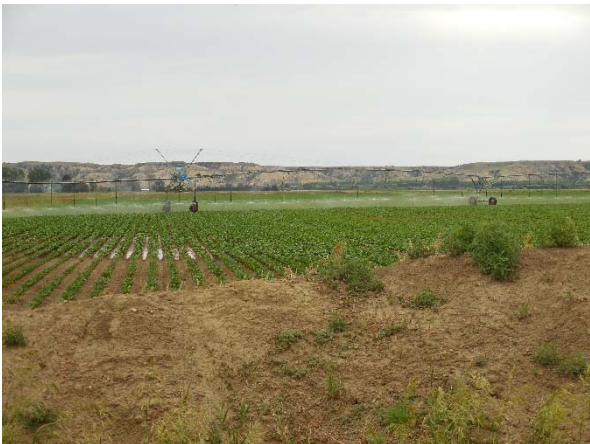
Photo 12/13: Pipeline corridor in foreground, facing southwest.

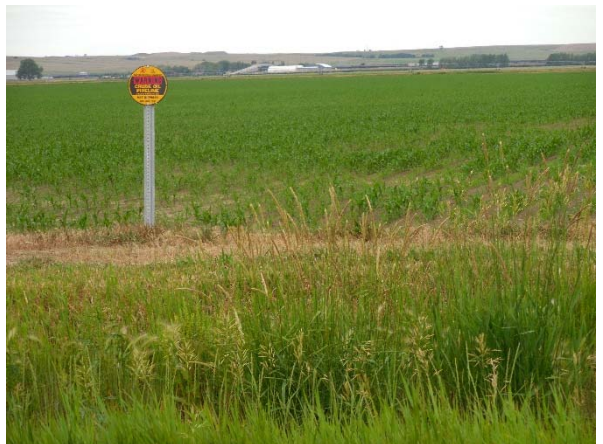
Photo 14: Pipeline corridor and signage facing west at 159th Avenue NW.

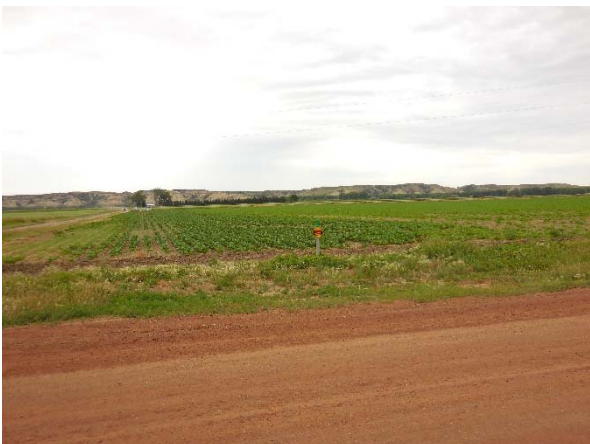
Photo 15: Pipeline corridor and signage facing east and 159th Avenue NW.

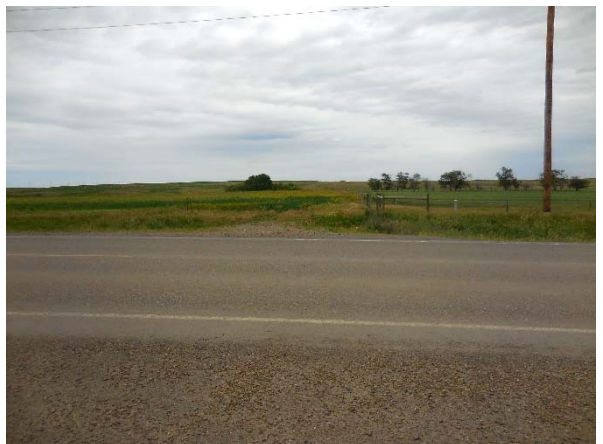
Photo 19: Pipeline corridor facing east at 33rd Street NW.

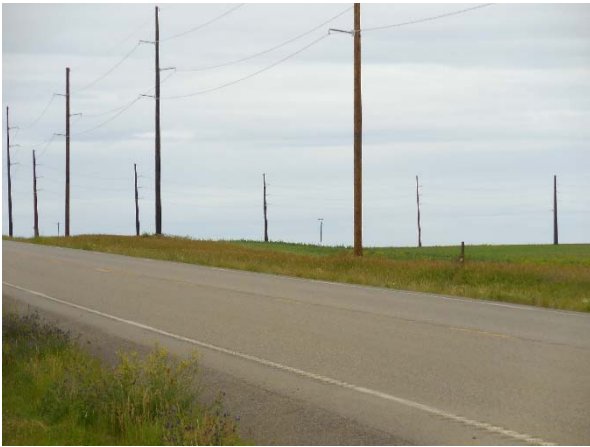
Photo 20: Pipeline corridor on the east side of Highway 16.

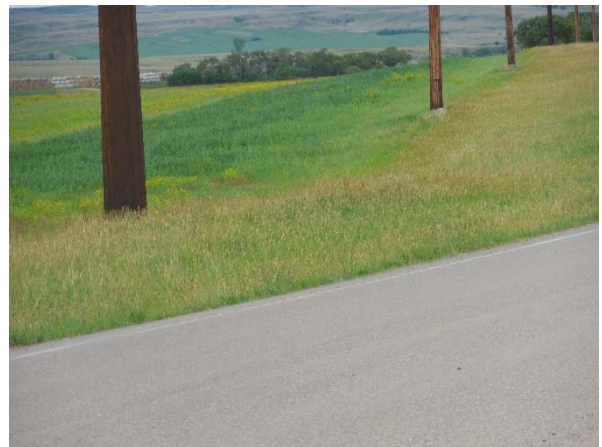
Photo 21: Pipeline corridor restoration area from Highway 16, facing south southeast.

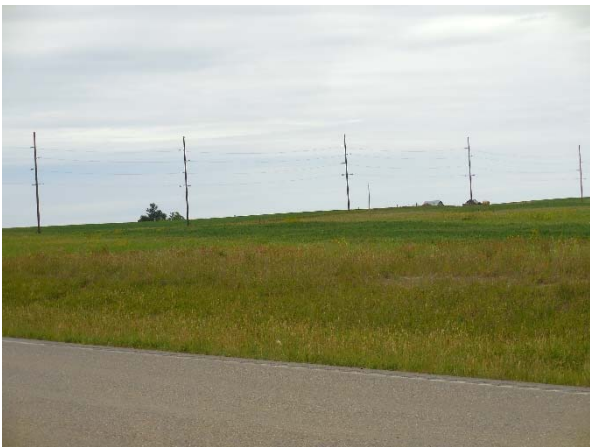
Photo 22: Pipeline corridor facing northeast parallel to Highway 16. Note the dominance of cultivated land.

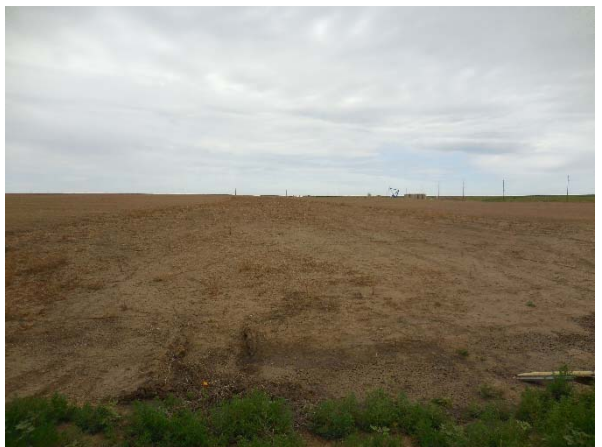
Photo 23: Pipeline corridor facing west at 154th Avenue NW. Bare land is present here, however these lands are intended for cultivation, so no seeding is necessary here.

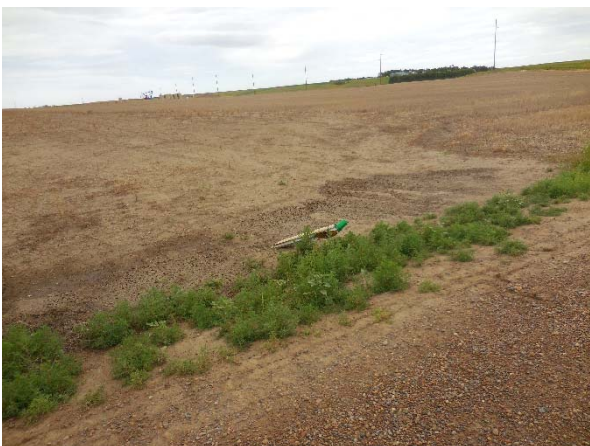
Photo 24: Pipeline signage in need of repair. At 154th Avenue NW, facing east.

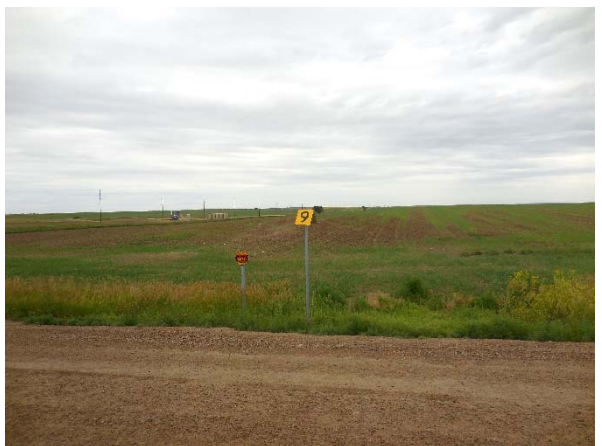
Photo 25: Corridor and signage facing east over recently planted agriculture land.

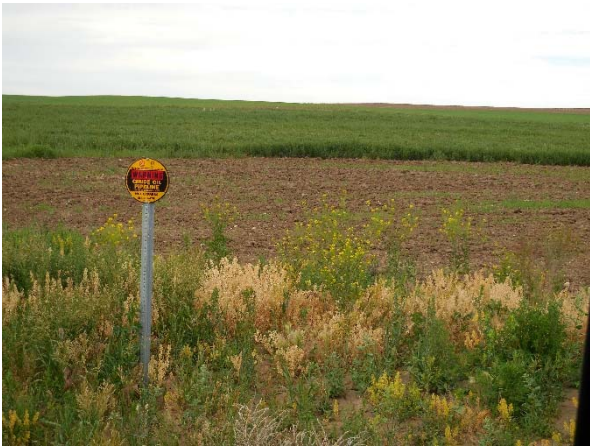
Photo 27: Corridor and signage facing southwest at 34th Street NW. Recent grading is observed in the foreground.

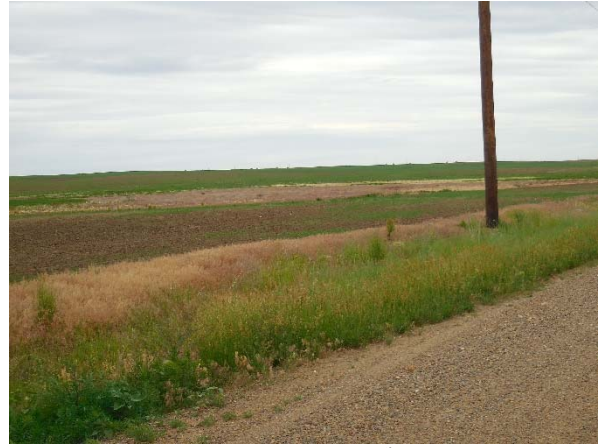
Photo 29: Pipeline corridor from 34th Street NW, facing east northeast. Grading footprint is visible.

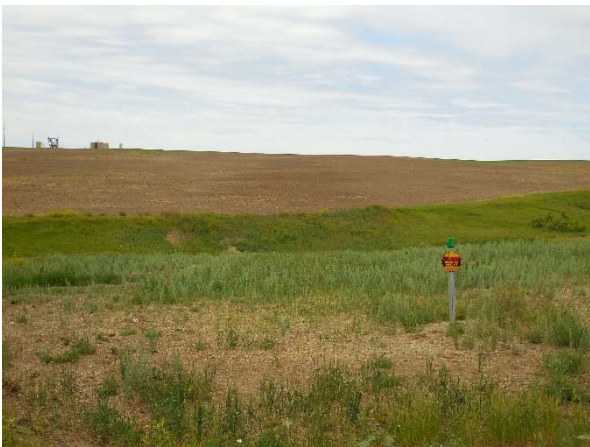
Photo 30: Pipeline corridor near 152nd Avenue NW, near intermittent stream. Facing west.

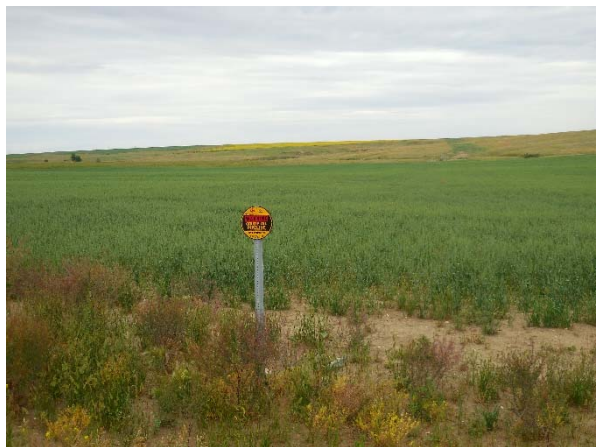
Photo 31: Pipeline corridor and signage near 152nd Avenue NW, facing east.

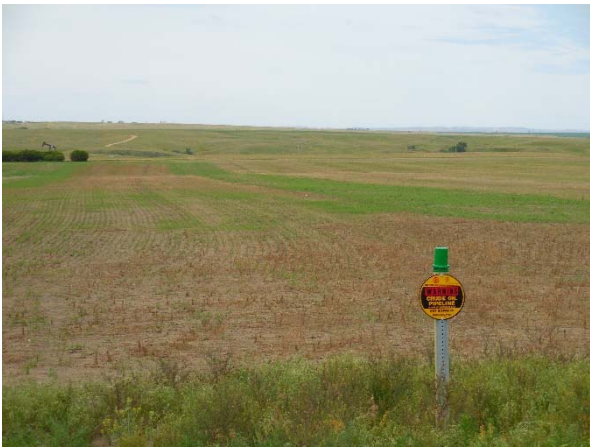
Photo 32: Pipeline corridor and signage facing west at 149th Avenue NW. Note recent agricultural tilling and planting.

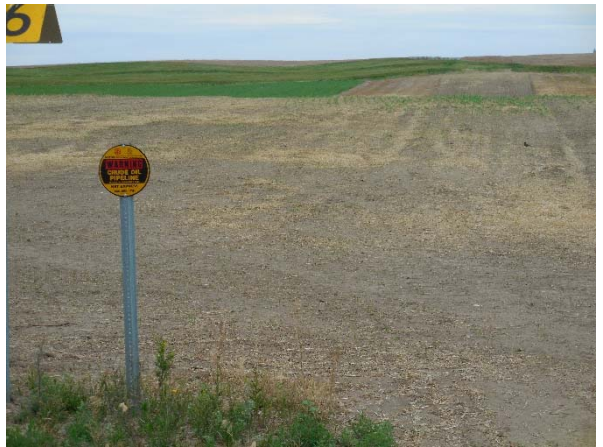
Photo 33: Pipeline corridor at 149th Avenue NW, facing east. Note recent tilling.

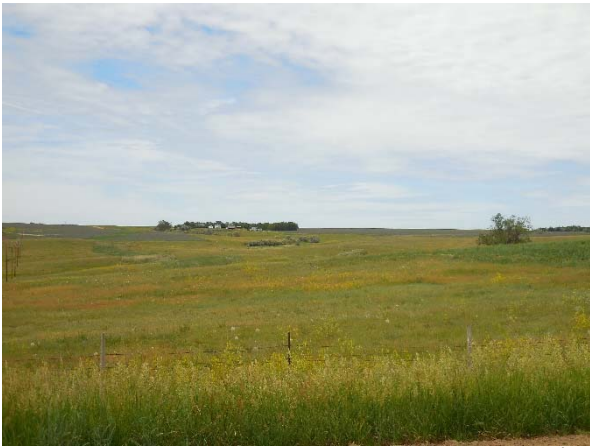
Photo 34: Pipeline corridor over range land at 149th Avenue NW, facing west. Corridor footprint is visible as the linear green path through the photo.

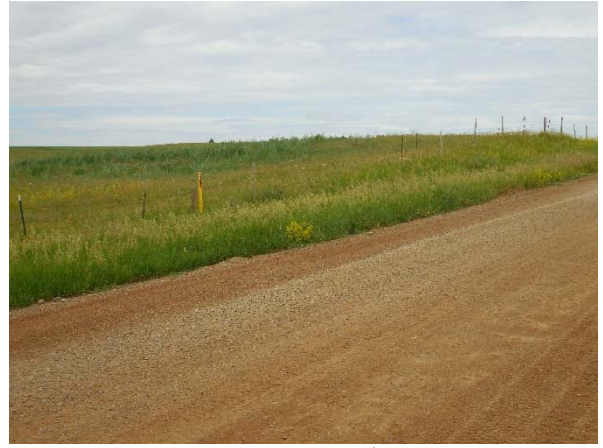
Photo 35: Pipeline corridor at 146th Avenue NW, facing north northwest.

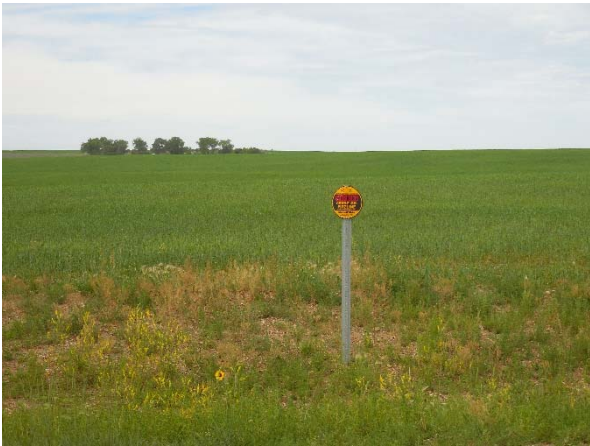
Photo 38: Pipeline corridor and signage at 146th Avenue NW, facing west.

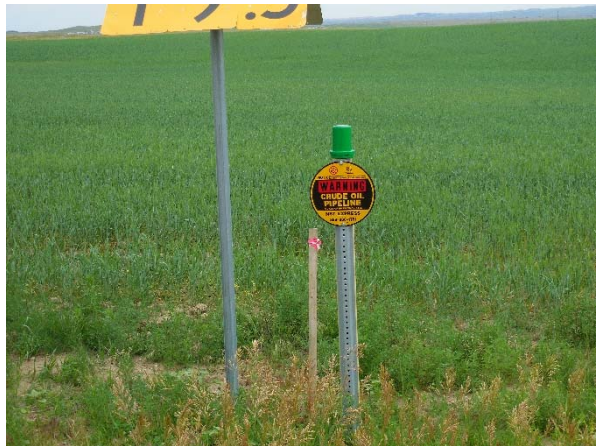
Photo 39: Pipeline corridor at 146th Avenue NW, facing east.

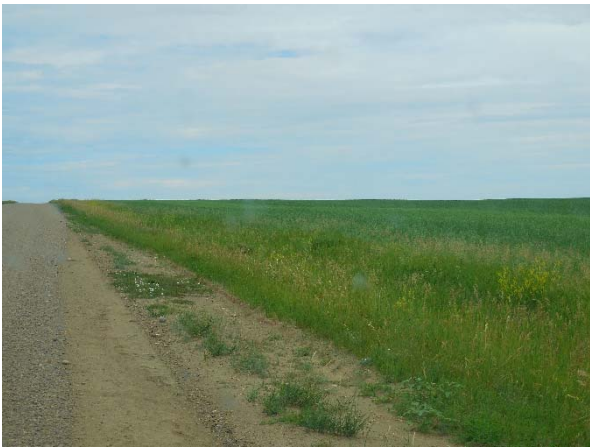
Photo 40: Pipeline corridor parallel to 146th Avenue NW, facing north.

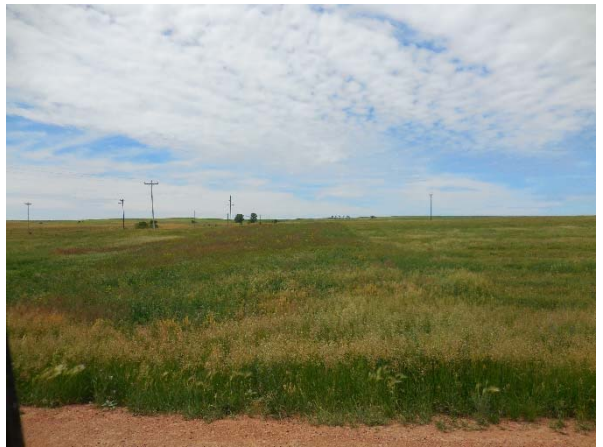
Photo 41/42: Pipeline corridor at 145th Avenue NW, facing east over range land. Pipeline footprint visible at the right side of photo.
