Hiland Partners
Holdings LLC
a Kinder Morgan company

RE: Hiland Crude, LLC.
New Town Expansion Project- Mountrail County
Post Construction Inspection Reclamation Report
Case No. PU-15-416

Attachment A
PU-15-416 New Town Expansion Project
Reclamation Photos taken May 22, 2017

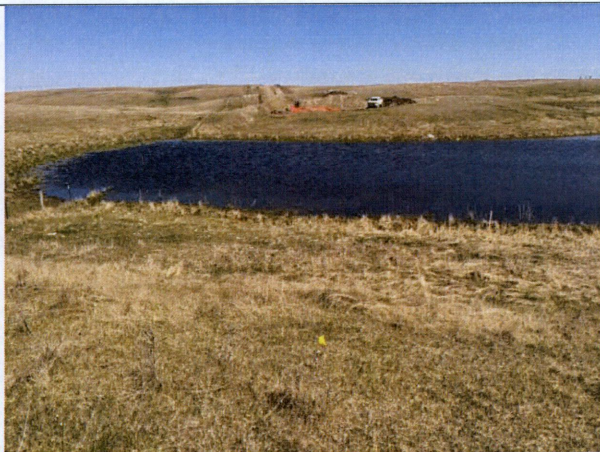
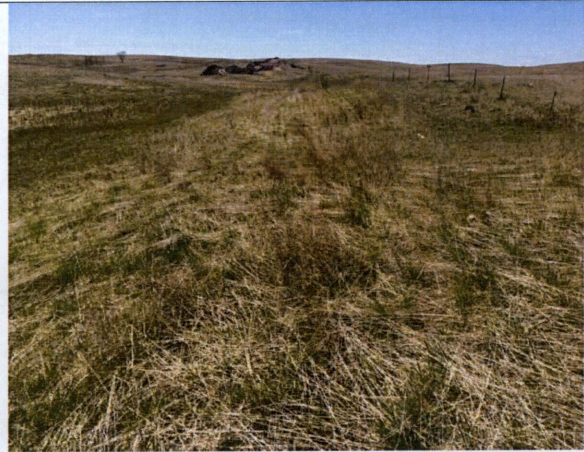
Station 625- This site was identified as Picture 37 by the Public Service Commission. Aerial interpretation of this site determined that the picture was taken approximately 7,000 feet south of the location identified in the KLJ report, where no Hiland pipeline is present. The location of the picture, using GPS coordinates on the photo caption; indicate that the photo was taken along the New Town pipeline route. Active construction is currently in progress at this location for another pipeline project. However this area was minimally disturbed during this construction and still contains sufficient vegetative cover. Photos 1 and 2 show the current state of the pipeline corridor. Hiland believes that this site has been adequately reclaimed and is not proposing any work at this site.

Photo 1- Site 37 current status

Photo 2- Site 37 Current status

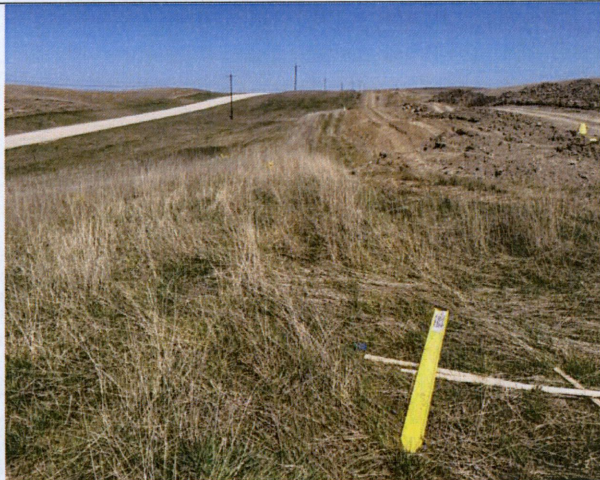
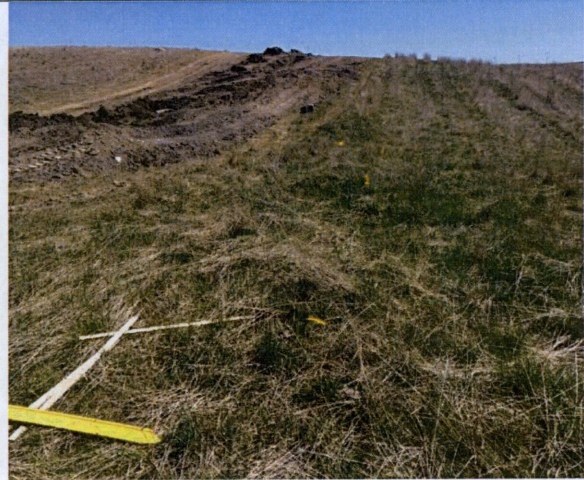
Station 635- This site was identified as picture 75 by the Public Service Commission. Aerial interpretation of this site determined that the picture was taken approximately 89,000 feet west of the location identified in the KLJ report. The location of the picture, using GPS coordinates on the photo caption; indicate that the photo was taken along the New Town pipeline route. Active construction is currently in progress at this location for another pipeline project. However this area was minimally disturbed during this

construction and still contains sufficient vegetative cover. Photos 3 and 4 show the current state of the pipeline corridor. Hiland believes that this site has been adequately reclaimed and is not proposing any work at this site.

Photo 3- Site 75 (pipeline on left side of active construction)

Photo 4- Site 75 (pipeline on right side of active construction)

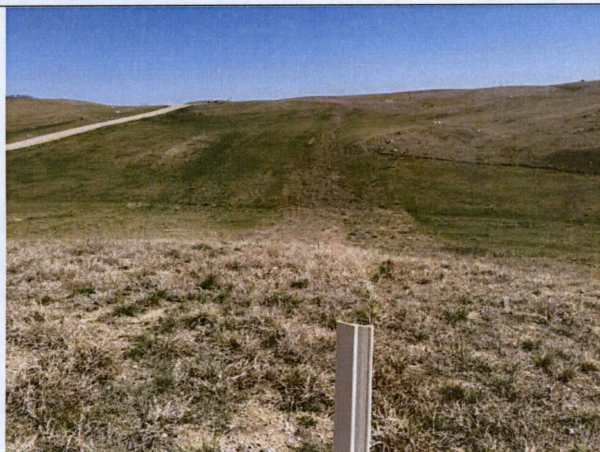
Site 62- Hiland performed visual field observations on this site and indicated that the pipeline corridor was establishing however had not reach a sufficient vegetation cover. Hiland performed reseeding activities at this location. Photograph 5 shows the pre-reclamation status of the ROW. Photo 7 shows the re-seeding activities. A copy of the seed ticket is located in Appendix B. The location of the picture in the KLJ Report, using GPS coordinates on the photo caption; indicate that the photo was taken along the New Town pipeline route. However KLJ shows the location of the picture 35,000 feet north of the gps coordinates on the photo caption.

Photo 5- Site 62 (Pre-Reclamation)

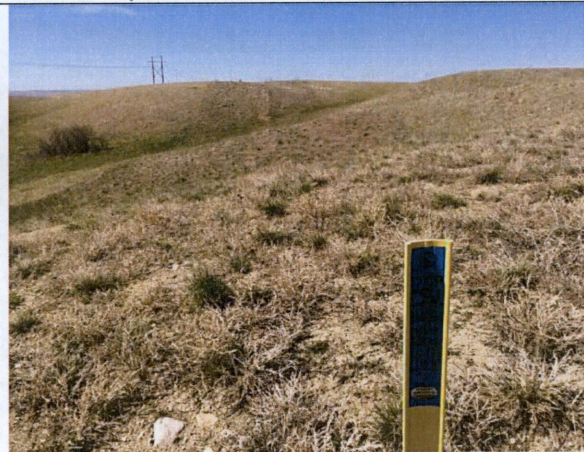
Site 65- Hiland performed visual field observations on this site and indicated that the pipeline corridor was establishing however had not reach a sufficient vegetation cover. Hiland performed reseeding activities at this location. Photograph 6 shows the pre-reclamation status of the ROW. Photo 8 shows the re-seeding activities. A copy of the seed ticket is located in Appendix B. The location of the picture in the KLJ Report, using GPS coordinates on the photo caption; indicate that the photo was taken along the New Town pipeline route. However KLJ shows the location of the picture 2,275 feet north of the gps coordinates on the photo caption.

Photo 6- Site 65 (Pre-Reclamation)

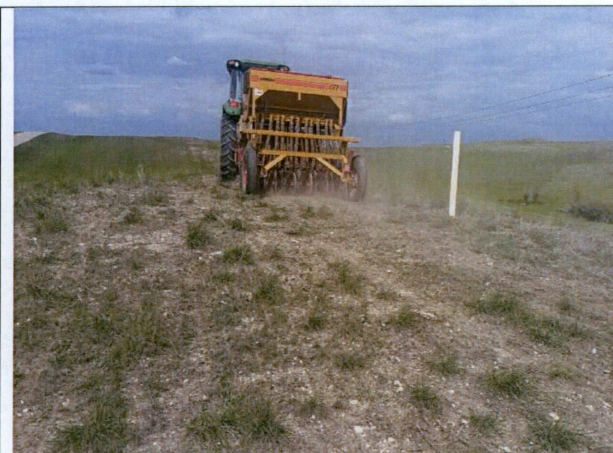
Photo 7- Site 62 (Post- Reclamation)

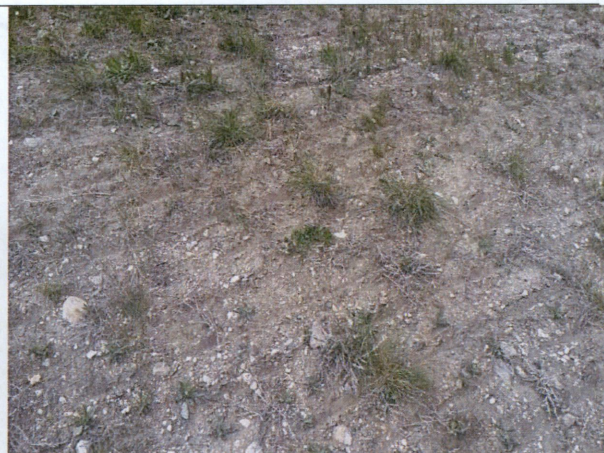
Photo 8-Site 65 (Post-Reclamation)

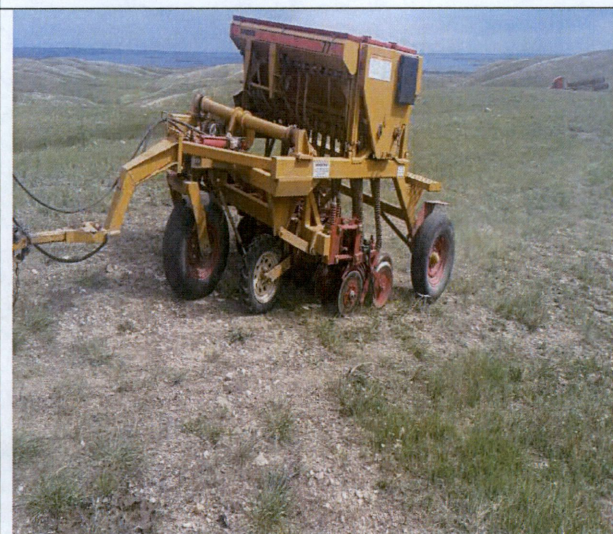
Photo 9- Seeder utilized for post-reclamation

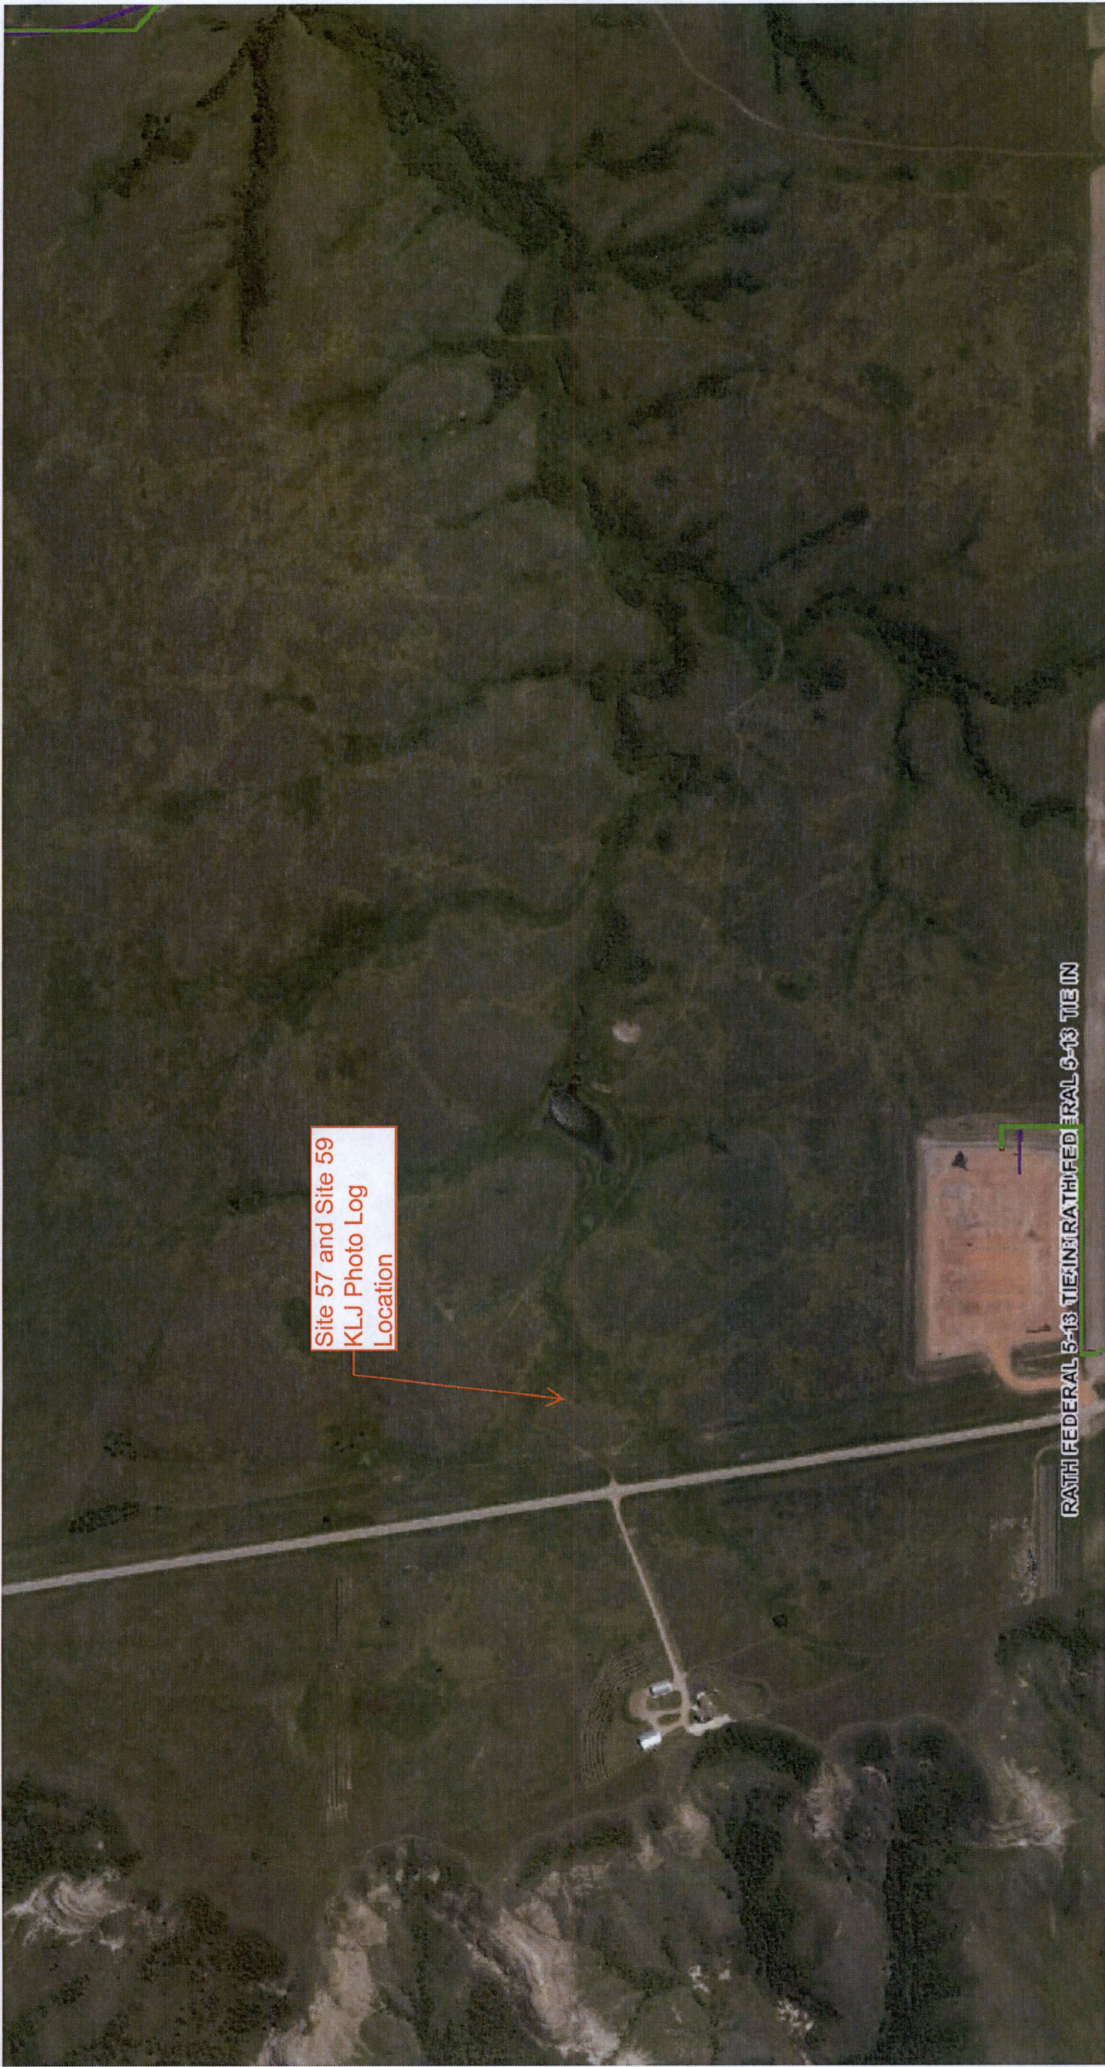
Site 57 and Site 59
KLJ Photo Log
Location

Site 57- Hiland does not believe that this site is located along the New Town Pipeline route. A figure showing this location and the absence of the New Town Pipeline is included in Appendix B. Hiland is not proposing any reclamation activities at this site.

Site 59- Hiland does not believe that this site is located along the New Town Pipeline route. A figure showing this location and the absence of the New Town Pipeline is included in Appendix B. Hiland is not proposing any reclamation activities at this site.
