# Hiland Crude, LLC.

## Reclamation and Revegetation Inspection Report

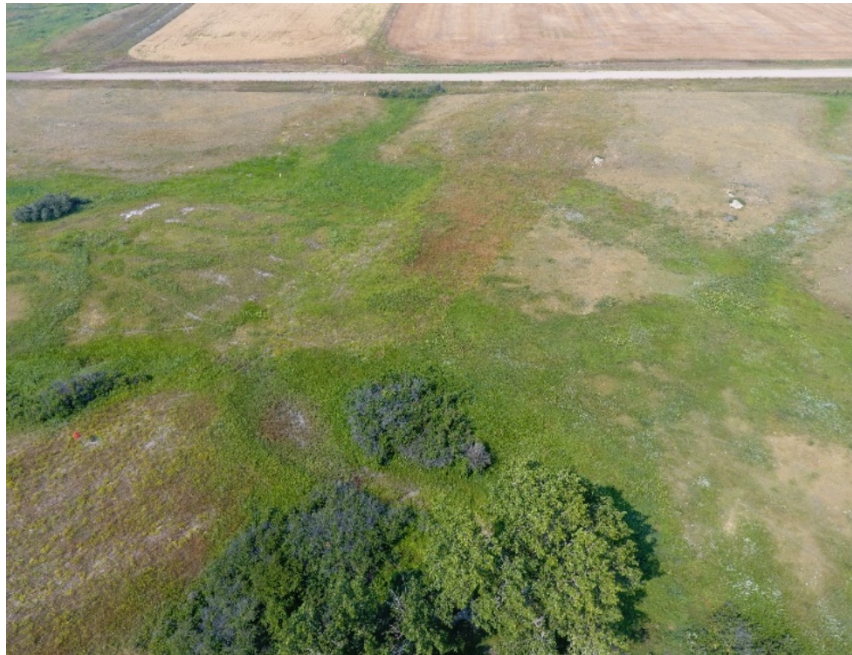
*Location 7, looking North (48.00573, -102.433693)  
Vegetation being established close to surrounding conditions*

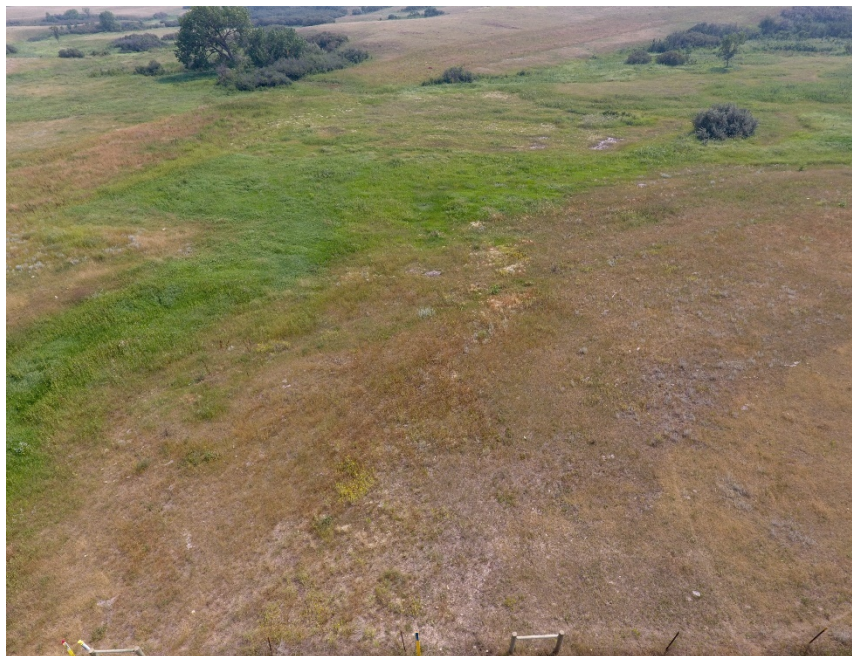
*Location 8, looking South (48.007252, -102.434273)*

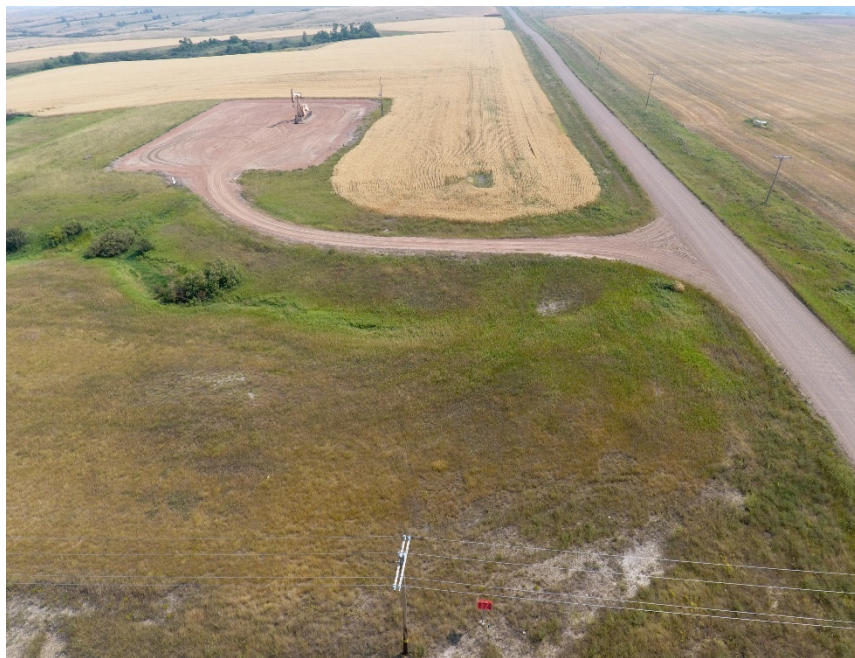
*Location 14, looking South (48.023304, -102.465897)  
Vegetation well established to adjacent conditions*

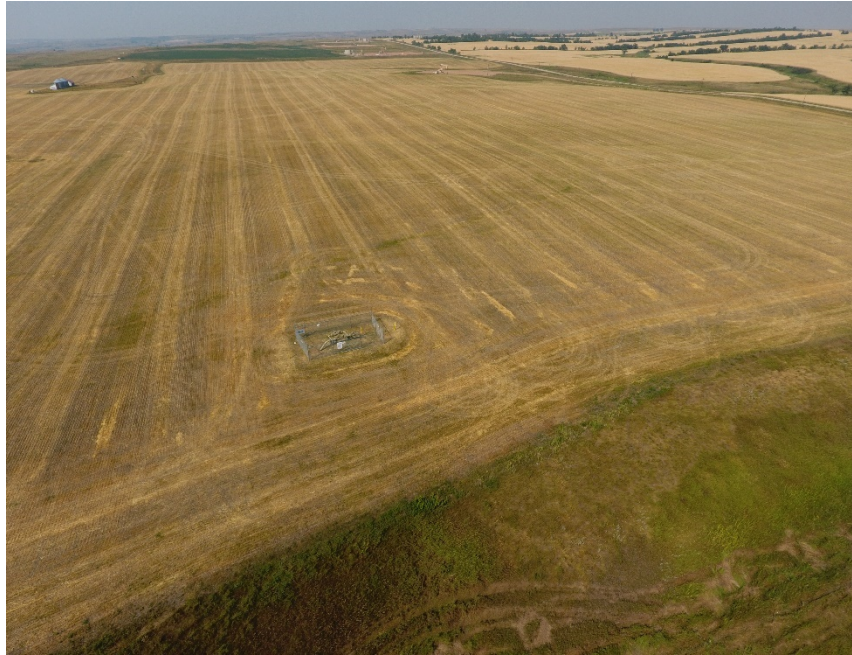
*Location 15, looking North (48.0233, -102.465897)  
Pipeline turns to the Right (East) at valve location*

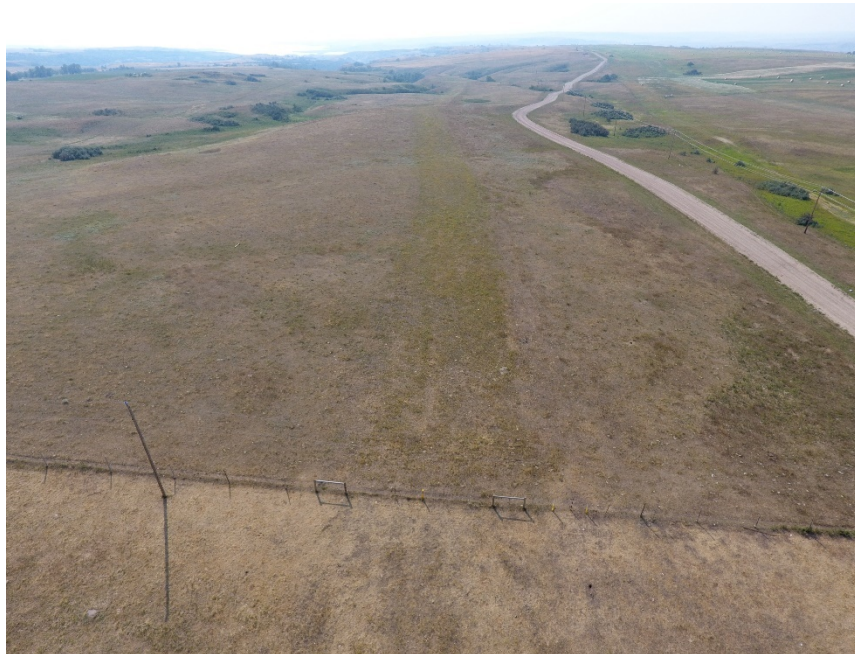
*Location 18, looking west (48.037025, -102.471939)  
Pipeline marker visible at fence. Vegetation blending well with surrounding conditions*

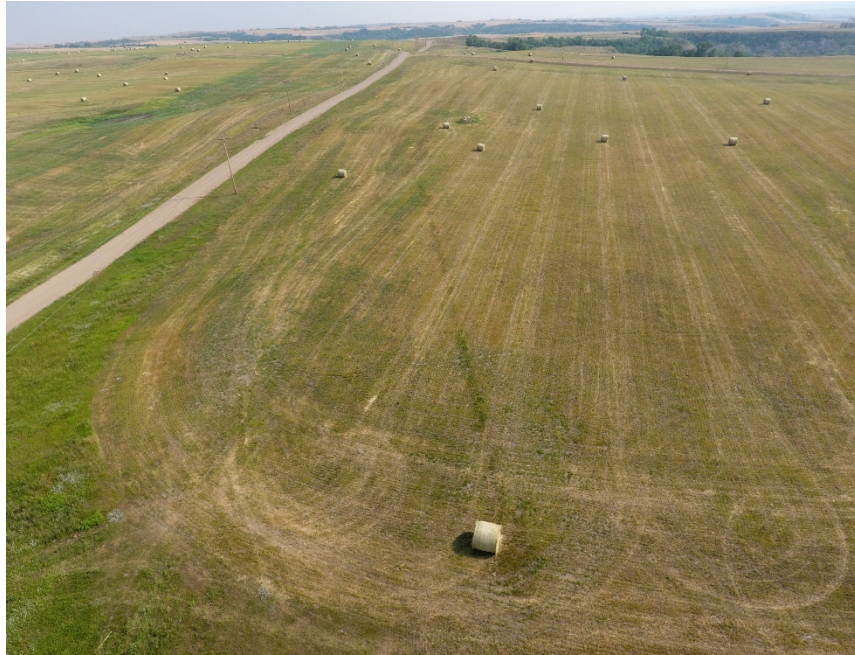
*Location 19, looking South (48.044998, -102.500023)  
Photo taken at pipeline marker, no visible scar through farmland*

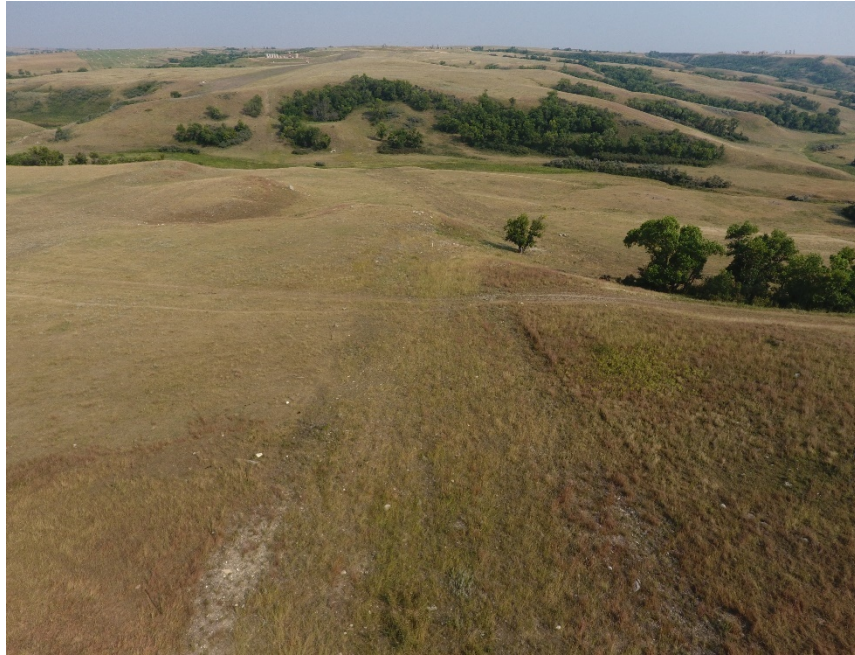
*Location 21, looking Southeast (48.052696, -102.516724)  
Scar visible in center of photo. Grass becoming well blended with surrounding conditions*

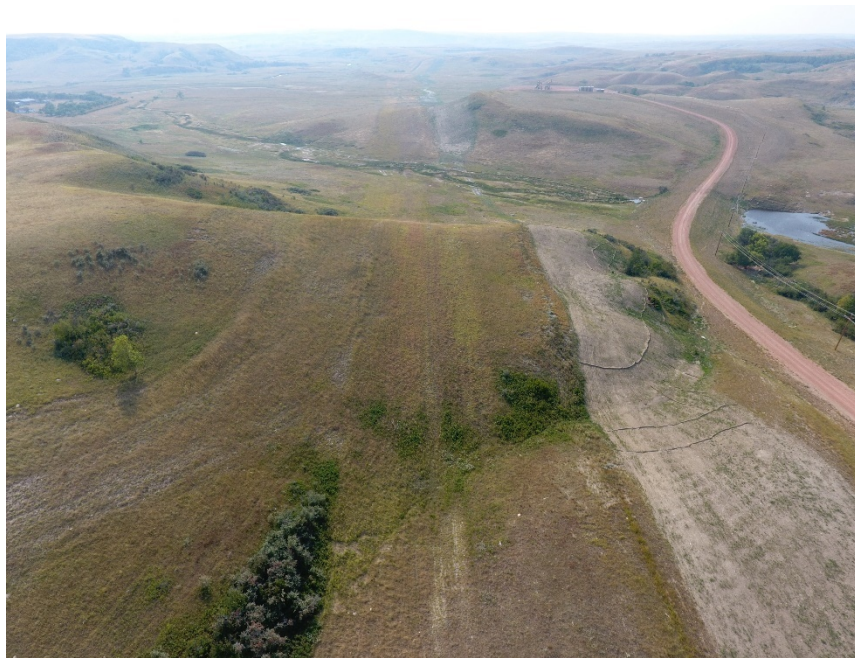
*Location 22, looking West (48.053665, -102.517097)  
Non-established scar at right of photo not from this pipeline*

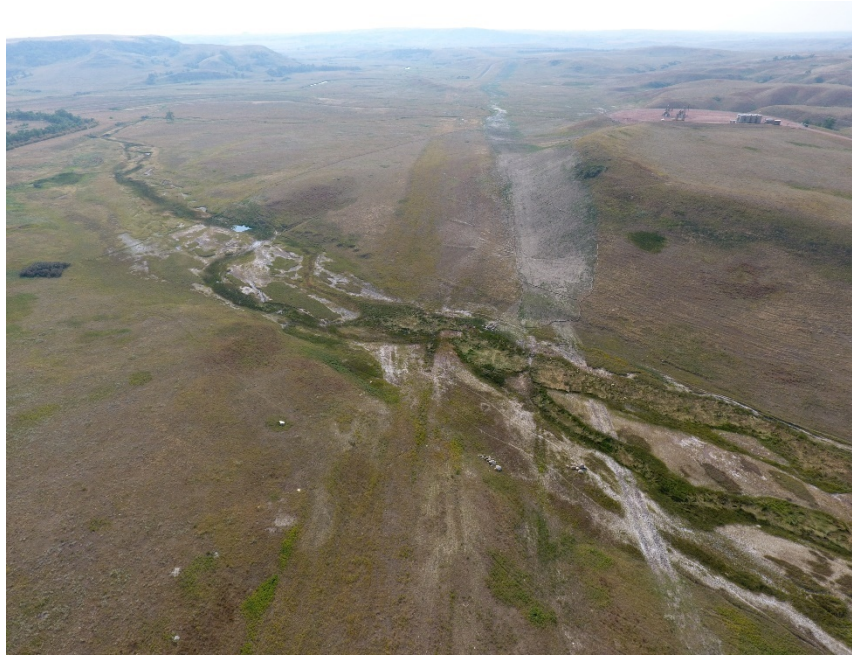
*Location 23, looking west (48.053795, -102.520447)  
Scar visible in center of photo, but beginning to blend with surrounding conditions*

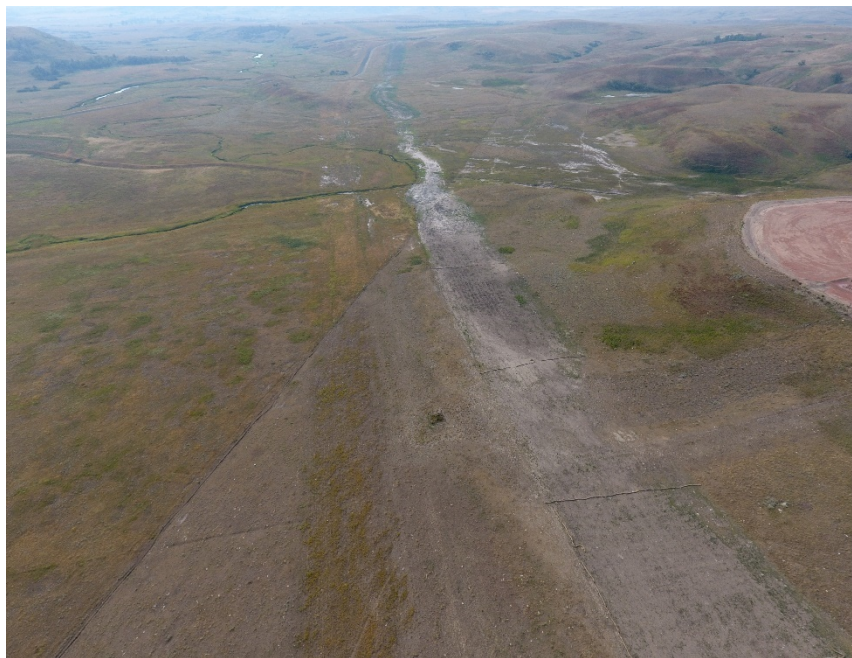
*Location 24, looking West (48.053711, -102.525238)  
Scar at left side in photo*

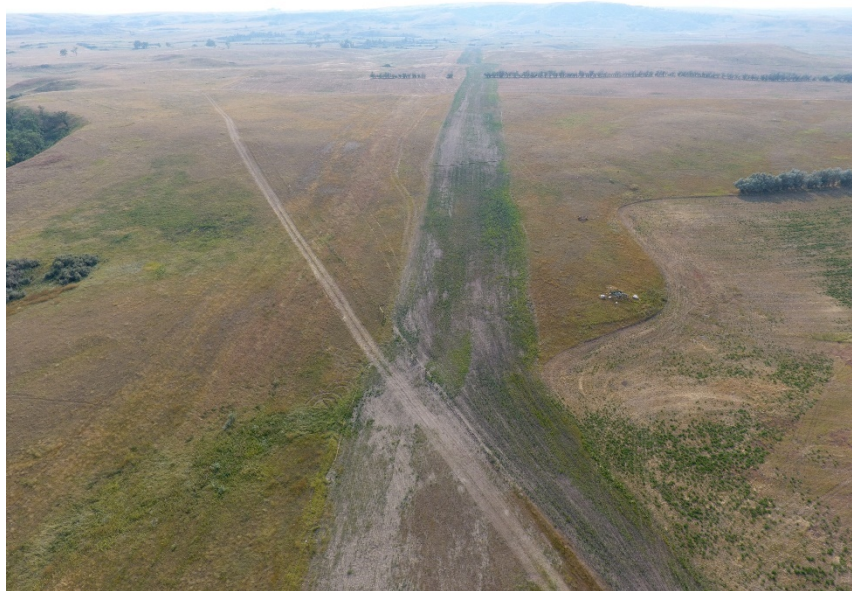
*Location 26, looking West (48.055264, -102.54528)  
Visible scar from adjacent pipeline noted at Location 25*

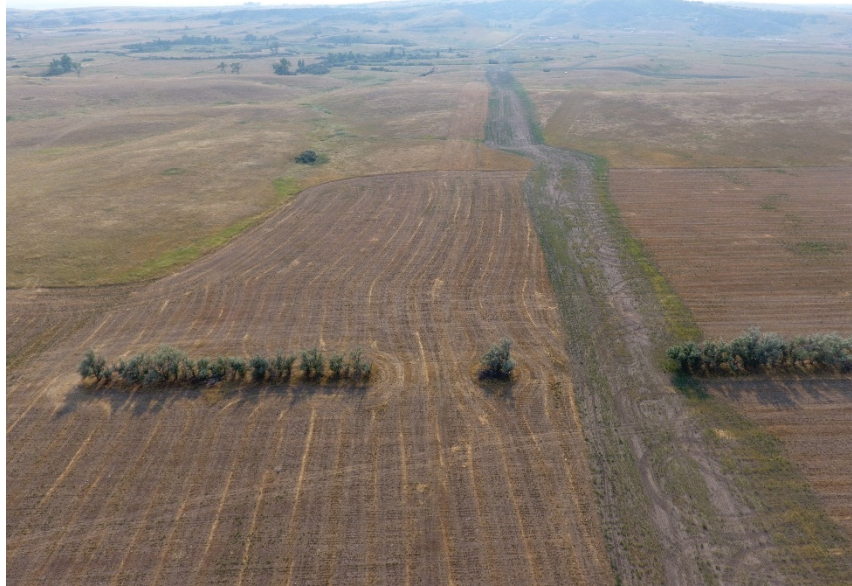
*Location 27, looking West (48.054081, -102.551117)  
Visible scar from adjacent pipeline noted at Location 25*

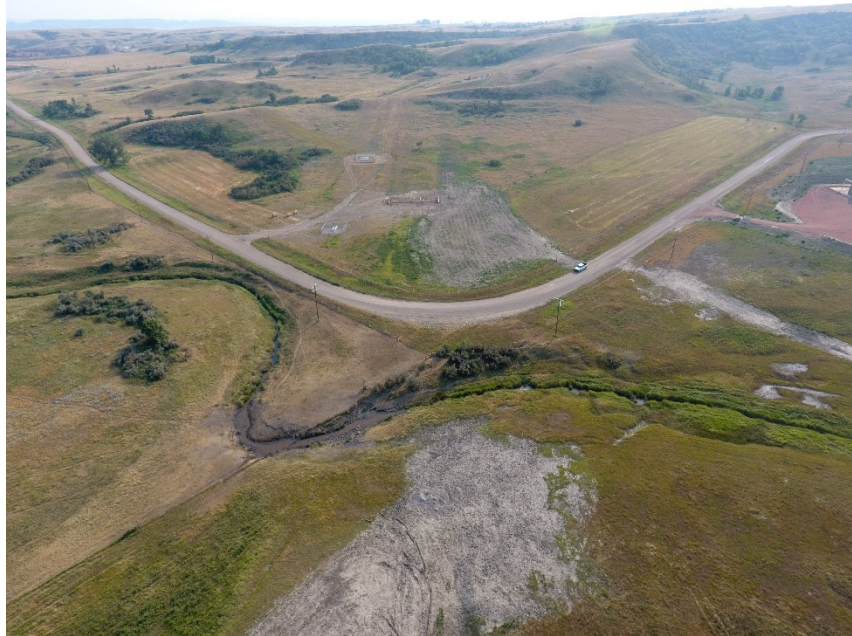
*Location 28, looking Southwest (48.053013, -102.562912)*

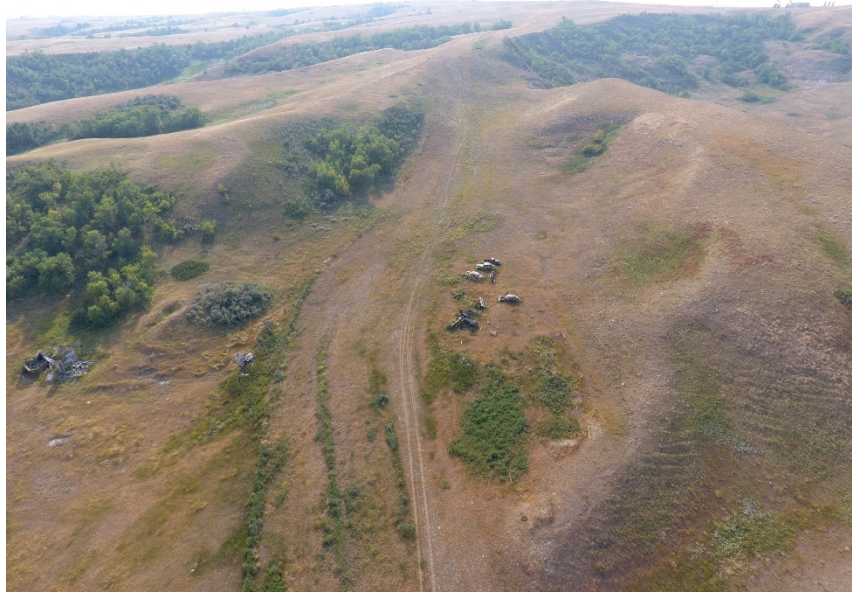
*Location 29, looking West (48.049789, -102.566978)  
Grass well established and blending with existing conditions*

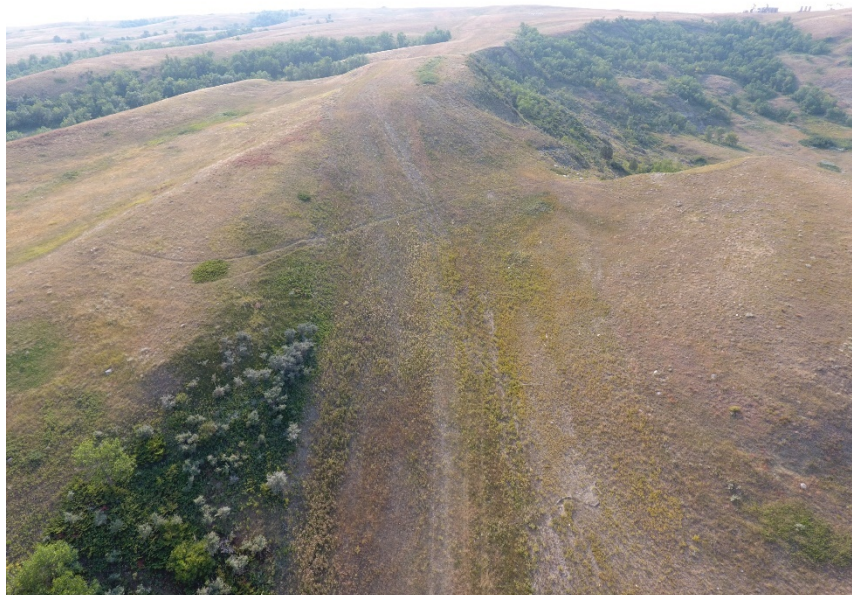
*Location 30, looking West (48.049702, -102.569336)  
Scar faintly visible in center of photo*

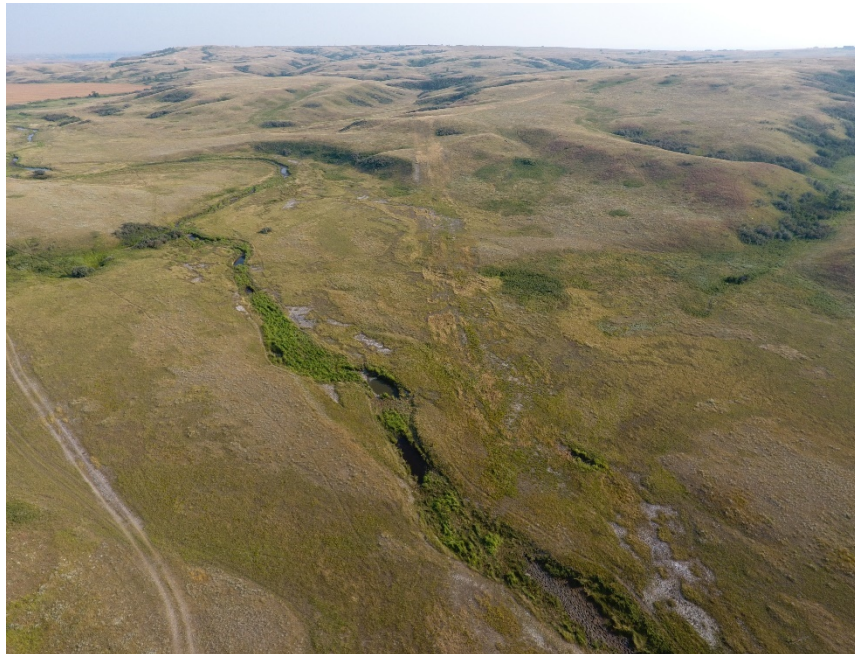
*Location 32, looking South (48.075985, -102.586487)  
Scar visible running straight south in photo, becoming well blended with surrounding conditions*

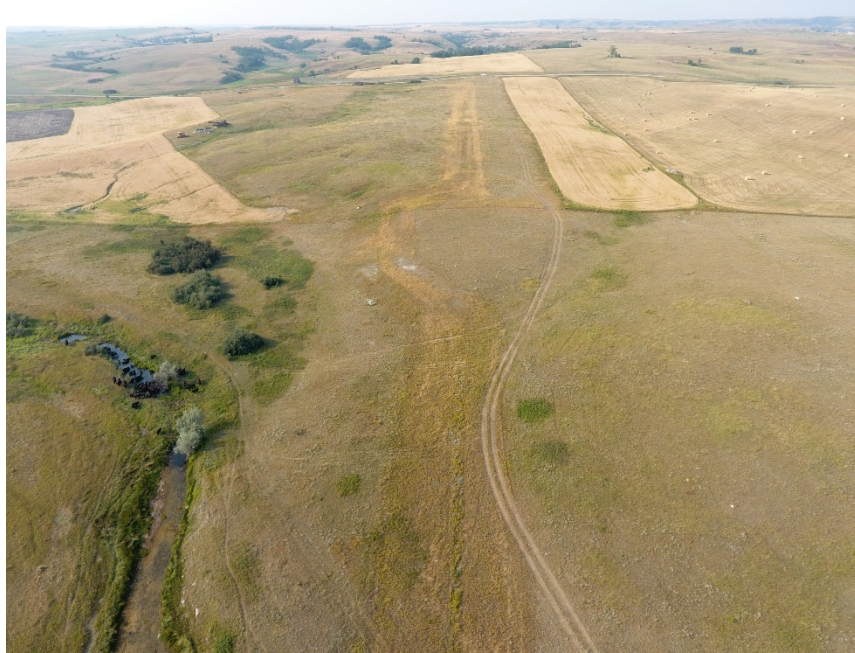
*Location 33, looking North (48.075951, -102.586739)  
Scar visible center of photo*

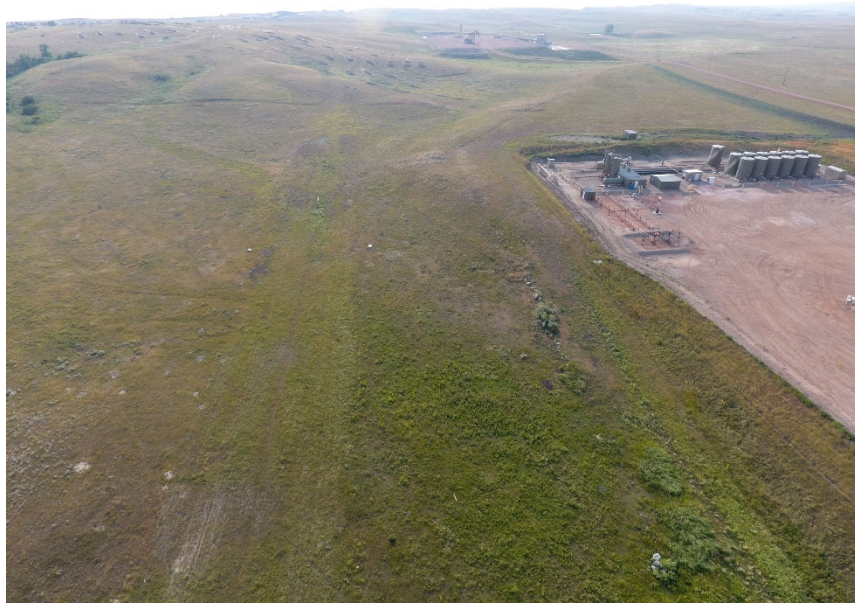
*Location 37, looking West (48.081062, -102.619835)  
Scar becoming well blended with existing conditions*

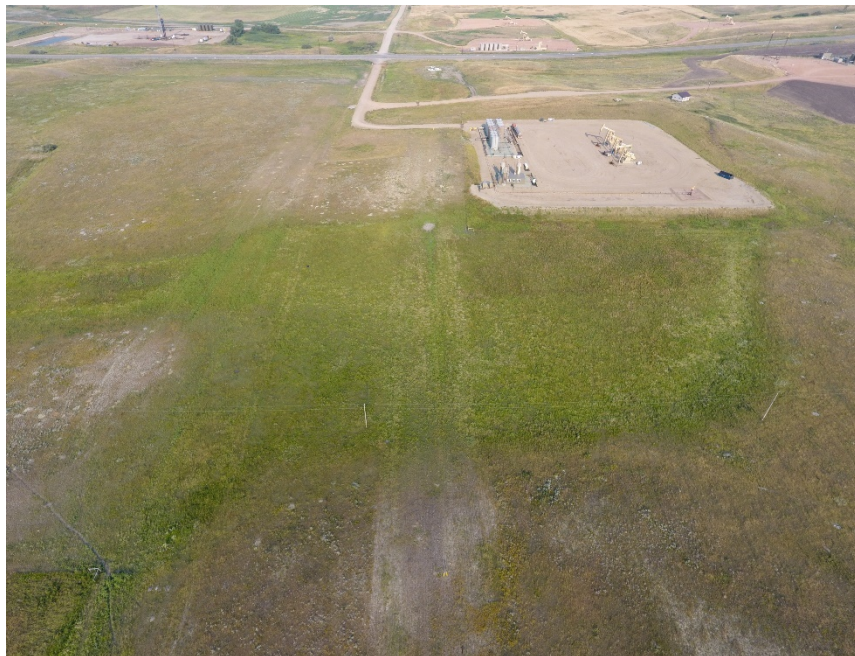
*Location 38, looking East (48.08094, -102.620033)  
Example of natural vegetation overtaking pipeline scar*

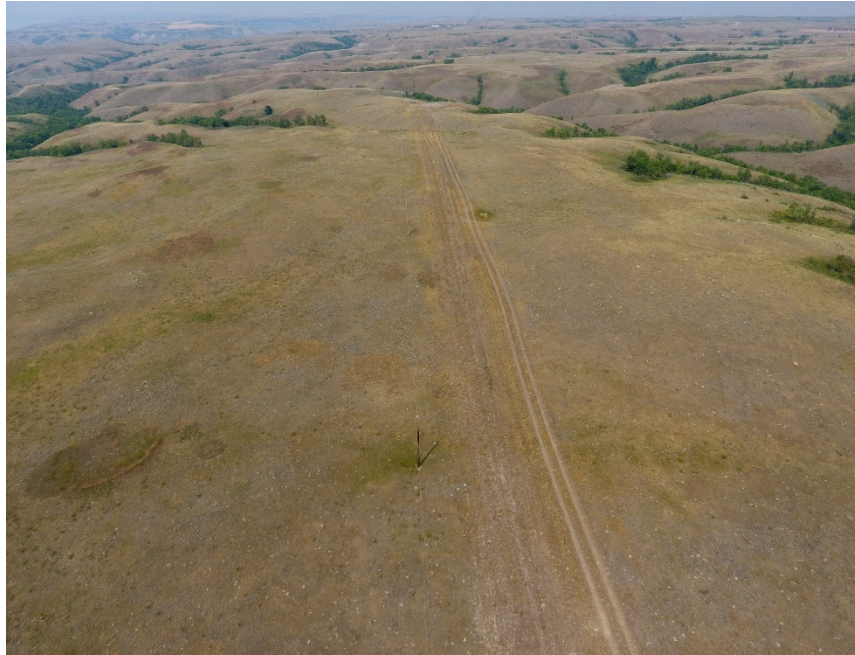
*Location 57, looking Northwest (48.121979, -102.684746)  
Vegetation well blended with existing conditions*

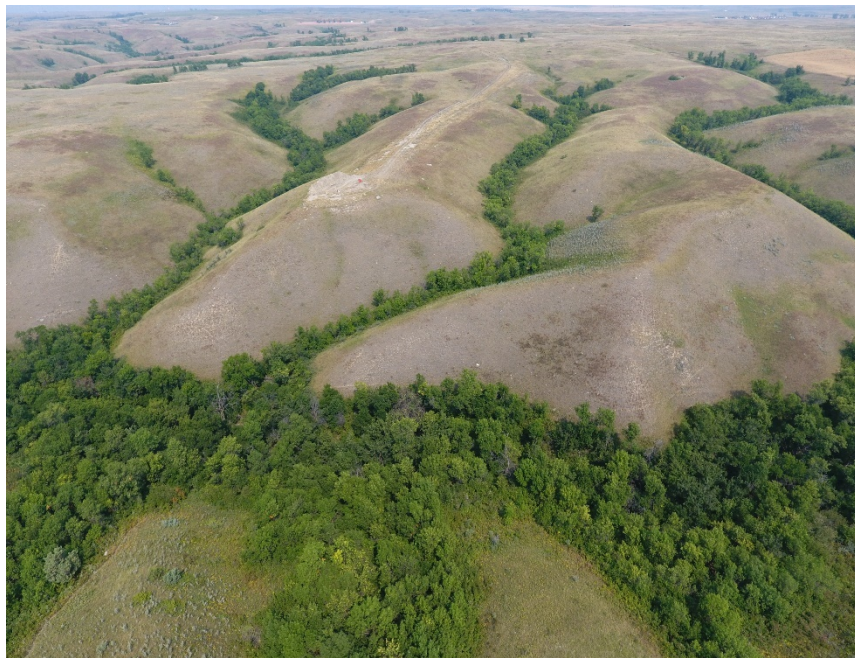
*Location 58, looking North (48.124924, -102.687737)*

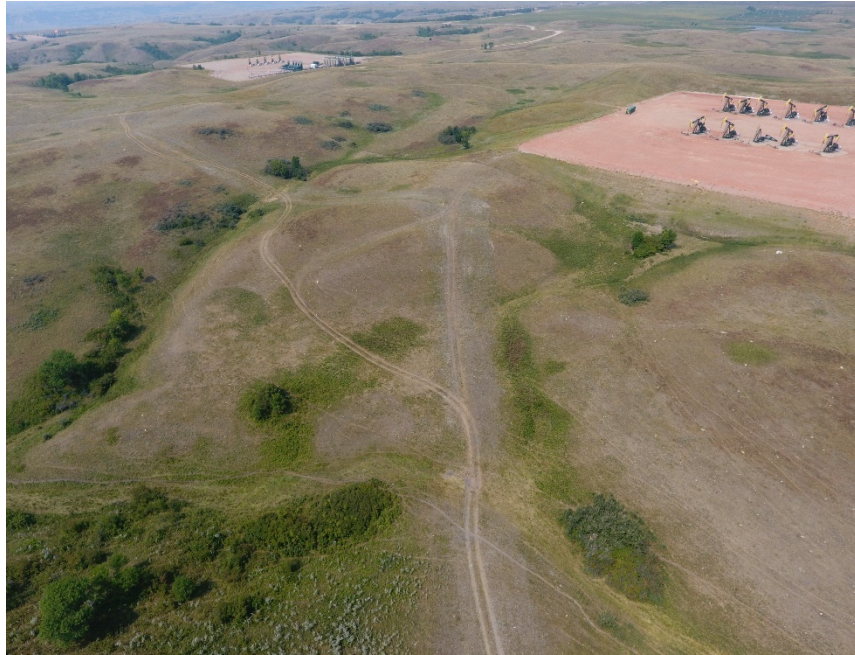
*Location 61, looking Northwest (48.137436, -102.686737)  
Reclamation well established to existing conditions. Pipeline scar visible in center of photo, then moving West and North to pad in background*

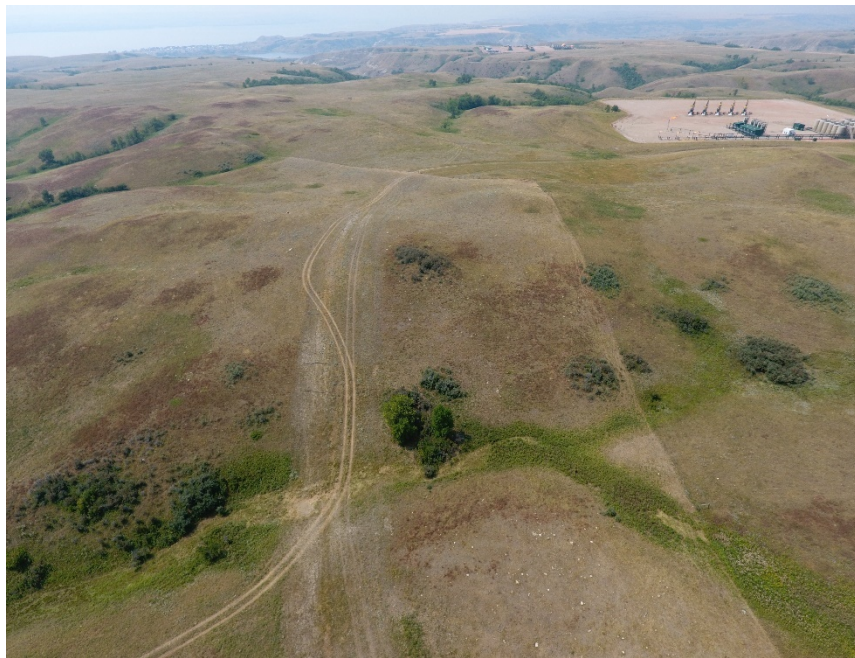
*Location 62, looking West (48.138809, -102.688652)*

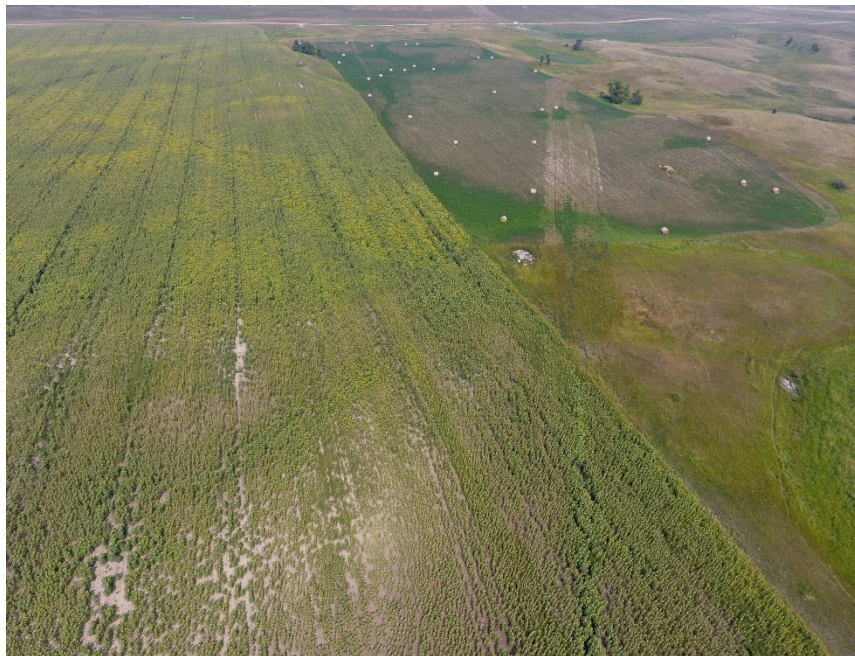
*Location 66, looking Northeast (48.147964, -102.692215)  
Vegetation consistent with adjacent conditions*

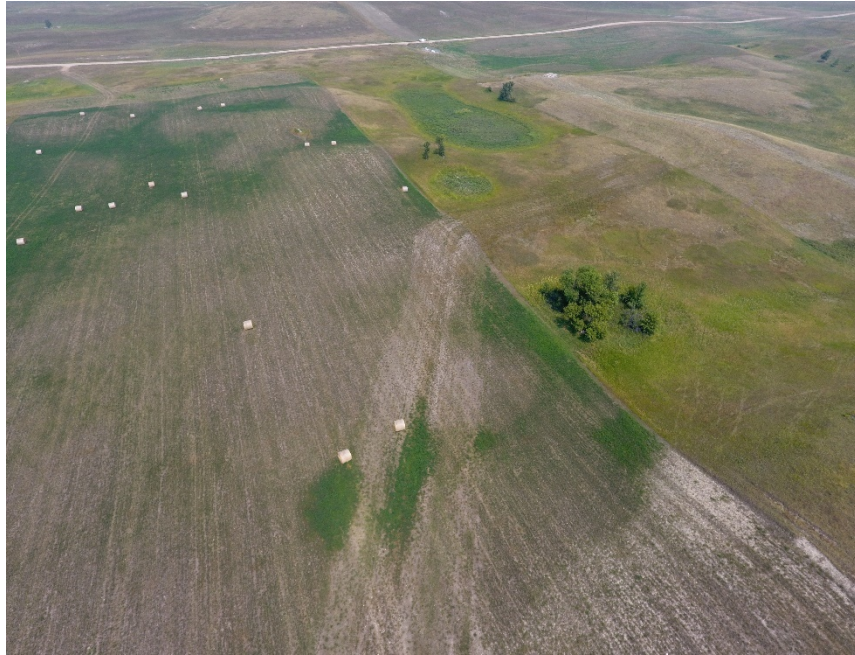
*Location 67, looking Northeast (48.149734, -102.690361)  
Vegetation consistent with adjacent conditions*

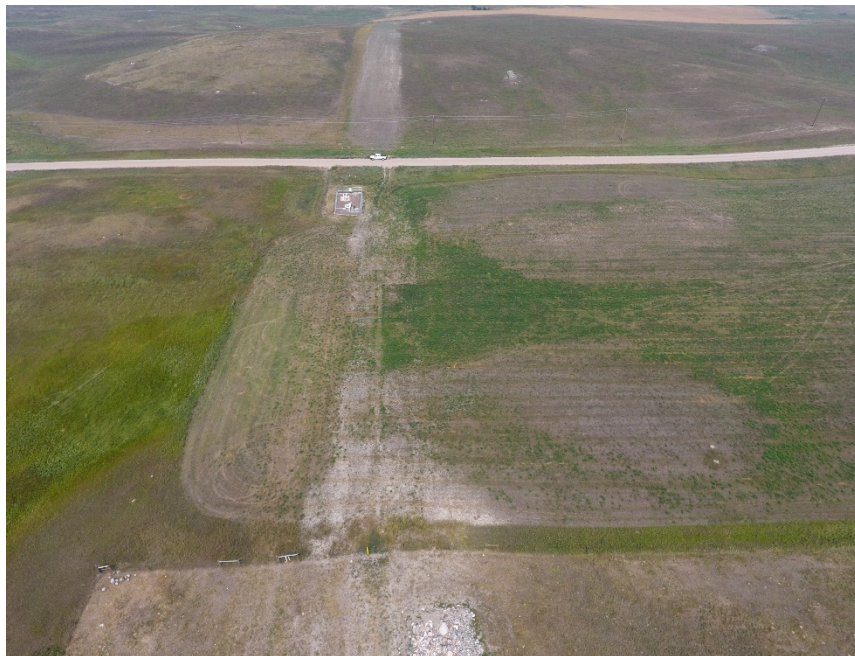
*Location 68, looking North (48.152023, -102.687767)*

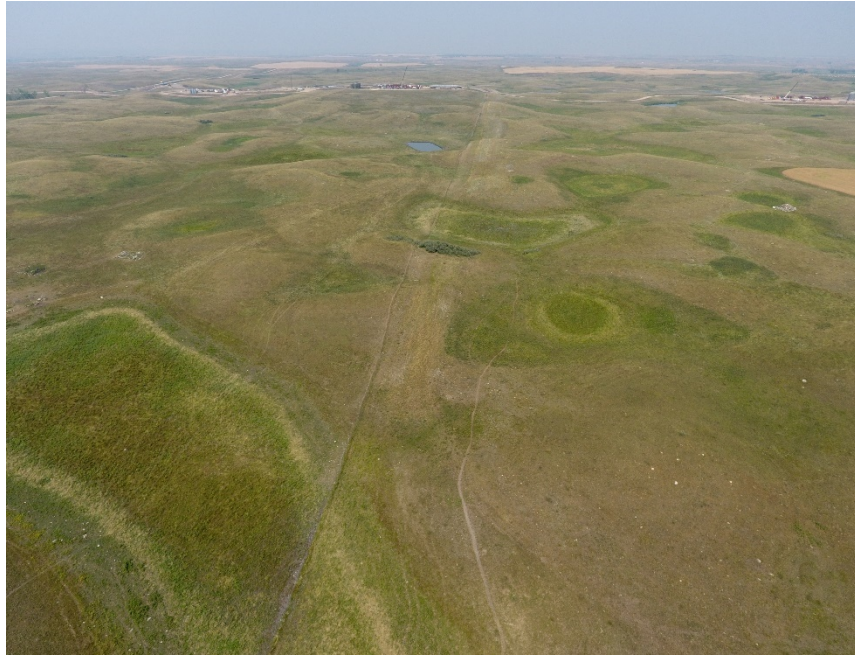
*Location 69, looking North (48.159924, -102.687958)  
Reclamation well established and consistent with existing conditions*

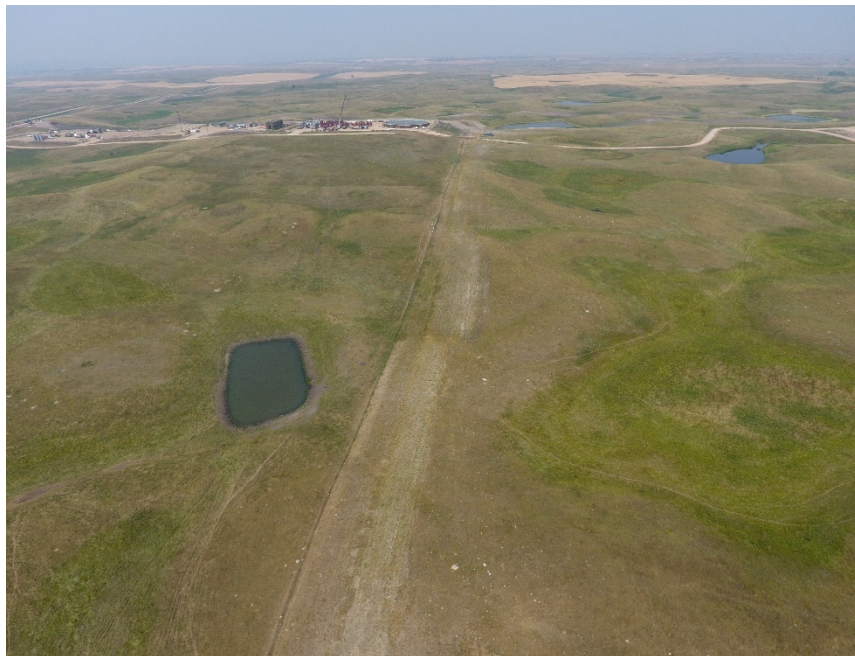
*Location 70, looking North (48.163025, -102.68792)*

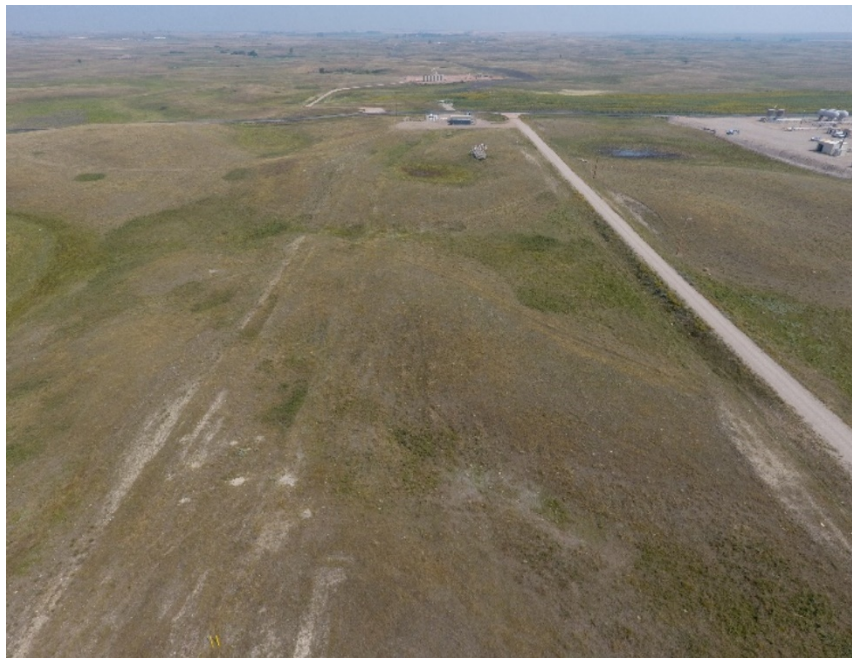
*Location 80, looking East (48.196304, -102.703835)*

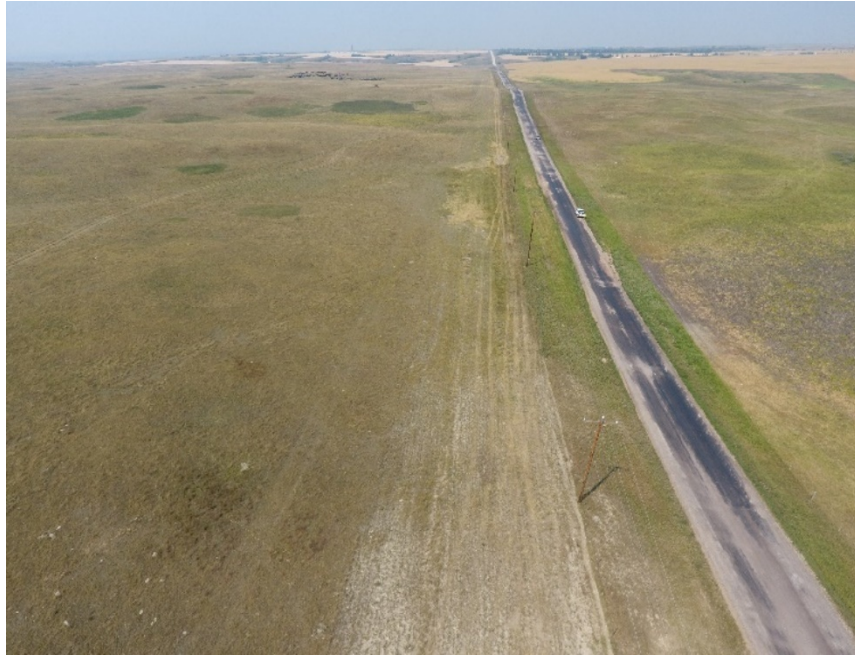
*Location 81, looking North (48.197979, -102.699196)*

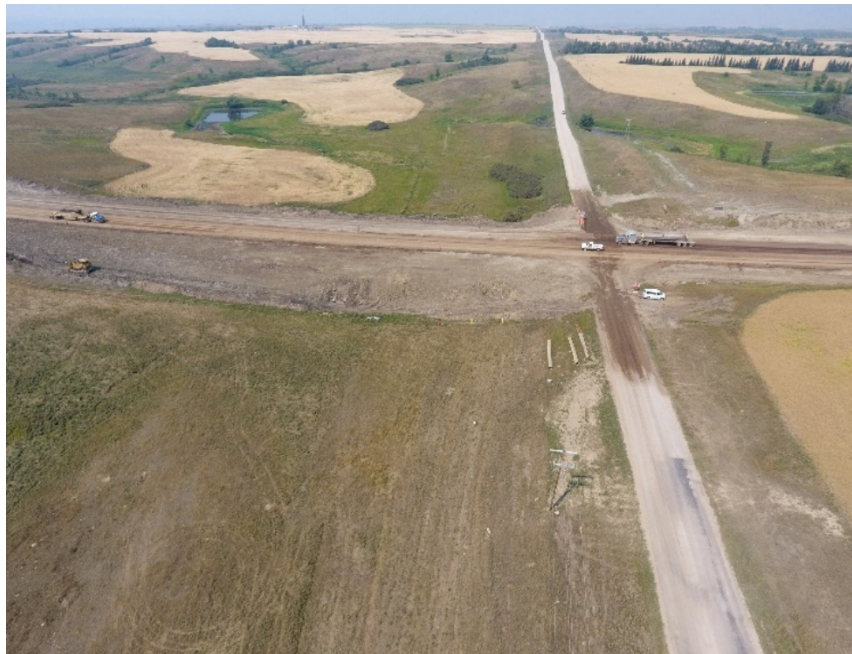
*Location 84, looking North (48.21043, -102.69912)  
Scar visible on West side of road, well established, matching existing conditions*

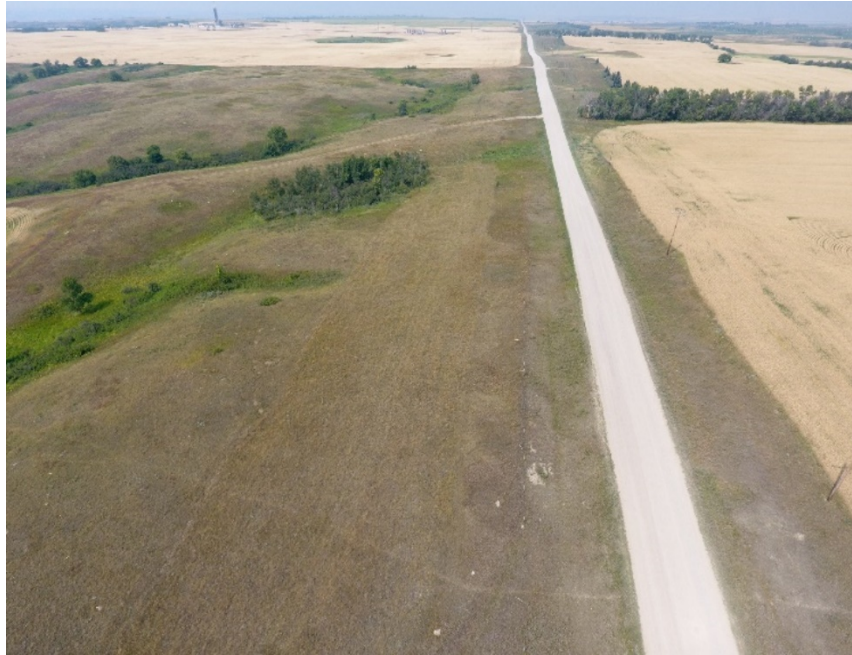
*Location 85, looking North (48.214714, -102.699112)  
Scar visible on West side of road, well established, matching existing conditions*

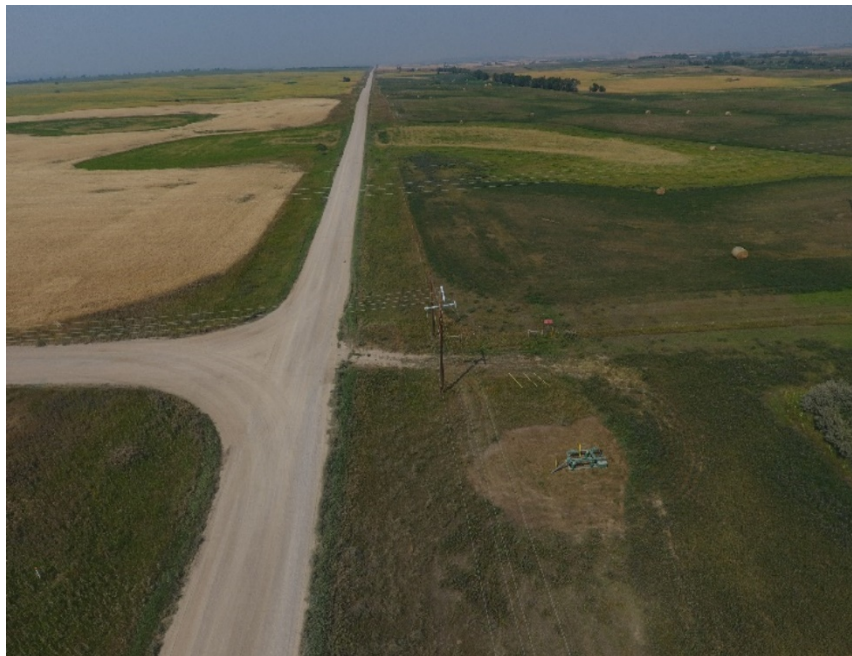
*Location 86, looking North (48.225655, -102.698692)*

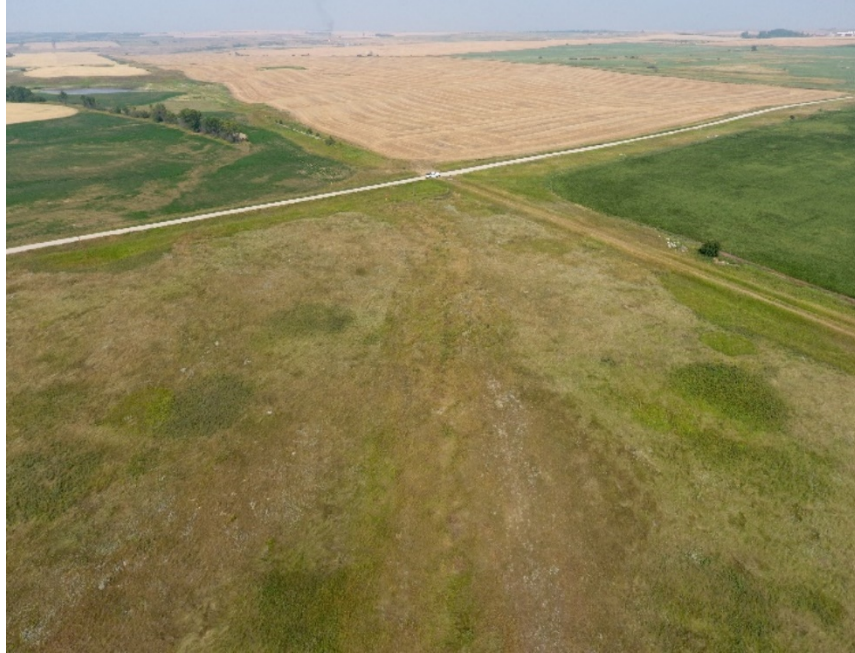
*Location 89, looking Northeast (48.253609, -102.679077)  
Faint scar visible, vegetation matching surrounding conditions*

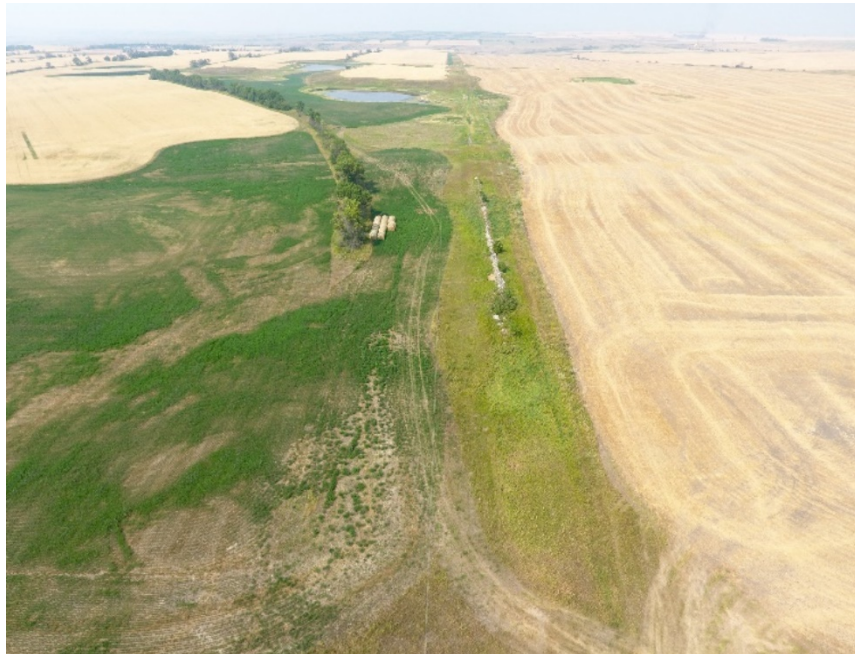
*Location 90, looking North (48.254971, -102.677895)*

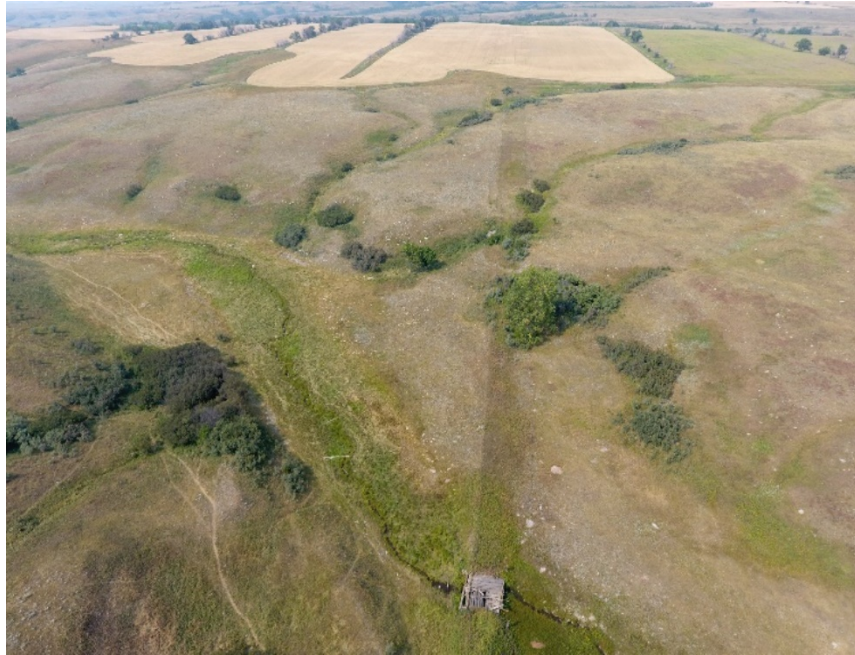
*Location 93, looking North (48.273453, -102.677628)  
Faint scar visible in center of photo, well blended with existing conditions*

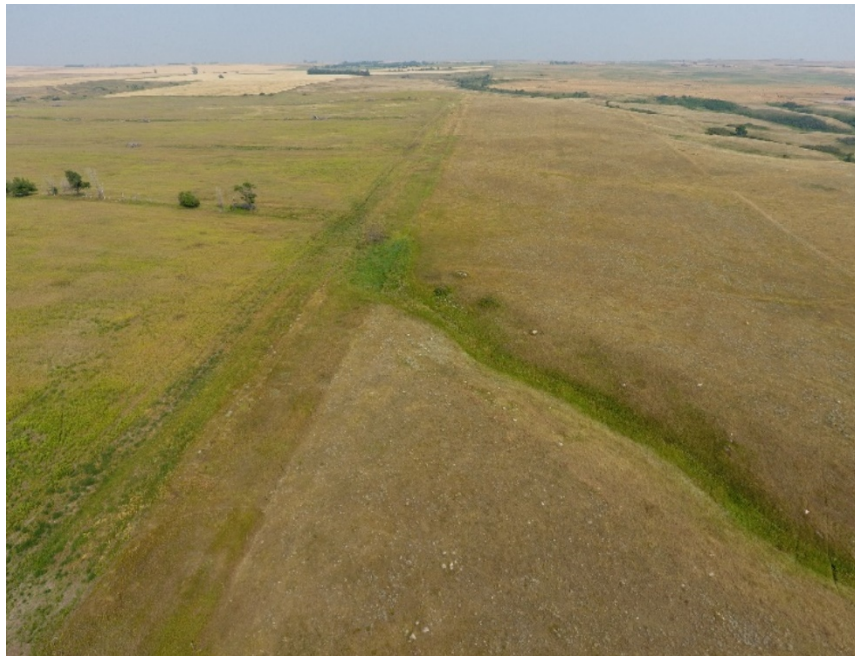
*Location 94, looking East (48.276531, -102.676491)*

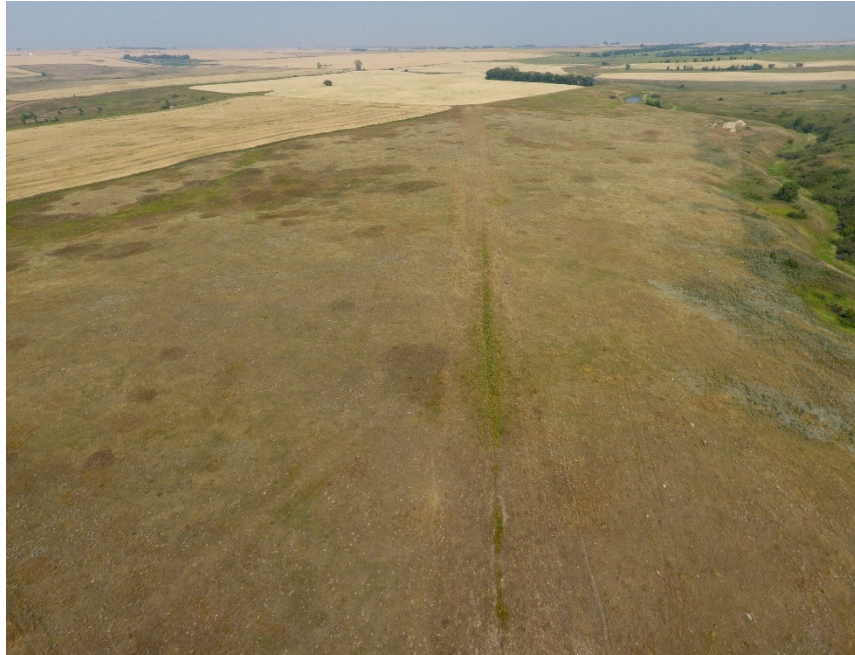
*Location 95, looking Northeast (48.276943, -102.666634)  
Vegetation well established to existing conditions*

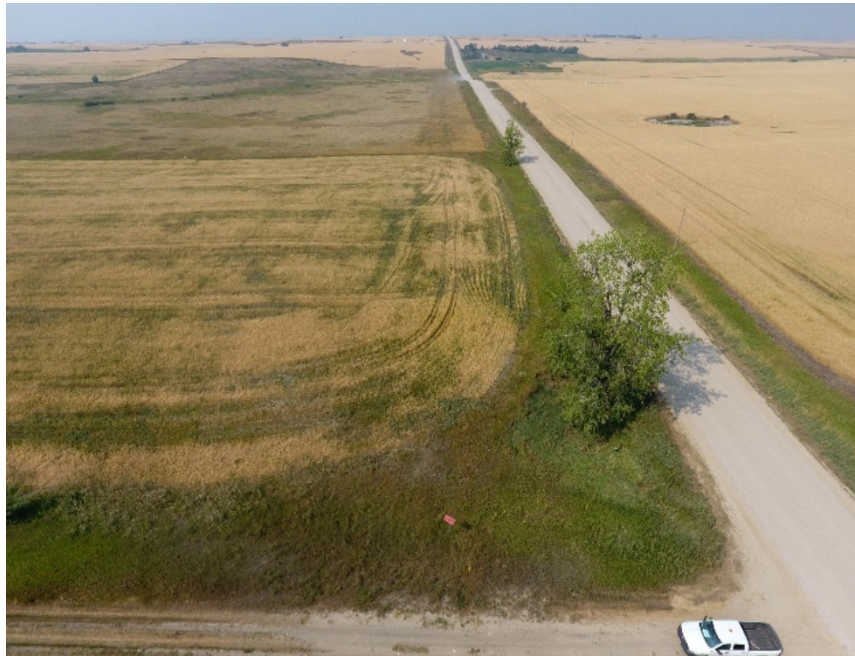
*Location 96, looking North (48.283817, -102.656342)*
