Carlson McCain, Inc. (CMI) conducted a topsoil removal inspection at the Lindahl Wind Farm Project – Williams County (Case No. PU-15-482) on May 25, 2016, on behalf of the North Dakota Public Service Commission (PSC). The project consists of installing 78 wind turbines, along with their supporting access roads, and transmission lines.

89 PU-15-482 Filed: 6/28/2016 Pages: 7  
Topsoil Removal Inspection Report

*Topsoil Removal Inspection*  
*PSC Case No. PU-15-482*

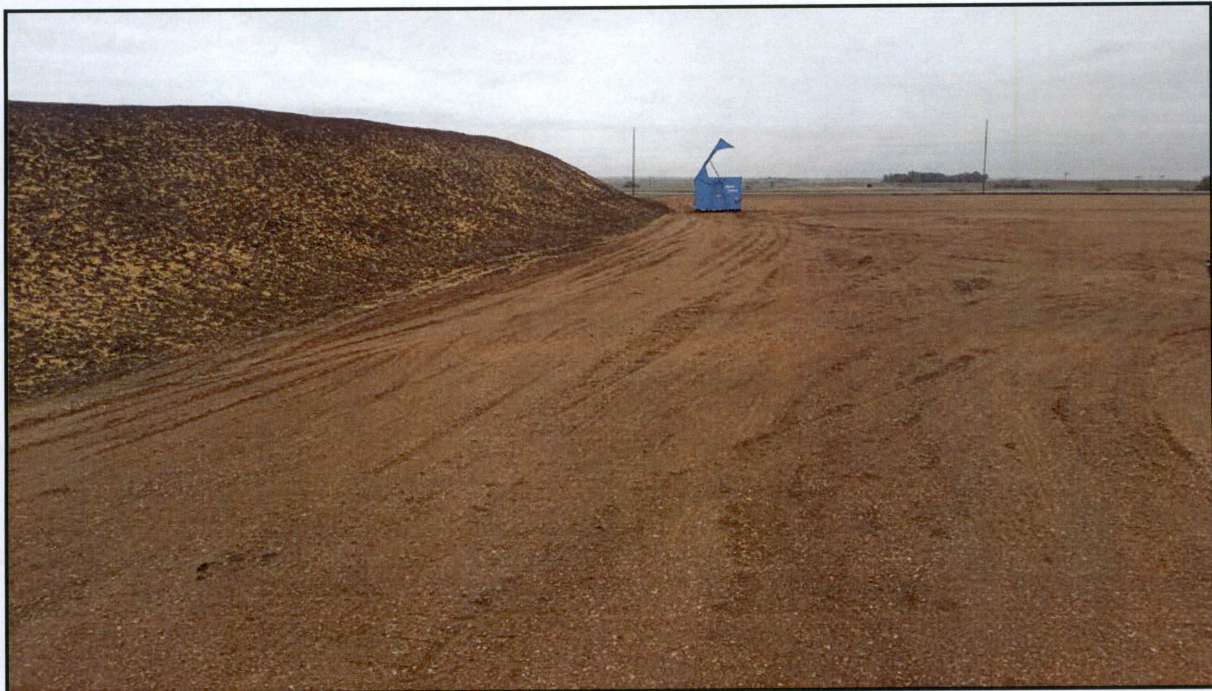
Topsoil from the lay down yard was stored on the northwest corner of the yard. The topsoil depth was approximately 6"-8" in depth. The subsoil was leveled and surfaced with rock. Silt fence was placed around the perimeter of the yard.

Figure 1. Photo taken facing east from the northwest corner of the lay down yard. Segregated topsoil and surfaced yard can be seen.

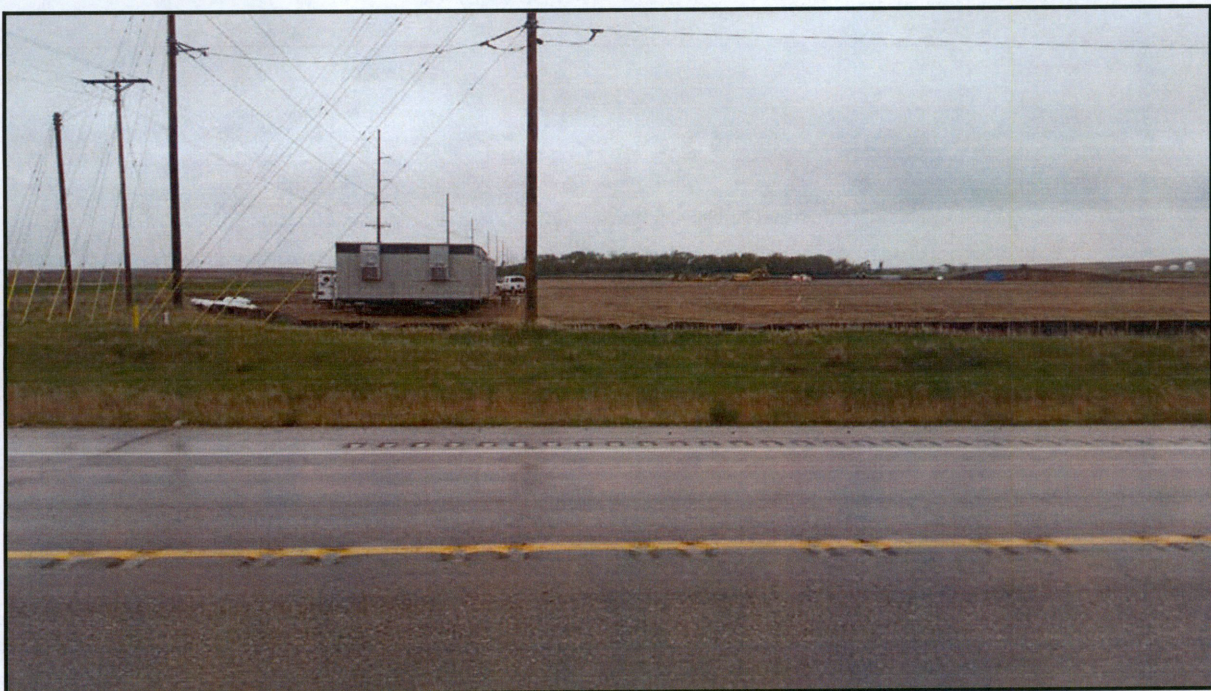
Figure 2. Photo taken looking west from Hwy 40 across the lay down yard in Section 3, T158N, R95W.

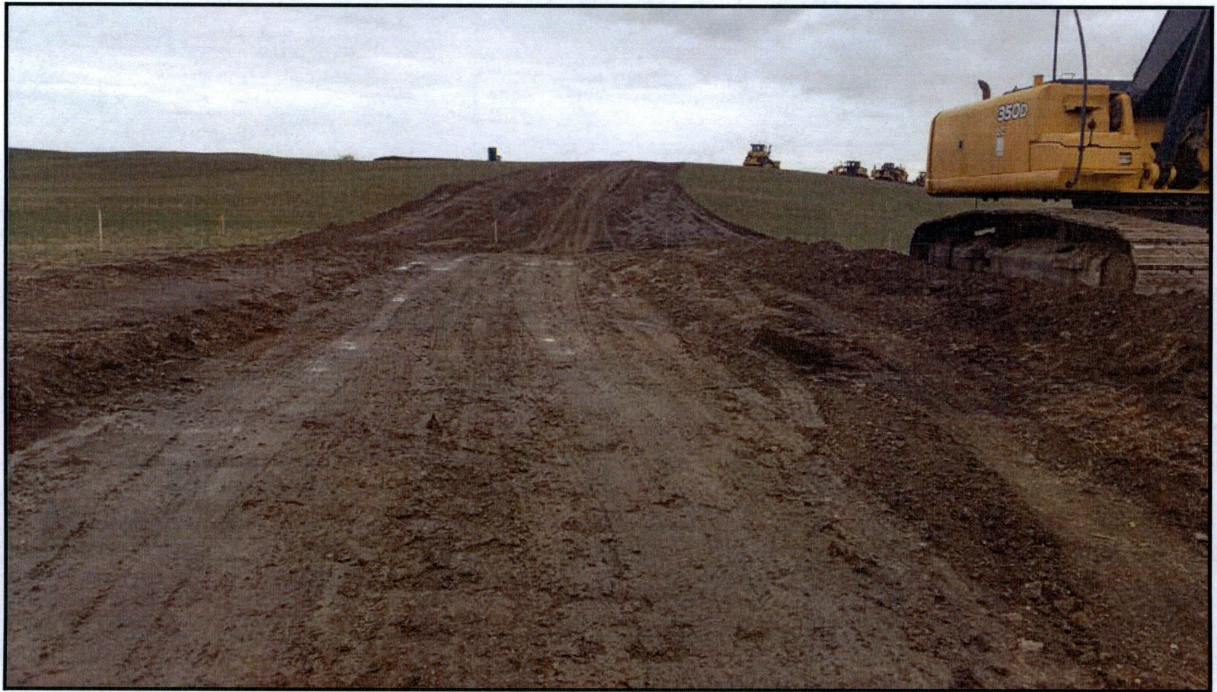
At the time of the survey, access roads for Turbines B-9 and B-10 were under construction. The pad for turbine B-10 was also under construction. Topsoil had been separated and properly stored on the edge of the ROW; however, due to rain, a shallow layer of topsoil had been re-spread to keep the subsoil dry. Enel planned to remove the topsoil once conditions improved. The topsoil was 6"-8" in depth in the construction areas.

Figure 3. Photo taken facing north from 72<sup>nd</sup> St. NW. Topsoil was stripped and stored for the access road to Turbine B-10. ROW markers were in place. Due to rain, a shallow layer of topsoil had been re-spread to protect subsoil.

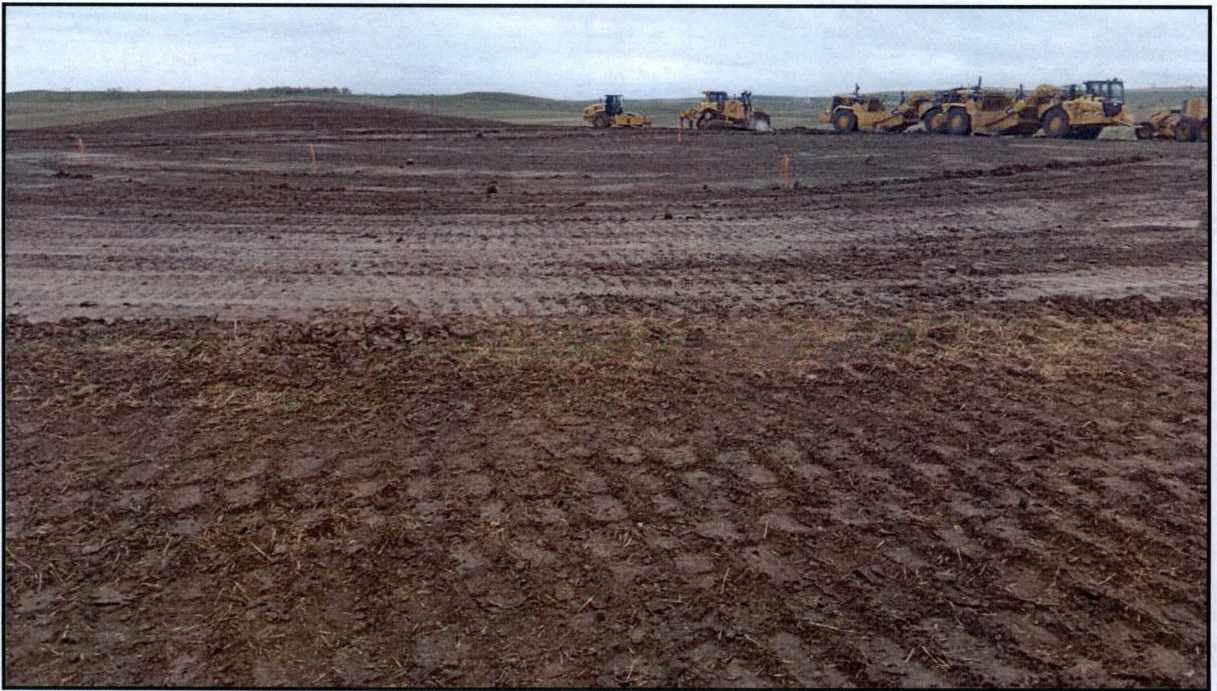
Figure 4. Photo of pad for Turbine B-10.

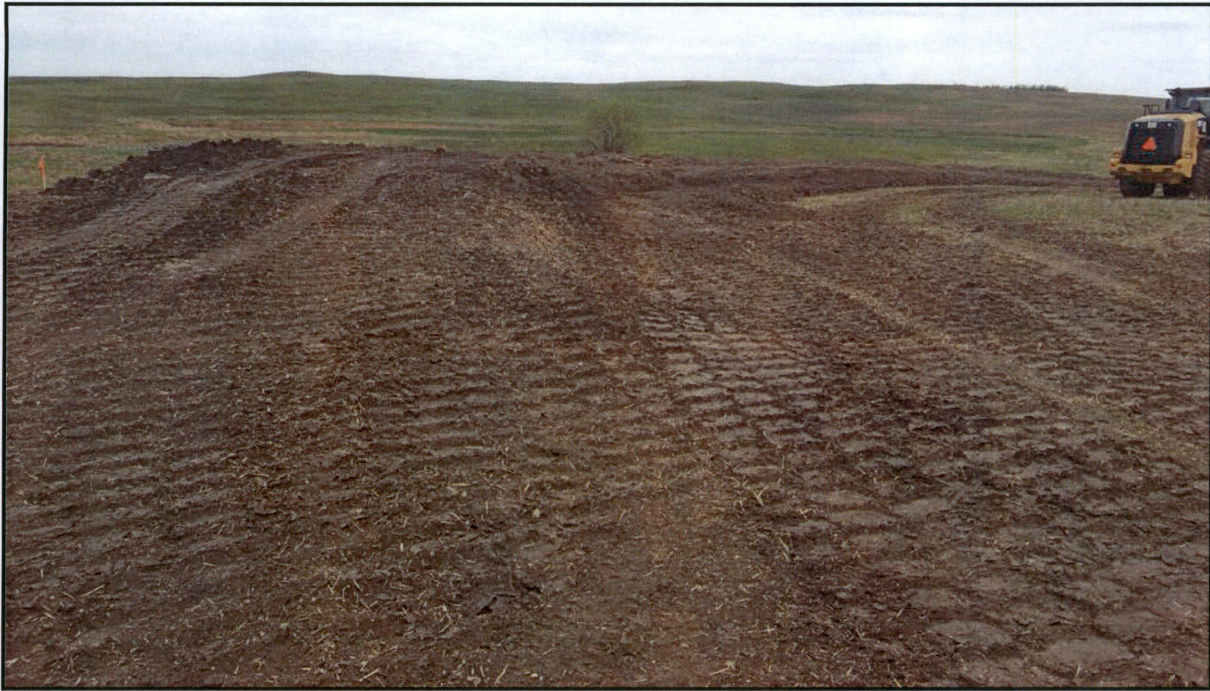
Figure 5. Photo segregated topsoil for Turbine B-10 pad.

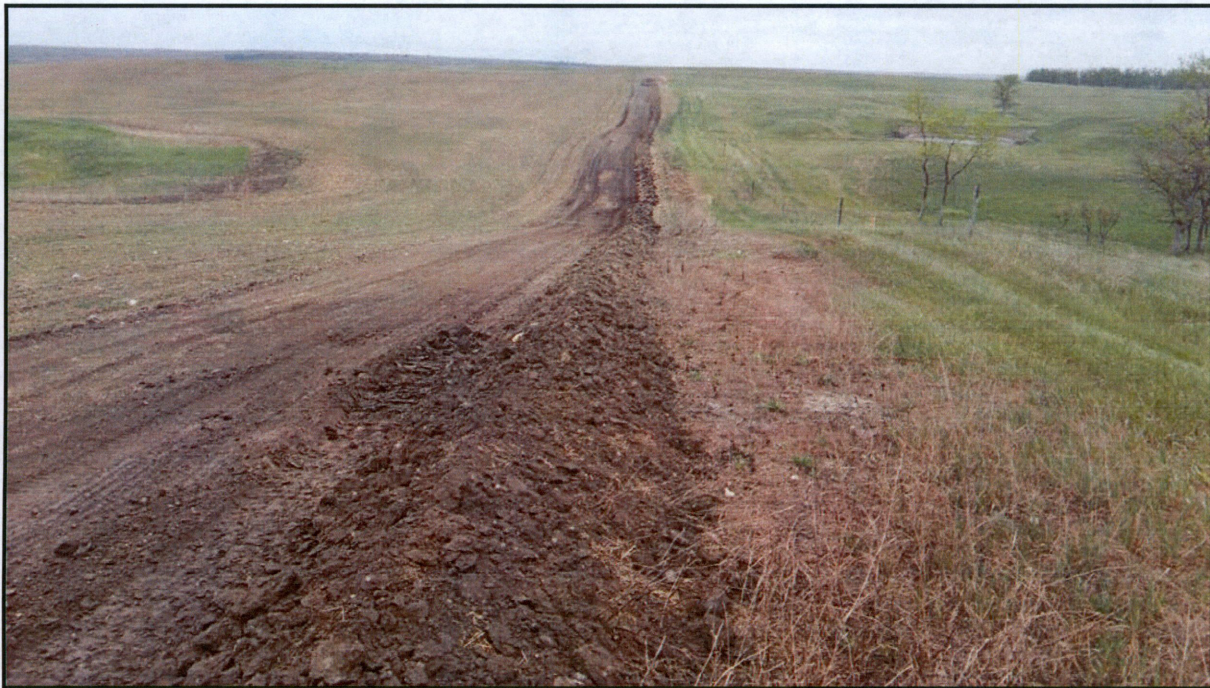
Figure 6. Photo taken looking west down the access road to Turbine B-9. Topsoil has been stripped and stored on the north side of road.
