November 16, 2016

Jerry Lein
North Dakota Public Service Commission
600 East Boulevard Avenue, Dept. 408
Bismarck, ND 58505-0480

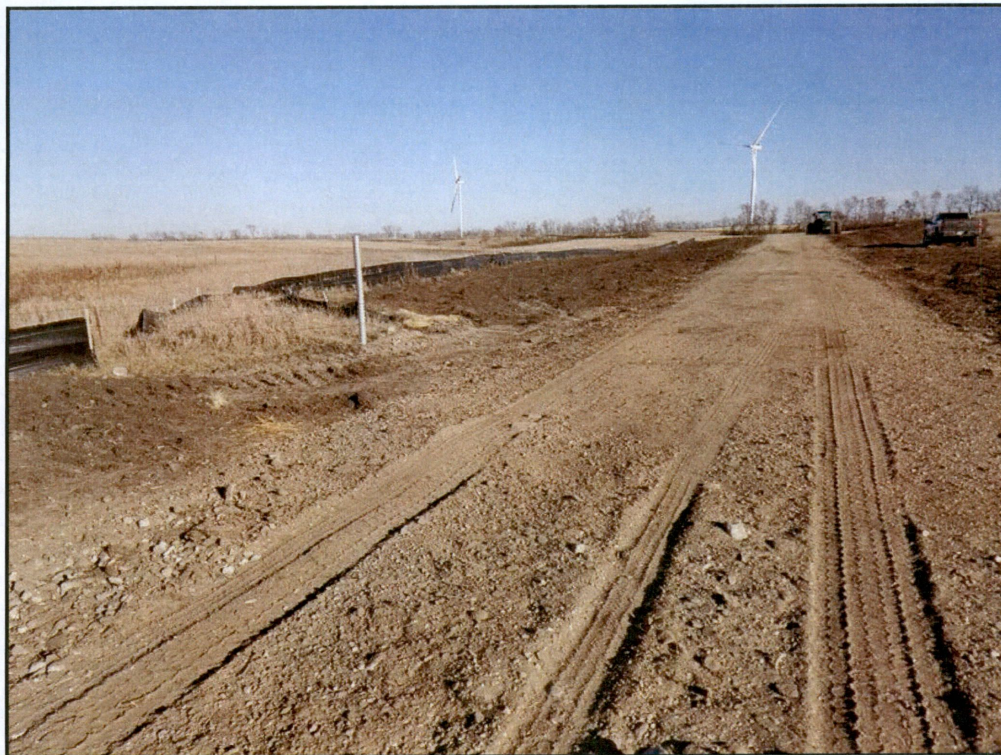
Figure 4. Photo taken facing east on access road to turbine B2 showing silt fence installed and in functional condition.

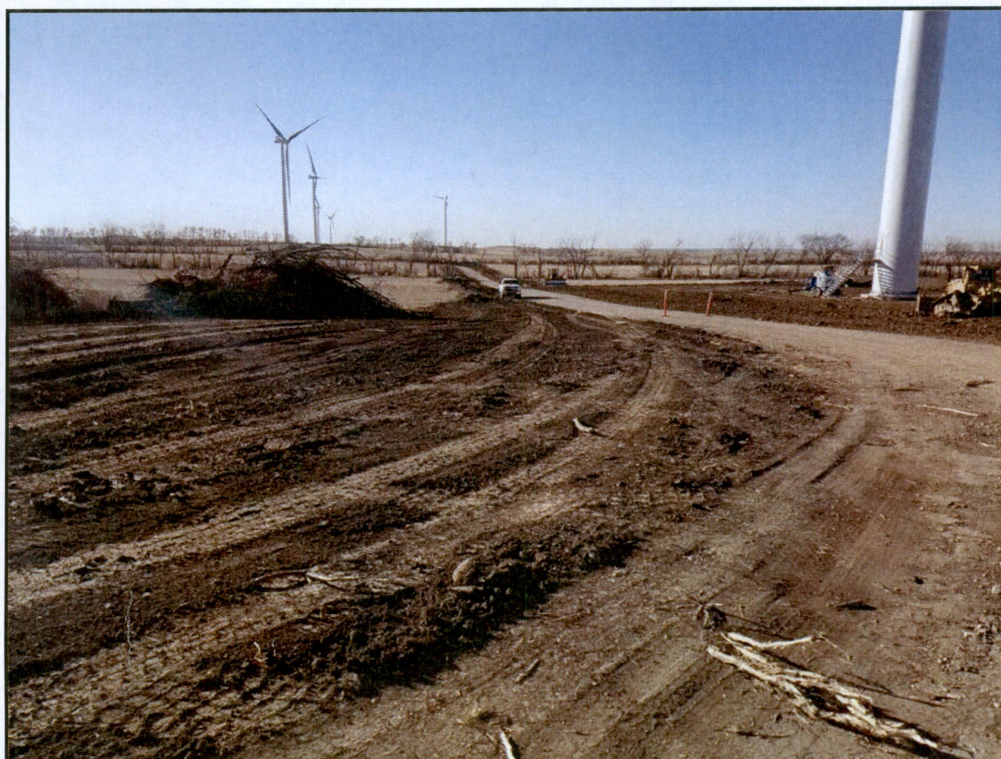
Figure 5. Photo of ongoing pad reclamation on turbine B4. Topsoil has been redistributed. Tree piles are awaiting disposal at landowner's requests.
