RE: Reclamation Inspection
PU-15-482, Lindahl Wind Farm

117 PU-15-482 Filed 11/02/2018 Pages: 9
Reclamation Inspection Report
Carlson McCain, Inc.
Toddd Hartleben, Principal Engineer

**Photo Locations
Reclamation Inspection
Lindahl Wind Project
ND Public Service Commission**

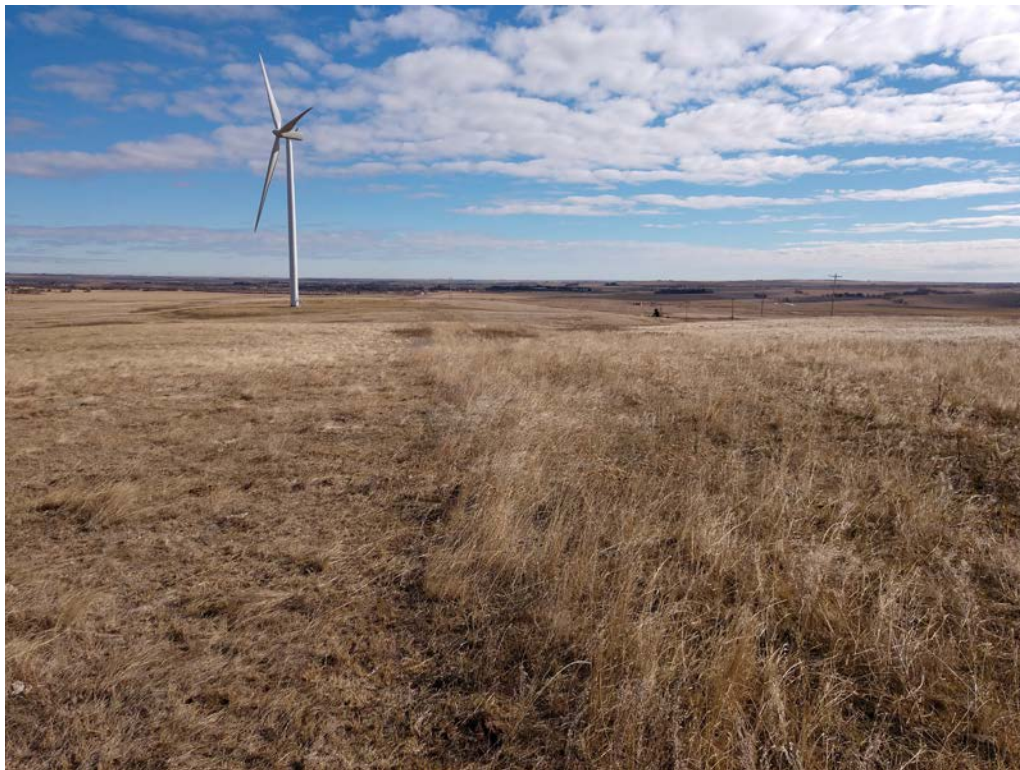
- Collector line(s) and disturbed areas on State School Trust property. During inspection of reclaimed areas on State School Trust property in the NW ¼ of Section 36, T159N, R94W, it was determined that a different seed mix than that prescribed by the North Dakota State Land Department was used for reclamation. Enel will prescribe burn the area(s) that were seeded in spring 2019 and re-seed with a seed mix approved by the State Land Department. Enel is coordinating with the State Land Department.

Photo 1. Photo taken facing east toward Turbine D4 along collector line on State School Trust property. The difference in vegetation marks where re-seeding with a native seed mix will occur in 2019.

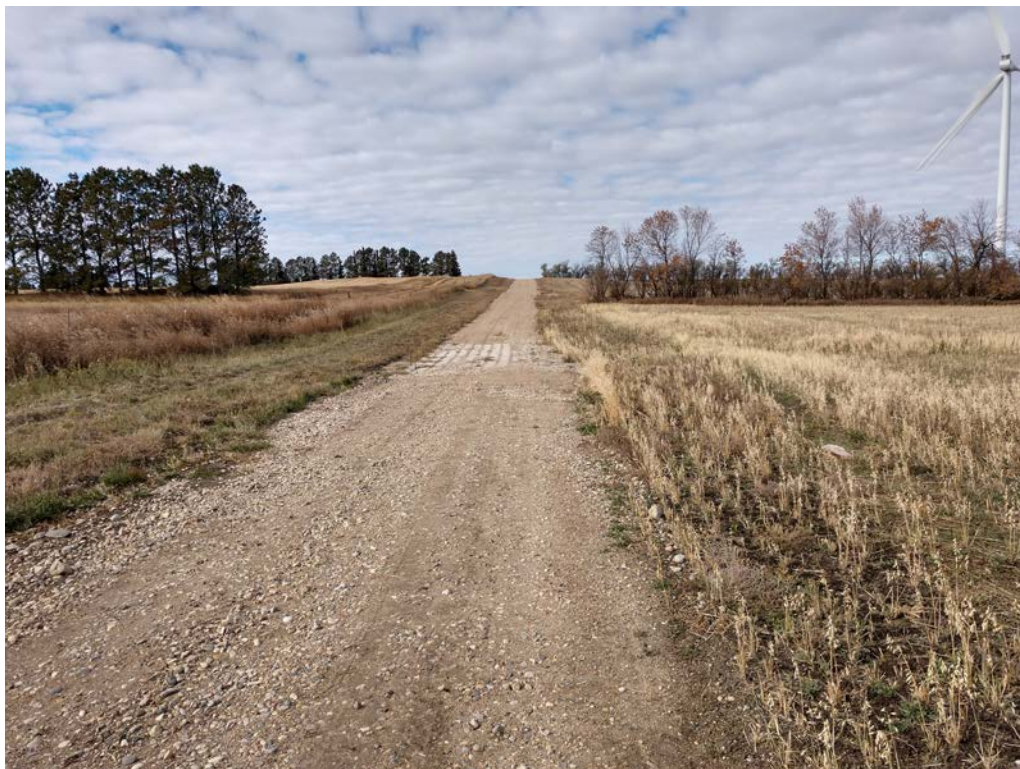
Photo 2. Photo of revetment mat at low water crossing on access road near Turbine D7 (looking west).

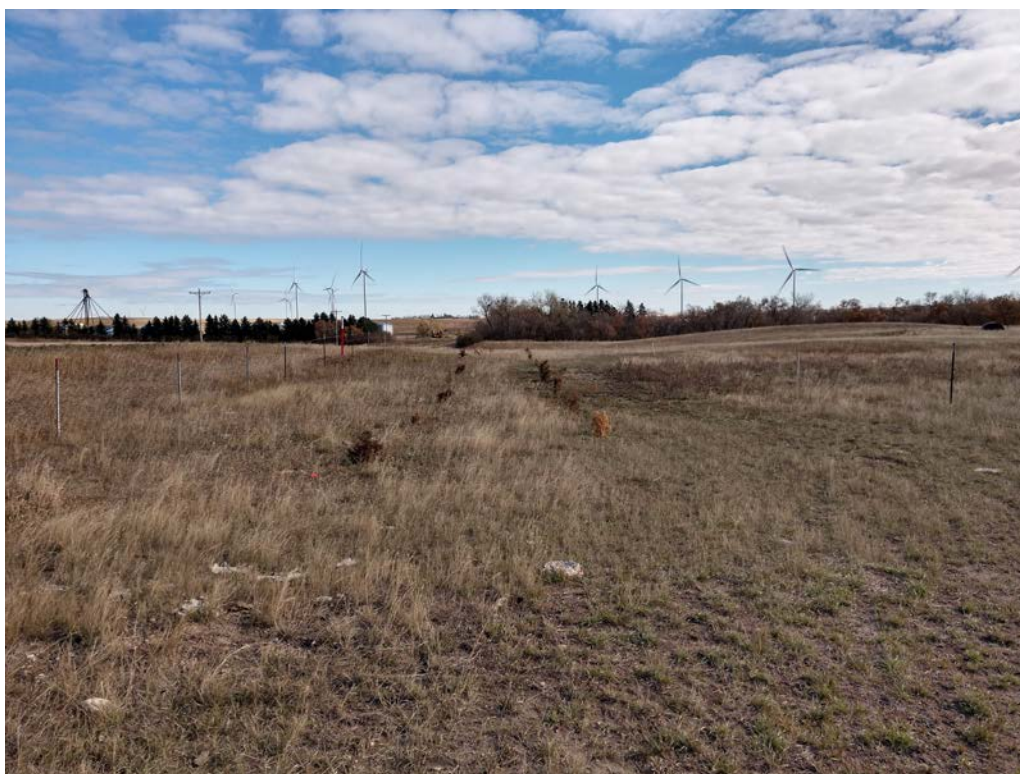
- Tree survival. Trees plantings at four locations were visited during the reclamation inspection. Survival of the plantings appeared to be of mixed success. At one location (adjacent to the substation) the landowner cultivated through the tree planting. Continued monitoring of tree survival is recommended.

Photo 4. Photo of tree planting facing east along 77th St. NW. Continued monitoring of tree survival is recommended.

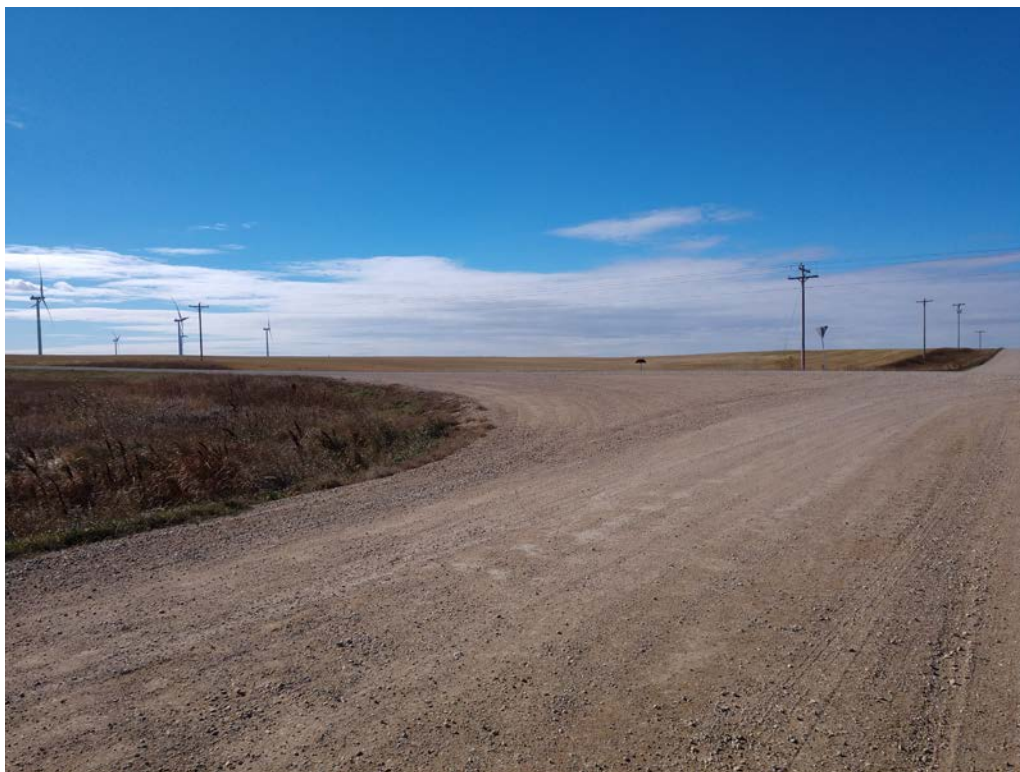
On-going maintenance of access roads is anticipated but normal. Turing radiuses at the intersection(s) of County Road 21 and 77th St. NW and Country Road 21 and 76th St. NW were left in place at the request of the county.

Photo 5. Photo of County Road 21 and 77th St. NW intersection (facing southwest). Widened turning radius was left in place at request of the County.

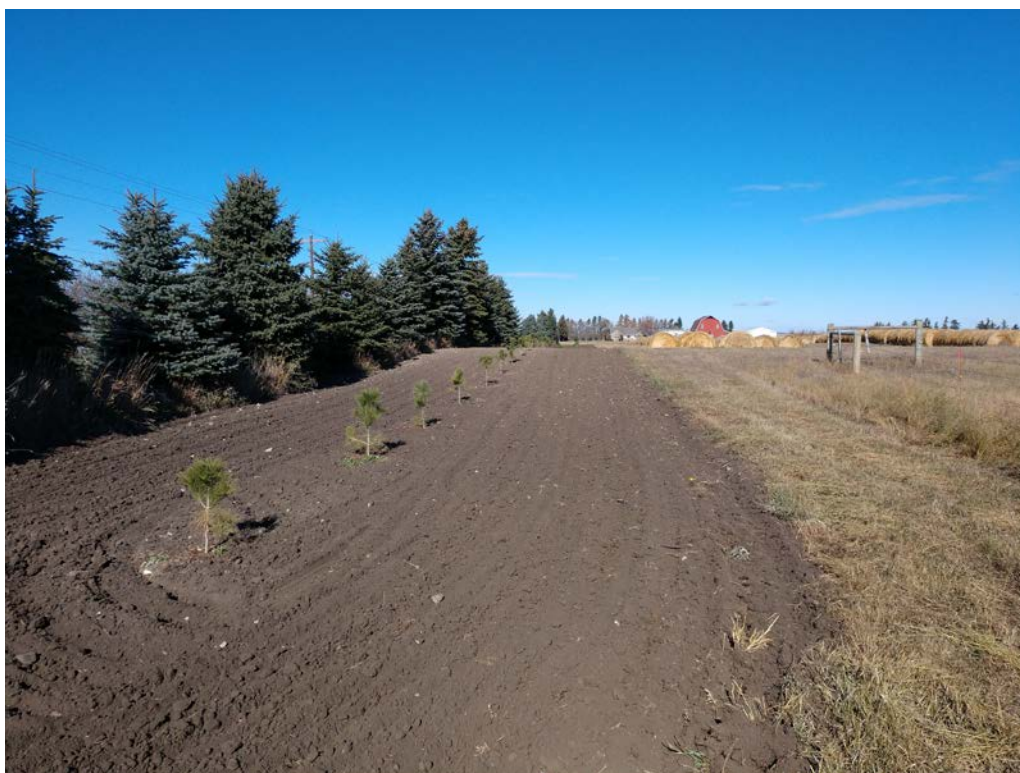
Photo 6. Photo of tree planting at landowner's residence (facing north).

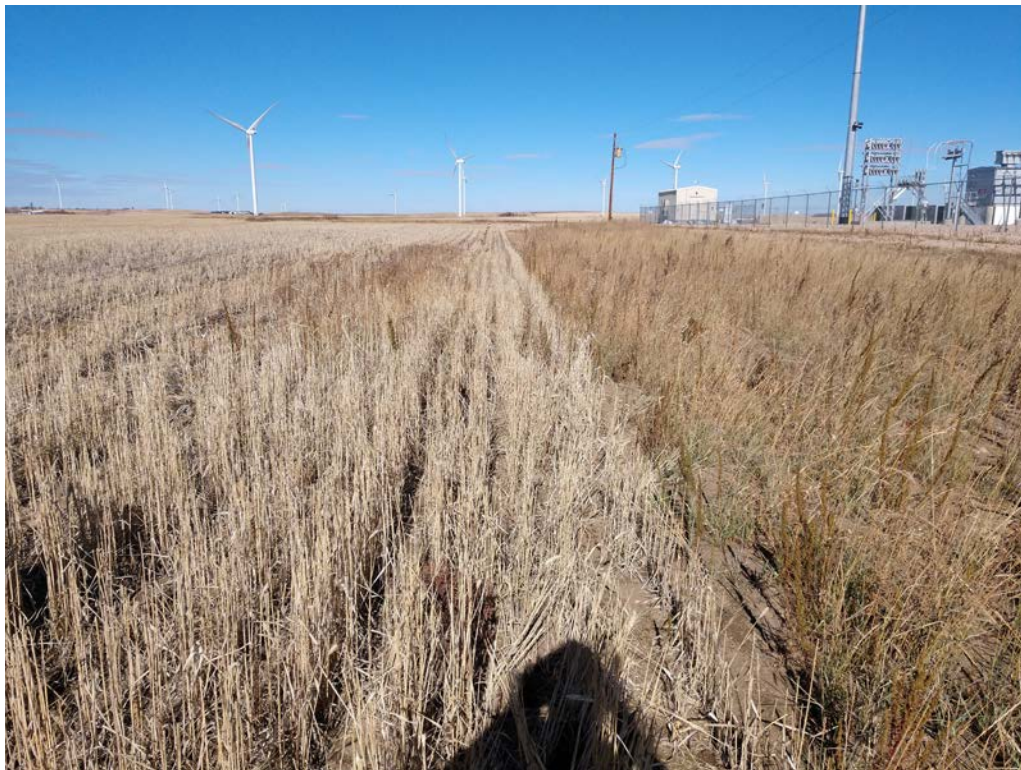
Photo 7. Photo of tree planting at substation (facing north). The landowner cultivated through the tree planting.

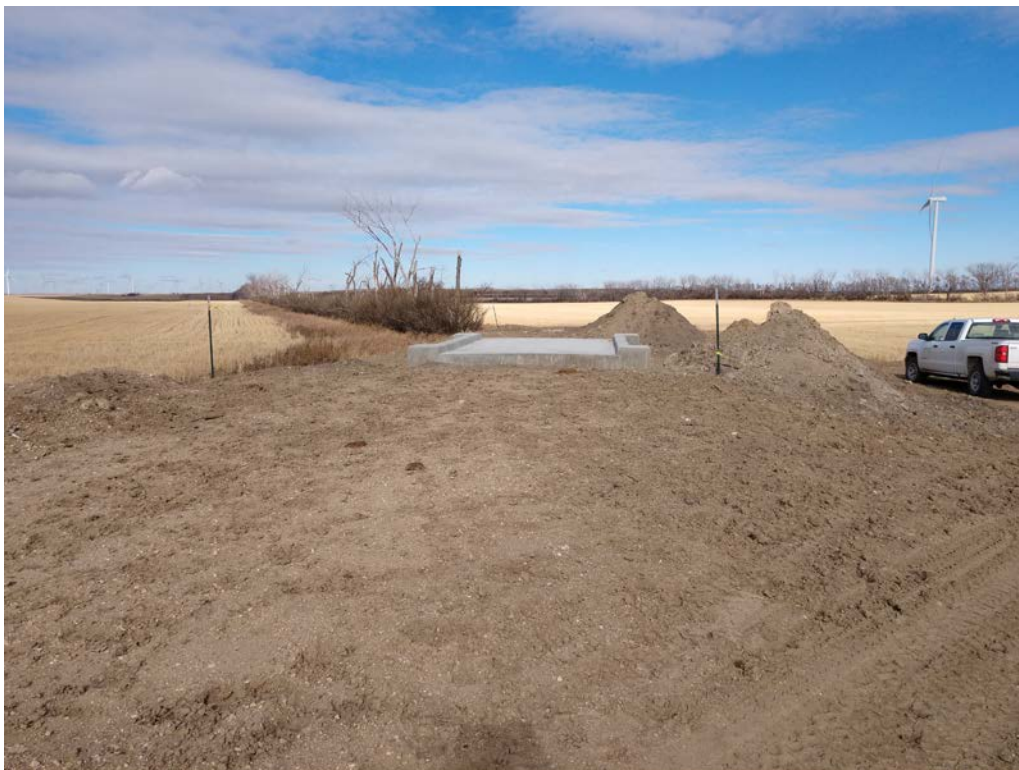
- Pembina Pipeline road crossing(s). There are two locations near Turbines B4 and B3 where the access road crosses a high-pressure gas line owned and operated by Pembina Pipeline. Pembina Pipeline has requested that concrete structures be placed at these locations to distribute the weight of equipment passing over the pipeline. At the time of this inspection, the concrete structures were in place but earthwork around the structures had not been completed. Enel will complete the earthwork this fall and re-seed as necessary in 2019.

Photo 10. Photo of high-pressure gas line crossing near Turbine B4 (facing northeast).
