Appendix A

Aerial View Station 0+00 thru Station 31+82

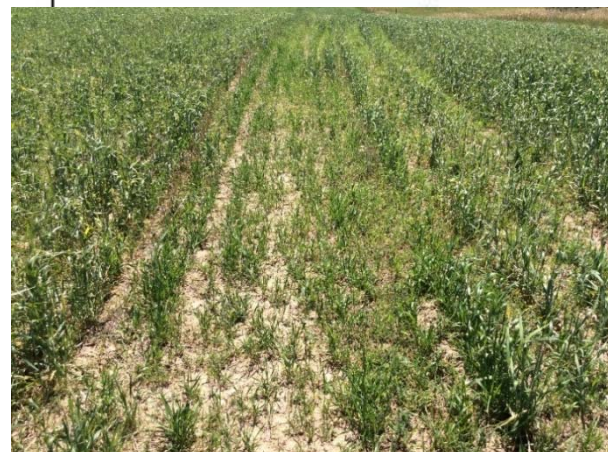
Station 31+99 thru 51+98 "PI#10 thru PI#14"
Reduction in crop growth within easement.

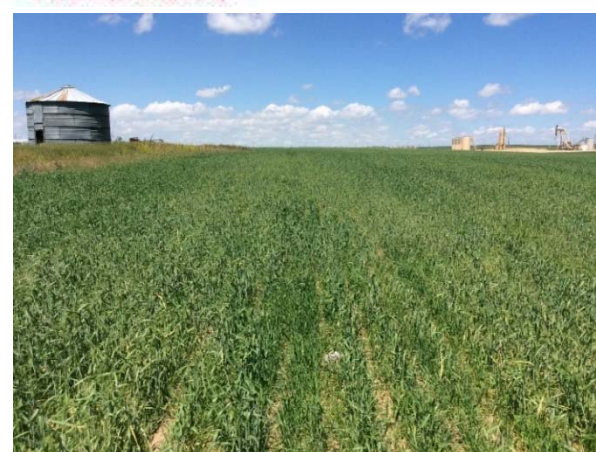
Station 51+98 North of PI#14 the crops have uniformity Good surface conditions.

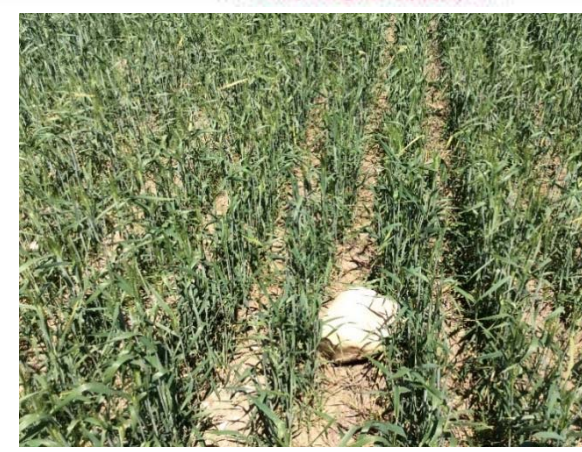
Station 57+71 "Between PI#15 and PI#17"
Surface rocks within easement observed.

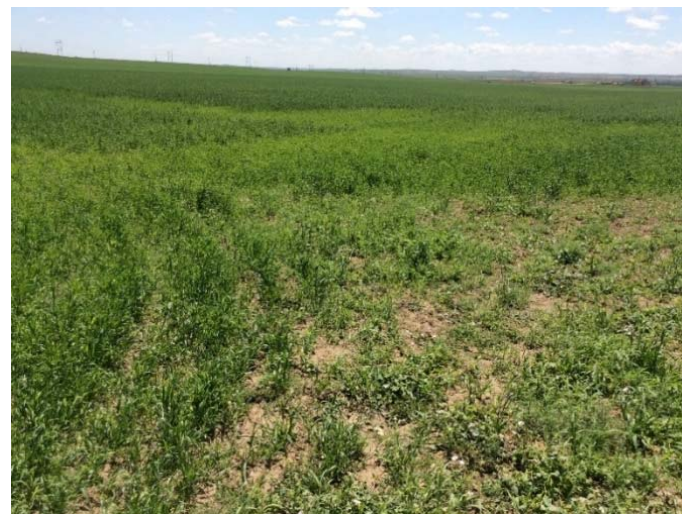
Station 96+25 thru 114+52 "PI#21 to PI#27 there are isolated areas where there is reduction in crop coverage.

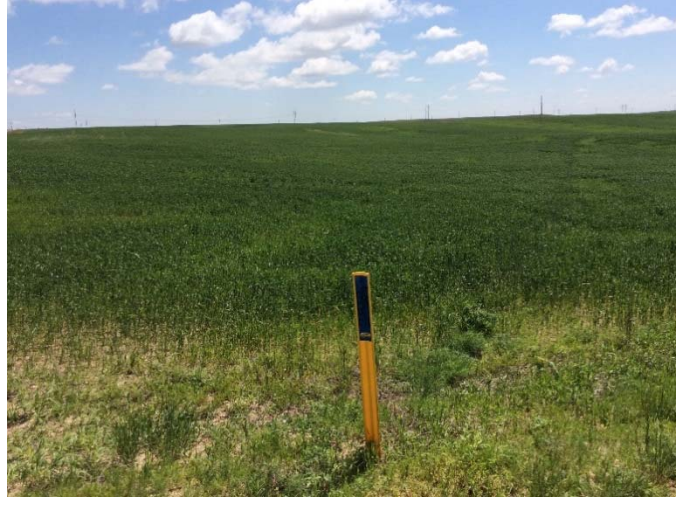
Station 123+95 "PI#31 Crop appears to be uniform in growth
 The subject area appears to have been left unrestored.

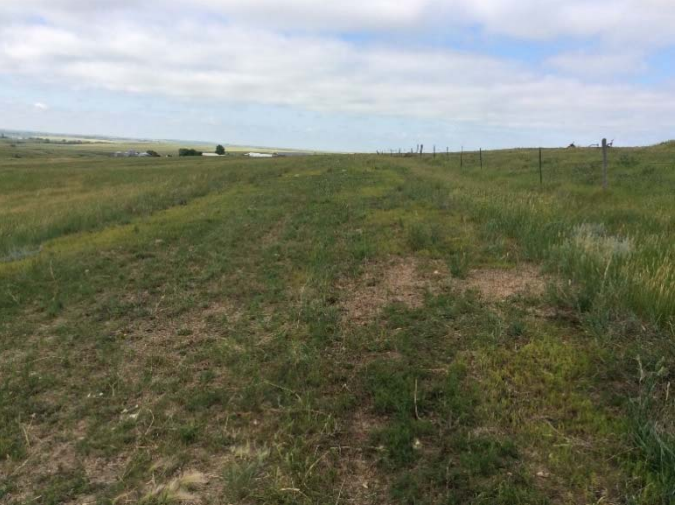
Station 143+18 thru 152+96 "PI#41 to south of PI#45
 The vegetation is weeds rather than crops.

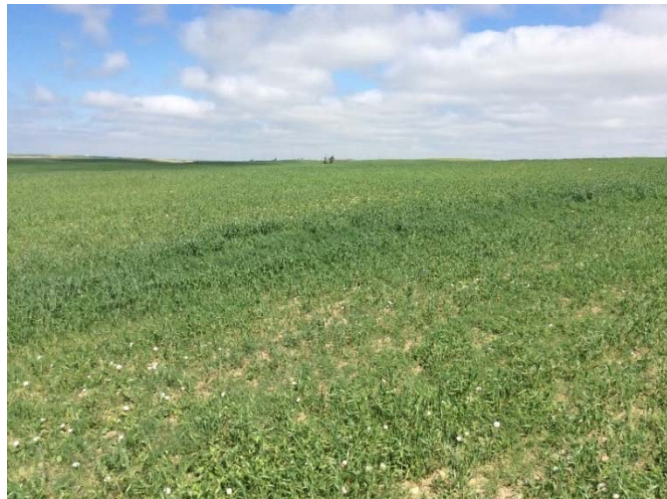
Station 179+95 "PI#49 barley crop
Reduced volumes and quality of crops."

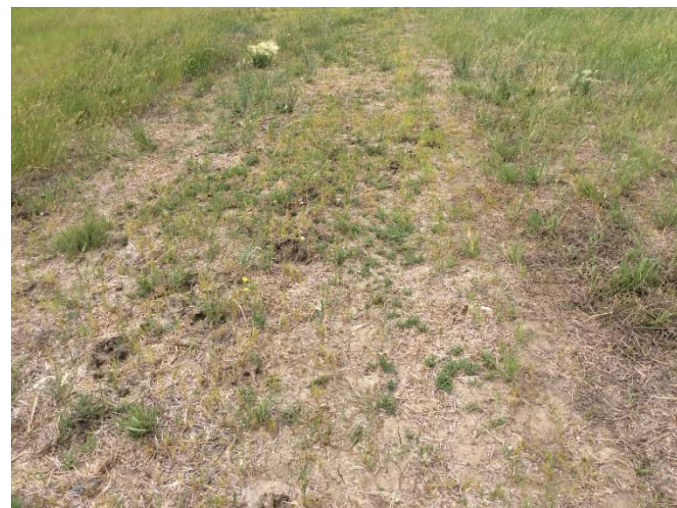
Station 187+91 thru 208+04 "PI#52 thru PI#53"
Poor crop conditions

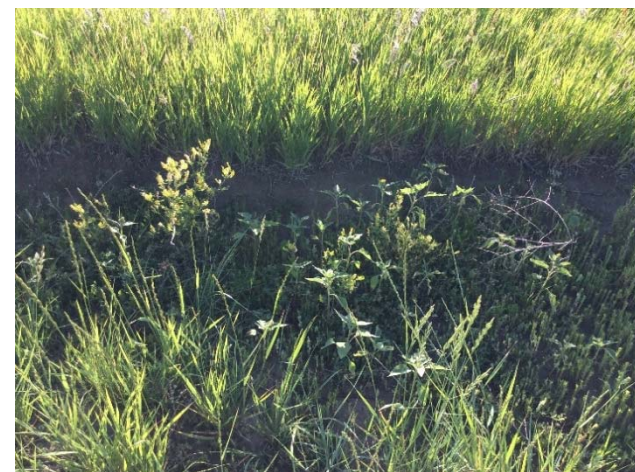
At the quarter section line of section (25) PI# 55 the separation area on Larry G. Novak property was not returned to the pre-construction grades. This subject area is .80 lower than the adjacent area. The recommendation is to regrade the easement to the adjacent elevations and reseeded.

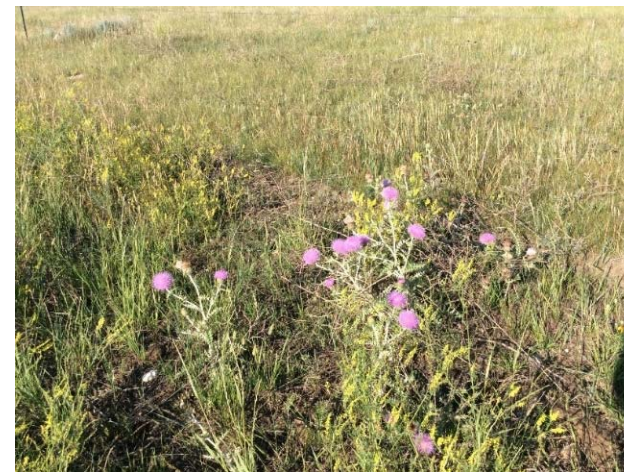
Along this easement there thistle weeds.

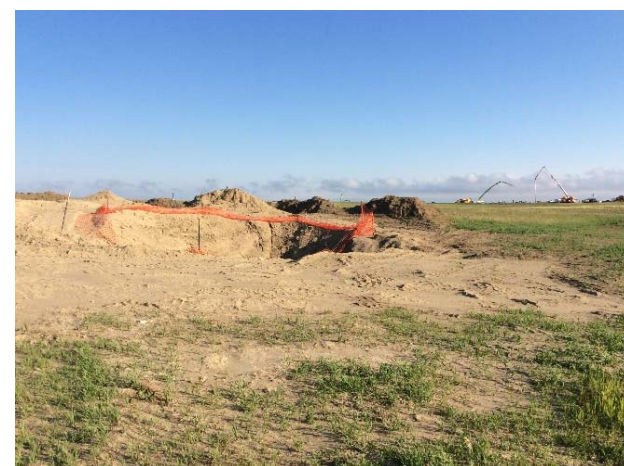
Near station 204+38 pipeline connection and rehabilitation will need to follow

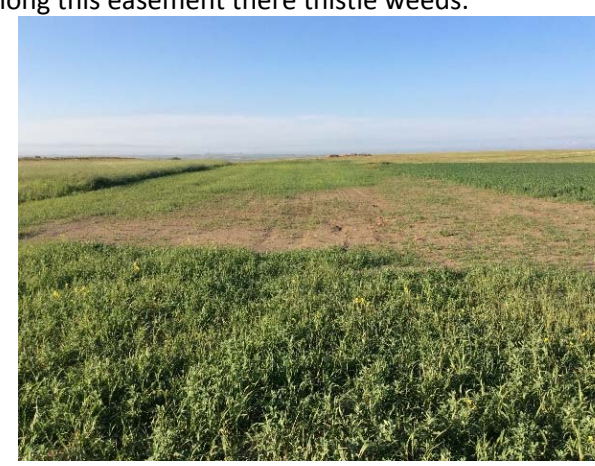
1000 feet south of McKenzie and some 300 feet west of 144th Ave. Near station 204+38 pipeline stub. This area appears to have been stripped of vegetation in Preparation of installing the pipeline.
