RE: Hiland Crude, LLC.
Alexander Tank Farm Crude Oil Pipeline- McKenzie County
Post Construction Inspection Reclamation Report
Case No. PU-15-486

Attachment A
PU-15-486 Alexander Tank Farm Crude Oil Loop Pipeline
Reclamation Photos taken April 21 and 22, 2017

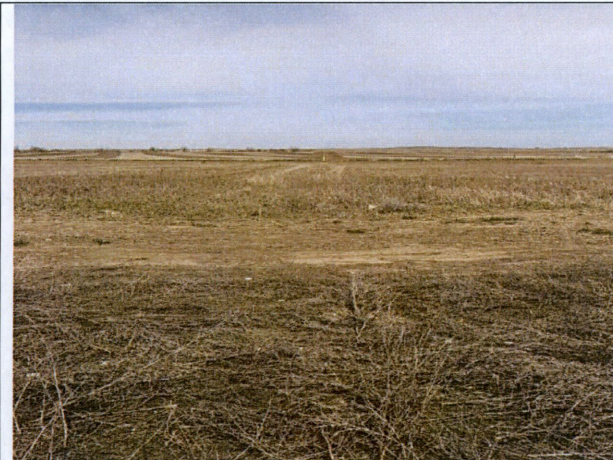
Photo 1- Addresses Recommendation 1 (Pre-Reclamation)

- 1) *Reduced quality and quantity of crop growth between PI#1 and PI# 8 station 0+00 thru 29+94 is an indication that top soil was not properly managed during construction. The addition of fertilizer and organics may provide the necessary improvements to the soil to improve crop conditions.*

Hiland performed additional post-construction grading activities between PI#1 and PI#8 as indicated in Photos 1 and 2. The affected lands had a small portion of sunken ditch but contained sufficient topsoil to regrade and level the sites. No additional material was added to these locations. The site was left in an acceptable condition for the landowner to begin seeding his lands.

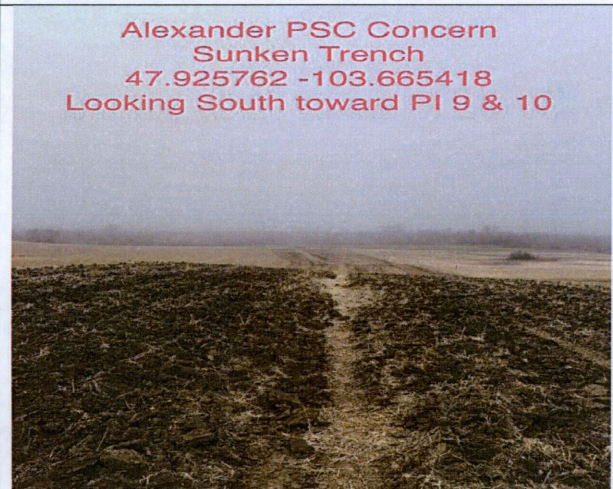
Photo 3- Addresses Recommendation 2 (Pre-Reclamation)

- 2) *Reduced quality and quantity of crop growth between PI#10 and PI#14 station 31+82 thru 51+98 is an indication that top soil was not properly managed during construction. The addition of fertilizer and organics may provide the necessary improvements to the soil to improve crop conditions.*

Alexander PSC Concern
Sunken Trench
47.925762 -103.665418
Looking South toward PI 9 & 10

Hiland performed additional post- construction grading activities between PI#10 and PI#14 as indicated in Photos 3, 4, and 5. Additional topsoil was added to the areas with excessive sunken ditch. Other areas contained enough top soil to regrade and level the sites. Photo 4 shows additional topsoil placement between PI #10 and PI #14. The site was left in an acceptable condition for the landowner to begin seeding his lands.

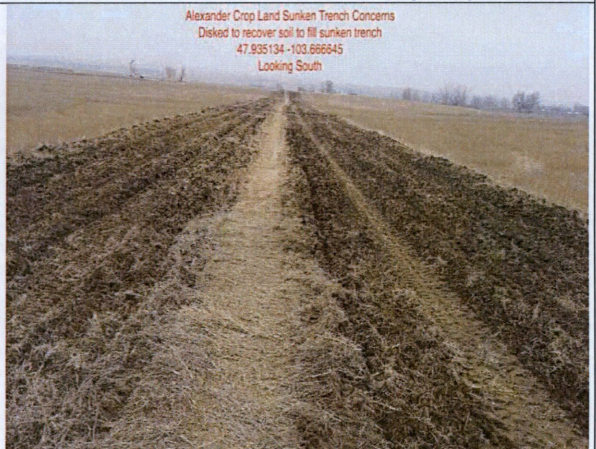
Photo 6- Addresses Recommendation 3 (Pre-Reclamation)

- 3) *Several rock of this size and smaller were observed from PI#15 thru PI#17(station 57+78 thru station 75+90) in the easement. The rocks need to be removed. There is also indications of reduced crop growth in sporadic locations within this area. The addition of fertilizer and organics may provide the necessary improvement to the soil to improve crop conditions.*

Alexander Crop Land Sunken Trench Concerns
Disked to recover soil to fill sunken trench
47.935134 -103.666645
Looking South

Hiland performed additional post-construction grading activities between PI #15 and PI#17 as indicated in Photos 6, 7, 8, and 9. The affected lands had sufficient topsoil to regrade and level the sites. Hiland did remove rock as per Recommendation 3 along the permanent right-of-way as shown in Photo 8. However it should be noted (and supported by photo 9) that similar diameter rock was present throughout the field and not isolated to the ROW. The site was left in an acceptable condition for the landowner to begin seeding his lands.

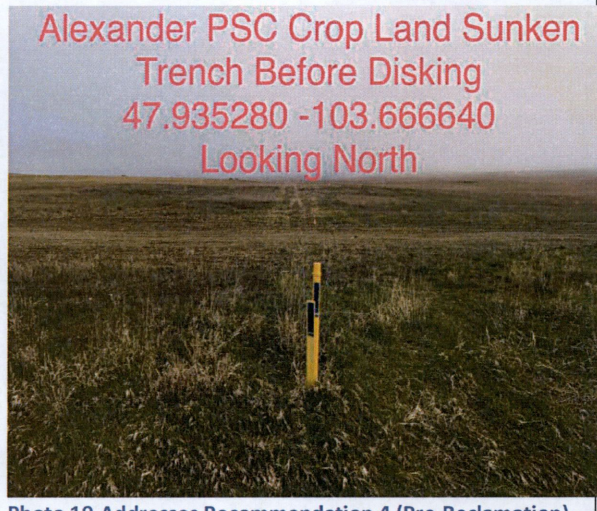
Photo 10-Addresses Recommendation 4 (Pre-Reclamation)

- 4) *Reduced quality and quantity of crop growth between stations PI# 27 to PI#21 is an indication that top soil was not properly managed during construction. The addition of fertilizer and organics may provide the necessary improvements to the soil to improve crop conditions.*

Alexander PSC Crop Land Sunken
Trench Before Disking
47.935280 -103.666640
Looking North

Hiland performed additional post-construction grading activities between PI#21 and PI# 27 as indicated in Photos 10 and 11. Additional topsoil was added to the areas with excessive sunken ditch. Other areas contained enough top soil to regrade and level the sites. Photo 11 shows the placement of additional topsoil placement between PI#21 and PI#27. The site was left in an acceptable condition for the landowner to begin seeding his lands.

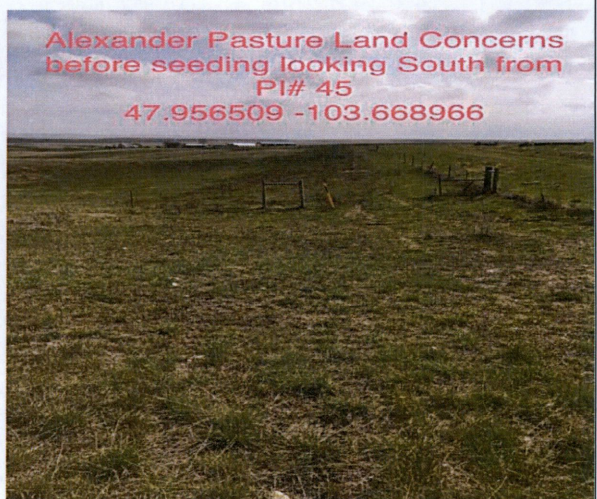
Photo 12- Addresses Recommendation 5 (Pre-Reclamation)

- 5) *Reduced quality and quantity of crop growth near station #49 and between stations #41 thru #45 is an indication that top soil was not properly removed and replaced. The addition of fertilizer and organics may provide the necessary improvements to the soil to improve crop conditions.*

Alexander Pasture Land Concerns
before seeding looking South from
PI# 45
47.956509 -103.668966

Hiland performed additional post-construction reseeding activities for sections of non-agriculture croplands between PI#41 and PI#45 as indicated in Photos 12 and 13. North Dakota State Land Mix was used at a rate of 38lbs per acre.

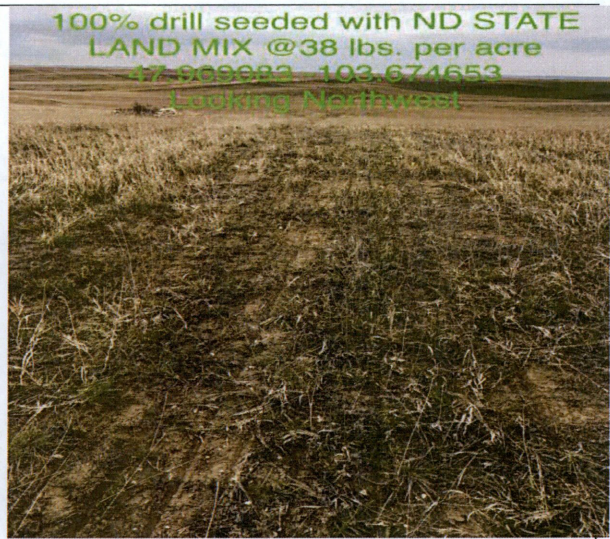
Photo 14- Addresses Recommendation 6 (Post-Reclamation)

- 6) *Reduced quality and quantity of crop growth between stations PI#51 and PI#52 is an indication that top soil was not properly managed during construction.*

Hiland performed additional post-construction reseeding activities between PI# 51 and PI#52 as indicated in Photos 14 and 15. It should be noted that coordinates for Photo 15 indicate that it was taken at PI#52 not PI#49 as indicated on the photo. North Dakota State Land Mix was used at a rate of 38lbs per acre.

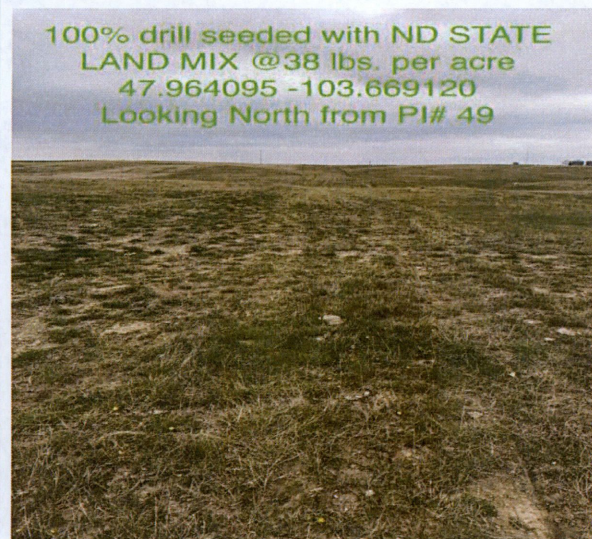
Photo 15- Addresses Recommendation 6 (Post-Reclamation)
Incorrect PI#, Coordinates for PI #52

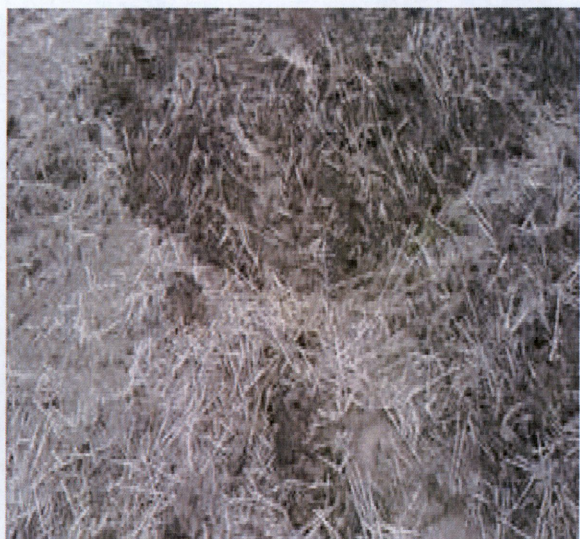
Photo 16- Addresses Recommendation 8 (Pre-Reclamation)

- 8) *Near the quarter section line of section (25) PI#55 to PI#56 (Station 215+62 to Station 220+83) the finished grade was not returned to the original ground elevation. This area is some .80 lower, this area needs to be returned to the same elevation and reseeded.*

Hiland performed additional post-construction grading activities between PI#55 and PI#56 as indicated in Photos 16 and 17. The affected lands had sufficient topsoil to regrade and level the sites. No additional material was added at this location. The site was left in an acceptable condition for the landowner to begin seeding his lands.
