**Re: Citizen Complaint of Casey Voigt**

### INSPECTION REPORT

PERMITTEE - MINE: Coyote Creek Mining Company, L.L.C. - Coyote Creek Mine

PERMITS INSPECTED: NACC-1301 and NACC-1302

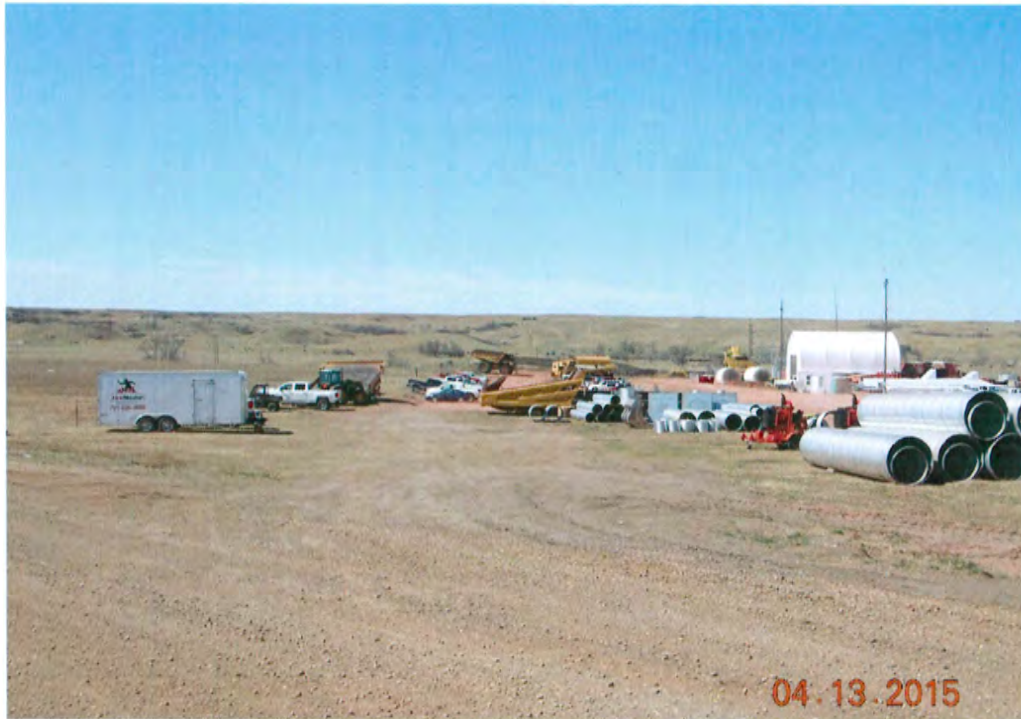
The inspection began by reviewing an area in the NE $\frac{1}{4}$ NE $\frac{1}{4}$ NE $\frac{1}{4}$  of Section 31 in Permit NACC-1301 where SPGM had not been removed but it was being used for contractor and equipment parking, and also for equipment and material storage as pictured in Figure 1 and outlined on Figure 5. Mr. Voigt expressed his concerns with possible topsoil degradation and erosion caused by vehicle and equipment traffic in the area. Although accelerated erosion or rutting was not evident in the area, the native rangeland vegetation was worn bare in the main traffic path, and it appeared that topsoil degradation and erosion would likely occur if current use of the area continued. SPGM removed from the E $\frac{1}{2}$ SE $\frac{1}{4}$  of Section 30 in Permit NACC-1301 in 2014 for the mine office-shop facility and access road was stockpiled north of the facility as depicted on Figure 5, as was SPGM removed from the N $\frac{1}{2}$ NE $\frac{1}{4}$ NE $\frac{1}{4}$  of Section 31 for contractor and equipment parking. Additional SPGM was removed from the contractor and equipment parking area in 2014 and 2015 when expansion became necessary. The August 7, 2014 and October 30, 2014 Coyote Creek Mine inspection reports noted that idle equipment could be stored on areas where SPGM was not removed, but SPGM should be removed from areas where traffic could cause SPGM degradation. Mr. Steffen explained that SPGM removal had not progressed eastward to the area of concern inspected on April 13, 2015 because CCMC desired to minimize disturbance, but he agreed that SPGM should be removed from the area to accommodate the need for expanded parking and equipment and material storage areas. SPGM removal from 0.3 acres in the area was viewed during an April 16, 2015 Coyote Creek Mine inspection and approved on April 20, 2015. Topsoil from the area is stored in a temporary stockpile west and adjacent 65 $\frac{1}{2}$ <sup>th</sup> AVE SW where it is expected to be used for road ditch revegetation of the reconfigured intersection of 65 $\frac{1}{2}$ <sup>th</sup> AVE SW and 17<sup>th</sup> ST SW to be constructed this year. Existing SPGM stockpiles located in NACC-1301 as depicted on Figure 5 are currently inaccessible for additional SPGM storage. Subsoil from the area was stored in a temporary stockpile south of pond P30-01.

**Figure 1.** Area in the NE $\frac{1}{4}$ NE $\frac{1}{4}$ NE $\frac{1}{4}$  of Section 31 in Permit NACC-1301 where SPGM had not been removed but is being used for contractor and equipment parking, and also for equipment and material storage - facing west with 65 $\frac{1}{2}$ <sup>th</sup> AVE SW in foreground, and scoria capped parking in background - refer to Figure 5 for area location

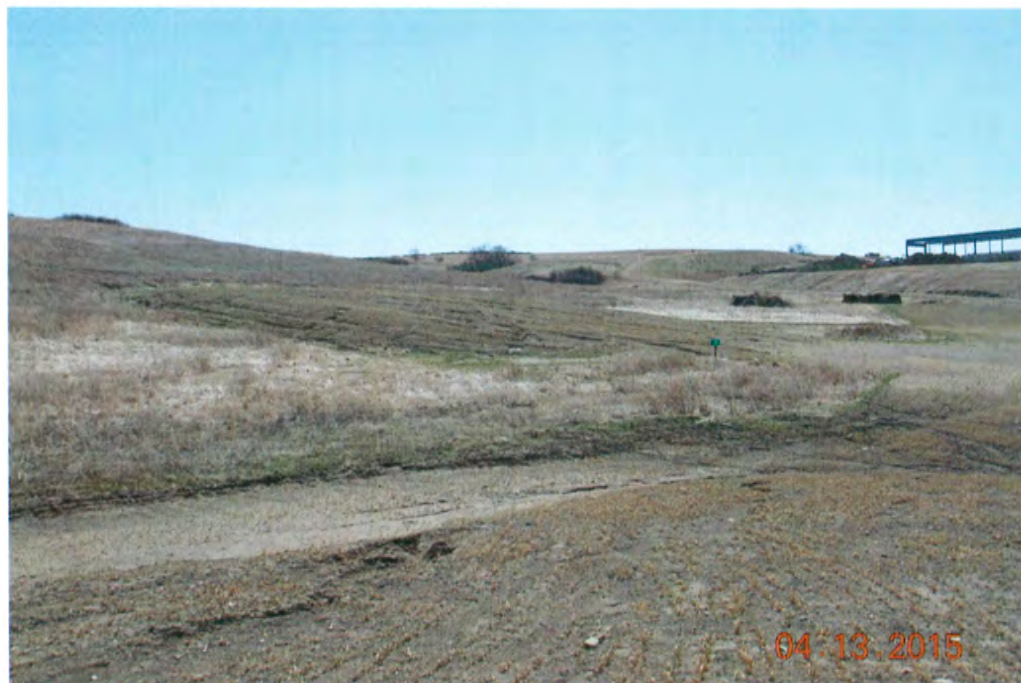
SPGM stockpiles located north of the mine office-shop facility in Permit NACC-1301 as depicted in Figure 5 were viewed near the close of the inspection after Casey Voigt had departed. These stockpiles and the surrounding associated disturbance had been seeded and mulched in the late summer and early fall of 2014 but it was evident that maintenance is required to repair and stabilize erosional rilling that had developed on the piles and disturbed areas as pictured in Figure 2. Mr. Steffen indicated that seeding and mulching equipment had been ordered and was expected to be delivered shortly whereupon CCMC personnel would repair the erosion and stabilize the stockpiles by reseeding or mulching.

**Figure 2.** Erosional rilling requiring repair on SPGM stockpiles and the surrounding associated disturbance areas in Section 30 in Permit NACC-1301 - facing southeast toward stockpile TS-3 with the mine office-shop building frame in background – refer to Figure 5 for location

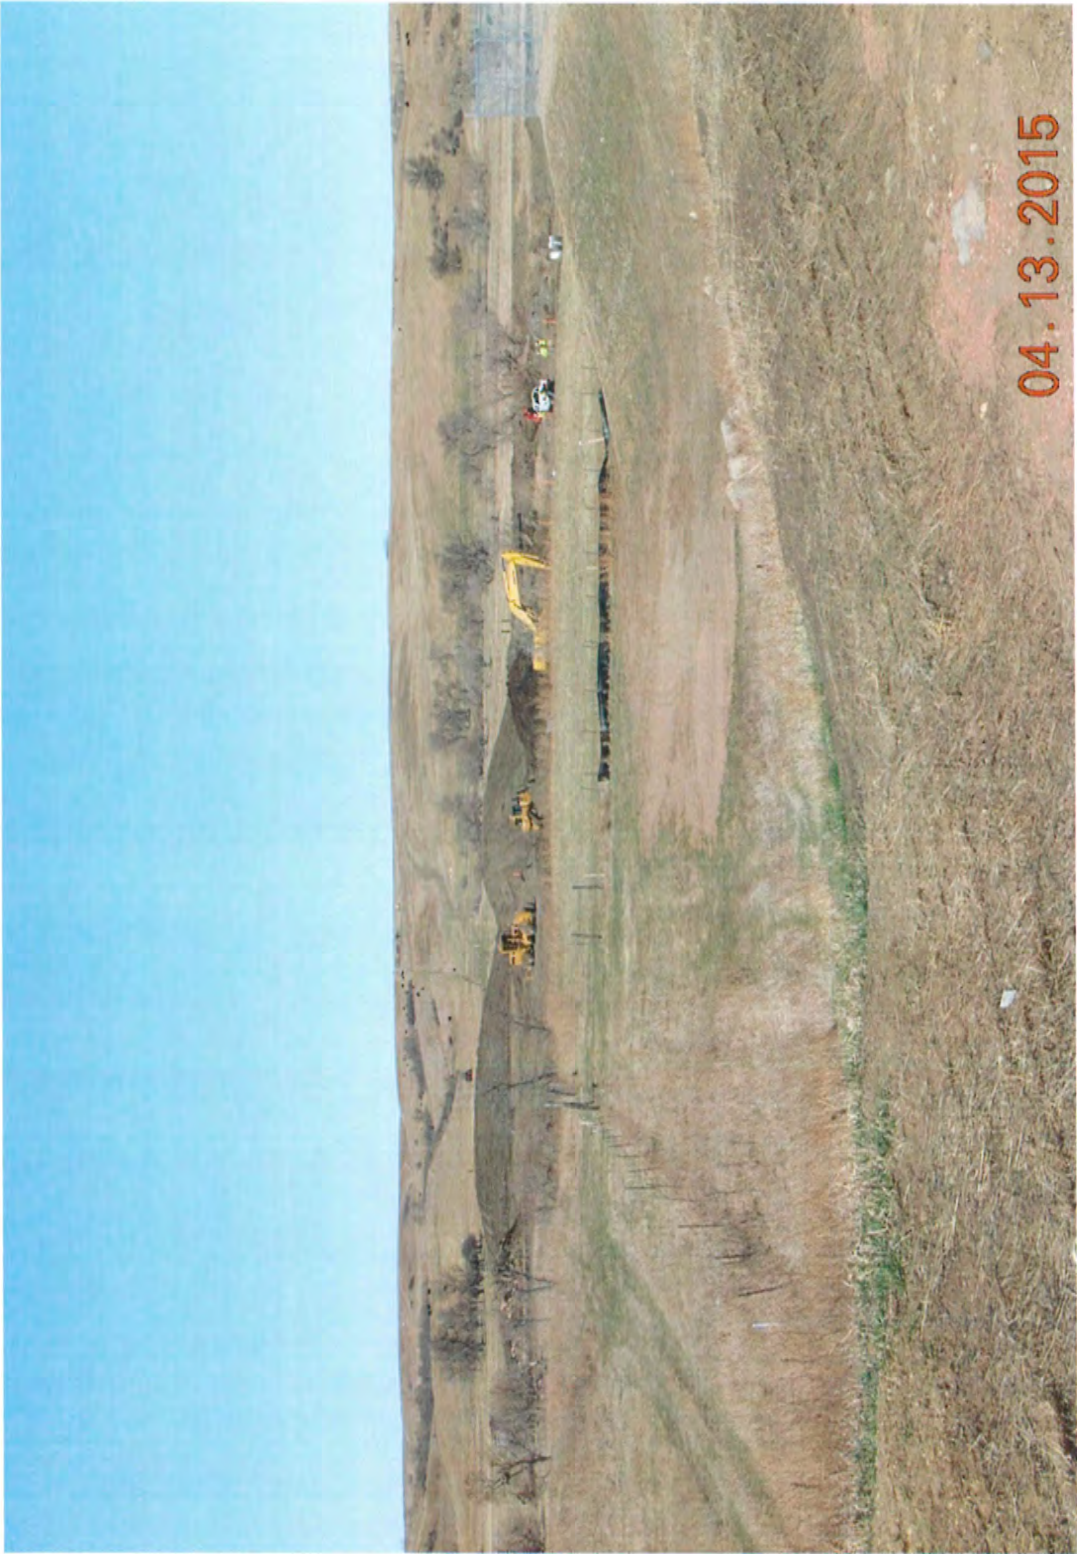
SPGM removal for a four acre segment of the Shop Access Road on both sides of Coyote Creek for which construction has just begun was viewed and approved during the inspection. As depicted on Figure 5, the Shop Access Road will extend westward from the mine office-shop facility to a haul road. CCMC had received prior approval to stockpile topsoil and subsoil in the Shop Access Road corridor until SPGM stockpile locations could be developed on the west side of the North-South Haul Road to be constructed in the W $\frac{1}{2}$  of Section 30. An overview of the SPGM removal area is pictured in Figure 3. SPGM removal monuments retained in the removal area indicated that subsoil had been removed to the depths indicated on the detailed soil survey map (Section 2.5.6 in Permit NACC-1302). The SPGM removal area included some prime farmland acreage on the west side of Coyote Creek but segregation of the prime and non-prime farmland topsoil and subsoil is not required because the access road corridor constitutes associated disturbance rather than actual mining disturbance. Runoff from the temporary stockpiles that are not located within the watershed of pond P30-01 will be managed with SPGM stripping edges, sumps, silt fences, shallow berms or ditches, or a combination thereof.

Figure 3. SPGM removal for a four acre segment of the Shop Access Road on both sides of Coyote Creek with a temporary topsoil stockpile in left background and a temporary subsoil stockpile in middle background – facing west with fence line in center-west marking the section line common to Section 30 on right (north) and Section 31 on left (south) – photograph taken south of large white hoop building pictured in right background in Figure 1

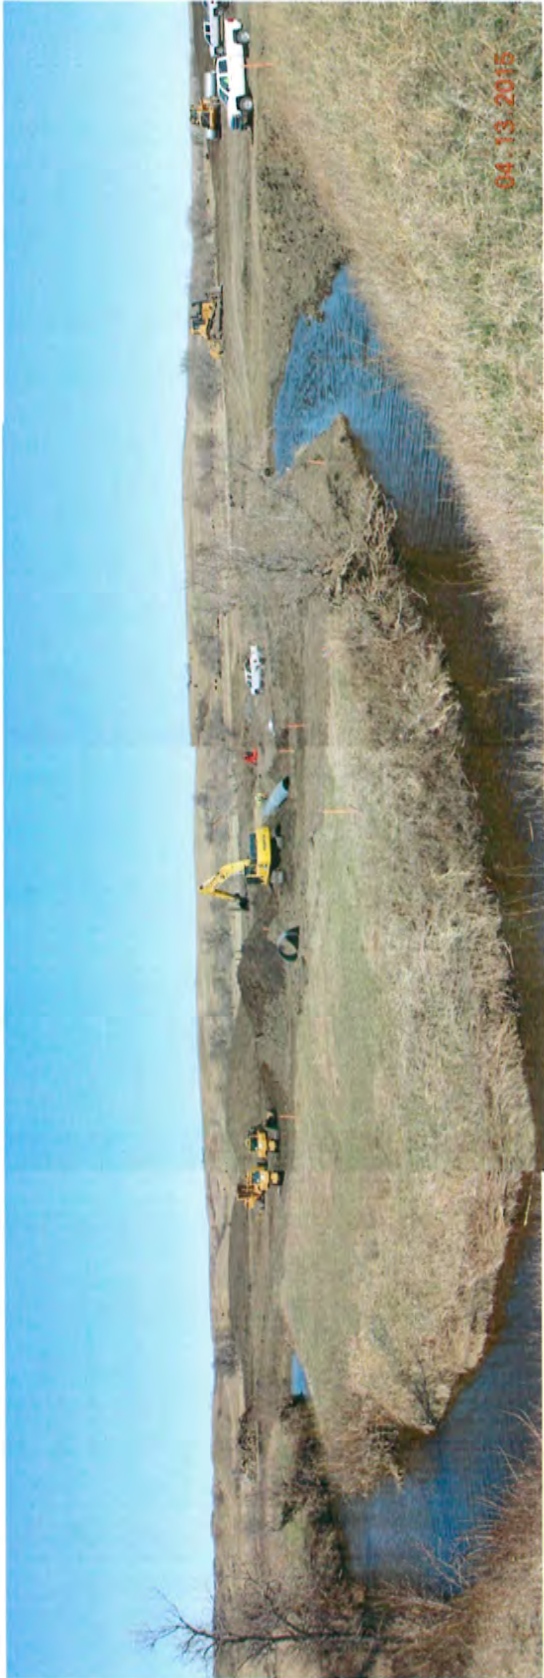
Culvert installation for the Shop Access Road Coyote Creek crossings was also viewed while viewing SPGM removal for a four acre segment of the Shop Access Road on both sides of Coyote Creek as previously described. At the time of inspection, the 36 inch low flow steel culvert was being installed as pictured in Figure 4. It should be noted that the approved design for the 36 inch culvert depicts a slight angle near the culvert's midpoint. The design was revised to depict a straight culvert with the application of Revision No. 1 to Permit NACC-1302 that is under review. The proposed design change was approved by the commission via email correspondence on March 19, 2015 and it received U.S. Army Corps of Engineers concurrence on March 20, 2015. Please refer to Figure 5 for the culvert types and locations for the Shop Access Road Coyote Creek crossings. Installation of the 36 inch low flow steel culvert would need to be completed no later than April 14<sup>th</sup> because CCMC's Regional General Permit from the U.S. Army Corps of Engineers does not allow regulated activity in Coyote Creek from April 15<sup>th</sup> to June 1<sup>st</sup>. Installation of the four 10 foot by 10 foot box culverts will follow but it appears that they will not be installed to divert Coyote Creek flow until after June 1<sup>st</sup>. Mr. Steffen indicated SPGM removal will proceed westward along the Shop Access Road corridor toward the location for pond P31-01 after the 36 inch low flow steel culvert installation is complete. Overburden from pond P31-01 excavation will provide the fill necessary to achieve grade for the Shop Access Road.

Based on the foregoing permit excerpts and observations from the April 13, 2015 inspection, it appears that CCMC is conducting operations for the Shop Access Road Coyote Creek culvert installations in reverse order of that approved in Permit NACC-1302. CCMC should have requested commission approval to revise culvert installation plans and provided adequate justification for doing so. Furthermore, it appears that potentially serious environmental risks are posed by installing the low flow culvert prior to diverting Coyote Creek flow through the box culverts. The Coyote Creek stream flow is now restricted through the low flow culvert until the box culverts are installed to divert the stream presumably after June 1<sup>st</sup>. High stream flow resulting from a heavy precipitation event may overtop the low flow culvert and cut through culvert backfill and the Shop Access Road corridor causing downstream sediment deposition. CCMC is advised to expedite box culvert installation so Coyote Creek flow can be diverted through the box culverts immediately after the U.S. Army Corps of Engineers spring restriction of regulated activity expires. CCMC is also advised to refrain from building any segment of the Shop Access Road near Coyote Creek that could function as an embankment and cause upstream flooding if stream flow is restricted by the low flow culvert.

Figure 4. Panorama of 36 inch low flow steel culvert installation in Coyote Creek for the Shop Access Road Coyote Creek crossing - facing west on left and rotating to face north on right with temporary culvert in place on center-right for equipment crossing – refer to Figure 5 for culvert location – note temporary topsoil stockpile in left background and a temporary subsoil stockpile in middle background – also note that dozer was in motion when photographs were taken

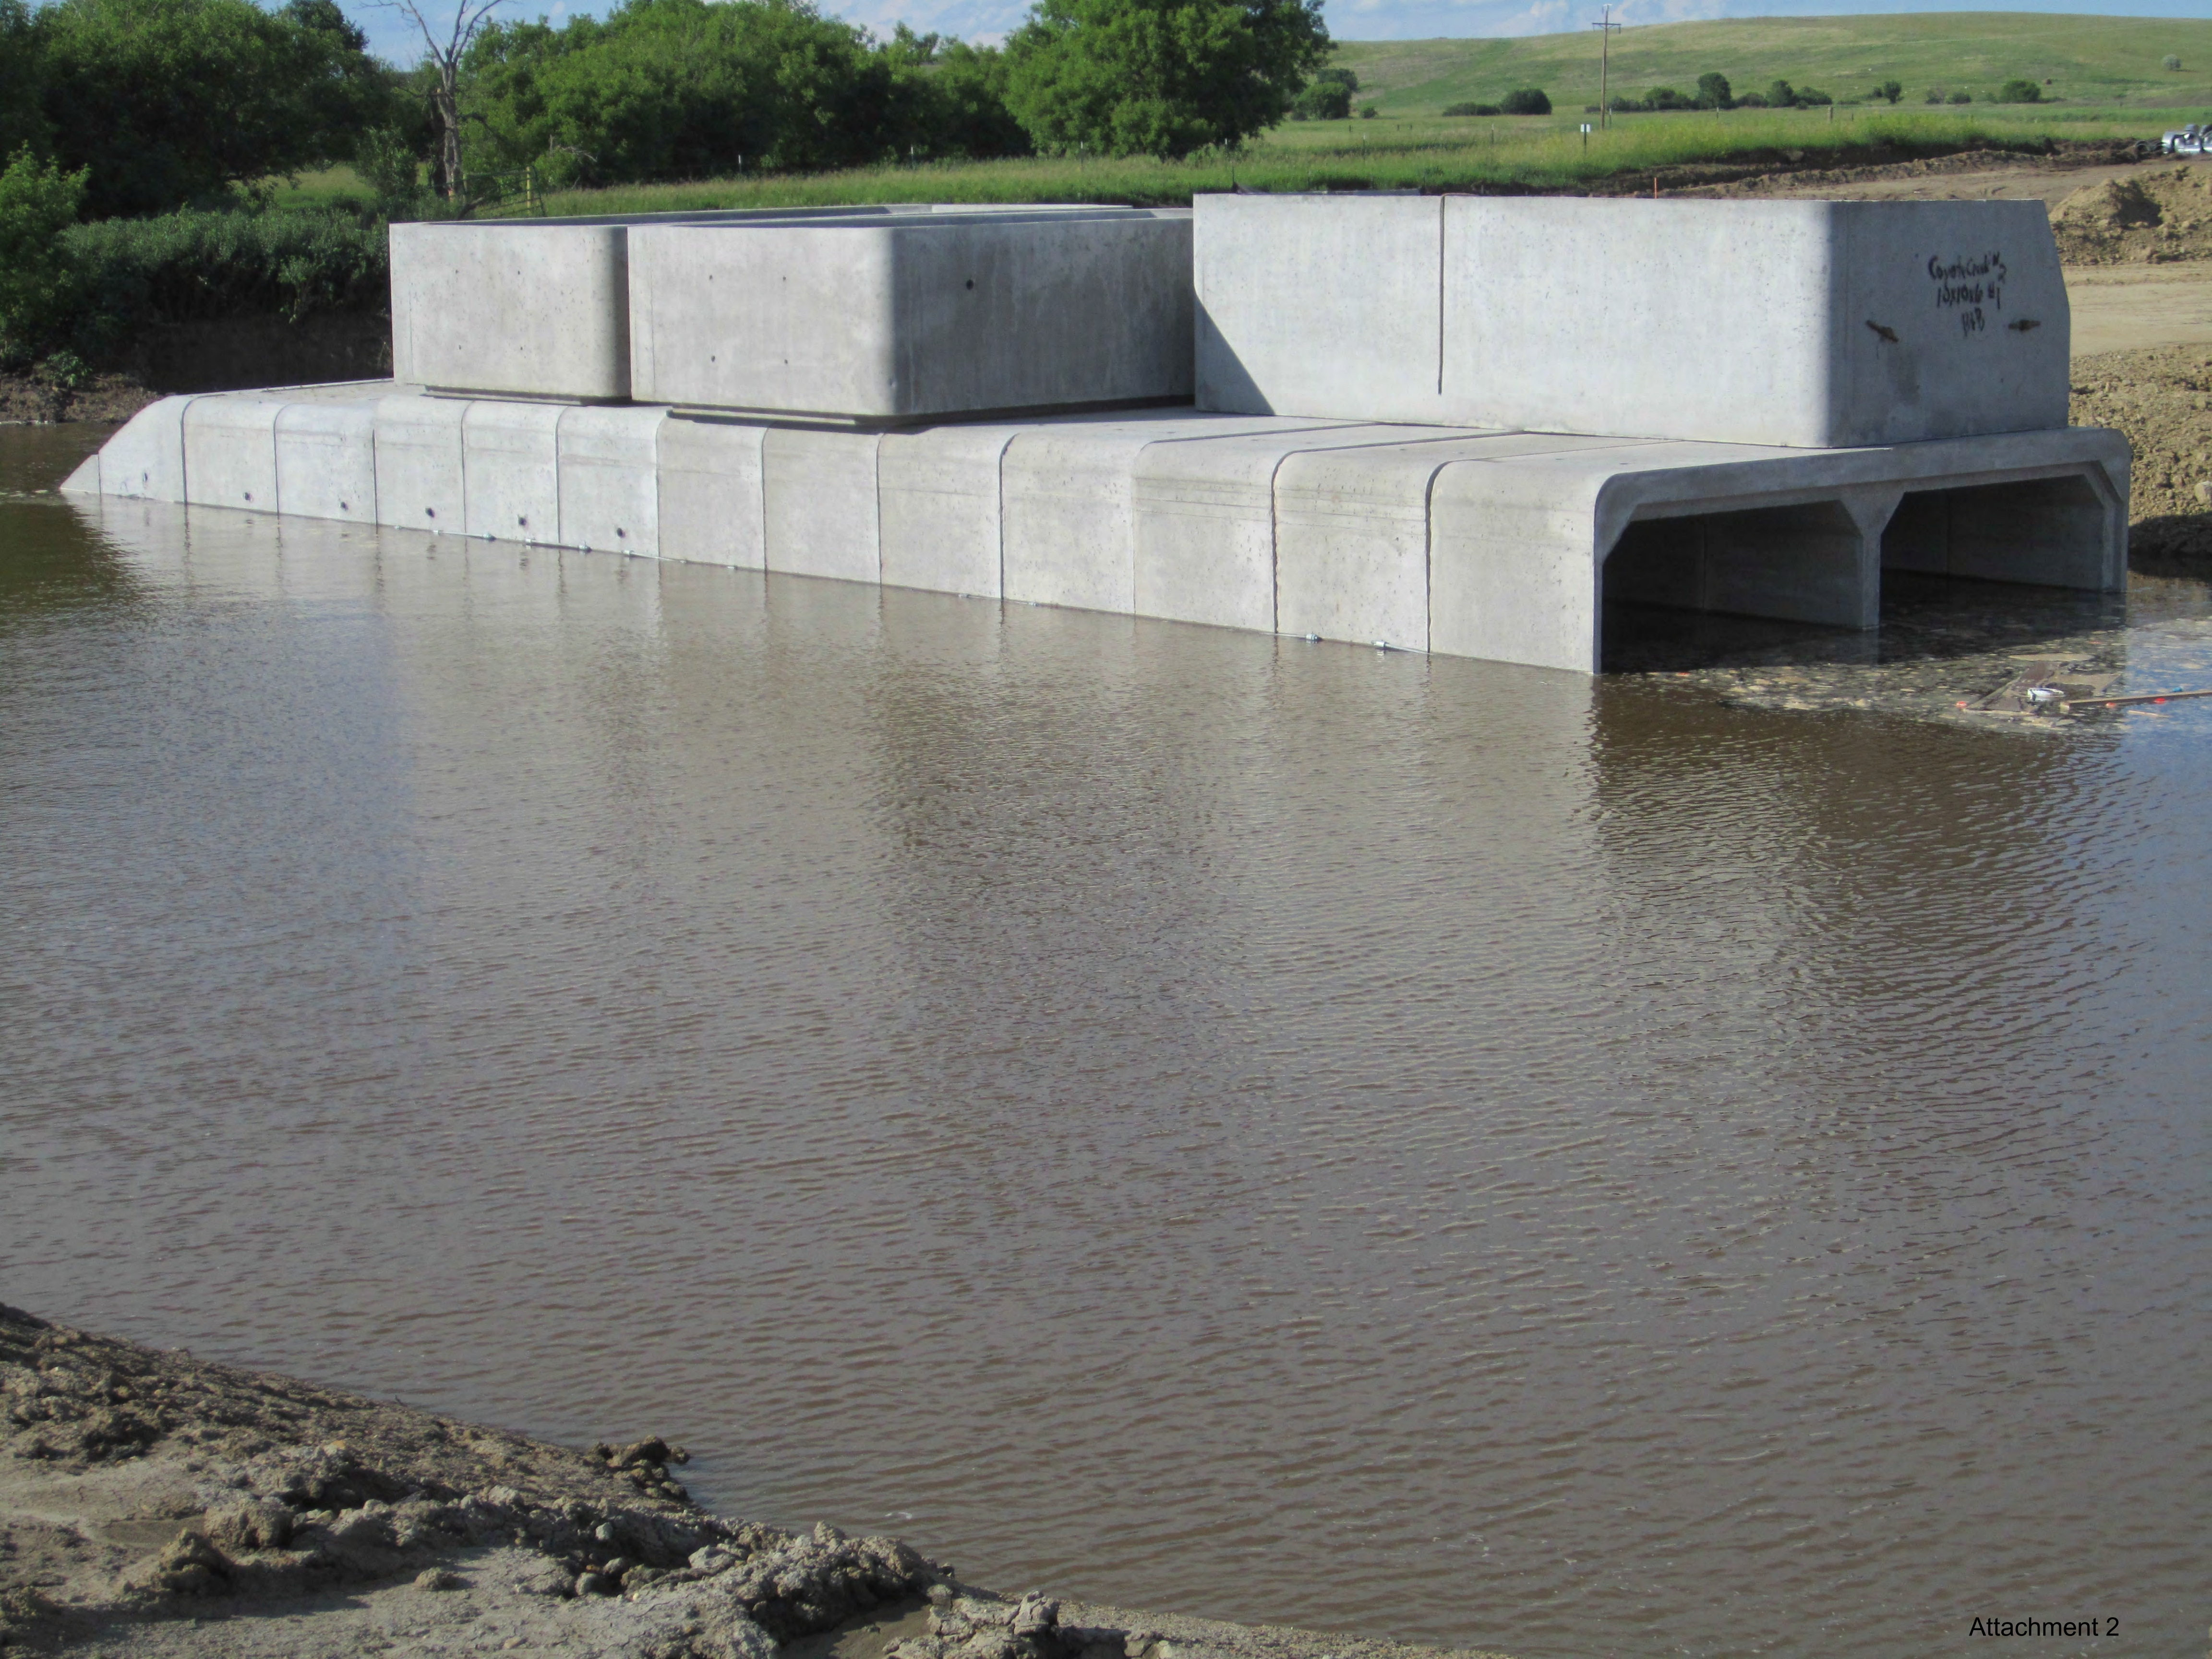
2. On June 19, the box culverts still had not been constructed, and the situation continues to present the ongoing serious environmental risk described by the PSC. Attachment 2 provides a photograph from Saturday, June 20, 2015 showing that the box culverts have not been constructed and instead are sitting, unused, on the property. In other words, over two months have now passed and Coyote Creek Mining Company has not remedied this problem even though they were notified of the serious environmental risk posed by this situation both verbally at the inspection itself and in writing in the PSC's follow-up inspection report.

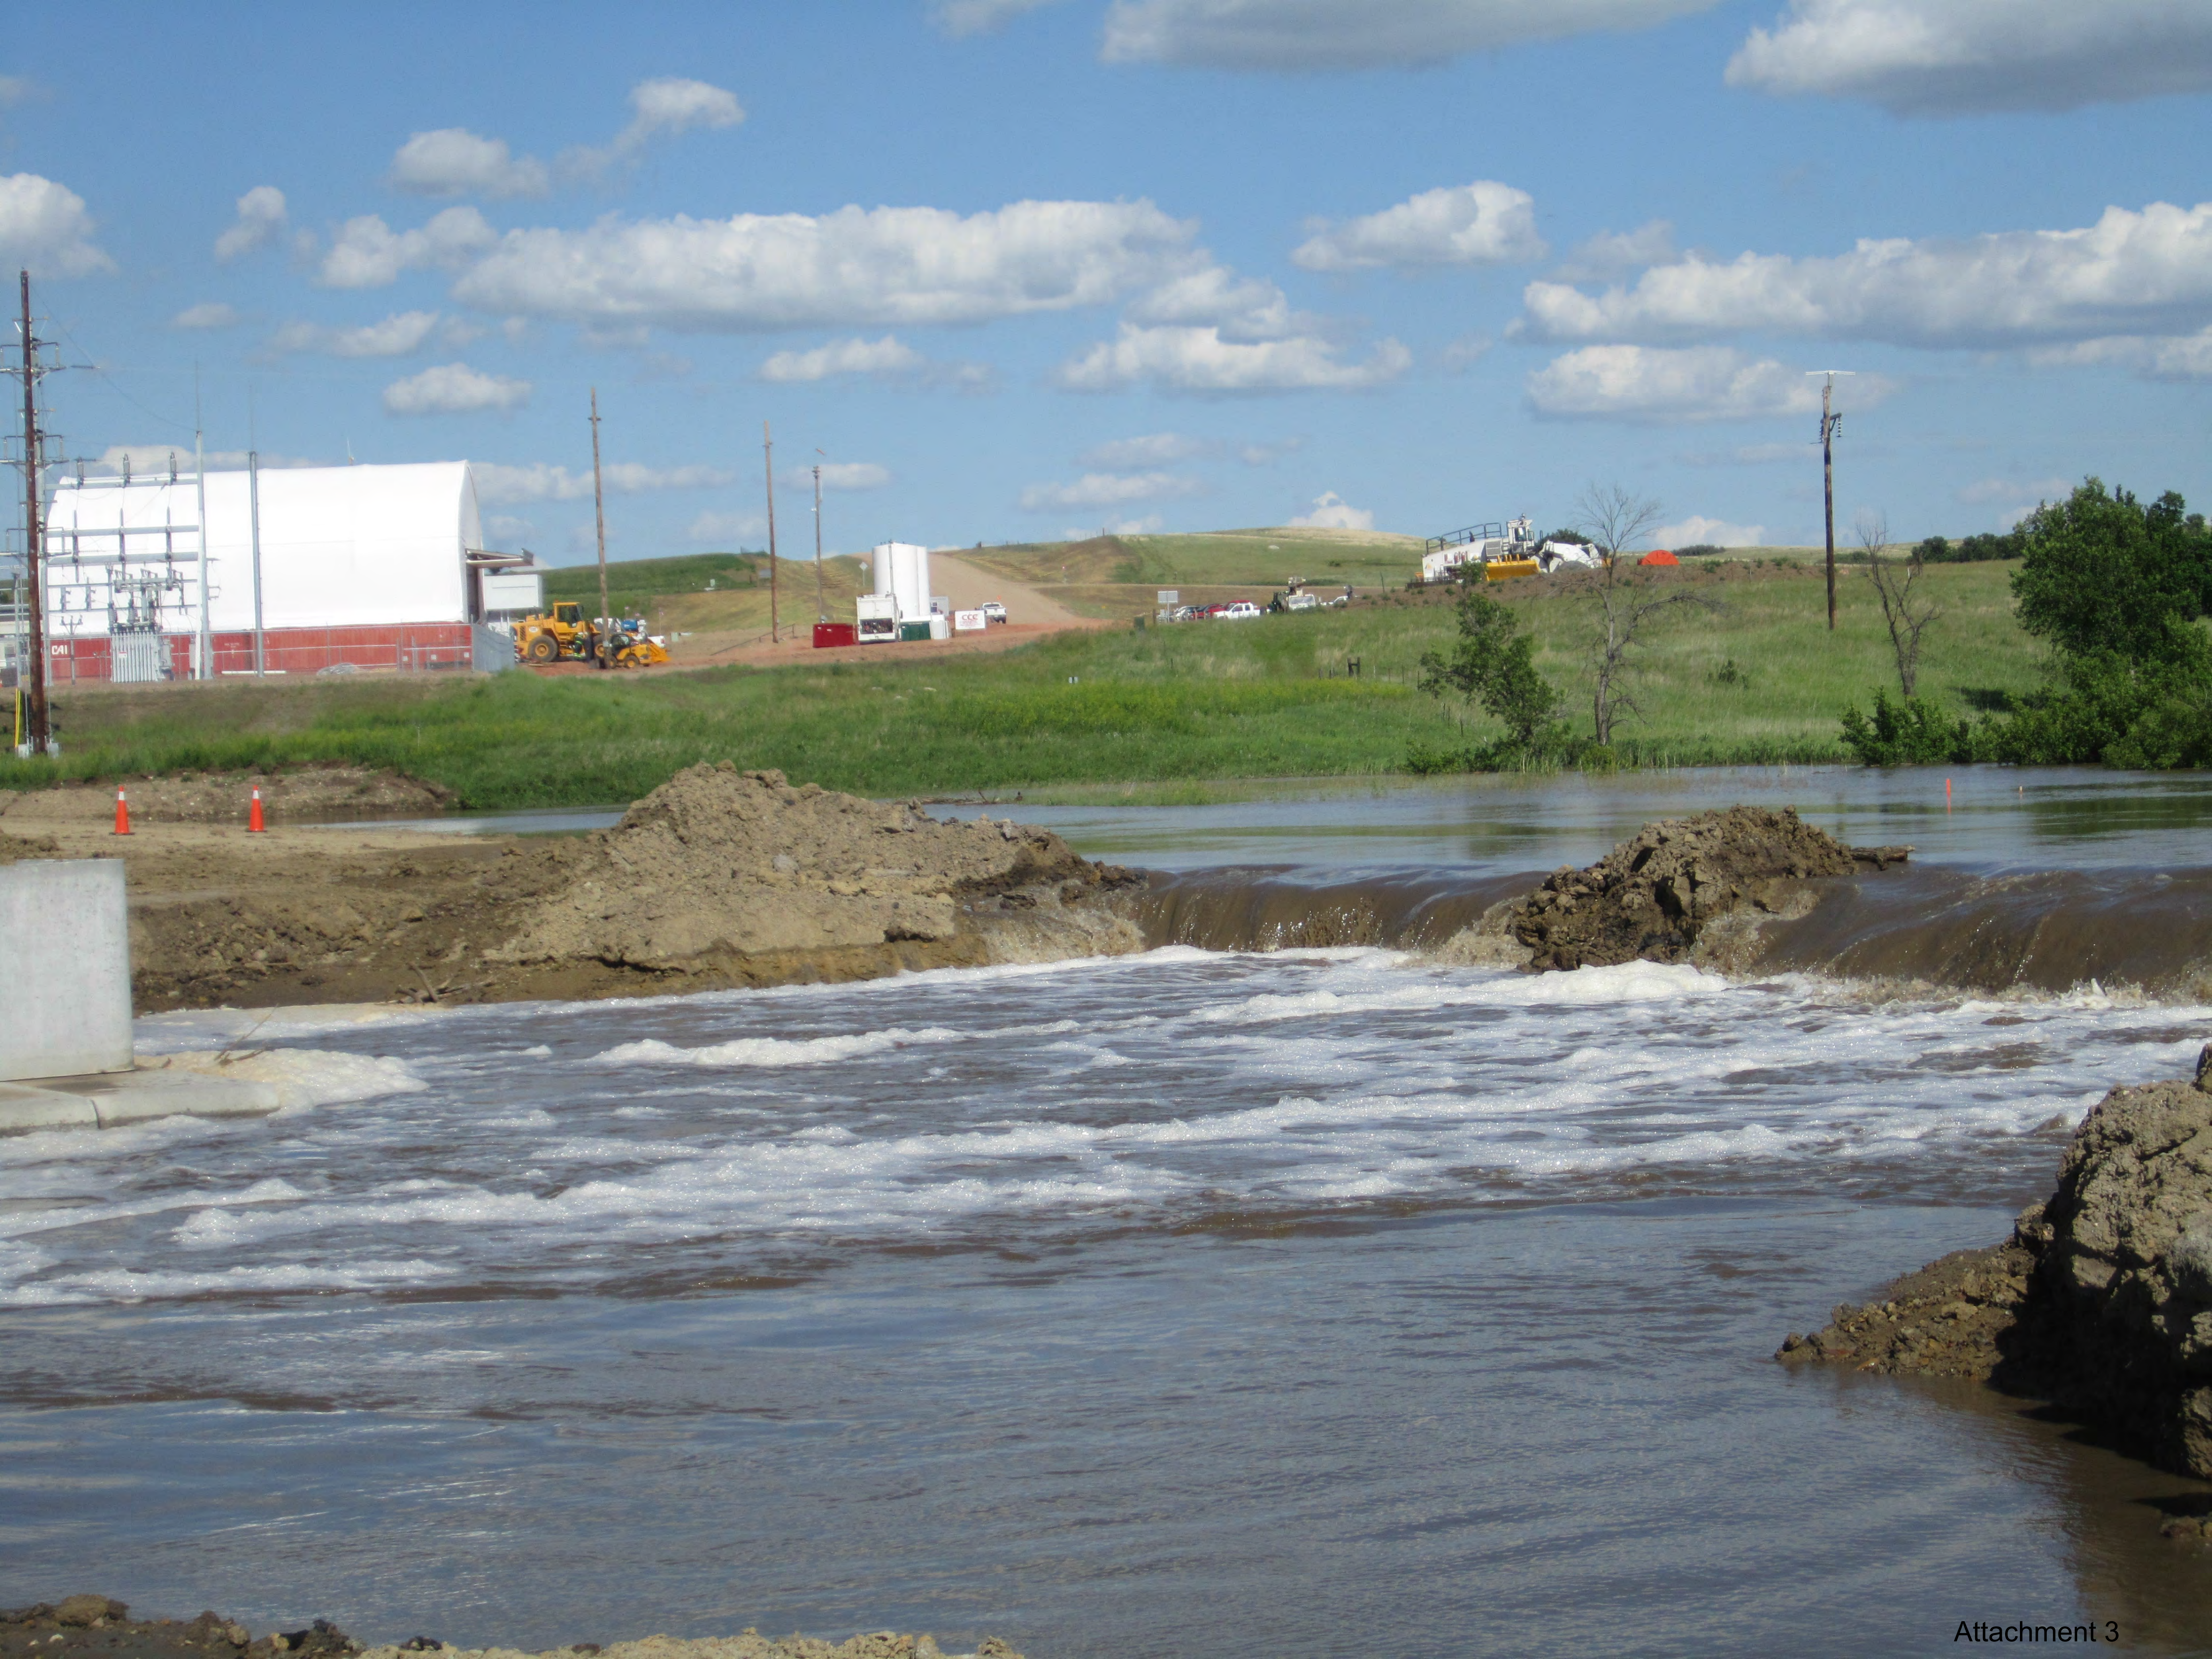
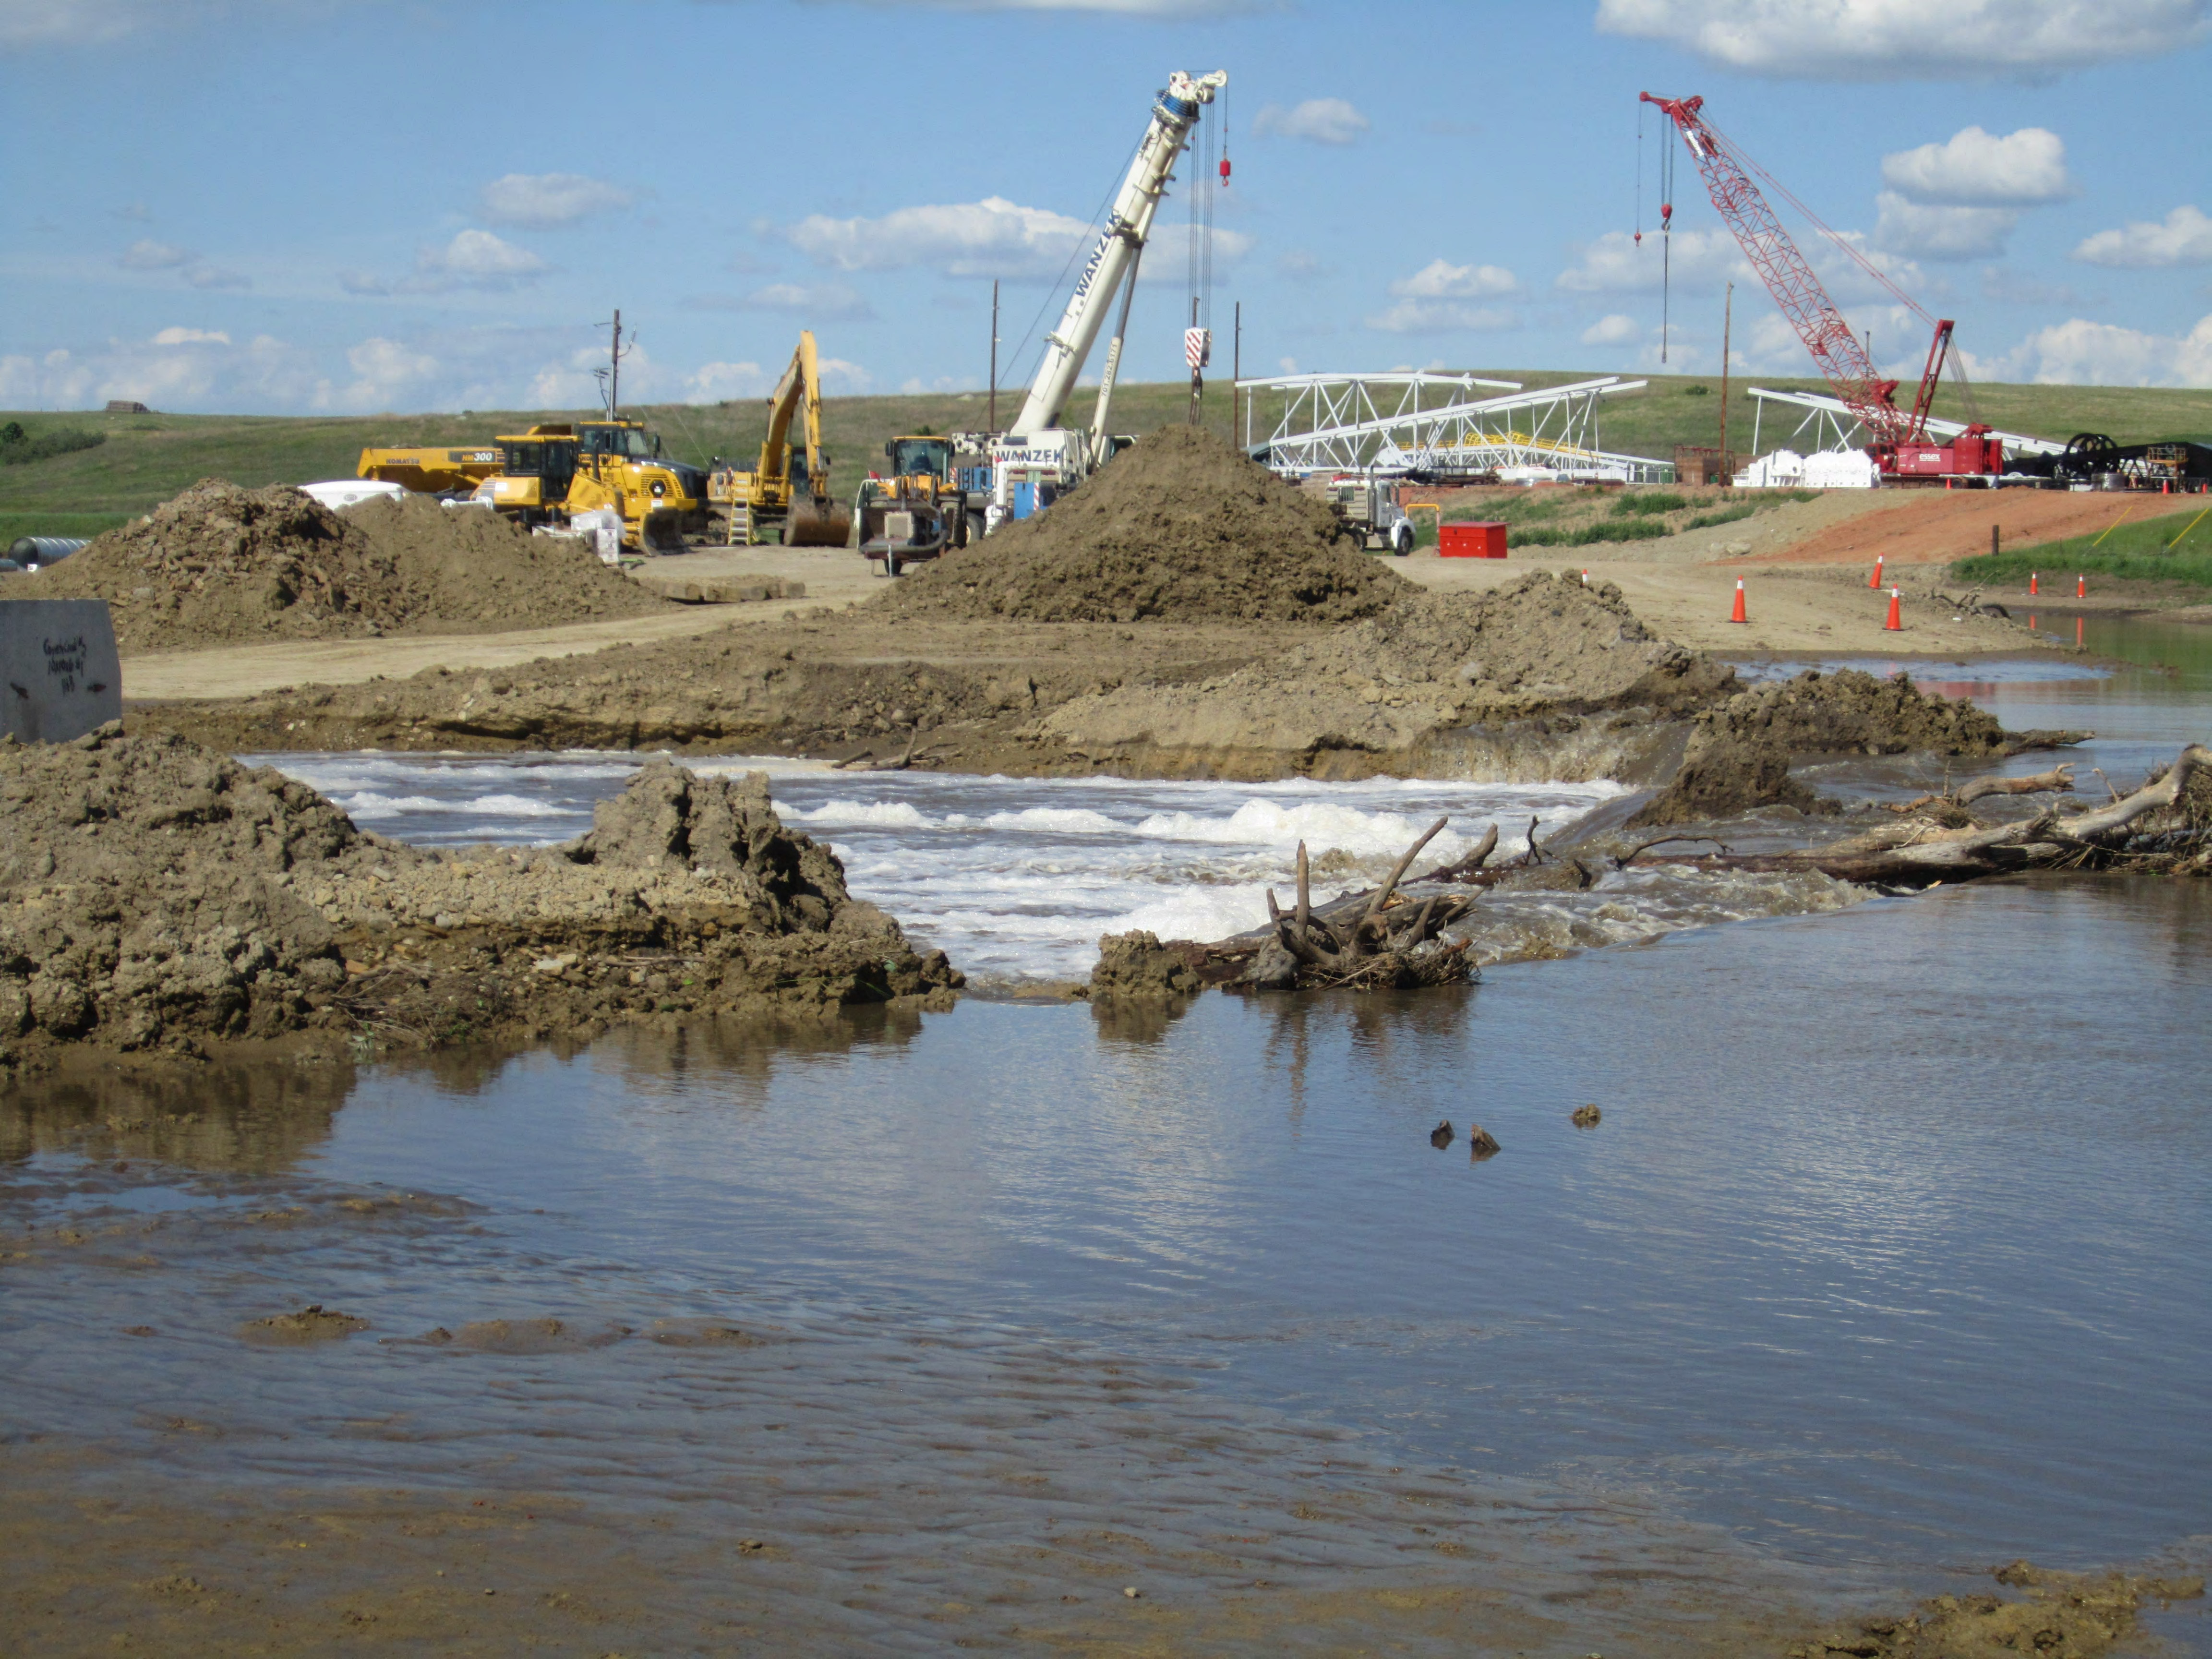
4. On June 22, the environmental risk described by PSC inspectors in the inspection report attached to this letter became a reality. Rainfall in the area caused Coyote Creek to overtop the dirt shop access road causing significant deposition of sediments into Coyote Creek. Coyote Creek, a Class III Stream, is a Water of the United States. Thus, Coyote Creek Mine's failure to comply with the terms of their permit and subsequent warnings by PSC inspectors has now led to contamination of a jurisdictional Water of the United States in violation of the

Clean Water Act. Attachment 3 provides two photographs taken at approximately 6PM, CDT, on Monday June 22, 2015 showing this event.
