Public Service Commission State of North Dakota

INSPECTION REPORT

DATE OF INSPECTION: June 25, 2015
TYPE OF INSPECTION: Partial
PERMITTEE - MINE: Coyote Creek Mine
PERMITS INSPECTED: NACC-1301, NACC-1302
PERSONS ACCOMPANYING INSPECTORS: Donn Steffen, Brenden Brinkman, and Lee Becker
INSPECTION CONDITIONS: The inspection was conducted between 10:50 a.m. and 3:45 p.m. CDT. Skies were partly cloudy. The temperature was near 75° F. Access was good.

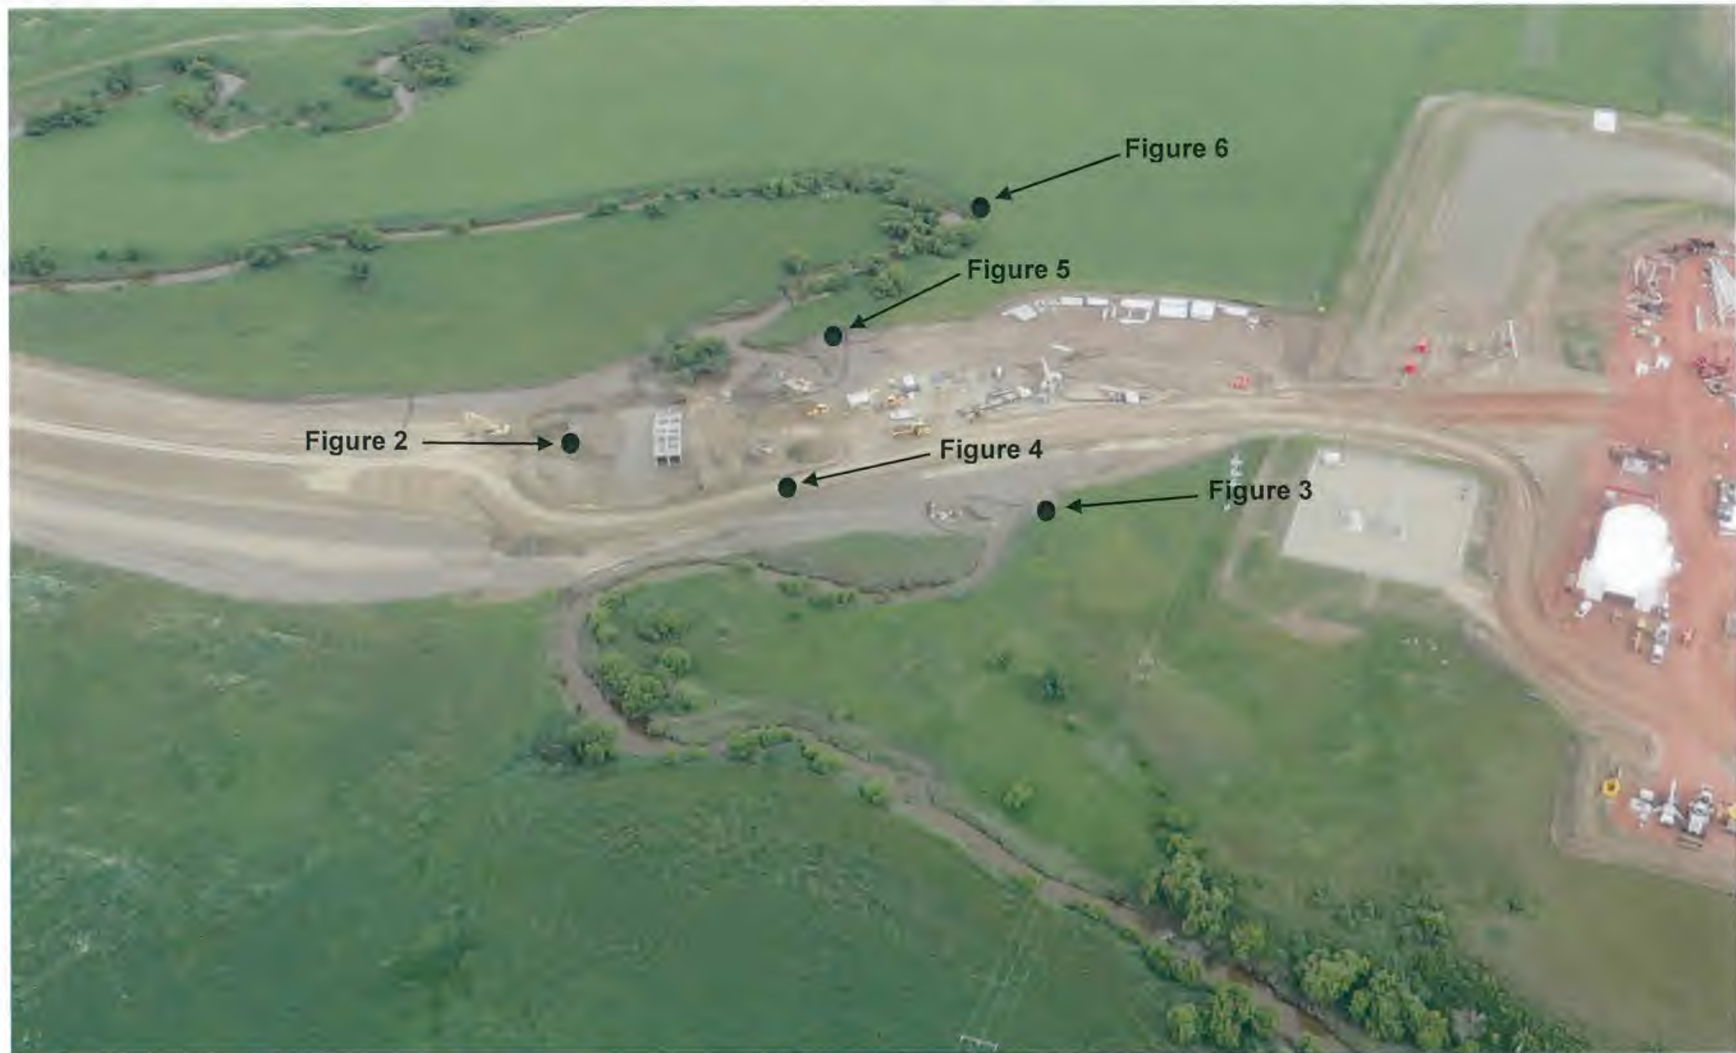
The box culvert installation site for the Shop Access Road was reviewed. Refer to Figure 1 for an overview of the construction site. The aerial photograph in Figure 1 was coincidentally taken on June 25, 2015 during the Commission's annual mine flyover inspections. Figure 1 also depicts the photograph locations and viewing directions shown in Figure 2 through Figure 6. The site had been dewatered after the flooding event that took place on June 22nd. The box culvert site appeared to have held up reasonably well after having been inundated and having floodwater from Coyote Creek flow through the site. It

appeared that water flowed over a section of road on the south side of the box culvert excavation and resulted in some undercutting of the road along the overflow path. The remainder of the excavation appears to have acted as a stilling basin because deposition was evident over most of the area of inundation. We were told water first entered the box culvert work area from the north (back flow from the Coyote Creek channel) thus reducing the potential erosion damage in the work area from flood waters flowing over the road. On the north side of the box culvert installation, a section of channel plug appeared to have been replaced since the flood event. As indicated by mine personnel, a section of the plug about 10 foot wide was excavated to allow water in and partially drain the box culvert area. It appeared that about 4 feet of additional fill material was recently added to the plug in this area.

Figure 1. Ongoing box culvert installation for the Shop Access Road in Permit NACC-1302 at the Coyote Creek Mine on June 25, 2015 pictured on a 2015 mine flyover inspection aerial photograph. Points represent Figure 2 through Figure 6 photograph locations and arrows indicate general photograph direction.

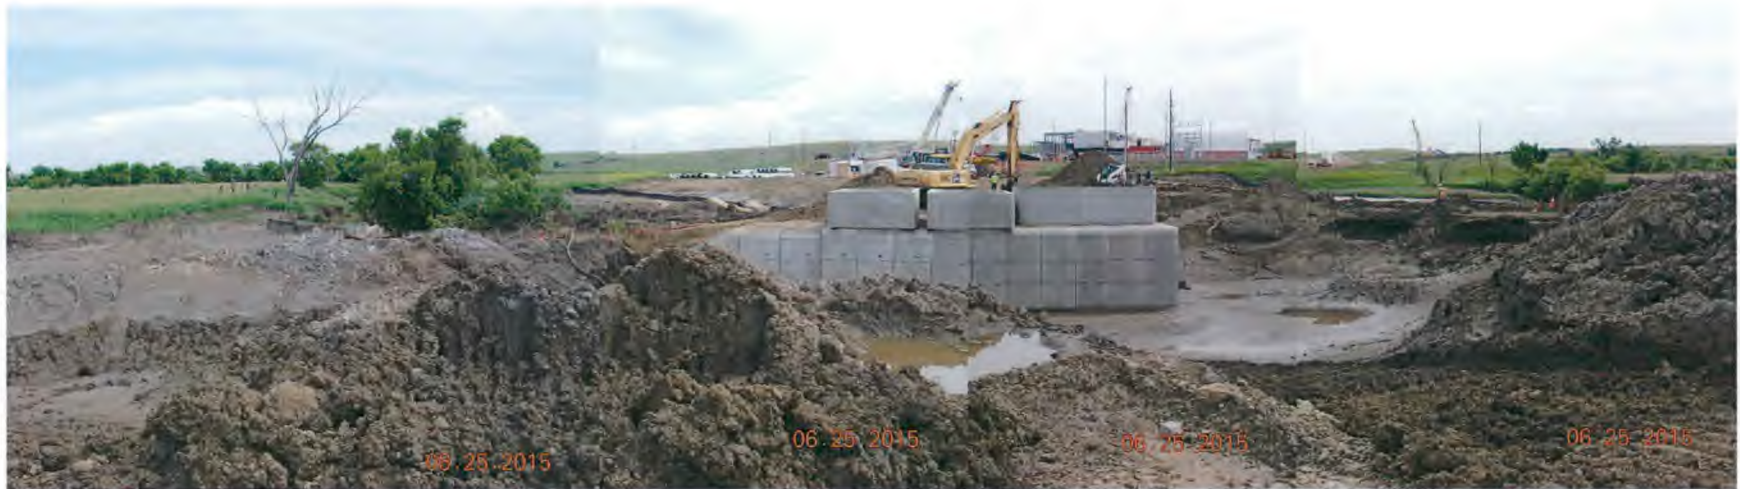
Figure 2. The first of two double box culverts being installed - facing easterly.

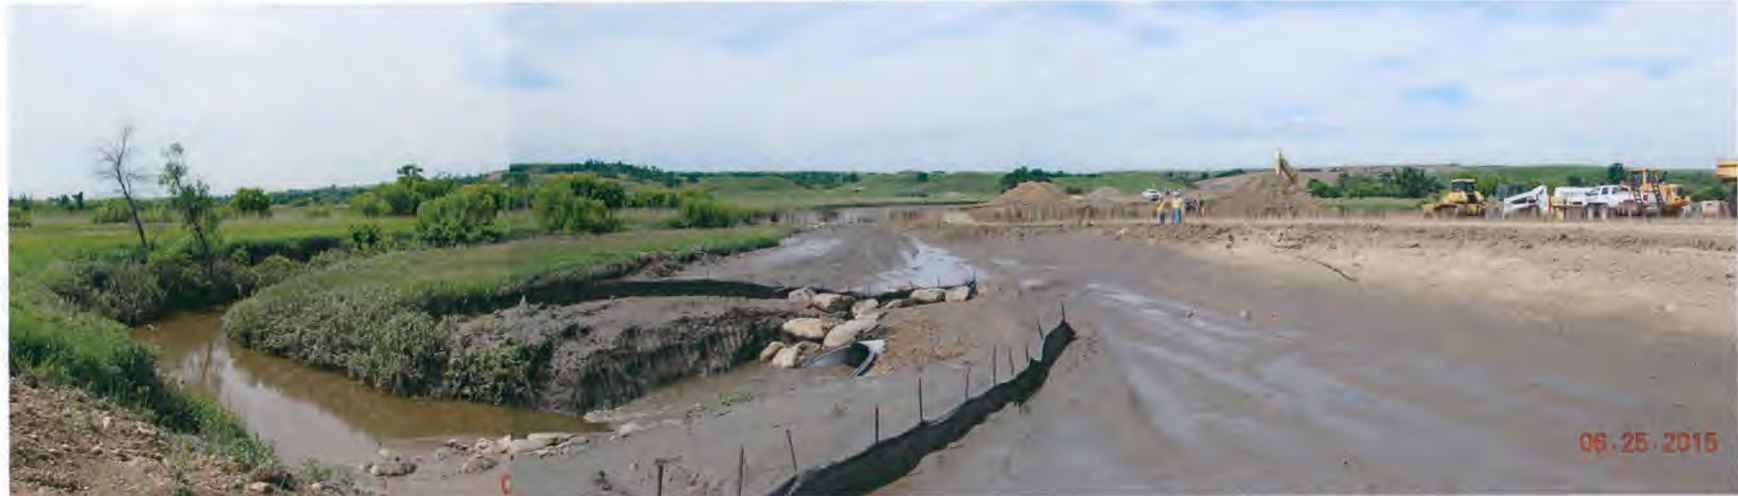
Figure 3. Coyote Creek flow into the low flow culvert - facing westerly with the Shop Access Road on the right.

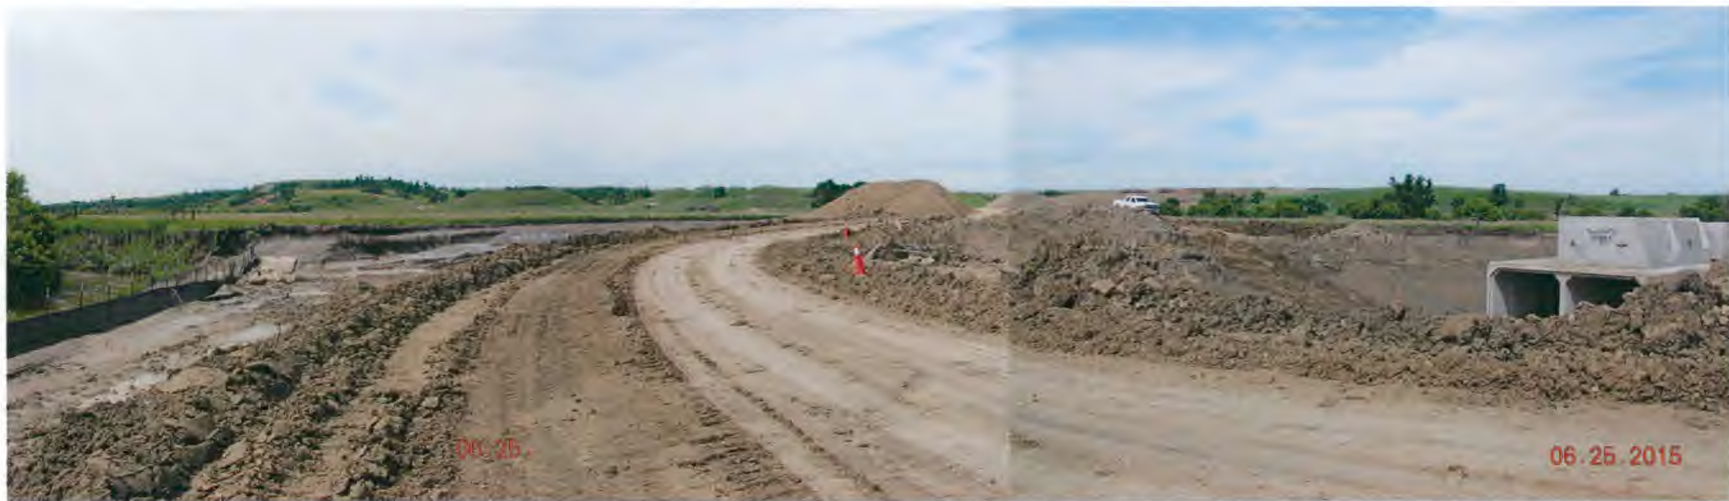
Figure 4. Box culverts on the right in relation to Coyote Creek across the Shop Access Road on the left - facing westerly.

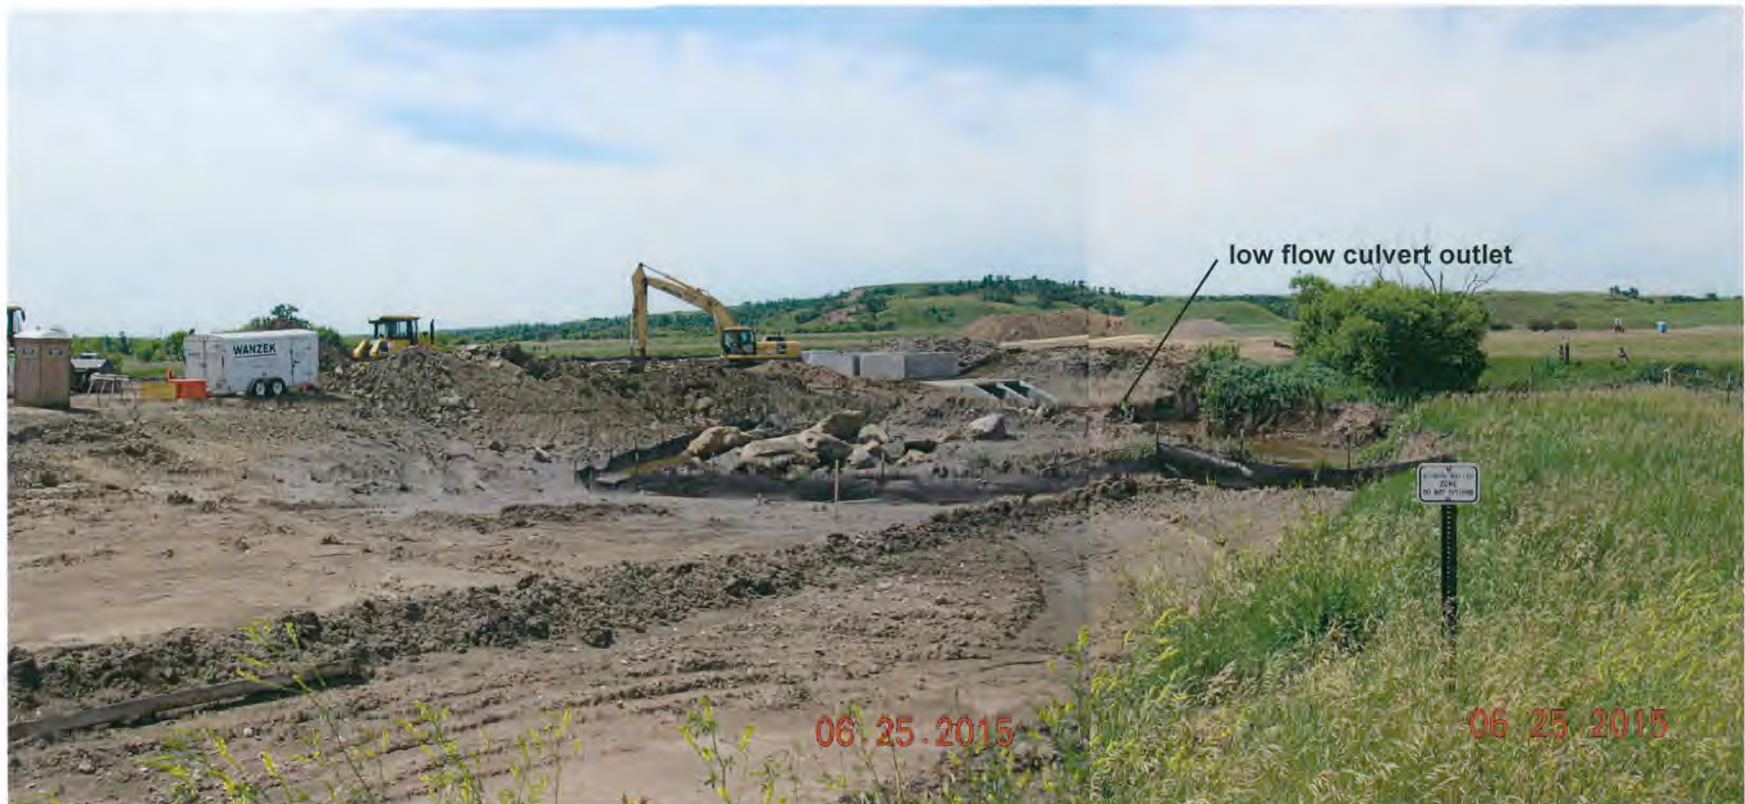
Figure 5. Area of Coyote Creek low flow culvert outlet (not visible but about at arrow location - see Figure 1 flyover photograph) in relation to the “island” with trees to right of culvert outlet in Coyote Creek planned for removal following box culvert installation - facing southwesterly.

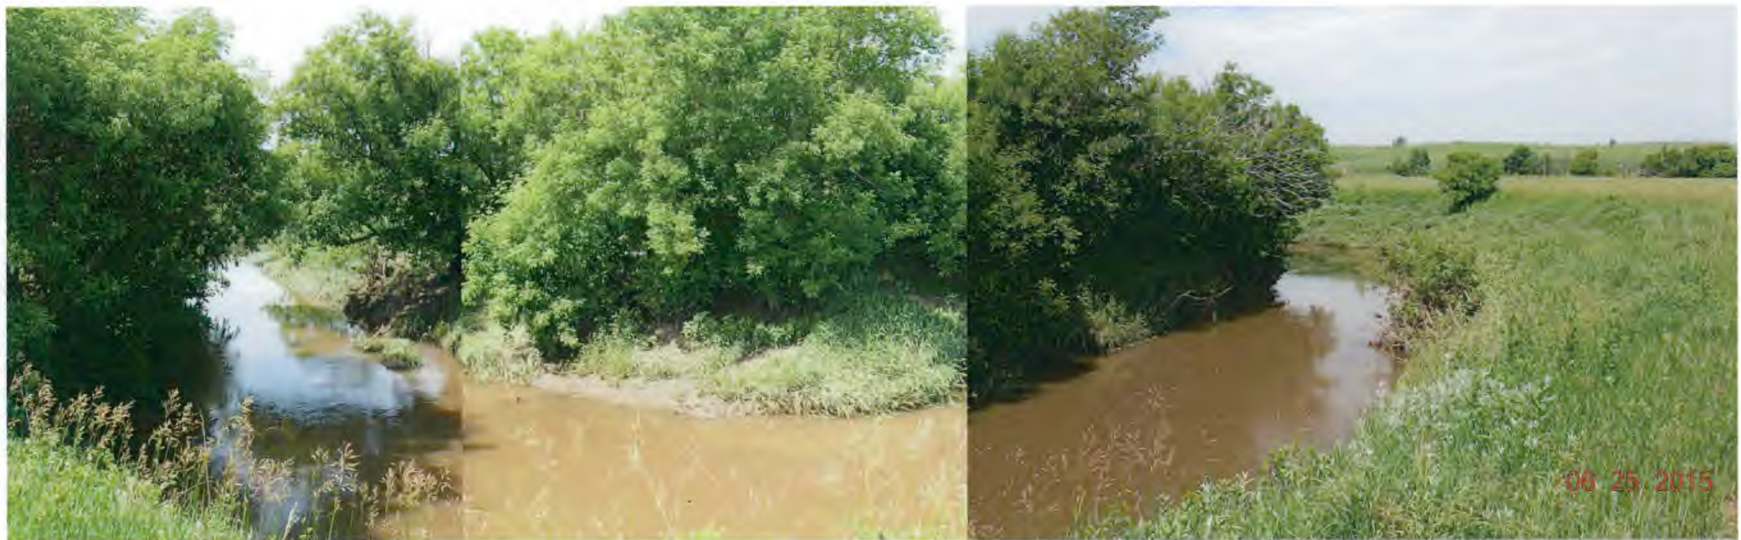
Figure 6. View of Coyote Creek downstream of the Shop Access Road - facing southwesterly.
