INSPECTION REPORT

DATE OF INSPECTION: June 30, 2015

PERMITTEE - MINE: Coyote Creek Mining Company, L.L.C. - Coyote Creek Mine

PERMITS INSPECTED: NACC-1302

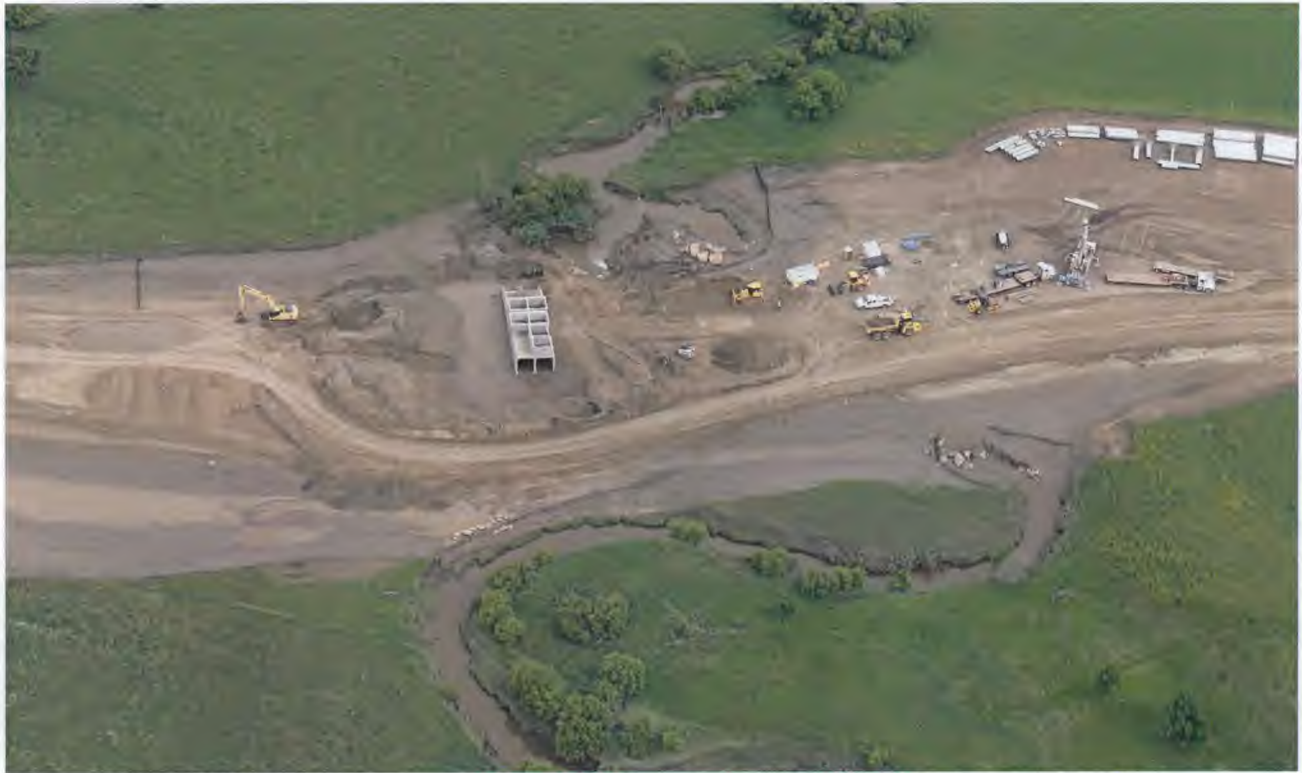
The access road crossing bisects Coyote Creek in an area of numerous stream meanders (see Figure 1). The erosion took place on a floodplain "island" surrounded by active stream and oxbow channels. This island is less than an acre in size and is dominated by shrub and natural floodplain vegetation. The permit soil survey indicates that the island is mapped as Straw loam channeled, 1 to 6% slopes with 18" of topsoil and 42" of subsoil. Mine personnel have indicated that this "island" will be removed and the area will be stabilized with concrete matting; however, they indicated that they did not plan to remove the island until the box culvert installation was complete. Since the start of the box culvert installation, the natural channel just downstream of the 60-inch culvert and upstream and downstream of the box culverts has been blocked to allow construction.

Figure 1- Coyote Creek at access road crossing site taken during June 25, 2015 flyover inspection

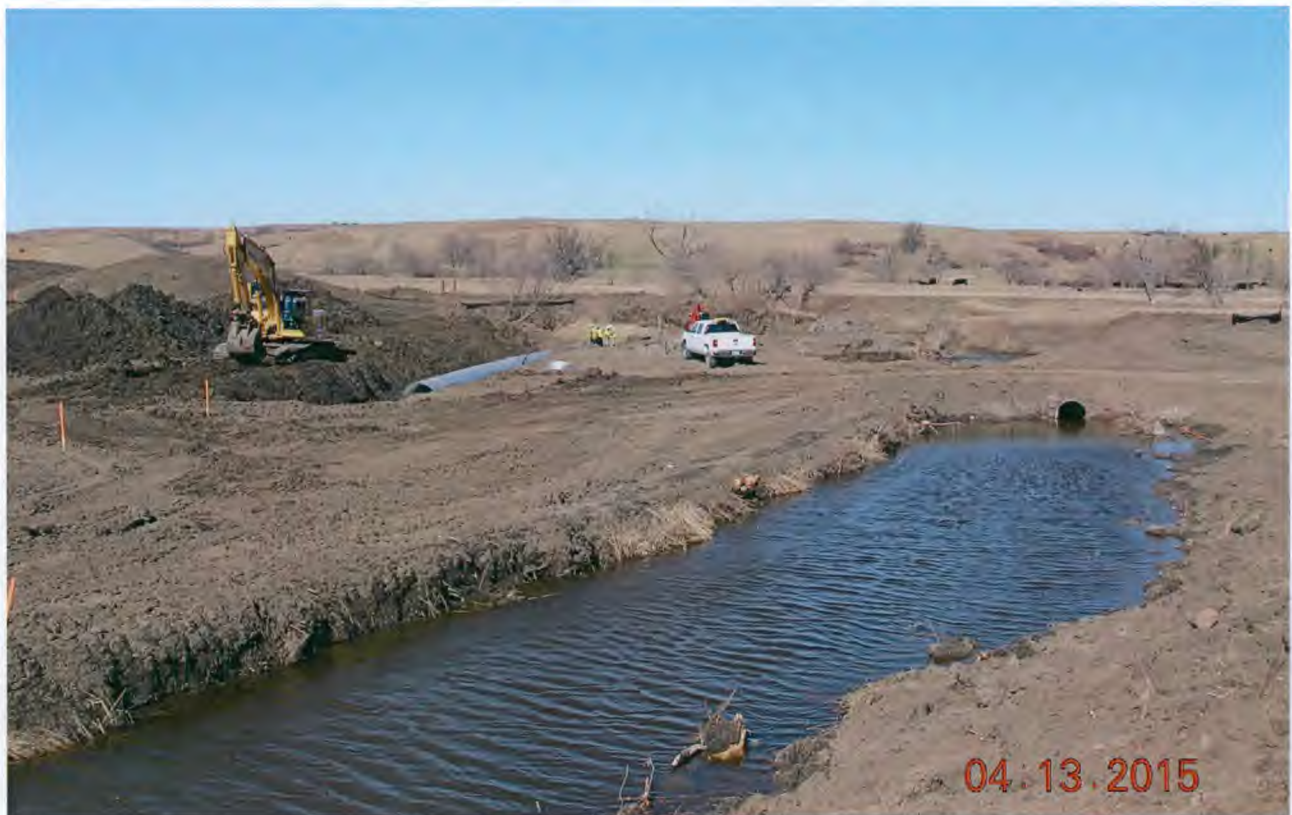
Figure 2 – Low flow culvert installation in progress on Coyote Creek on April 13, 2015

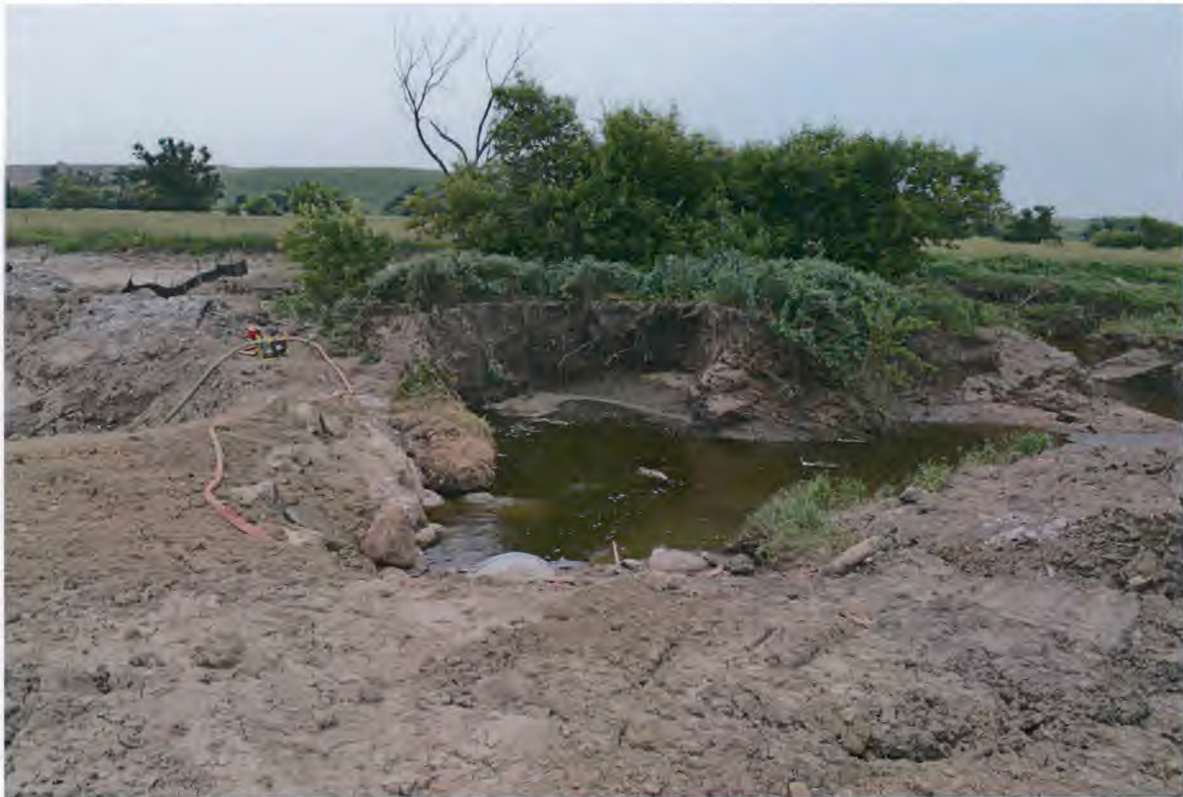
This inspection confirmed that the stream bank across from the 60-inch culvert is eroded apparently due to high volume discharge flows from the culvert. The culvert is positioned in a manner that it outlets in the stream channel at nearly a right angle to the stream channel. The stream flow from the culvert outlet now flows through an excavated channel cut through a meander point, approximately 100 feet north of the 60-inch culvert, at which point it re-enters the natural stream channel. It appears that flows from the culvert hit the opposite bank of Coyote Creek thus creating the erosion feature. The erosion feature was estimated to be 15 to 20 feet wide and deep into the bank and about 10 feet deep from the natural ground surface. No stabilization or erosion protection or remnants of erosion control measures were observed on the opposite bank. See attached Figures 3 and 4.

Figure 3- Erosion to stream bank, center. Channel plug and box culvert site to the left.

As a result of this inspection, Notice of Violation (NOV) 1502 will be issued to Coyote Creek Mining Company, L.L.C. for failure to control erosion at the low flow culvert outlet.

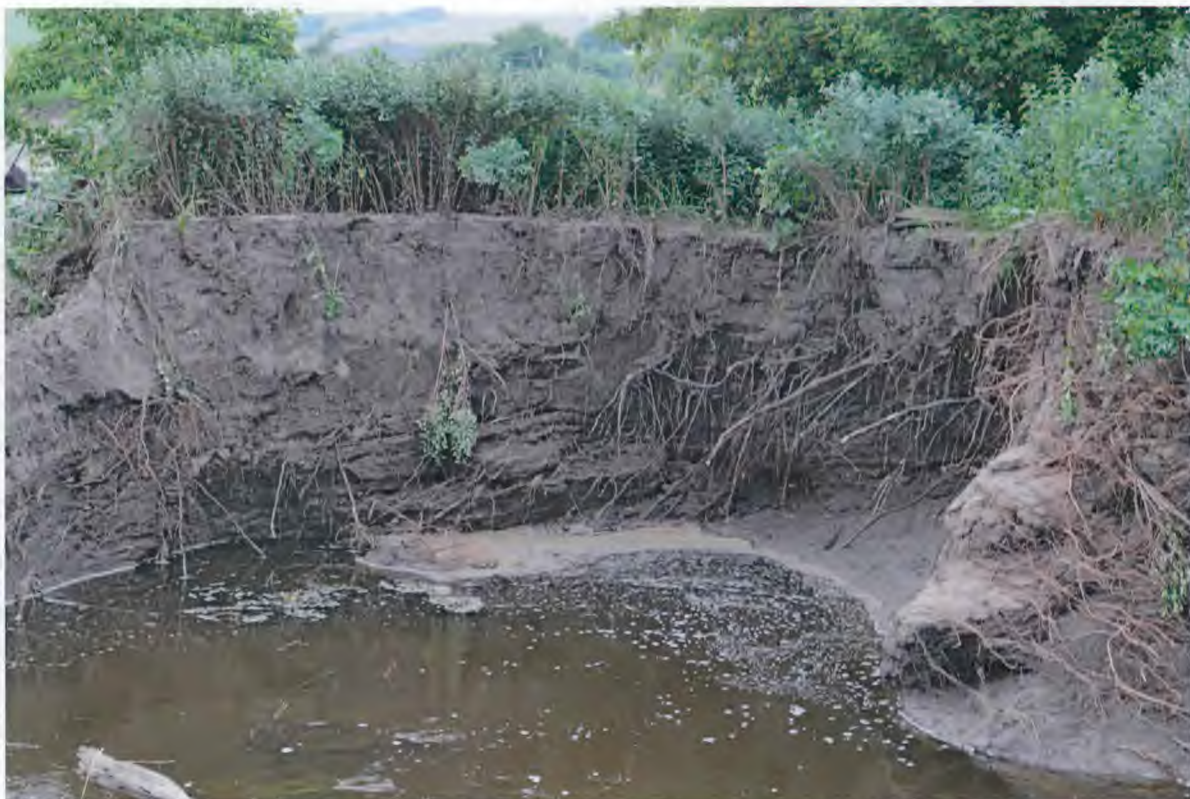
Figure 4- Closer view of bank erosion feature located across from the 60-inch culvert
