PSC April 13, 2015 Inspection Report

INSPECTION REPORT

PERMITTEE - MINE: Coyote Creek Mining Company, L.L.C. - Coyote Creek Mine

PERMITS INSPECTED: NACC-1301 and NACC-1302

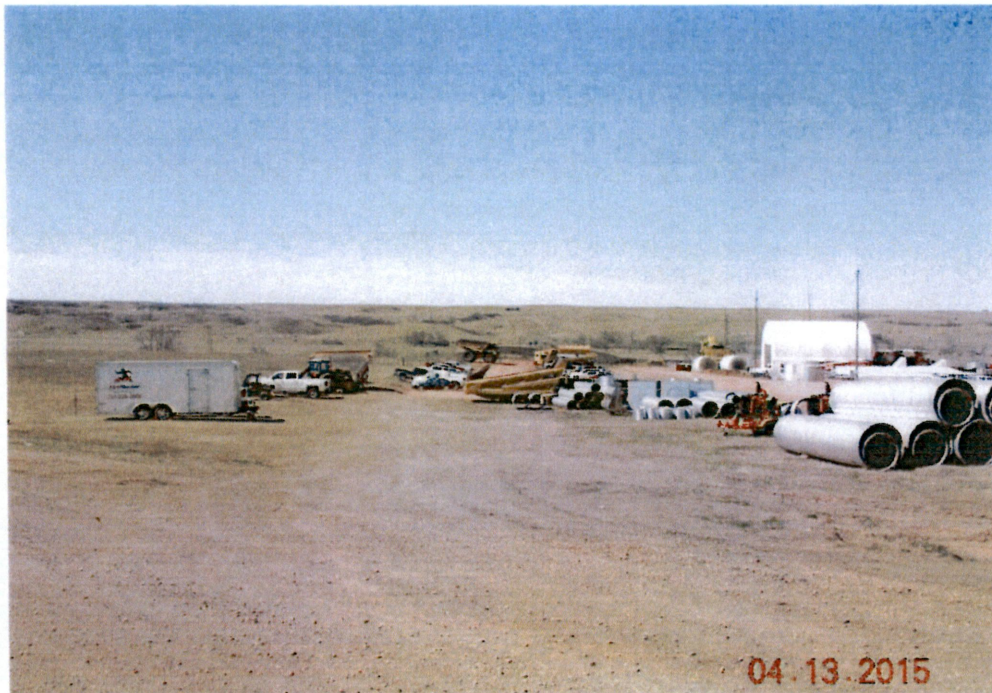
The inspection began by reviewing an area in the NE $\frac{1}{4}$ NE $\frac{1}{4}$ NE $\frac{1}{4}$ of Section 31 in Permit NACC-1301 where SPGM had not been removed but it was being used for contractor and equipment parking, and also for equipment and material storage as pictured in Figure 1 and outlined on Figure 5. Mr. Voigt expressed his concerns with possible topsoil degradation and erosion caused by vehicle and equipment traffic in the area. Although accelerated erosion or rutting was not evident in the area, the native rangeland vegetation was worn bare in the main traffic path, and it appeared that topsoil degradation and erosion would likely occur if current use of the area continued. SPGM removed from the E $\frac{1}{2}$ SE $\frac{1}{4}$ of Section 30 in Permit NACC-1301 in 2014 for the mine office-shop facility and access road was stockpiled north of the facility as depicted on Figure 5, as was SPGM removed from the N $\frac{1}{2}$ NE $\frac{1}{4}$ NE $\frac{1}{4}$ of Section 31 for contractor and equipment parking. Additional SPGM was removed from the contractor and equipment parking area in 2014 and 2015 when expansion became necessary. The August 7, 2014 and October 30, 2014 Coyote Creek Mine inspection reports noted that idle equipment could be stored on areas where SPGM was not removed, but SPGM should be removed from areas where traffic could cause SPGM degradation. Mr. Steffen explained that SPGM removal had not progressed eastward to the area of concern inspected on April 13, 2015 because CCMC desired to minimize disturbance, but he agreed that SPGM should be removed from the area to accommodate the need for expanded parking and equipment and material storage areas. SPGM removal from 0.3 acres in the area was viewed during an April 16, 2015 Coyote Creek Mine inspection and approved on April 20, 2015. Topsoil from the area is stored in a temporary stockpile west and adjacent 65 $\frac{1}{2}$ th AVE SW where it is expected to be used for road ditch revegetation of the reconfigured intersection of 65 $\frac{1}{2}$ th AVE SW and 17th ST SW to be constructed this year. Existing SPGM stockpiles located in NACC-1301 as depicted on Figure 5 are currently inaccessible for additional SPGM storage. Subsoil from the area was stored in a temporary stockpile south of pond P30-01.

Figure 1. Area in the NE $\frac{1}{4}$ NE $\frac{1}{4}$ NE $\frac{1}{4}$ of Section 31 in Permit NACC-1301 where SPGM had not been removed but is being used for contractor and equipment parking, and also for equipment and material storage - facing west with 65 $\frac{1}{2}$ th AVE SW in foreground, and scoria capped parking in background - refer to Figure 5 for area location

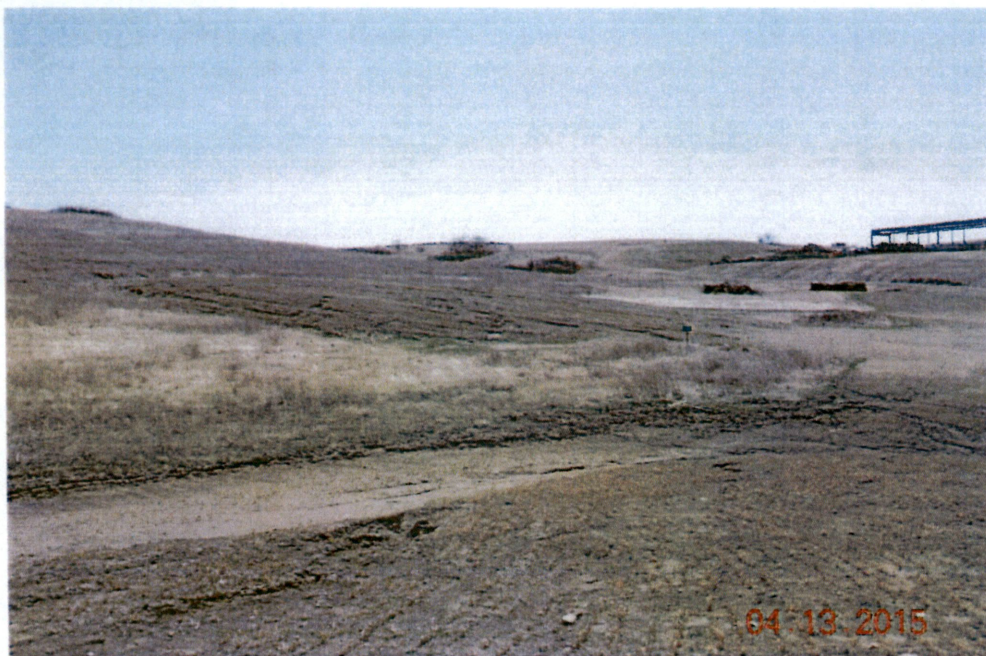
SPGM stockpiles located north of the mine office-shop facility in Permit NACC-1301 as depicted in Figure 5 were viewed near the close of the inspection after Casey Voigt had departed. These stockpiles and the surrounding associated disturbance had been seeded and mulched in the late summer and early fall of 2014 but it was evident that maintenance is required to repair and stabilize erosional rilling that had developed on the piles and disturbed areas as pictured in Figure 2. Mr. Steffen indicated that seeding and mulching equipment had been ordered and was expected to be delivered shortly whereupon CCMC personnel would repair the erosion and stabilize the stockpiles by reseeding or mulching.

Figure 2. Erosional rilling requiring repair on SPGM stockpiles and the surrounding associated disturbance areas in Section 30 in Permit NACC-1301 - facing southeast toward stockpile TS-3 with the mine office-shop building frame in background – refer to Figure 5 for location

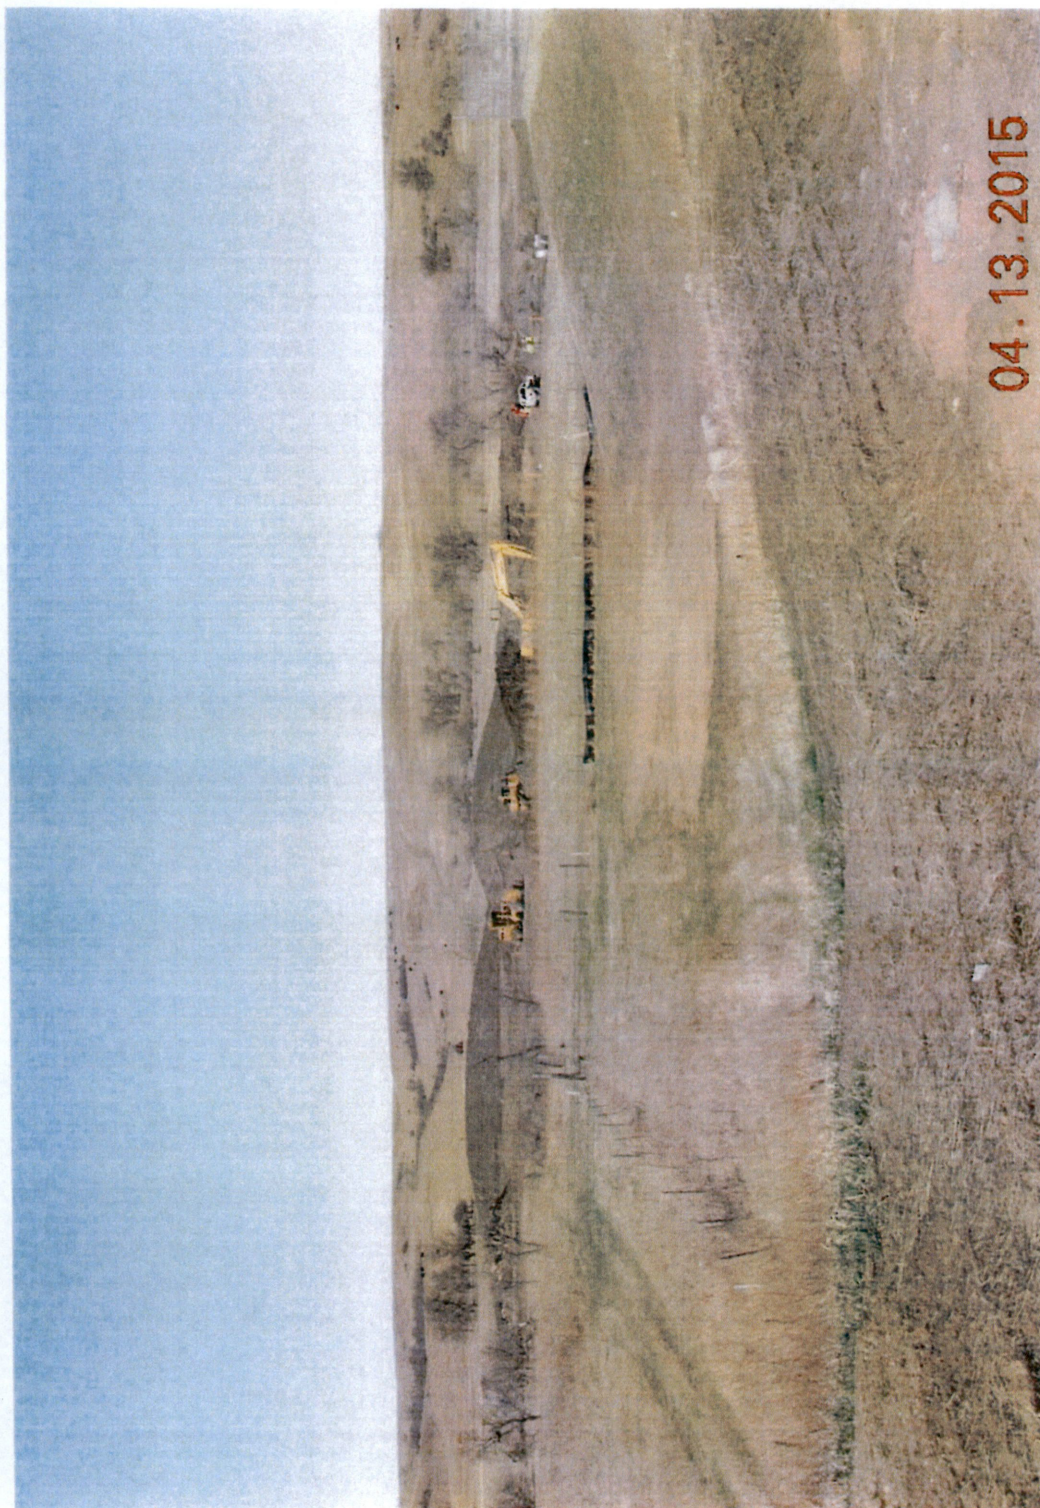
SPGM removal for a four acre segment of the Shop Access Road on both sides of Coyote Creek for which construction has just begun was viewed and approved during the inspection. As depicted on Figure 5, the Shop Access Road will extend westward from the mine office-shop facility to a haul road. CCMC had received prior approval to stockpile topsoil and subsoil in the Shop Access Road corridor until SPGM stockpile locations could be developed on the west side of the North-South Haul Road to be constructed in the W $\frac{1}{2}$ of Section 30. An overview of the SPGM removal area is pictured in Figure 3. SPGM removal monuments retained in the removal area indicated that subsoil had been removed to the depths indicated on the detailed soil survey map (Section 2.5.6 in Permit NACC-1302). The SPGM removal area included some prime farmland acreage on the west side of Coyote Creek but segregation of the prime and non-prime farmland topsoil and subsoil is not required because the access road corridor constitutes associated disturbance rather than actual mining disturbance. Runoff from the temporary stockpiles that are not located within the watershed of pond P30-01 will be managed with SPGM stripping edges, sumps, silt fences, shallow berms or ditches, or a combination thereof.

Figure 3. SPGM removal for a four acre segment of the Shop Access Road on both sides of Coyote Creek with a temporary topsoil stockpile in left background and a temporary subsoil stockpile in middle background – facing west with fence line in center-west marking the section line common to Section 30 on right (north) and Section 31 on left (south) – photograph taken south of large white hoop building pictured in right background in Figure 1

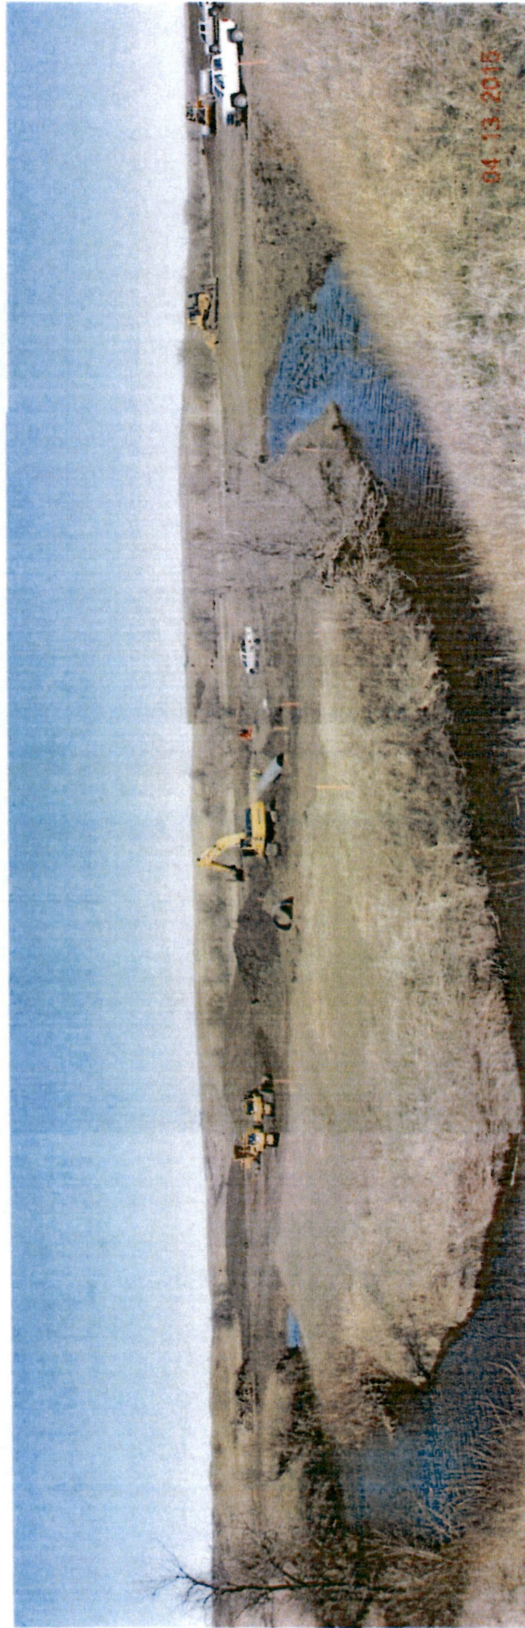
Culvert installation for the Shop Access Road Coyote Creek crossings was also viewed while viewing SPGM removal for a four acre segment of the Shop Access Road on both sides of Coyote Creek as previously described. At the time of inspection, the 36 inch low flow steel culvert was being installed as pictured in Figure 4. It should be noted that the approved design for the 36 inch culvert depicts a slight angle near the culvert's midpoint. The design was revised to depict a straight culvert with the application of Revision No. 1 to Permit NACC-1302 that is under review. The proposed design change was approved by the commission via email correspondence on March 19, 2015 and it received U.S. Army Corps of Engineers concurrence on March 20, 2015. Please refer to Figure 5 for the culvert types and locations for the Shop Access Road Coyote Creek crossings. Installation of the 36 inch low flow steel culvert would need to be completed no later than April 14th because CCMC's Regional General Permit from the U.S. Army Corps of Engineers does not allow regulated activity in Coyote Creek from April 15th to June 1st. Installation of the four 10 foot by 10 foot box culverts will follow but it appears that they will not be installed to divert Coyote Creek flow until after June 1st. Mr. Steffen indicated SPGM removal will proceed westward along the Shop Access Road corridor toward the location for pond P31-01 after the 36 inch low flow steel culvert installation is complete. Overburden from pond P31-01 excavation will provide the fill necessary to achieve grade for the Shop Access Road.

Based on the foregoing permit excerpts and observations from the April 13, 2015 inspection, it appears that CCMC is conducting operations for the Shop Access Road Coyote Creek culvert installations in reverse order of that approved in Permit NACC-1302. CCMC should have requested commission approval to revise culvert installation plans and provided adequate justification for doing so. Furthermore, it appears that potentially serious environmental risks are posed by installing the low flow culvert prior to diverting Coyote Creek flow through the box culverts. The Coyote Creek stream flow is now restricted through the low flow culvert until the box culverts are installed to divert the stream presumably after June 1st. High stream flow resulting from a heavy precipitation event may overtop the low flow culvert and cut through culvert backfill and the Shop Access Road corridor causing downstream sediment deposition. CCMC is advised to expedite box culvert installation so Coyote Creek flow can be diverted through the box culverts immediately after the U.S. Army Corps of Engineers spring restriction of regulated activity expires. CCMC is also advised to refrain from building any segment of the Shop Access Road near Coyote Creek that could function as an embankment and cause upstream flooding if stream flow is restricted by the low flow culvert.

Figure 4. Panorama of 36 inch low flow steel culvert installation in Coyote Creek for the Shop Access Road Coyote Creek crossing - facing west on left and rotating to face north on right with temporary culvert in place on center-right for equipment crossing – refer to Figure 5 for culvert location – note temporary topsoil stockpile in left background and a temporary subsoil stockpile in middle background – also note that dozer was in motion when photographs were taken
