# PSC June 25, 2015 Inspection Report

### INSPECTION REPORT

DATE OF INSPECTION: June 25, 2015

PERMITTEE - MINE: Coyote Creek Mine

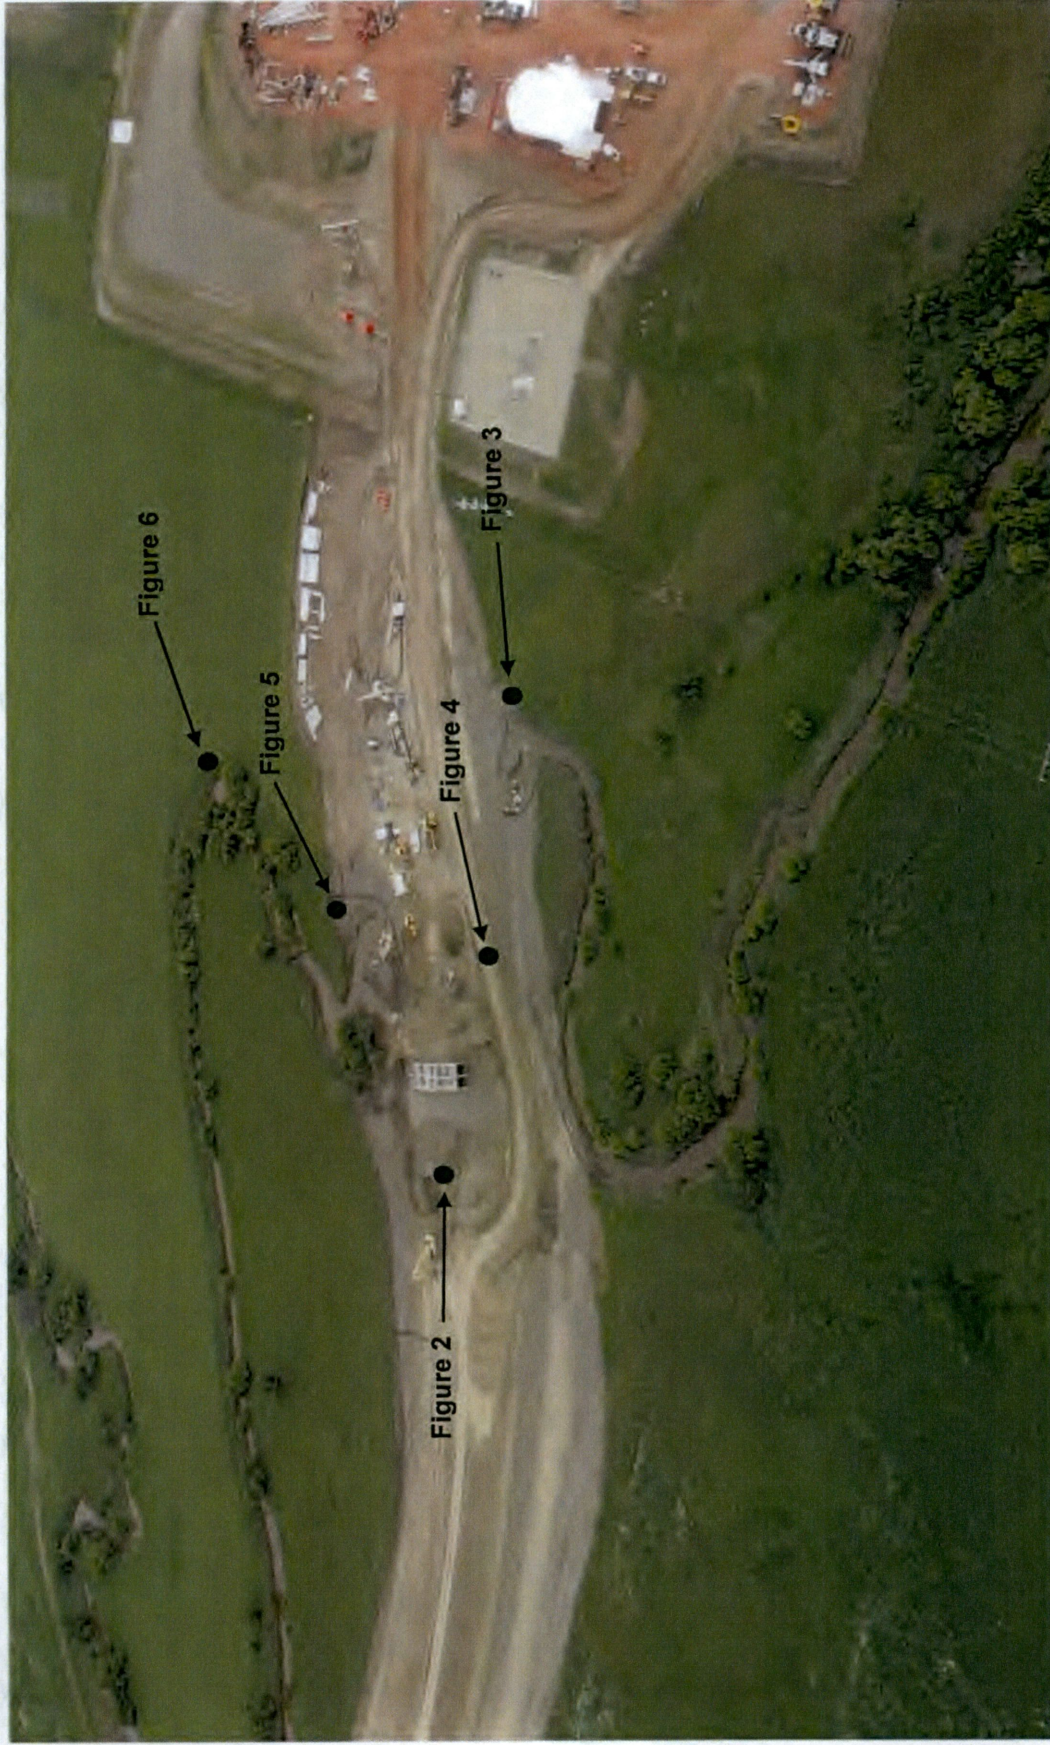
The box culvert installation site for the Shop Access Road was reviewed. Refer to Figure 1 for an overview of the construction site. The aerial photograph in Figure 1 was coincidentally taken on June 25, 2015 during the Commission's annual mine flyover inspections. Figure 1 also depicts the photograph locations and viewing directions shown in Figure 2 through Figure 6. The site had been dewatered after the flooding event that took place on June 22<sup>nd</sup>. The box culvert site appeared to have held up reasonably well after having been inundated and having floodwater from Coyote Creek flow through the site. It

appeared that water flowed over a section of road on the south side of the box culvert excavation and resulted in some undercutting of the road along the overflow path. The remainder of the excavation appears to have acted as a stilling basin because deposition was evident over most of the area of inundation. We were told water first entered the box culvert work area from the north (back flow from the Coyote Creek channel) thus reducing the potential erosion damage in the work area from flood waters flowing over the road. On the north side of the box culvert installation, a section of channel plug appeared to have been replaced since the flood event. As indicated by mine personnel, a section of the plug about 10 foot wide was excavated to allow water in and partially drain the box culvert area. It appeared that about 4 feet of additional fill material was recently added to the plug in this area.

Figure 1. Ongoing box culvert installation for the Shop Access Road in Permit NACC-1302 at the Coyote Creek Mine on June 25, 2015 pictured on a 2015 mine flyover inspection aerial photograph. Points represent Figure 2 through Figure 6 photograph locations and arrows indicate general photograph direction.

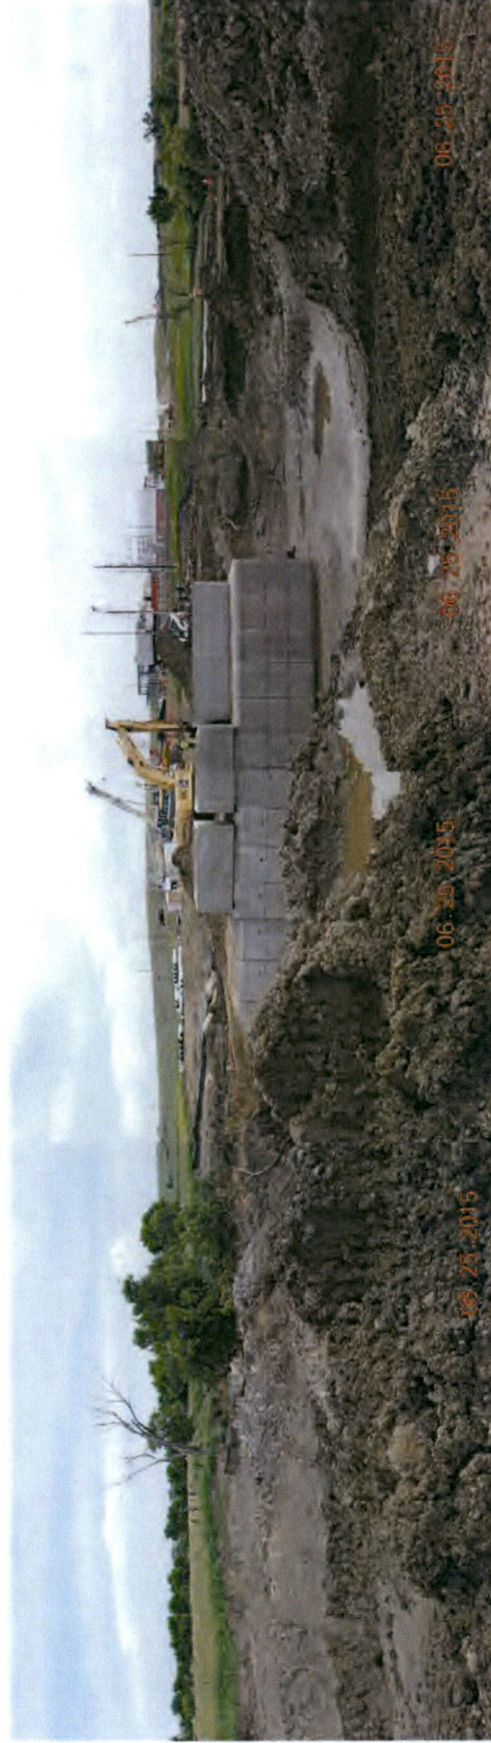
Figure 2. The first of two double box culverts being installed - facing easterly.

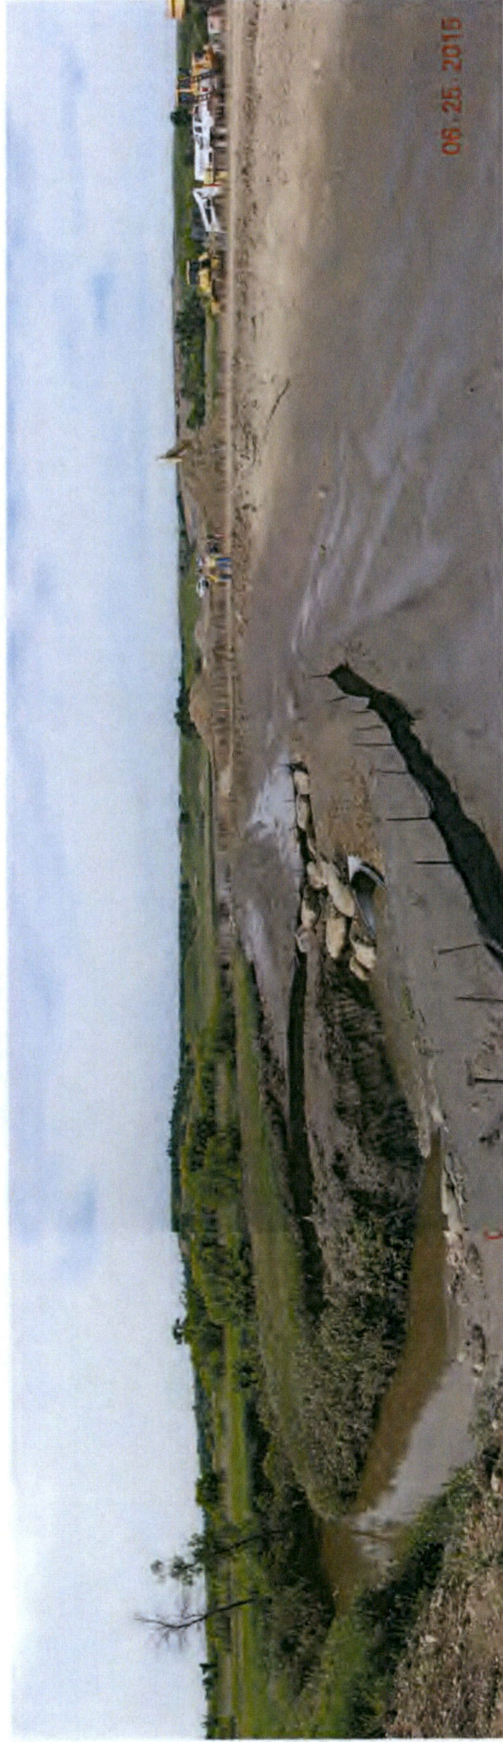
**Figure 3. Coyote Creek flow into the low flow culvert - facing westerly with the Shop Access Road on the right.**

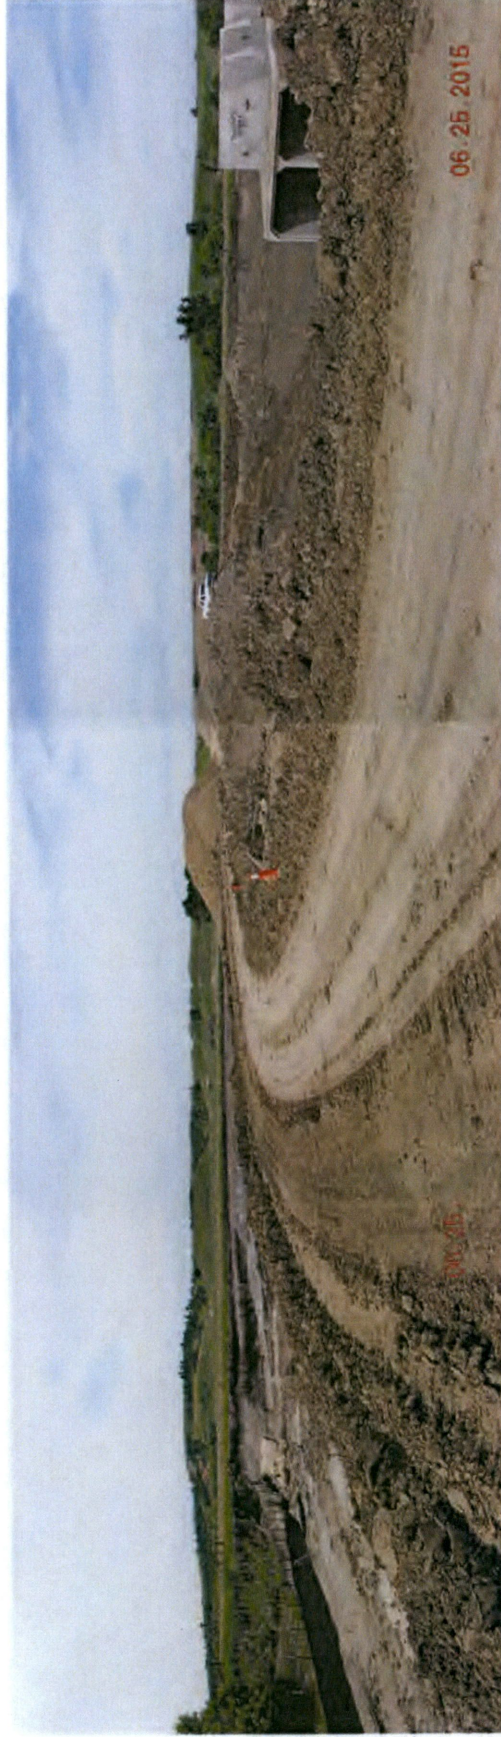
Figure 4. Box culverts on the right in relation to Coyote Creek across the Shop Access Road on the left - facing westerly.

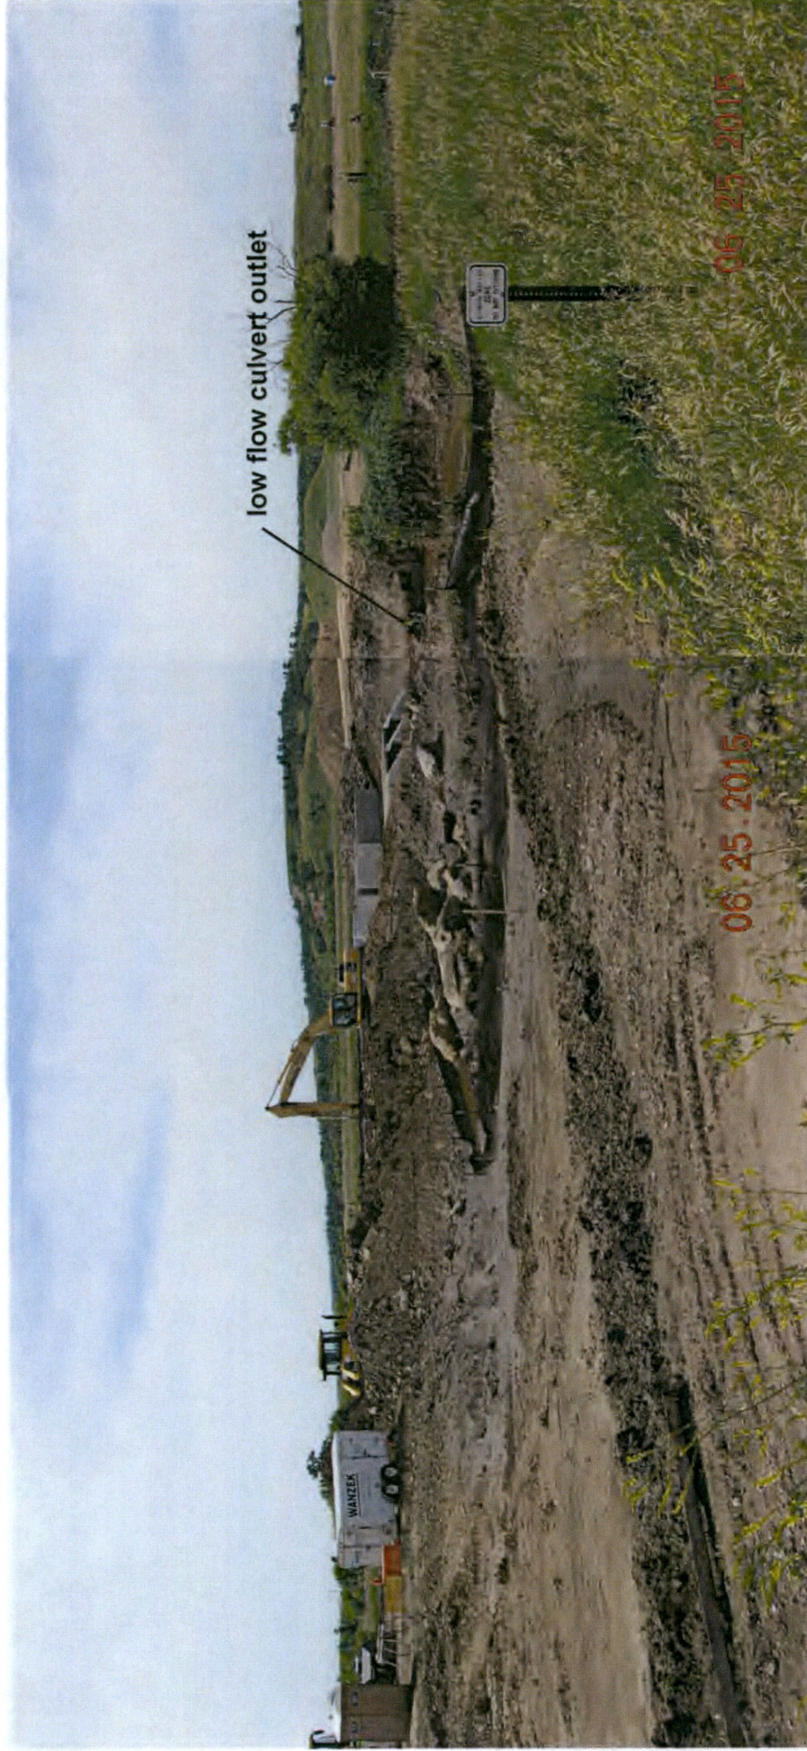
Figure 5. Area of Coyote Creek low flow culvert outlet (not visible but about at arrow location - see Figure 1 flyover photograph) in relation to the "island" with trees to right of culvert outlet in Coyote Creek planned for removal following box culvert installation - facing southwesterly.

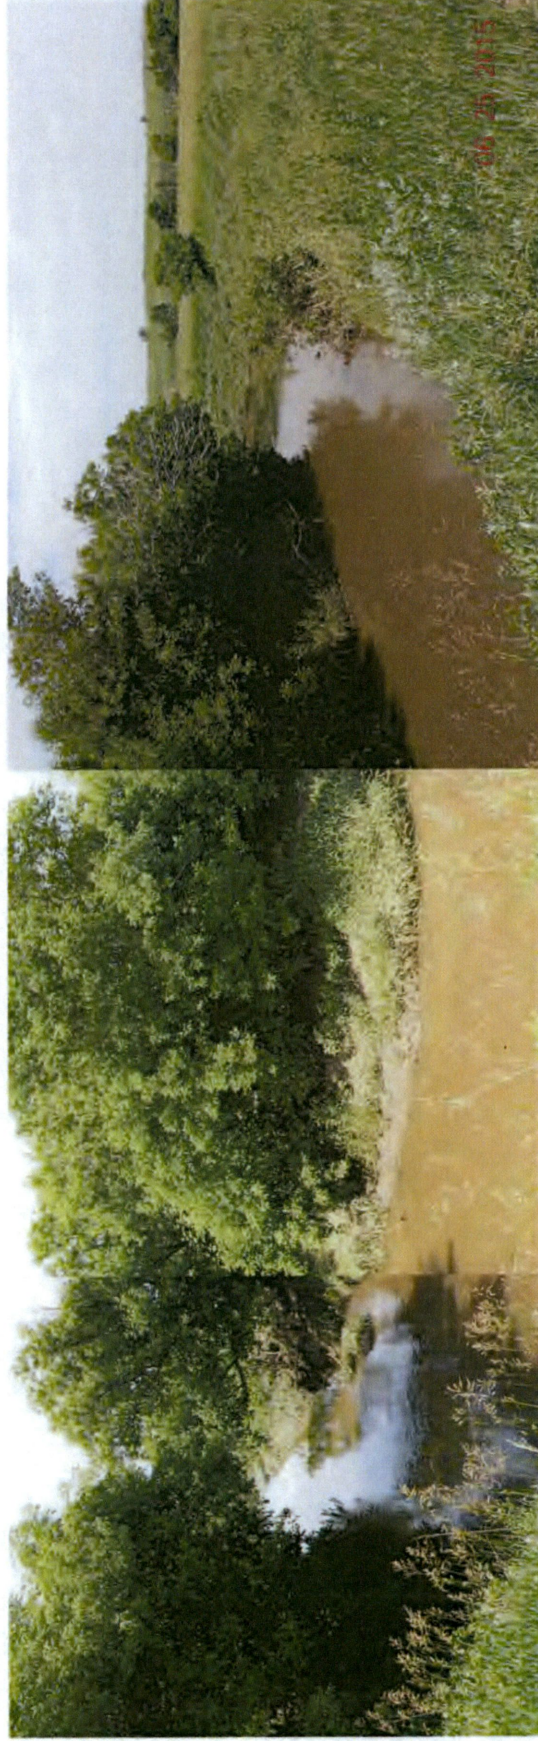
**Figure 6. View of Coyote Creek downstream of the Shop Access Road - facing southwesterly.**
