# PSC June 30, 2015 Inspection Report

### INSPECTION REPORT

PERMITTEE - MINE: Coyote Creek Mining Company, L.L.C. - Coyote Creek Mine

PERMITS INSPECTED: NACC-1302

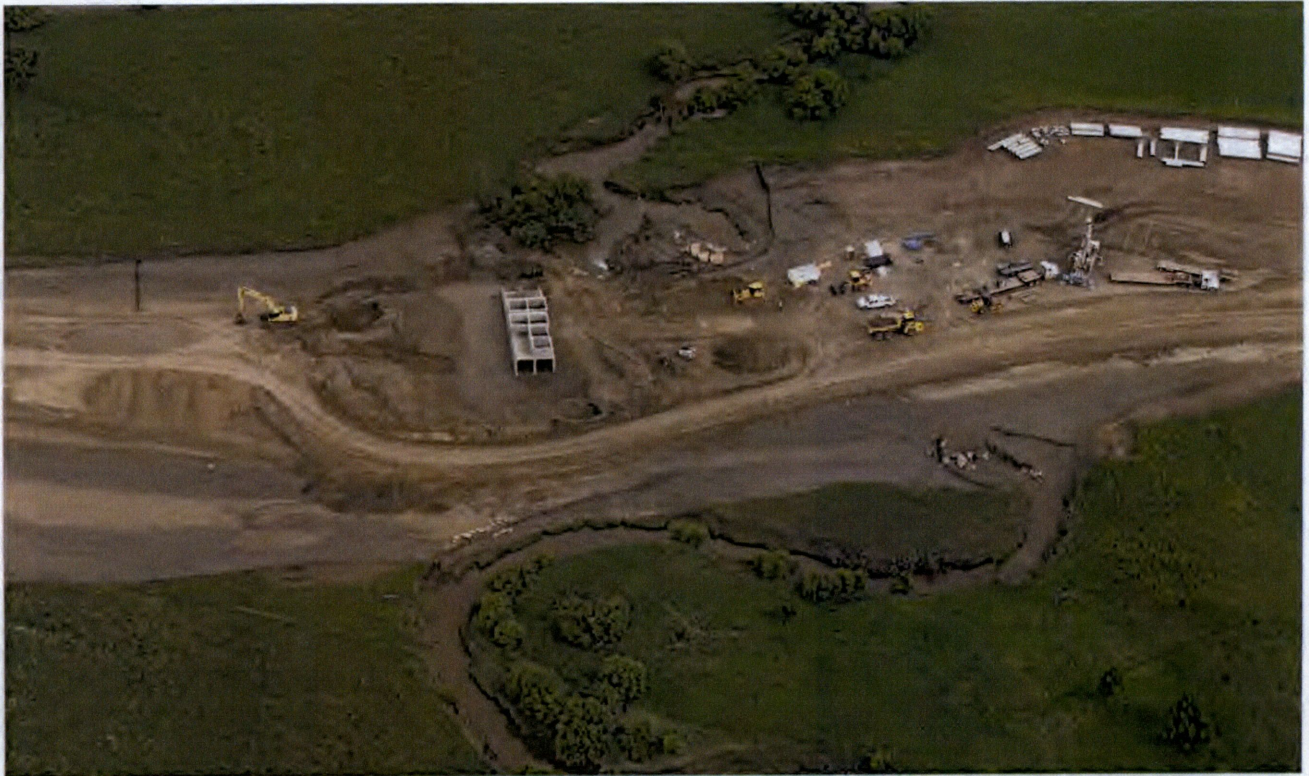
The access road crossing bisects Coyote Creek in an area of numerous stream meanders (see Figure 1). The erosion took place on a floodplain "island" surrounded by active stream and oxbow channels. This island is less than an acre in size and is dominated by shrub and natural floodplain vegetation. The permit soil survey indicates that the island is mapped as Straw loam channeled, 1 to 6% slopes with 18" of topsoil and 42" of subsoil. Mine personnel have indicated that this "island" will be removed and the area will be stabilized with concrete matting; however, they indicated that they did not plan to remove the island until the box culvert installation was complete. Since the start of the box culvert installation, the natural channel just downstream of the 60-inch culvert and upstream and downstream of the box culverts has been blocked to allow construction.

Figure 1- Coyote Creek at access road crossing site taken during June 25, 2015 flyover inspection

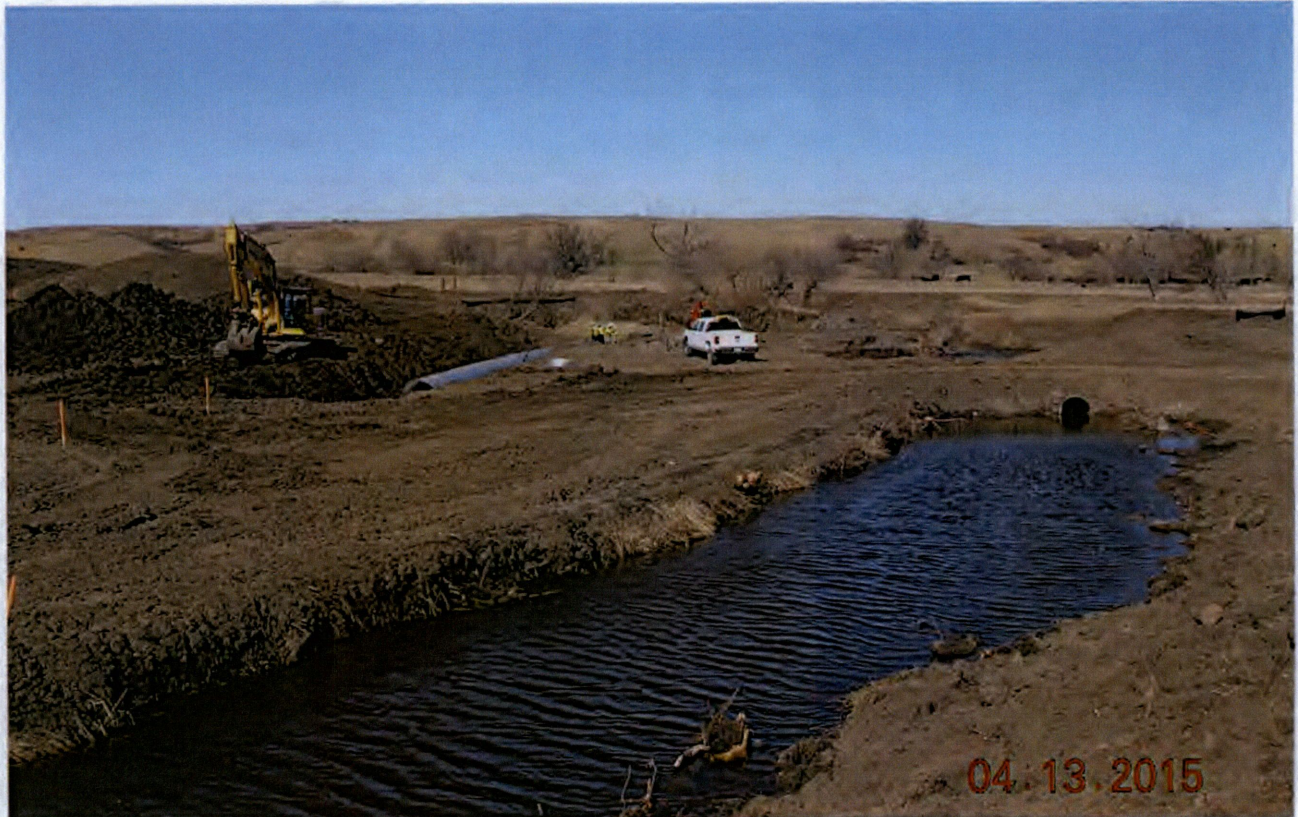
Figure 2 – Low flow culvert installation in progress on Coyote Creek on April 13, 2015

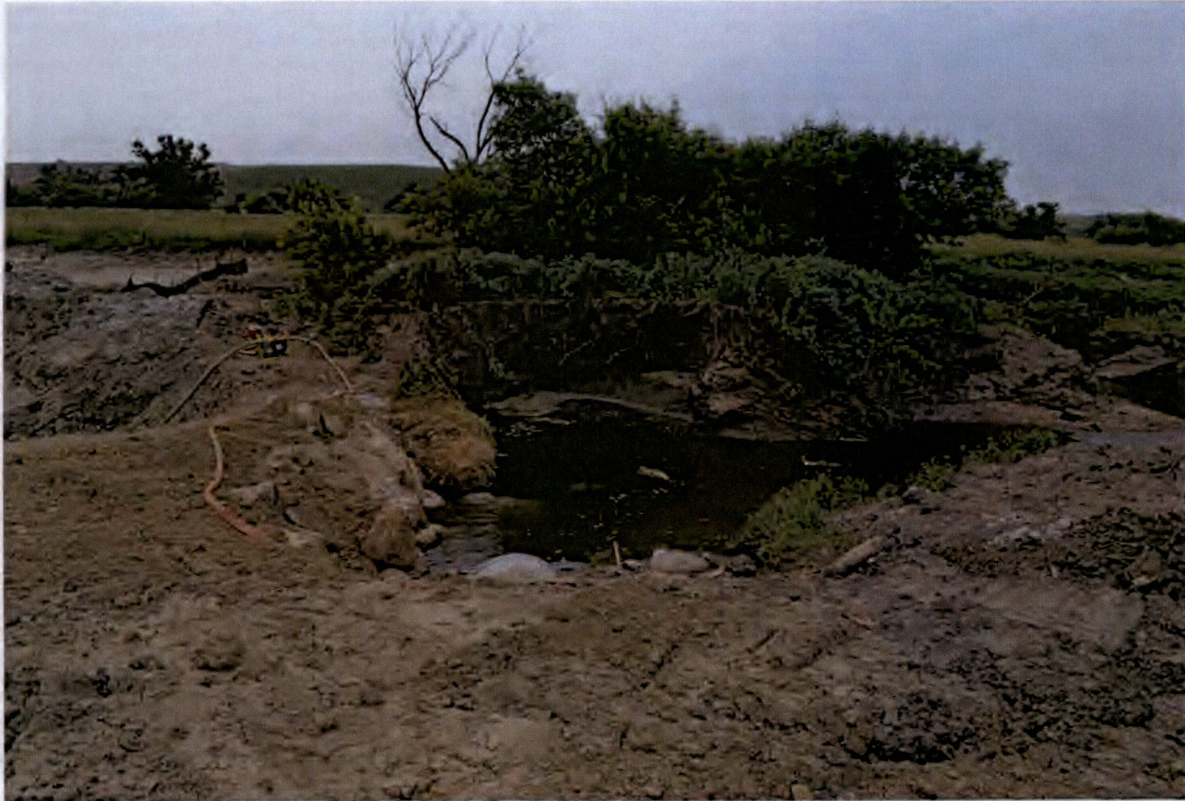
This inspection confirmed that the stream bank across from the 60-inch culvert is eroded apparently due to high volume discharge flows from the culvert. The culvert is positioned in a manner that it outlets in the stream channel at nearly a right angle to the stream channel. The stream flow from the culvert outlet now flows through an excavated channel cut through a meander point, approximately 100 feet north of the 60-inch culvert, at which point it re-enters the natural stream channel. It appears that flows from the culvert hit the opposite bank of Coyote Creek thus creating the erosion feature. The erosion feature was estimated to be 15 to 20 feet wide and deep into the bank and about 10 feet deep from the natural ground surface. No stabilization or erosion protection or remnants of erosion control measures were observed on the opposite bank. See attached Figures 3 and 4.

Figure 3- Erosion to stream bank, center. Channel plug and box culvert site to the left.

As a result of this inspection, Notice of Violation (NOV) 1502 will be issued to Coyote Creek Mining Company, L.L.C. for failure to control erosion at the low flow culvert outlet.

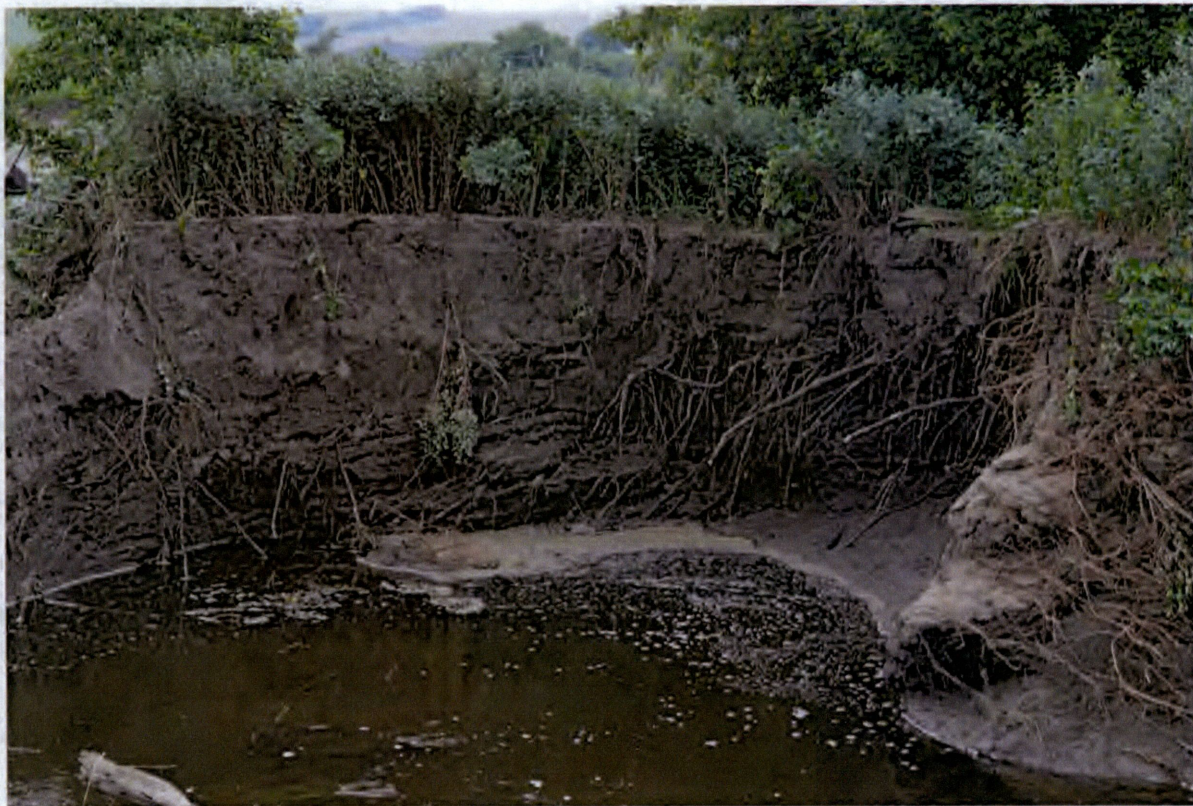
Figure 4- Closer view of bank erosion feature located across from the 60-inch culvert
