Image from the June 30, 2015 Coyote Creek Mine inspection picturing the erosion feature in relation to the low flow culvert outlet.

ND Public Service Commission August 27, 2015

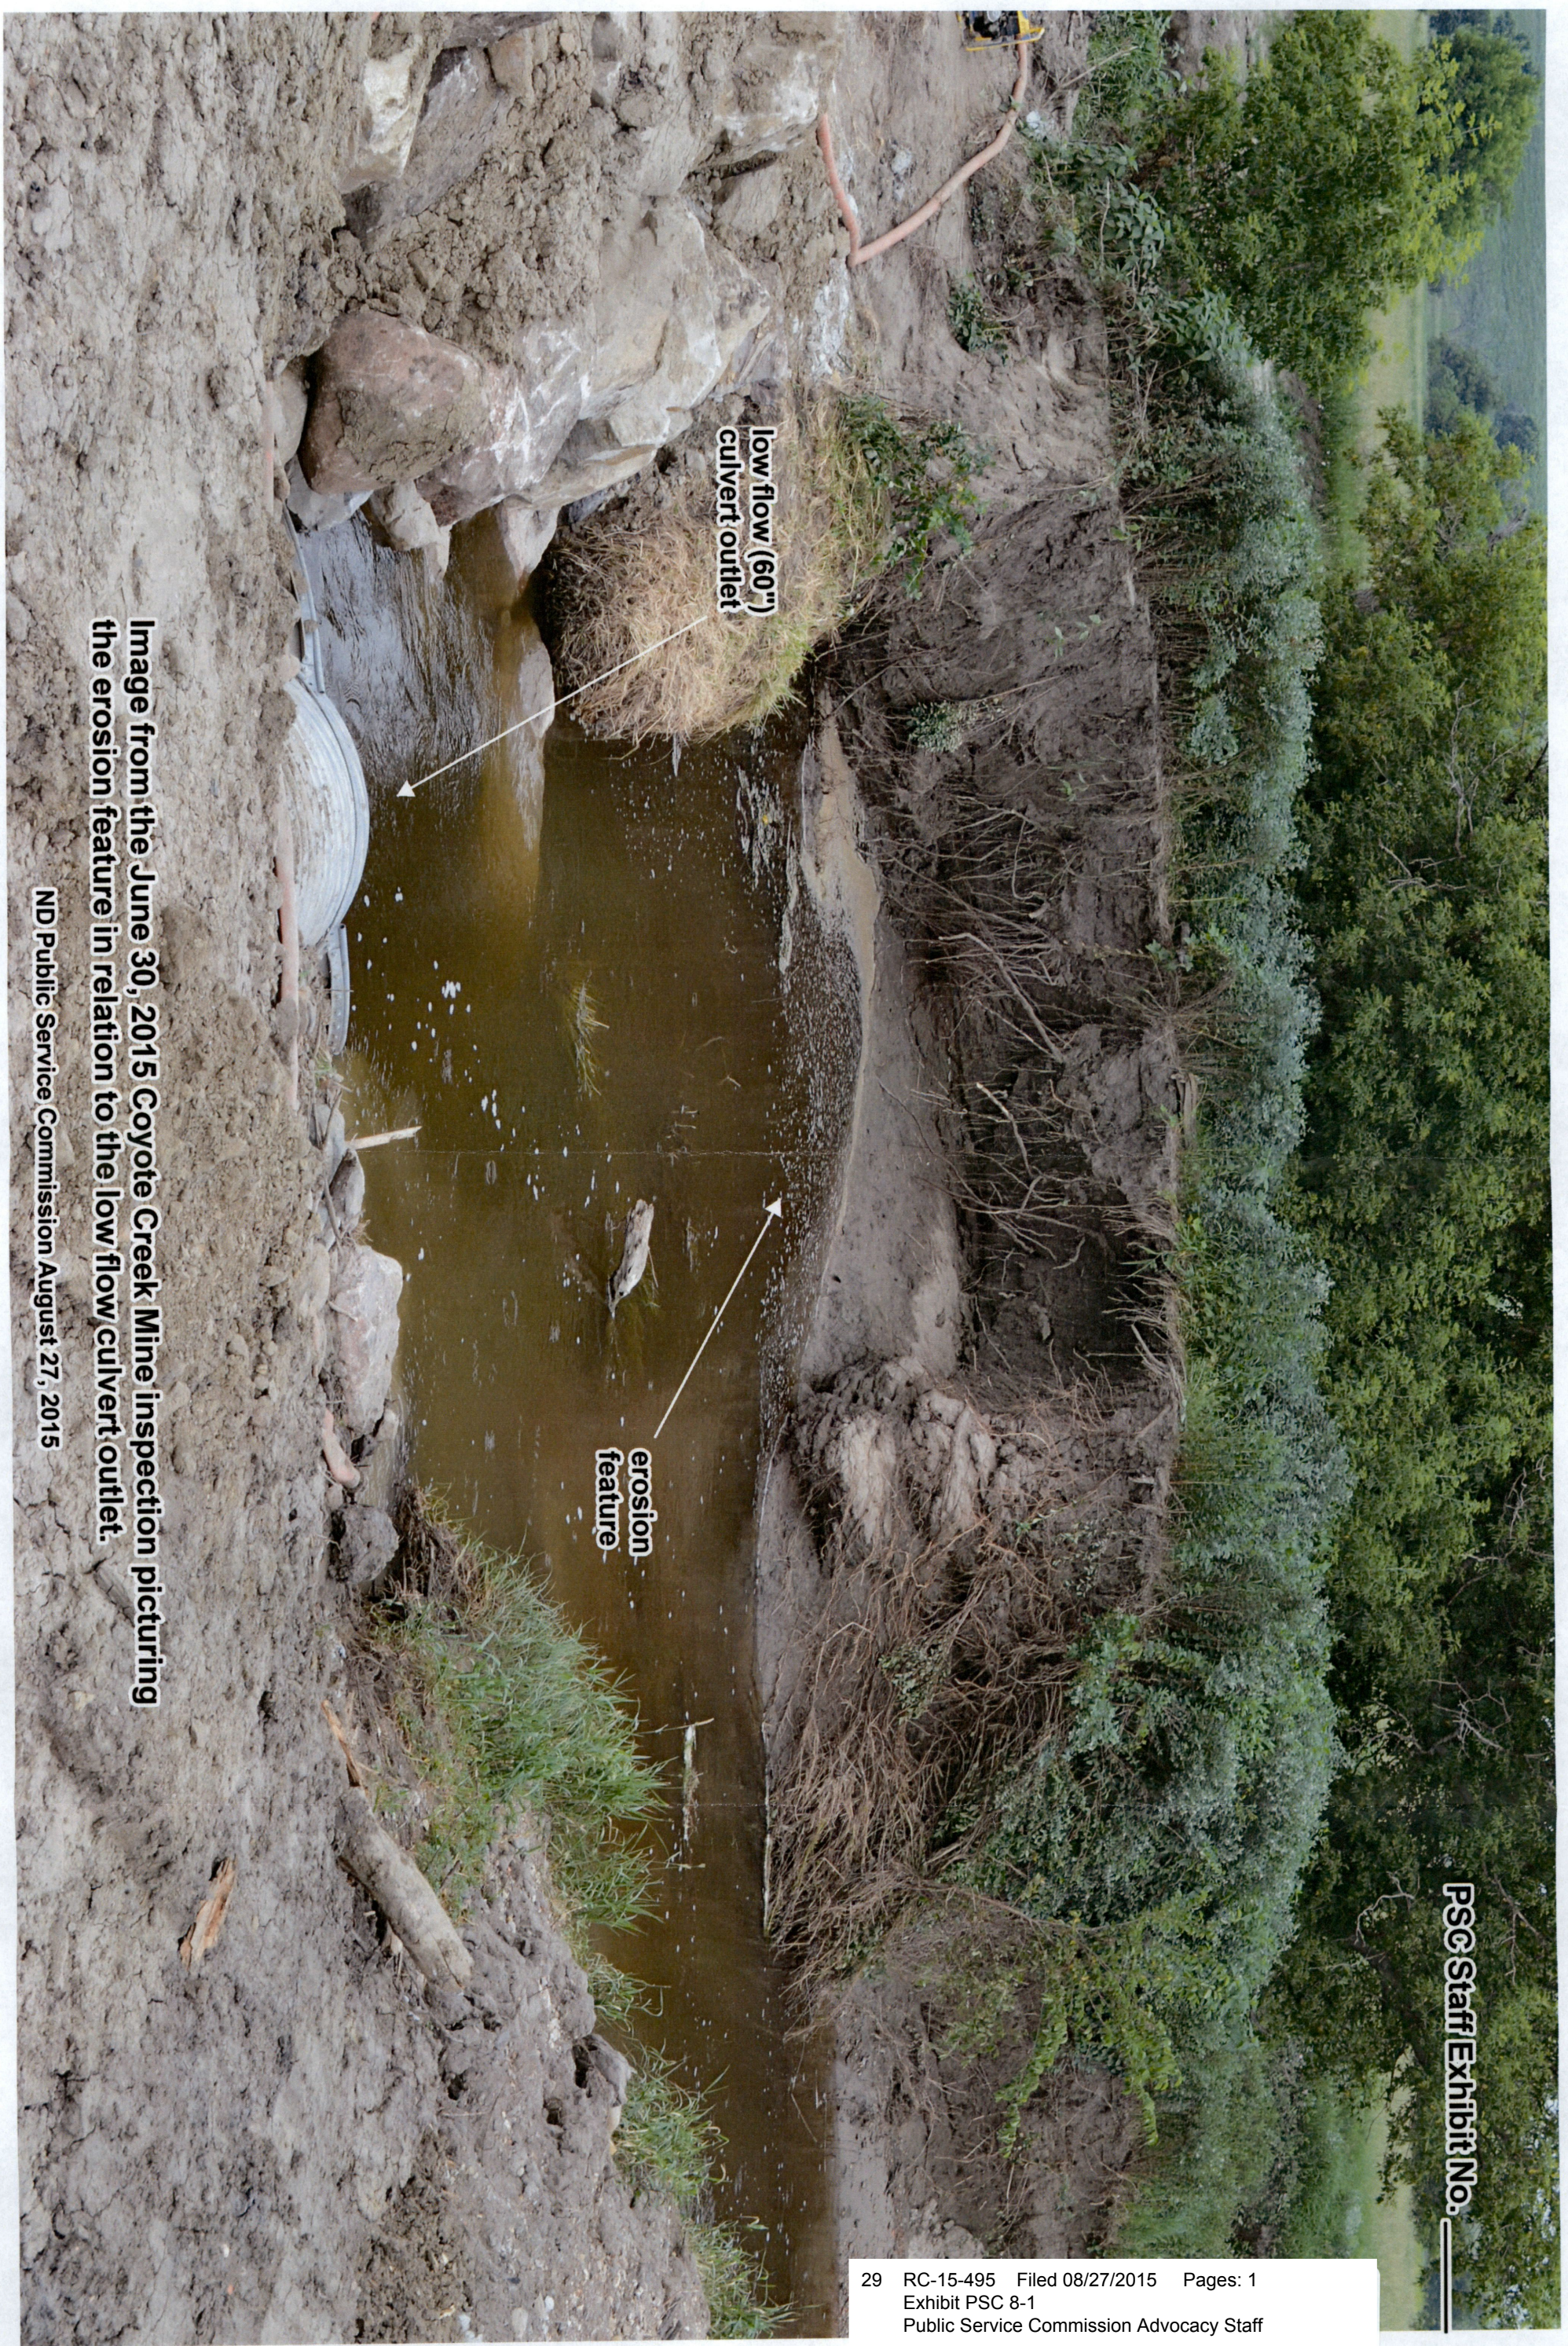
low flow (60")  
culvert outlet

erosion  
feature
