ND Public Service Commission August 27, 2015

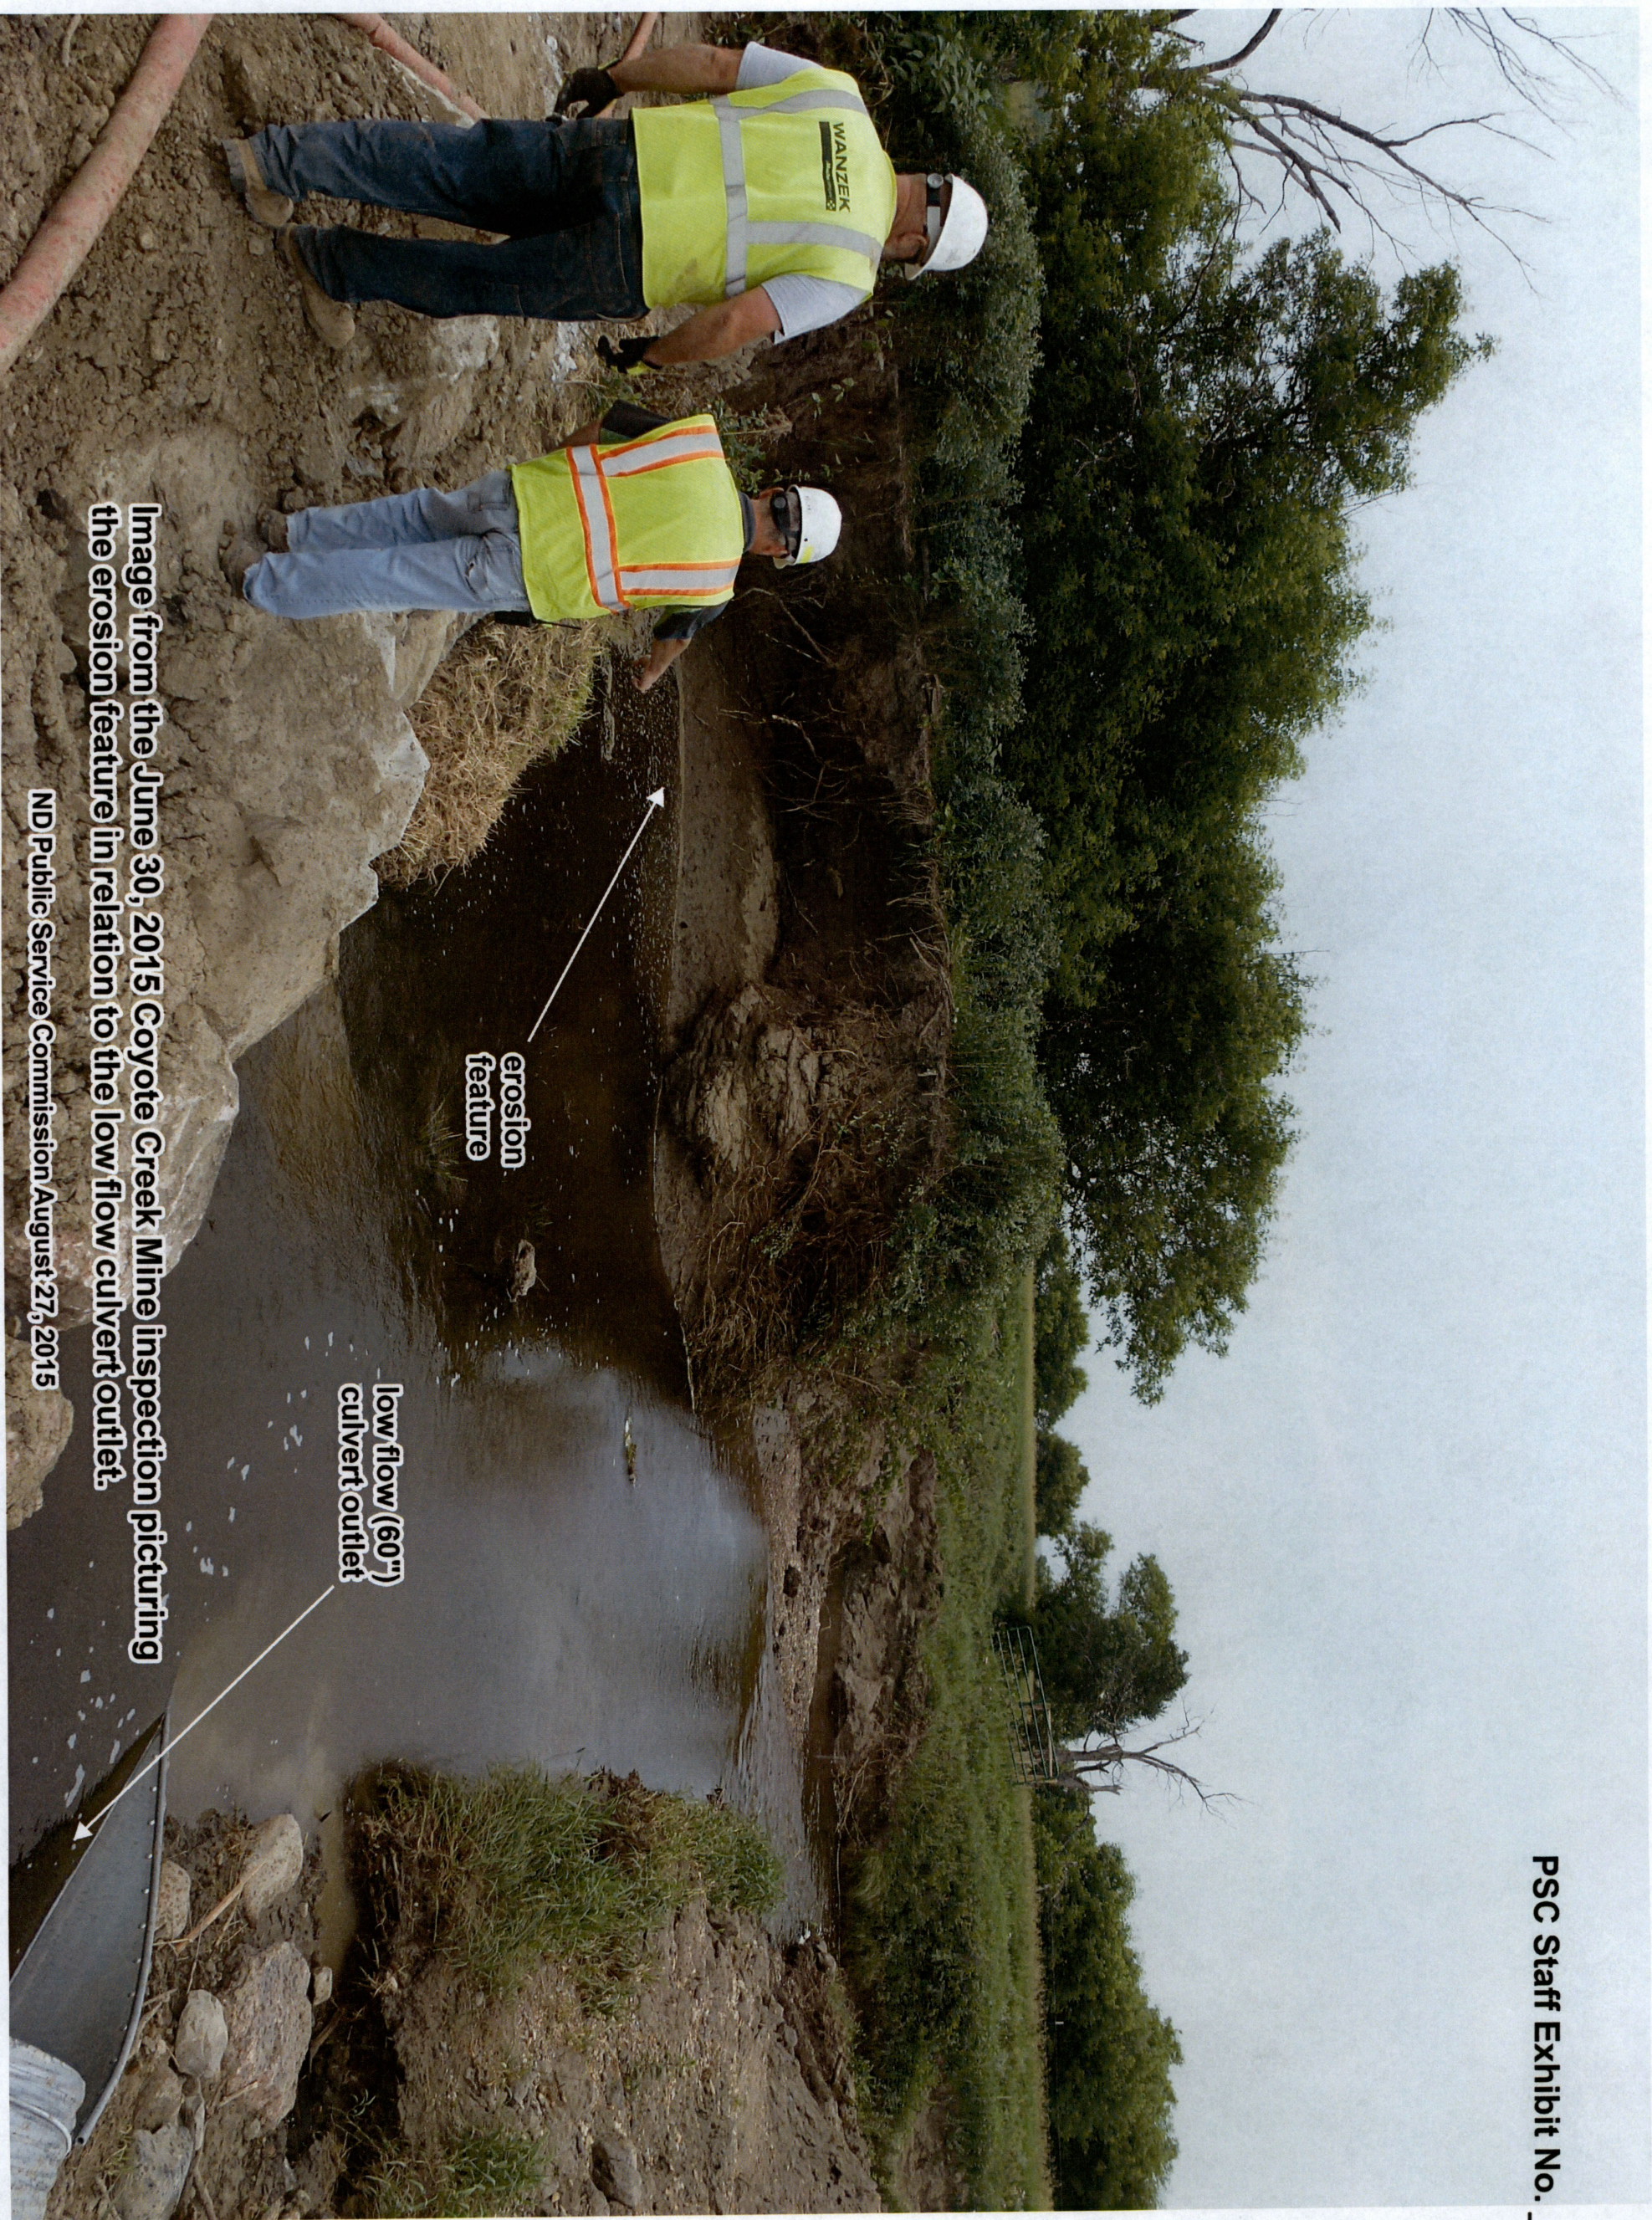
Image from the June 30, 2015 Coyote Creek Mine inspection picturing the erosion feature in relation to the low flow culvert outlet.
