# 150 MW THUNDER SPIRIT WIND PROJECT, (PU-11-601)

## Permit compliance inspection report #2

The North Dakota Public Services Commission has contracted with Houston Engineering, Inc. (HEI) to perform permit compliance inspection services for the 150 MW Thunder Spirit Wind Project, (NDPSC Case No. PU-11-601). The first field inspection for the project was conducted September 2015 and the progress report was submitted on Oct. 16, 2015. The inspection included our observations of the initial construction observations and noted minor issues on site. A second site visit was conducted on July 18, 2016 following completion of the wind project. The focus of this site visit was environmental compliance inspection of the constructed wind project, including: restoration of disturbed areas, integrity of access roads, erosion issues, and impacts to cultural resource and wetland areas. Please note MDU tower numbers differ from HEI documents, all tower numbers referenced correlate with HEI maps. The following items were targeted for inspection during our site visit:

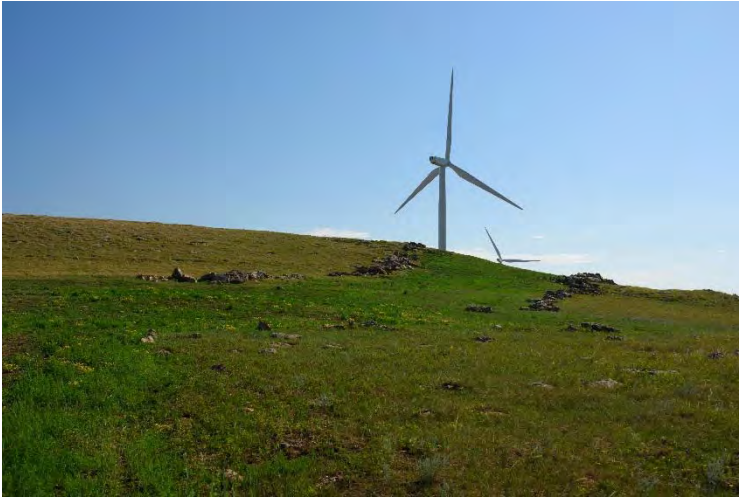
Impacts to the cultural site adjacent to Tower 30 were avoided; construction did not approach the site and no impacts were observed. The construction area around Tower 30 is vegetated. Some areas of minor

**Photo 1:** Tower 30 (facing East)  
no impacts to cultural site.

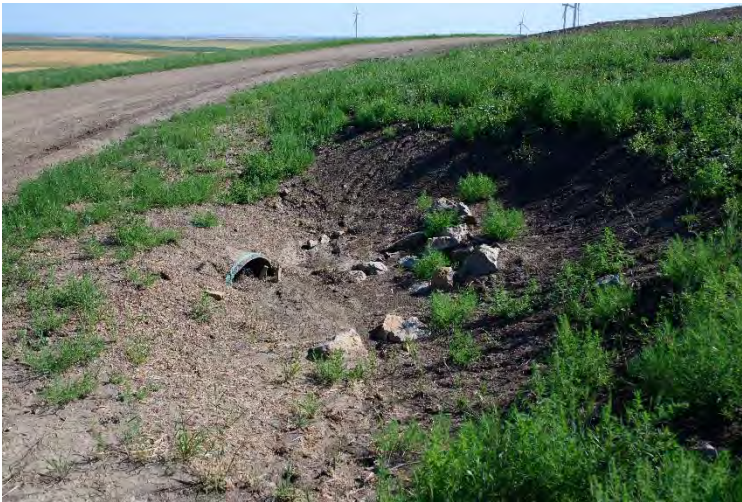
erosion were observed in the area of the buried line between Towers 30 and 40, which is not vegetated (**Photographs 3 and 4**). A wetland crossing was bored along the buried line between these towers; no temporary or permanent impacts were observed. Another buried power line crossed a wetland (**Photograph 15**) and temporary impacts were observed. Also between Towers 30 and 40 is a culvert running under the road (**Photograph 2**). The area around this culvert is not vegetated and was found with soil stability/erosion issues; the culvert was found 66% filled with sediment and does not have sufficient capacity to convey stormwater.

**Photo 2:** Between Tower 30 and  
31 (facing North). Significant  
erosion, culvert filling with  
sediments (approximately 66% full)

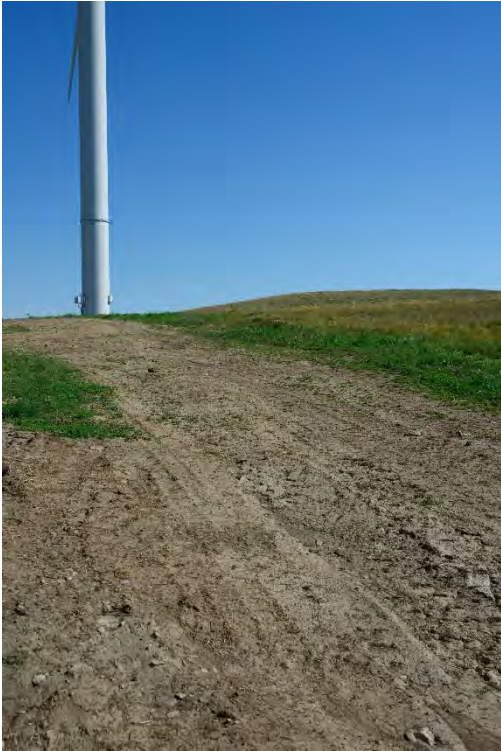
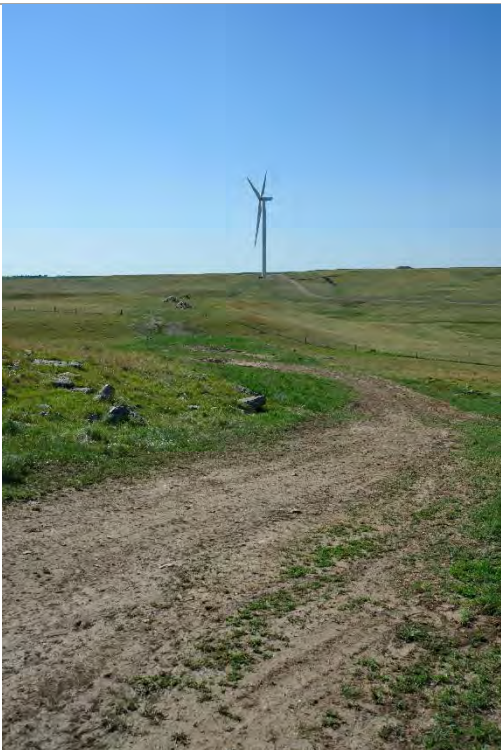
**Photo 3:** Between Tower 30 and 40 (facing Southeast) bare area.

**Photo 4:** Between Tower 30 and 40 (facing Northeast) bare area.

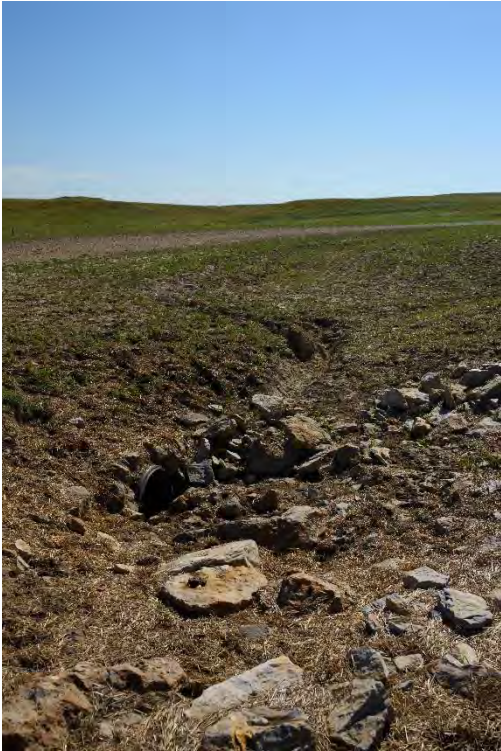
No impacts were observed to the cultural site located in the vicinity of the Tower 31 roadway. Vegetation at this tower was established and observed adequate. Another culvert under the roadway between Towers 30 and 40 appears to be experiencing minor sediment loading (**Photograph 8**) as there is some minor erosion observed along the roadway. The access road was observed to be experiencing erosion of the surface aggregate (**Photograph 14**).

**Photo 8:** Tower 40 (facing East)  
minor erosion; sediment loading to  
culvert.

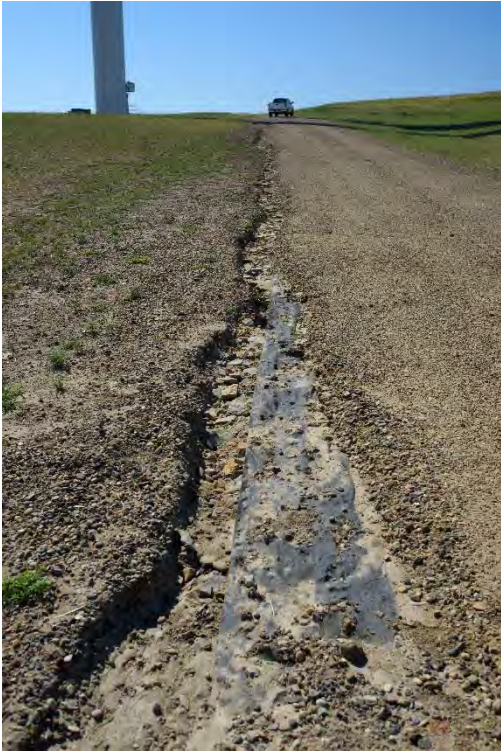
**Photo 14:**  
Tower 40 (facing Southeast)  
erosion to access road; aggregate  
surfacing erosion.

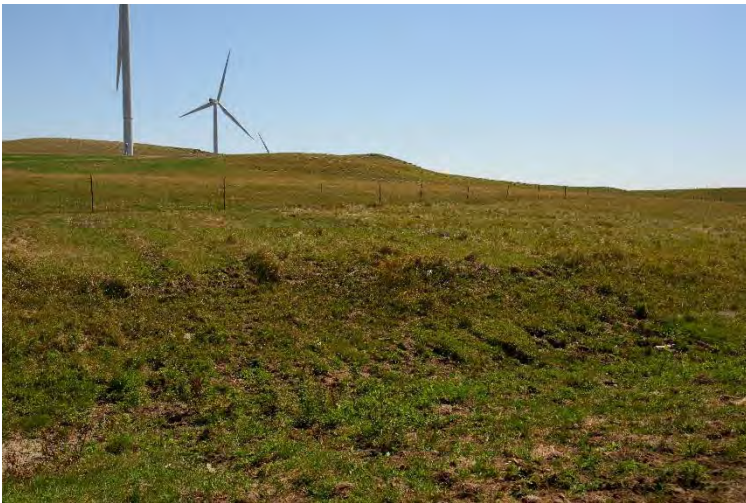
**Photo 15:** Tower 40 access road  
(facing Northeast).

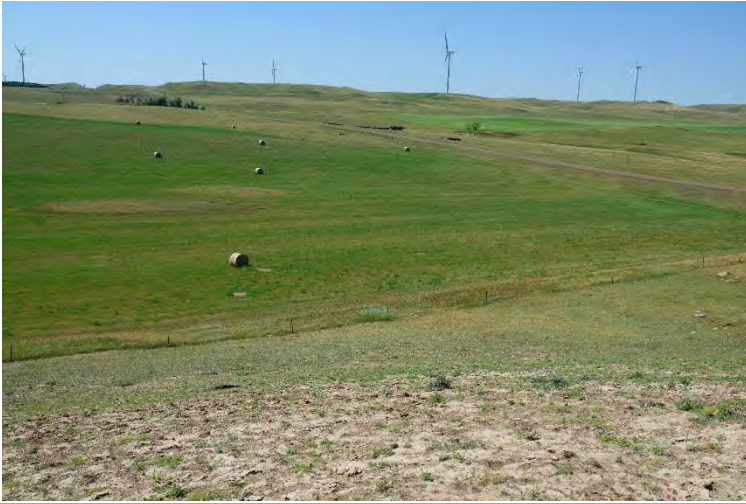
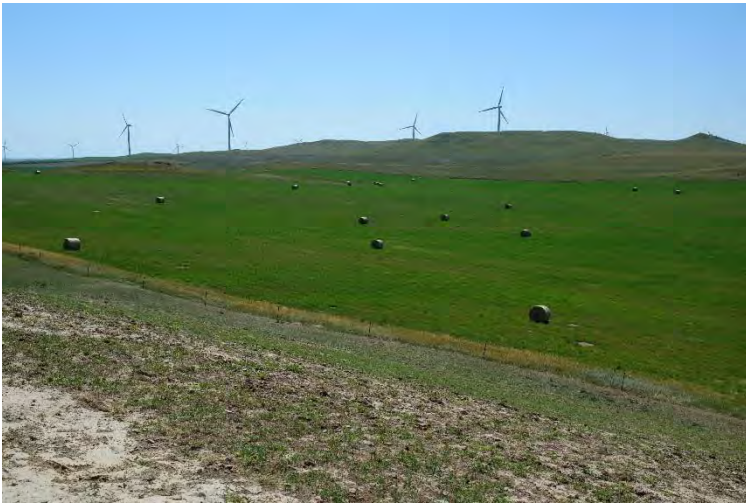
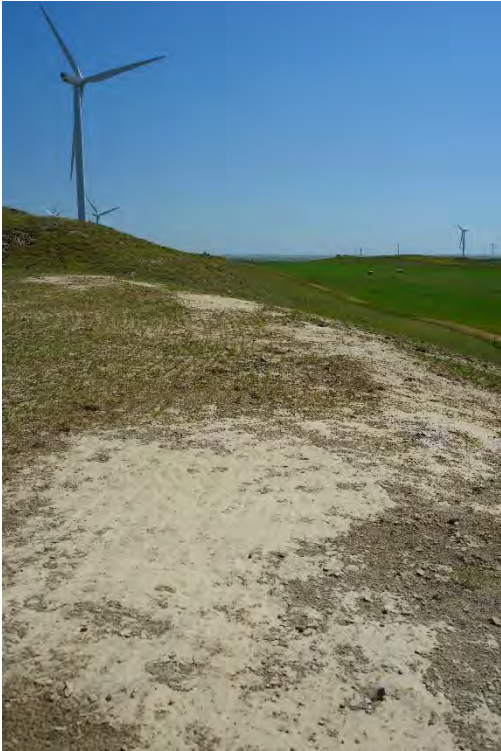
The cultural site south of Tower 7 was not impacted by site grading. Tower 7 was observed to have little vegetation established and some bare areas. It appeared that there is little SPGM at this site, which may contribute to revegetation issues. See **Photographs 16 through 18**.

**Photo 16:** Tower 7 (facing Southwest).

**Photo 17:** Tower 7 (facing Southeast).

**Photo 18:** Tower 7 (facing East).  
Seeding activities are visible,  
however germination thus far is  
patchy and bare soil is visible.

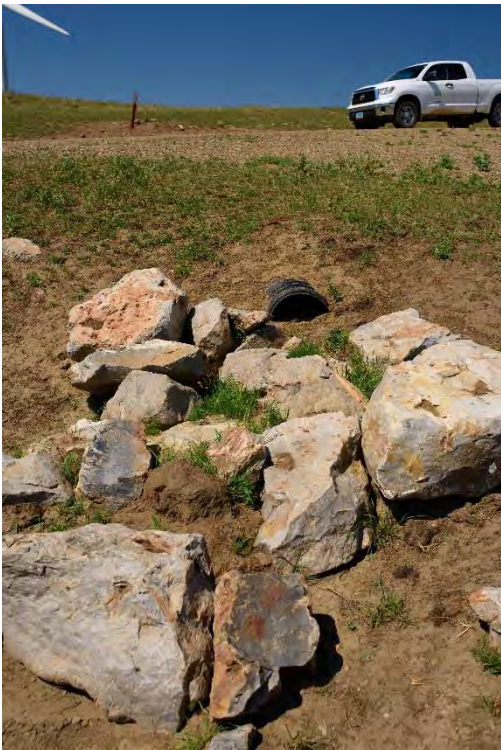
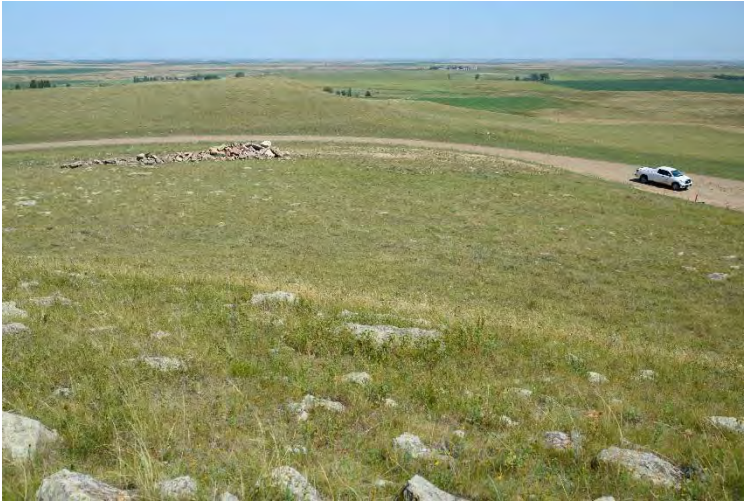
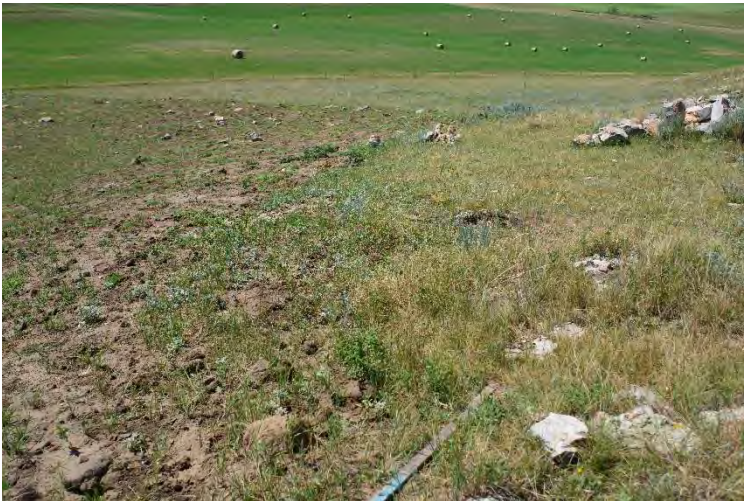
Tower 8 access road had observable erosion. A culvert at this site was observed to be 50% filled with sediment; the sediment loading does not appear to be causing overflow of the roadway. Adjacent to the tower, grading occurred near the cultural site, but no impacts were observed. See **Photographs 19 through 21**.

**Photo 19:** Tower 8 (facing West).

**Photo 20:** Tower 8 (facing South).

**Photo 21:** Tower 8 (facing Southwest).

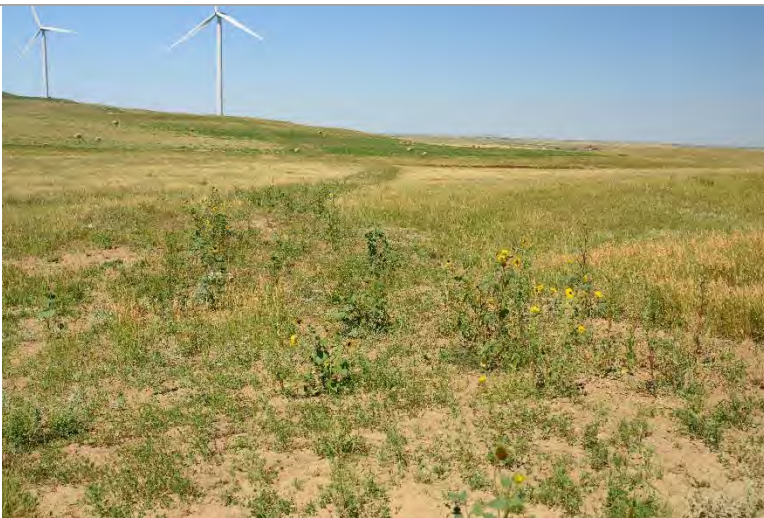
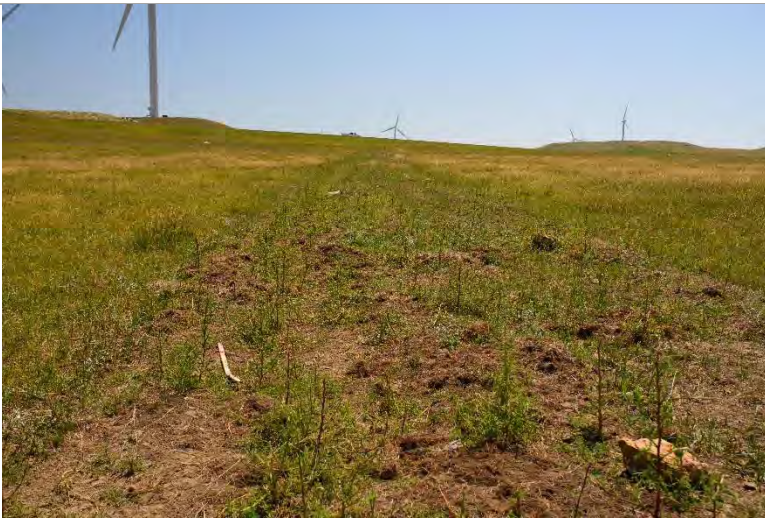
An underground cable was installed between Towers 6 and 7; reclamation to half of this area was observed rough with large piles of SPGM and minimal vegetation established. Half way between Towers 6 and 7 a wetland crossing was bored; no impacts were observed.

**Photo 22:** Between Tower 6 and 7 (facing Northwest).

**Photo 24:** Between Tower 6 and 7 (facing Southeast).

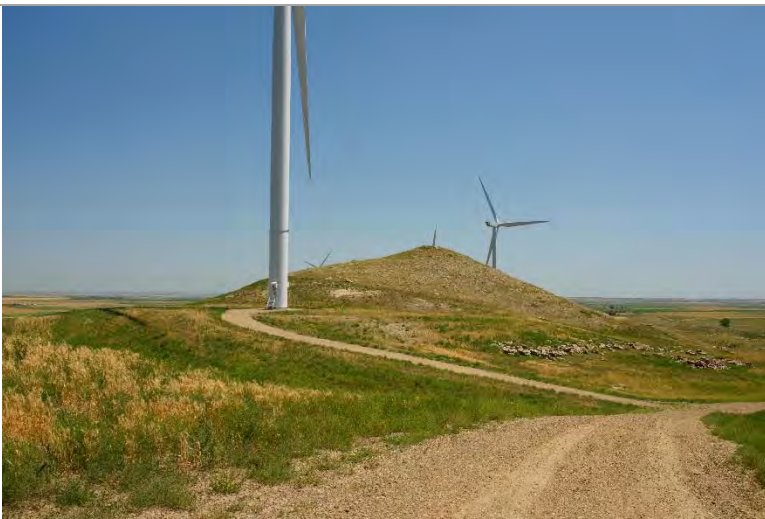
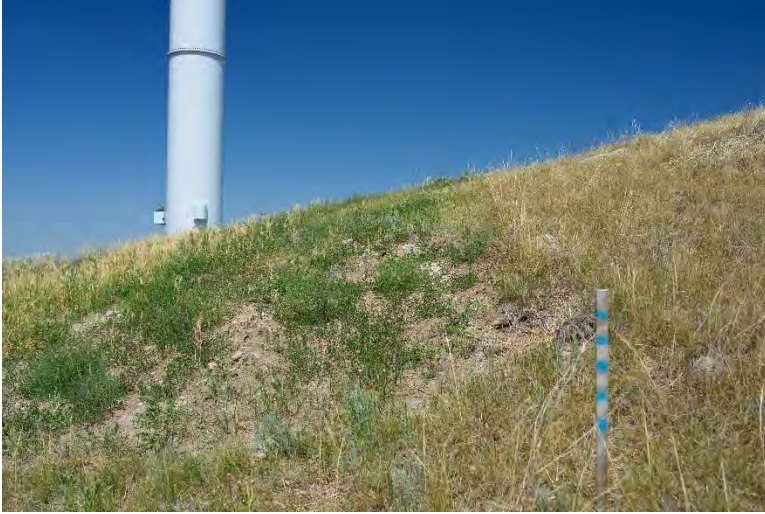
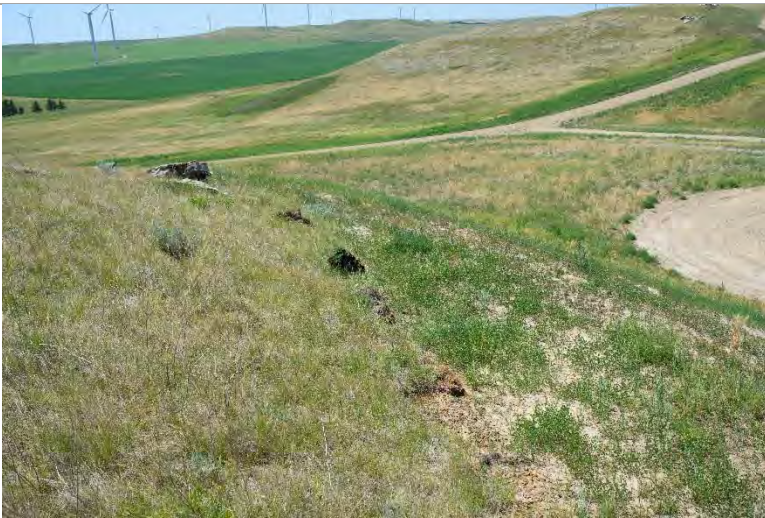
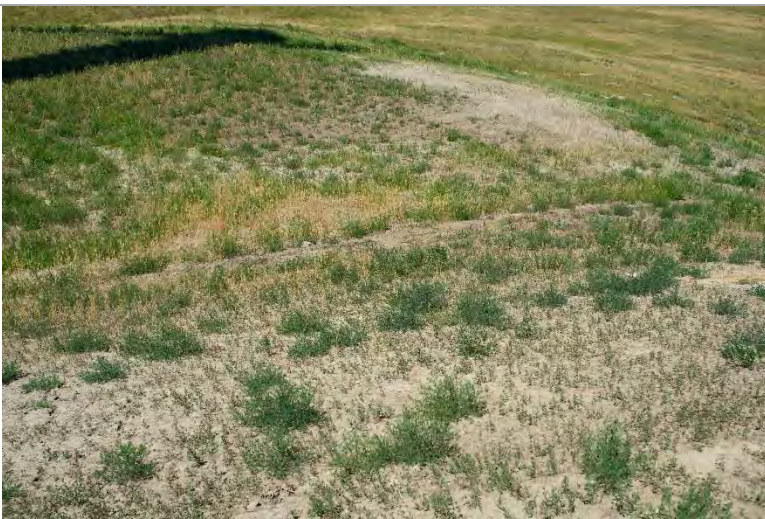
Impacts to the cultural site at Tower 10 were avoided; grading occurred adjacent to the site and no impacts were observed. The slope adjacent to the cultural site is somewhat steep and vegetation is having a hard time establishing. Some rill erosion was observed, which may have potential to develop into larger issues and erode into the cultural site. Other reclamation areas at Tower 10 appear to be adequately vegetated. See **Photograph 25 through 28**.

**Photo 25:** Tower 10 (facing East).

**Photo 26:** Tower 10 (facing North).

**Photo 27:** Tower 10 (facing South).

**Photo 28:** Tower 10 (facing Northwest).

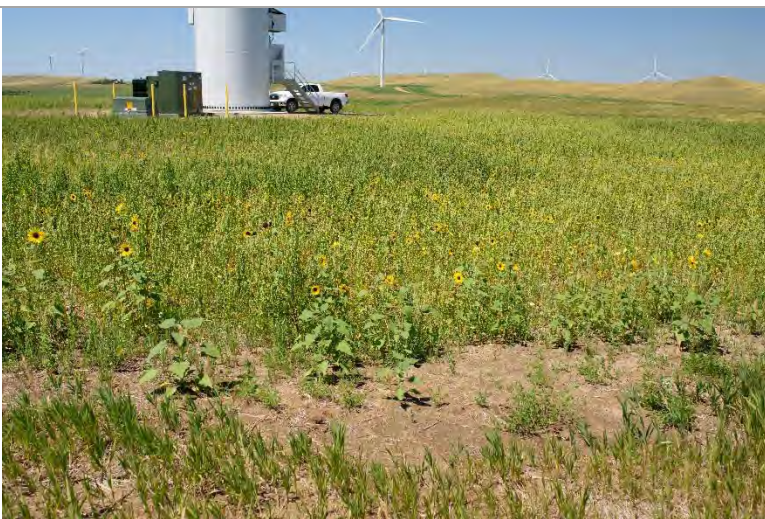
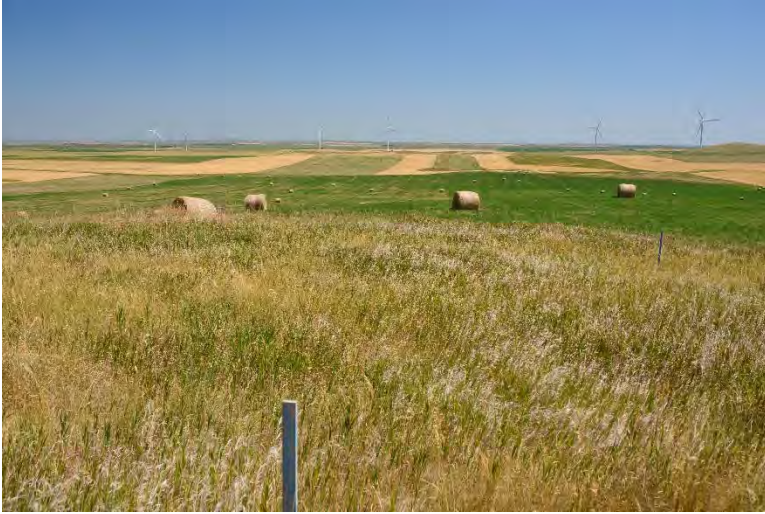
Reclamation adjacent to Tower 21 did not approach the cultural area; no impacts were observed. Vegetation at Tower 21 was observed adequate (**Photographs 31 and 32**).

**Photo 31:** Tower 21 (facing Northwest).

**Photo 32:** Tower 21 (facing East).
