**From:** Bob Bachmeier (701-628-9397) <Bob.Bachmeier@AuxSable.com>  
**Sent:** Thursday, September 10, 2015 11:32 AM  
**To:** Morman, Aaron A.; Reamann, Craig R.; Fahn, Patrick J.  
**Cc:** Kris Nielsen (701-628-9381); Neil Footh (701-628-9382); Jeff White (815-941-5812); Todd Grieff (815-941-5838)  
**Subject:** NDPSC Proposed Compliance Order  
**Attachments:** 3777\_001.pdf; IMG\_0401.JPG; photo 3.JPG; photo 2.JPG; photo 1.JPG; 4723\_001.pdf

Below are Aux Sable's response to the August 13<sup>th</sup>, 2015 Warning Letter and Proposed Compliance Order.

2 **GS-15-632** Filed: 9/10/2015 Pages: 8  
Response to Aug. 13, 2015 letter

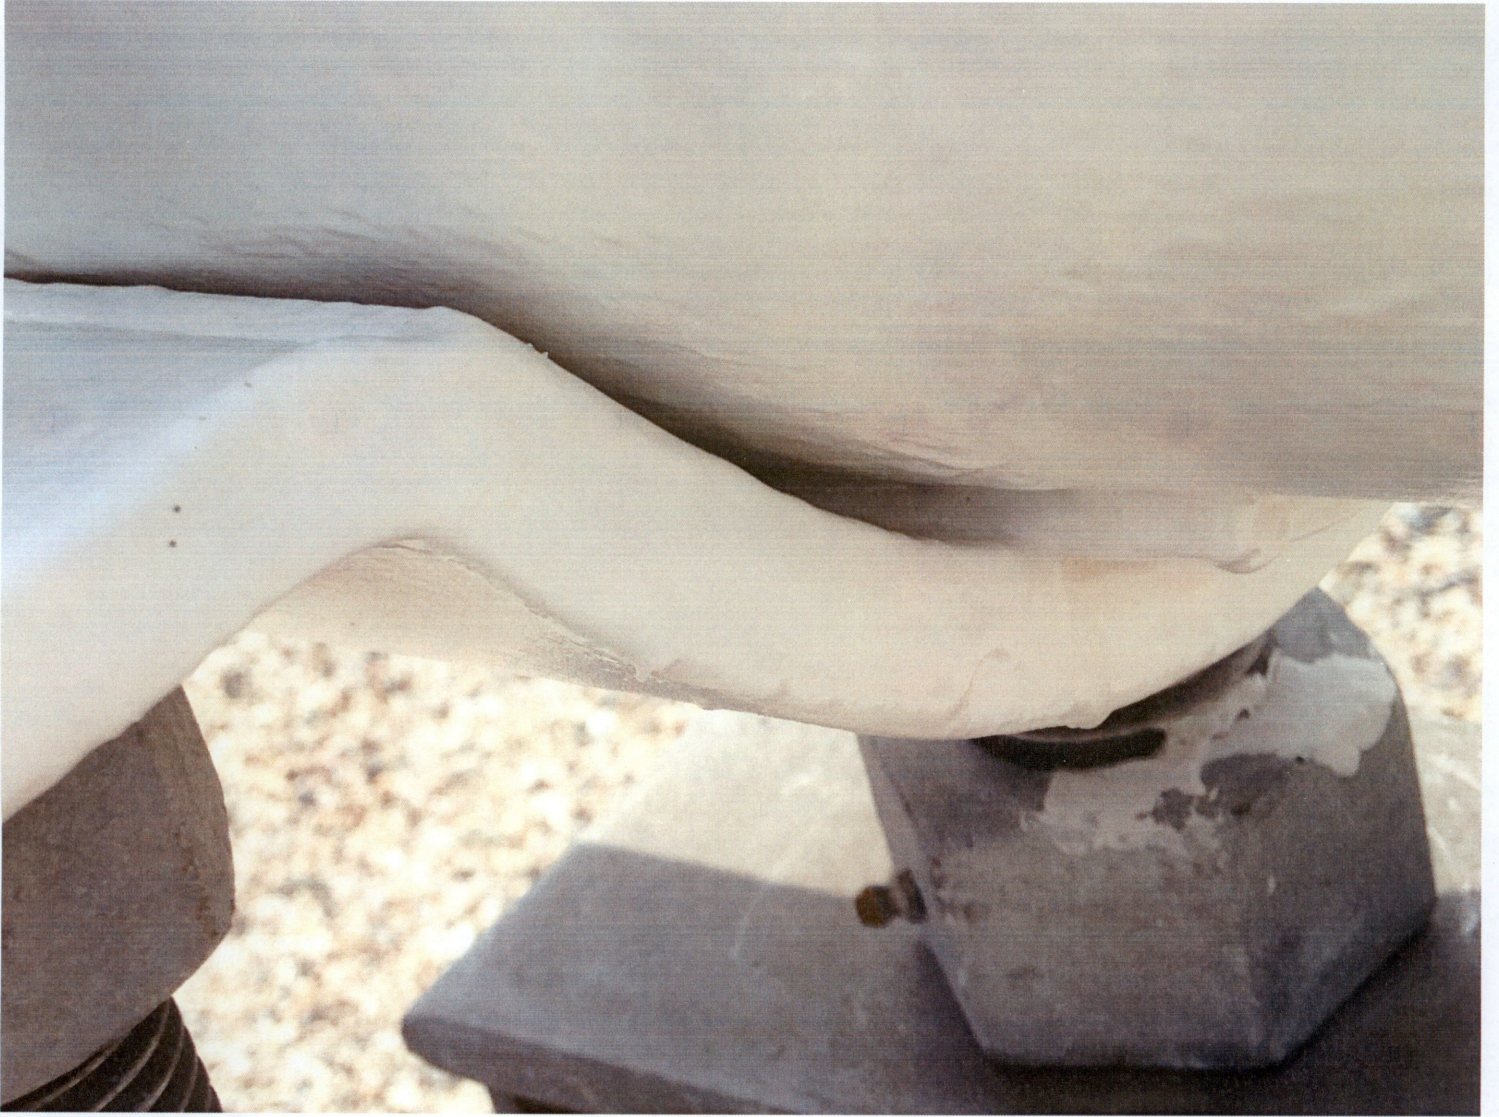
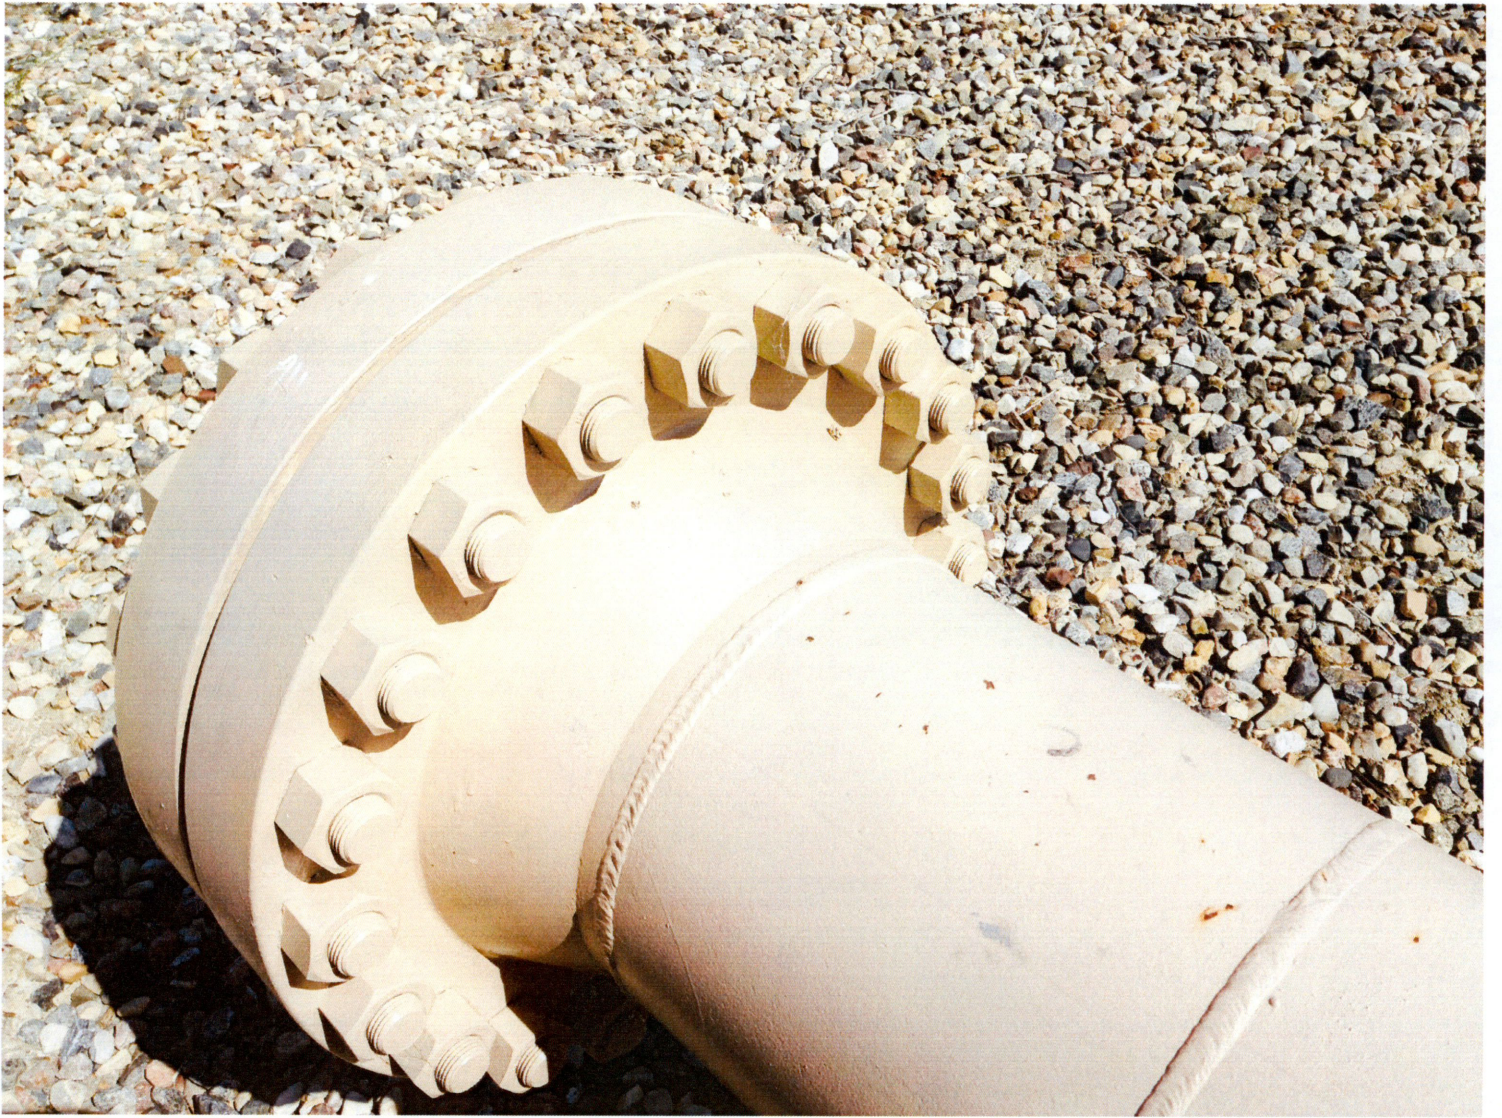
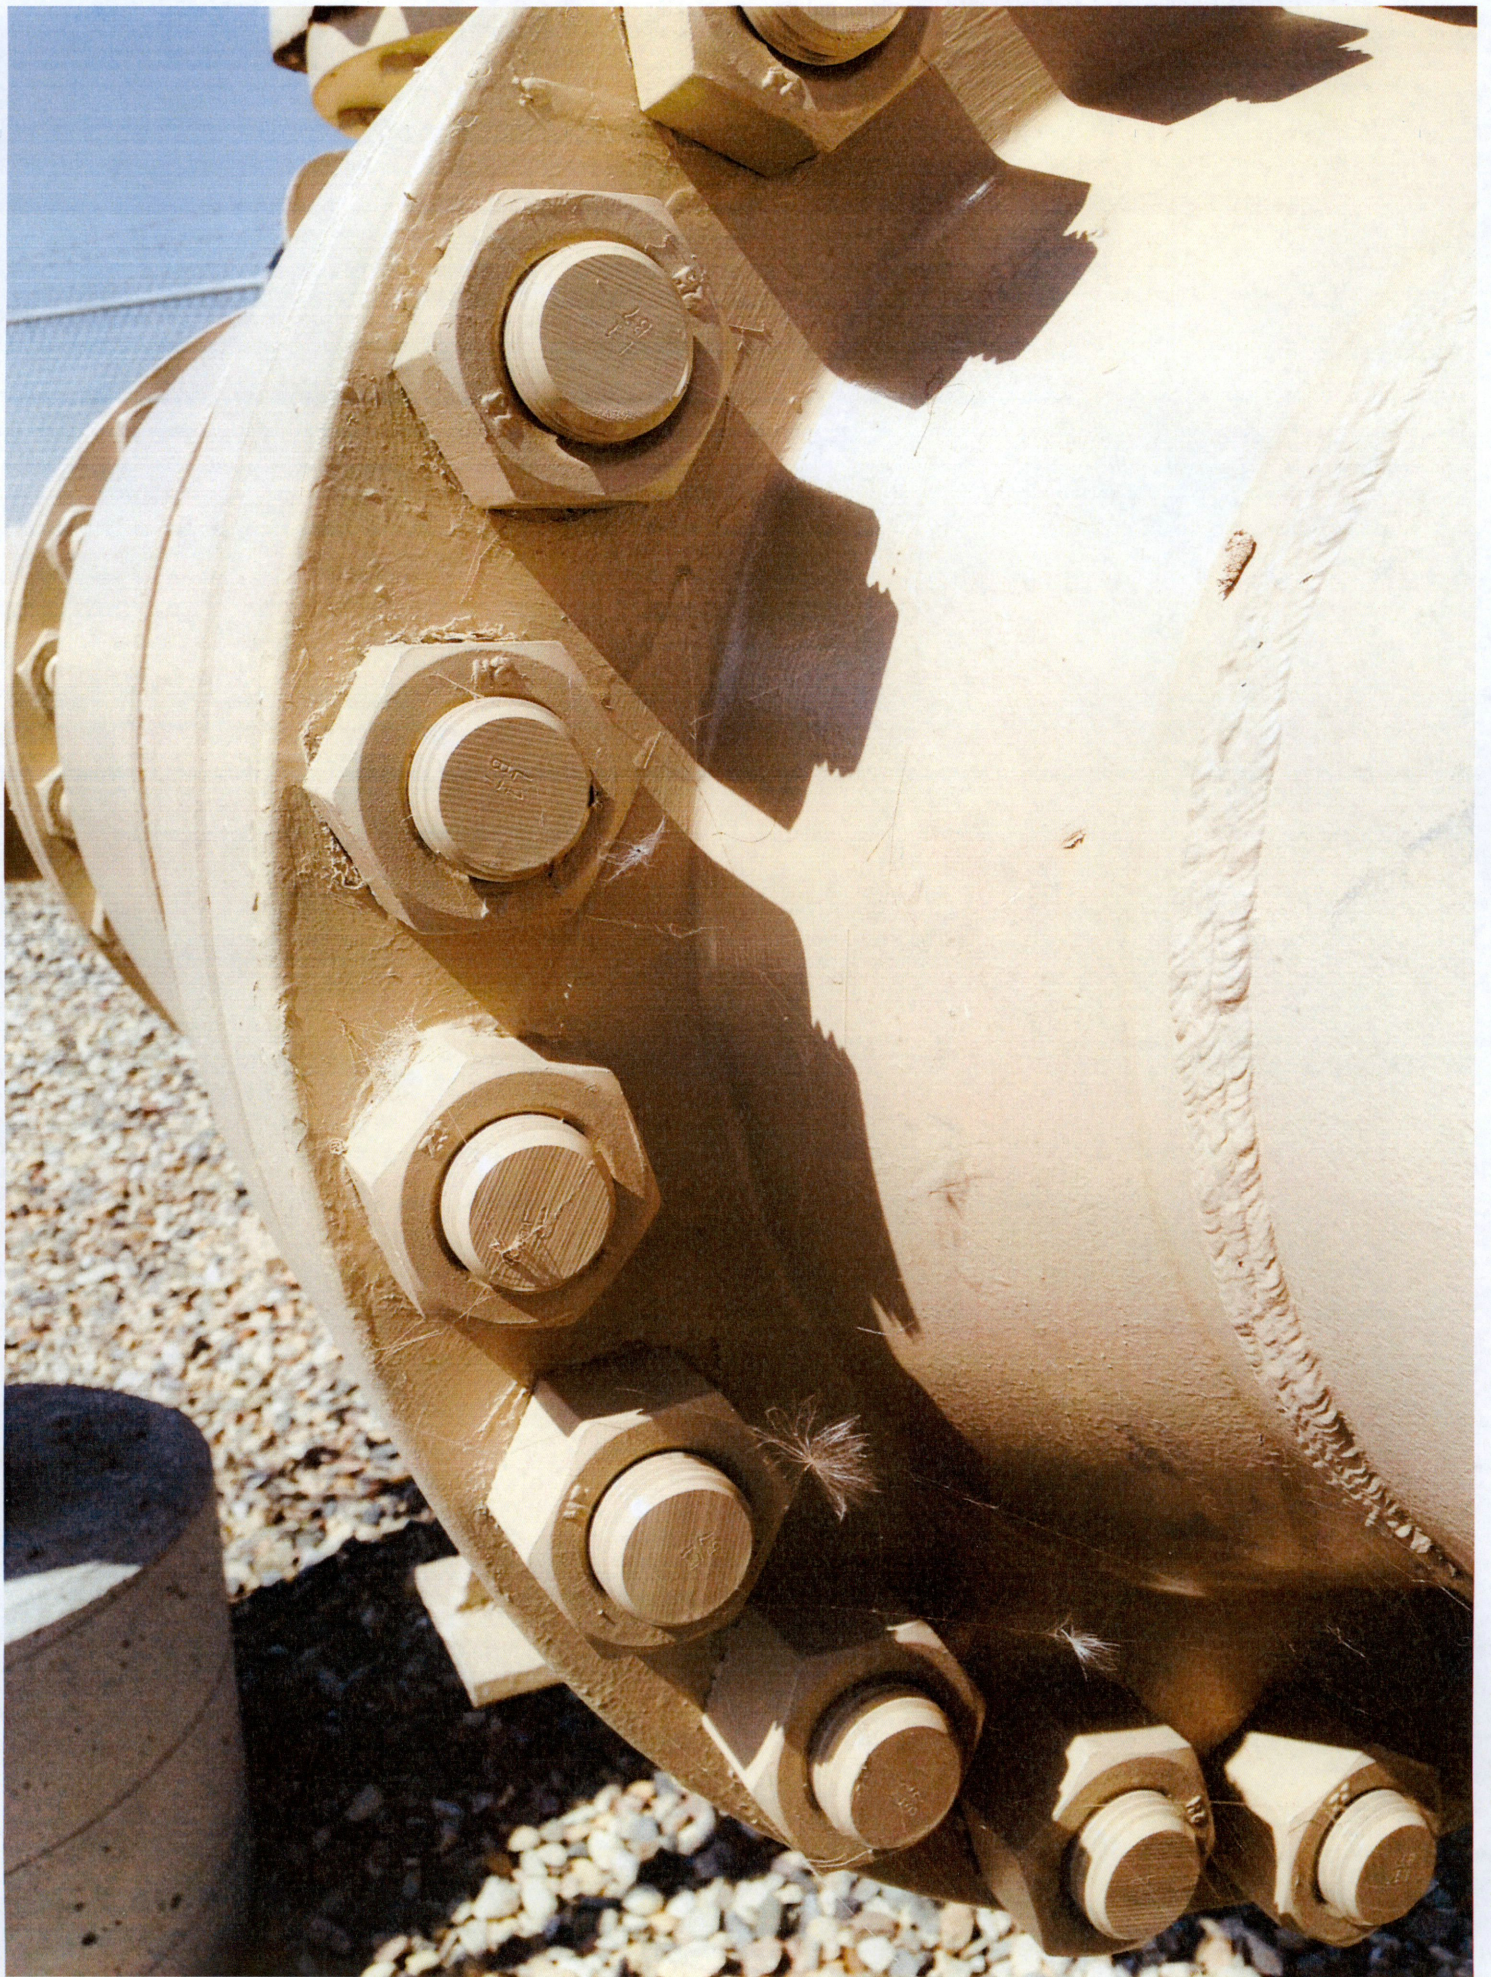
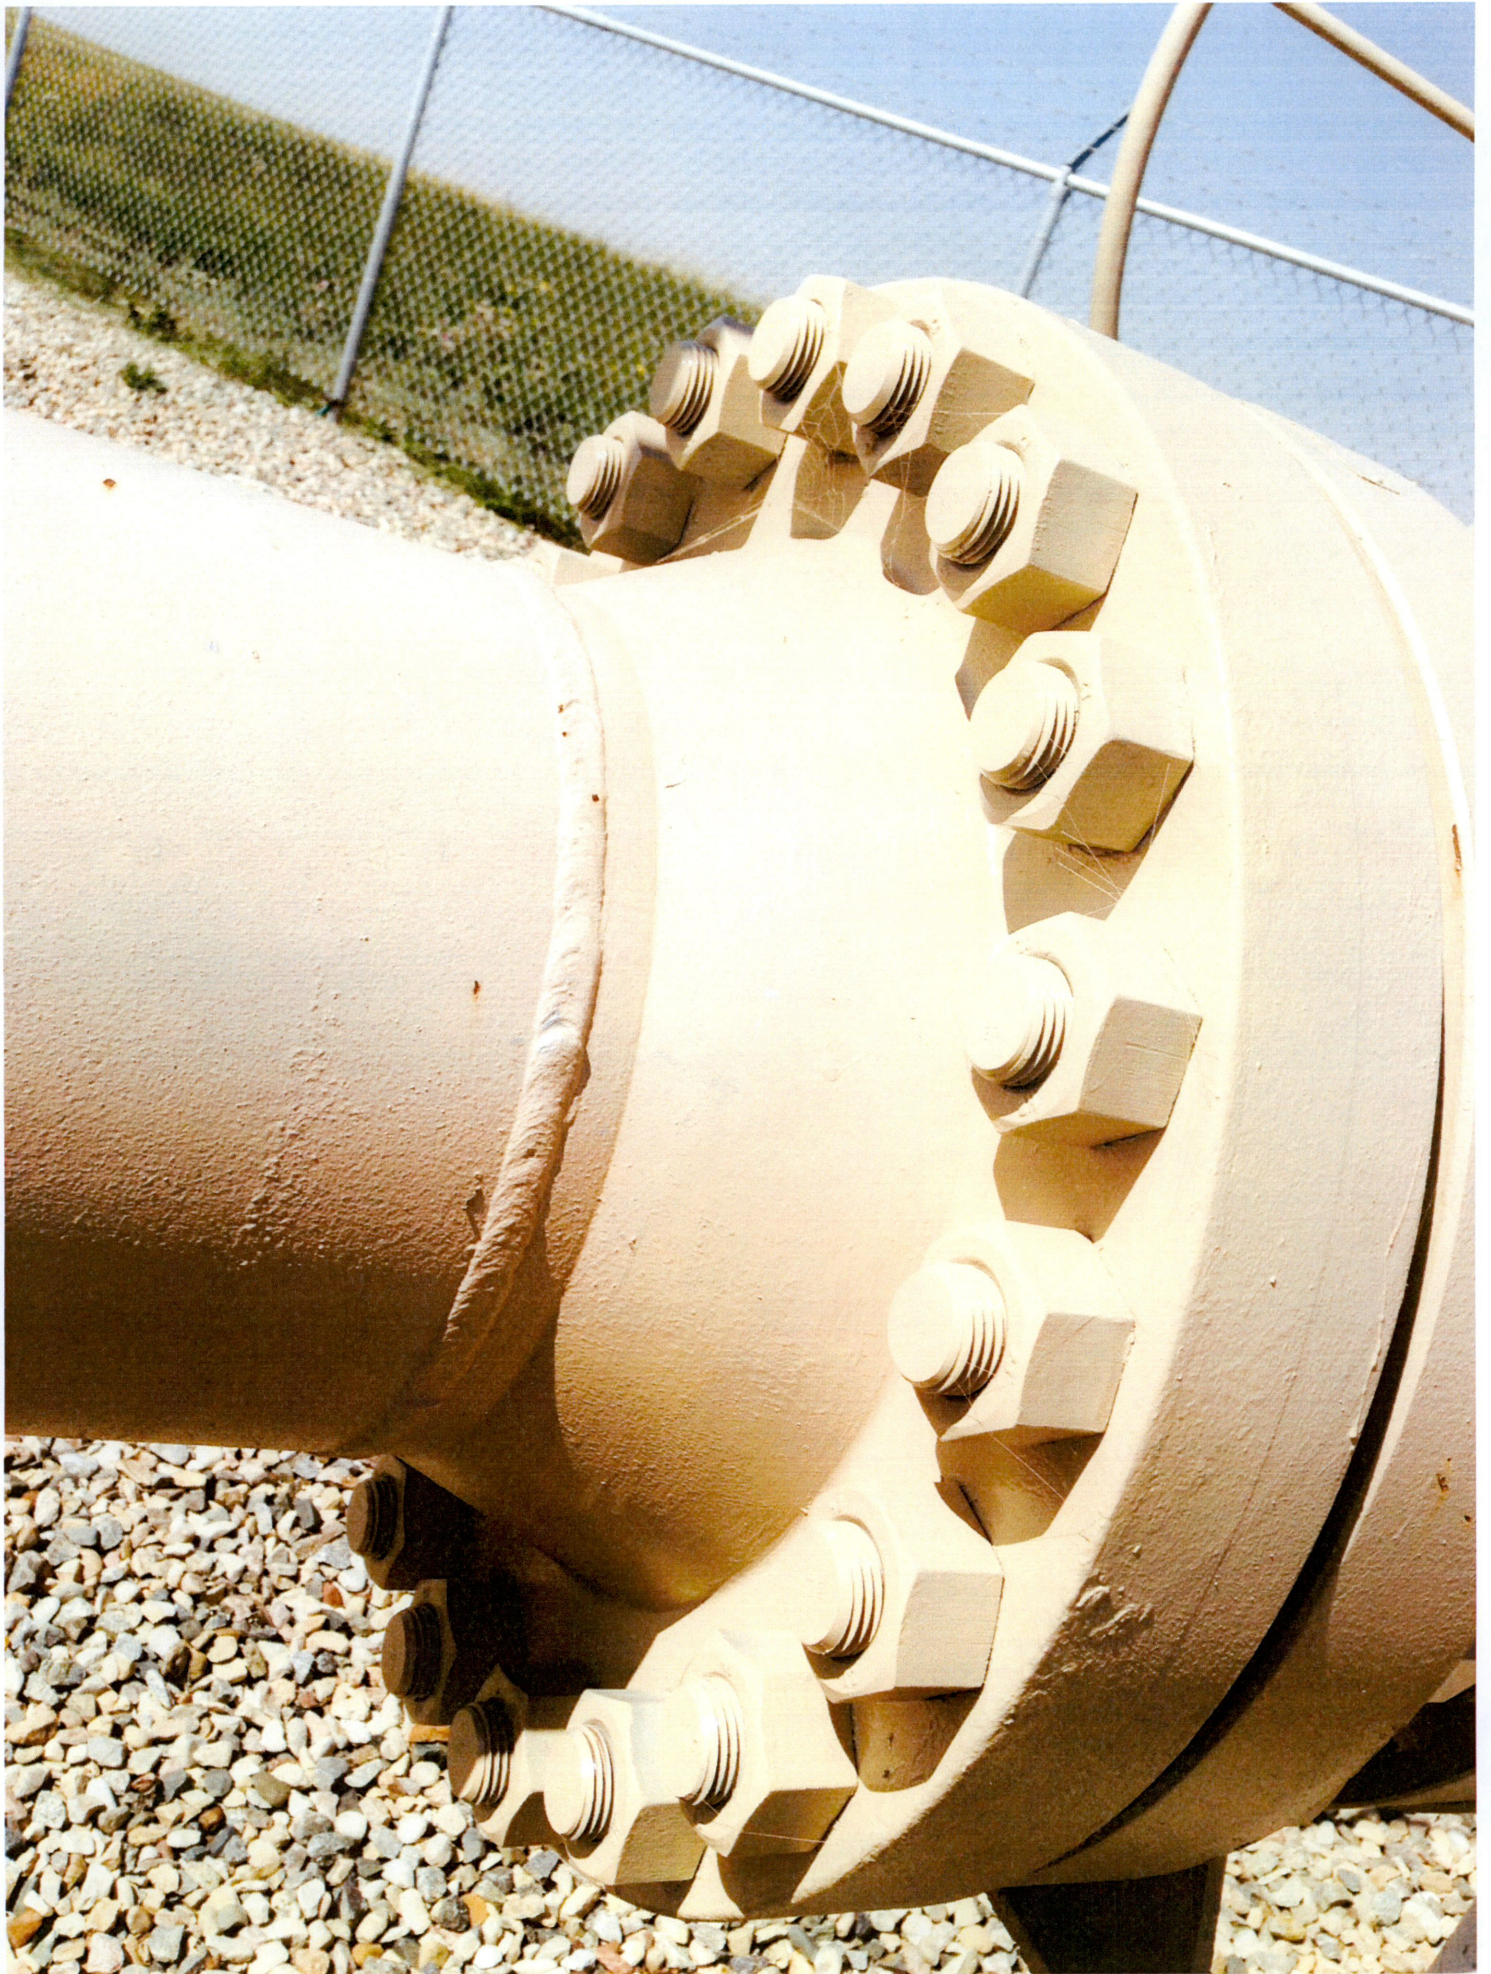
**Probable Violation #2:** On September 4<sup>th</sup> Aux Sable employees wire brushed and painted the areas of concern at the Stanley Interconnect (see pictures photo 1-2-3 above), this will be a temporary coating until Cathodic Protection Management Inc. can get here this week (September 11<sup>th</sup>) to sandblast and coat the pipe properly (see attached PO 3777 001). FYI, Cathodic Protection Management Inc. will sandblast and coat all piping at the Stanley Interconnect (Whiting Oil and Gas interconnect). I will keep you updated on the progress of the project, when completed I will send pictures.
