Re: Topsoil Inspection Report for Sacagawea Pipeline Project
Palermo to Enbridge Crude Oil Pipeline
PU-15-670

SACAGAWEA PIPELINE PROJECT
PALERMO TO ENBRIDGE CRUDE OIL PIPELINE, MOUNTRAIL COUNTY
TOPSOIL INSPECTION REPORT
PU-15-670

KLJ File #1216107
April 2016

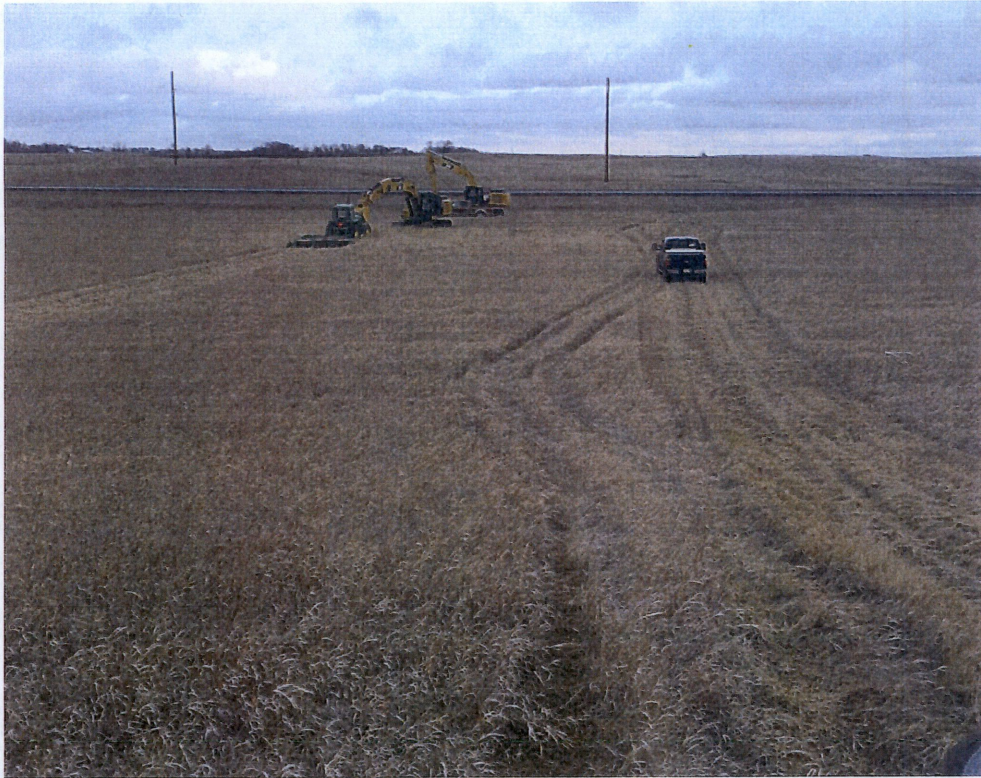
Above: Photo 1- Located at station 122+00. Direction looking north showing Highway 2 beyond. Start of contractor mowing CRP grass vegetation.

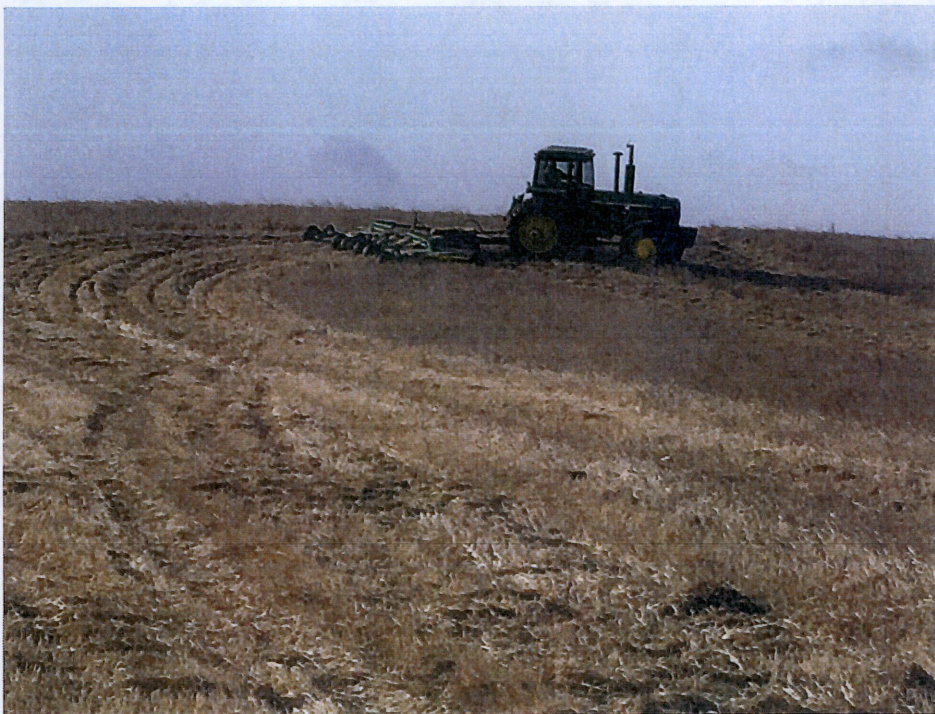
Below: Photo 2- Located at station 128+00. Direction looking south/southwest. Contractor mowing grass vegetation within right of way.

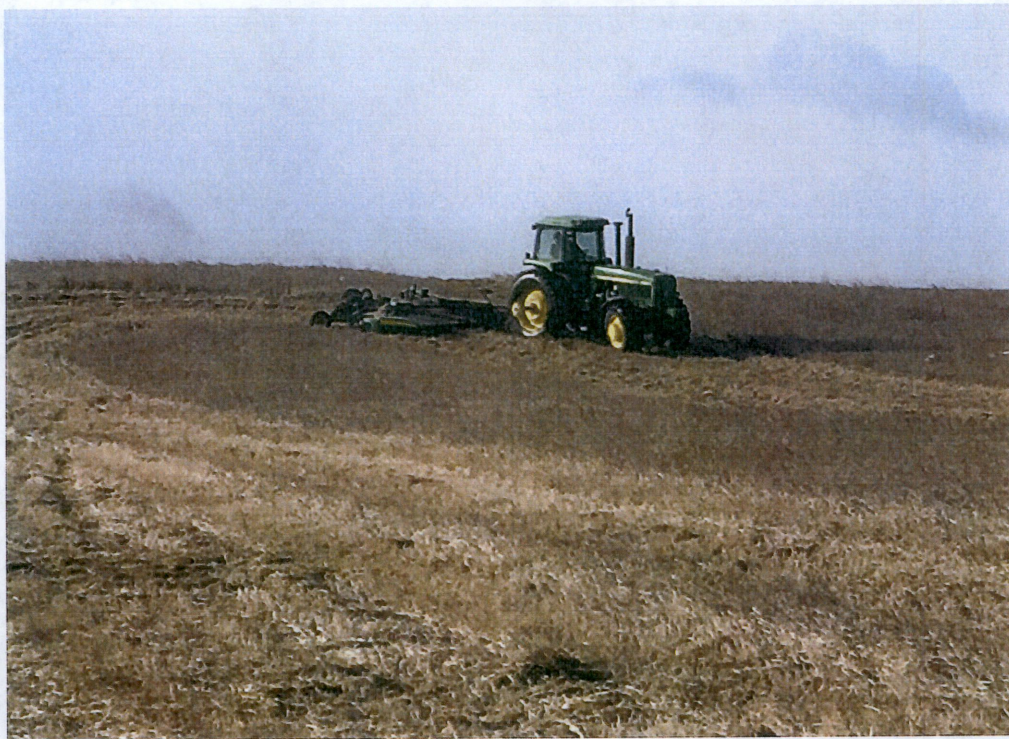
Above: Photo 3- Direction looking south. Contractor moving grass vegetation within right of way.

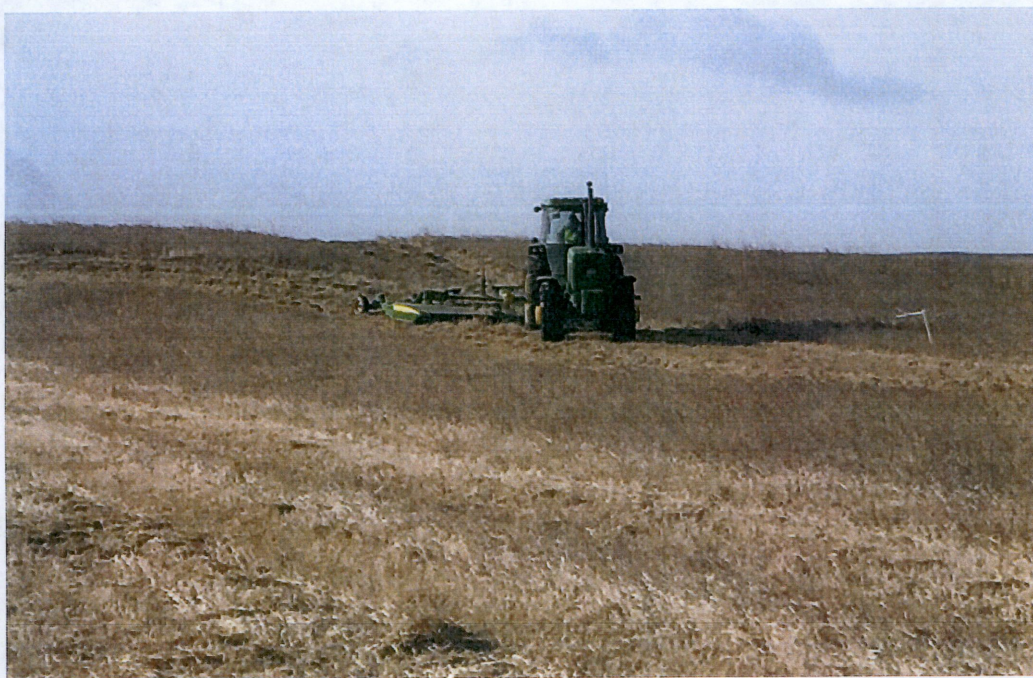
Below: Photo 4- Located at station 124+00. Direction looking south. Contractor mowing grass vegetation within right of way.

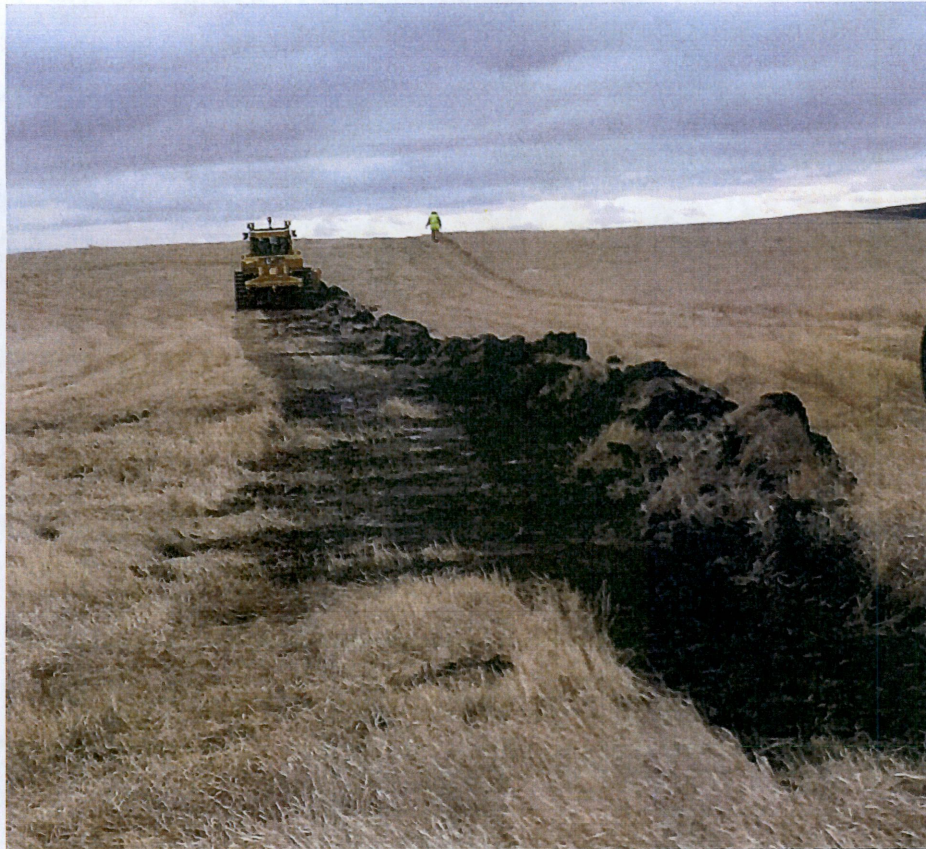
Above: Photo 5- Located at station 118+00. Direction looking south. Right of way extending up hill. Start of top soil stripping on right of way.

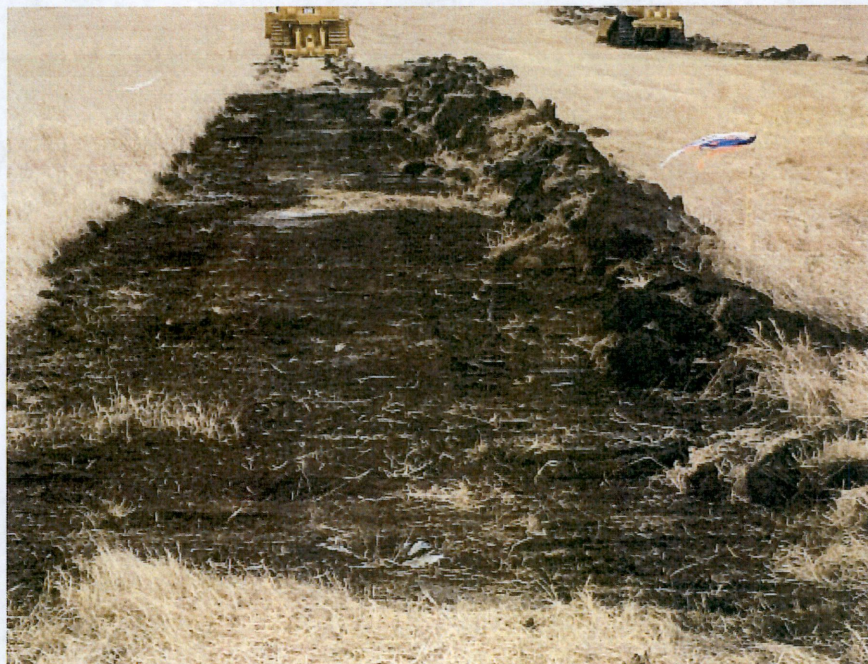
Below: Photo 6- located at bore exit 111+42.20. South side of Highway 2 looking south. Start of ripping and top soil removal on right of way.

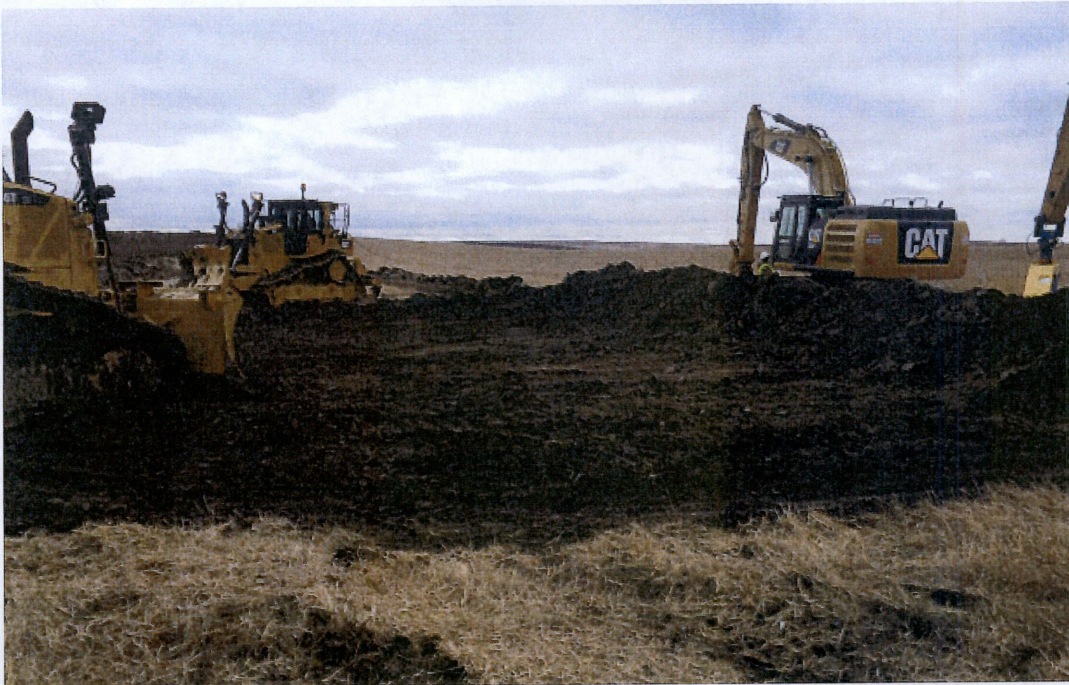
Above: Photo 7- Located at bore exit 111+42.20.South side of Highway 2 looking west. Start of ripping and top soil removal on right of way.

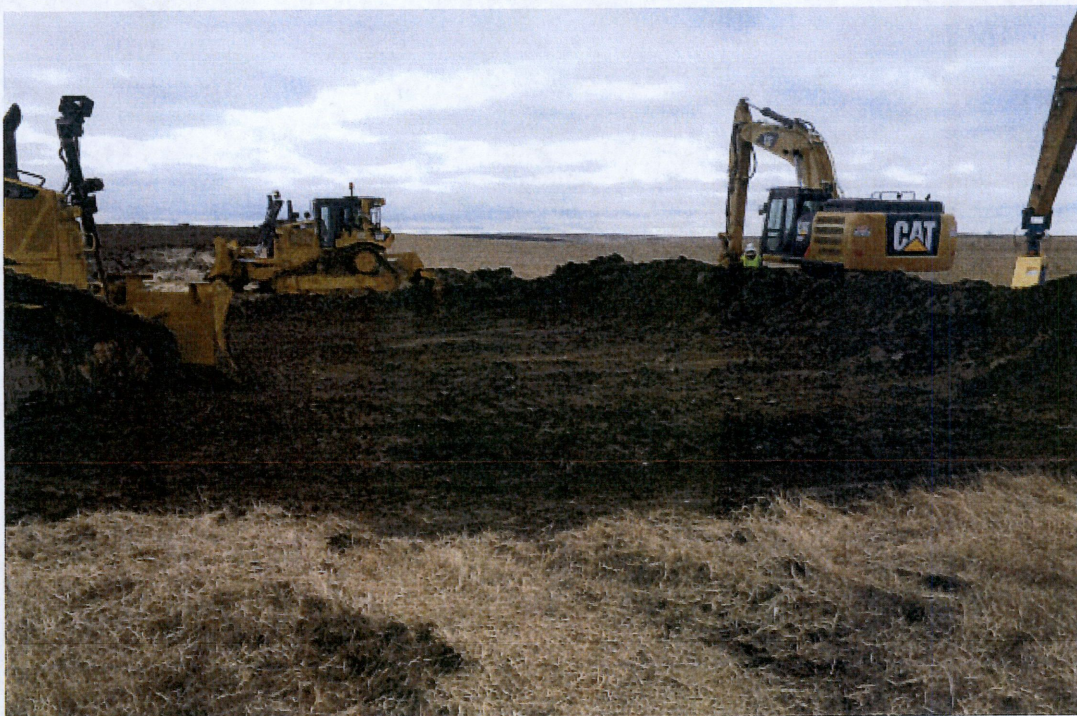
Below: Photo 8- Located at bore exit 111+42.20.South side of Highway 2 looking west. Top soil being stripped and being pushed to opposite side on right of way.

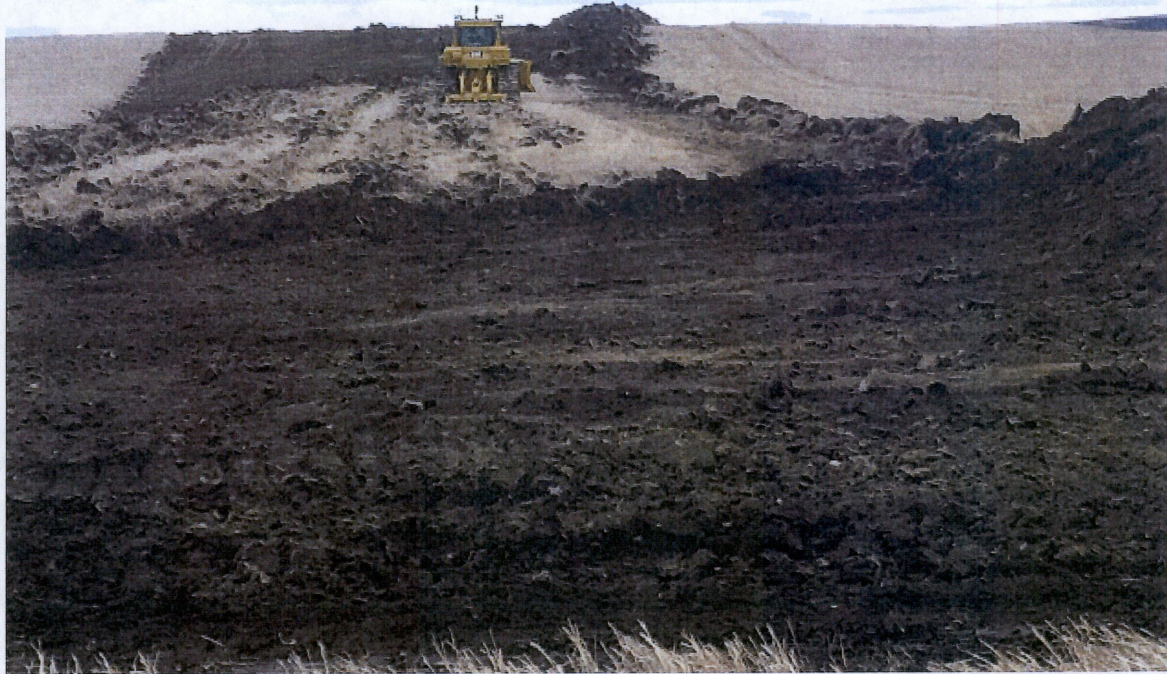
Above: Photo 9- Located at station 122+00 looking south. Top soil being ripped and stripped. Top soil being placed at west side on right of way.

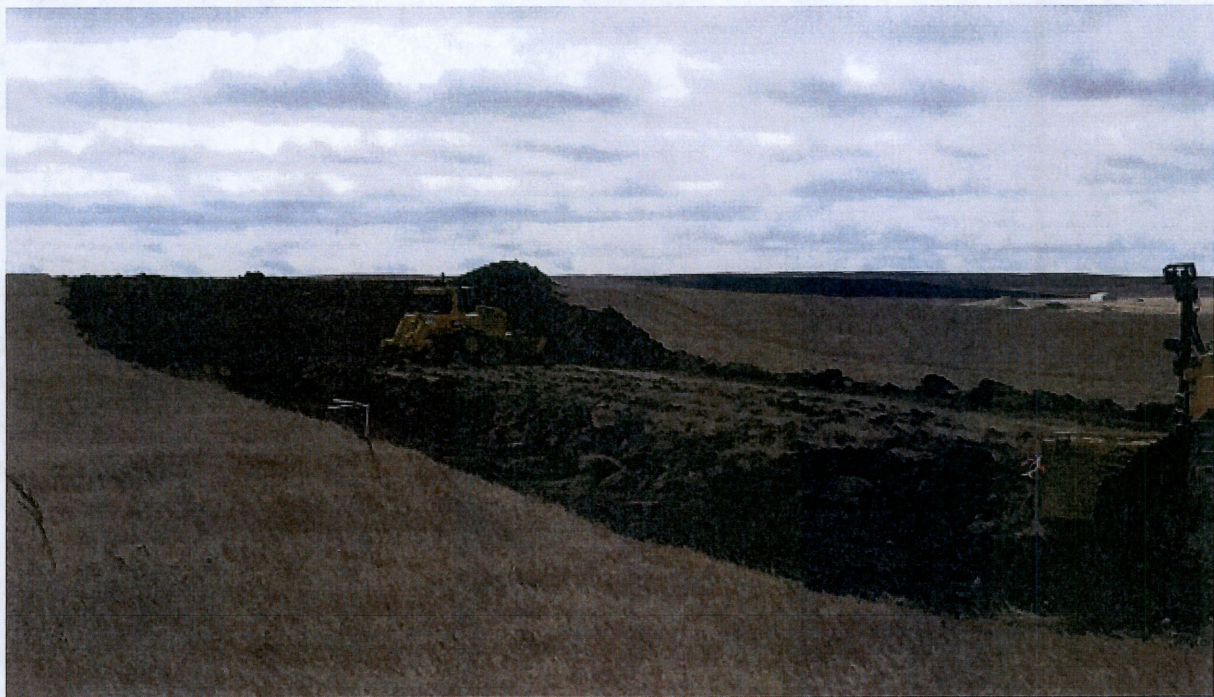
Below: Photo 10- Located at station 116+00 looking south/southwest. Top soil being stripped and pushed to west side on edge of right of way easement.

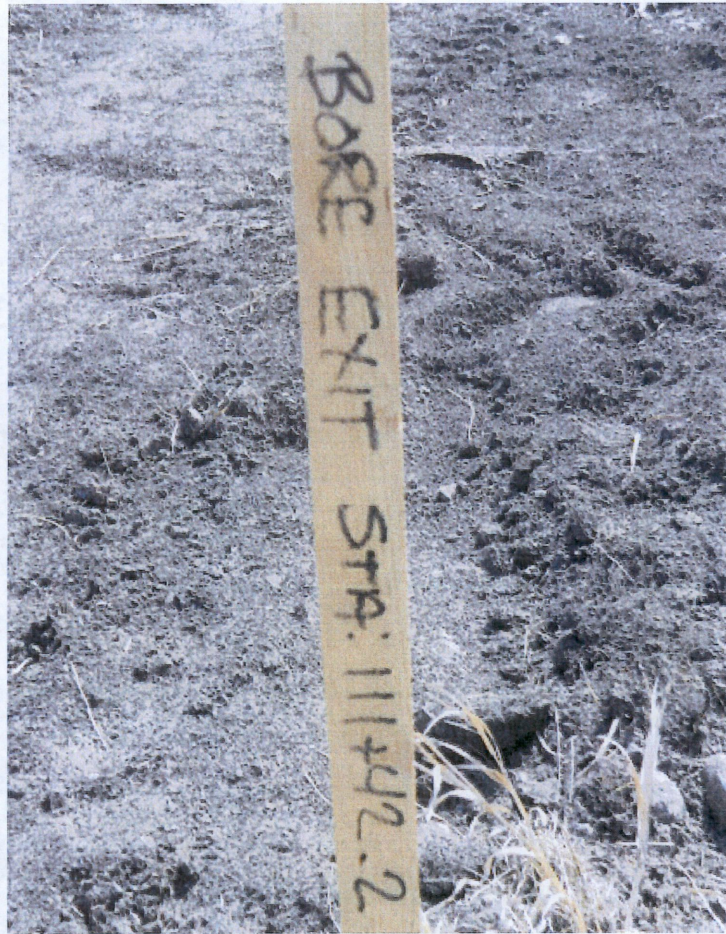
Above: Photo 1- Start of right of way inspection at bore exit stationing 111+42.2 located on south side of Highway 2. Photo shows start of top soil stripping.

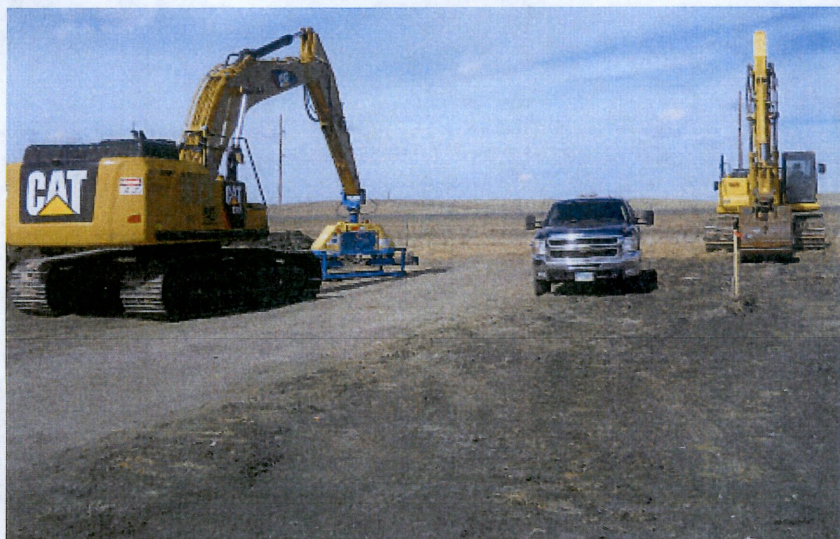
Below: Photo 2- Station 111+42.20 bore exit on south side of Highway 2 showing stripped right of way extending south with construction equipment on the side.

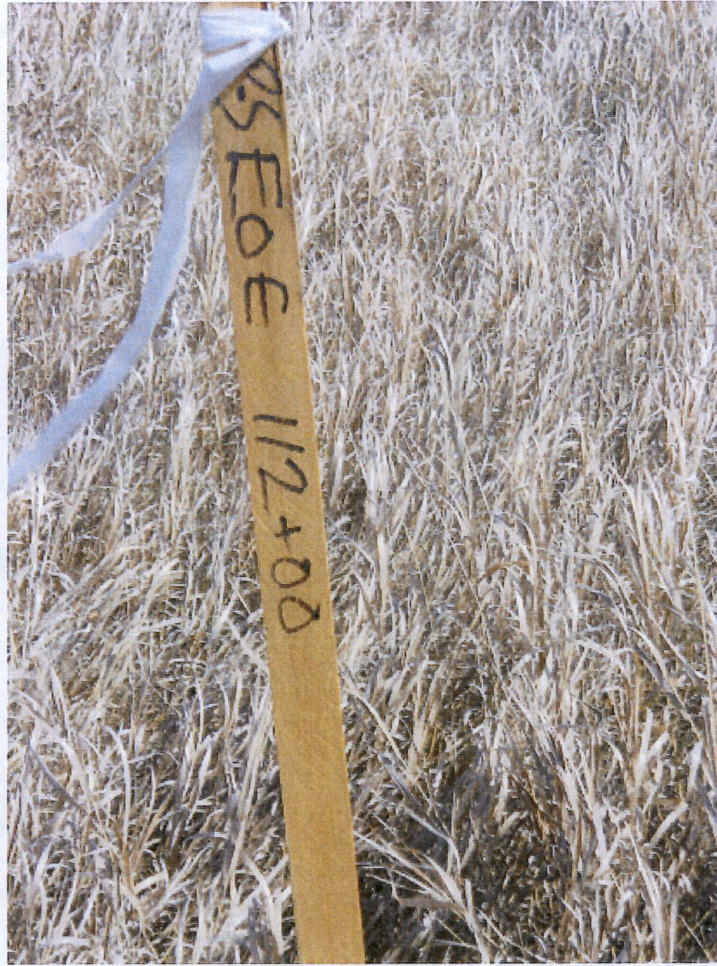
Above: Photo 3- Photo showing station 112+00. Vegetation shown is off right of way looking east.

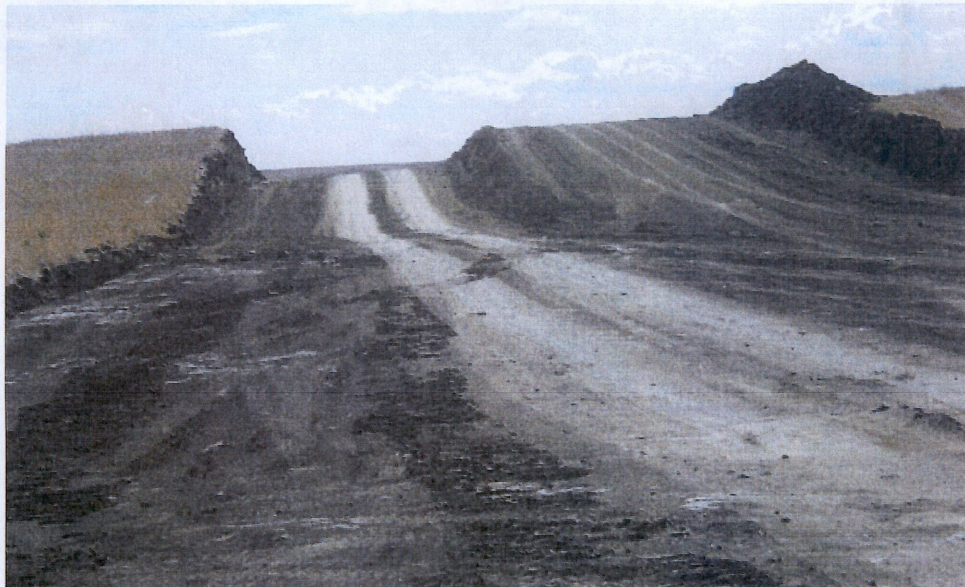
Below: Photo 4- Looking south at hillside located at station 120+00. Right of way has been stripped with top soil located at west side of right of way.

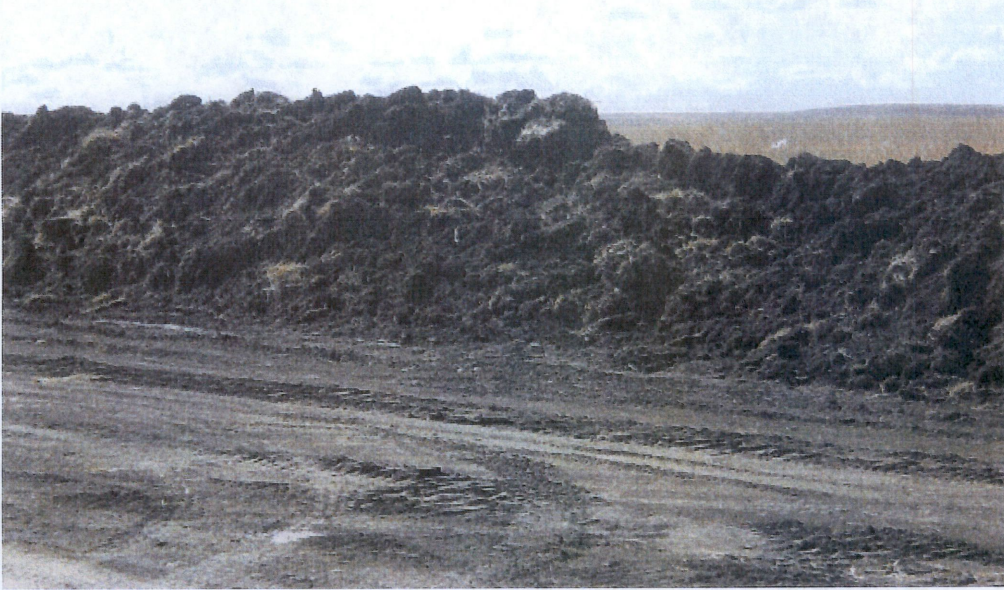
Above: Photo 5- Looking at top soil pushed off right of way located at west side of easement. Photo showing right of way stripped at station 114+00.

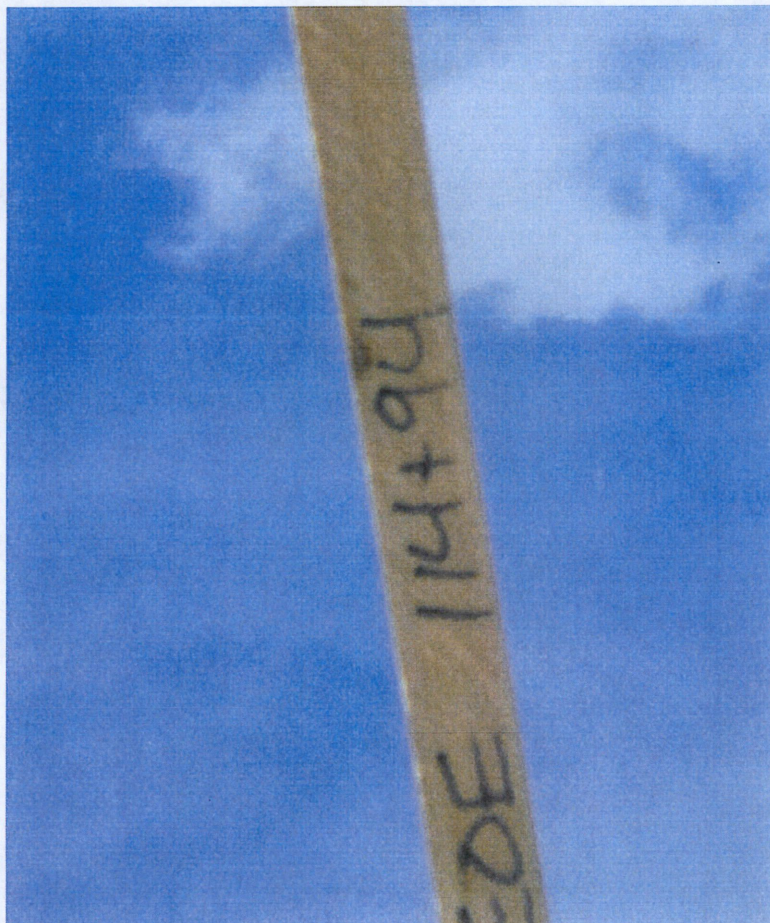
Below: Photo 6- Photo showing station 114+94. Right of way has been stripped with top soil located at opposite side of right of way.

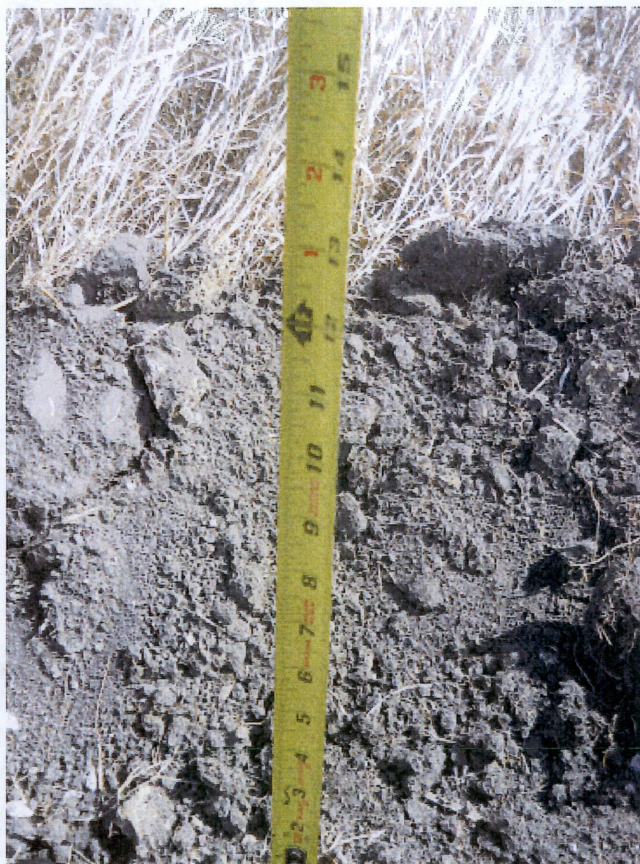
The second right of way topsoil inspection conducted by KLJ, was done on 24 March 2016. The stripping of topsoil was complete. Field measurements were taken for appropriate depth, with the average measurement showing an 8 to 12 inch depth along right of way. (**Appendix A, Photos 7, 8, 10 & 11 from inspection #2**).

Above: Photo 7- Photo showing depth of approximately 12" top soil after right of way has been stripped. Station location is 114+00.

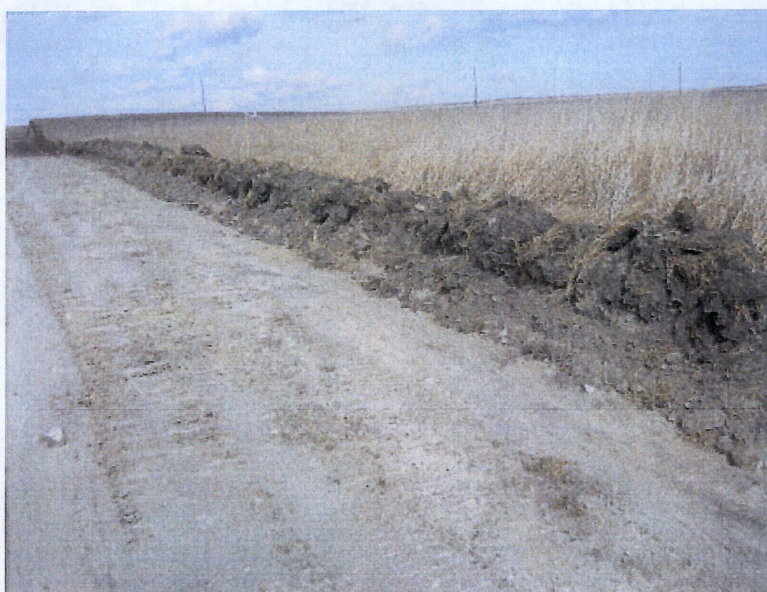
Below: Photo 8- Looking south at station 116+00 showing right of way being stripped with depth of top soil approximately 12". Photo taken at west side of right of way.

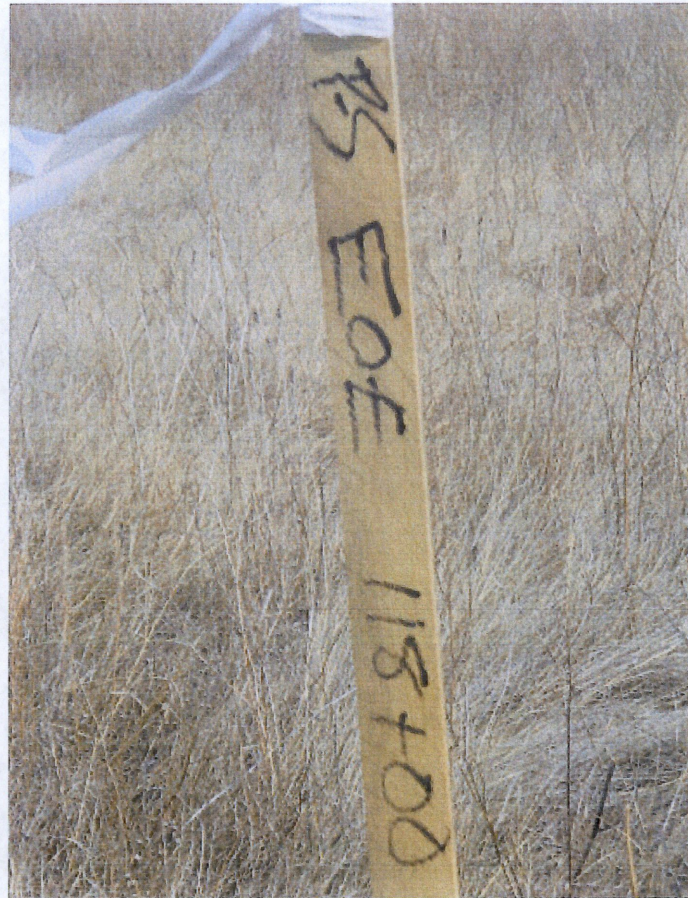
Above: Photo 9- Photo showing station 118+00. Vegetation shown is off right of way looking east.

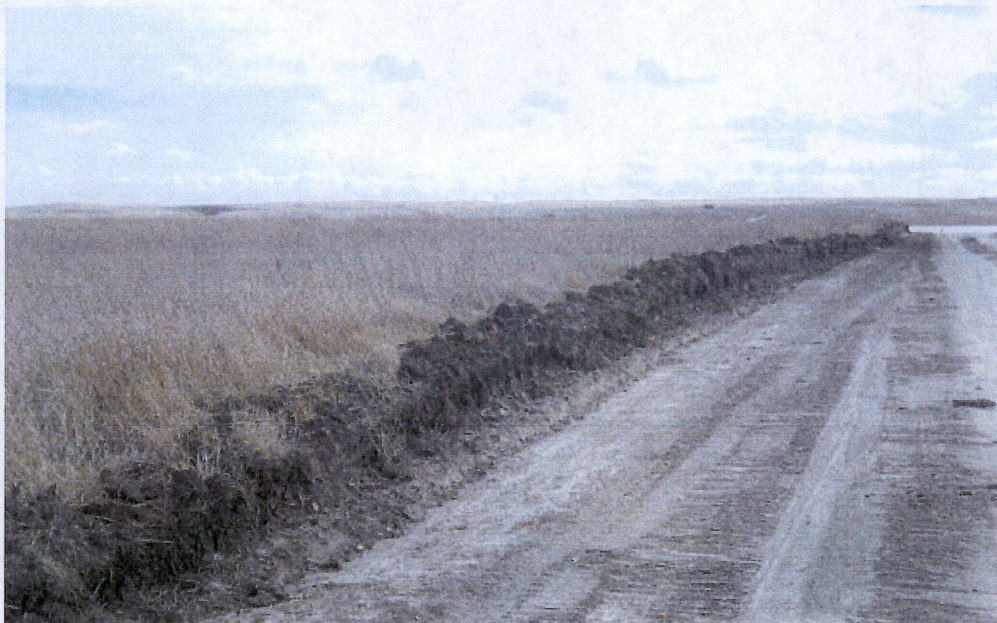
Below: Photo 10- Looking south at station 118+00 showing stripped right of way at approximate top soil depth of 12'. Photo is showing east side of right of way. Upper right hand side of photo is location of water resting habitat to be bored.

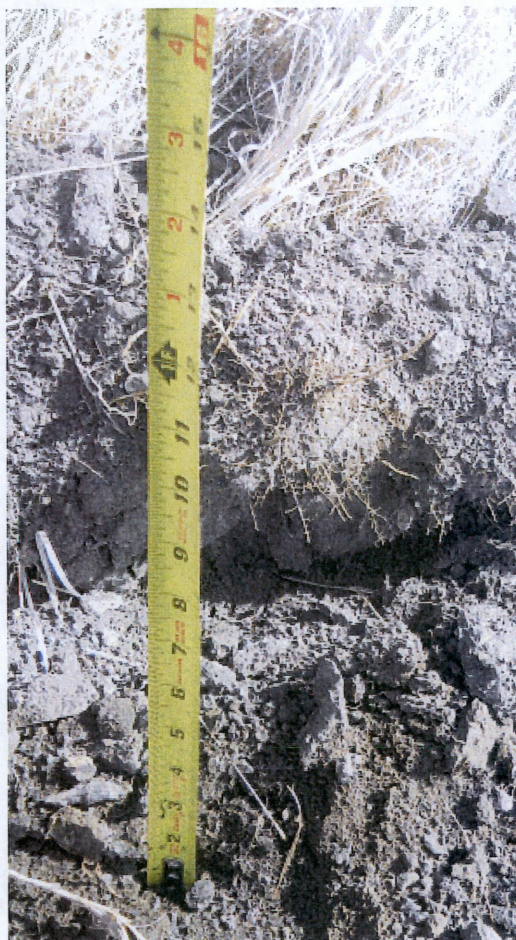
Above: Photo 11- Photo showing depth of approximately 12" top soil after right of way has been stripped. Station location is 118+00.

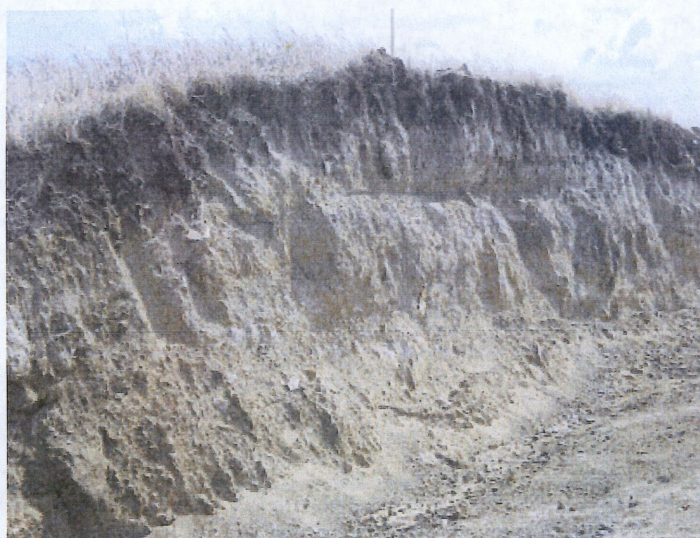
Below: Photo 12- Looking at east side of right of way cut through hillside at station 124+00. Photo showing approximately 12" top soil with subsoil located below.

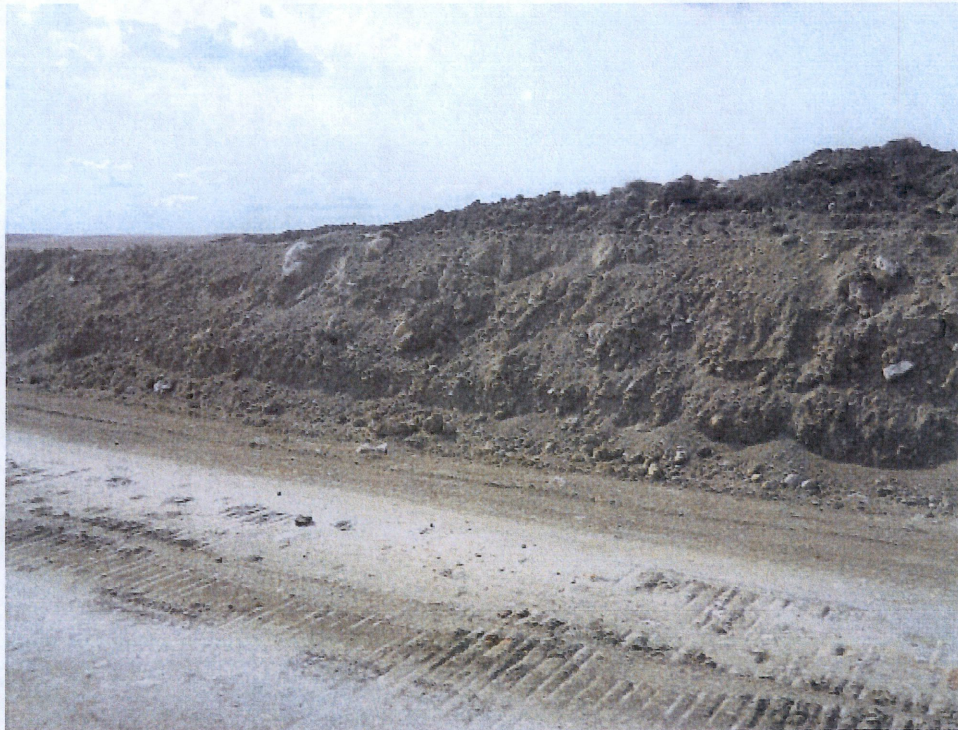
Above: Photo 13- Looking at west side of deep cut through hill at station 124+00. Right of way is stripped showing subsoil at left. Top soil is placed on east edge of right of way beyond subsoil location.

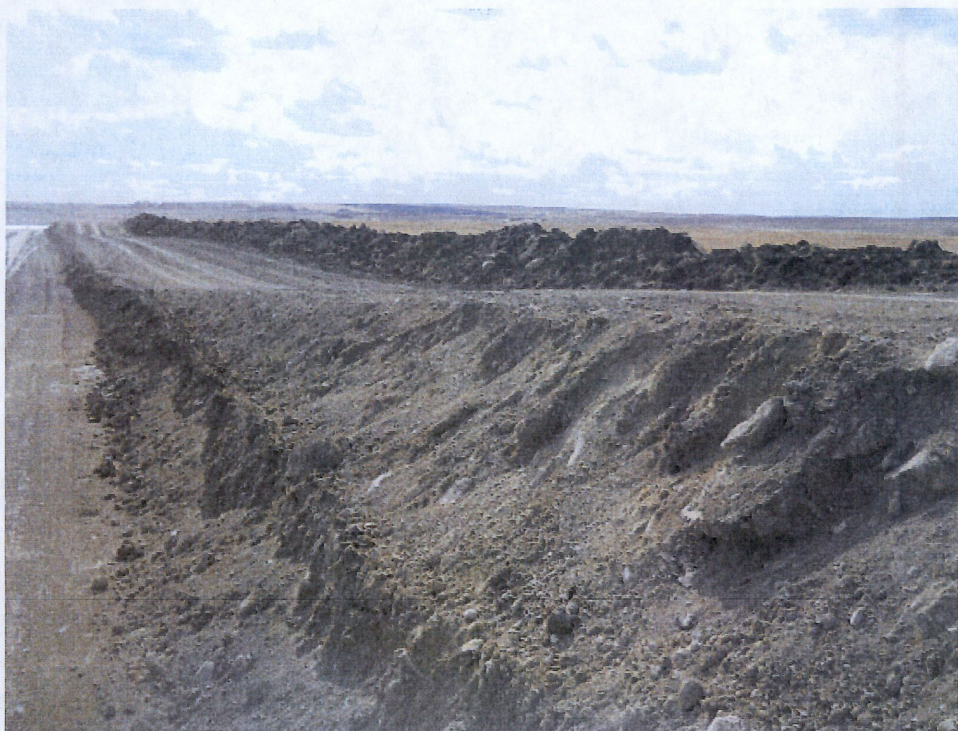
Below: Photo 14- Looking south at stripped right of way through hillside showing subsoil location with top soil placed at edge of right of way on west side of easement.

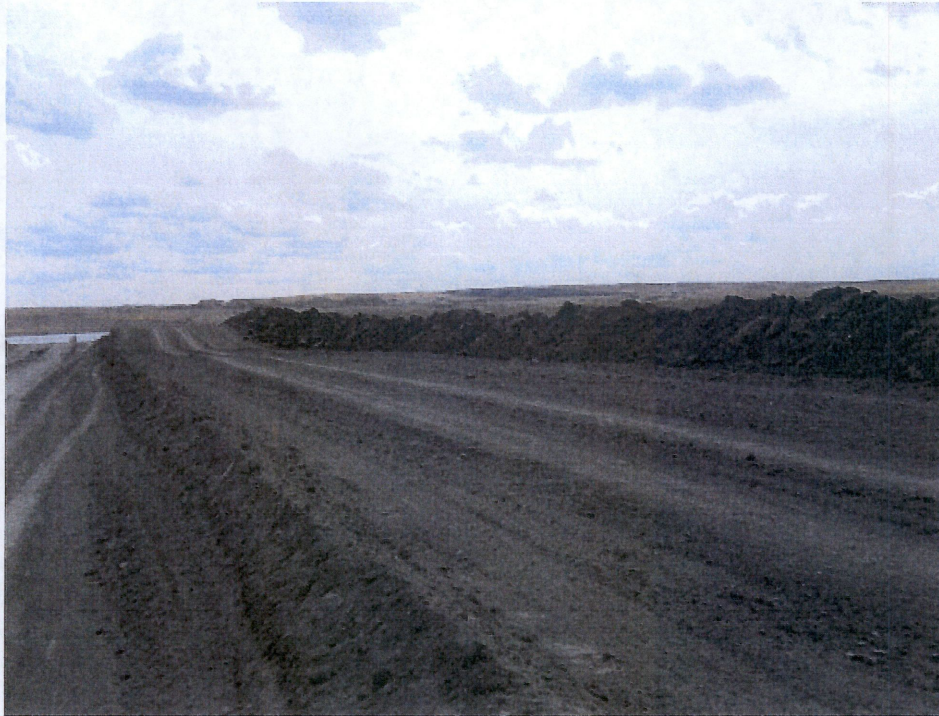
Above: Photo 15- Looking south at stopped right of way through hillside showing subsoil location lower left side of photo. Top soil placed at edge of right of way on west side easement. Station location 126+00.

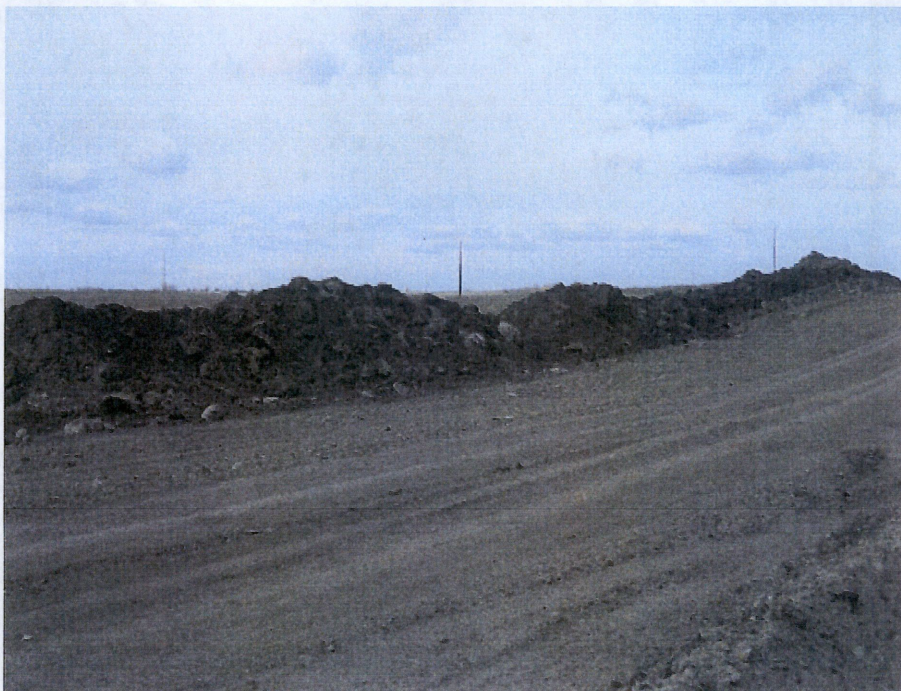
Below: Photo 16- Looking at west side of right of way with easement heading south. Photo location approximately 126+00. Work done from photo shows right of way graded with op soil placed on west side of right of way. Large rocks pushed off right of way into top soil location. Rocks need to be removed off right of way.

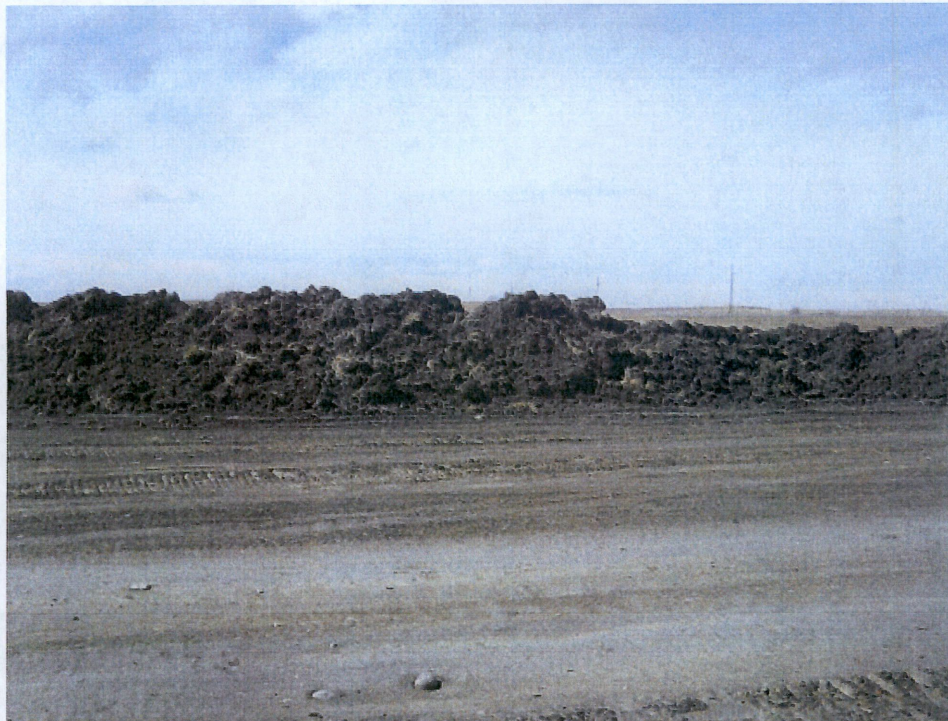
Above: Photo 17- Looking at west side of right of way with easement heading south. Photo station location approximately 124+00. Work done from photo shows right of way graded with top soil pushed on west side of right of way.

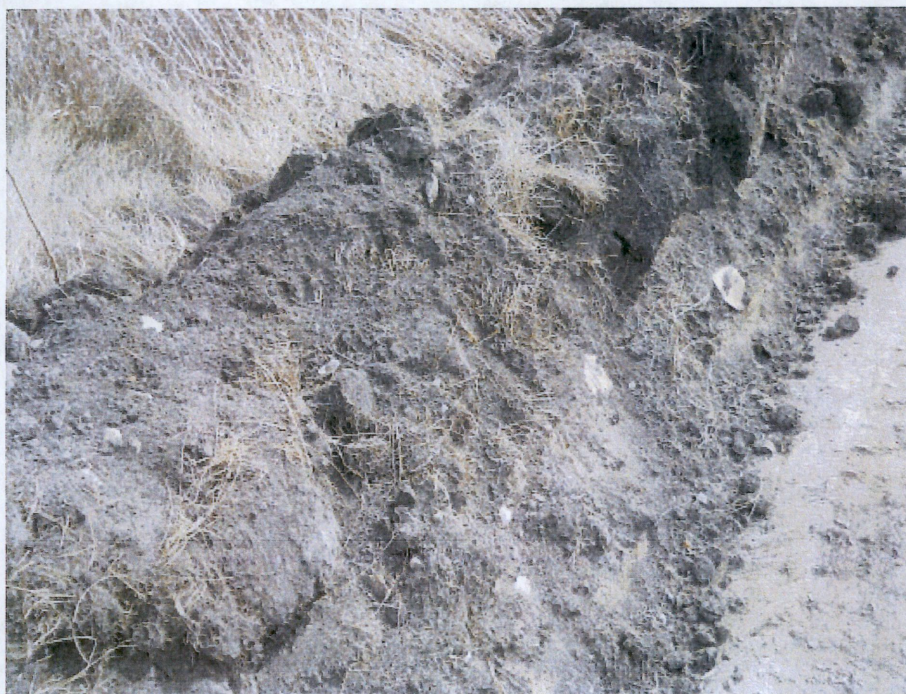
Below: Photo 18- Looking at west edge of right of way at station 128+00. Graded right of way showing subsoil is located at right hand side of photo. Approximately 12" top soil depth shown at west edge of right of way.

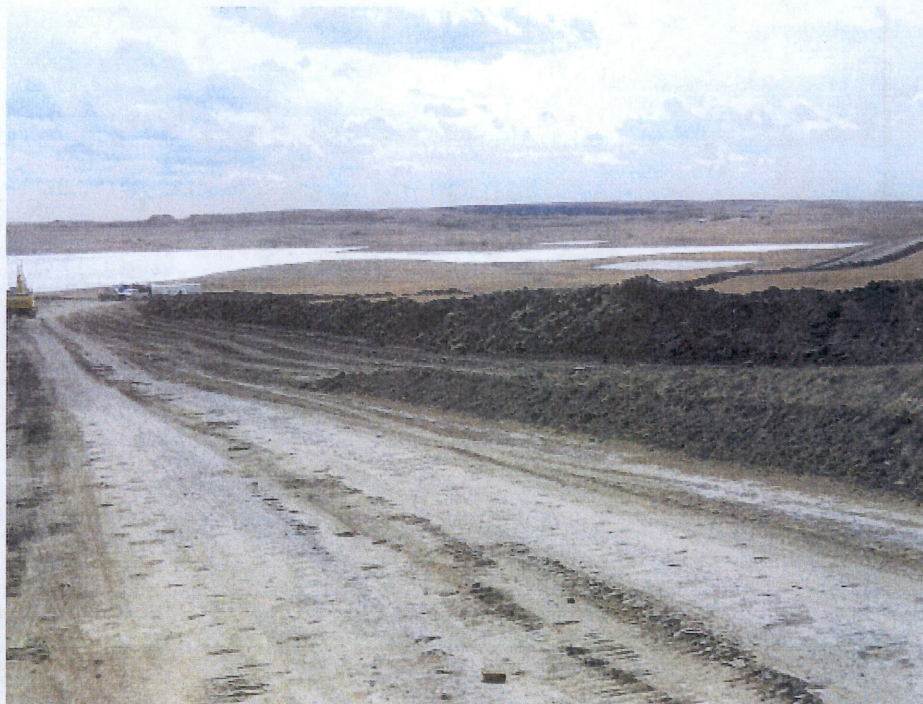
Above: Photo 19- Looking south from graded right of way at station 128+00. Subsoil shown in middle of photo with top soil pushed off right of way at edge of easement at west location. Photo also shows right of way turning west with water slough nesting area beyond. Contractor is shown beyond hydro testing bore piping.

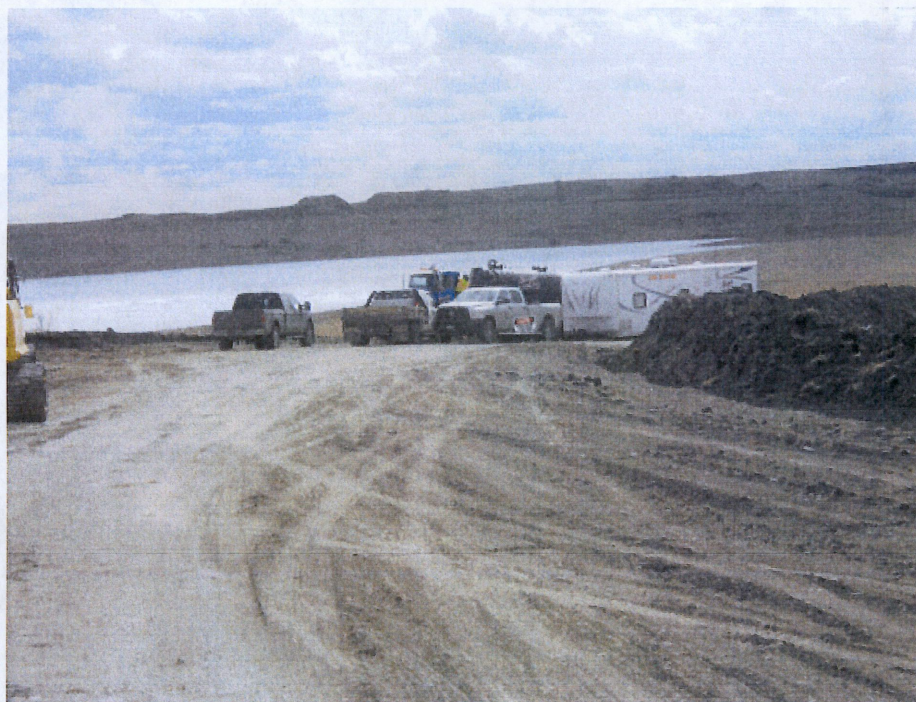
Below: Photo 20- Looking south at PI station 128+43.8 where right of way turns right and heads west. Photo shows contractor on site hydro testing bore piping. Pipe not showing in this photo.

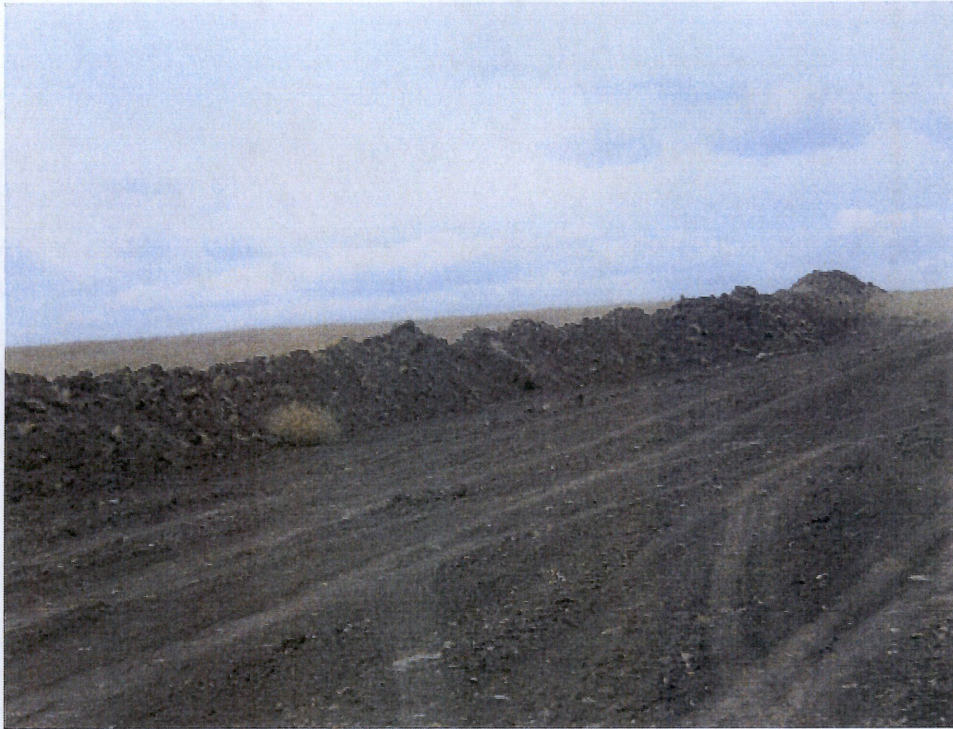
Above: Photo 21- Photo taken from east end right of way heading west towards left side of photo at station 132+00. Right of way graded with top soil pushed to north edge of right of way easement.

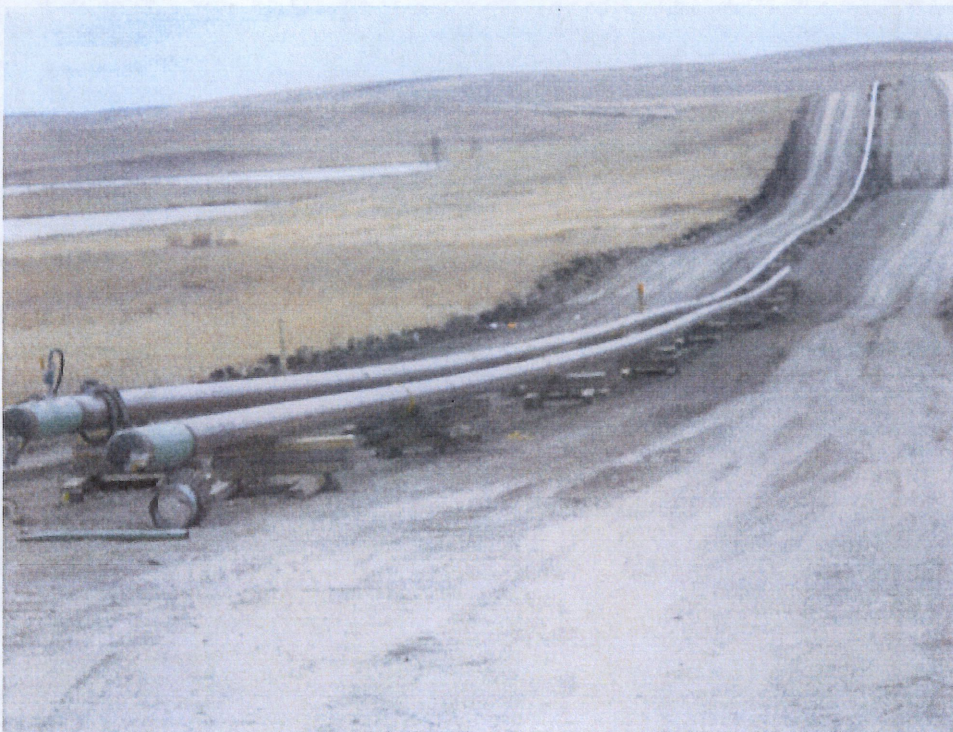
Below: Photo 22- Looking west from east end at graded right of way. Right of way has top soil depth of 12". Top soil is pushed off right of way located at right hand side of photo. Top soil not shown on photo. 12" bore piping shown on skids being hydro tested. Station location 130+00.

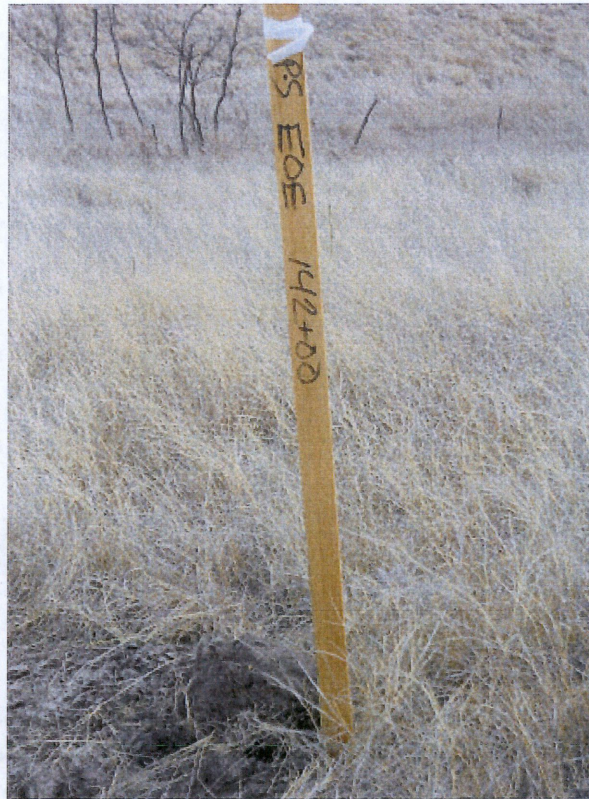
Above: Photo 23- Photo showing station 142+00. Vegetation shown is off right of way. At station 142+57.7, bore entry starts across wetland water slough to not disturb Piping Plover habitat nesting ground.
