Re: Topsoil Inspection Report for Sacagawea Pipeline Project
Palermo to Enbridge Crude Oil Pipeline
PU-15-670

SACAGAWEA PIPELINE PROJECT
PALERMO TO ENBRIDGE CRUDE OIL PIPELINE, MOUNTRAIL COUNTY
TOPSOIL INSPECTION REPORT
PU-15-670

KLJ File #1216107
April 2016

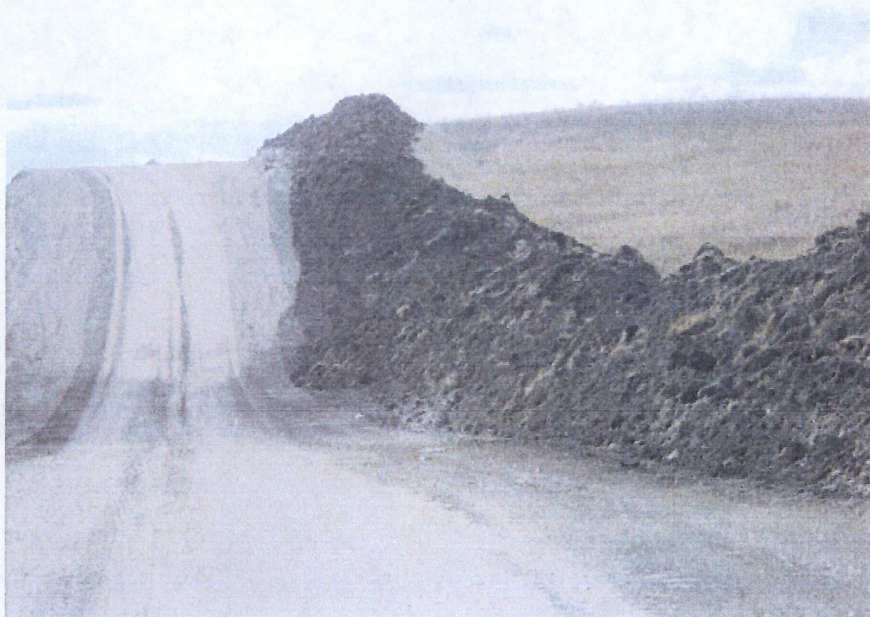
Below: Photo 24- Photo taken from east end of right of way facing west, heading uphill at station 134+00. Right of way graded with top soil pushed to north edge of right of way easement. No BMP's have been installed along entire length of right of way for erosion control.

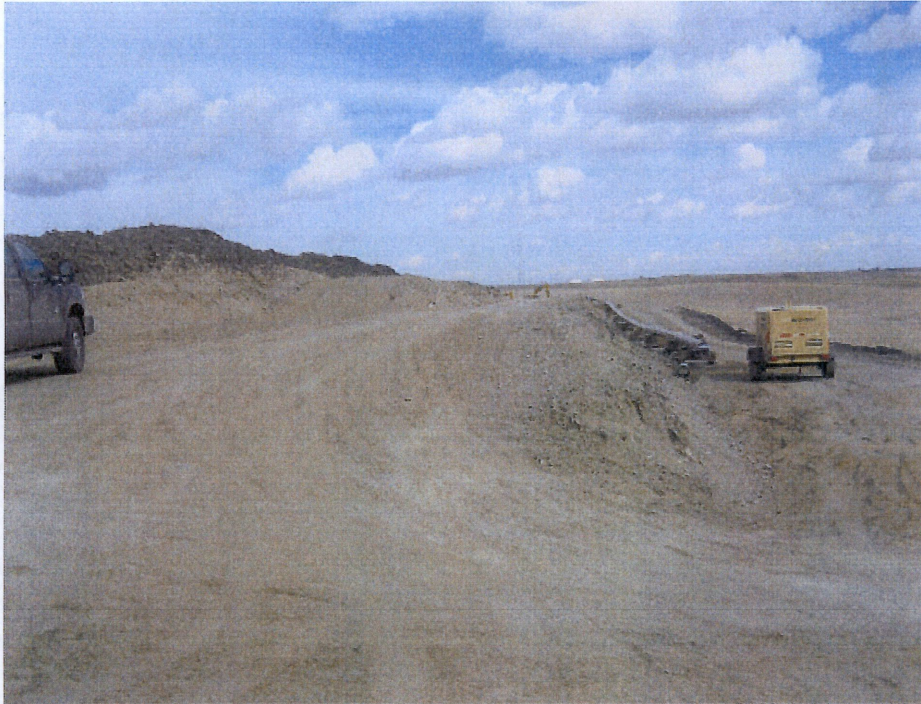
Above: Photo 25- Photo taken from west side of right of way facing east at bore stationing entry 142+52.8 Photo shows graded right of way with top soil shown at upper portion of photo. It appears that top soil is mixed together with subsoil deposit.

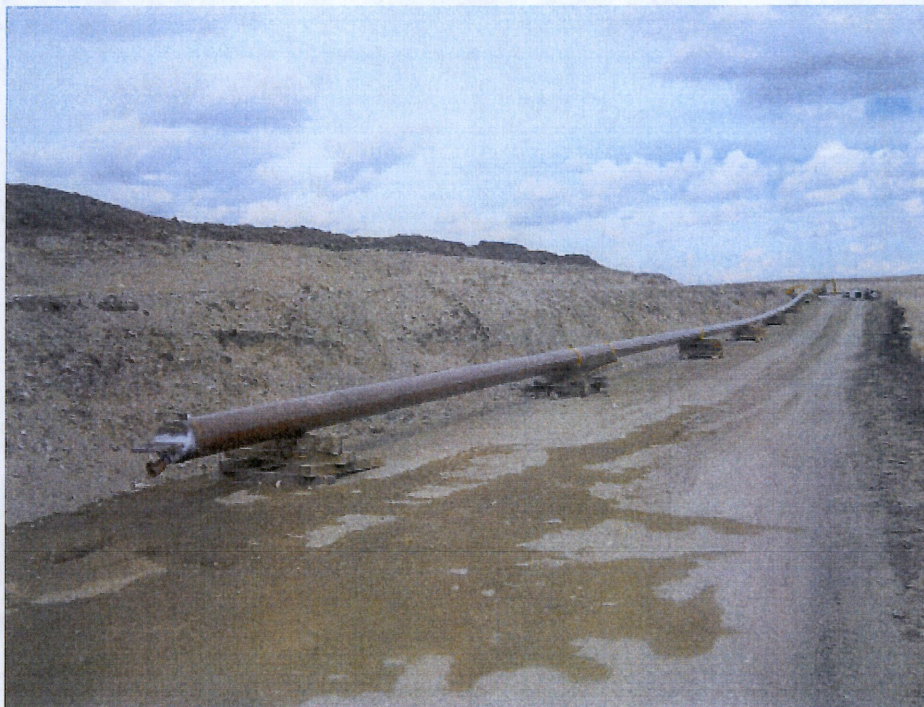
Below: Photo 26- Looking at west side of bore piping placed on skids at bore station 142+52.8. Photo showing right of way graded with top soil shown at top of photo. It appears that top soil is mixed together with subsoil deposits.

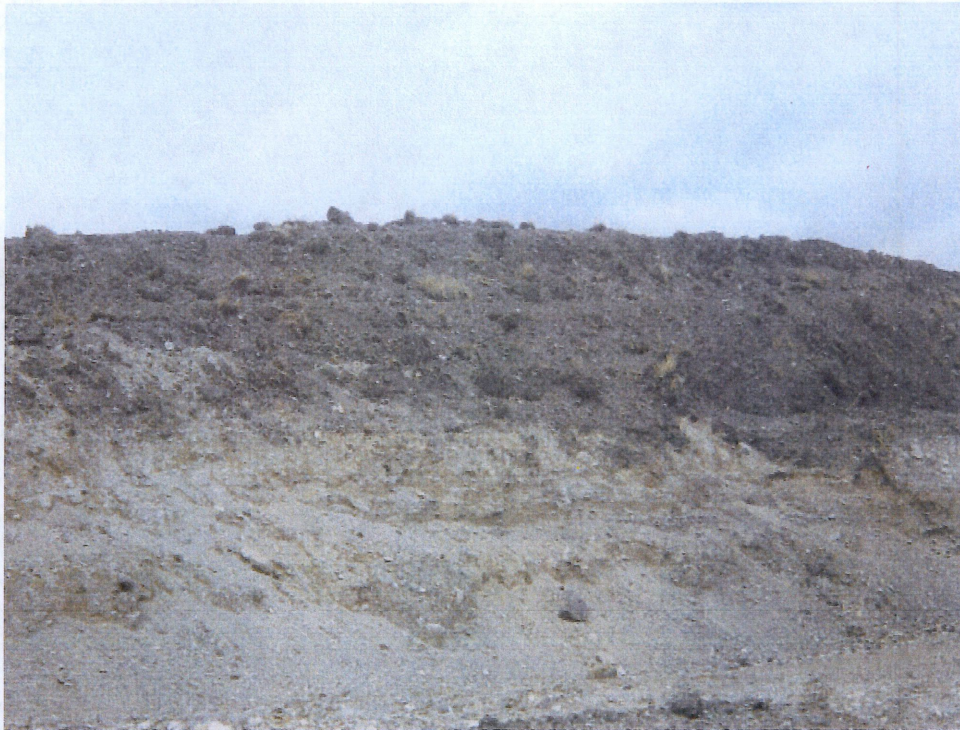
When the topsoil inspections was conducted at east end wetland location, a minor Issue was noted at Station 142+57.7 heading east to Station 133+00, lighter subsoil was deposited up against top soil, mixing both together. (**Observation Point 9 and 8, Appendix A, Figure 1.A.1 and Photos #27, 28, 29, and 30**). KLJ advises contractor/ equipment operators need to take special care along right of way soil deposit areas, not to mix both topsoil and sub soils together. KLJ recommends monitoring these areas after reclamation has been completed and re-vegetation established.

Above: Photo 27- Looking at north side of right of way at station 144+00. Photo shows top soil location with lighter subsoil deposits mixed in with top soil.

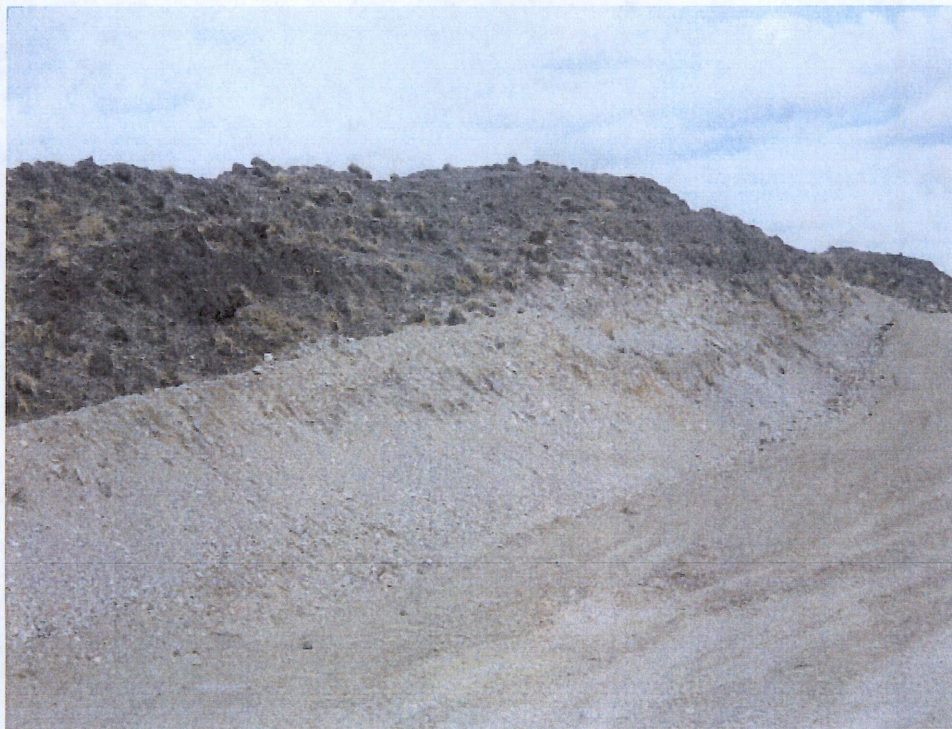
Below: Photo 28- Looking at north side of right of way at station 145+00. Photo shows graded right of way with top soil shown at top of photo. Lighter subsoil is deposited up against top soil, mixing both together.

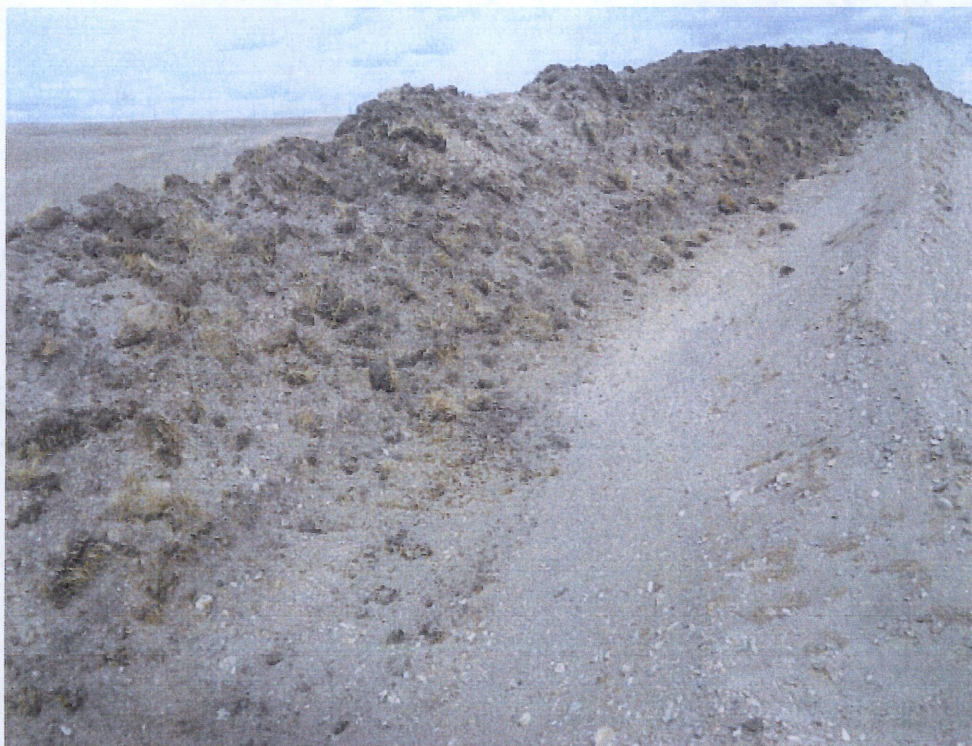
Above: Photo 29- Showing topsoil deposited at north side of right of way west end, looking back east. Subsoil ridge is shown placed up against top soil mixing both together.

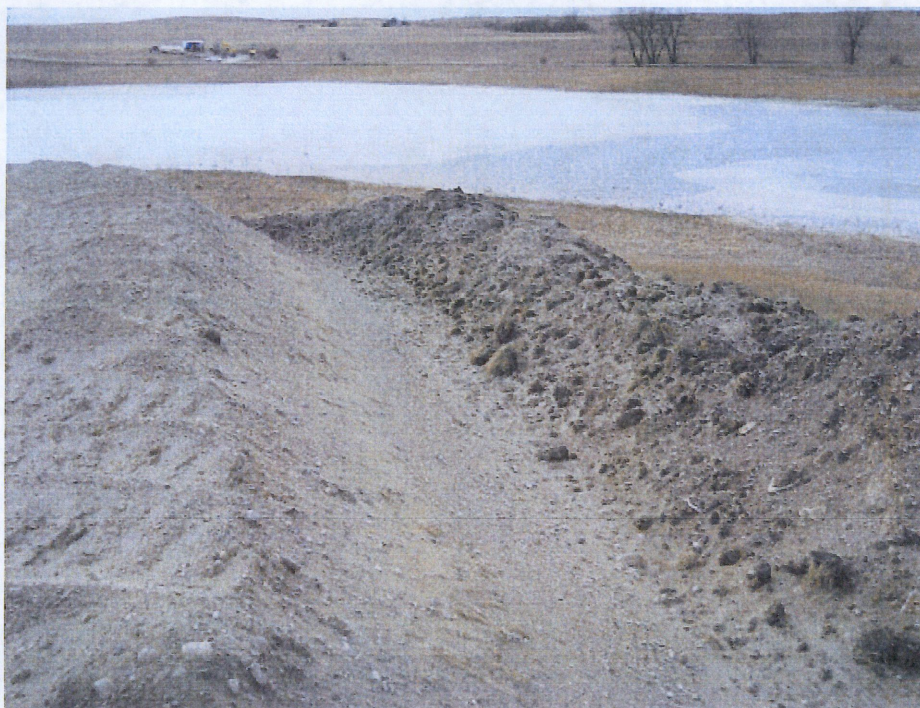
Below: Photo 30- Looking west for bore entry station 142+57.7 looking across water way slough. Top soil is placed at north side of right of way to left side of photo with subsoil ridge at left side of photo. Both subsoil and top soil appear to be mixed together. Bore contractor is shown beyond at bore exit station 156+72.8 across county road 77th Ave. NW.

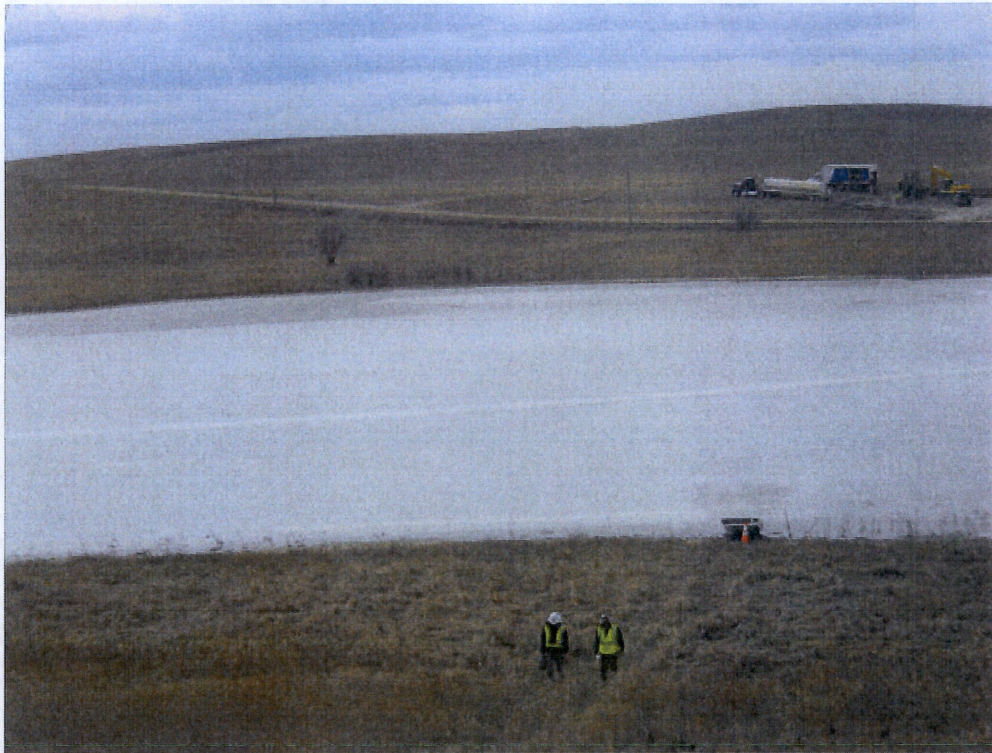
Above: Photo 31- Standing on west hillside at bore entry station 142+57.7 looking across waterway slough to be bored due to nesting habitat. Bore contractor on site working.

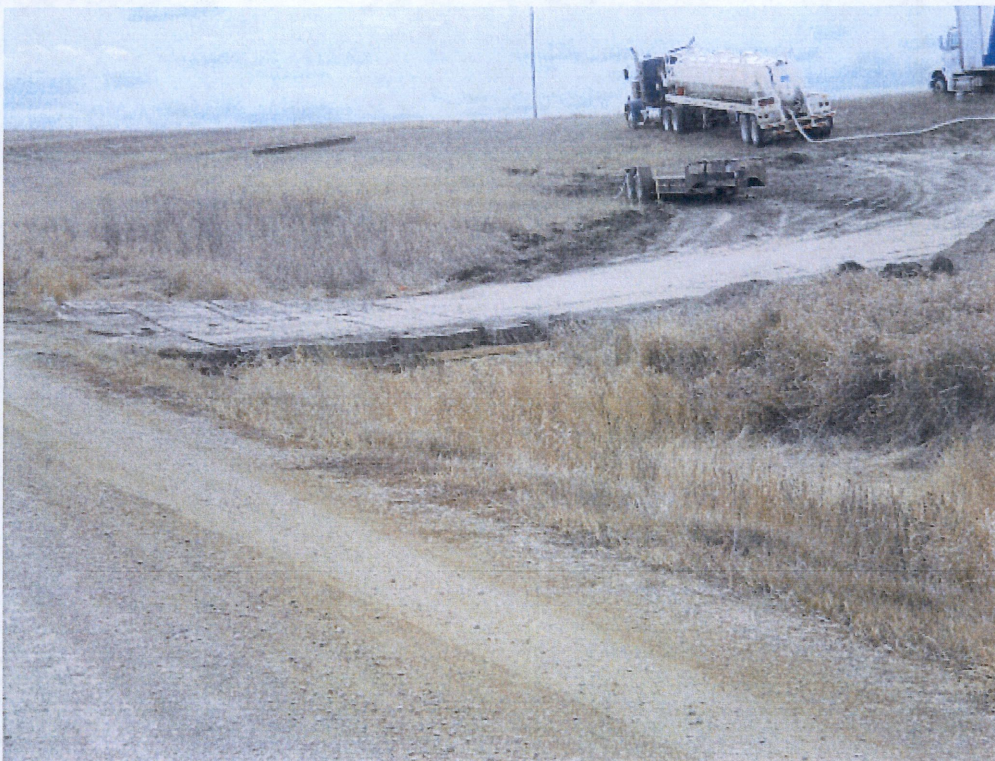
Below: Photo 32- Photo taken from county road 77th Ave. NW. shown bridge mats in road ditch for contractor at bore exit 158+72.8.

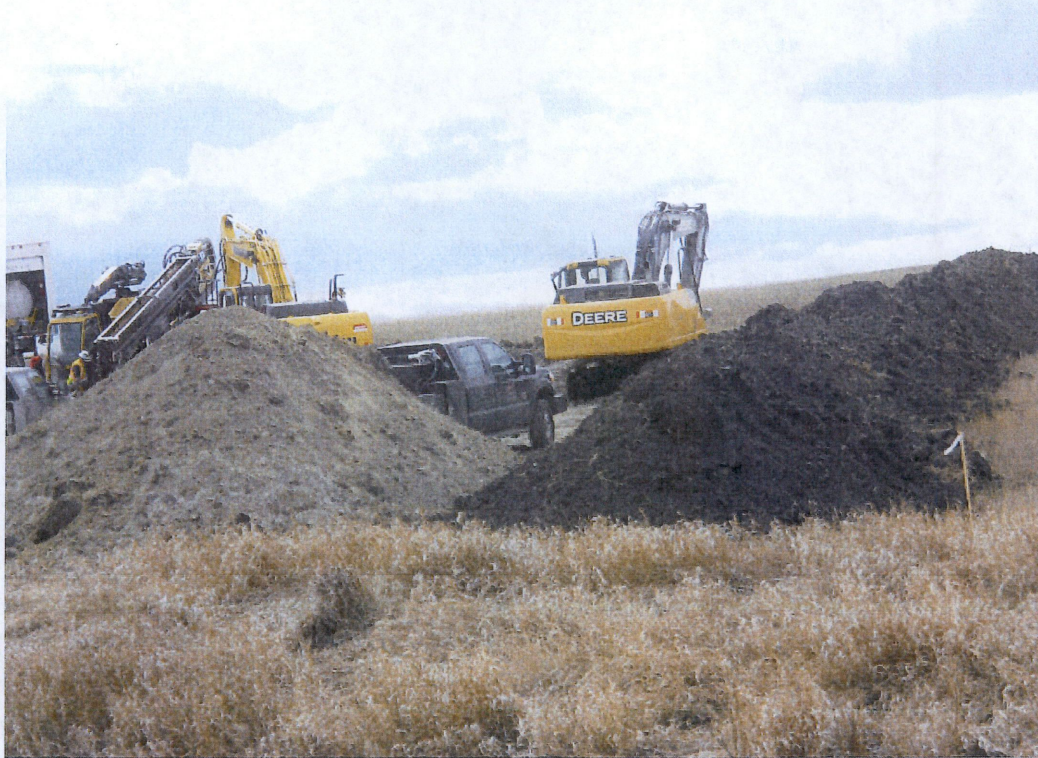
At one location the subsoil pile was observed touching the topsoil pile at a bell hole bore pit at station 156+72.8 on west side of county road 77th Ave. NW. (**Appendix A, Photo # 33 from inspection #2**). Most of the topsoil was piled on the opposite side of the right of way. When the right of way was extended, a portion of the topsoil was pushed near or touching the trench spoil (subsoil) pile locations. Two-toning areas appeared to be in good condition for topsoil segregation; however, trench spoil (subsoil) piles in the two-toning areas need to be observed and watched during the site inspection visits.

Above: Photo 33- Photo taken at bore exit 158+72.8 located on west side of county road 77th Ave. NEW. Bore contractor on site working. Bore site was stripped of top soil and placed on west edge of site. Subsoil dug out for bell pits was deposited and mixed with top soil. Top soil should have been moved further from subsoil deposit.

When the topsoil inspection for the project was conducted, a minor issue was noted, on a location where the subsoil pile was observed touching the topsoil pile at the bell hole pit by Station 156+72.8 located on west side of county road 77th Ave NW, (**Observation Point 10, Appendix A, Figure 1.A.1 and Photo # 33 Appendix C**). Contractors/ equipment operators need to take special care in this area not to mix the topsoil and subsoil. KLJ recommends monitoring and documentation of this area to ensure vegetation becomes established after reclamation.
