# Sacagawea Pipeline Co.

Palermo to Enbridge Crude Oil Pipeline  
Construction Inspection Report  
PU-15-670  
KLJ#1216107

*March 7, 2017*

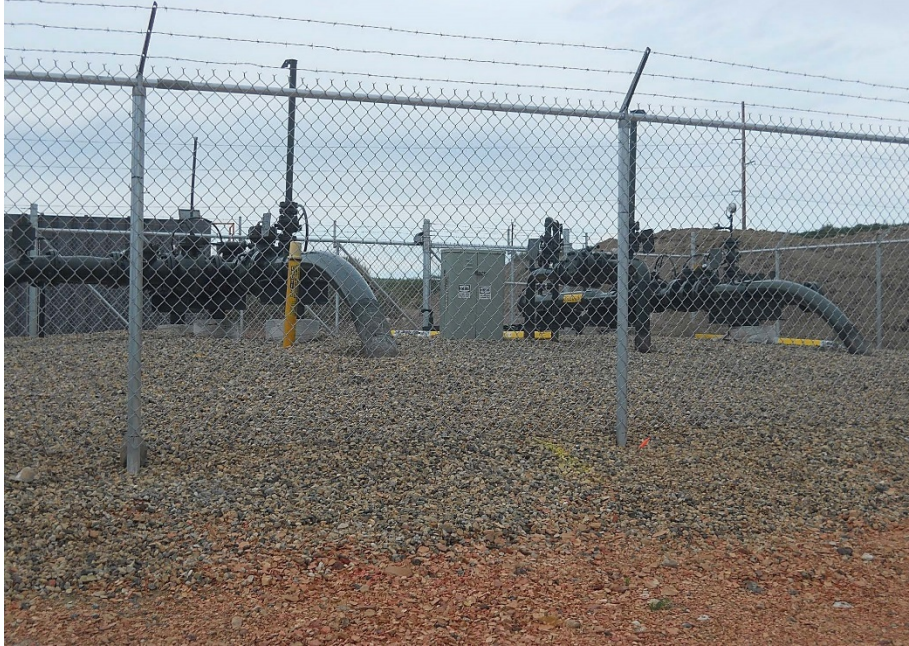
*Photo 1: Located at station 2+00, looking north east at Palermo tie-in locations, for Beginning of Pipe (BOP) start.*

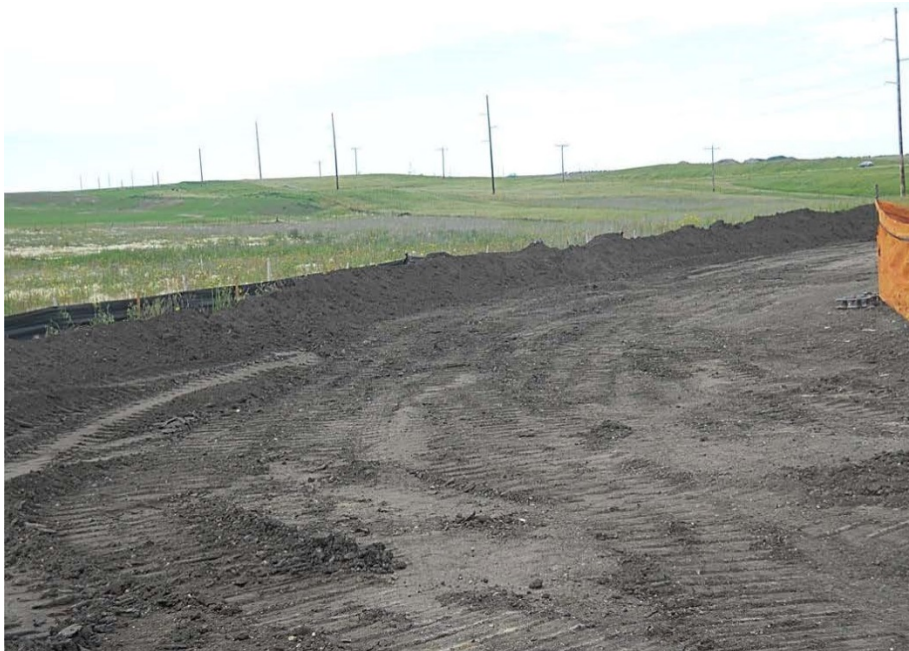
*Photo 2: Located at station 8+00, looking south west at graded Right of Way ready for string out pipe. Right of Way has BMP's installed ready to stop any erosion sediment runoff if it should occur.*

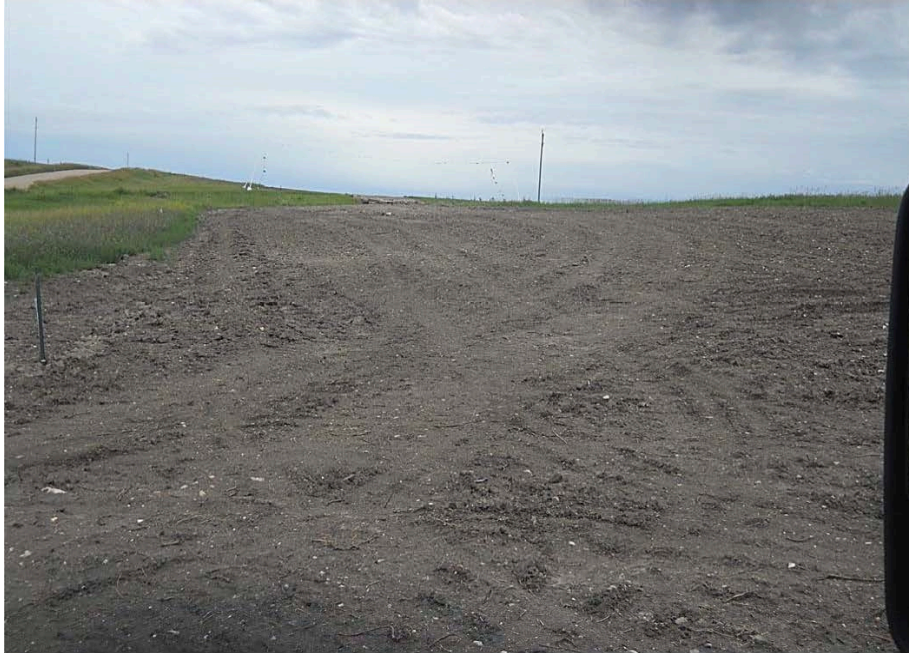
*Photo 3: Located at station 14+00, looking west at graded Right of Way, ready for string out pipe. Bridge mats and overhead power markers are installed beyond towards wetland.*

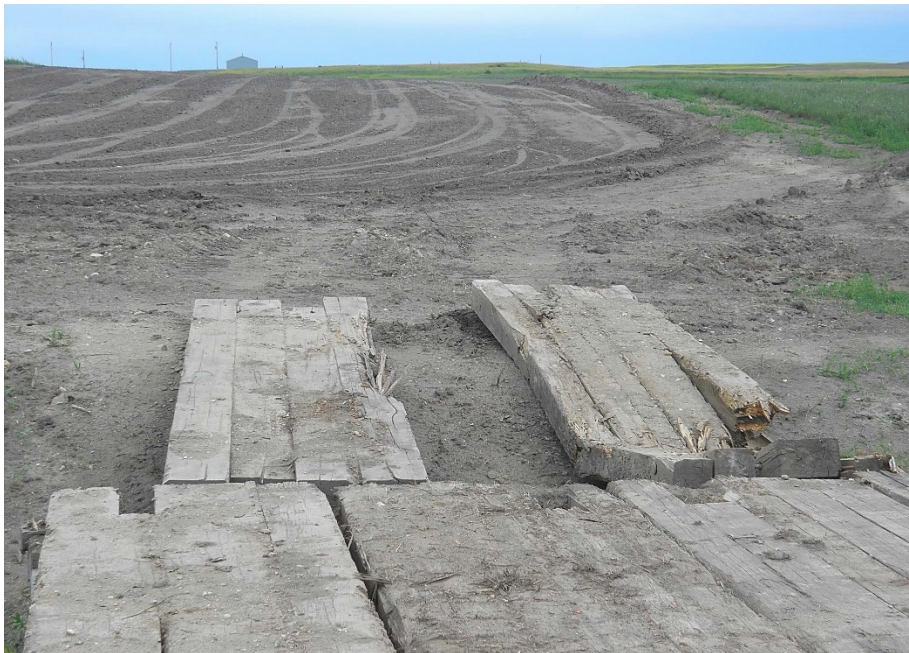
*Photo 4: Located at station 24+00, looking west at graded Right of Way, ready for string out pipe. Bridge mats and overhead power markers are installed beyond towards wetland.*

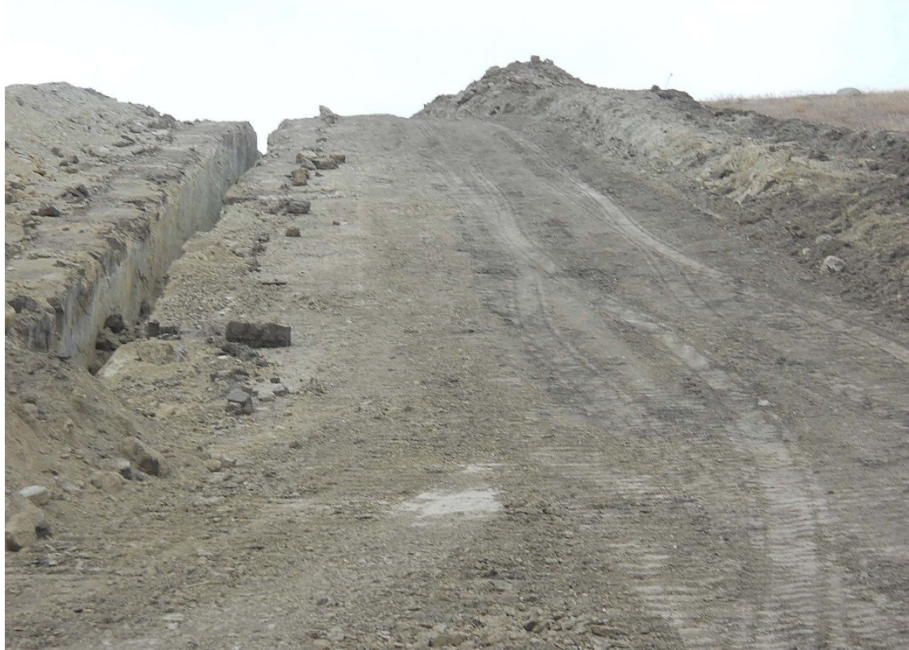
*Photo 5: Located at station 34+00, looking east at graded Right of Way, with top and subsoil pushed off edge of Right of Way trenching was underway. No pipe has been stringed out on Right of Way.*

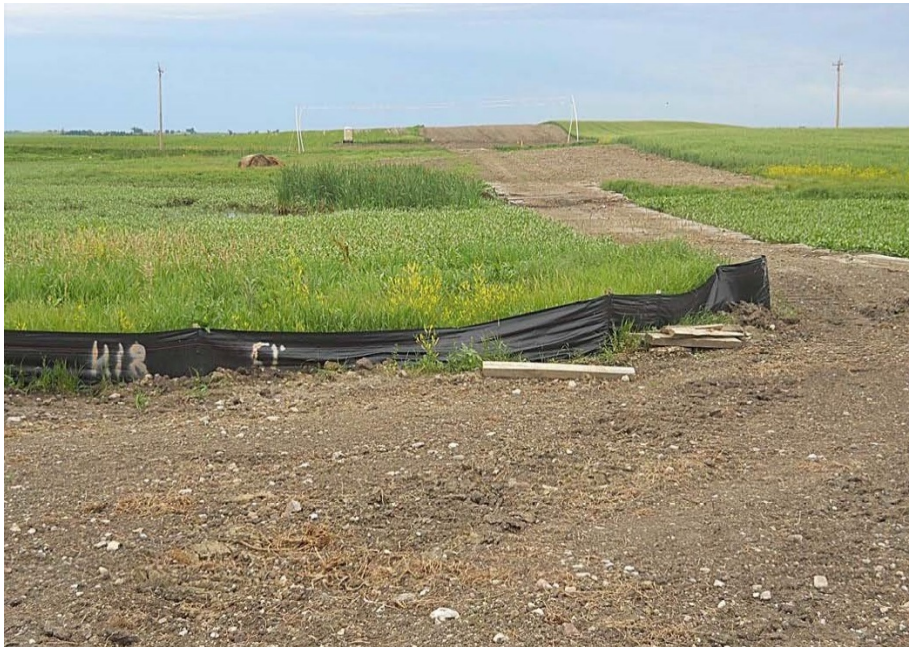
*Photo 6: Located at station 34+00, looking west showing Right of Way with BMP's installed with bridge matting laid across wetland for Right of Way access. Overhead power connection lines beyond.*

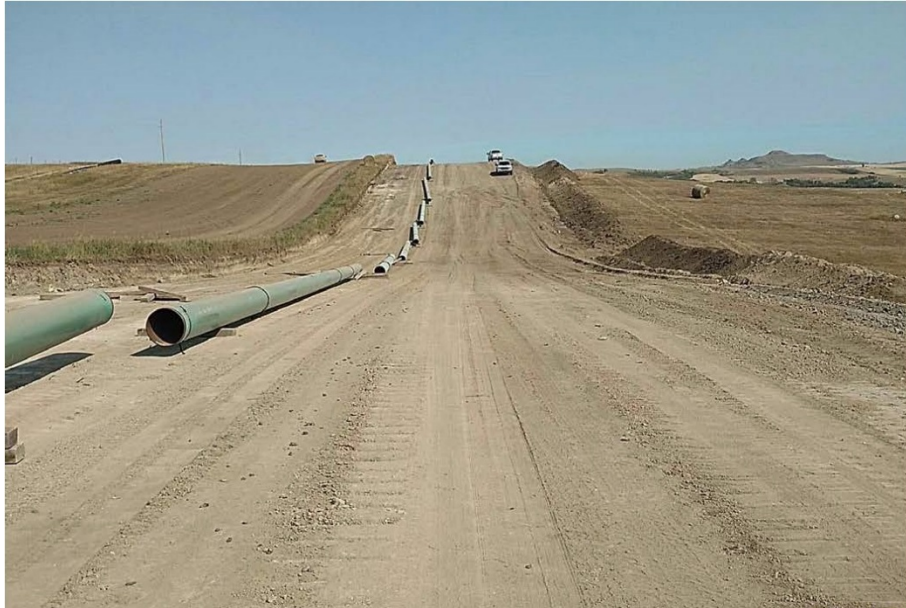
*Photo 7: Located at station 54+00, looking east showing piping strung out on Right of Way, ready for welding.*

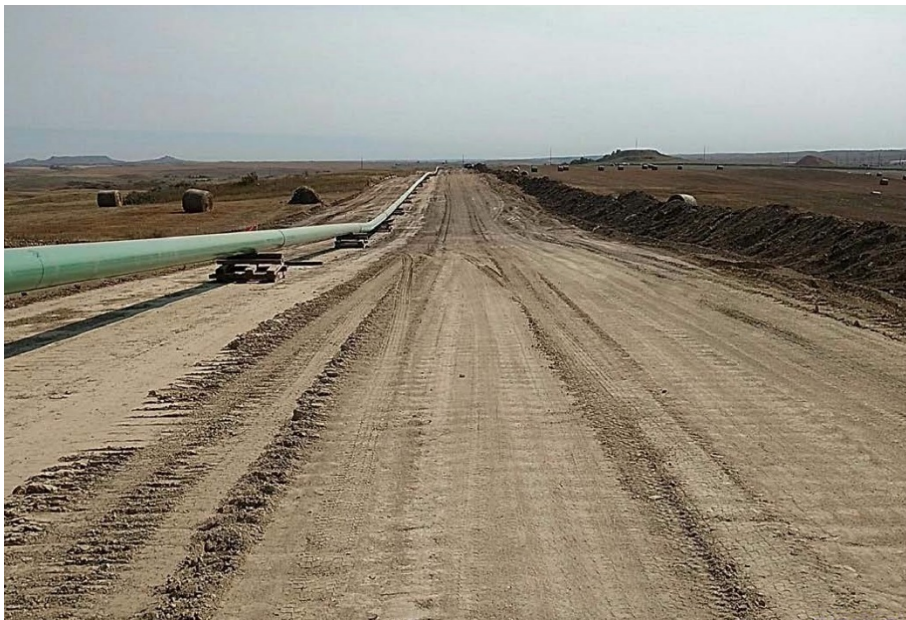
*Photo 8: Located at station 62+00, looking east showing piping welded and sitting on skids ready for excavation. Piping is located on graded Right of Way.*

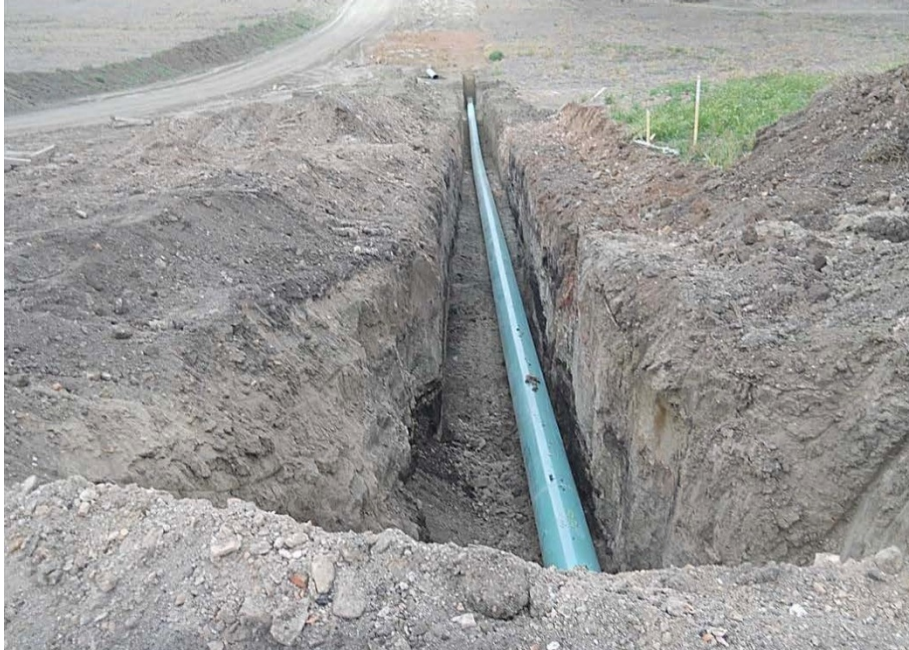
*Photo 9: Located at station 70+00, looking west at pipe located in trench. Depth of trench was measured and found to have 4'0" of cover from the top of pipe.*

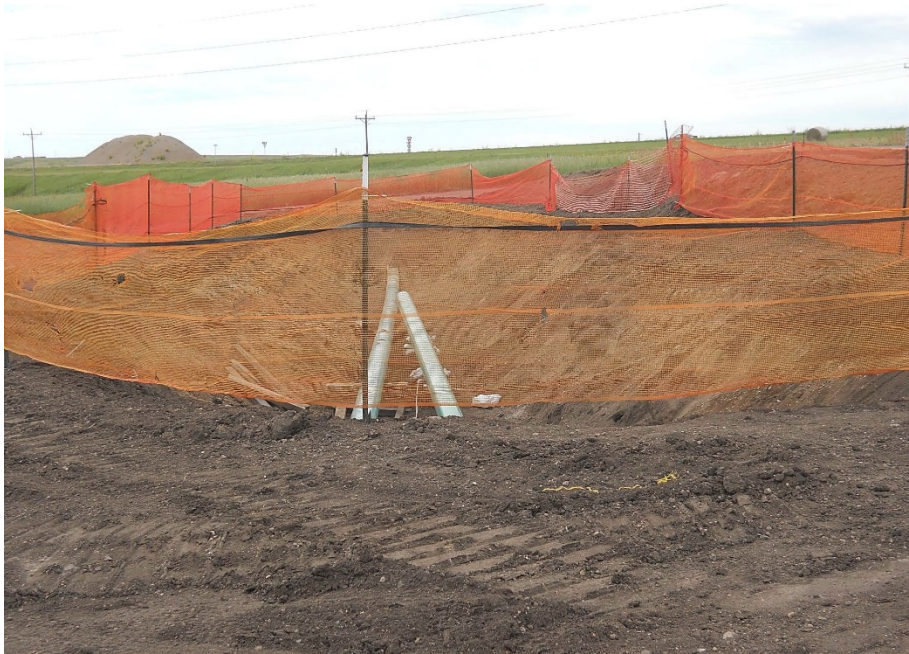
*Photo 10: Looking west at bore pit entry Station PI 24+75.81 and exit bore pit beyond station PI 76+47.7, to cross under oil well access road. Piping has been pulled into bore pits and ready for connection.*

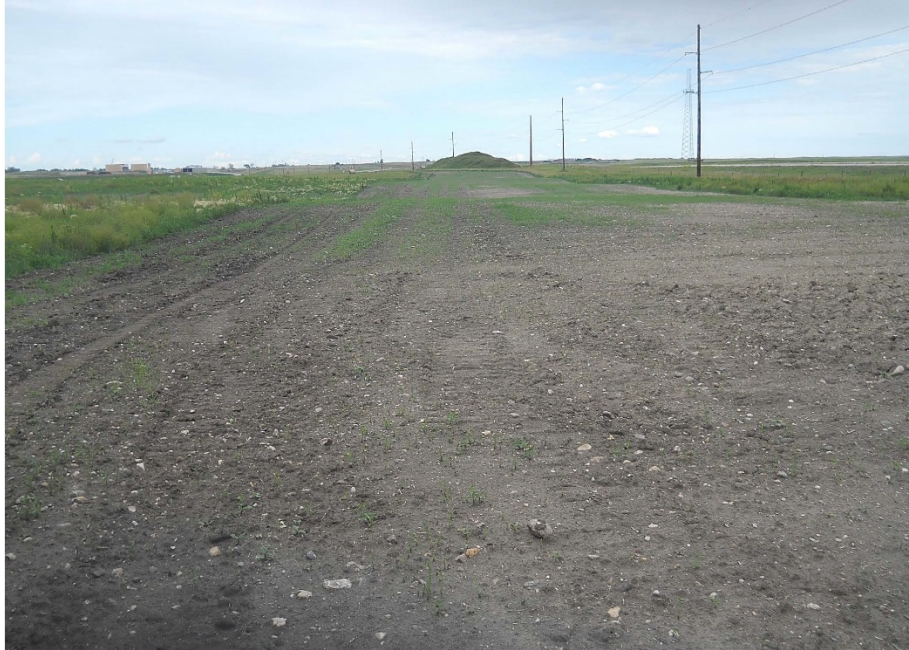
*Photo 11: Located at station 84+00, looking south east at graded Right of Way, ready to string out piping. Right of Way is located on north side of Highway 2.*

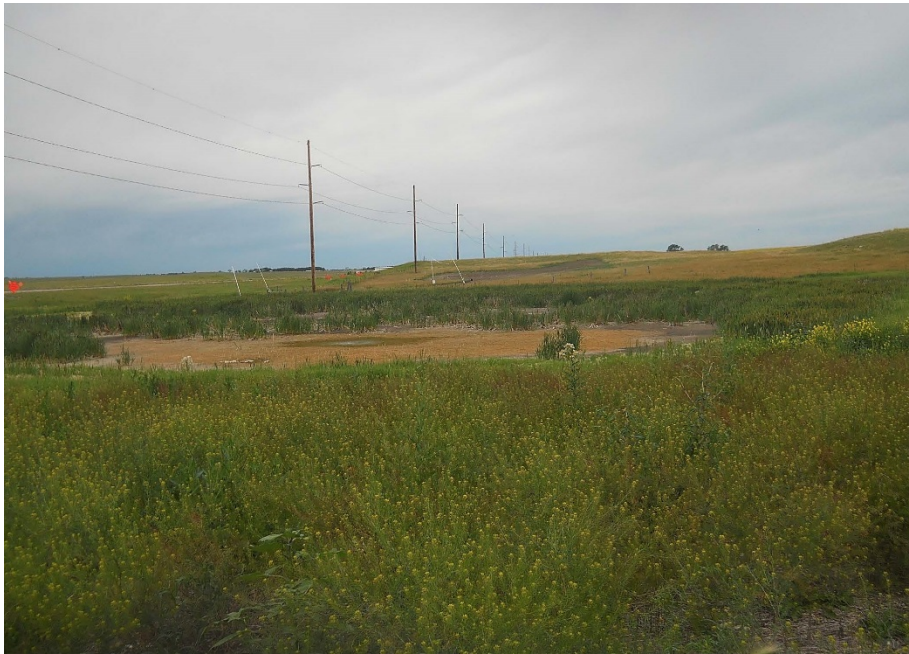
*Photo 12: Located at station 98+00, looking southwest at wetland to be bored. At time of inspection, contractor had not gotten to location. Highway 2 is just to the south (left).*

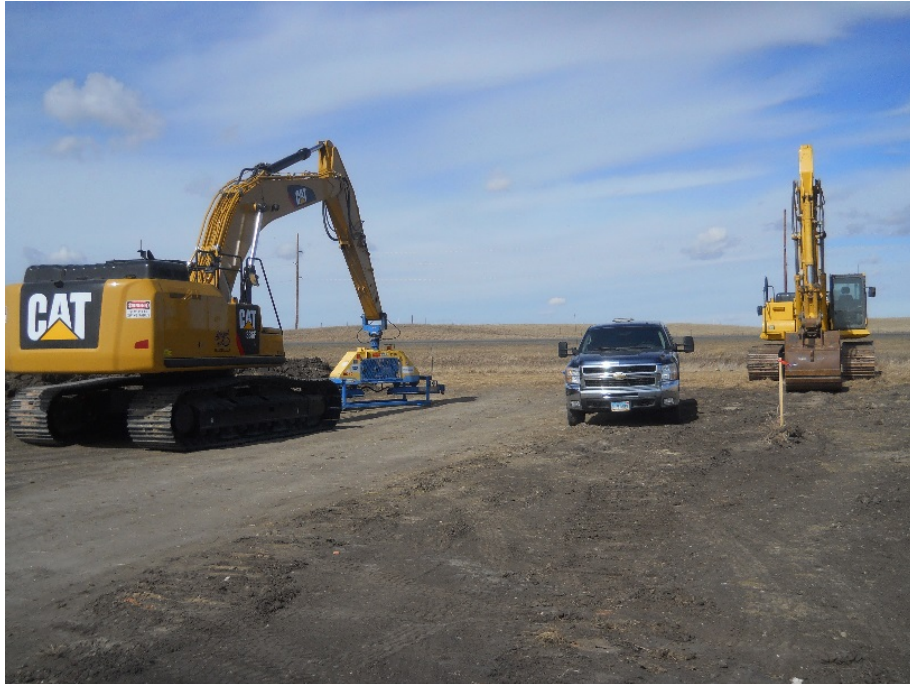
*Photo 13 - Located at station 111+42.20, looking north across Highway 2. Bore exit on south side of Highway. Construction equipment on excavation getting ready to start bore pits.*

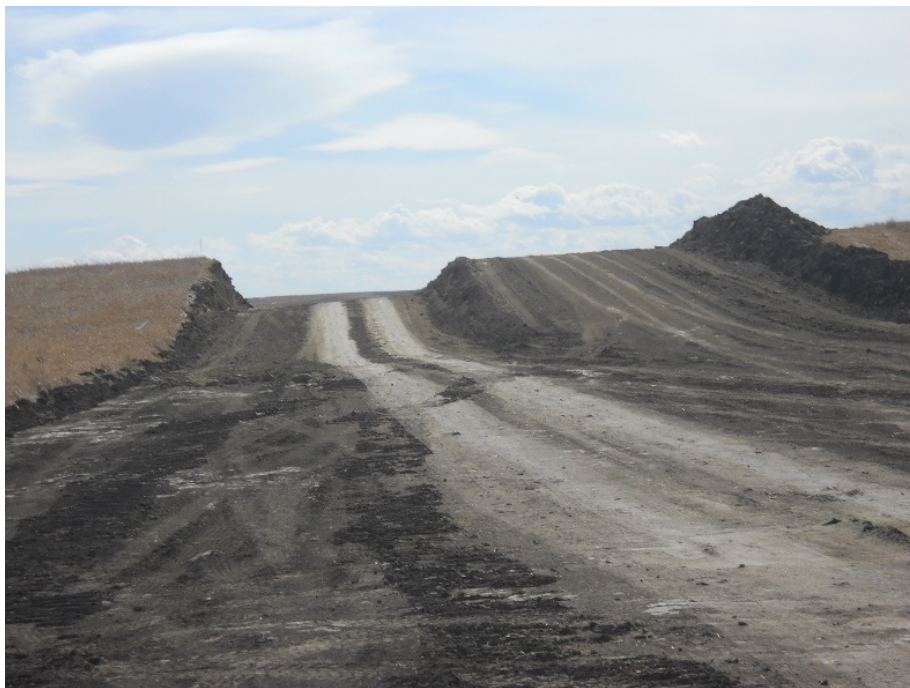
*Photo 14 - Located at station 120+00, looking south showing graded Right of Way ready for pipe installation and trenching.*

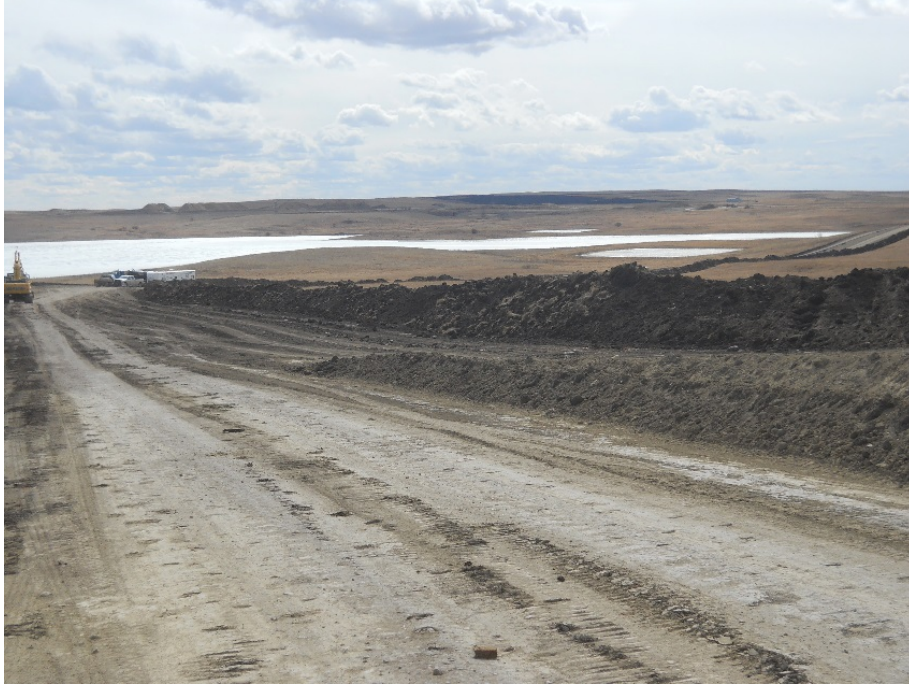
*Photo 15 - Located at station 128+00, looking south showing graded Right of Way ready to string out piping and start trenching. Photo also shows Right of Way turning west with water slough nesting area beyond.*

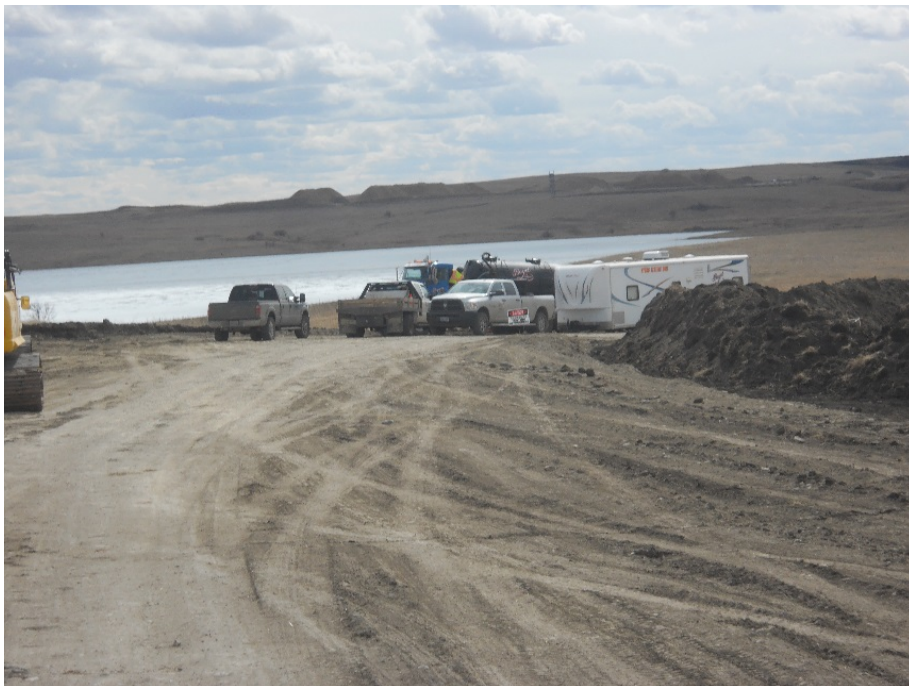
*Photo 16 - Located at station PI 128+43.8, looking south where Right of Way turns right and heads west. Photo shows contractor on site hydro testing welded bore piping.*

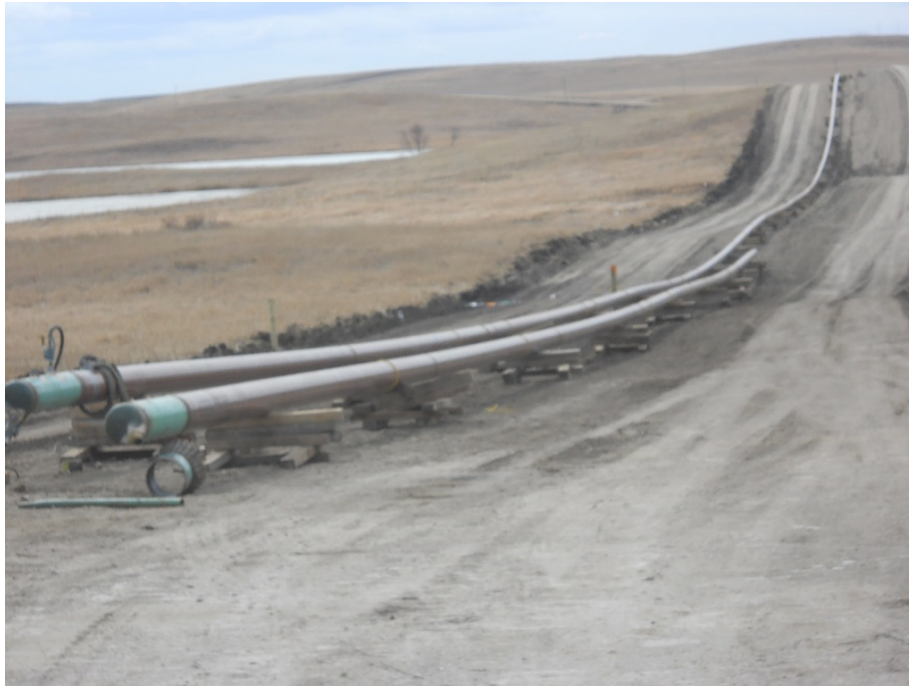
*Photo 17 - Located at station 130+00, looking west showing graded Right of Way with bore pipe sitting on skids and under hydro test. Bore piping to be pulled under site slough when hydro test completed. Contractor was onsite at time of inspection.*

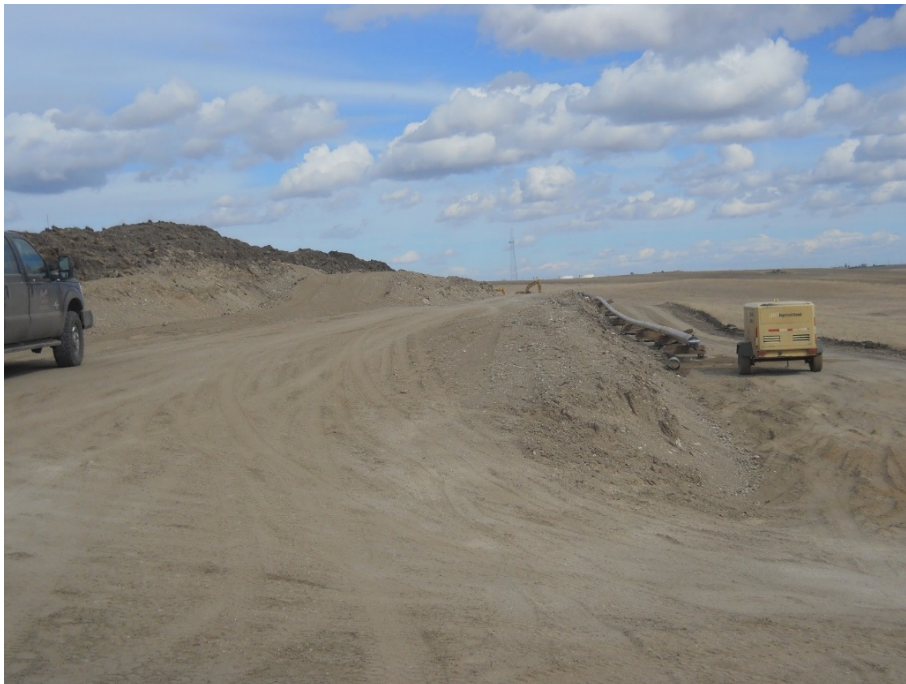
*Photo 18 - Located at station 142+52.8, photo taken from west end of Right of Way facing east at bore entry. Bore piping being hydro tested at time of inspection.*

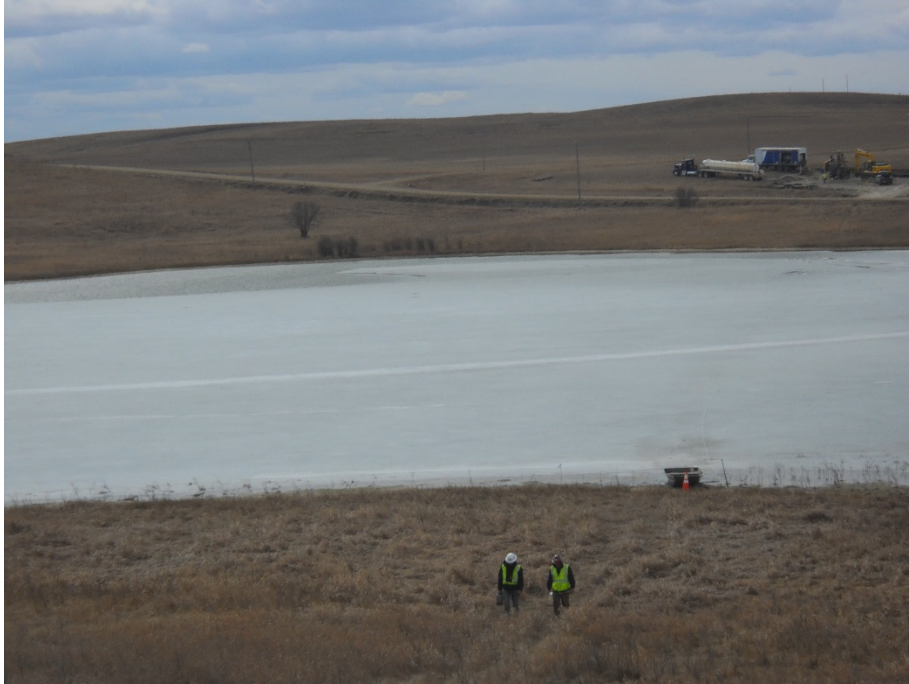
*Photo 19 - Located at station 148+00, standing on west hillside, looking across waterway slough to be bored due to nesting habitat.*

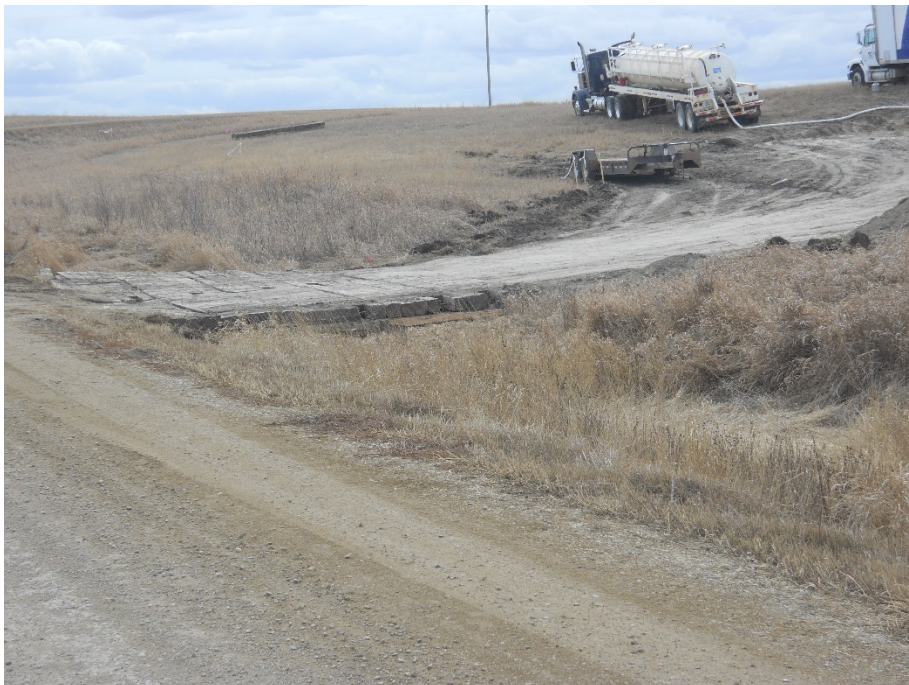
*Photo 20 - Located at station 156+00, photo taken from county road 77<sup>th</sup> Ave NW, shown bridge mats in road ditch for access point to have contractor perform bore work at station 158+72.8.*

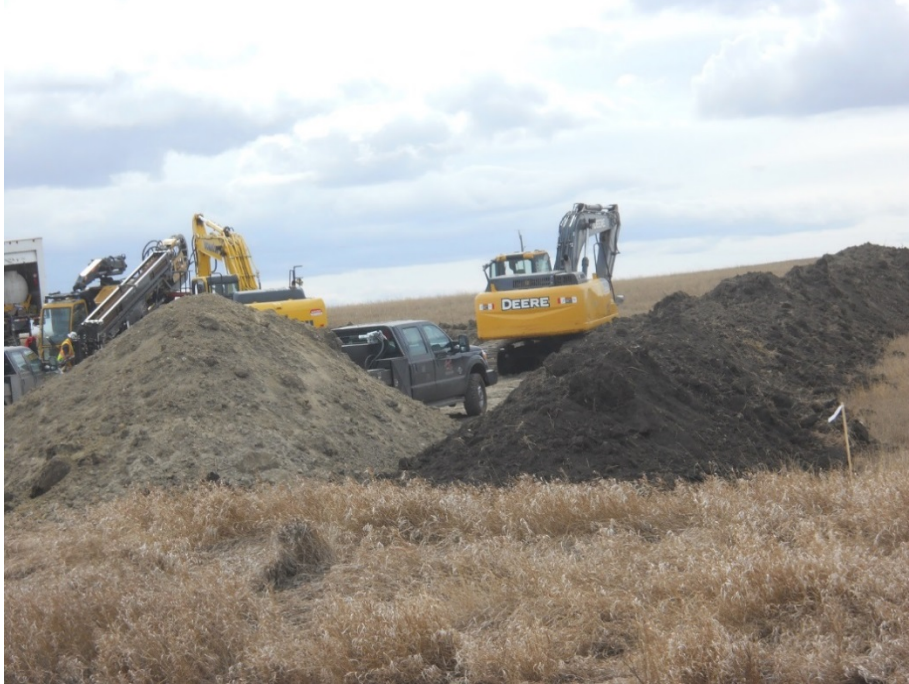
*Photo 21 - Located at station 158+72.8, photo taken at bore pit exit station, located on west side of County Road 77<sup>th</sup> Ave NW, at time of inspection contractor on site doing bore work.*

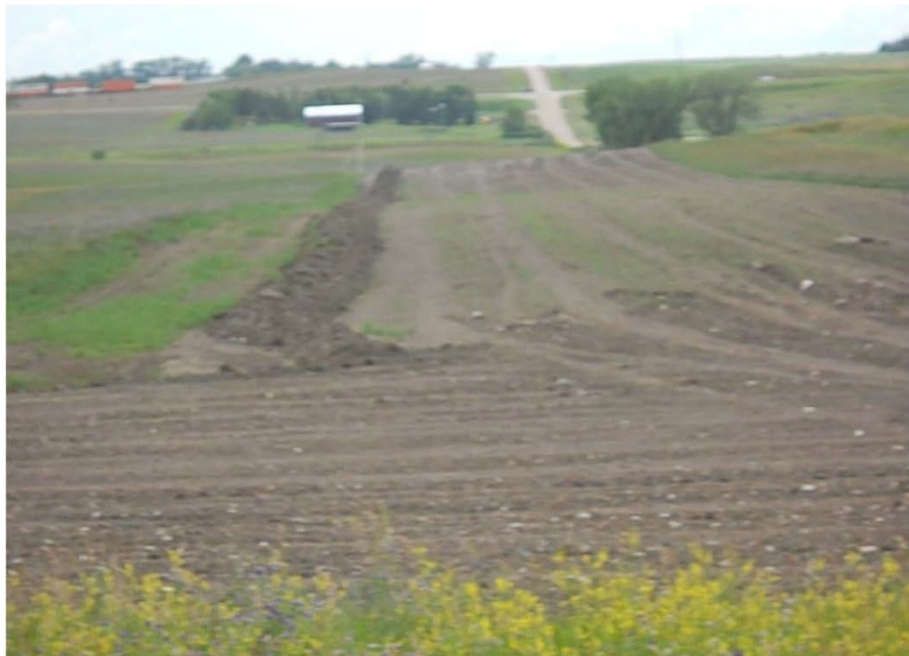
*Photo 22 - Located at station 174+00, photo looking south at graded Right of Way, ready to string out pipe. Right of Way extends left towards west.*

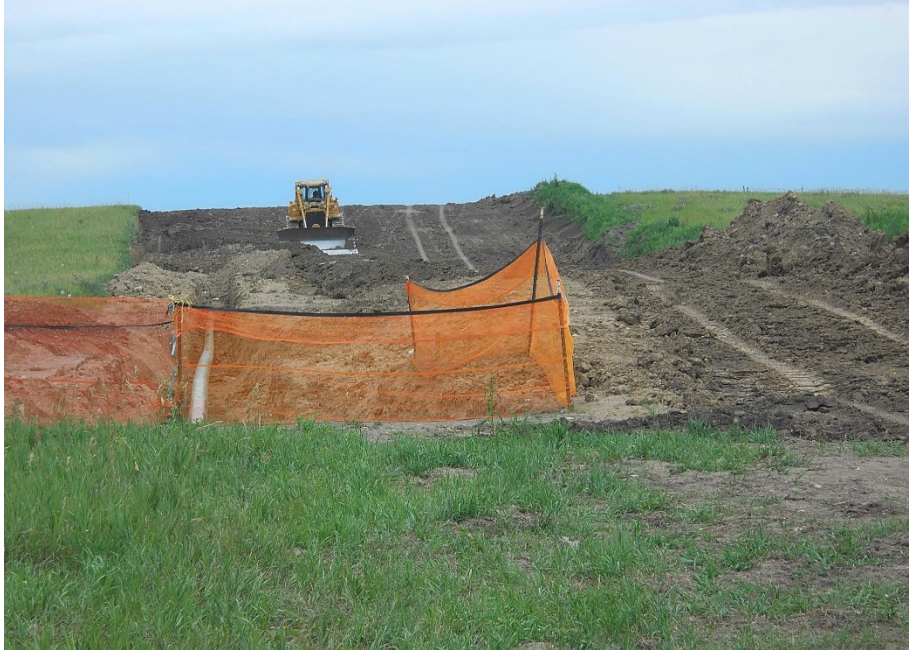
*Photo 23 - Located at station 199+76.6, photo looking south at bore entry station, with bore exit station 203+57.3 beyond. Right of Way graded and ready to string pipe. Bore pit was rated during inspection to have installed fence barricade for safety.*

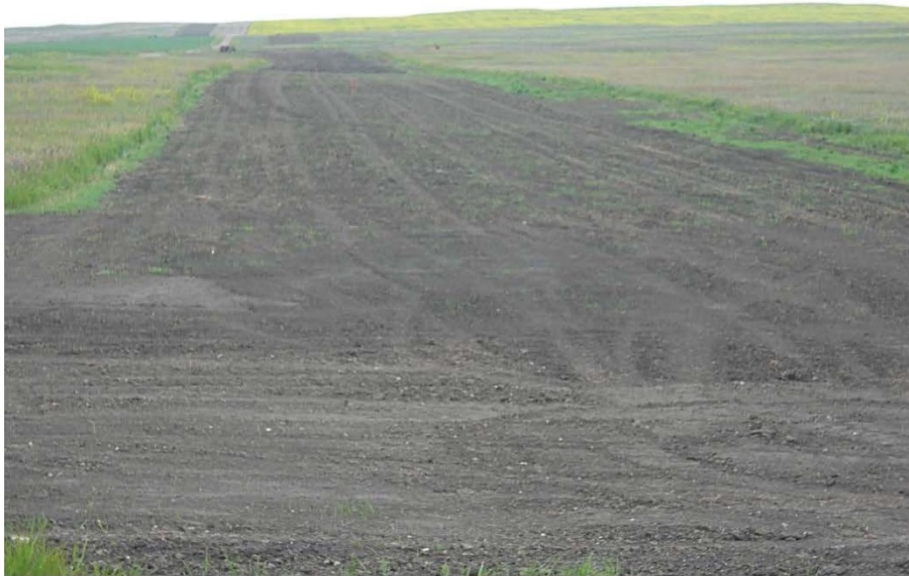
*Photo 24 - Located at station 220+00, photo looking north west at graded Right of Way ready to string out pipe.*

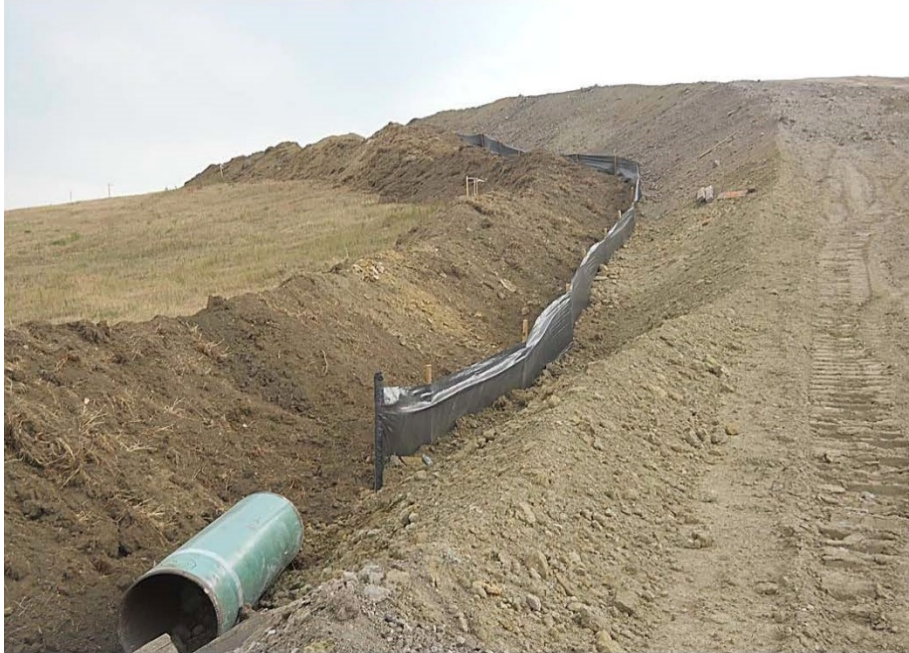
*Photo 25 - Located at station 232+00, photo looking north west showing graded Right of Way with BMP silt fence installed to separate top and subsoil types from touching. Right of Way turns and heads south.*

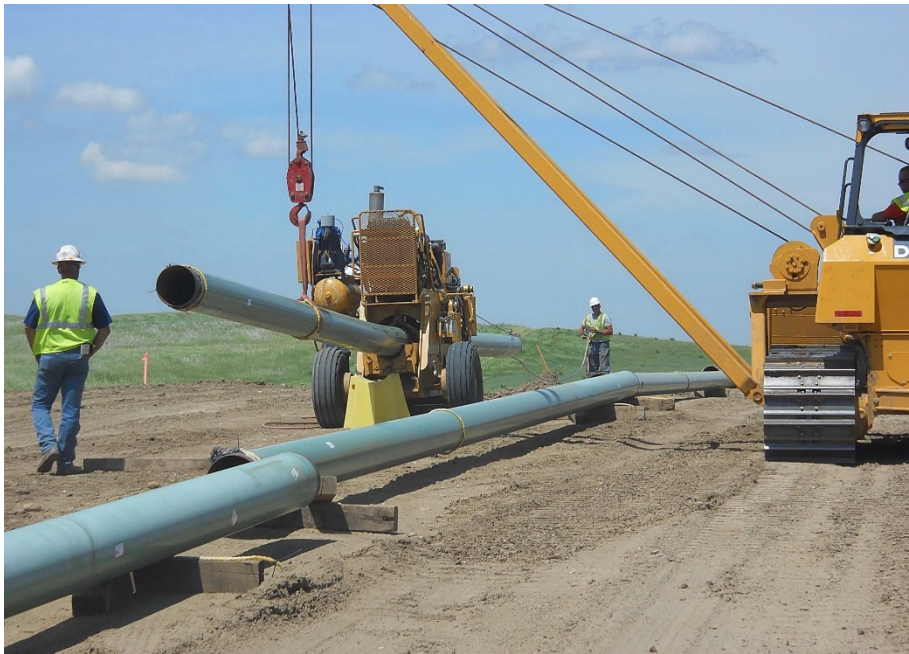
*Photo 26 - Located at station 246+00, photo looking south with contractor bending pipe as required for installation. Pipe is strung out on graded Right of Way ready for welding and trenching.*

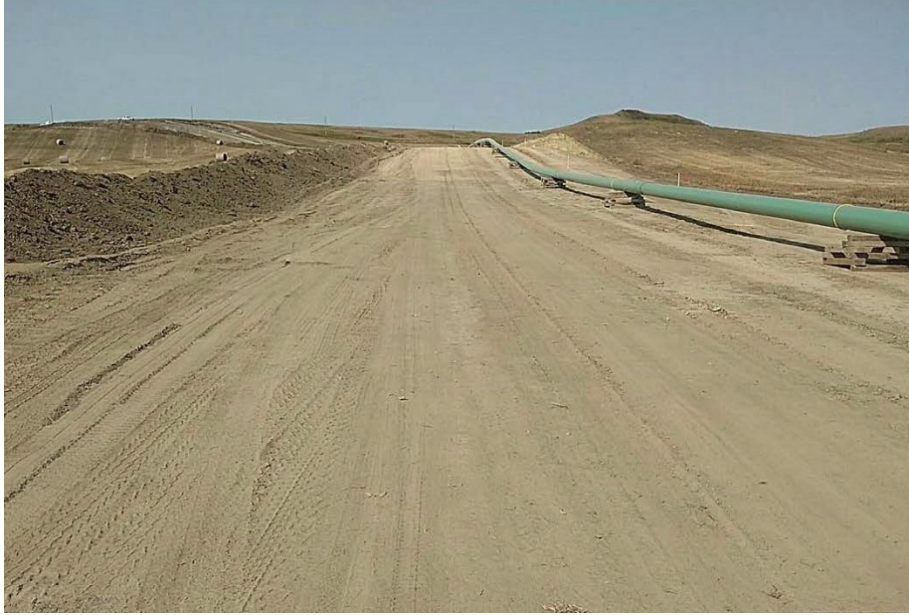
*Photo 27 - Located at station 250+00, photo looking south at graded Right of Way with welded piping sitting on skids ready for trenching.*

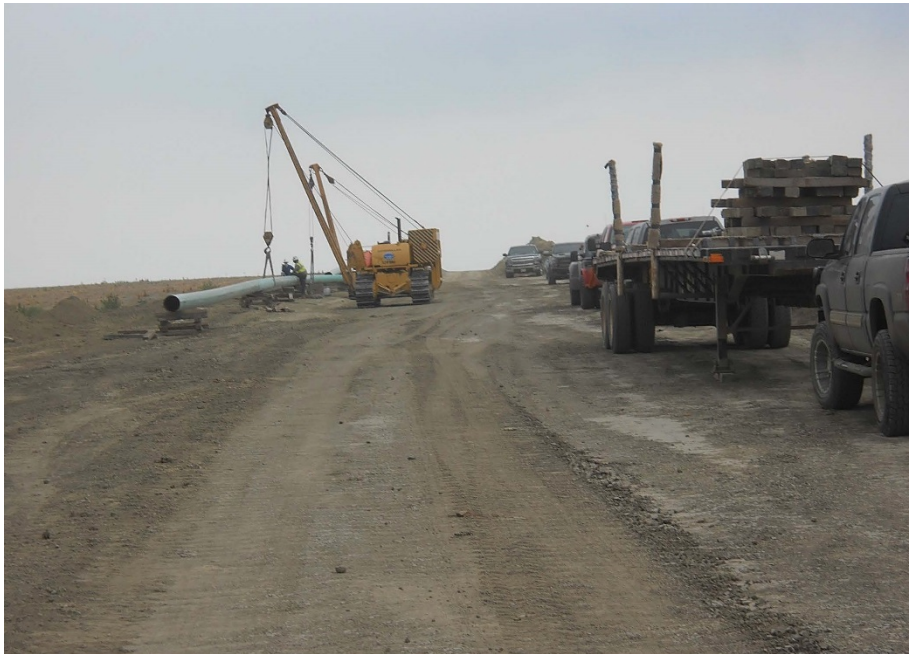
*Photo 28 - Located at station 310+00, photo looking west showing contractor working on installing welded piping into trench.*

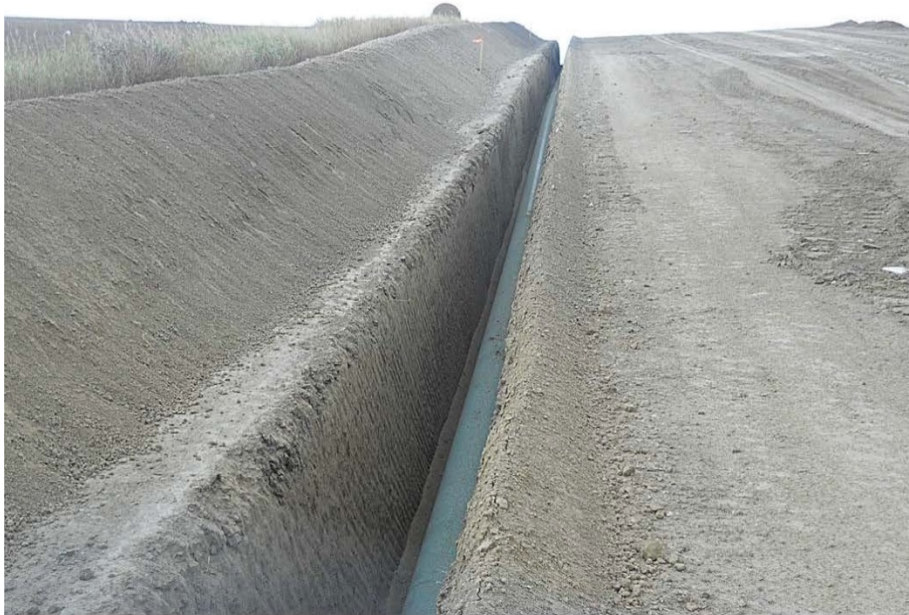
*Photo 29 - Located at station 316+00, photo looking west showing piping installed in trench. Depth of trench was measured and was found to have top of pipe 4'-0" to top of Right of Way trench opening. Trench appeared to be ready to be backfilled.*

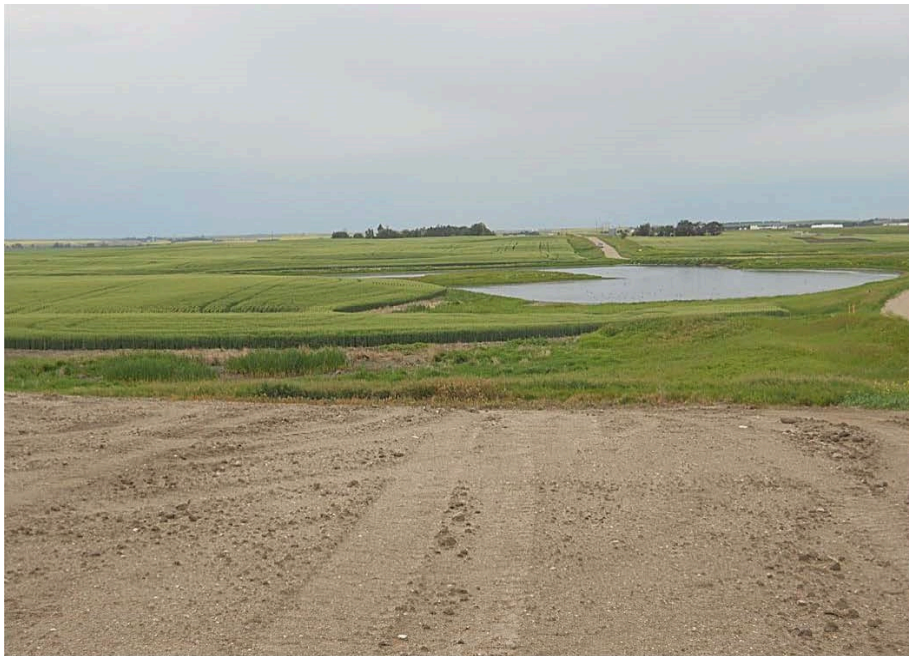
*Photo 30 - Located at station 347+70.3, photo looking west at bore entry at wetland. No bore work has started yet. Right of Way is graded.*

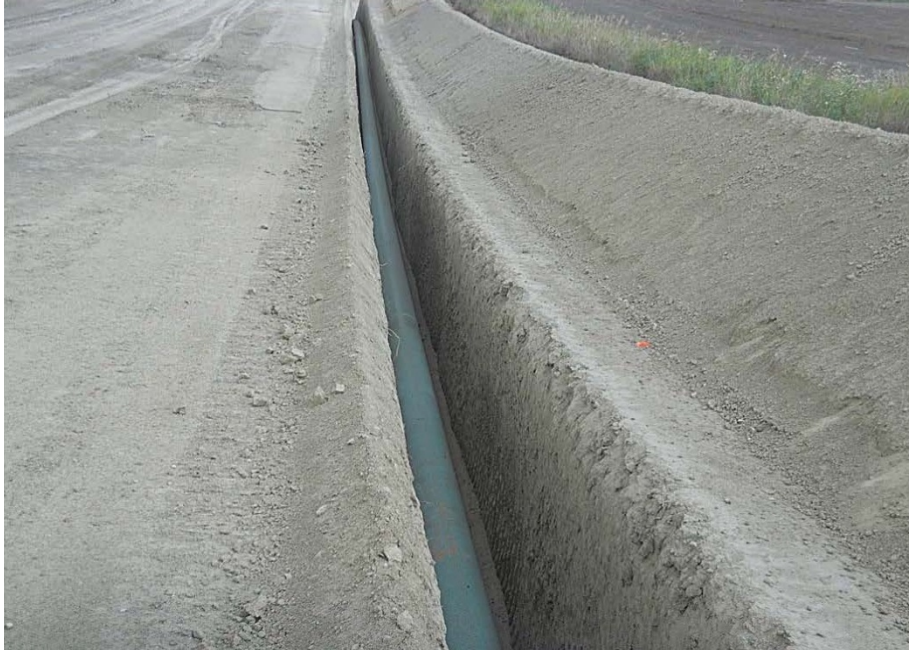
*Photo 31 - Located at station 368+00, photo looking west showing piping installed in trench. Depth of trench was measured and was found to have top of pipe 4'0" to top of Right of Way trench opening. Trench was ready to be backfilled.*

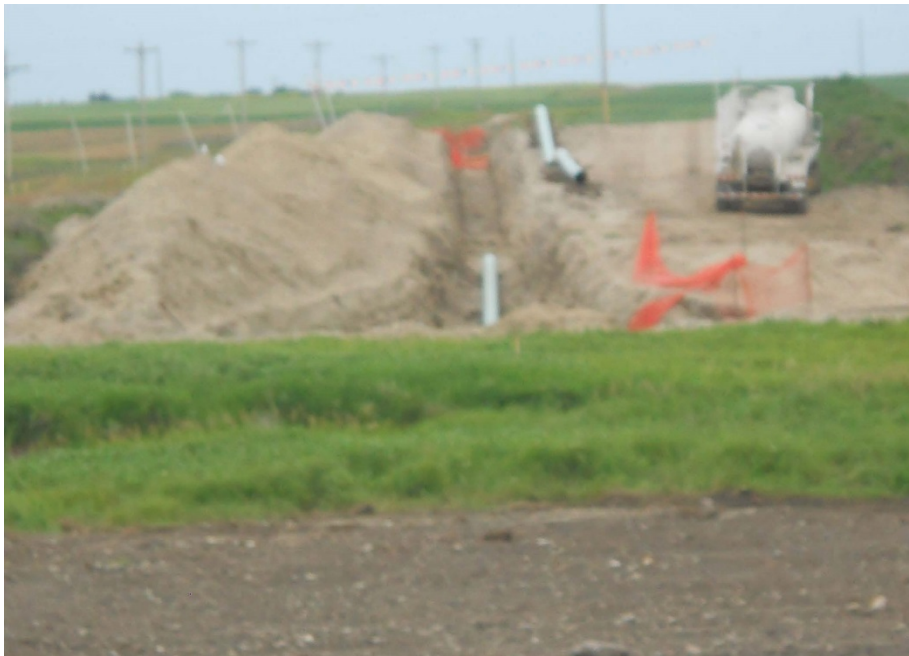
*Photo 32 - Located at station 412+75.9, photo looking east at bore pit. Piping has been bored under wetland, with pipe pulled through trench. Fenced barricade has been installed around bore pit.*

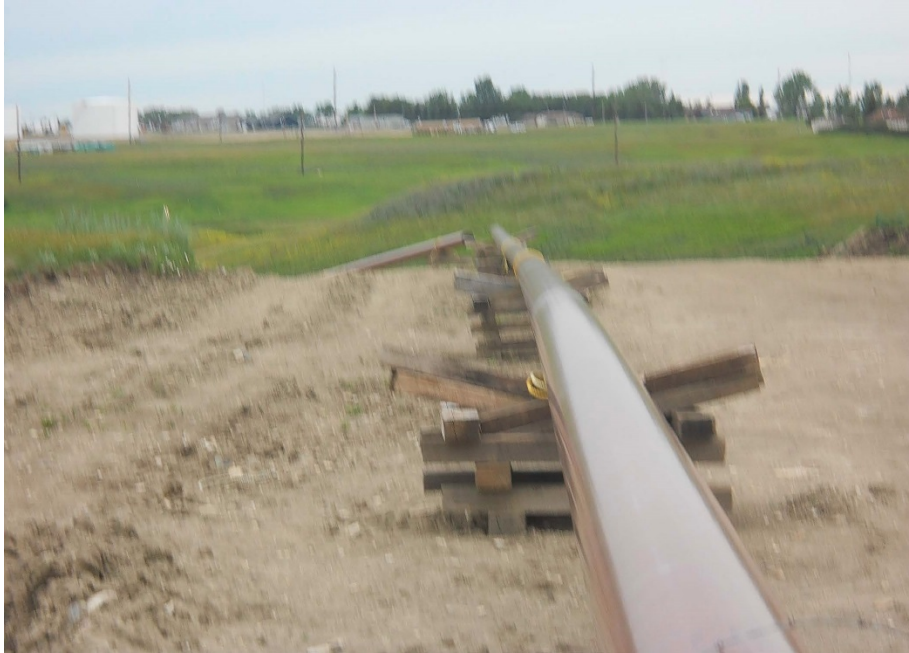
*Photo 33 - Located at station 414+00, photo looking south west, showing pipe sitting on skids ready to be bored under wetland across from Enbridge tanks.*

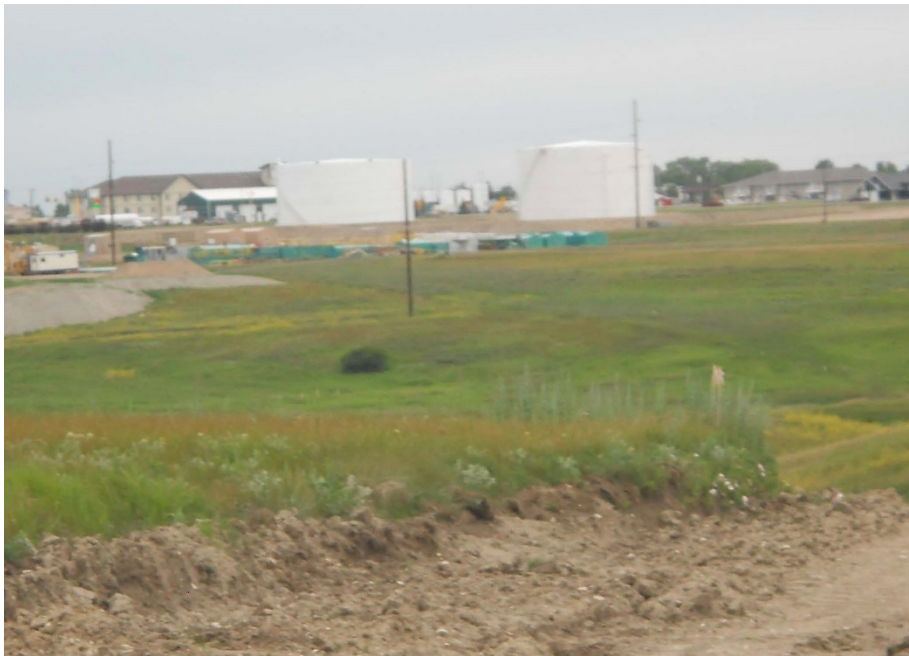
*Photo 34 - Located at station 423+56.8, End of Pipeline, photo looking south west at exit bore site across wetland towards tie-in at Enbridge tanks at Stanley, ND.*
