# Sacagawea Pipeline Co.

## Reclamation and Revegetation Inspection Report Palermo to Enbridge Crude Oil Pipeline

Case No. PU-15-670

*December 17, 2018*

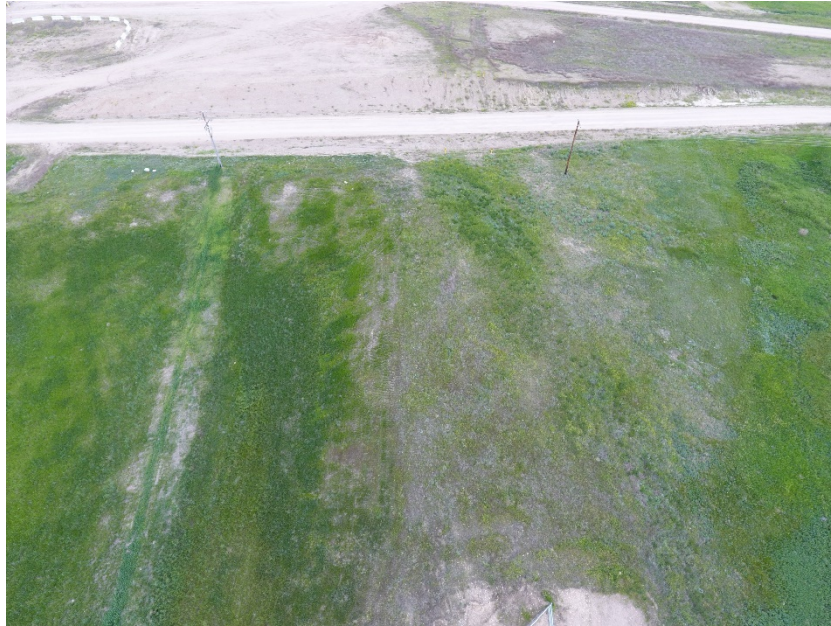
Location 1, page 10: Conditions of reclaimed area consistent with surrounding vegetation.

Location 1 (48.331055, -102.242615)  
Vegetation matching surrounding conditions

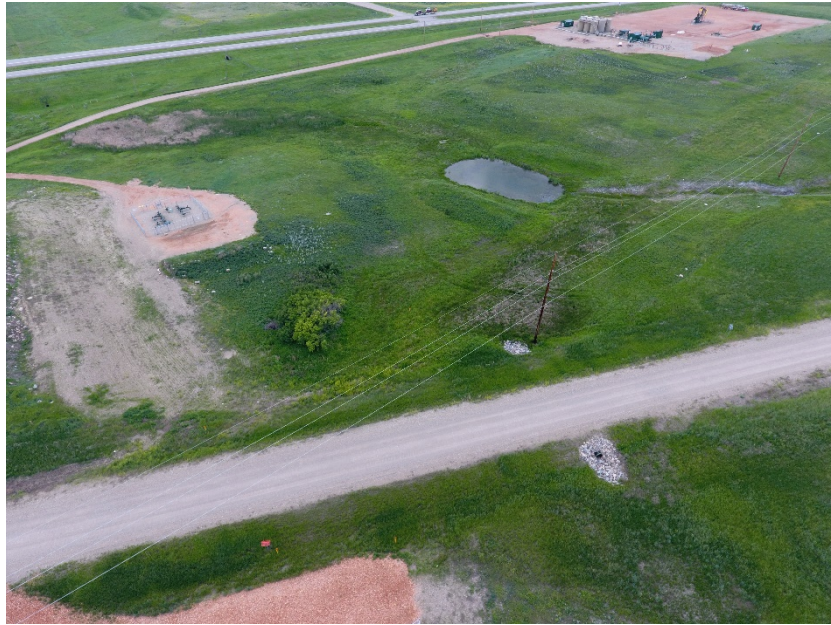
Location 3 (48.331062, -102.242607)  
Vegetation well established to previous conditions

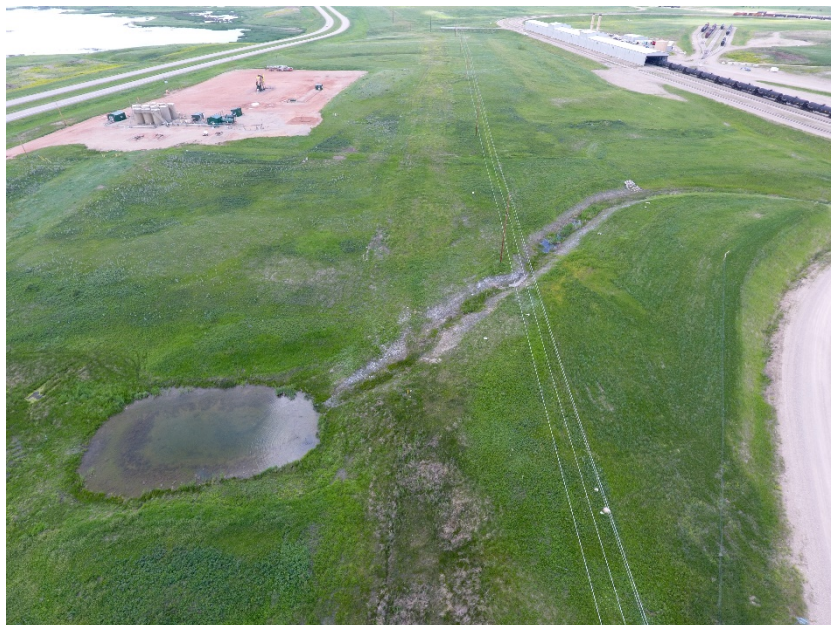
Location 4, page 11: Vegetation well blended into surroundings.

Location 4 (48.330578, -102.243401)  
Pipeline scar visible, but blending well into adjacent conditions

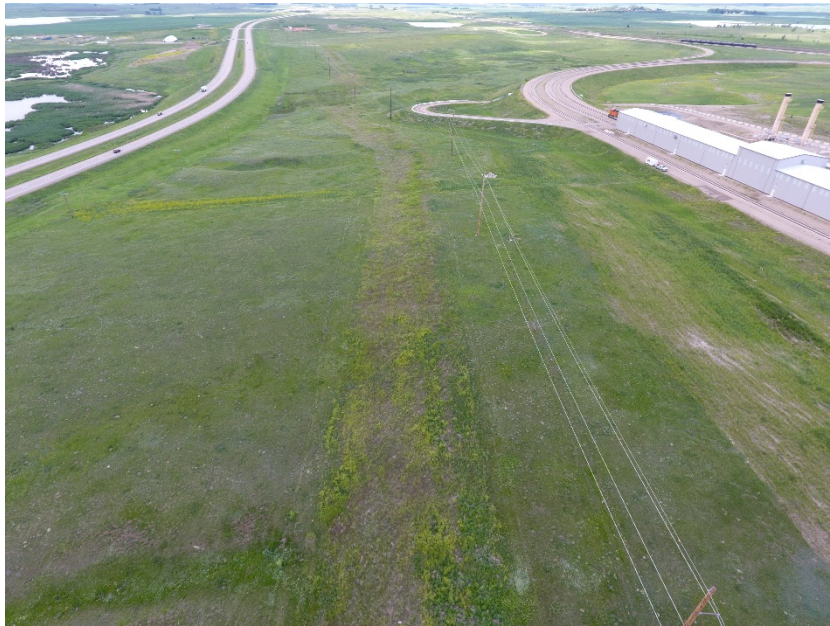
Location 5 (48.330578, -102.24939)  
Vegetation established, some thin areas present

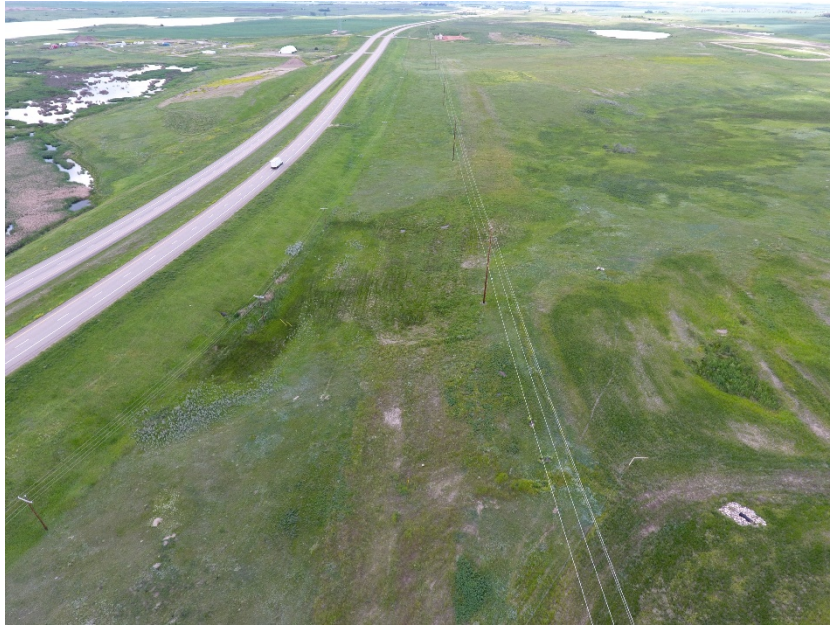
Location 7 (48.330334, -102.253983)

Location 7, page 13: Example of differing types of grassland blending well into reclaimed area of pipeline.

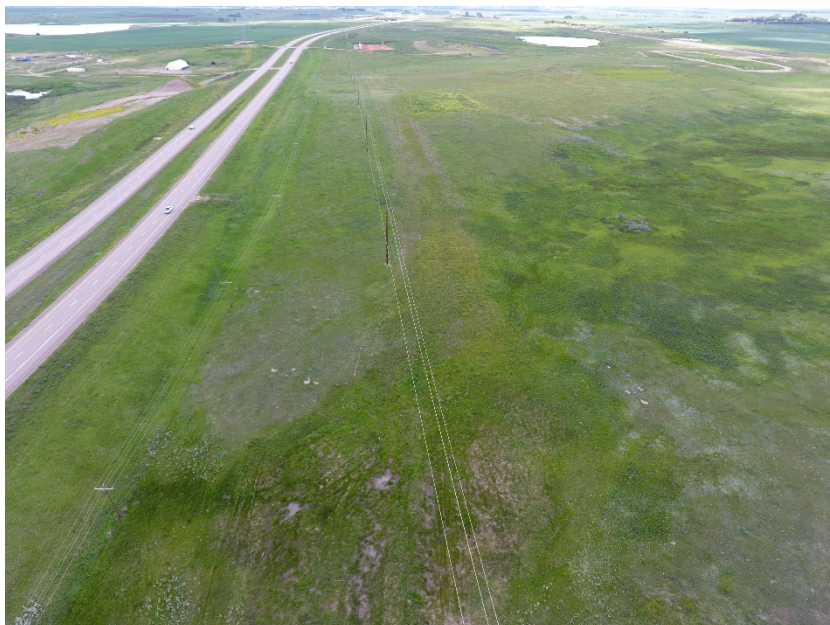
Location 8 (48.330128, -102.255562)  
Well established and matching existing conditions

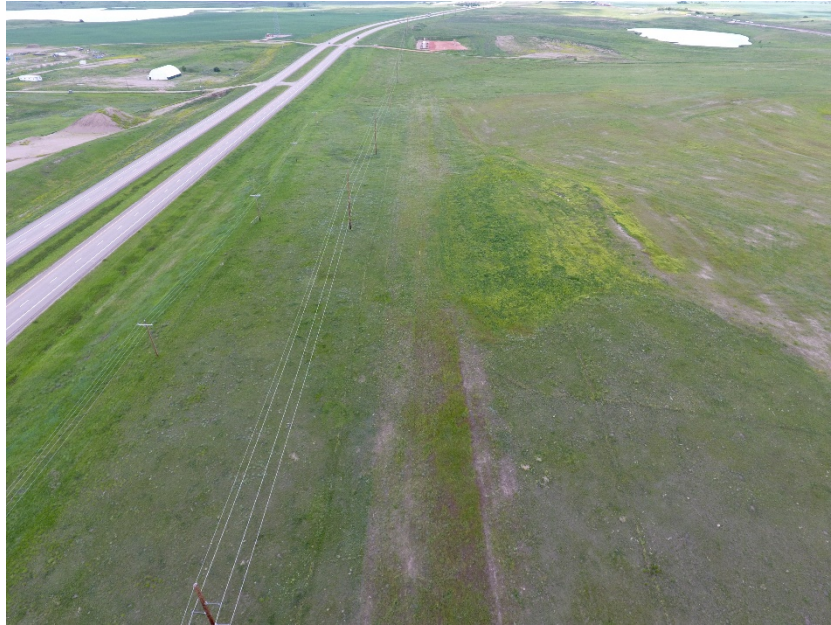
Location 8 (48.330128, -102.255562)  
Consistency in vegetation similar to adjacent areas

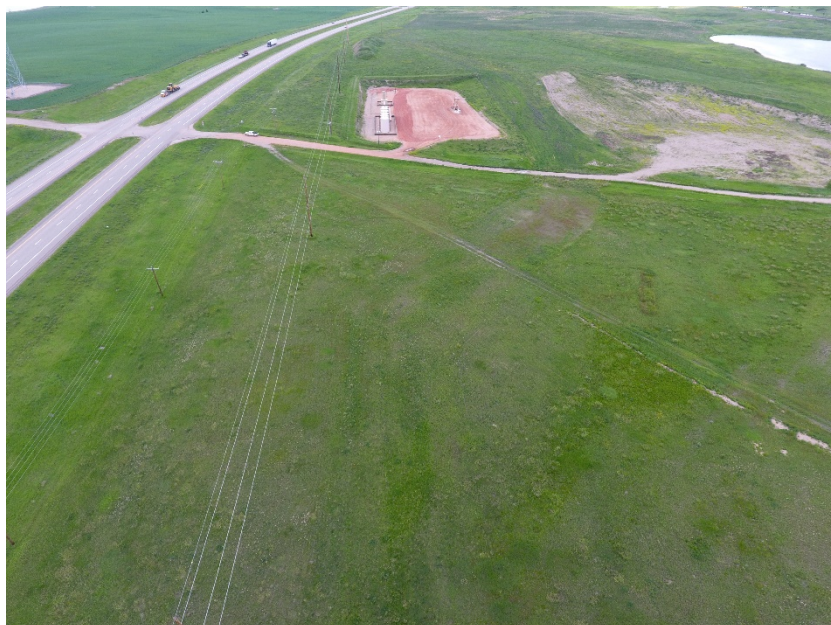
Location 10 (48.32872, -102.265045)  
Well established and matching existing conditions

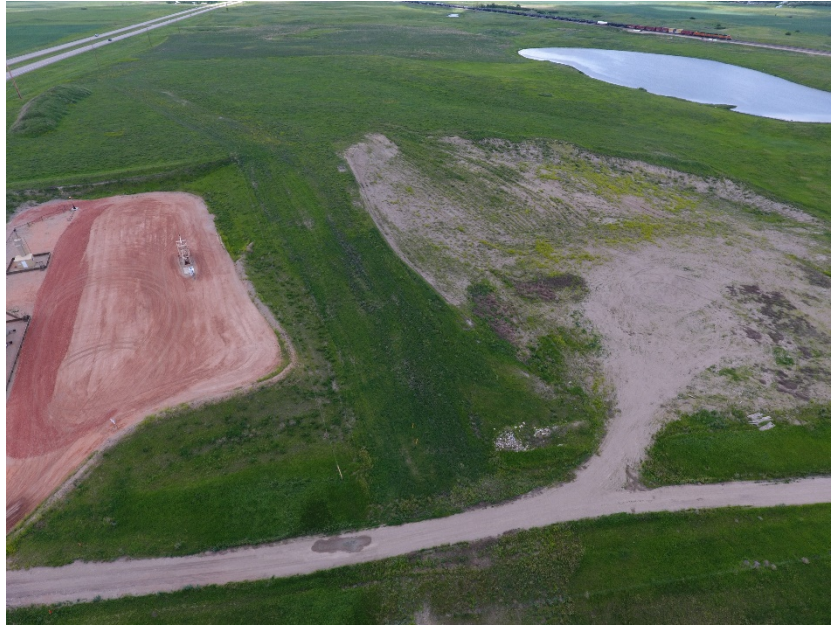
Location 11 (48.328789, -102.267319)  
Scar blending well with existing vegetation

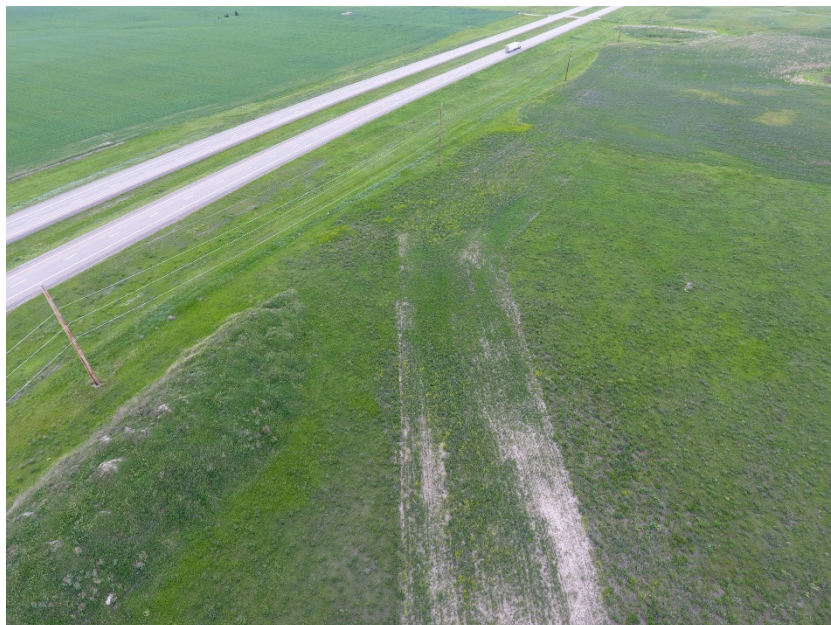
Location 12 (48.32795, -102.271362)  
Vegetation thin, but growing to match adjacent conditions

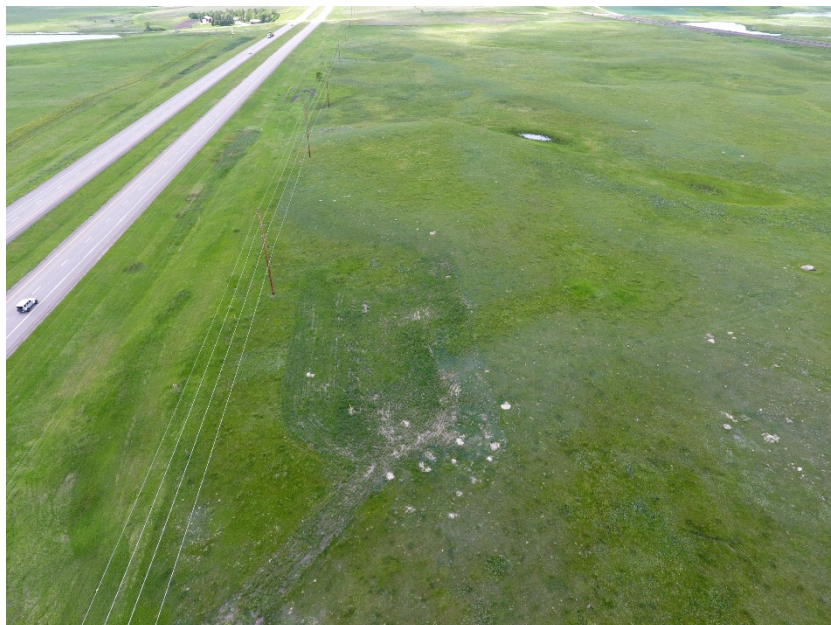
Location 14, page 16: Vegetation established to match adjacent grassland, some thin areas seen are consistent with surrounding conditions.

Location 14 (48.327526, -102.278656)  
Well blended into native vegetation

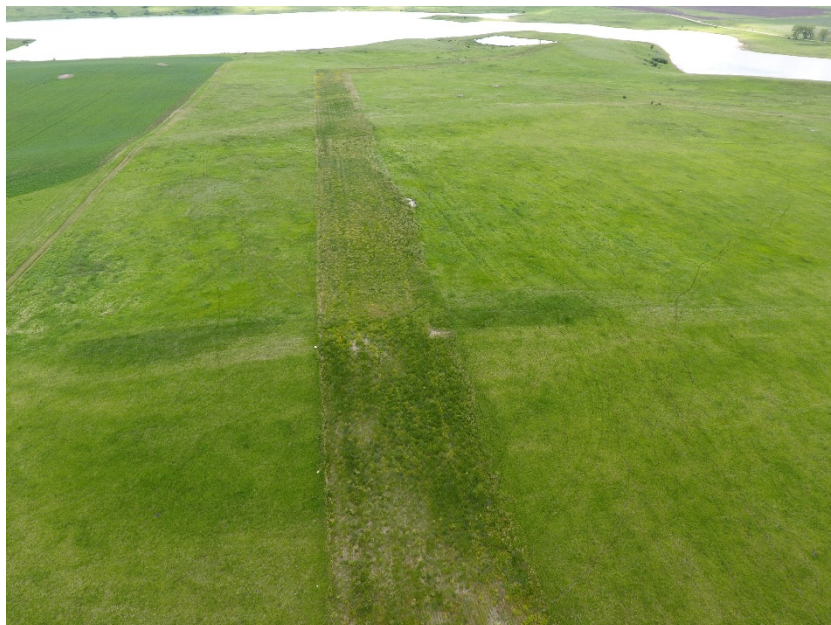
Location 16, page 17: In this area, vegetation has been well established, but not consistent with the surrounding grasslands. We feel this is likely due to the time in which the area was seeded. However, we would expect vegetation to closer match the surrounding conditions in future growing seasons.

Location 16 (48.325684, -102.279823)  
Recent reclamation, not yet blended into adjacent vegetation

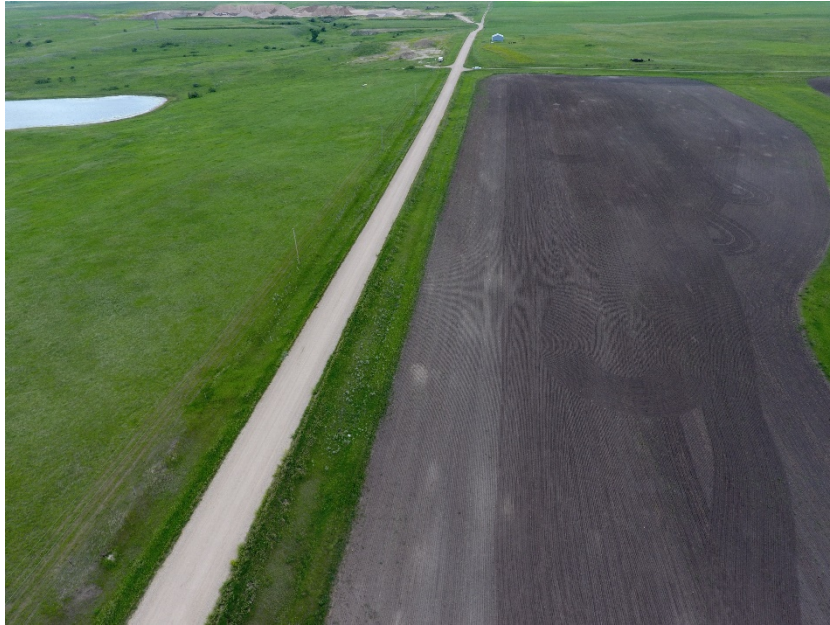
Location 19, page 19: Reclaimed area in cropland, no issues present.

Location 19 (48.316025, -102.289864)  
Cropland, no issues present

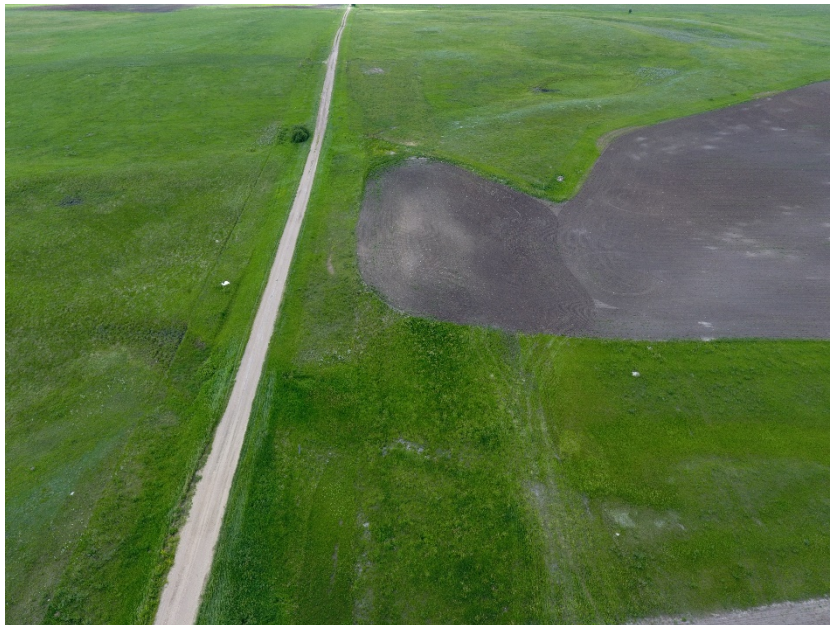
Location 20 (48.312859, -102.291298)  
Vegetation well established to match adjacent conditions

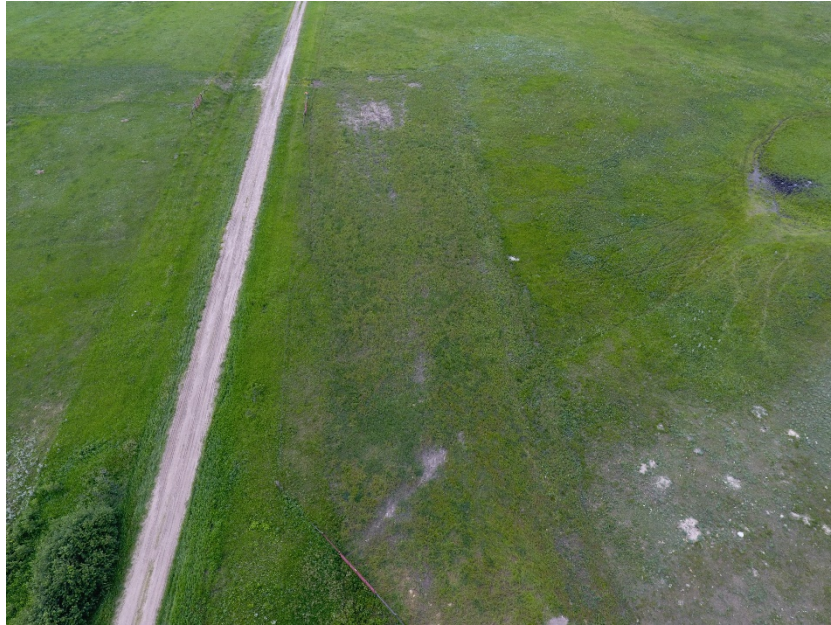
Location 21 (48.312893, -102.293488)

Thin vegetation, but beginning to blend well with adjacent conditions

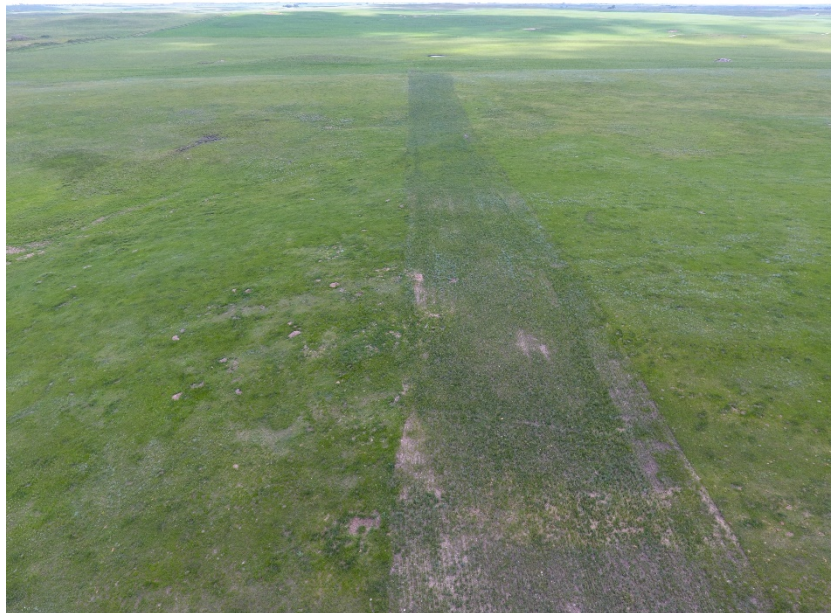
Location 22 (48.312489, -102.294922)

Location 22, page 20: Areas of thin growth and vegetation not closely matching the surrounding conditions. Near the middle of the picture, evidence can be seen of the existing vegetation growing into the reclaimed area. This is another area of concern that would be expected to improve with time.

Believed to be more recent reclamation work here than other areas

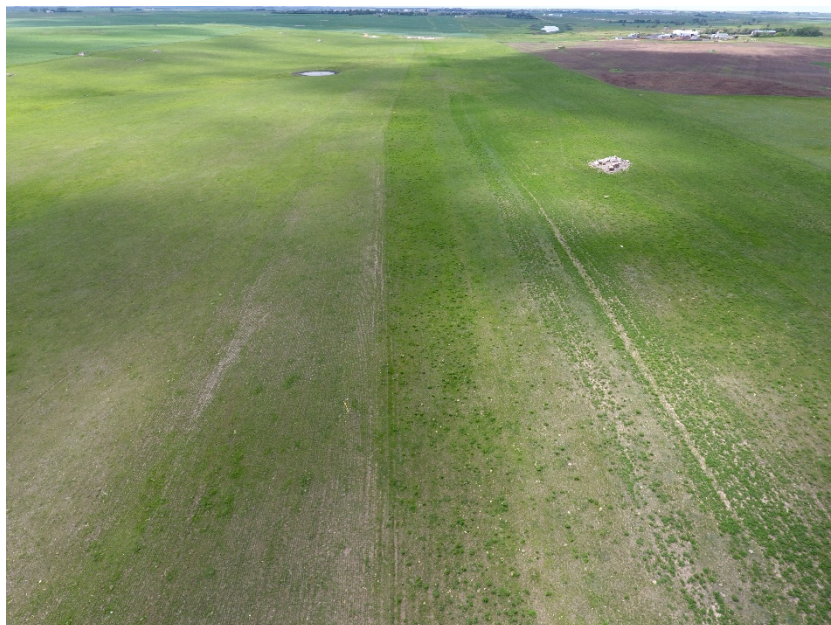
Location 24, page 21: Vegetation established and blending well against adjacent grassland.

Location 24 (48.308014, -102.29628)  
Well blended into adjacent vegetation

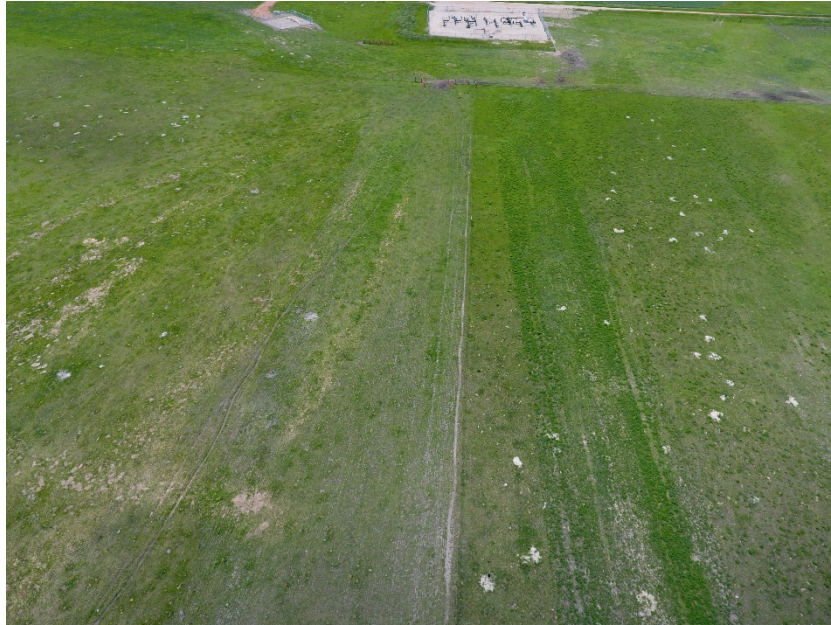
Location 27 (48.307938, -102.306343)  
Vegetation established to match adjacent conditions

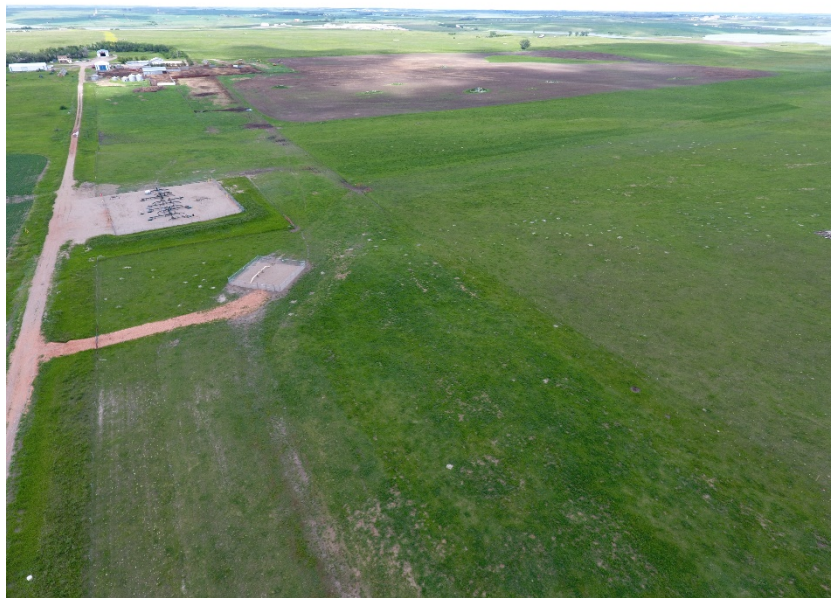
Location 28 (48.306168, -102.309608)  
Vegetation established to match adjacent conditions

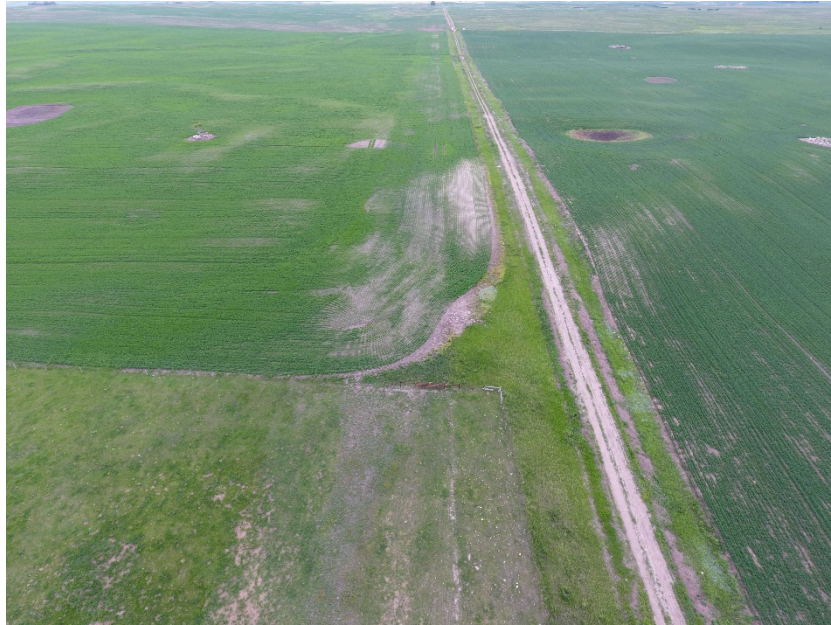
Location 29 (48.306179, -102.309654)  
Minimal disturbance in farm land

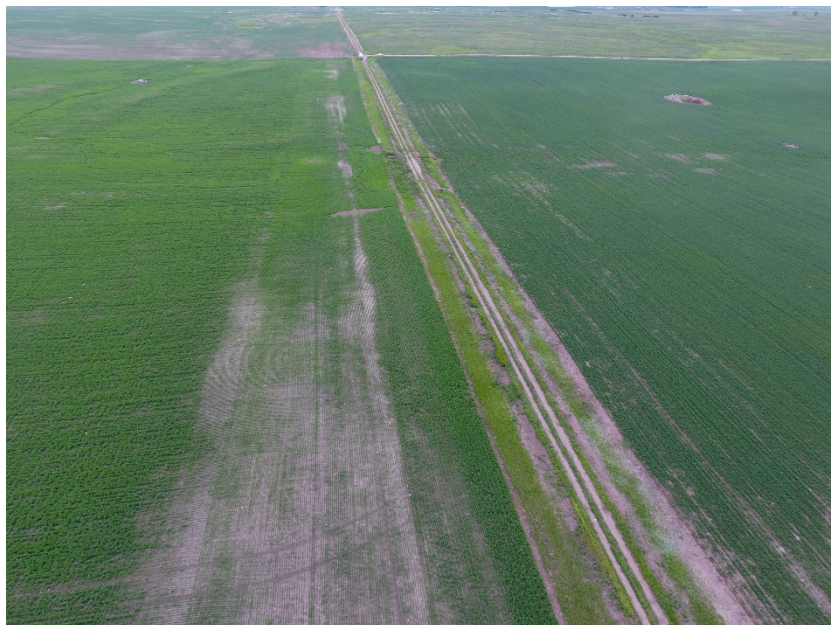
Location 30 (48.30283, -102.309647)  
Area of low growth in farm land

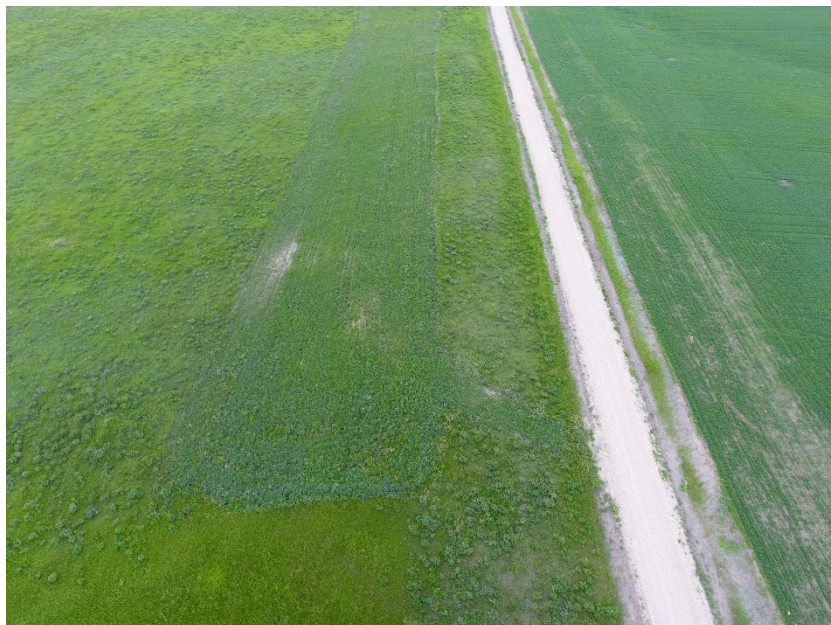
Location 32 (48.298004, -102.311348)  
Native species beginning to become established at pipeline scar

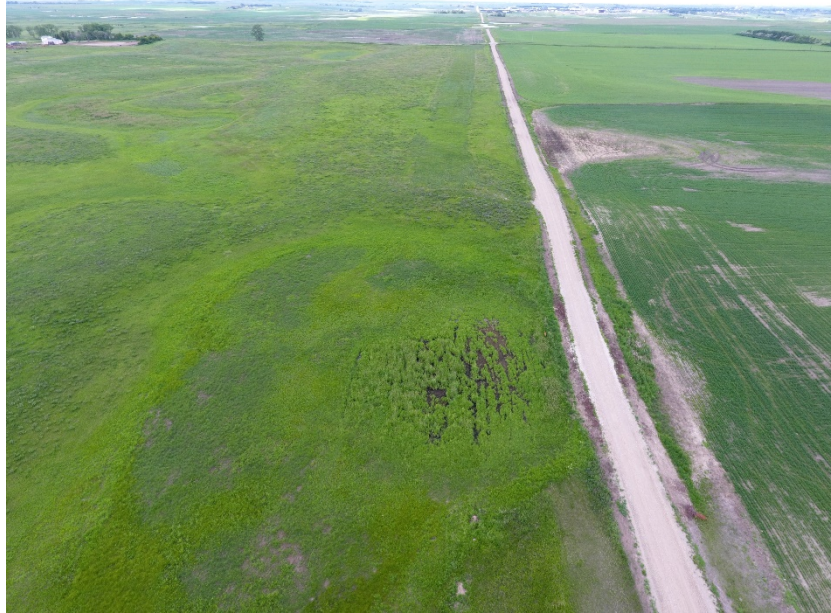
Location 35 (48.297985, -102.32206)  
Well blended to surrounding conditions

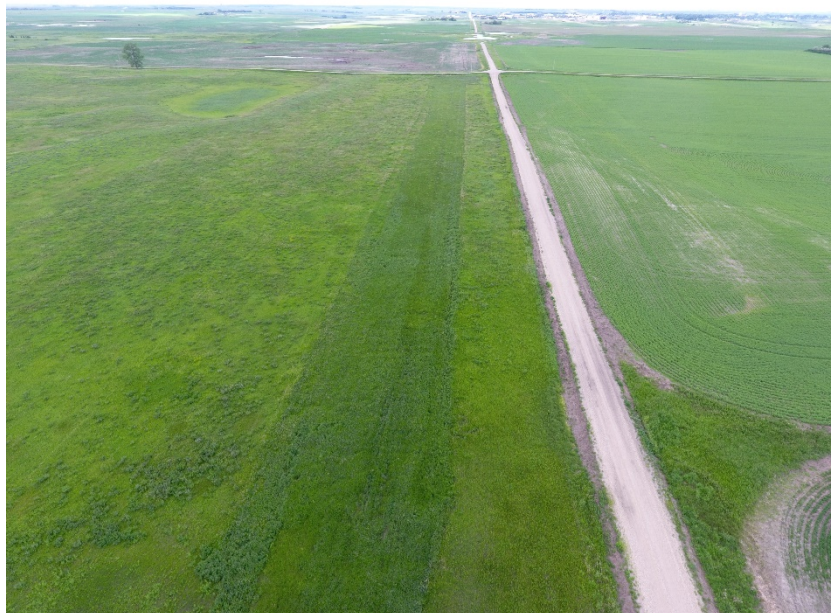
Location 36 (48.297996, -102.325592)

Location 36, page 27: Location of reclamation visible, but vegetation and growth present is consistent with adjacent grassland. Areas as this are presumed to be less detectable in future growing seasons.

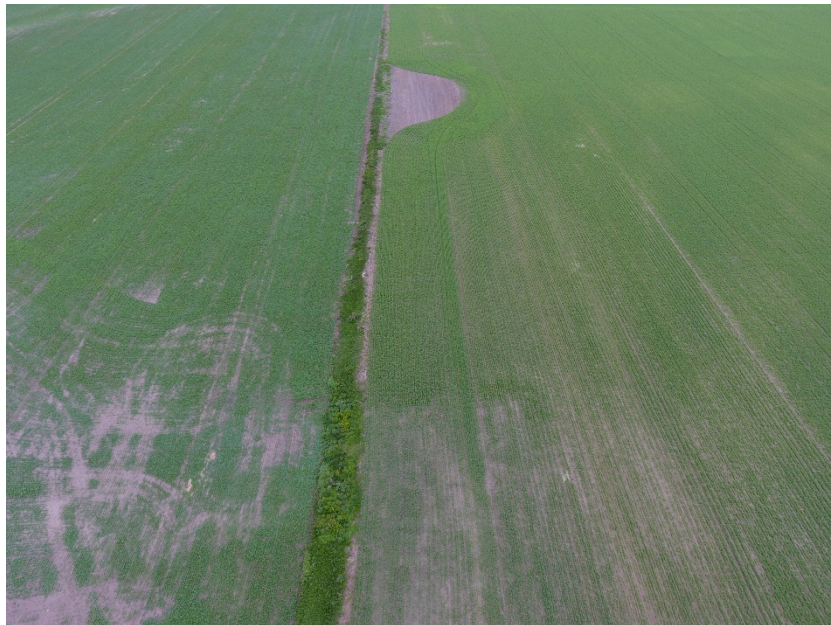
Location 38 (48.298798, -102.336975)  
Minimal disturbance in farm land

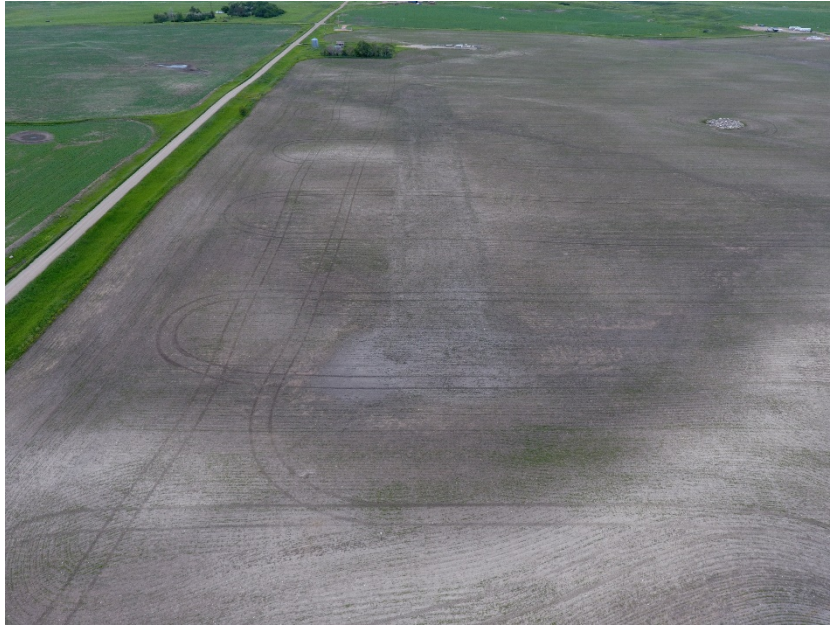
Location 41 (48.299091, -102.344627)  
Minimal disturbance to farmland

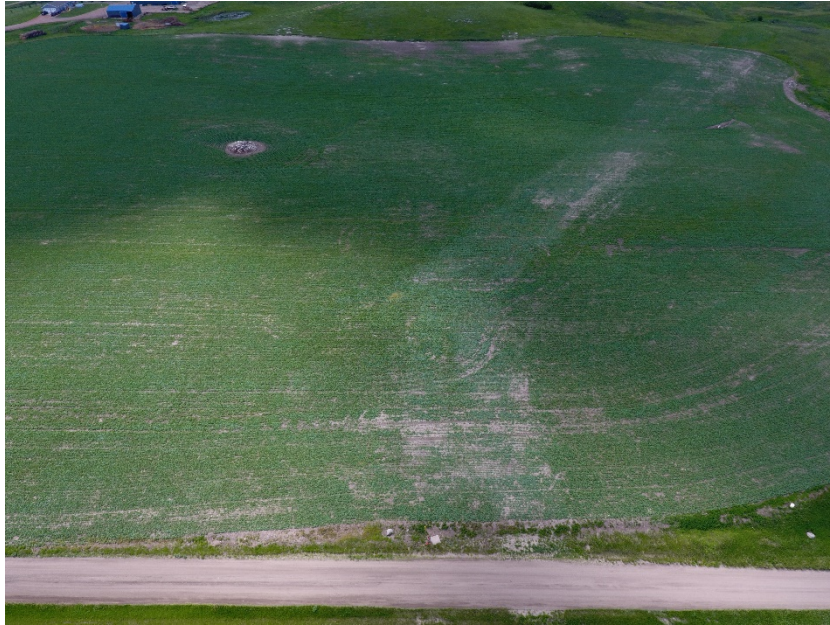
Location 43 (48.300842, -102.353127)

Location 43, page 30: Minimal evidence of reclamation visible in farm land.

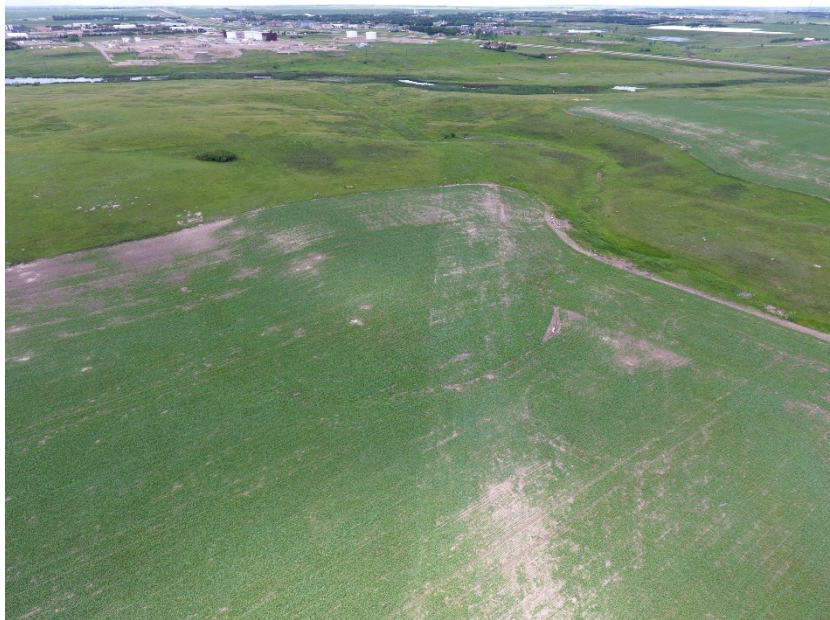
Location 44 (48.301102, -102.354843)  
Established vegetation closely matching adjacent conditions
