# NUSTAR PIPELINE

## Topsoil Removal Inspection Report

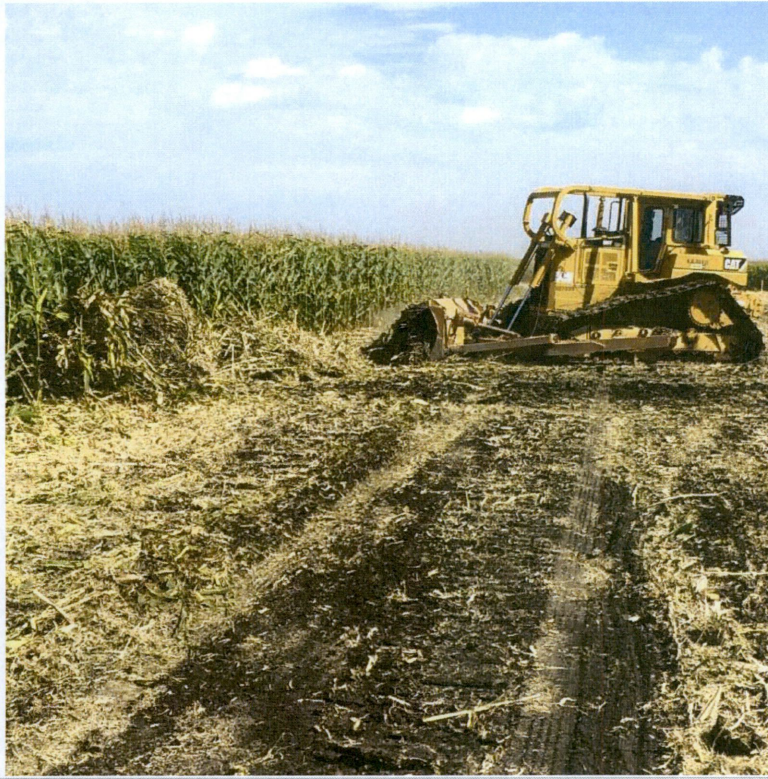
Photo 1: Topsoil scraping to the construction easement edge.

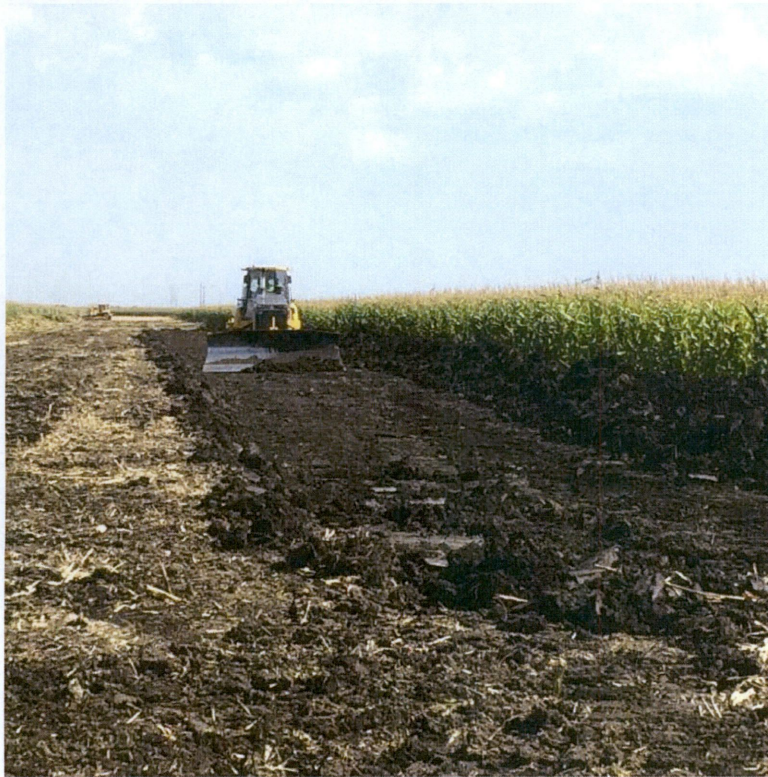
Photo 3: Topsoil scraping and removal depth.

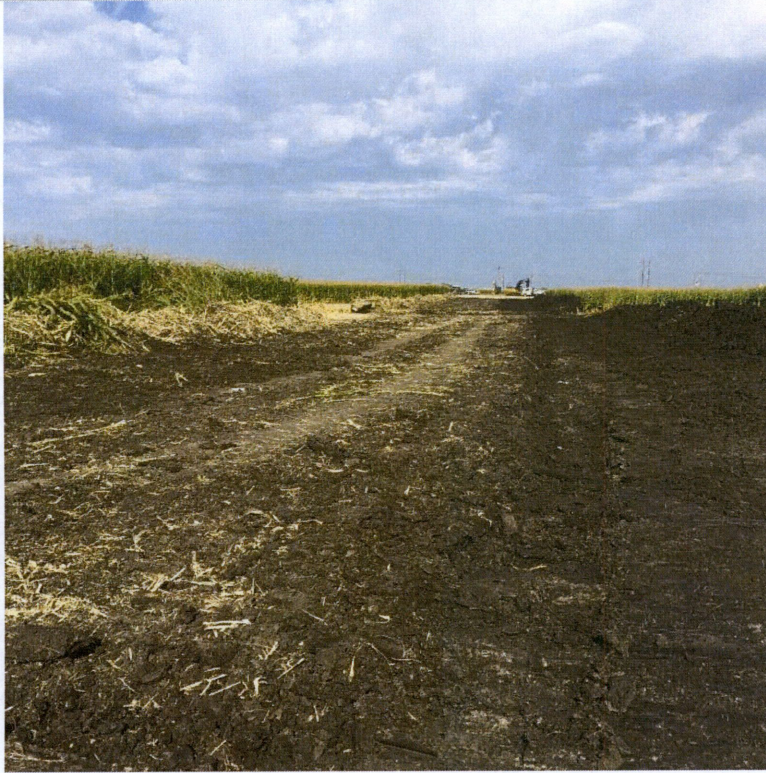
**Photo 4: View of easement;  
topsoil segregation in progress.**

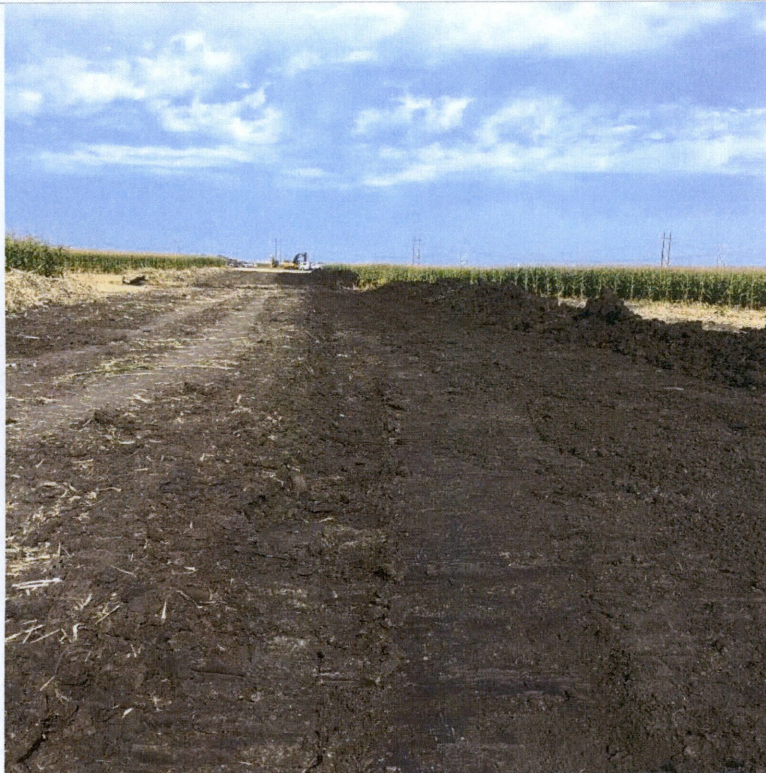
**Photo 5: Topsoil placement at  
construction easement edge.**

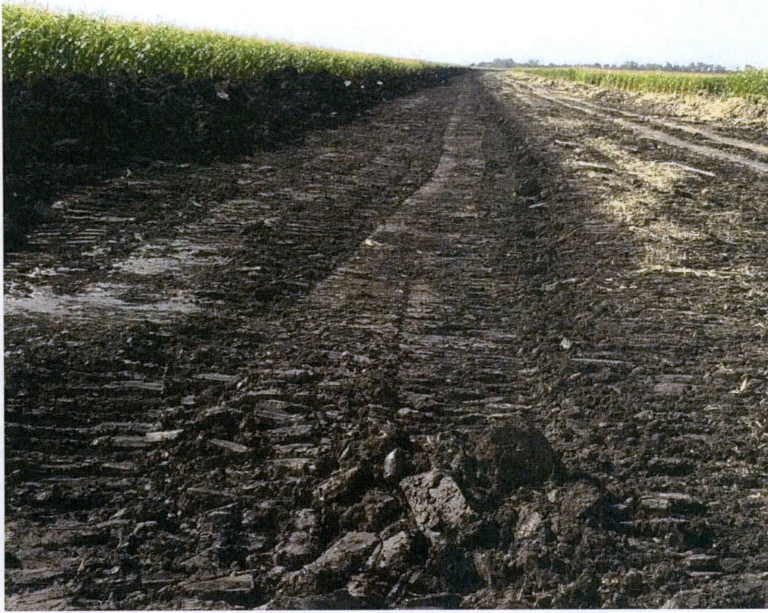
**Photo 6: Topsoil placement at construction easement edge.**
