## **Daily Environmental Inspection Reports of Construction of the Laurel Interconnect Pipeline, Cass County, North Dakota**

**NuStar Pipeline Operating Partnership L.P.**

**SWCA Environmental Consultants**

September 2016

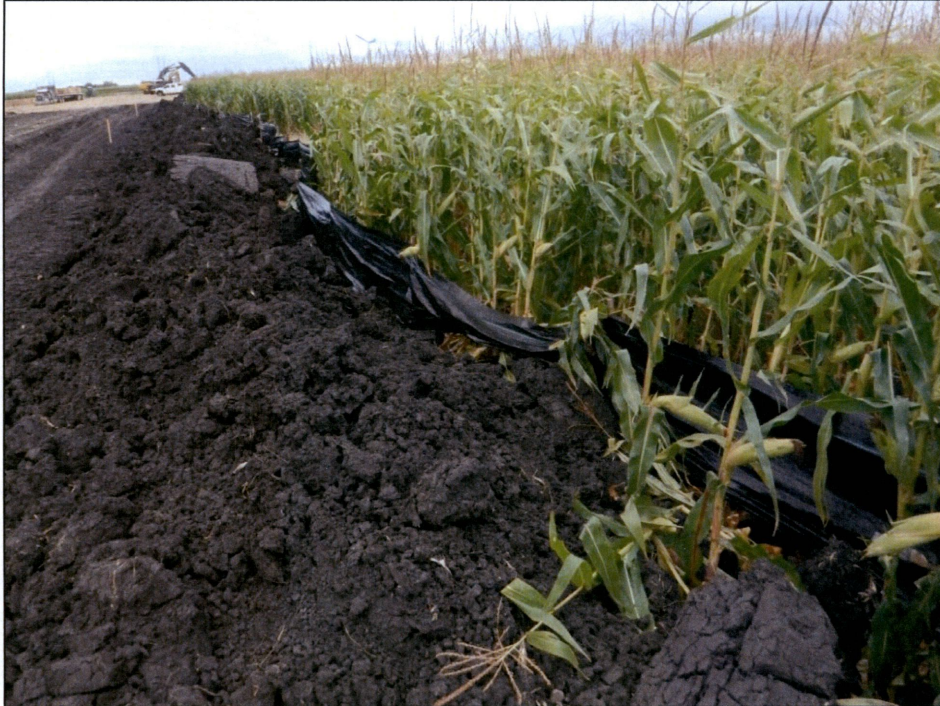
For Outfall 001, silt fence was installed on the north side of the ROW from approximately Station 2+40 to Station 4+40, on the south side of the ROW from Station 4+00, and on the west side of the ROW at Station 12+00 to Station 13+20, as shown in Figure 1, Figure 2, and Figure 3. For Outfall 002, silt fence was installed across the ROW at the northern and southern locations for the horizontal directional drilling (HDD) bore pits (Station 29+00 and Station 31+00, respectively) for the Lower Branch Rush River crossing, as shown in Figure 4 and Figure 5. For Outfall 003, silt fence was installed on the northern and southern sides of the ROW at the HDD bore locations (Station 57+20 and Station 60+40, respectively) for the wetland crossing along County Road 20, as shown in Figure 6 and Figure 7.

**Figure 1.** Outfall 001– Silt fence installed on the north side of the ROW at Station 002+40 to Station 004+40, looking northwest.

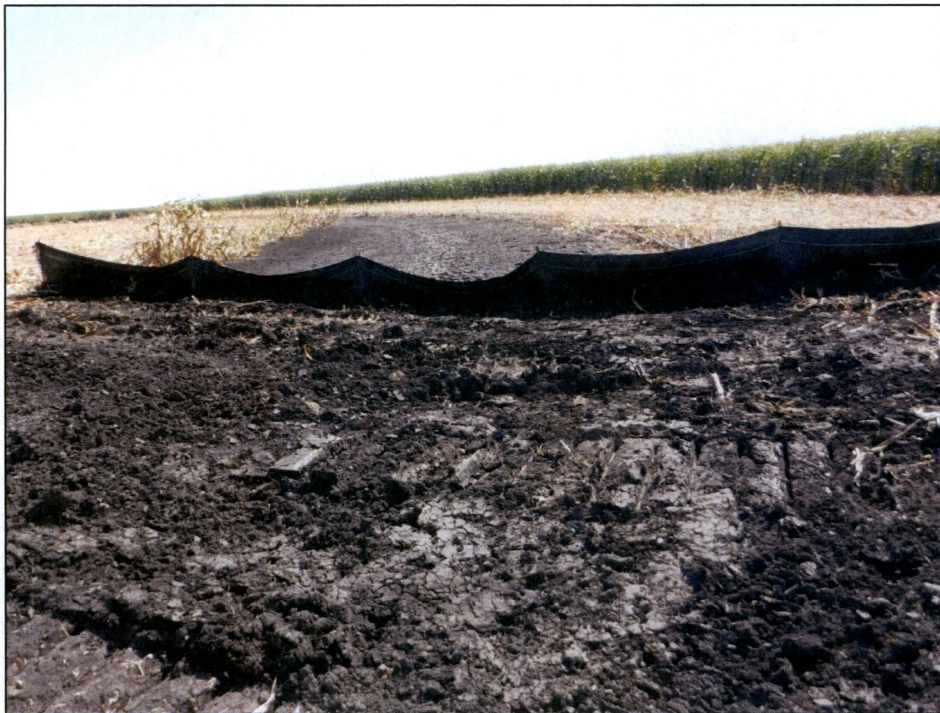
**Figure 2.** Outfall 001, silt fence on south side of Station 004+50, looking south.

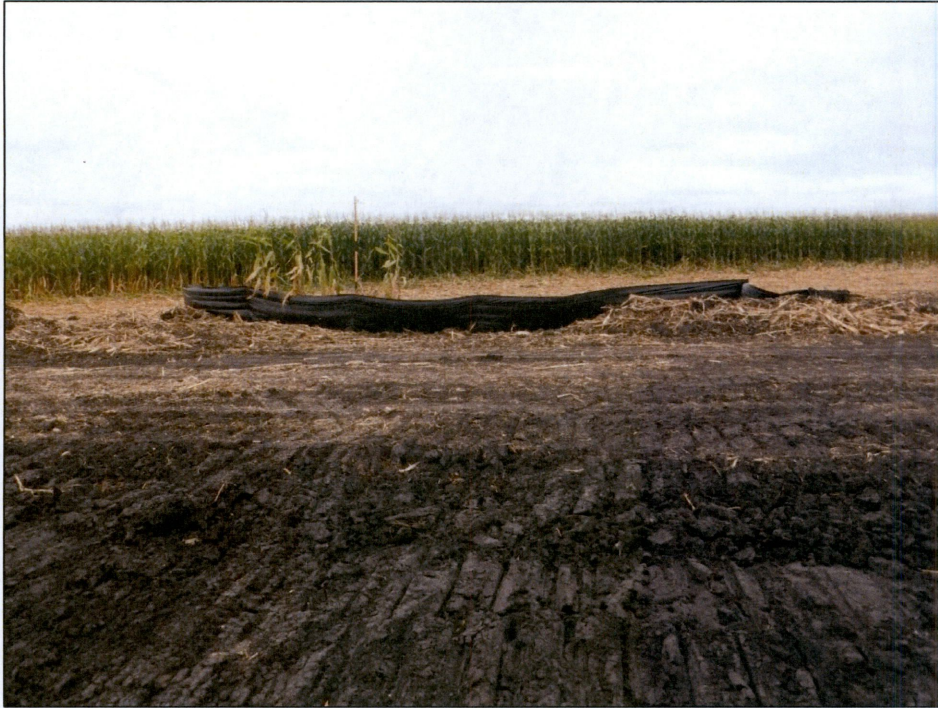
**Figure 3. Outfall 001, silt fence on west side of ROW at Station 012+00.**

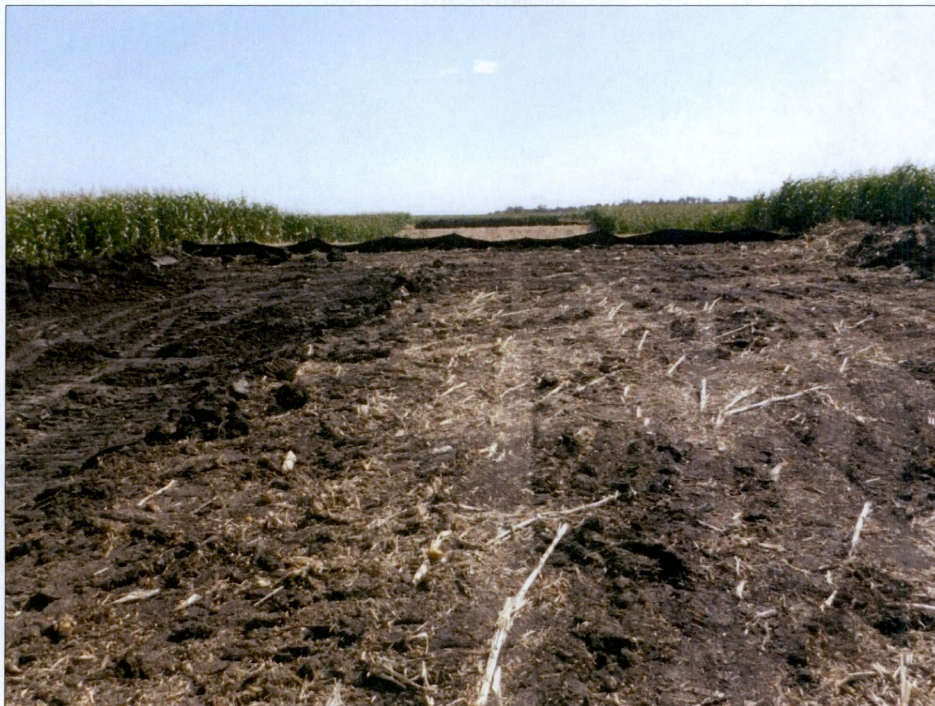
**Figure 4. Outfall 002, silt fence on the north side (foreground) of the Lower Branch Rush River, looking south.**

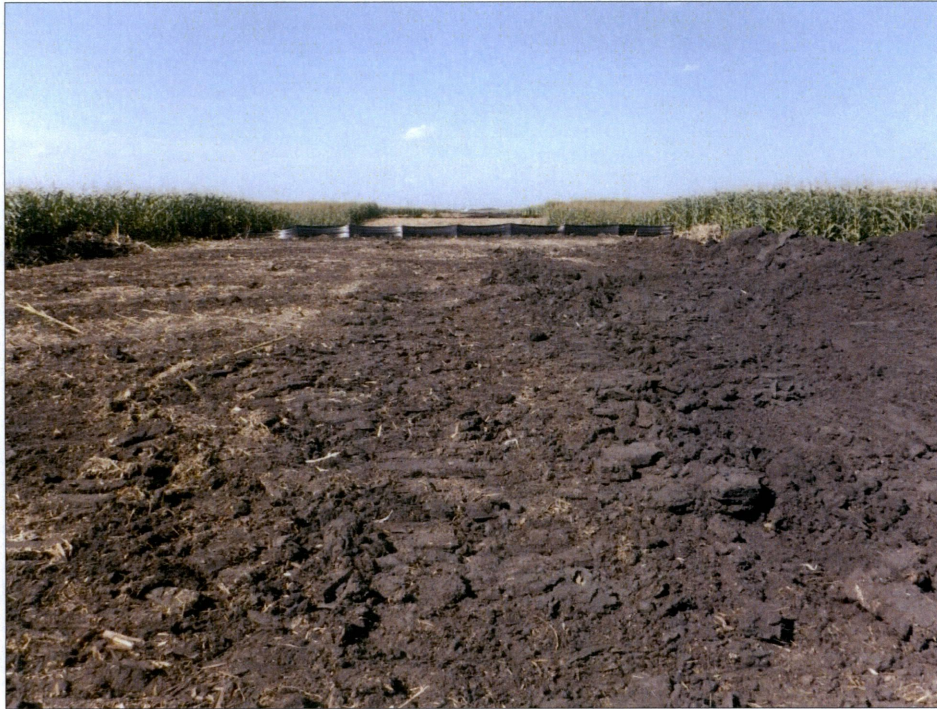
**Figure 5.** Outfall 002, silt fence on the south side (foreground) of the Lower Branch Rush River, looking north.

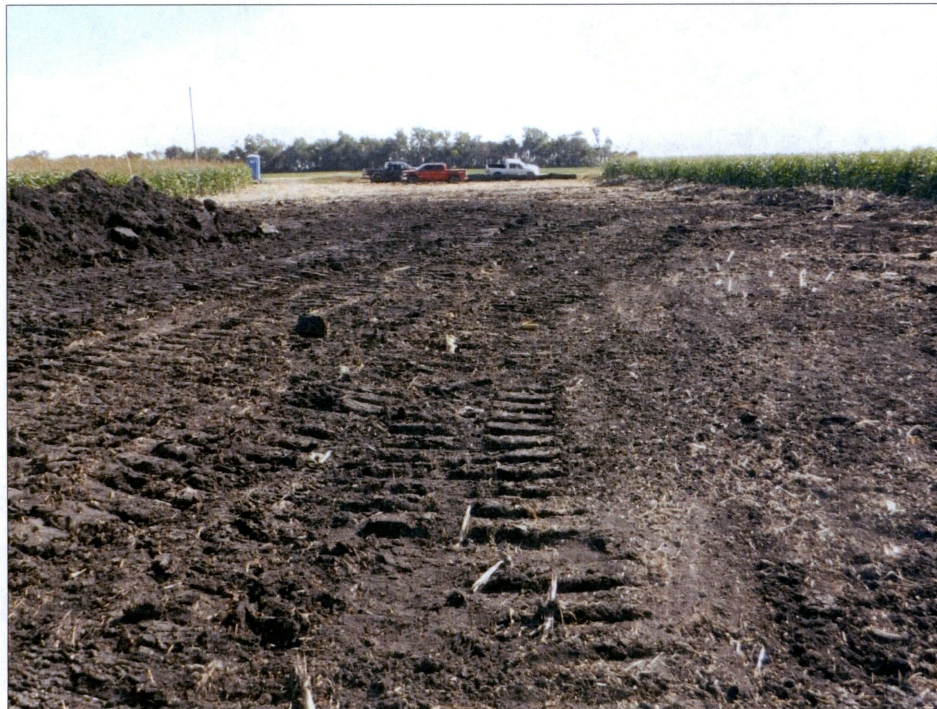
**Figure 6.** Outfall 003, silt fence on the north side of County Road 20, looking south.

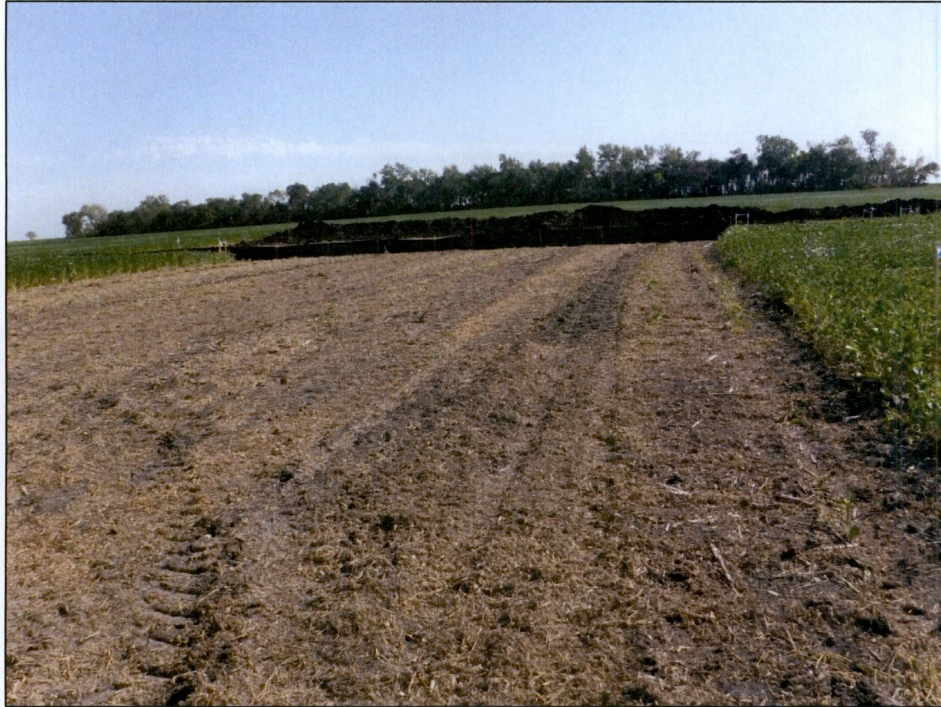
**Figure 7.** Outfall 003, silt fence on the north side of County Road 20, looking south.

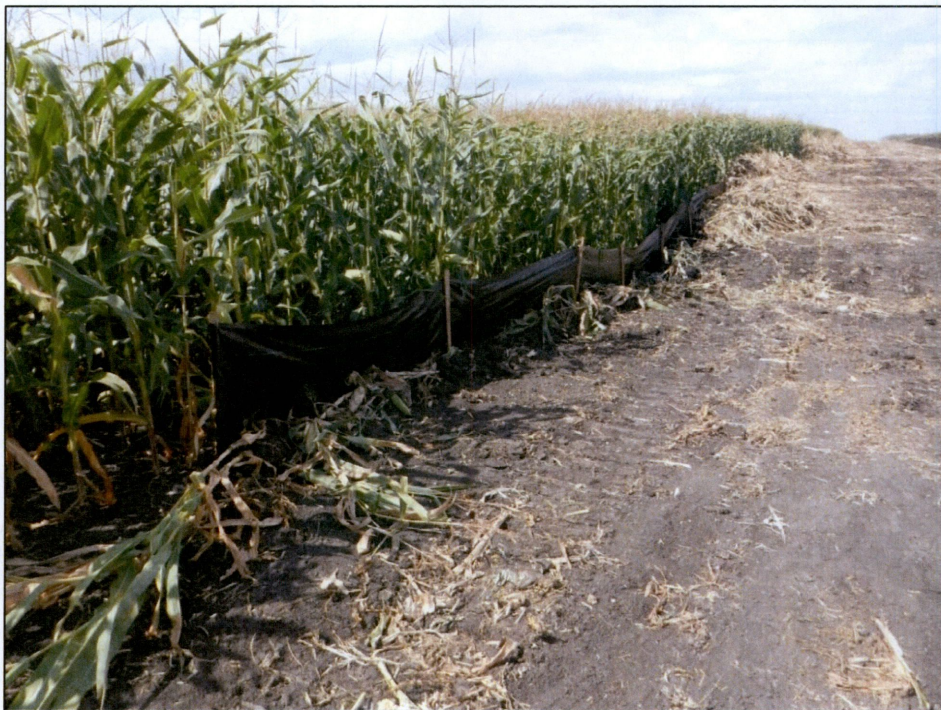
For Outfall 004, silt fence was installed on the east and west sides of the ROW, between Station 84+00 and Station 85+00, as shown in Figure 8 and Figure 9. For Outfall 005, silt fence was installed on the south side of the ROW at Station 98+50, as shown in Figure 10. On the north side of Outfall 005, mowing of the corn had stopped where the HDD bore pit would be located, but had not been installed as of this date. Silt fence was installed between Station 141+10 and Station 143+75, as shown in Figure 11. For Outfall 006, silt fence was installed across the ROW and temporary work space at Station 193+90, Station 195+10, and Station 196+00, as shown in Figure 12 and Figure 13.

**Figure 8.** Outfall 004, silt fence on the west side of the ROW at Station 084+00 and Station 085+00.

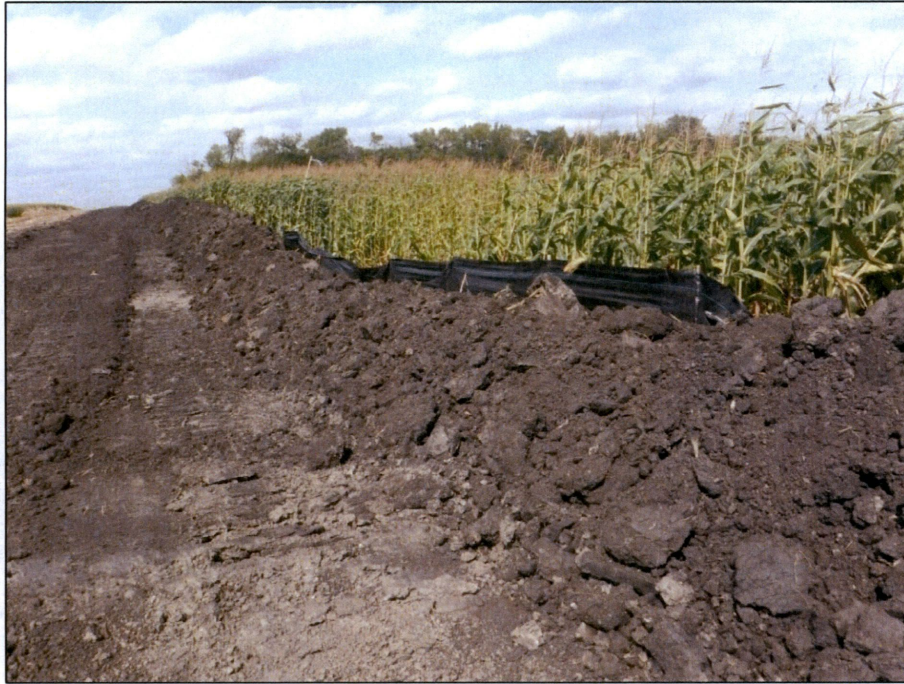
**Figure 9.** Outfall 004, silt fence on the east side of the ROW at Station 084+00 and Station 085+00.

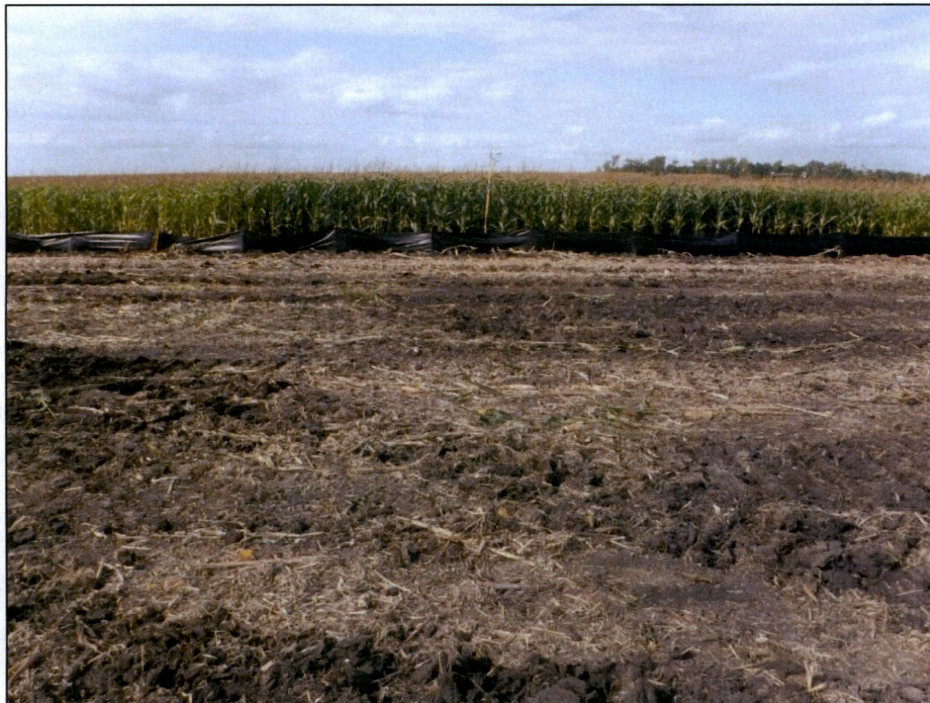
**Figure 10.** Outfall 005, silt fence installed on the south side of the Maple River at Station 098+00, looking north.

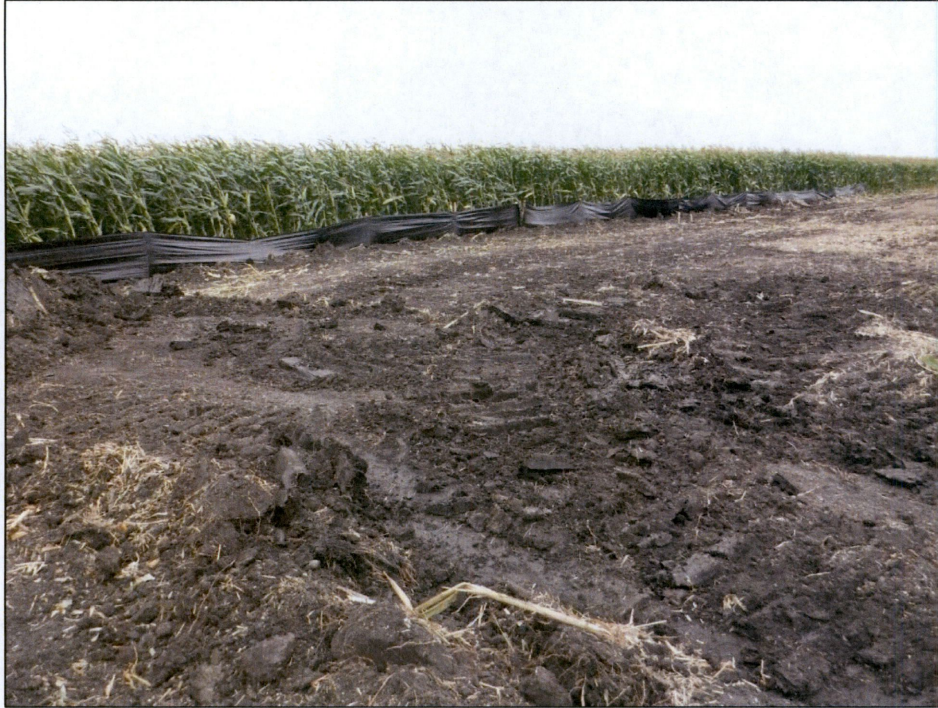
**Figure 11.** Silt fence installed from Station 141+00 to Station 144+00, looking southwest.

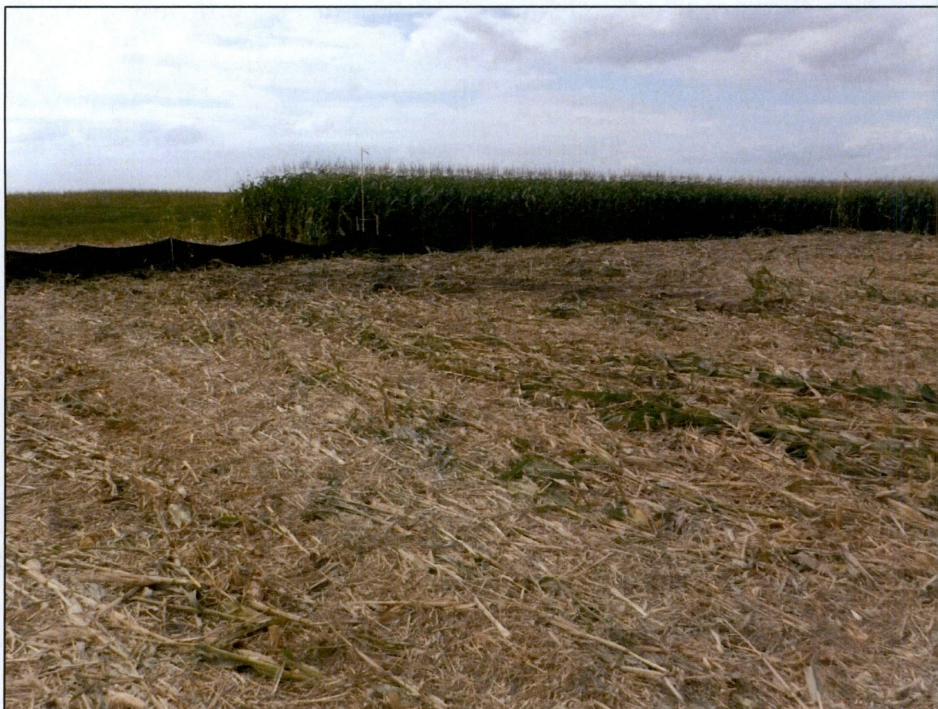
**Figure 12.** Outfall 006, silt fence installed on the east side of 165th Ave. SE, between Station 194+00 and Station 196+00, looking west.

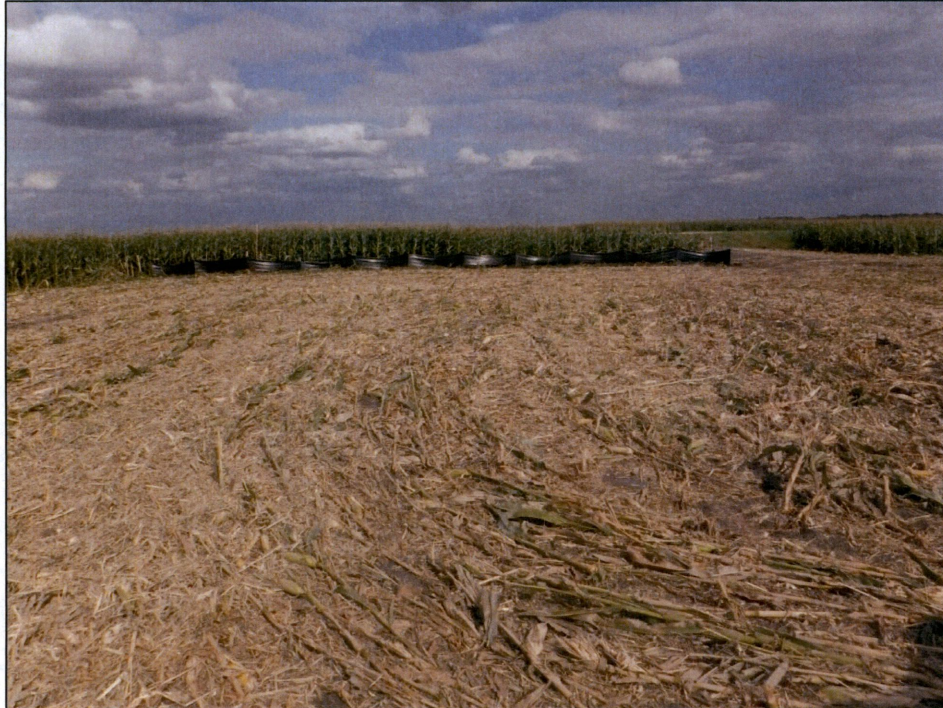
**Figure 13.** Outfall 006, silt fence installed on the west side of 165th Ave. SE. between Station 194+00 and Station 196+00, looking northwest.

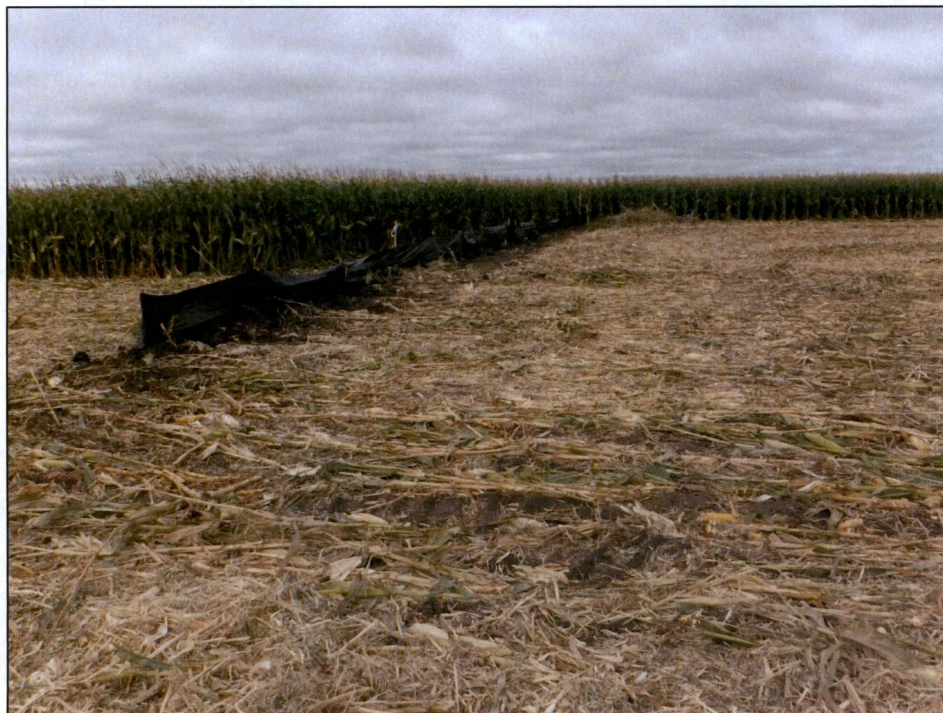
For Outfall 007, silt fence was installed at/near Station 221+00, Station 224+00, Station 225+00, and Station 226+00, as shown in Figure 14, Figure 15, Figure 16, and Figure 17. For Outfall 008, silt fence was installed at Station 233+50 and Station 235+60, as shown in Figure 18 and Figure 19.

**Figure 14.** Outfall 7, silt fence at 221 looking west.

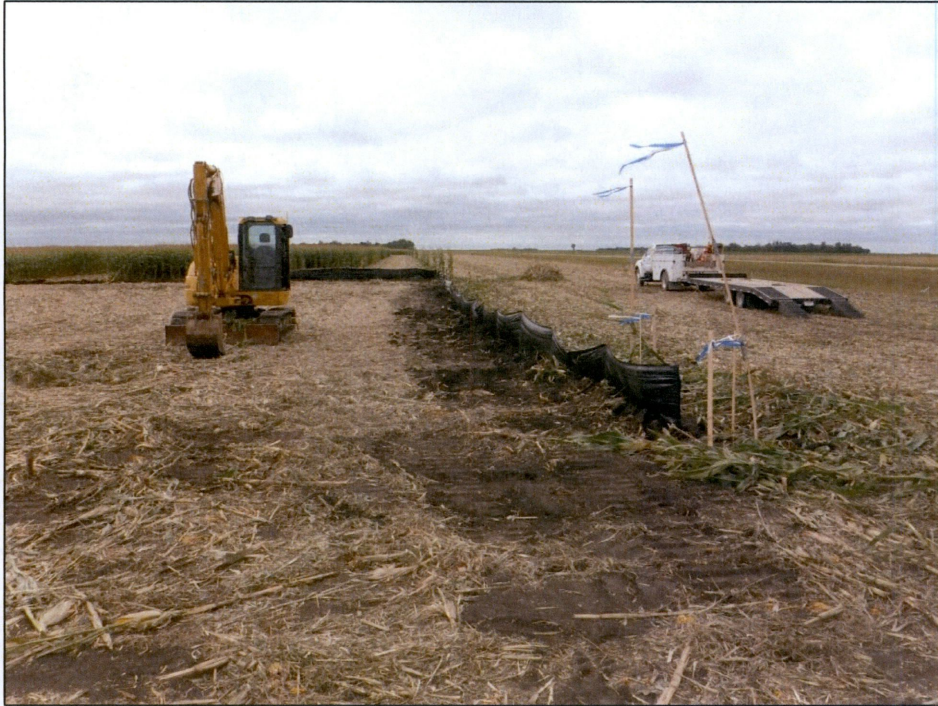
**Figure 15.** Outfall 007, silt fence installed at Station 225+00, looking south.

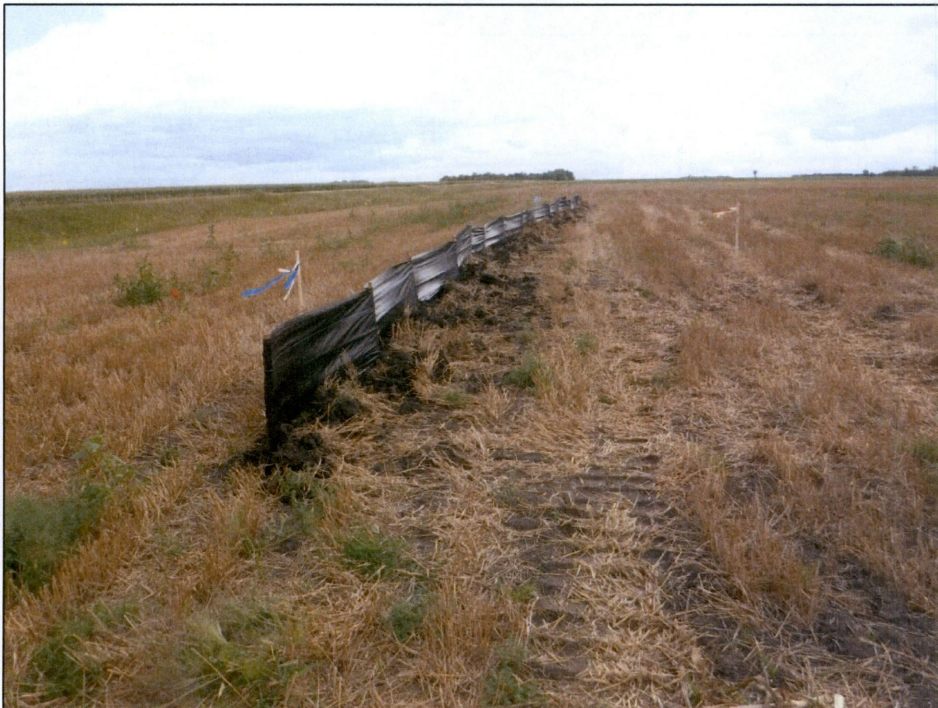
**Figure 16.** Outfall 007, silt fence installed at Station 224+00, looking south.

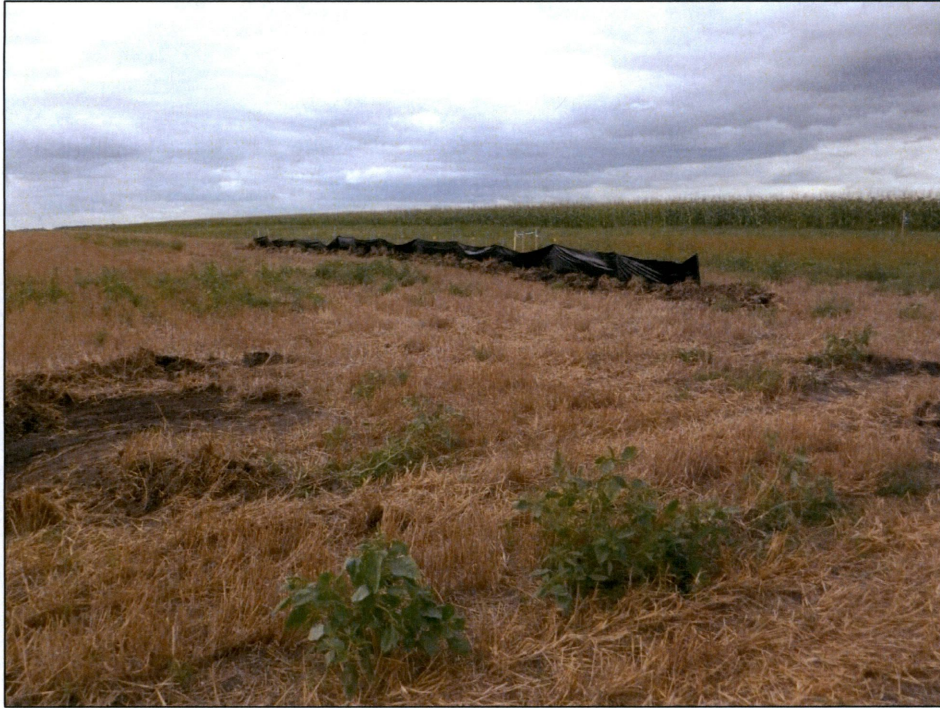
**Figure 17.** Outfall 007, silt fence installed at Station 224+00, looking northwest.

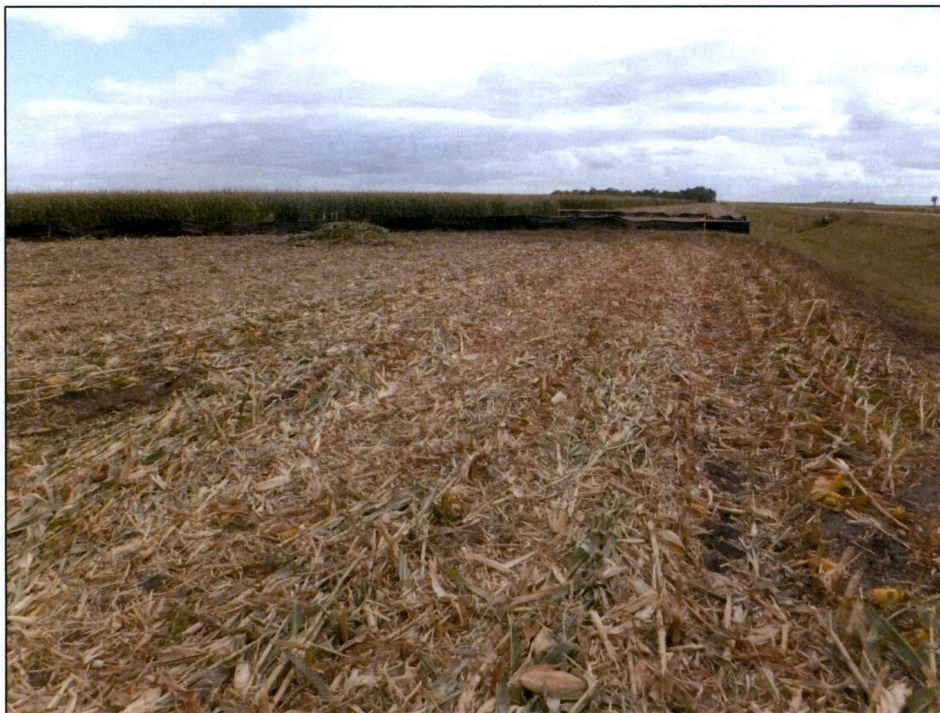
**Figure 18.** Outfall 008, silt fence installed at Station 233+00 (foreground), looking south.

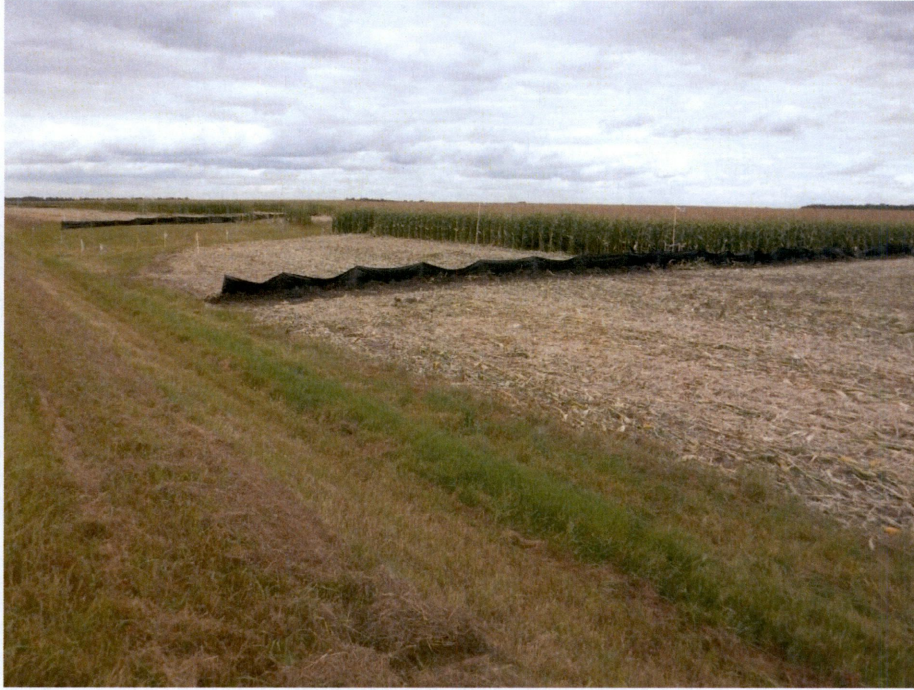
**Figure 19.** Outfall 008, silt fence installed at Station 236+00 (foreground), looking north.

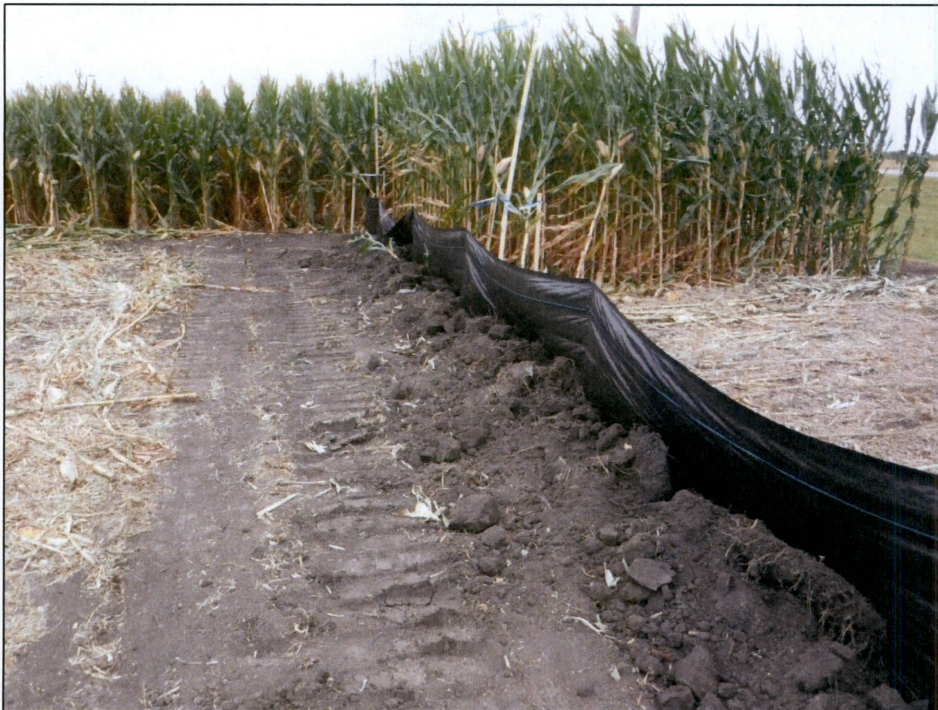
**Figure 20.** Outfall 009, silt fence installed at Station 289+00, looking southeast.

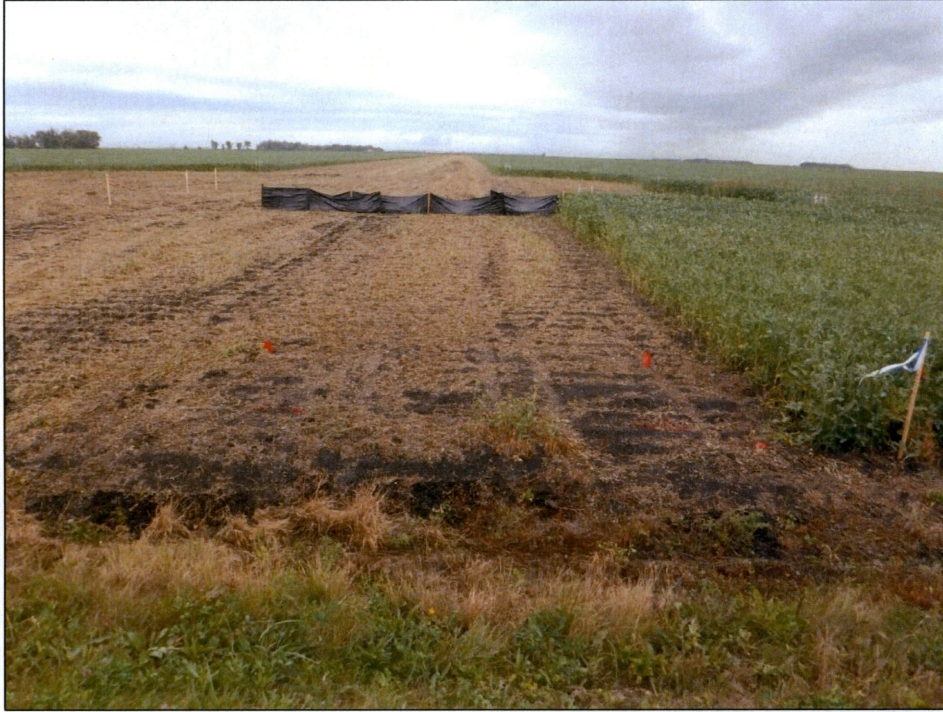
Topsoil was stripped and windrowed on top of the mowed and cleared corn field up to Station 194+00 and the topsoil excavation depths were checked at Station 185+00, Station 253+00, and Station 260+00, as summarized in Table 1. Topsoil stripping was planned to occur from Station 197+00 to Station 263+00, but was not completed before the end of the day. Construction activity was focused around Outfall 007 and Outfall 008, where silt fences had been installed the previous day. Ditch wetlands were avoided. For Outfall 009, silt fence was installed ahead of the scrapers at Station 288+50, as shown in Figure 20, while for Outfall 010, silt fence was installed across the ROW at Station 304+40. For Outfall 011, silt fence was installed at station 343+10, as shown in Figure 21.

**Figure 21.** Silt fence installed at Station 337+00, looking north.
